Progress in the Evaluation of Alkali-Aggregate Reaction in Concrete Construction in the Pacific Northwest, United States and Canada

Chapter K of
Contributions to Industrial-Minerals Research

Bulletin 2209–K

By Fred H. Shrimmer

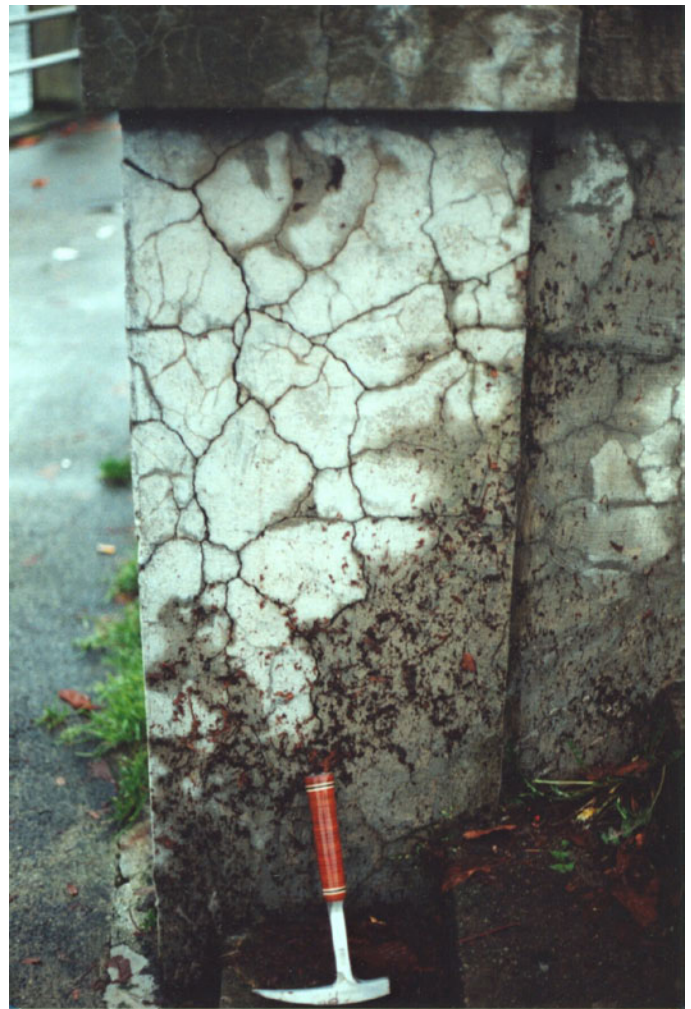
Figure 2. Concrete column in Stanley Park, Vancouver, British Columbia, showing typical “map” cracking throughout entire column, induced by expansion of concrete due to swelling alkali-silica gel. Reactive aggregates include andesite and dacite from Mount Garibaldi near Whistler, British Columbia, as well as quartzite, chert, and granodiorite. Concrete was cast in the 1920s; specific aggregate source (that is, location of pit) is unknown.

Typically, AAR occurs in concrete between a reactive silica (or silicate) mineral and alkali compounds derived from the cement, producing an alkali-silica gel (fig. 1) that absorbs water from the concrete pores and subsequently swells. Swelling of the alkali-silica gel generates tensile stresses in the concrete that, if sufficiently great, may cause cracking. In other words, if enough reactive aggregate, alkalis, and moisture are present in concrete, expansion and cracking of the concrete may occur, affecting its serviceability or structural capacity. Features associated with AAR include cracking of concrete (figs. 2, 3) and leaching or “efflorescence” of carbonate and alkali-silica gel out of concrete through cracks (fig. 4).

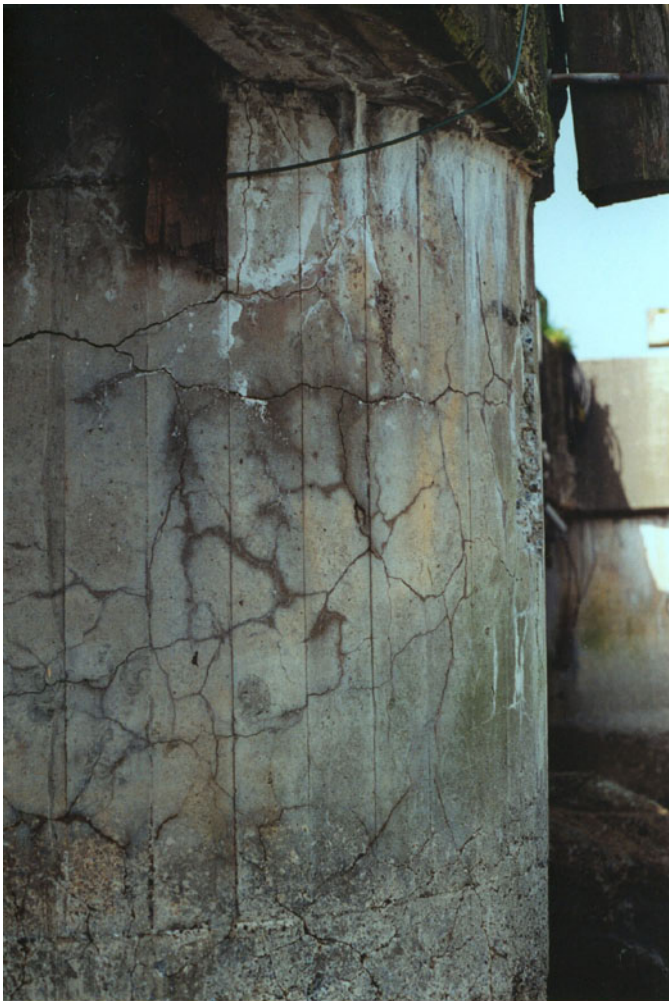
Figure 3. Pier in Seattle harbor, showing well-defined “map” cracking induced by alkali-aggregate reaction. Reactive aggregates include andesite from the Mount Rainier-Mount St. Helen’s area, Wash., as well as sandstone, chert, and quartzite of unknown provenance. Field of view, 1 by 1.3 m.

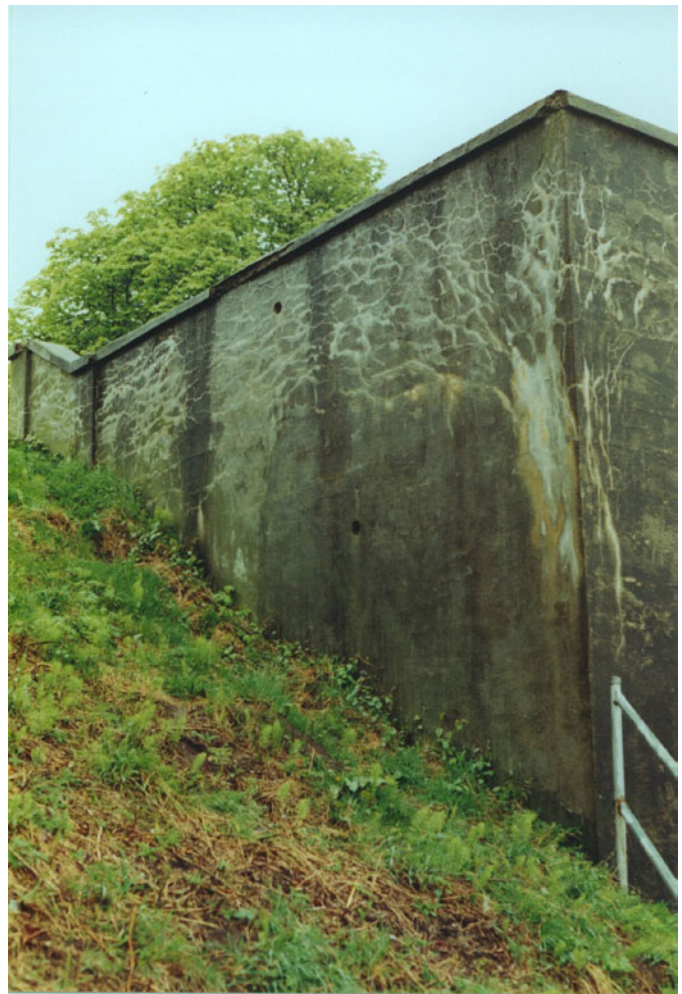
Figure 4. Wall in Stanley Park, Vancouver, British Columbia, showing white deposits of leachate emanating from cracks in concrete. These “efflorescence” deposits are composed of a mixture of alkali-silica gel and calcium carbonate.

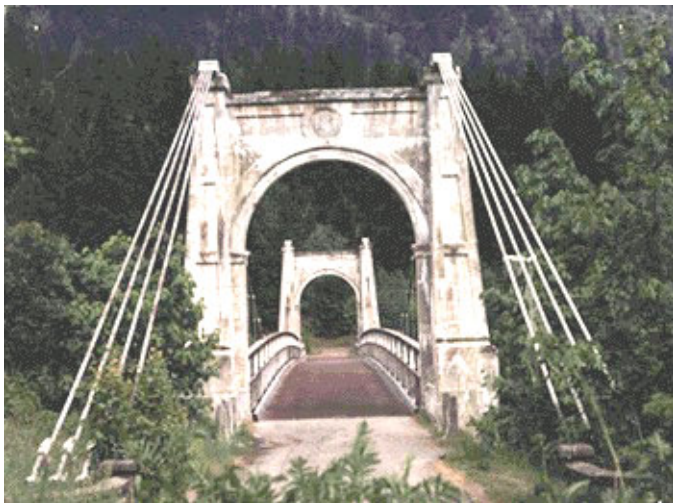
Figure 5. Old Alexandra Bridge in Fraser Canyon, near Boston Bar, British Columbia, showing piers and abutments damaged by both alkali-aggregate reaction and freeze-thaw cycles.

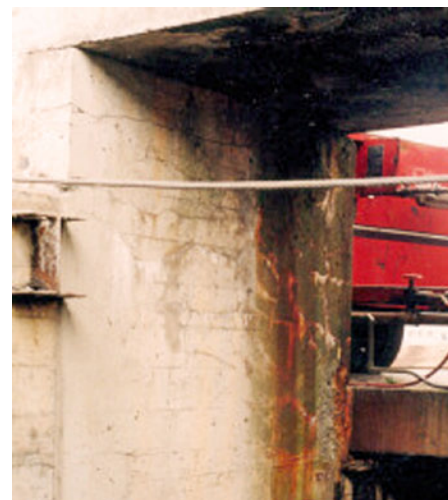
Figure 6. Part of a dock structure in Vancouver, British Columbia, showing “map” cracking. Reactive aggregates include Mount Garibaldi volcanic rocks, opal (in volcanic vugs), granitic rocks, and quartzite. Aggregate was derived from the now-closed Britannia Pit, located near Squamish, British Columbia.

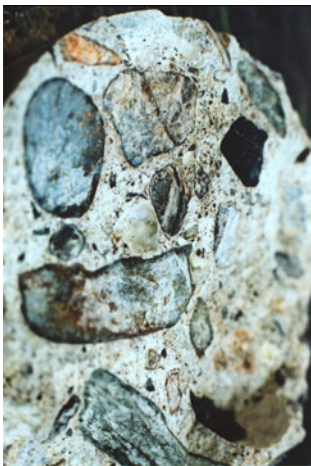
Figure 8. Fracture surface on a sample of core drilled from alkali-aggregate-reaction-damaged concrete, showing dried white gel patches on several aggregate particles. Darker “reaction rims” also are clearly visible on many aggregate particles. Field of view, approximately 60 by 100 mm.

Evidence of AAR is determined through various means, such as macroscopic examination of the concrete structure, and microscopic examination and chemical analyses of concrete samples obtained from the structure. Visual evidence includes reaction rims (figs. 7, 8), cracks induced by the pressures exerted by swelling alkali-silica gel (fig. 9), and the presence of alkali-silica gel (figs. 1, 8).

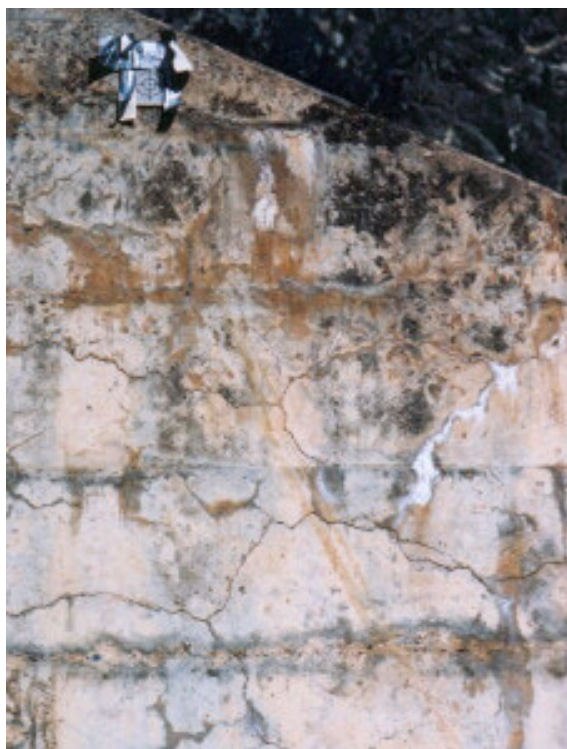
Figure 10. Section of a wall in a dam in southern British Columbia, showing well-developed “map” cracking and efflorescence, both indicators of alkali-silica reaction. Concrete was about 47 years old at time of photograph.

In a recent study of a dam in southern British Columbia, Shrimer (2003) reported that its safe operation was being compromised by the expansion of concrete elements, resulting in poor operation of the radial gates. The typical condition of some AAR-affected concrete elements—efflo-

rescence, discoloration, and “map” cracking (fig. 10)—illustrates the potentially serious effects of AAR. At the time of the study, the dam was 47 years old.

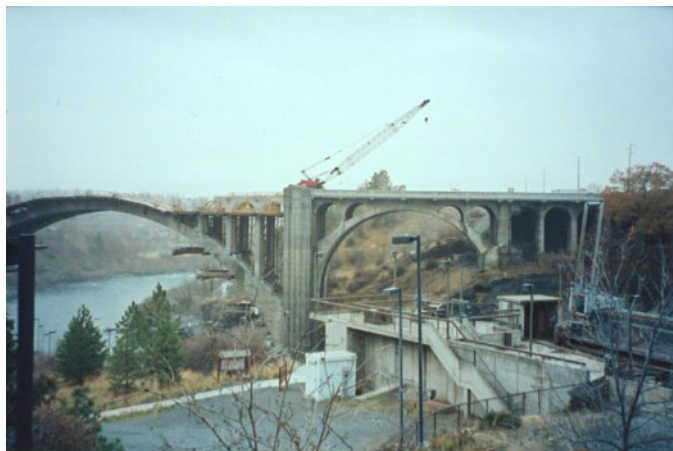
Figure 12. Monroe Street Bridge in Spokane, Wash., undergoing rehabilitation work in fall 2003.

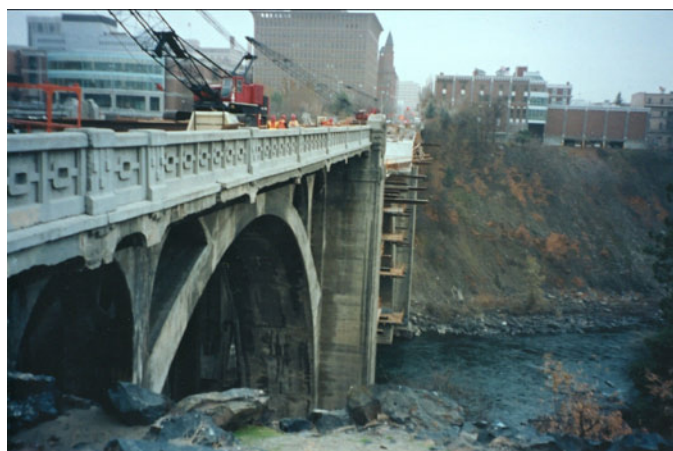
Figure 13. Closeup of Monroe Street Bridge, Spokane, Washington, showing section of main arch. Concrete removed from demolished sections was determined to have been affected by alkali-silica reaction.

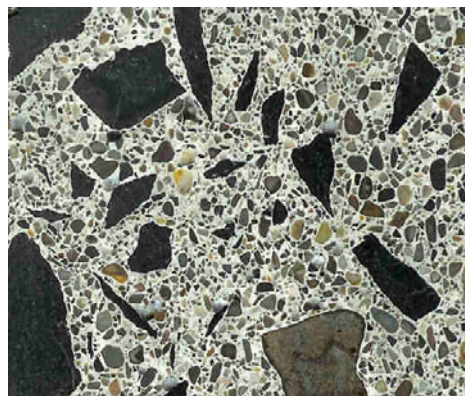
Figure 14. Polished sample of concrete from the Monroe Street Bridge in Spokane, Wash., showing reaction rims on andesitic aggregate particle and on smaller aggregate particles, indicating reaction with alkalis in concrete.
