IMPACT OF HURRICANE ANDREW ON THE TIMBALIER ISLANDS TERREBONNE PARISH, LOUISIANA

Shea Penland¹, Chris Zganjar², Karen A. Westphal², Paul Connor¹
Jeff List³ and S. Jeffress Williams³

INTRODUCTION

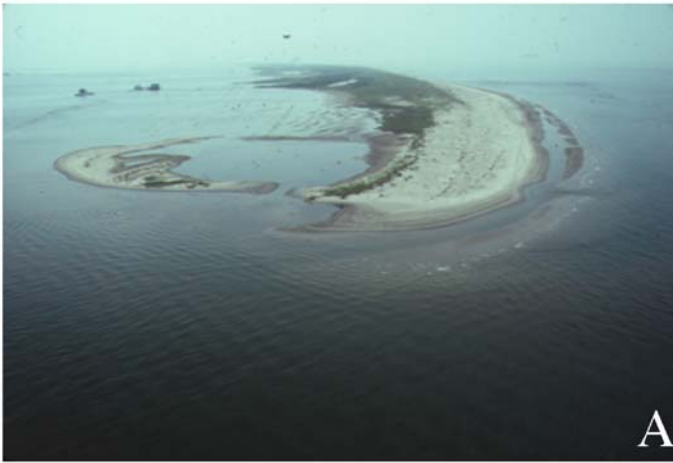
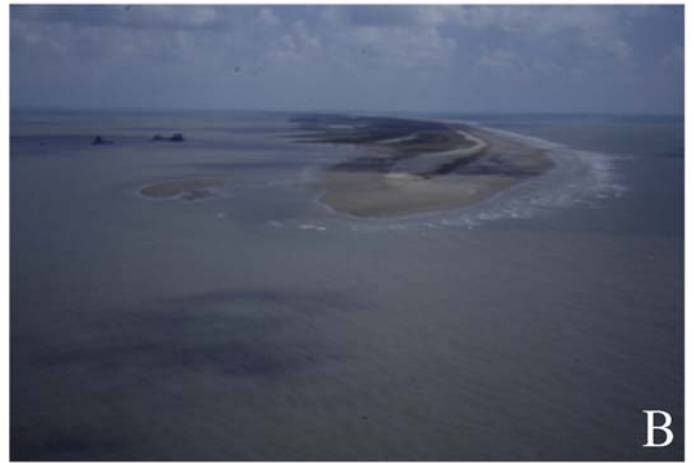
Figure 3. Photographs taken 7 weeks apart of the west end of Timbalier Island illustrating the sand dune destruction and shoreline erosion cause by Hurricane Andrew: A) Before - taken July 9, 1992, and B) After - taken August 30, 1992.

The storm surge of Hurricane Andrew inundated the Timbalier Islands with severe overwash conditions that produced dramatic shoreline erosion, barrier island breaching, and sand dune destruction. The areas of greatest erosion produced by Hurricane Andrew occurred along the margins of Little Pass Timbalier and Raccoon Pass between 1990 and 1992. The high wave energy and storm conditions widened these tidal inlets and completely eroded many sections of shoreline (Figures 3-6).

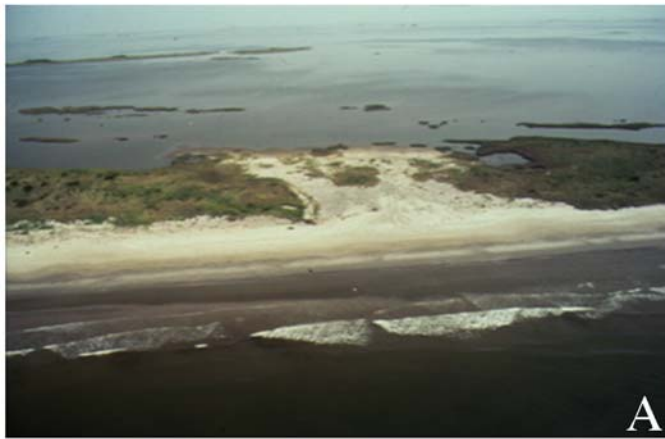
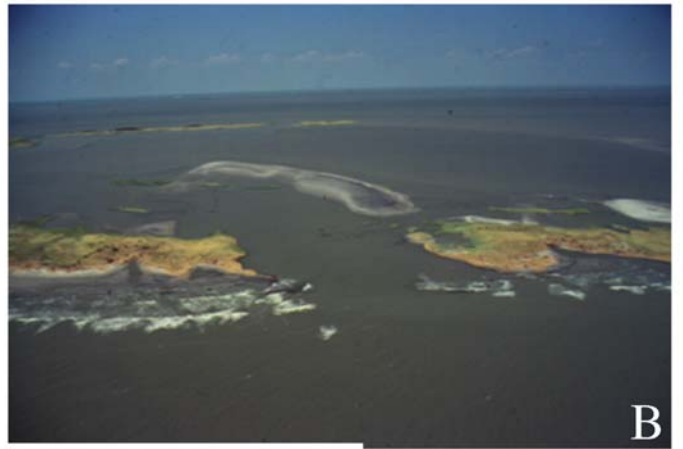
Figure 4. Photographs taken 7 weeks apart of a breach created through Timbalier Island as a result of Hurricane Andrew: A) Before - taken July 9, 1992, and B) After - taken August 30, 1992.

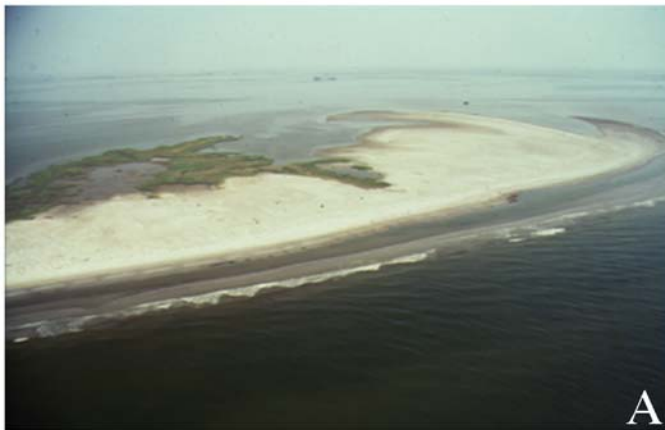
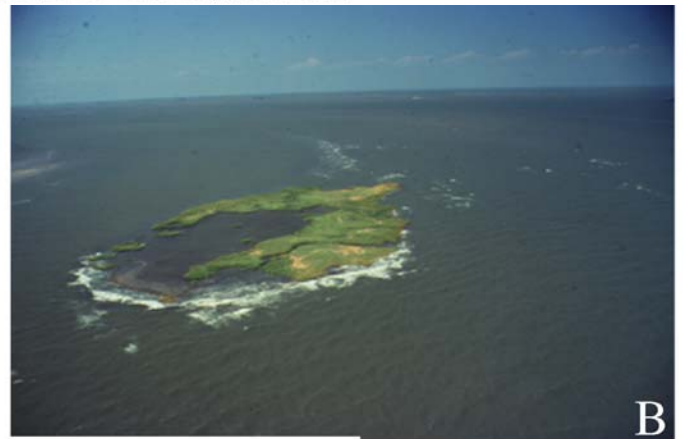
Figure 5. Photographs taken 7 weeks apart of the east end of Timbalier Island illustrating the severe erosion that occurred along the margin of Little Pass Timbalier during Hurricane Andrew: A) Before - taken July 9, 1992, and B) After - taken August 30, 1992.

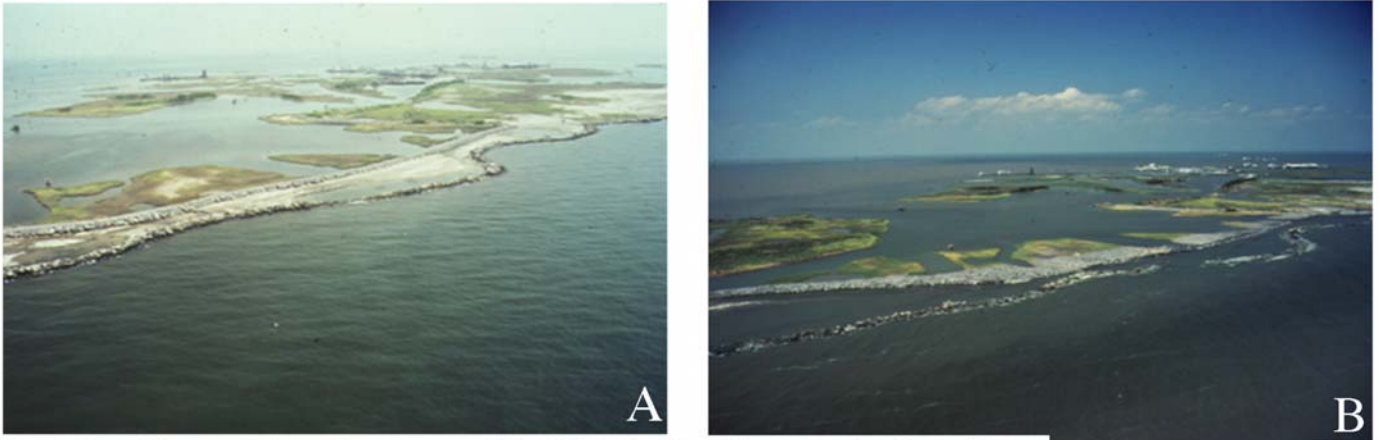
Figure 6. Photographs taken 7 weeks apart of East Timbalier Island illustrating the effects of Hurricane Andrew along this armored, low-sediment shoreline. Loose sand was removed and the rocks of the seawall were rearranged: A) Before - taken July 9, 1992, and B) After - taken August 30, 1992.
