# **Physical and Vegetative Characteristics of a Relocated Stream Reach, Constructed Wetland, and Riparian Buffer, Upper Saucon Township, Lehigh County, Pennsylvania, 2000–04**

Scientific Investigations Report 2006-5042

**U.S. Department of the Interior  
U.S. Geological Survey**

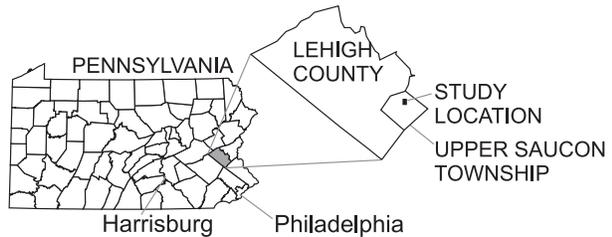
**Figure 1.** Topographic setting and physical features in the vicinity of the relocated stream reach, constructed wetland, and riparian buffer in Upper Saucon Township, Lehigh County, Pennsylvania.

The constructed wetland is bounded on the north by an agricultural field that was planted annually with corn by no-till methods during the study period. Water is provided to the wetland by an intermittent tributary that originates on the forested south-facing slope of South Mountain (fig. 1) and flows through a sparsely wooded riparian buffer that bisects the agri-

The relocated stream reach and associated riparian buffer extend from a box culvert on the downstream side of Center Valley Parkway for approximately 570 ft downstream (fig. 2). Tailings piles from an abandoned mine extend parallel to Center Valley Parkway on the upstream side of the box culvert (fig. 1). Grey sediment from these piles is readily mobilized and deposited within the riparian buffer and relocated stream reach. The riparian buffer ranges from about 75 ft wide at the northern end to 100 ft wide at the southern end.

The bed-particle distribution of a stream is indicative of the sediment load being supplied to the stream system as well as the capacity of the stream to transport it. Tailings piles from an abandoned mine (fig. 1) extend parallel to Center Valley Parkway on the upstream side of the box culvert. Grey, extremely fine sediment from these piles is readily mobilized and introduced into the constructed channel. The resulting excessive fine sediment within the channel is an indication of this abundant source of fine material and an indication the stream has insufficient energy, over the range of flow conditions, to move the entire load of fine material being supplied to the system.

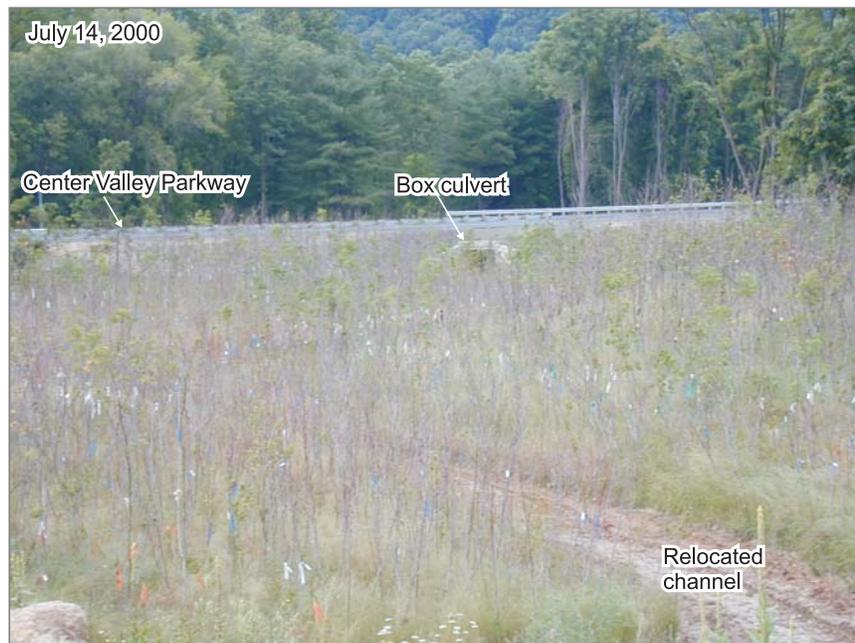
**Figure 18.** View of trees and shrubs planted in the riparian buffer, Upper Saucon Township, Lehigh County, Pennsylvania. Photographed from the southern end of the riparian buffer facing north (upstream). Photographed by Jeffrey J. Chaplin, U.S. Geological Survey, on July 14, 2000.

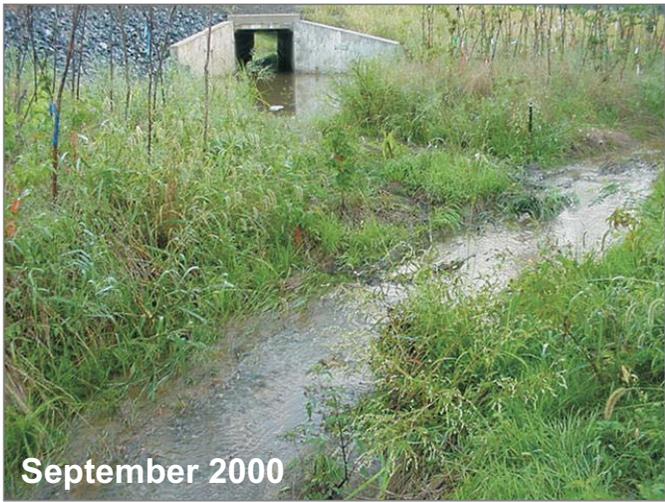
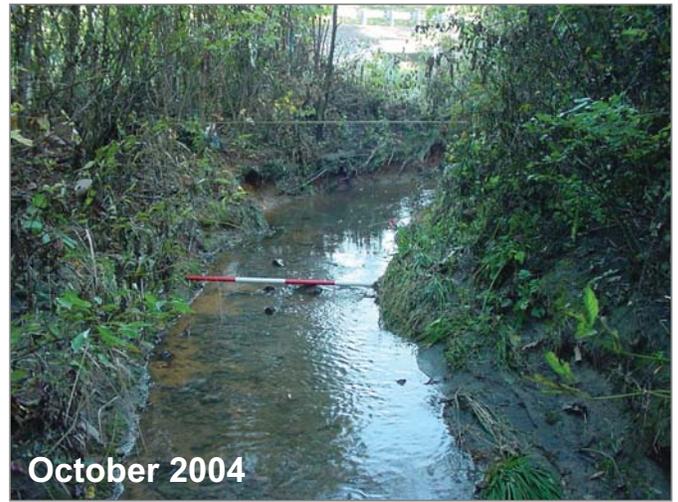
**Figure 1-2.** Looking upstream at relocated stream reach at cross section surveyed 97 feet downstream of a box culvert under Center Valley Parkway, Upper Saucon Township, Lehigh County, Pennsylvania. Photographed by Kirk E. White, U.S. Geological Survey.

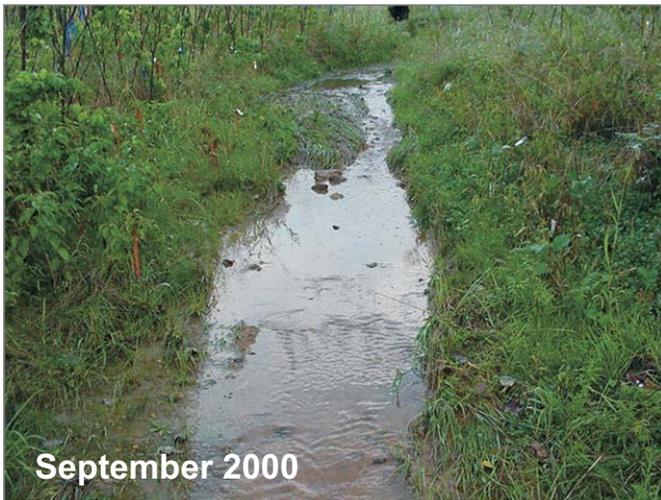
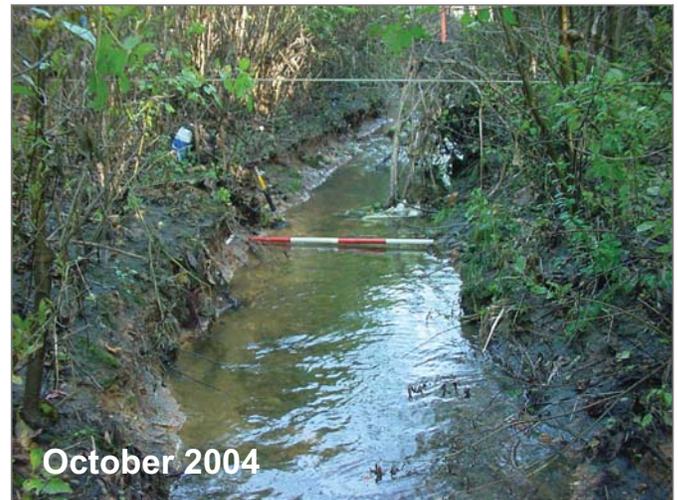
**Figure 1-3.** Looking upstream at relocated stream reach at cross section surveyed 134 feet downstream of a box culvert under Center Valley Parkway, Upper Saucon Township, Lehigh County, Pennsylvania. Photographed by Kirk E. White, U.S. Geological Survey.

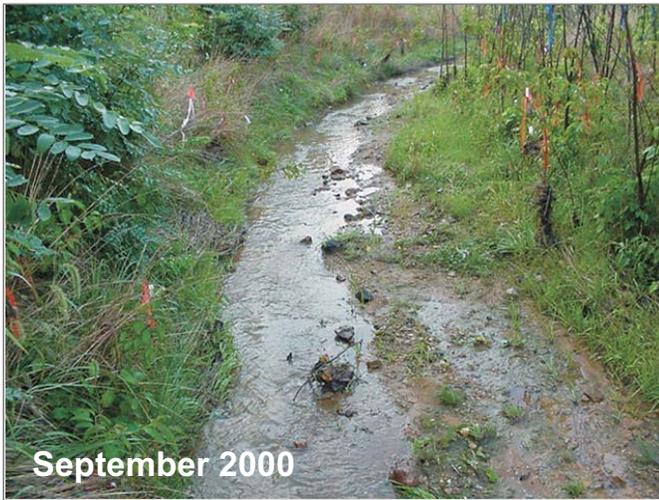
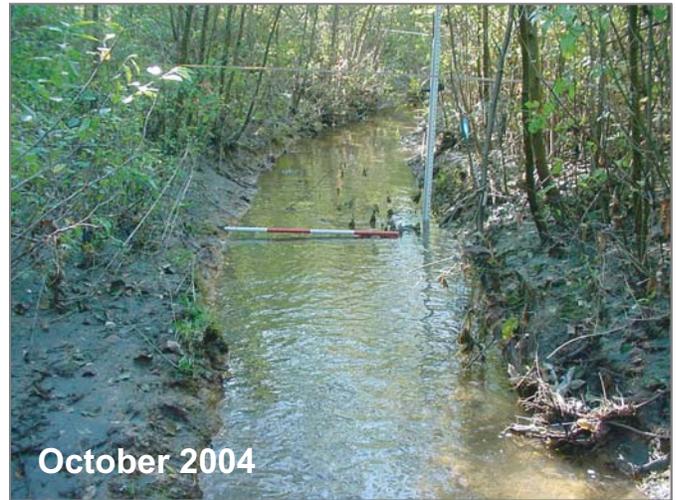
**Figure 1-4.** Looking downstream at relocated stream reach at cross section surveyed 174 feet downstream of a box culvert under Center Valley Parkway, Upper Saucon Township, Lehigh County, Pennsylvania. Photographed by Kirk E. White, U.S. Geological Survey.

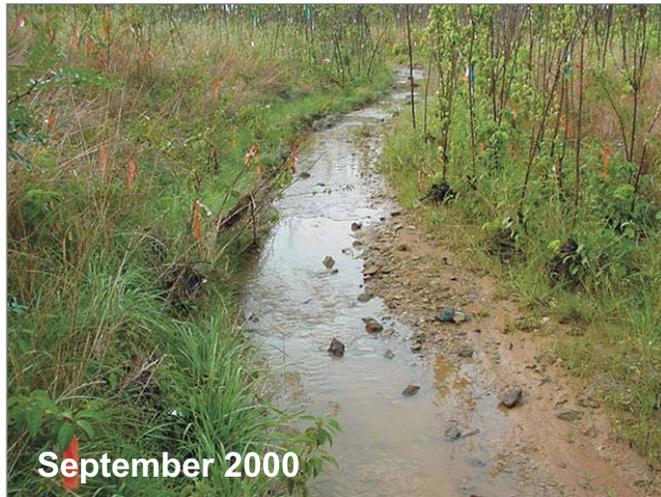
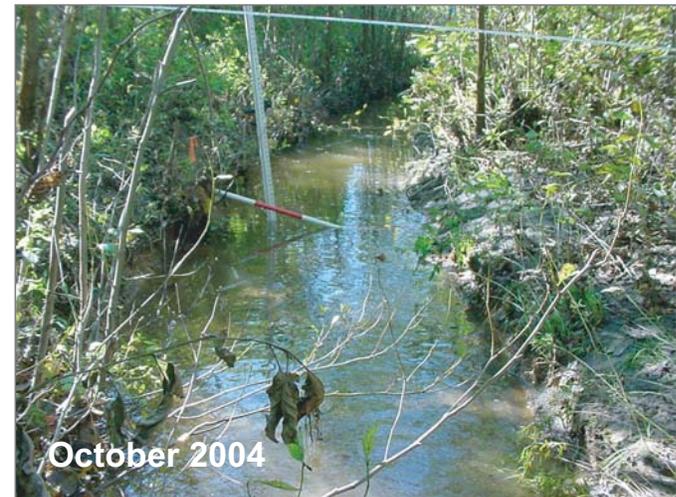
**Figure 1-5.** Looking downstream at relocated stream reach at cross section surveyed 214 feet downstream of a box culvert under Center Valley Parkway, Upper Saucon Township, Lehigh County, Pennsylvania. Photographed by Kirk E. White, U.S. Geological Survey.

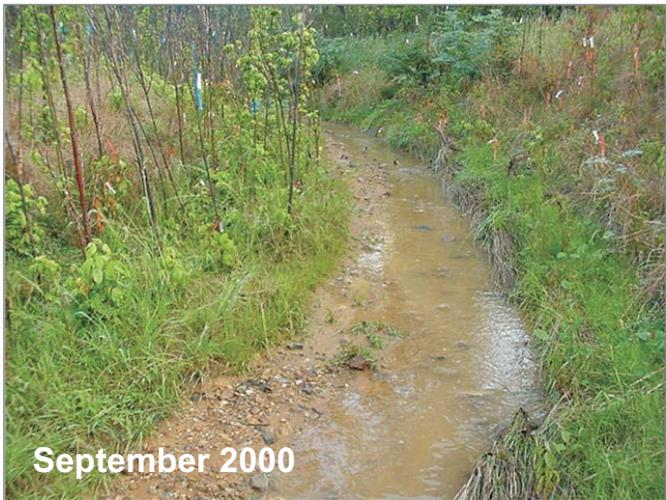
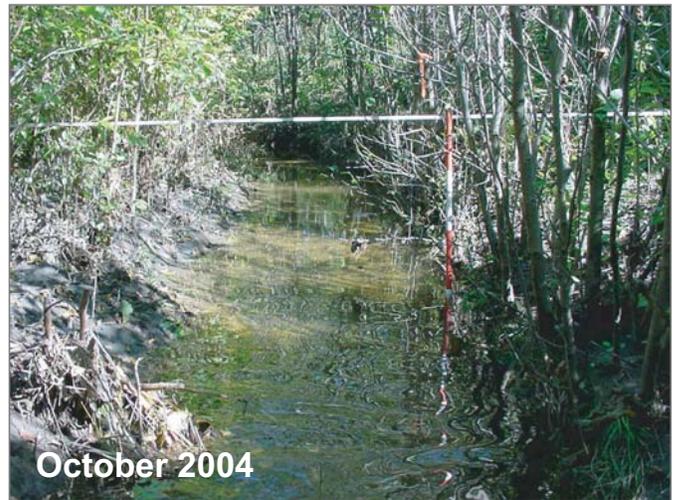
**Figure 1-6.** Looking upstream at relocated stream reach at cross section surveyed 261 feet downstream of a box culvert under Center Valley Parkway, Upper Saucon Township, Lehigh County, Pennsylvania. Photographed by Kirk E. White, U.S. Geological Survey.

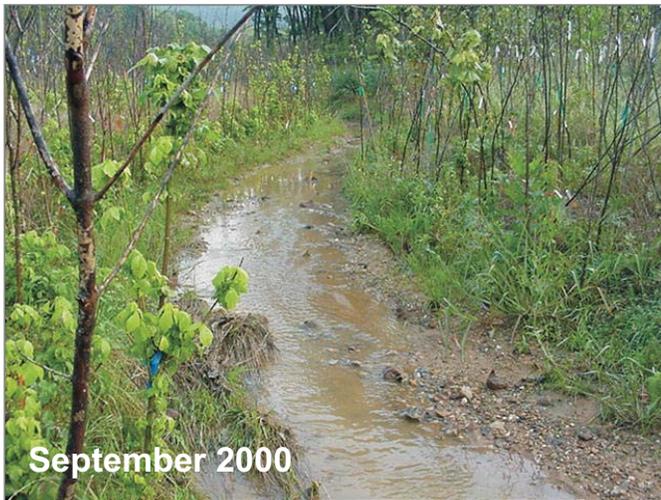
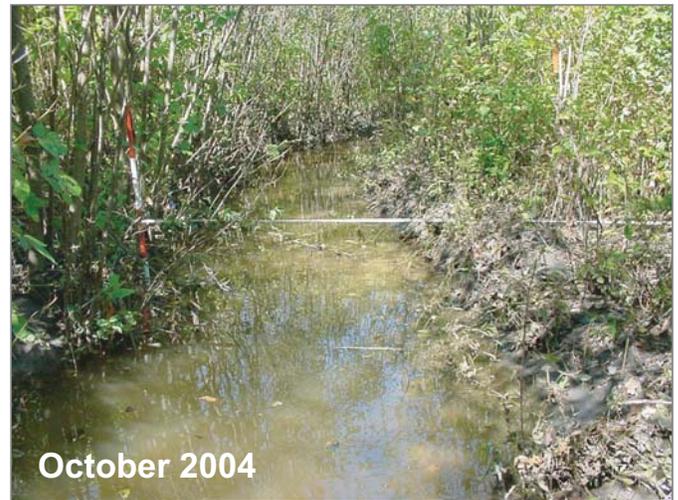
**Figure 1-7.** Looking upstream at relocated stream reach at cross section surveyed 315 feet downstream of a box culvert under Center Valley Parkway, Upper Saucon Township, Lehigh County, Pennsylvania. Photographed by Kirk E. White, U.S. Geological Survey.

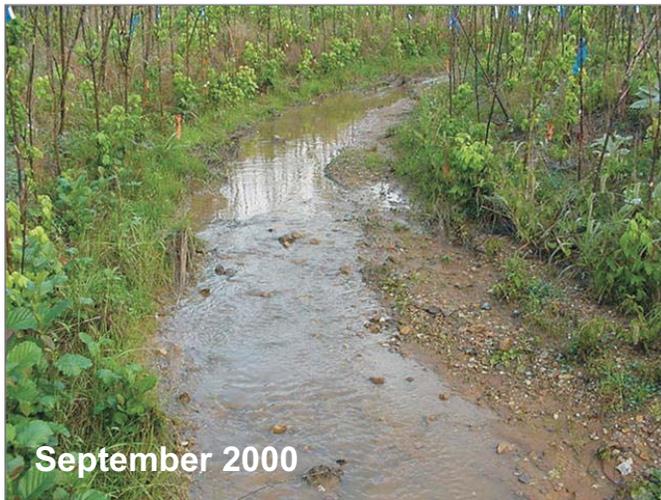
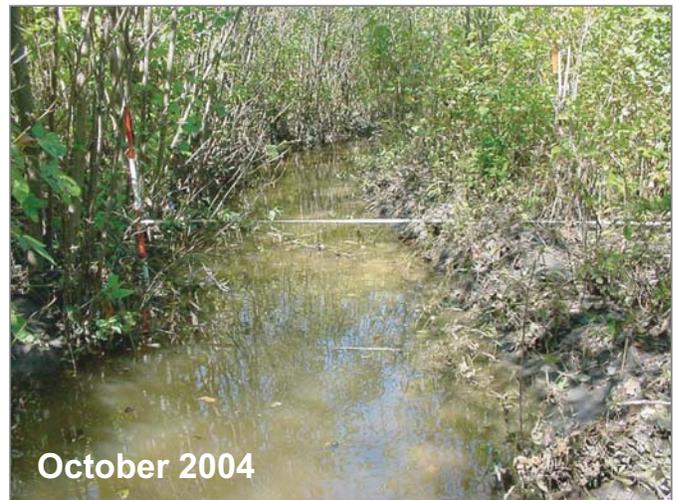
**Figure 1-8.** Looking upstream at relocated stream reach at cross section surveyed 357 feet downstream of a box culvert under Center Valley Parkway, Upper Saucon Township, Lehigh County, Pennsylvania. Photographed by Kirk E. White, U.S. Geological Survey.

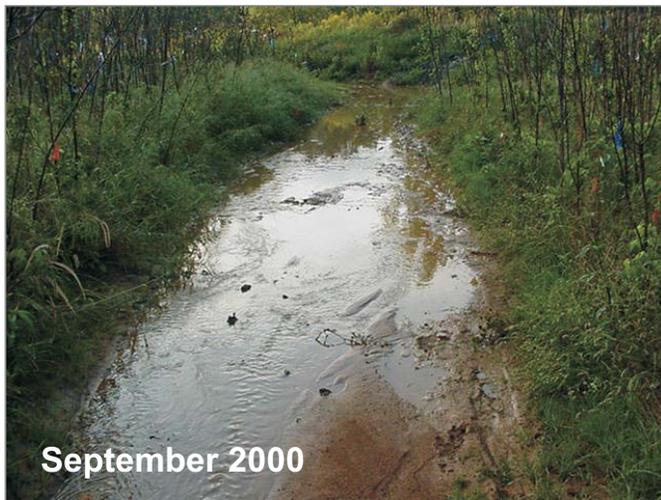
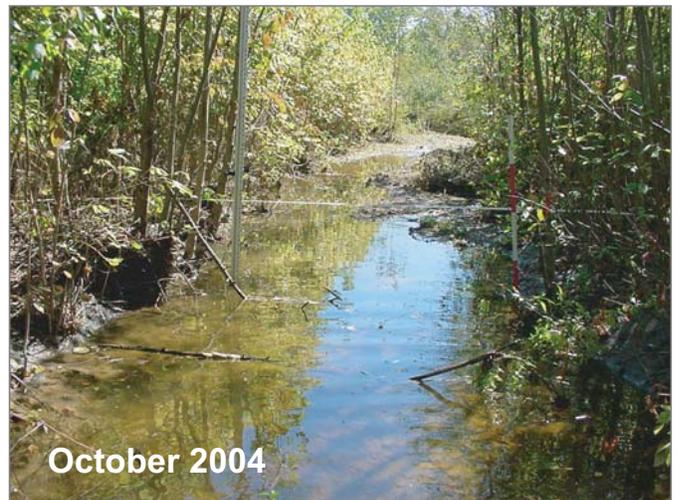
**Figure 1-9.** Looking downstream at relocated stream reach at cross section surveyed 390 feet downstream of a box culvert under Center Valley Parkway, Upper Saucon Township, Lehigh County, Pennsylvania. Photographed by Kirk E. White, U.S. Geological Survey.

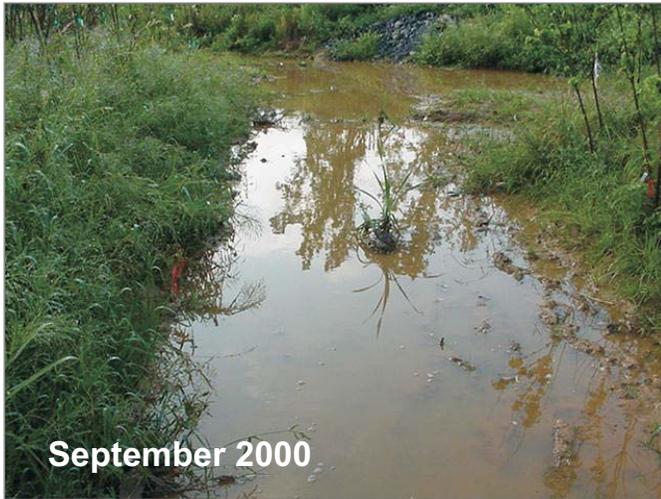
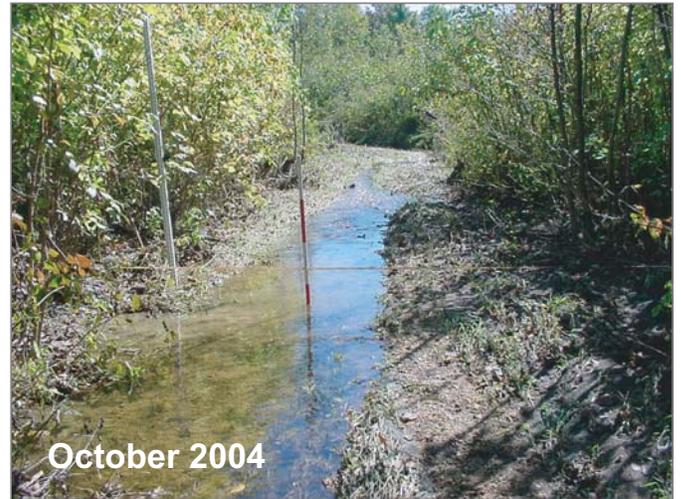
**Figure 1-10.** Looking downstream at relocated stream reach at cross section surveyed 425 feet downstream of a box culvert under Center Valley Parkway, Upper Saucon Township, Lehigh County, Pennsylvania. Photographed by Kirk E. White, U.S. Geological Survey.

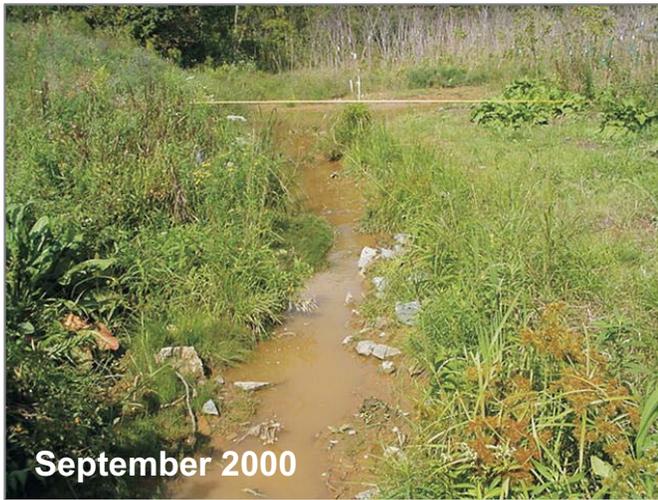
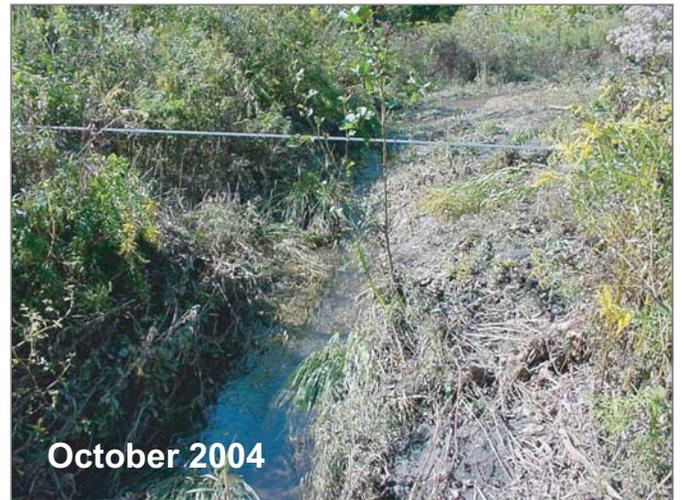
**Figure 1-11.** Looking upstream at relocated stream reach at cross section surveyed 506 feet downstream of a box culvert under Center Valley Parkway, Upper Saucon Township, Lehigh County, Pennsylvania. Photographed by Kirk E. White, U.S. Geological Survey.

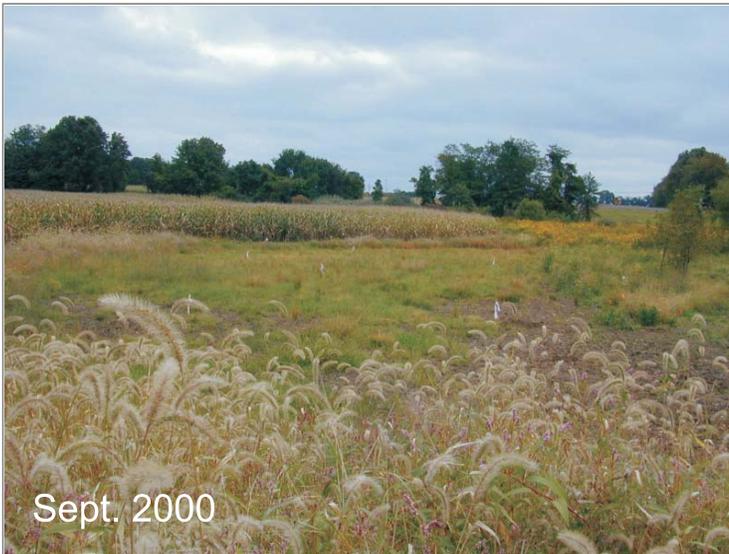
**Figure 2-2.** Looking west to east from photo-documentation station 1 at the constructed wetland, September 2000, Upper Saucon Township, Lehigh County, Pennsylvania. Photographed by Jeffrey J. Chaplin, U.S. Geological Survey. See figure 2-1 for location and orientation of photo-documentation stations.

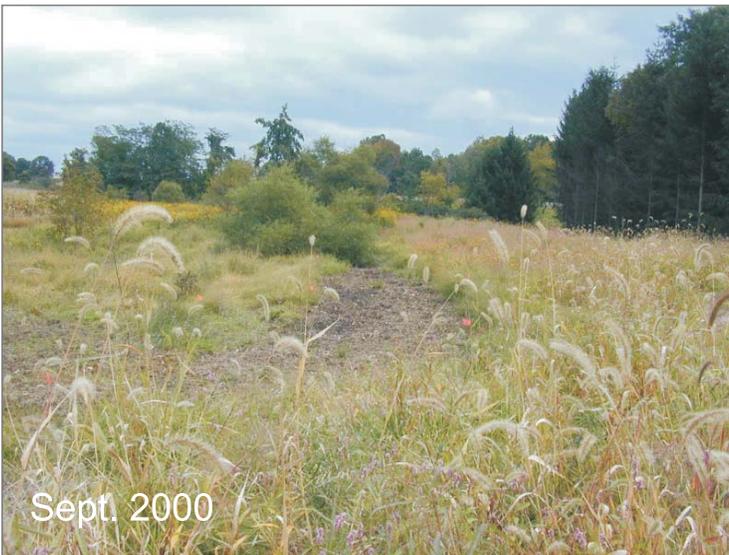
**Figure 2-3.** Looking west to east from photo-documentation station 2 at the constructed wetland, September 2000, Upper Saucon Township, Lehigh County, Pennsylvania. Photographed by Jeffrey J. Chaplin, U.S. Geological Survey. See figure 2-1 for location and orientation of photo-documentation stations.

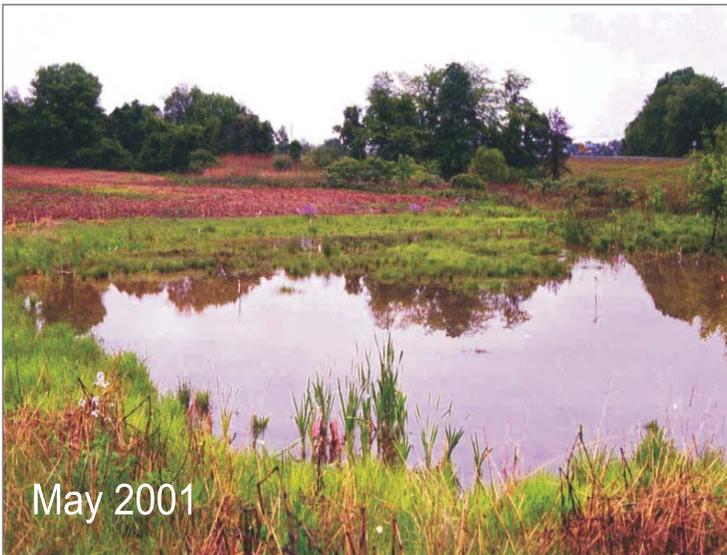
**Figure 2-4.** Looking west to east from photo-documentation station 1 at the constructed wetland, May 2001, Upper Saucon Township, Lehigh County, Pennsylvania. Photographed by Jeffrey J. Chaplin, U.S. Geological Survey. See figure 2-1 for location and orientation of photo-documentation stations.

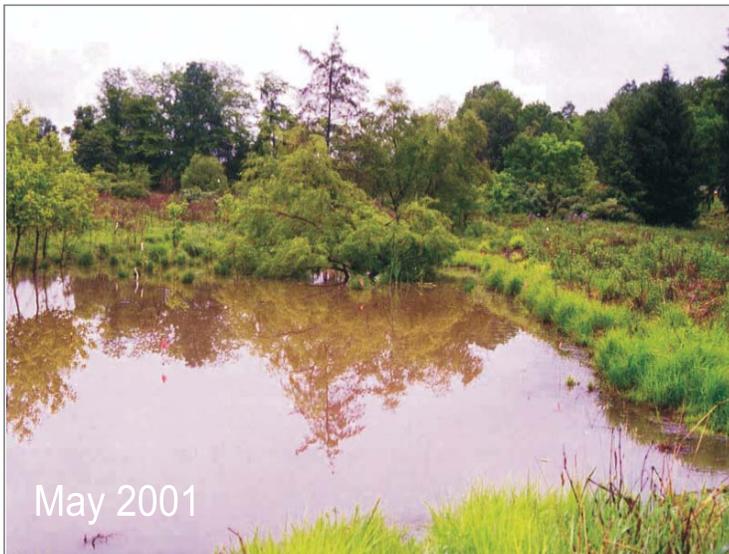
**Figure 2-5.** Looking west to east from photo-documentation station 2 at the constructed wetland, May 2001, Upper Saucon Township, Lehigh County, Pennsylvania. Photographed by Jeffrey J. Chaplin, U.S. Geological Survey. See figure 2-1 for location and orientation of photo-documentation stations.

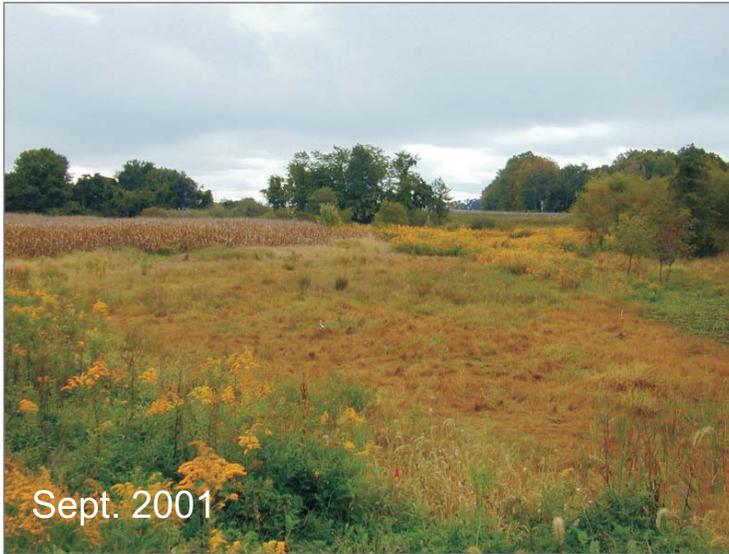
**Figure 2-6.** Looking west to east from photo-documentation station 1 at the constructed wetland, September 2001, Upper Saucon Township, Lehigh County, Pennsylvania. Photographed by Jeffrey J. Chaplin, U.S. Geological Survey. See figure 2-1 for location and orientation of photo-documentation stations.

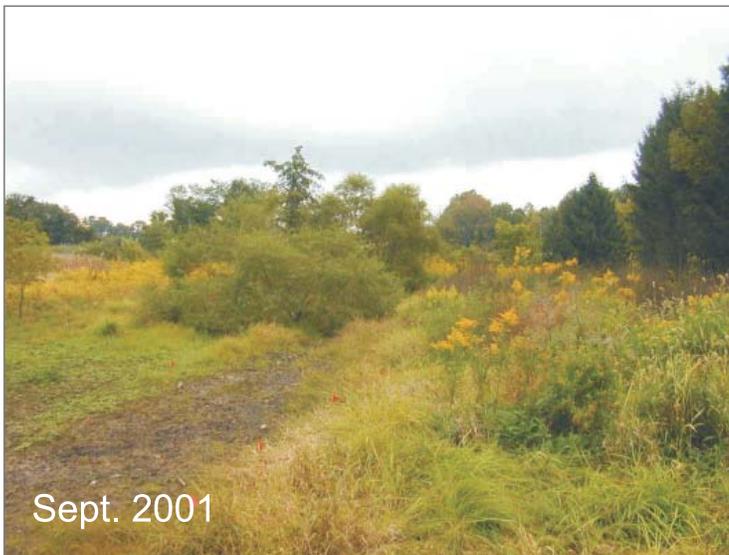
**Figure 2-7.** Looking west to east from photo-documentation station 2 at the constructed wetland, September 2001, Upper Saucon Township, Lehigh County, Pennsylvania. Photographed by Jeffrey J. Chaplin, U.S. Geological Survey. See figure 2-1 for location and orientation of photo-documentation stations.

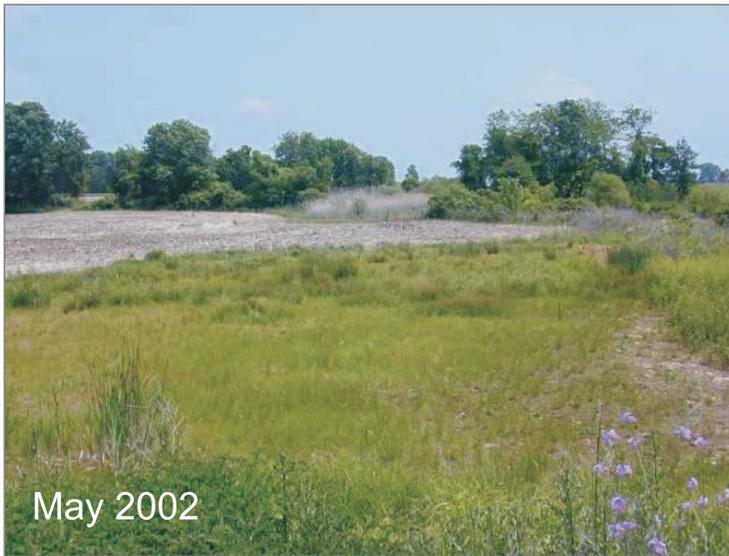
**Figure 2-8.** Looking west to east from photo-documentation station 1 at the constructed wetland, May 2002, Upper Saucon Township, Lehigh County, Pennsylvania. Photographed by Jeffrey J. Chaplin, U.S. Geological Survey. See figure 2-1 for location and orientation of photo-documentation stations.

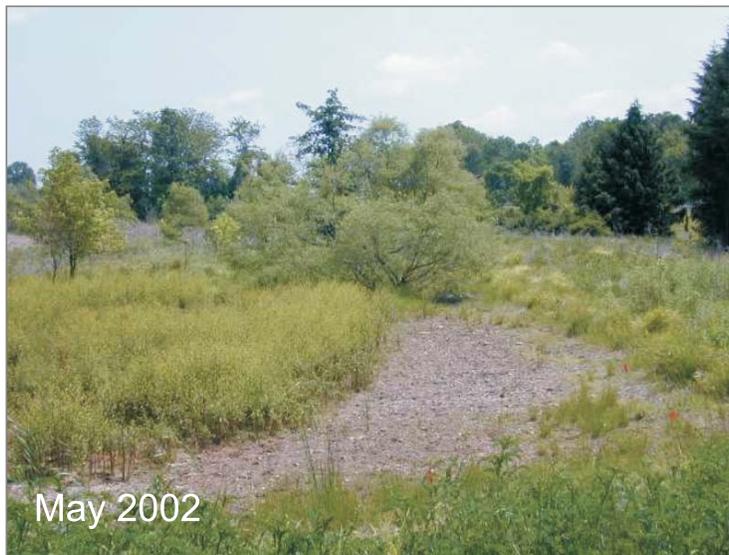
**Figure 2-9.** Looking west to east from photo-documentation station 2 at the constructed wetland, May 2002, Upper Saucon Township, Lehigh County, Pennsylvania. Photographed by Jeffrey J. Chaplin, U.S. Geological Survey. See figure 2-1 for location and orientation of photo-documentation stations.

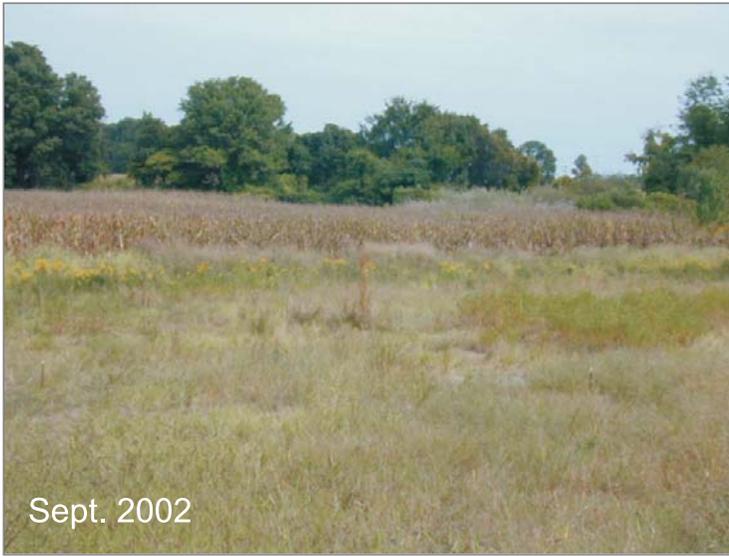
**Figure 2-10.** Looking west to east from photo-documentation station 1 at the constructed wetland, September 2002, Upper Saucon Township, Lehigh County, Pennsylvania. Photographed by Jeffrey J. Chaplin, U.S. Geological Survey. See figure 2-1 for location and orientation of photo-documentation stations.

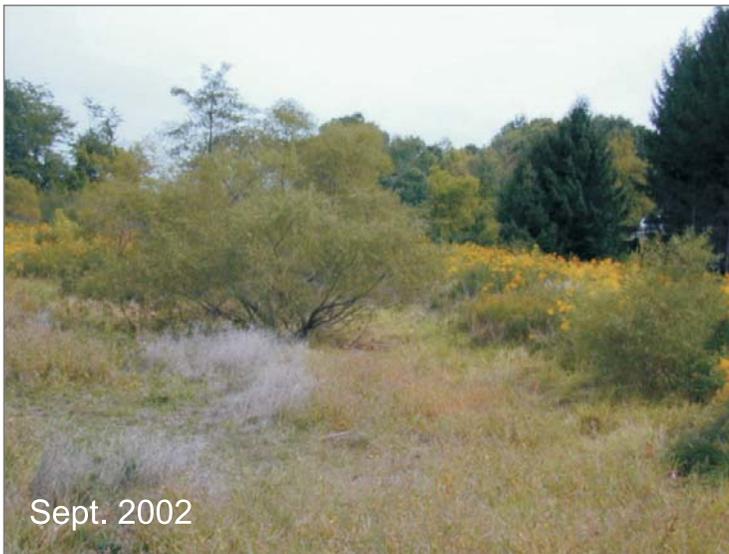
**Figure 2-11.** Looking west to east from photo-documentation station 2 at the constructed wetland, September 2002, Upper Saucon Township, Lehigh County, Pennsylvania. Photographed by Jeffrey J. Chaplin, U.S. Geological Survey. See figure 2-1 for location and orientation of photo-documentation stations.

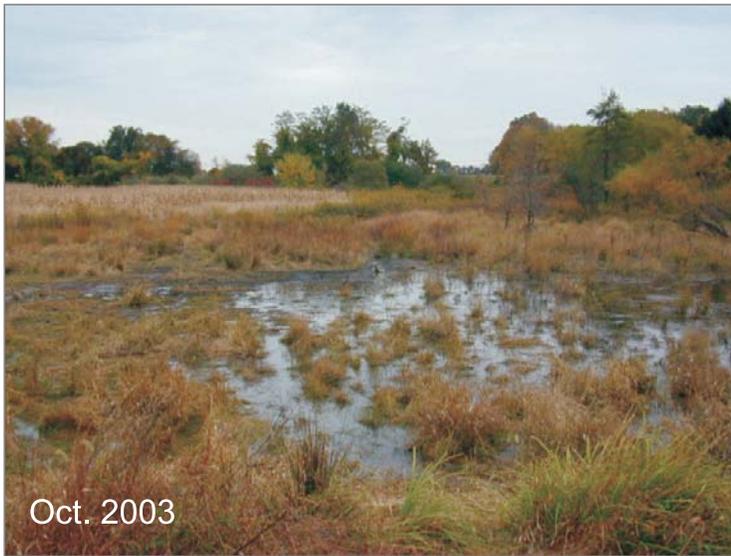
**Figure 2-12.** Looking west to east from photo-documentation station 1 at the constructed wetland, October 2003, Upper Saucon Township, Lehigh County, Pennsylvania. Photographed by Jeffrey J. Chaplin, U.S. Geological Survey. See figure 2-1 for location and orientation of photo-documentation stations.

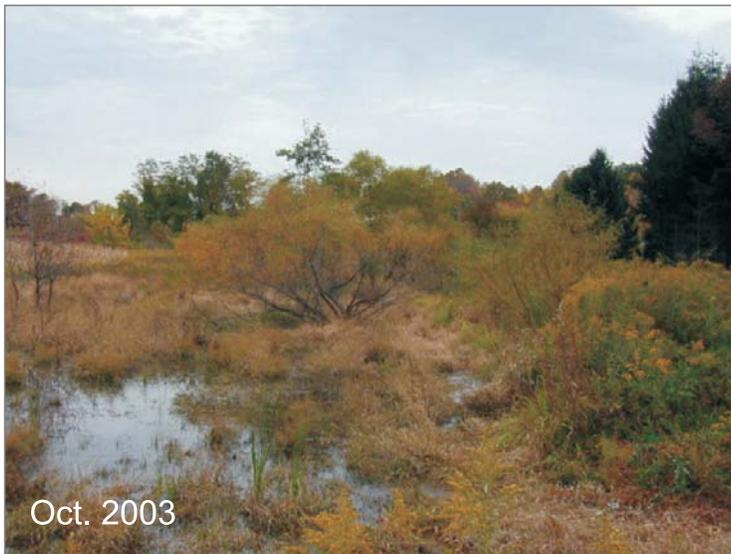
**Figure 2-13.** Looking west to east from photo-documentation station 2 at the constructed wetland, October 2003, Upper Saucon Township, Lehigh County, Pennsylvania. Photographed by Jeffrey J. Chaplin, U.S. Geological Survey. See figure 2-1 for location and orientation of photo-documentation stations.

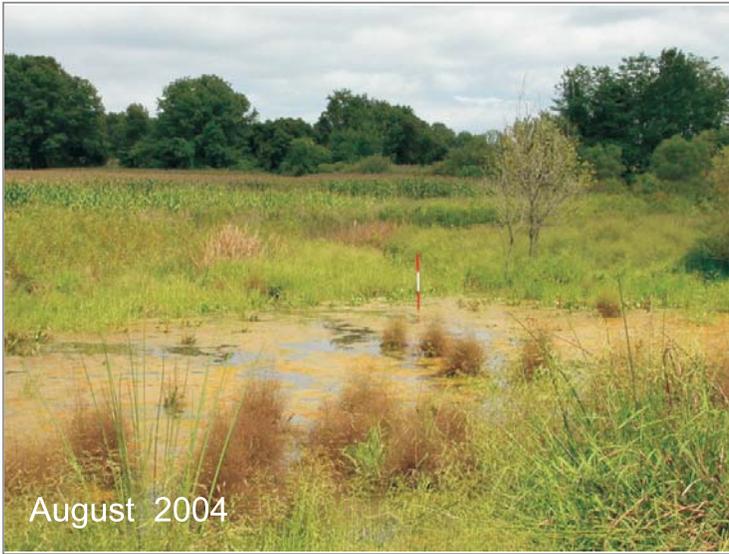
**Figure 2-14.** Looking west to east from photo-documentation station 1 at the constructed wetland, August 2004, Upper Saucon Township, Lehigh County, Pennsylvania. Photographed by Jeffrey J. Chaplin, U.S. Geological Survey. See figure 2-1 for location and orientation of photo-documentation stations.

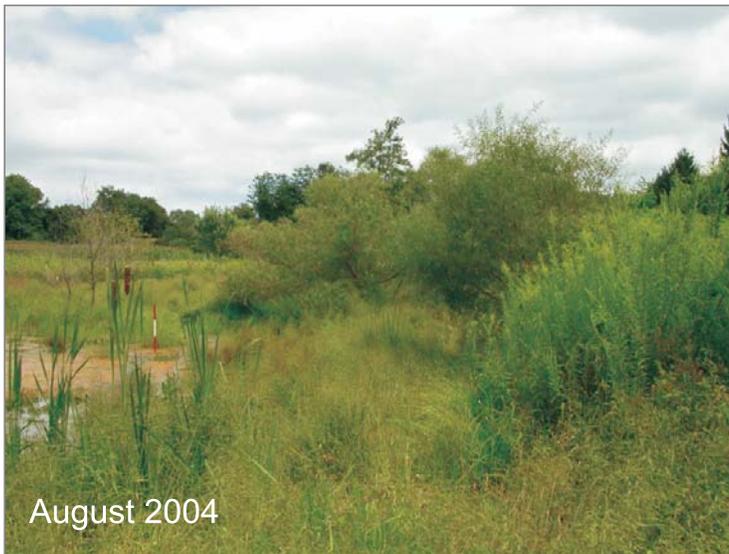
**Figure 2-15.** Looking west to east from photo-documentation station 2 at the constructed wetland, August 2004, Upper Saucon Township, Lehigh County, Pennsylvania. Photographed by Jeffrey J. Chaplin, U.S. Geological Survey. See figure 2-1 for location and orientation of photo-documentation stations.

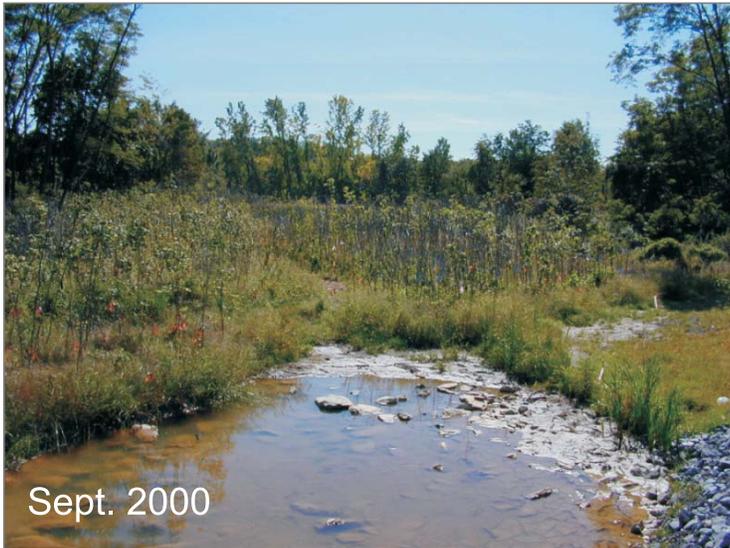
**Figure 3-2.** Looking north to south from photo-documentation station 1 at the riparian buffer, September 2000, Upper Saucon Township, Lehigh County, Pennsylvania. Photographed by Jeffrey J. Chaplin, U.S. Geological Survey. See figure 3-1 for location and orientation of photo-documentation stations.

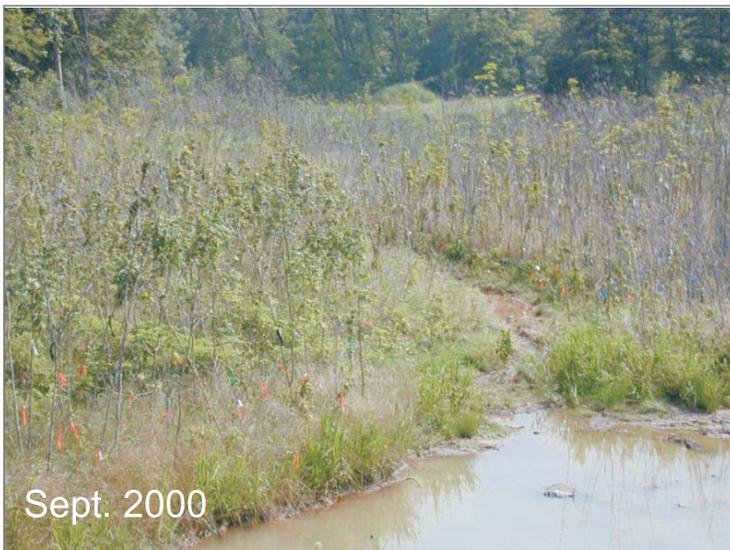
**Figure 3-3.** Looking south to north from photo-documentation station 2 at the riparian buffer, September 2000, Upper Saucon Township, Lehigh County, Pennsylvania. Photographed by Jeffrey J. Chaplin, U.S. Geological Survey. See figure 3-1 for location and orientation of photo-documentation stations.

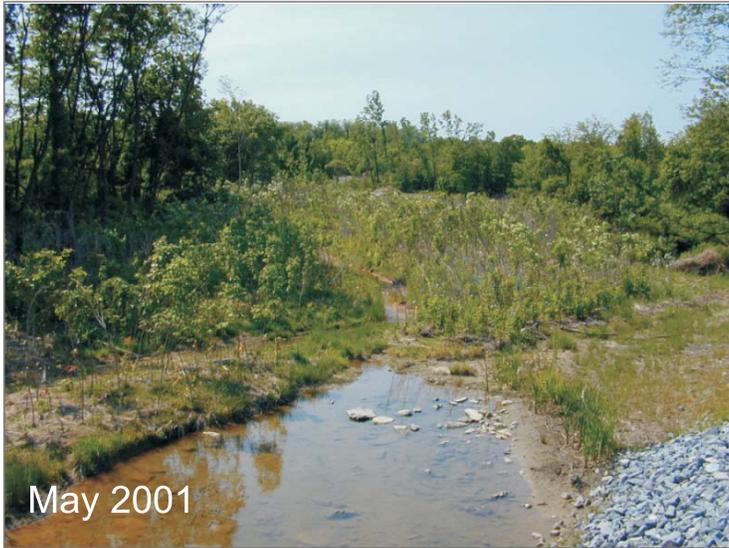
**Figure 3-4.** Looking north to south from photo-documentation station 1 at the riparian buffer, May 2001, Upper Saucon Township, Lehigh County, Pennsylvania. Photographed by Jeffrey J. Chaplin, U.S. Geological Survey. See figure 3-1 for location and orientation of photo-documentation stations.

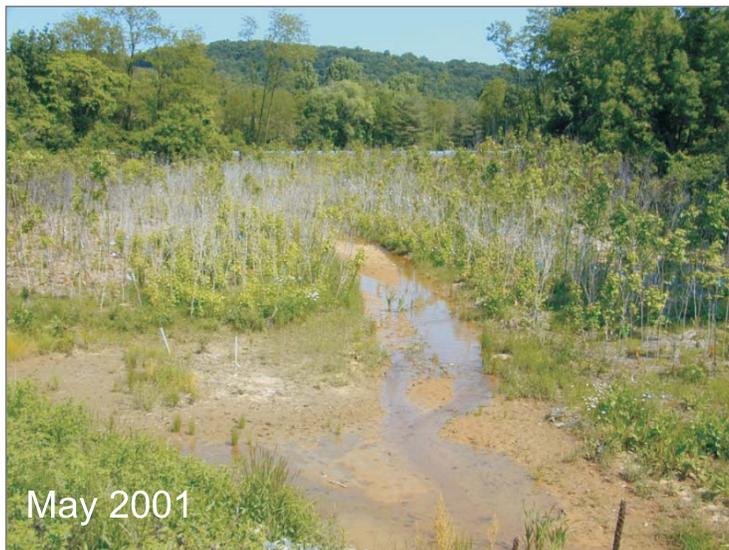
**Figure 3-5.** Looking south to north from photo-documentation station 2 at the riparian buffer, May 2001, Upper Saucon Township, Lehigh County, Pennsylvania. Photographed by Jeffrey J. Chaplin, U.S. Geological Survey. See figure 3-1 for location and orientation of photo-documentation stations.

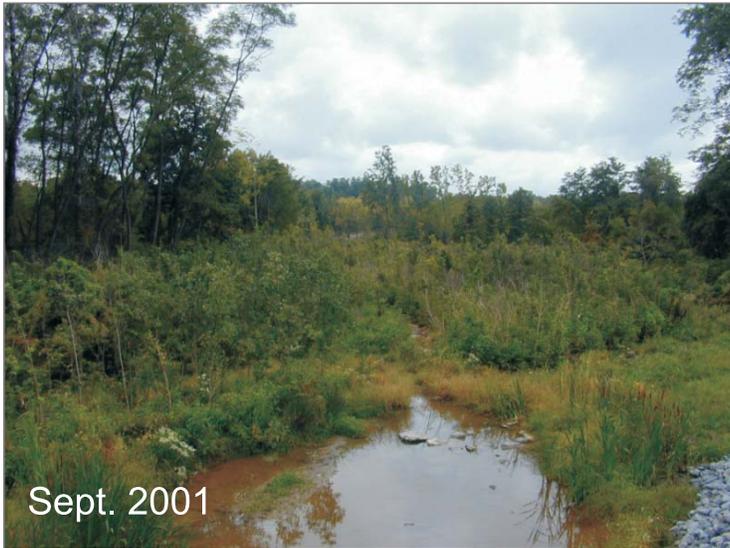
**Figure 3-6.** Looking north to south from photo-documentation station 1 at the riparian buffer, September 2001, Upper Saucon Township, Lehigh County, Pennsylvania. Photographed by Jeffrey J. Chaplin, U.S. Geological Survey. See figure 3-1 for location and orientation of photo-documentation stations.

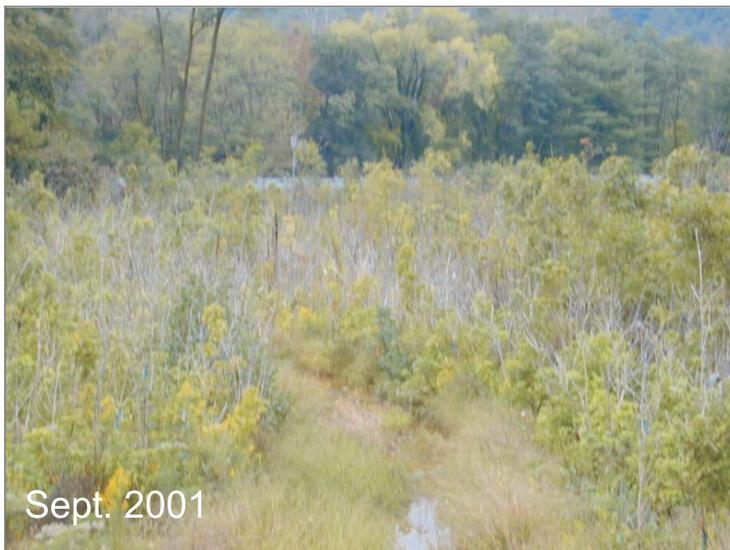
**Figure 3-7.** Looking south to north from photo-documentation station 2 at the riparian buffer, September 2001, Upper Saucon Township, Lehigh County, Pennsylvania. Photographed by Jeffrey J. Chaplin, U.S. Geological Survey. See figure 3-1 for location and orientation of photo-documentation stations.

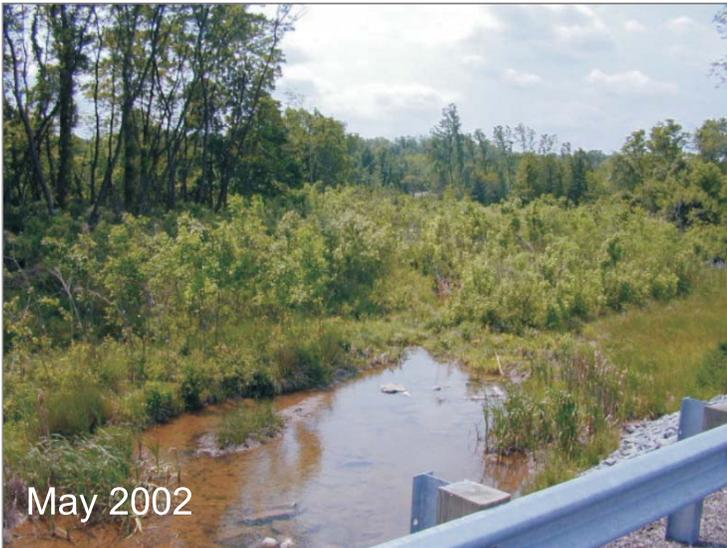
**Figure 3-8.** Looking north to south from photo-documentation station 1 at the riparian buffer, May 2002, Upper Saucon Township, Lehigh County, Pennsylvania. Photographed by Jeffrey J. Chaplin, U.S. Geological Survey. See figure 3-1 for location and orientation of photo-documentation stations.

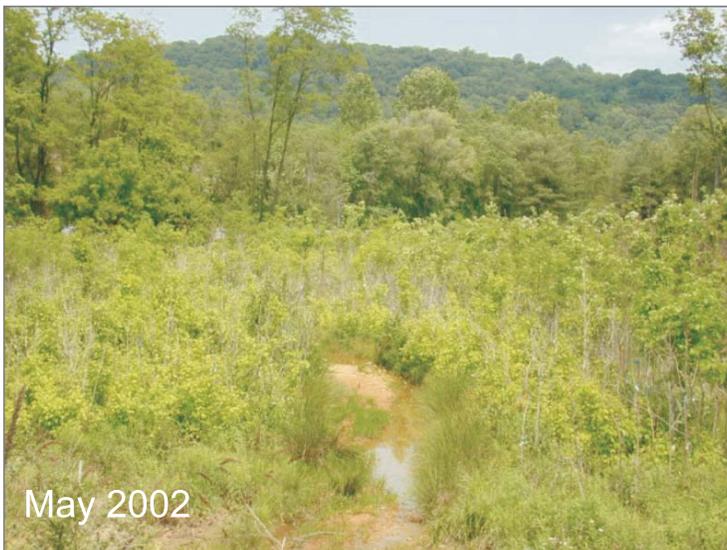
**Figure 3-9.** Looking south to north from photo-documentation station 2 at the riparian buffer, May 2002, Upper Saucon Township, Lehigh County, Pennsylvania. Photographed by Jeffrey J. Chaplin, U.S. Geological Survey. See figure 3-1 for location and orientation of photo-documentation stations.

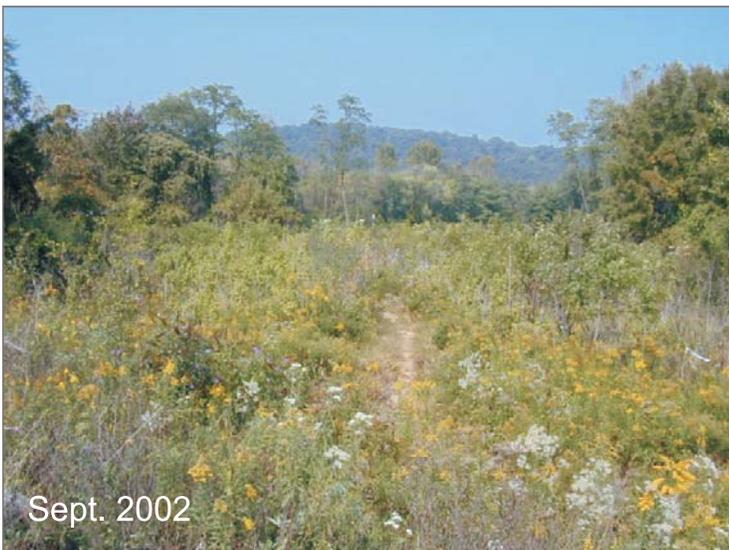
**Figure 3-11.** Looking south to north from photo-documentation station 2 at the riparian buffer, September 2002, Upper Saucon Township, Lehigh County, Pennsylvania. Photographed by Jeffrey J. Chaplin, U.S. Geological Survey. See figure 3-1 for location and orientation of photo-documentation stations.

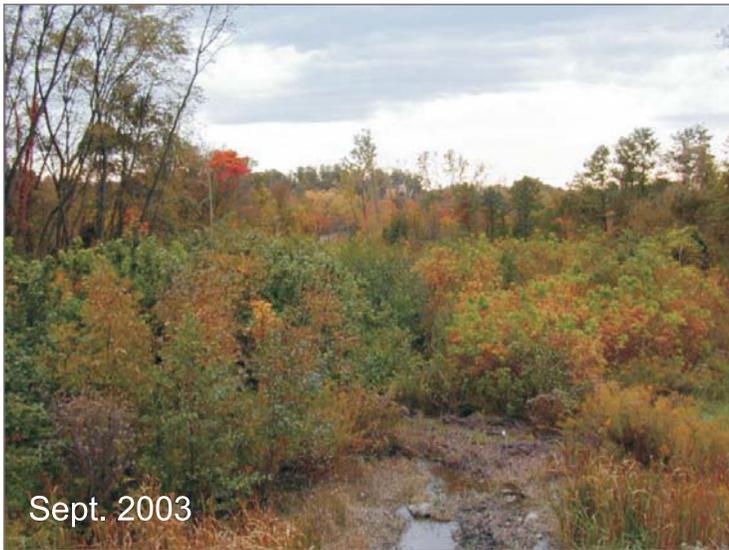
**Figure 3-12.** Looking north to south from photo-documentation station 1 at the riparian buffer, September 2003, Upper Saucon Township, Lehigh County, Pennsylvania. Photographed by Jeffrey J. Chaplin, U.S. Geological Survey. See figure 3-1 for location and orientation of photo-documentation stations.

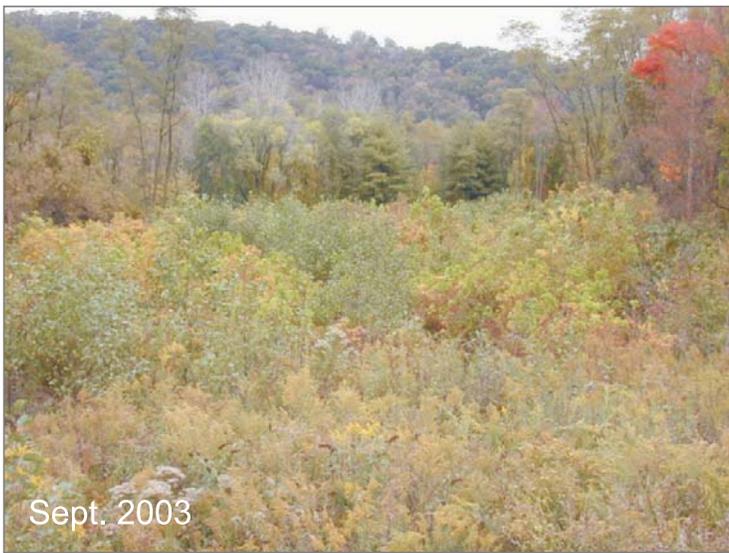
**Figure 3-13.** Looking south to north from photo-documentation station 2 at the riparian buffer, September 2003, Upper Saucon Township, Lehigh County, Pennsylvania. Photographed by Jeffrey J. Chaplin, U.S. Geological Survey. See figure 3-1 for location and orientation of photo-documentation stations.

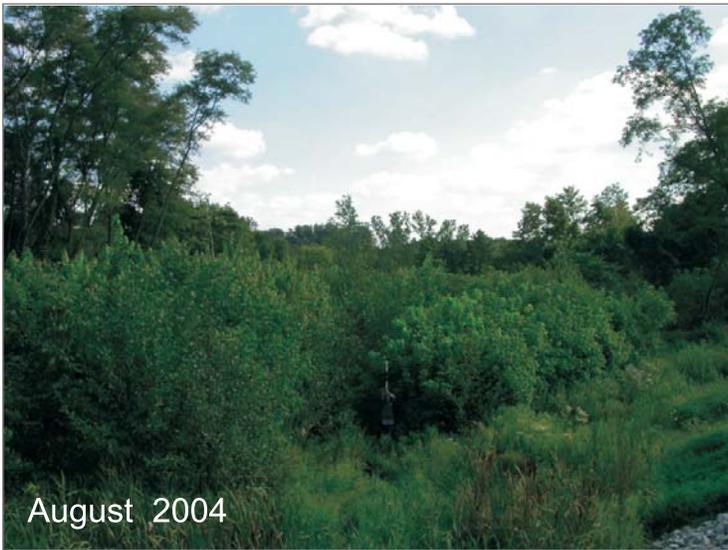
**Figure 3-14.** Looking north to south from photo-documentation station 1 at the riparian buffer, August 2004, Upper Saucon Township, Lehigh County, Pennsylvania. Photographed by Jeffrey J. Chaplin, U.S. Geological Survey. See figure 3-1 for location and orientation of photo-documentation stations.

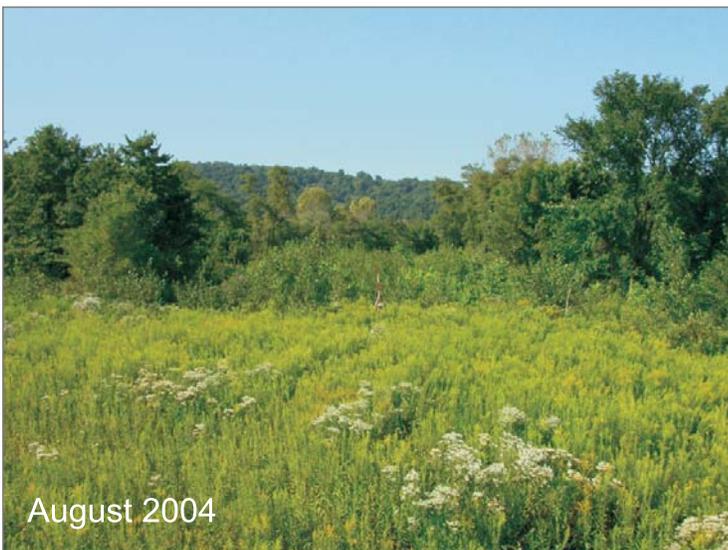
**Figure 3-15.** Looking south to north from photo-documentation station 2 at the riparian buffer, August 2004, Upper Saucon Township, Lehigh County, Pennsylvania. Photographed by Jeffrey J. Chaplin, U.S. Geological Survey. See figure 3-1 for location and orientation of photo-documentation stations.
