Mapa de Deslizamientos de Tierra Inducidos por El Huracán Mitch, Hoja Senahú (2262-III), Guatemala

Map of Landslides Triggered by Hurricane Mitch, Senahú Quadrangle (2262-III), Guatemala

This map is 1 of 20 that shows areas impacted by landslides adjacent to the Motagua and Polochic river valleys of Guatemala in response to the torrential rainfall that accompanied Hurricane Mitch in October and November of 1998. The maps provide a comprehensive record of landslides over a large geographic area (~10,000 km²) of diverse geology, geomorphology, microclimates, and vegetation. If combined with data on the physical properties of hillslope-mantling materials, hillslope form, and rainfall characteristics, the maps provide a foundation for evaluating the susceptibility of other similar areas to landsliding.

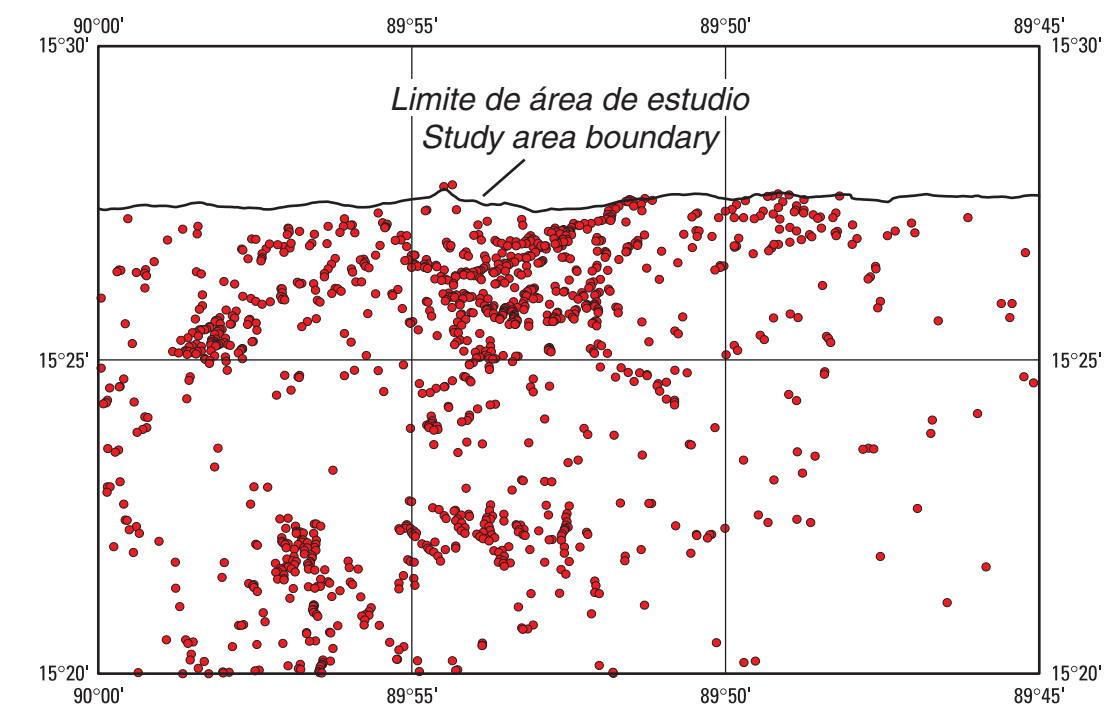
Mapa mostrando la distribución de deslizamientos de tierra en este cuadrángulo. Los puntos rojos muestran el final de la inclinación ladera arriba de cada deslizamiento de tierra. Hay 1174 deslizamientos de tierra en este mapa.

Map showing distribution of landslides in this quadrangle. Red dots show the upslope end of each landslide. There are 1174 landslides on this map.
