Photos of the East Fork Landslide

Pagosa Ranger District, San Juan National Forest

May, 2008

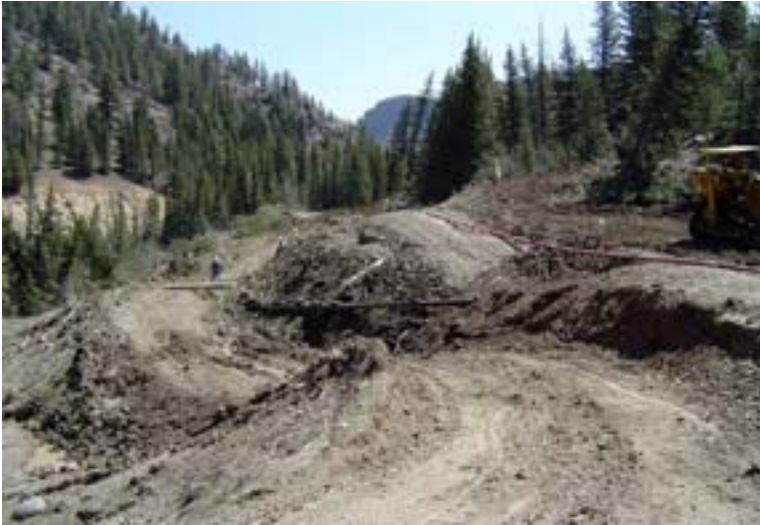
The lower road bench on the left is the old East Fork Road that has slid downhill from its previous location. The black pipe in the center is the old 8" gas pipeline that was buried in the shoulder of the road. Xcel has cleared and graded the bench on the right to lay temporary pipe. This cleared area is the approximate location of where the East Fork Road used to be. The red pipeline is the temporary 4" gas pipeline that Xcel has laid on the surface of the ground.

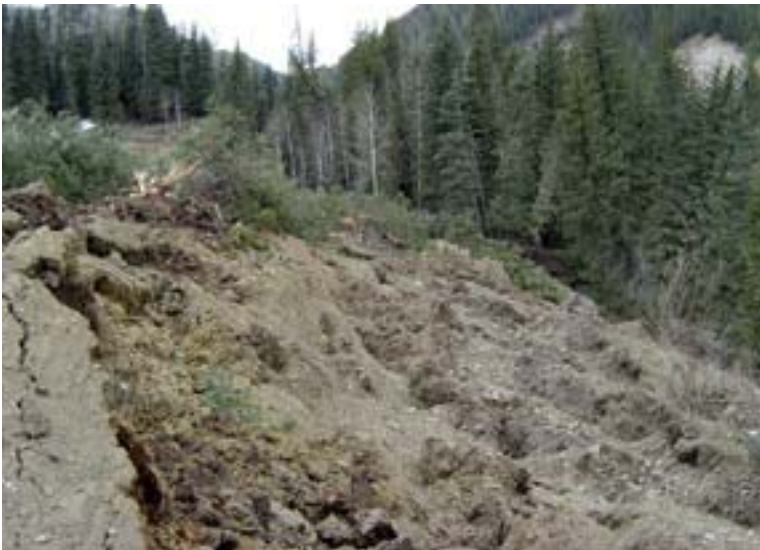
An actively sliding area below the old road.

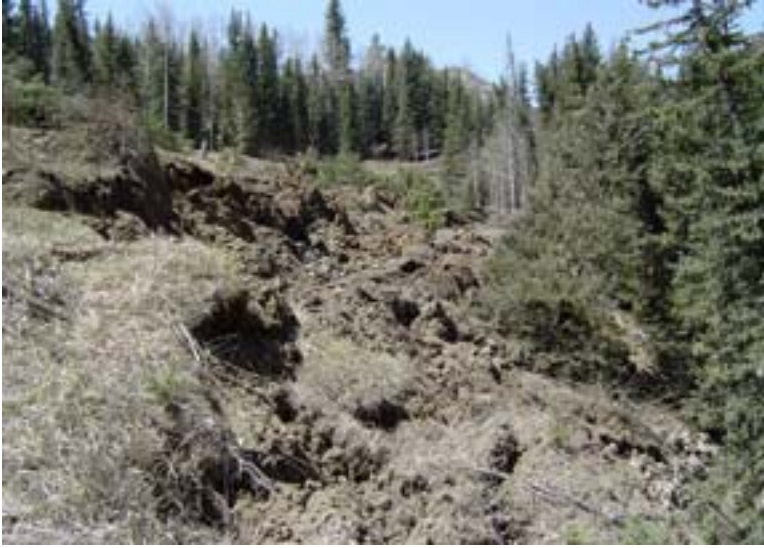
Same area as previous photo, showing actively sliding area below the old road and leaning trees that have been tilted as a result of slide movement.

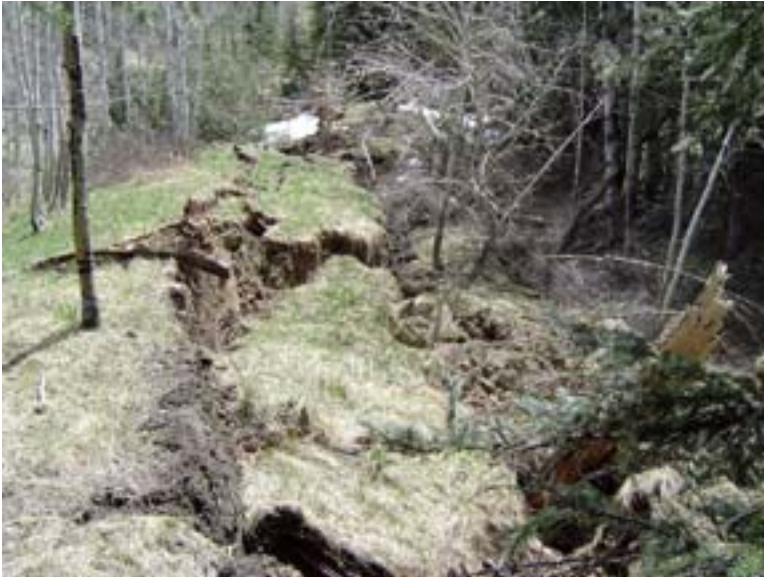
Cracking and shifting of the ground above the old road.

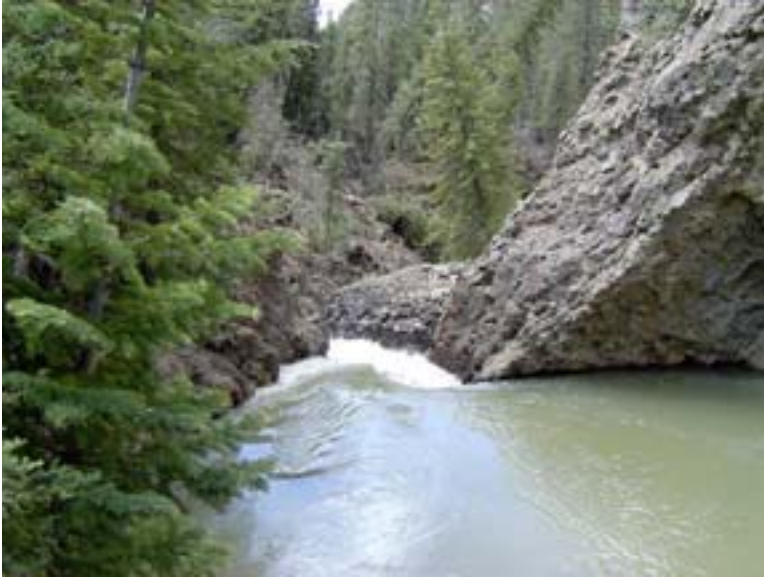
The slide is moving down the slope from the left of the photo and encroaching on the East Fork of the San Juan River.

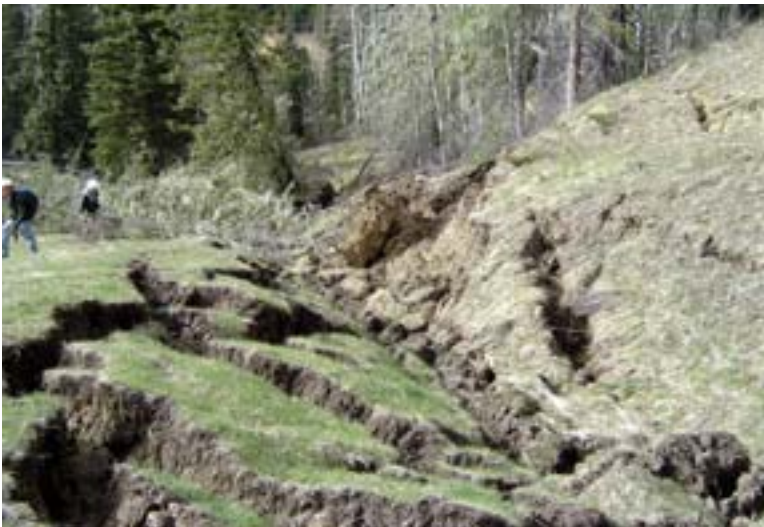
Cracking and shifting of the ground above the old road. The photo is looking downhill at the eastern edge of the active slide.

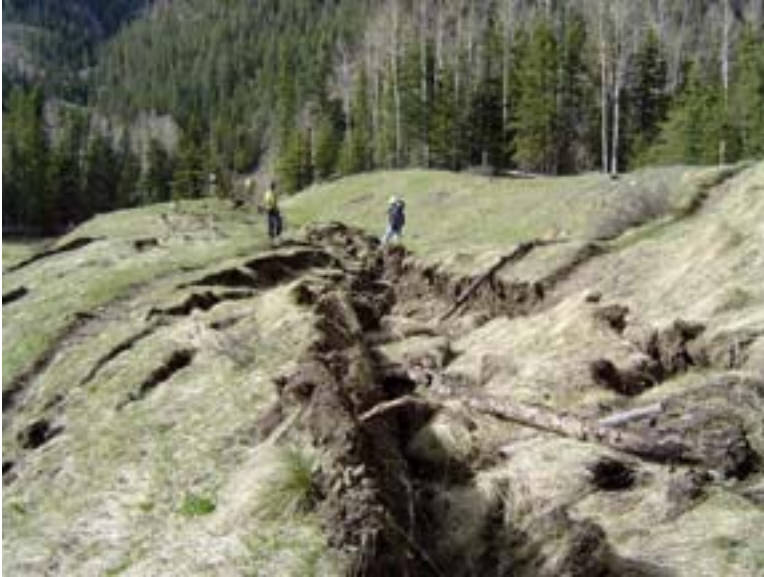
Upslope of previous picture. Coal Creek trail is shown coming in from the right. The trail is also visible on the left. Prior to the recent movement, the trail went straight across what is now the cracked area. The offset between the ends of the trail on either side of the fissure, was 50 feet on the date this photo was taken. This is an indication of total movement in this area.

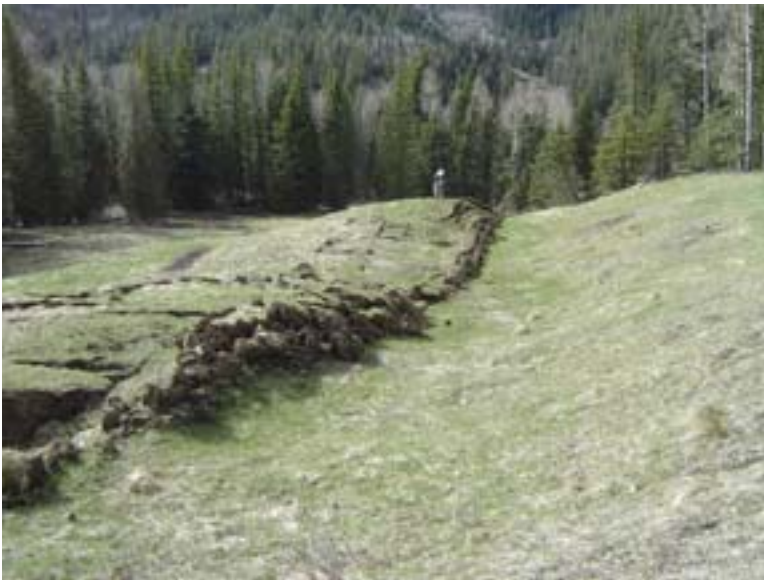
Same area as previous two photos. The area on the left of the crack where the person is standing is moving downhill and vertically up. The area on the right of the crack has not moved.

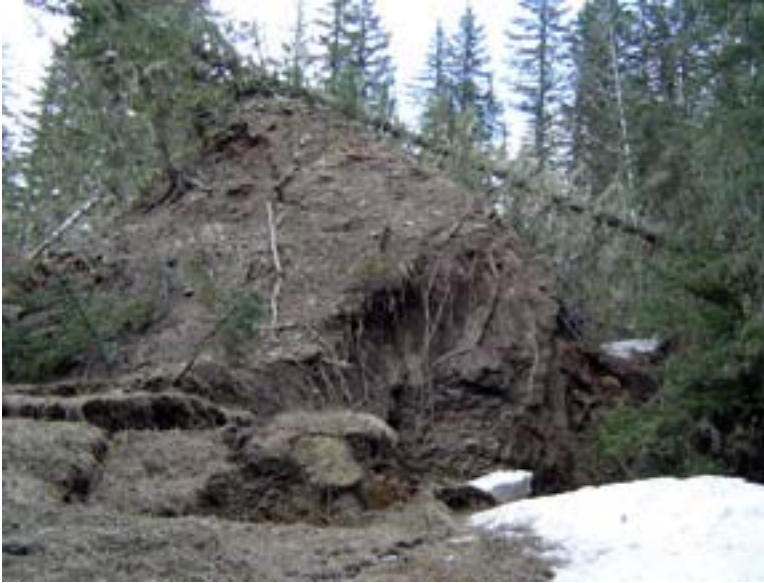
Large block of material that has been pushed upward and rotated by the movement of the slide. The exposed roots were at ground level prior to the recent movement.

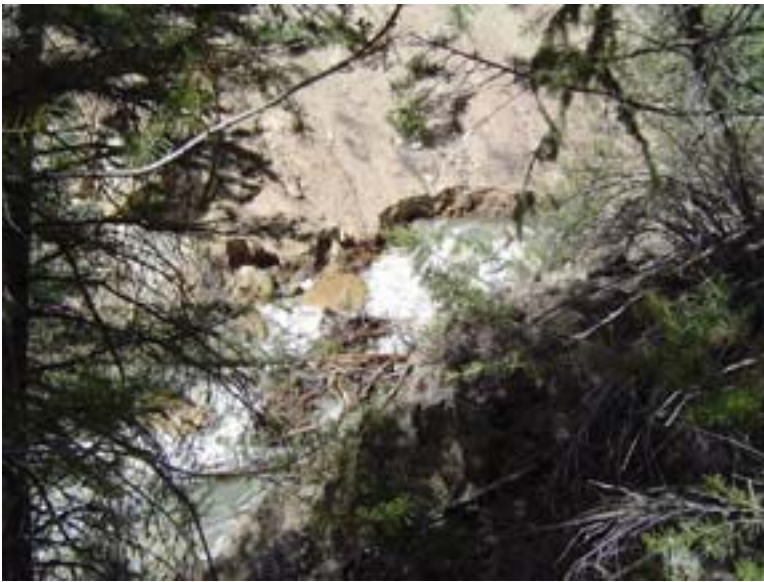
View of the East Fork of the San Juan River showing erosion of the stream bank across the river from the active slide. Photo also shows woody debris (trees) that have slid into the river and been washed downstream.

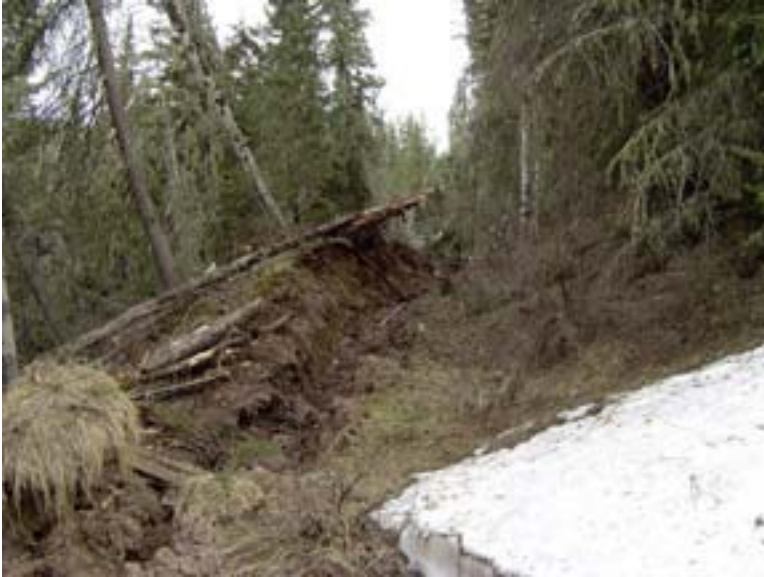
Cracking and shifting of the ground on the western edge of the active slide. Photo is looking upslope. The area on the left has been vertically raised and tilted. This area is also moving downhill. The area on the right has not moved.

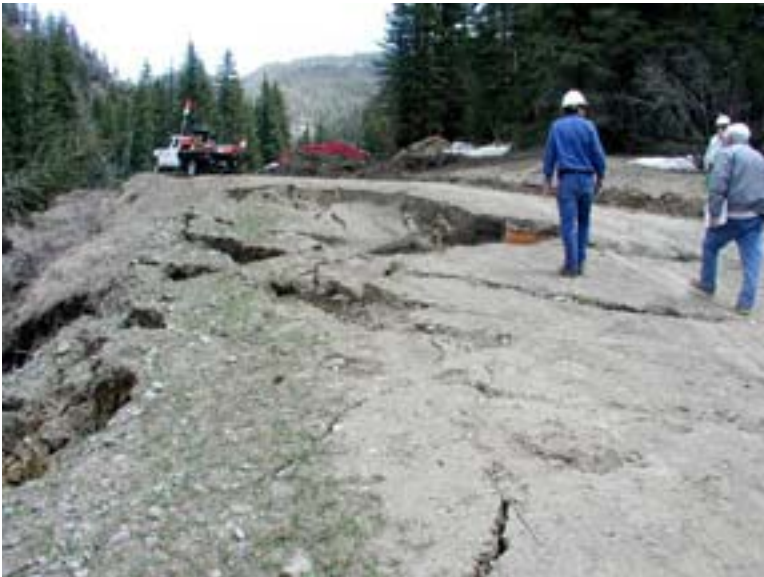
Cracking and slumping of the East Fork Road. This photo was taken early during the recent movement, and current conditions have changed dramatically, because this portion of the road has slid downhill since the photo was taken.
