Lonely Gulch Watershed Restoration Monitoring Report, 2002-2006

USDA Forest Service
Lake Tahoe Basin Management Unit

April 2008

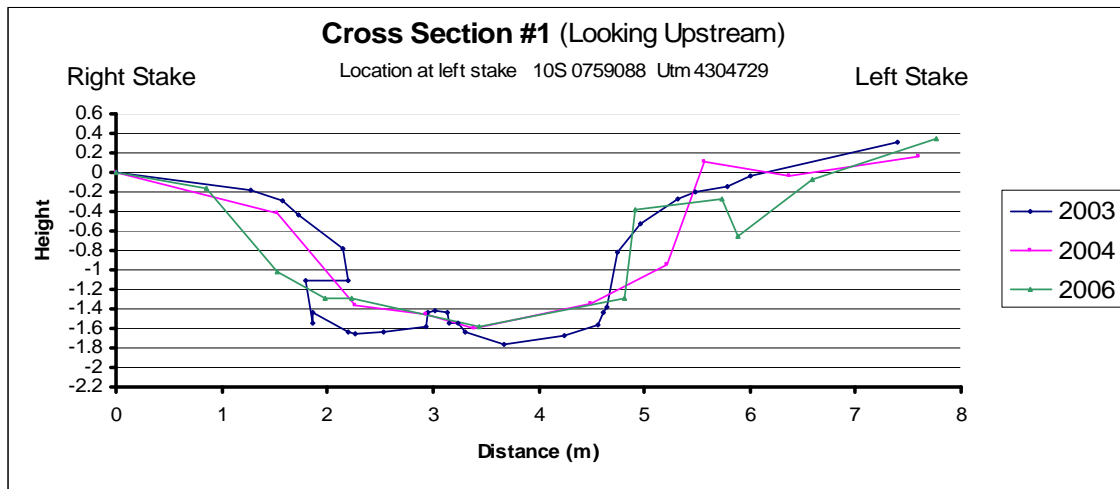
Cross-section #1. Approximately 0.5 to 0.75 meters of material eroded from the right bank while the stream bottom filled approximately 0.5 meters of sediment material. The left bank showed no change except for a boulder placed during restoration, which shifted toward the channel and left a 1-meter deep hole

minor in nature and do not appear to be affecting overall stability. Lateral adjustments are a result of several large rocks sliding down slope and a tree pulling away from the bank in cross sections one and three; these adjustments probably occurred during the Dec 31 2005 flood. Most importantly, flows have not outflanked any of the grade-control structures.

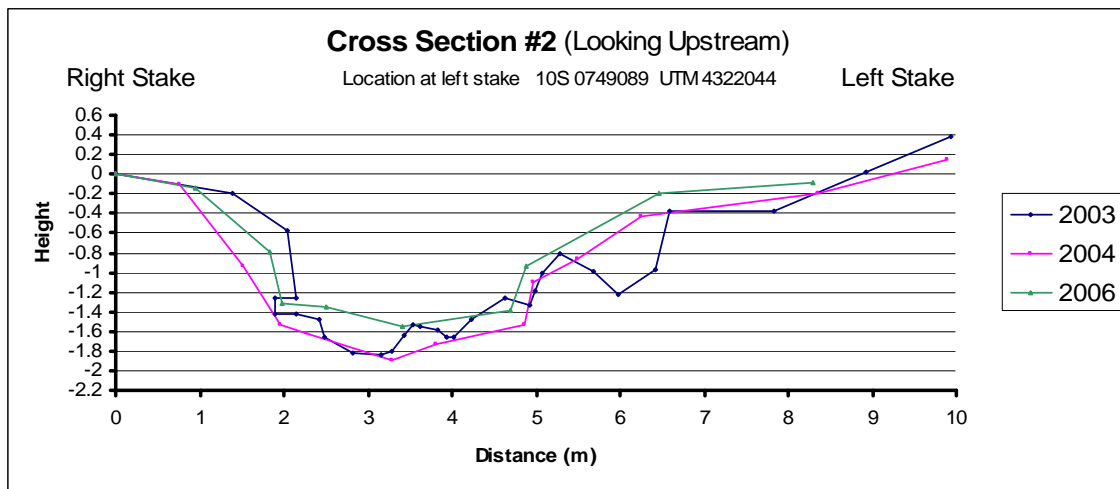
Cross-section #2. Aggradation occurred on the left bank and the stream bottom. The channel aggraded to a depth of approximately 0.5 meters. Right bank displayed minor erosion.

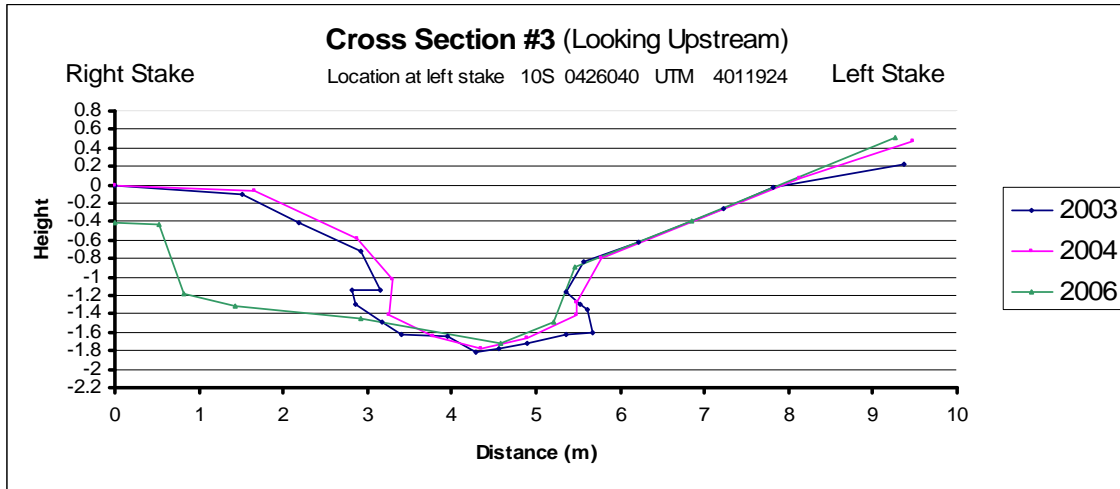
Cross-section #3. The right bank experienced a big cut from 2003 to 2006 because a large dead tree that once stood by the channel fell creating a large steep cut bank with a block of sediment exposed. The left bank showed no change from before restoration to after restoration. The stream bottom also remained the same.

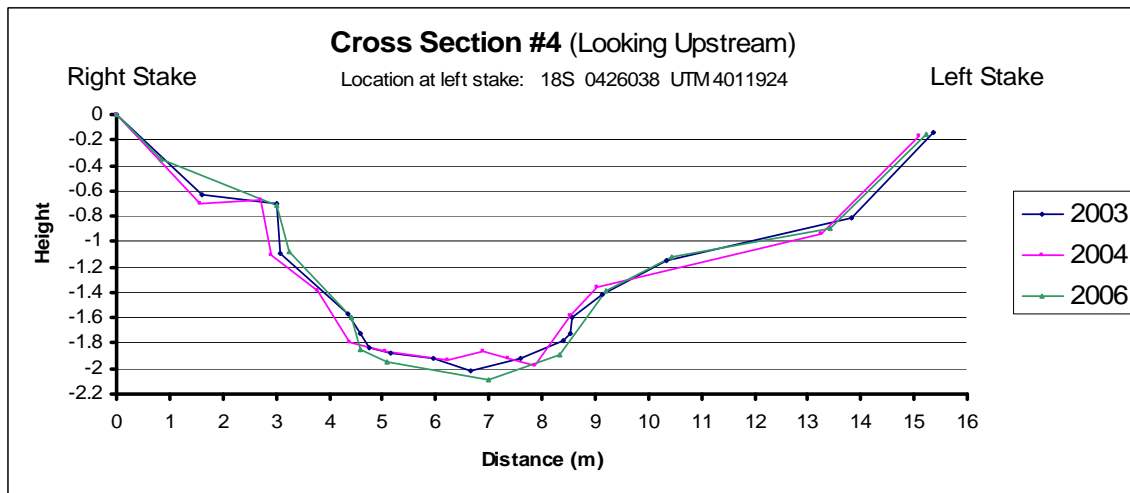
3.4 Cross-section #4. This cross section located at the downstream end of the project show no changes in deposition or erosion. This is probably because this cross section has more riparian vegetation than the other 3 cross sections.

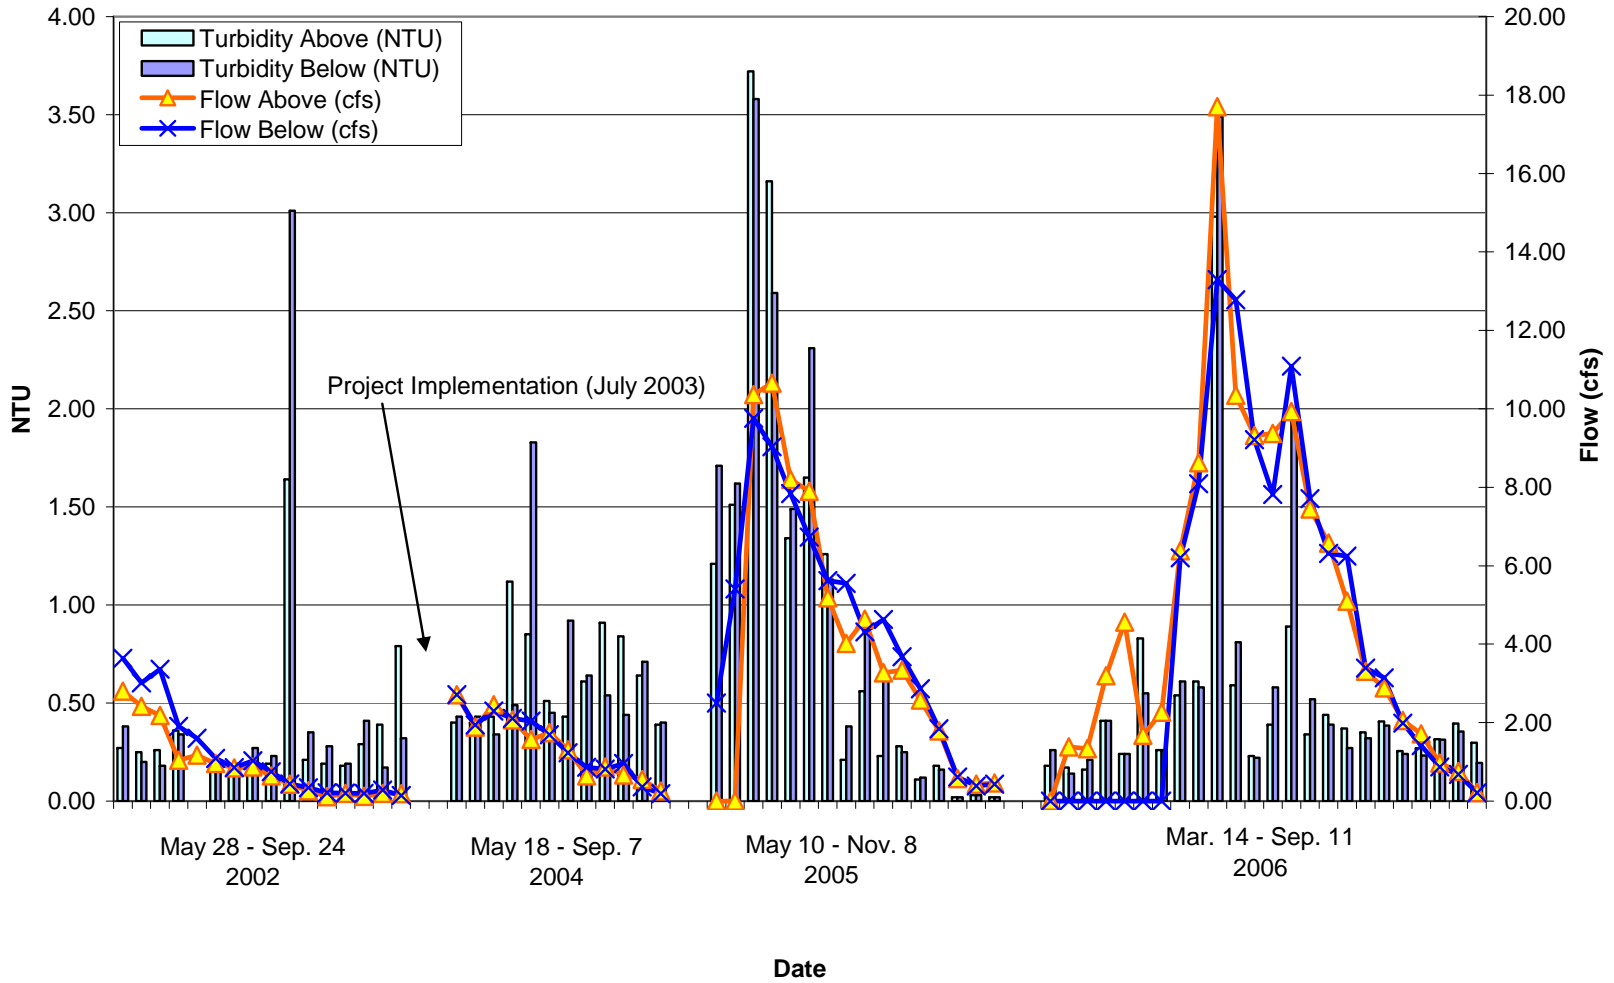
Lonely Gulch - Turbidity

The graphs presented in Appendix A1 illustrate that two of the post project water years (2005 and 2006) had much higher flows than the one pre- project 2002 water year. Turbidity concentrations at both the above and below sites generally seemed to increase with increased flow, particularly in 2005. On the other hand, suspended sediment concentrations seemed to reflect less pulsing of sediment during 2005 and 2006, when compared to the pre-project data collected in 2002.

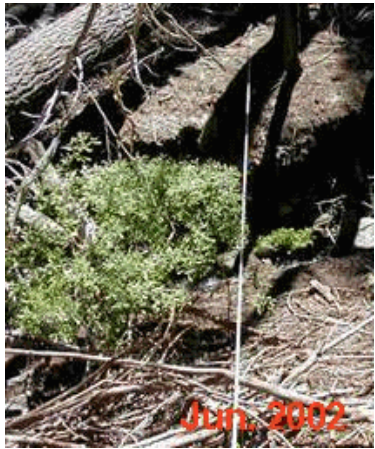
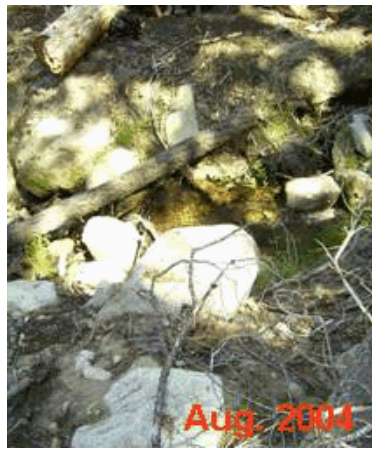
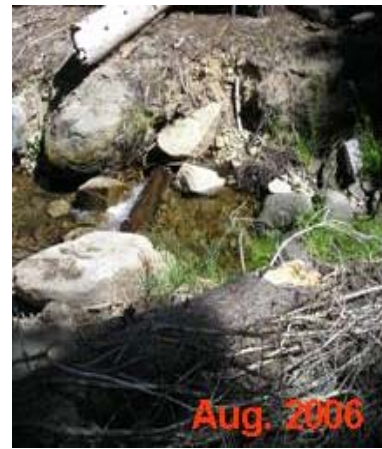
Photo Series #1. Photo taken looking down cross section #1 at right bank (UTM 10s 749002 4322212. Compass bearing 90°).

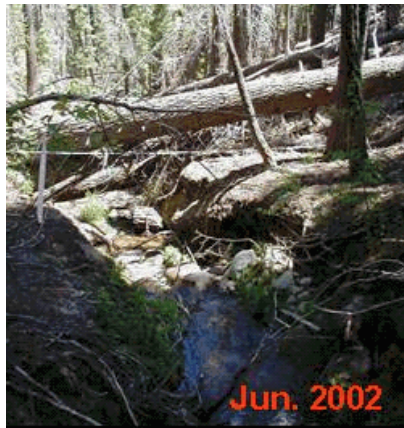
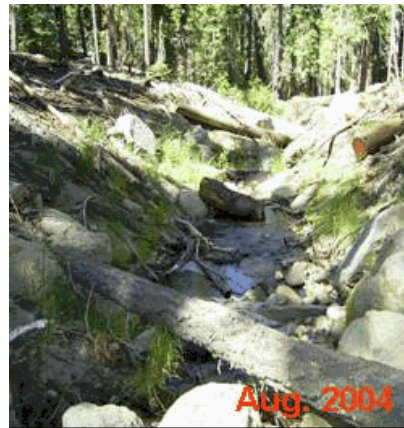
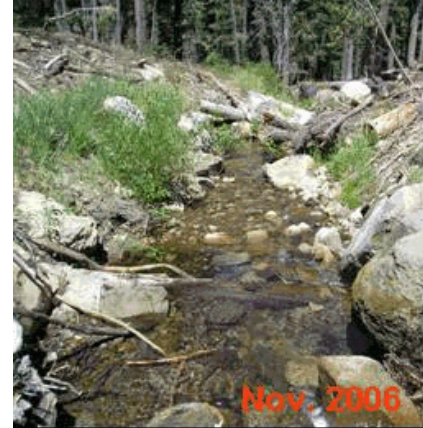
Photo Series #2. Photo taken on cross section #1 in center of channel looking downstream (UTM 10s 749002 4322212. Compass bearing 20°).

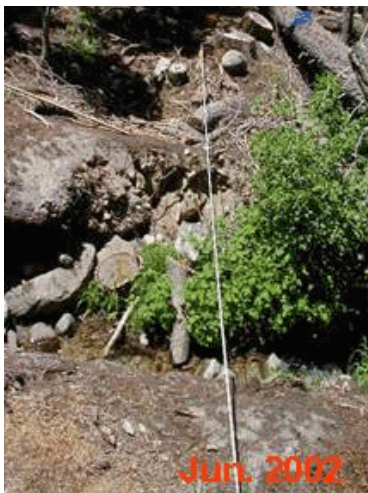
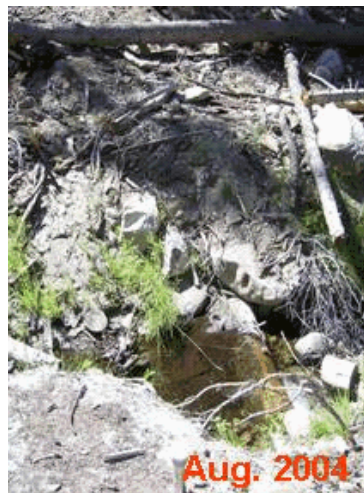
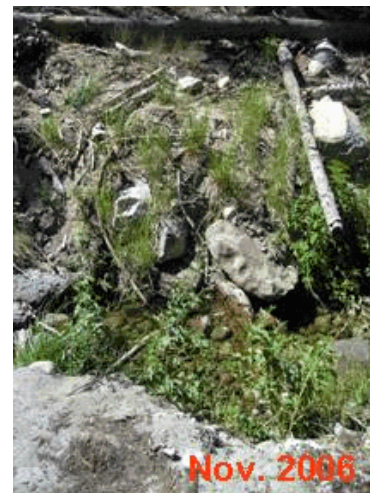
Photo Series #3. Photo taken looking down cross section #2 at left bank (UTM 10s 0749013 4322226. Compass bearing 280°).

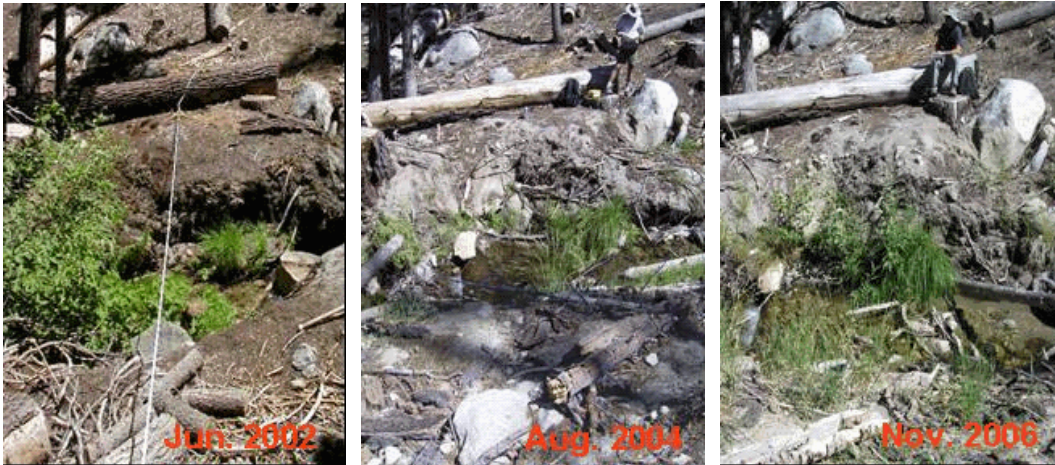
Photo Series #4. Photo taken looking down cross section #2 at right bank (UTM 10s 0749013 4322226. Compass bearing 90°).

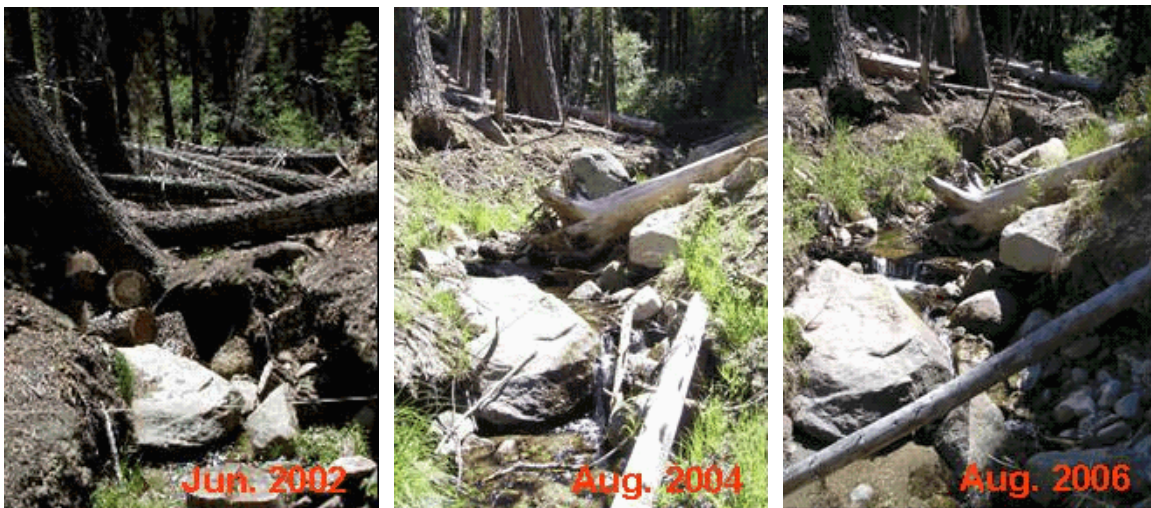
Photo Series #5. Photo taken on cross section #2 in center of channel looking upstream (UTM 10s 0749013 4322226. Compass bearing 165°).

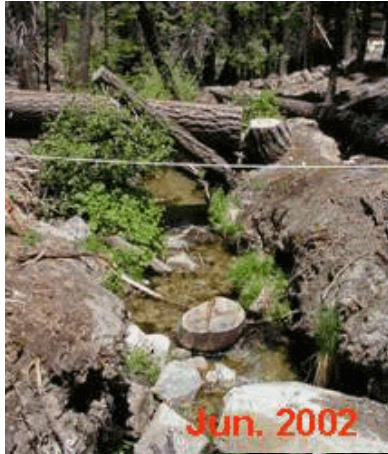
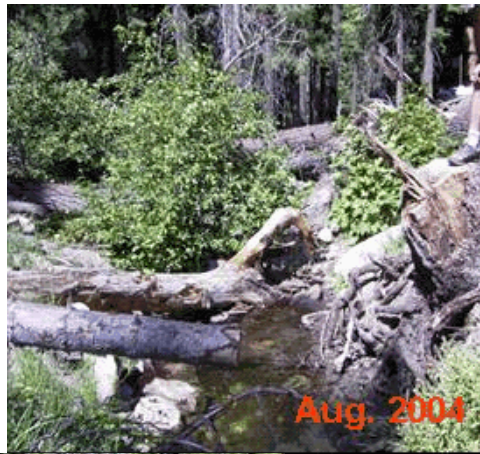
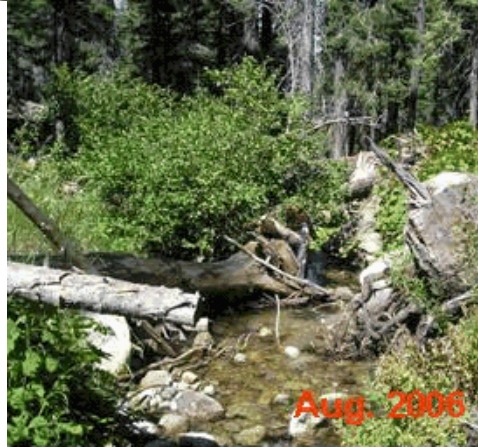
Photo Series #6. Photo taken on cross section #2 in center of channel looking downstream (UTM 10s 0749013 4322226. Compass bearing 10°).

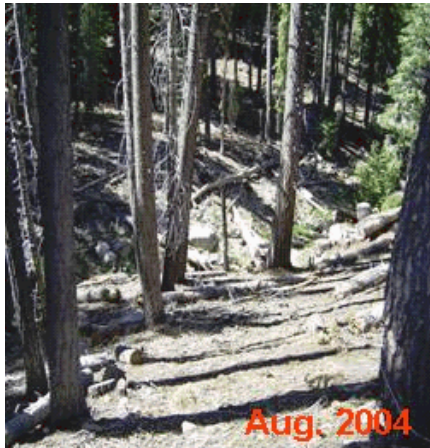
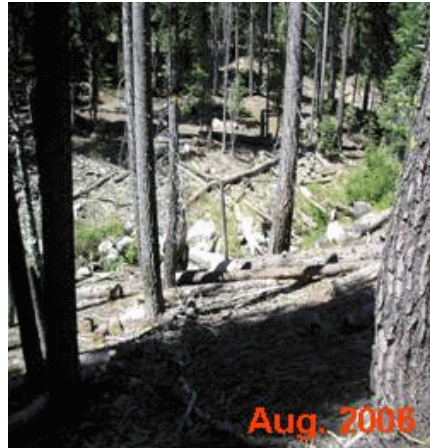
Photo Series #7. Photo taken from photopoint #4 (UTM 10s 0749017 4322205. Compass bearing 290°).
