## Caught In/Between Steel Beam and Boom Lift

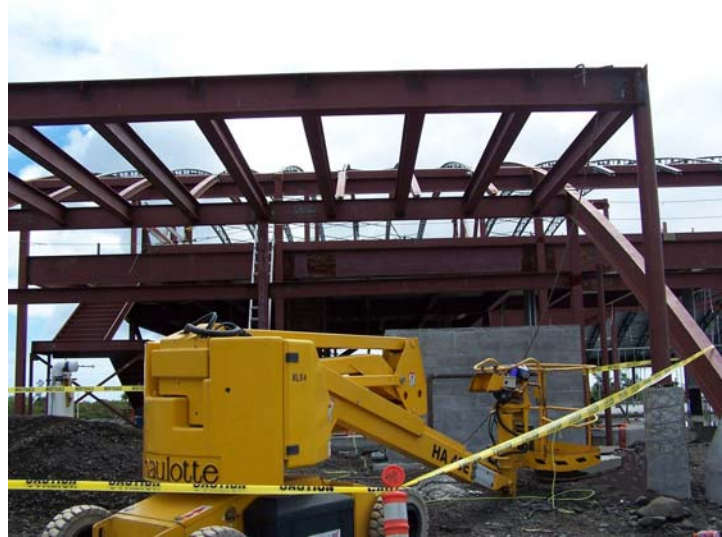
In mid-2006, a welder was killed when his head was caught between a steel beam and the control panel of the boom lift he was working from. The victim had been working alone welding a steel beam from an articulated boom-supported aerial work platform. A co-worker noticed that the victim was no longer moving and shouted out his name. He remained unresponsive. Other co-workers tried to lower the boom, but the key to switch the basket controls from the basket to the ground was missing. They tried to use a forklift to push the basket down, but that only bent the basket side rail. Finally an employee used a crescent wrench to open the hydraulic lines, which released the pressure and lowered the basket. The victim was not breathing so co-workers began to administer CPR, finally driving him to the nearest hospital approximately 2 miles away. He was pronounced dead 30 minutes later. Cause of death was traumatic compression asphyxia.

1. Train employees in the safe use and operation, including emergency procedures of the specific equipment to be used, e.g. the switchover key and the emergency lowering system. Never assume that all such equipment operate in the same way or have the same features.
2. Follow manufacturer’s instructions regarding inspection, maintenance, and operations, including the assignment of the switchover key to a person trained and responsible for emergency and rescue.
3. Manufacturers are encouraged to provide pressure sensor/relief valves in accordance with the International Organization for Standardization (ISO) Standard for articulated boom-supported aerial work platforms.

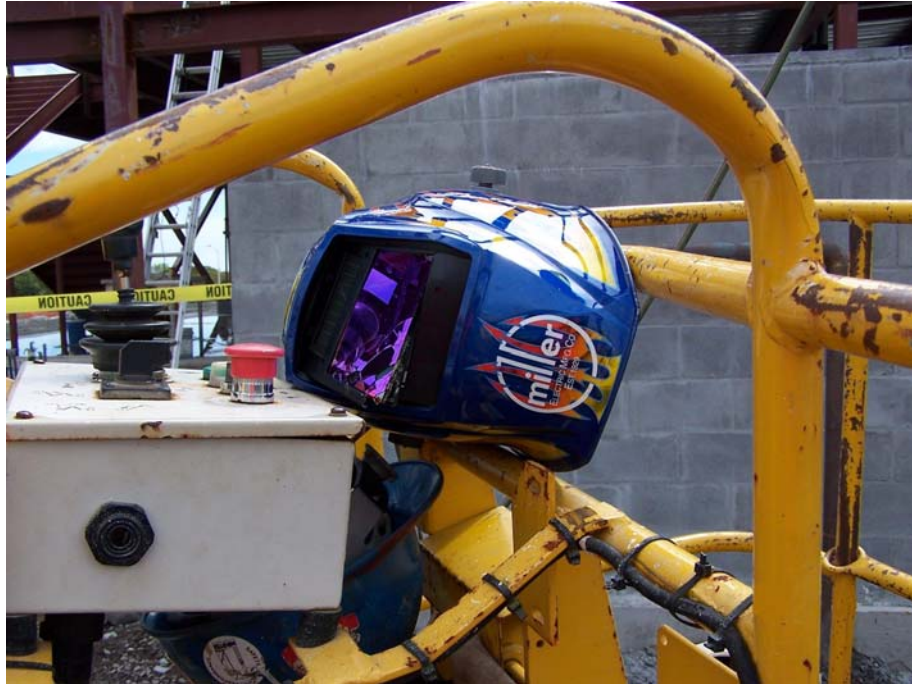
It was found that the boom lift was rented, and that no detailed inspection was performed upon accepting the equipment. The equipment rental company gave a demonstration of how to operate the lift. A selector switch on the base is used to give control of the lift to either the control panel in the lift basket or the one on the base. Switching control from one panel to the other requires the use of a key, which can be removed after the selection is made. The operating manual states that the key is to be “removed and kept by a person on the site who is properly trained in emergency and rescue operations.” The employer had not read the manual and did not assign the key to an appropriate person. The manual also describes how to operate the emergency lowering system, using a hand-operated hydraulic pump on the base of the machine, in the event of a power failure or other such emergency. Employees were not trained on the use of the emergency lowering system.

The equipment was inspected and no defects were found. It is believed that the victim inadvertently depressed the lift controls and became so wedged between the steel beam and the control panel that he could not reach the controls.
