ConocoPhillips Mississippi River Pipeline Release

August 6 - October 3, 2003

presented by Tim Ganz, former State On-Scene Coordinator,
Missouri Department of Natural Resources
Environmental Emergency Response Section

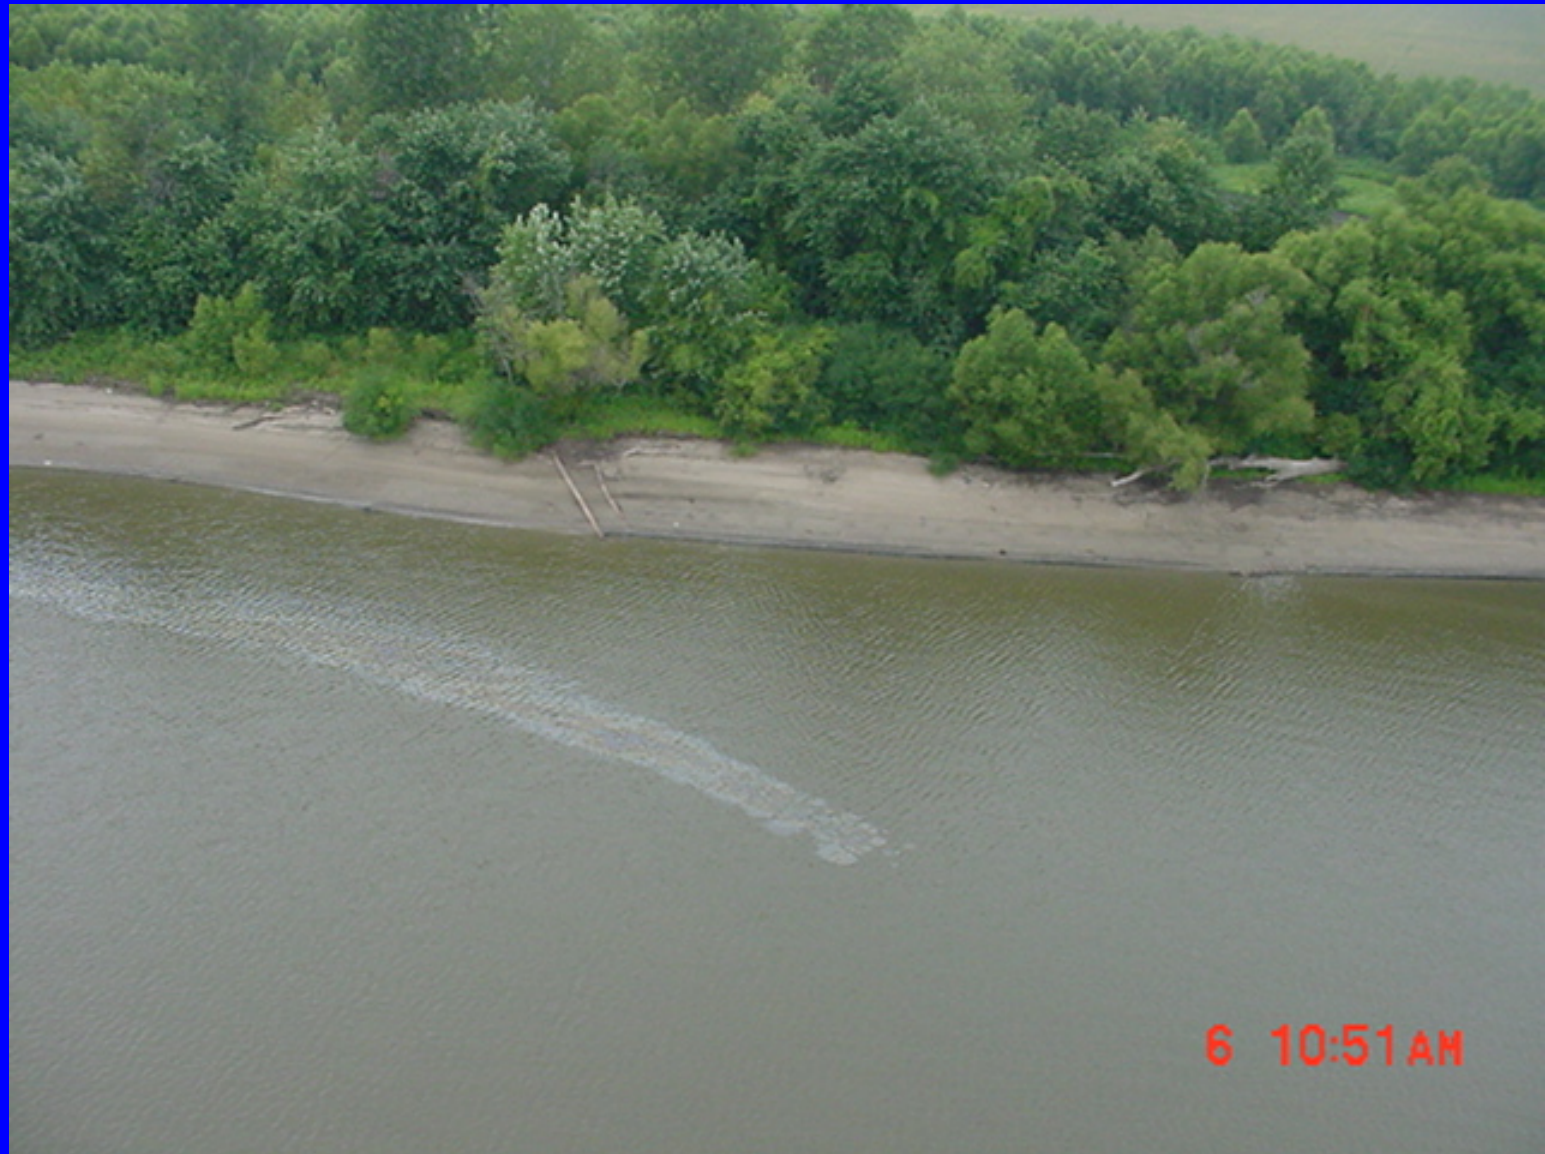
Crude Oil Sheen from South Line - 8/06/03

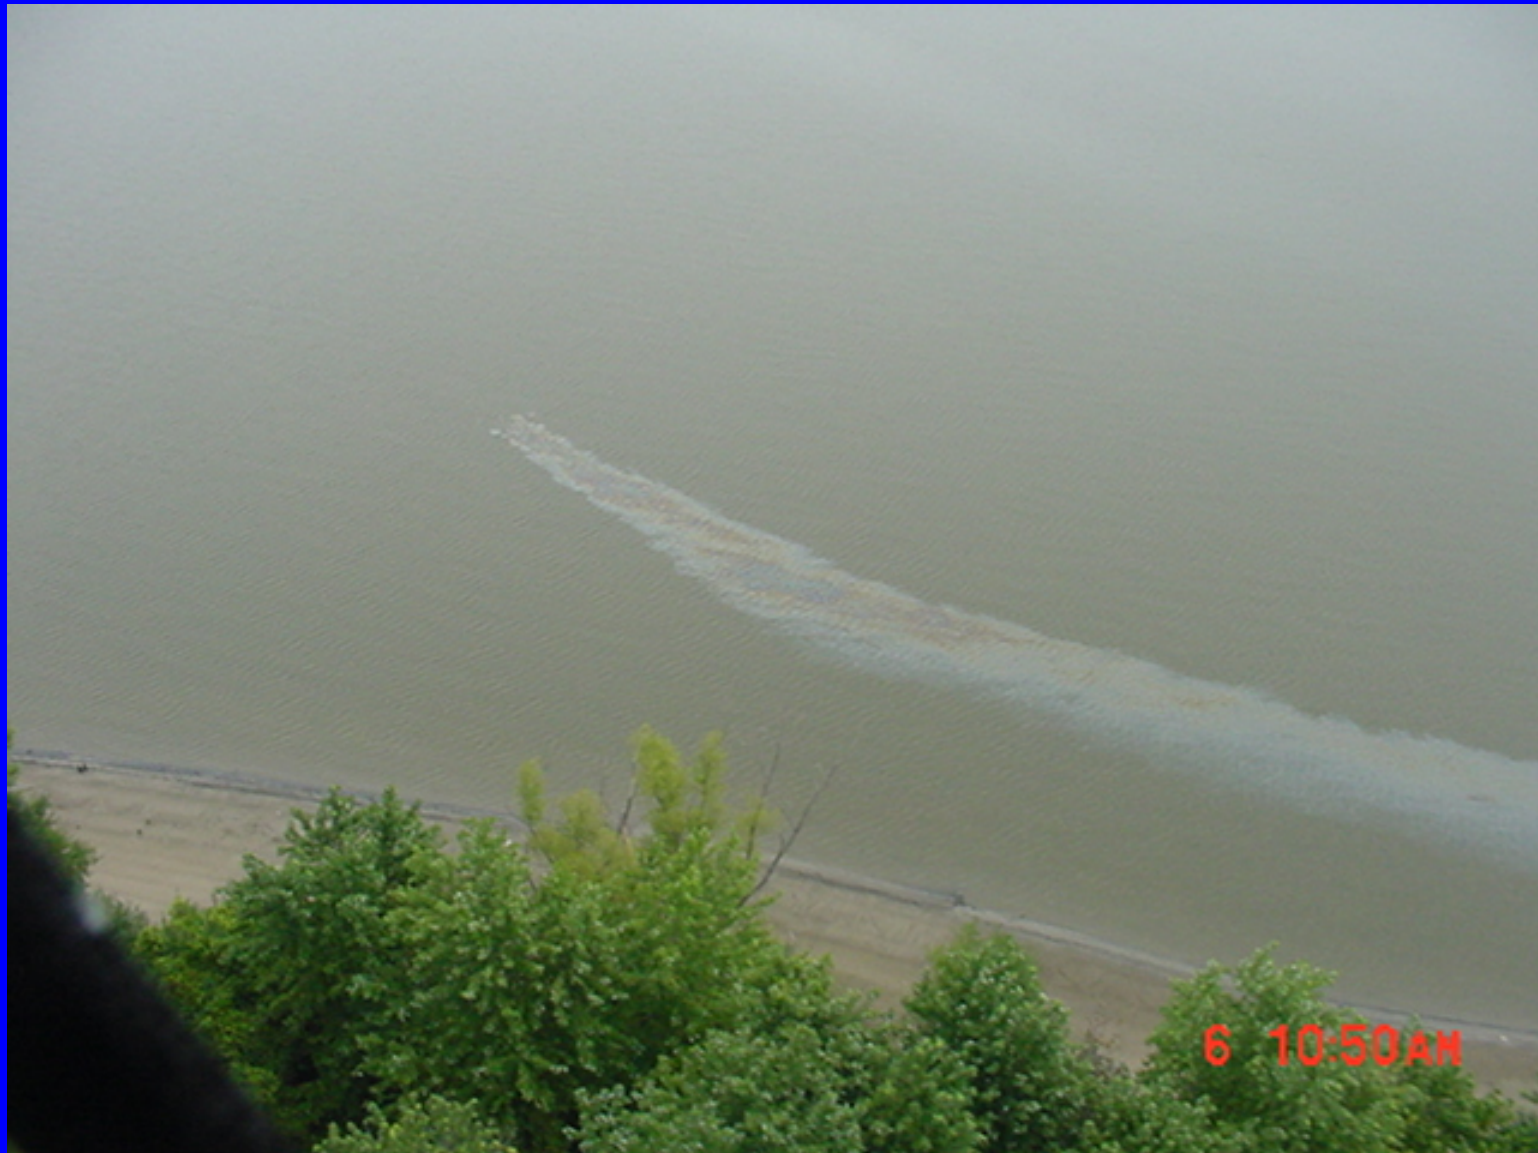
Crude Oil Sheen from South Line - 8/06/03

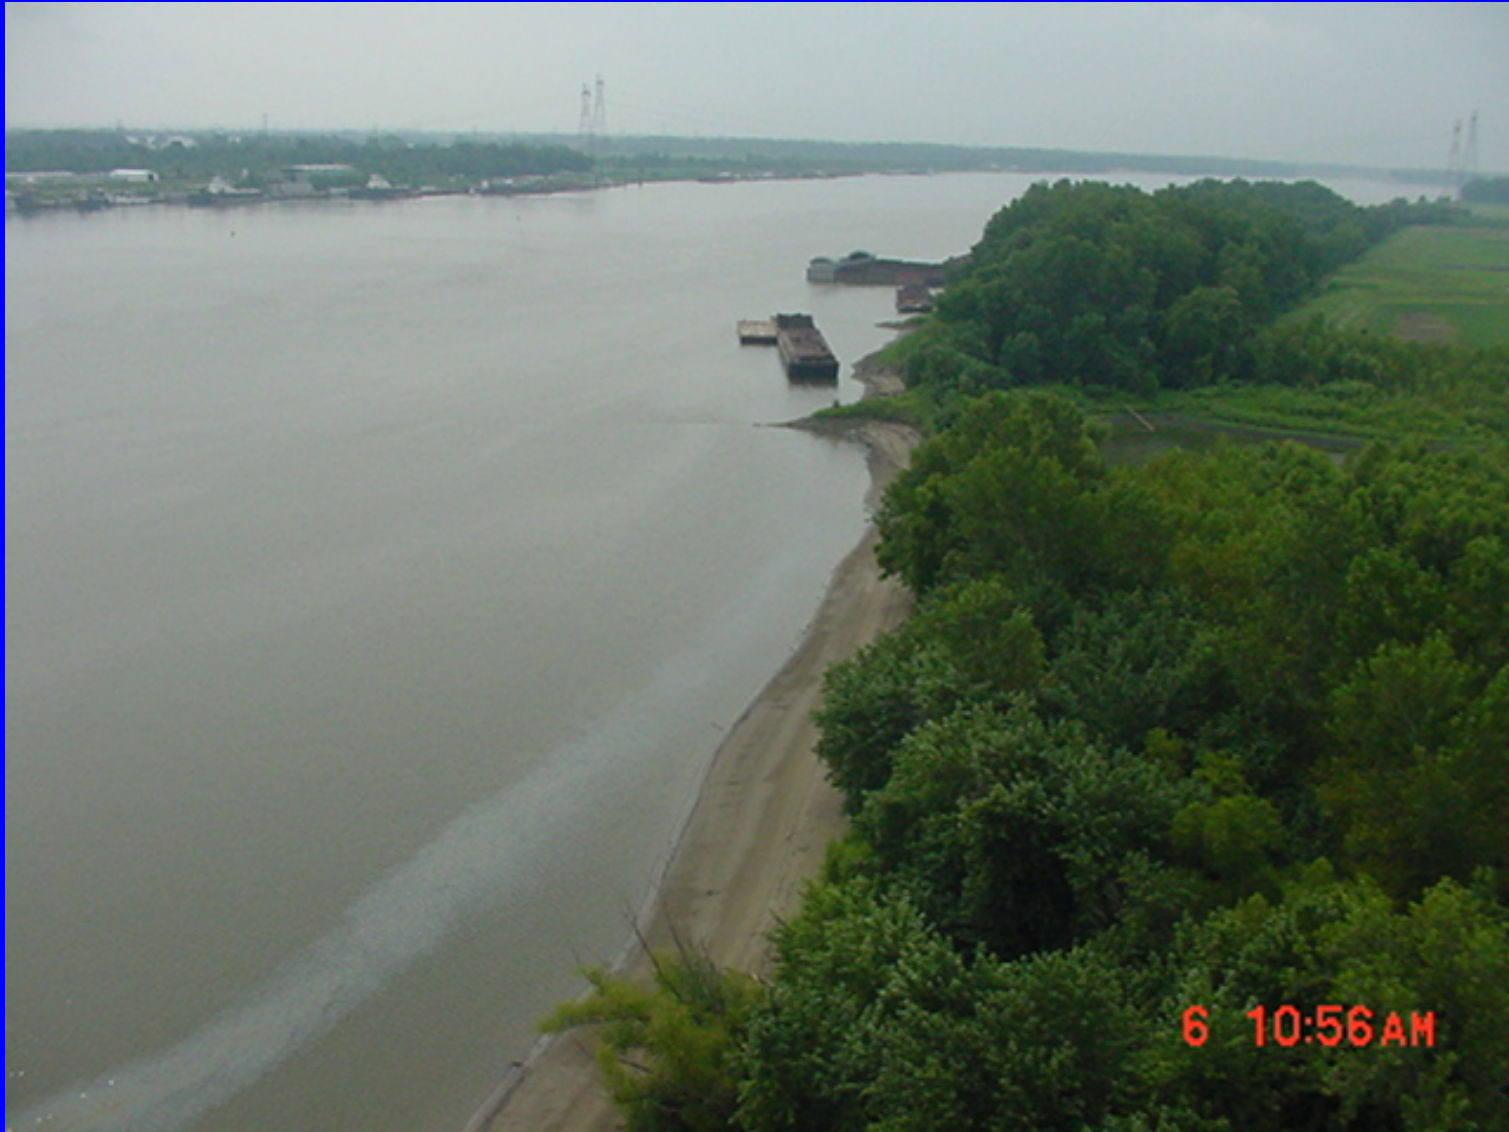
Crude Oil Sheen from South Line - 8/06/03

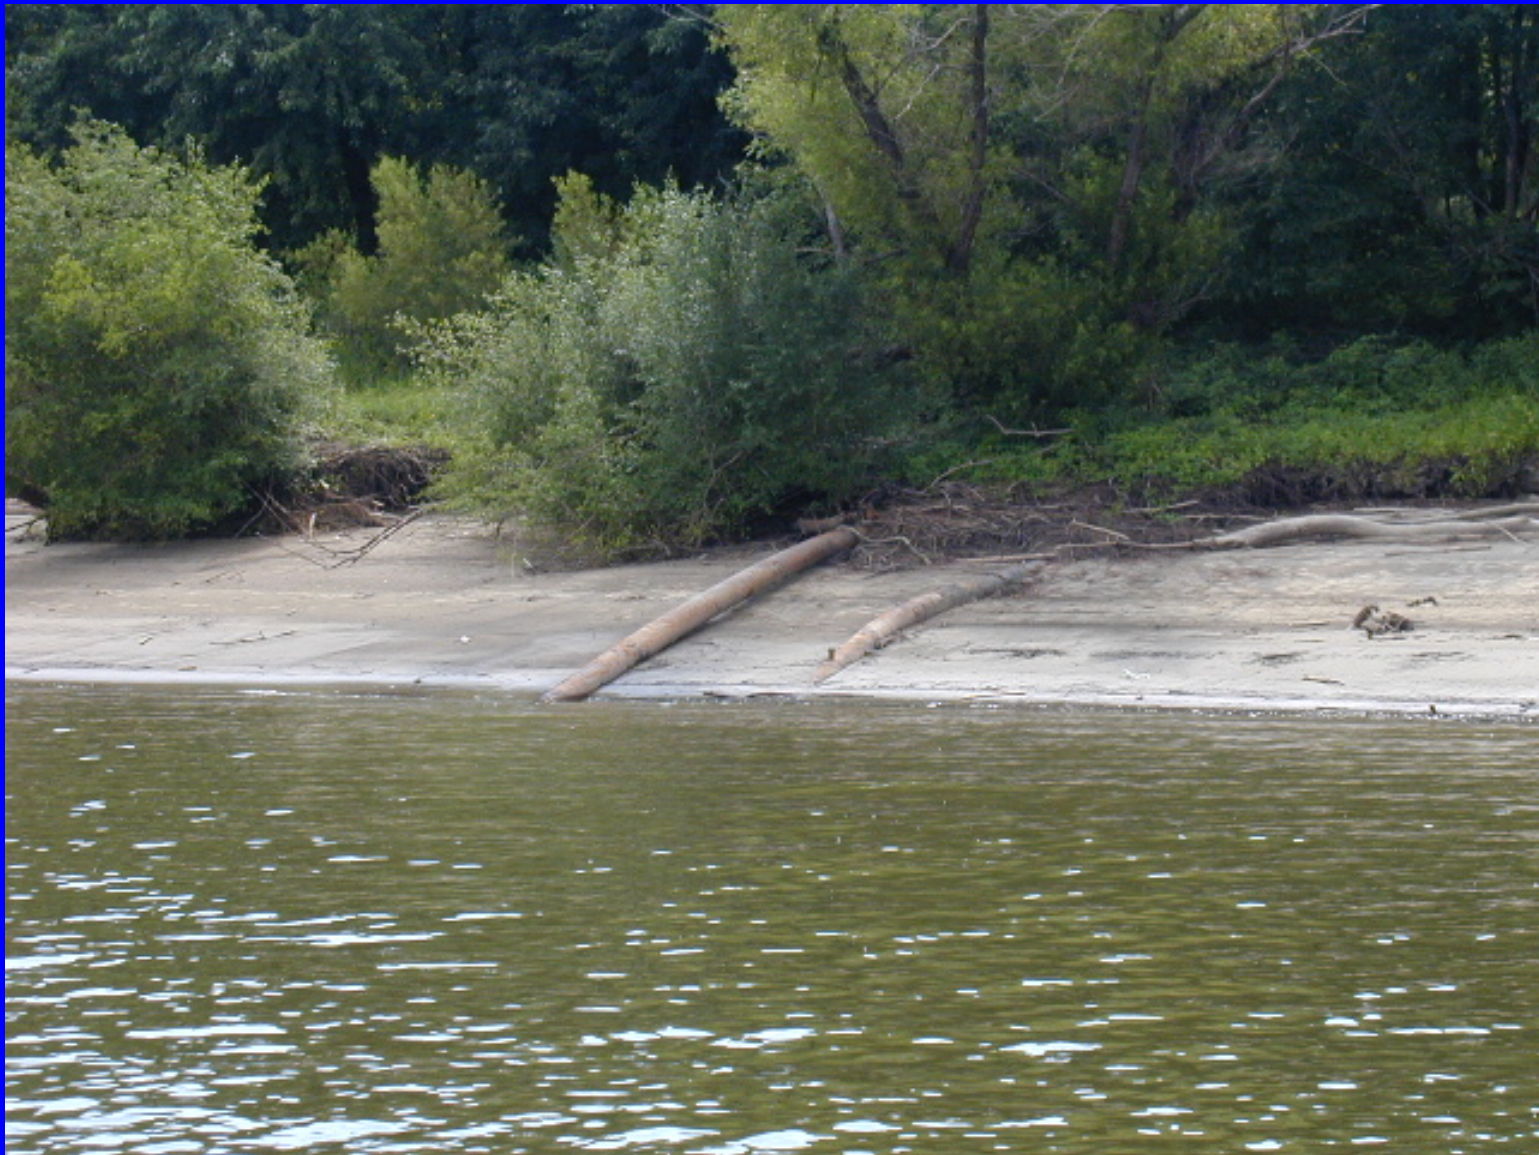
Abandoned pipelines on Missouri side - 08/06/03

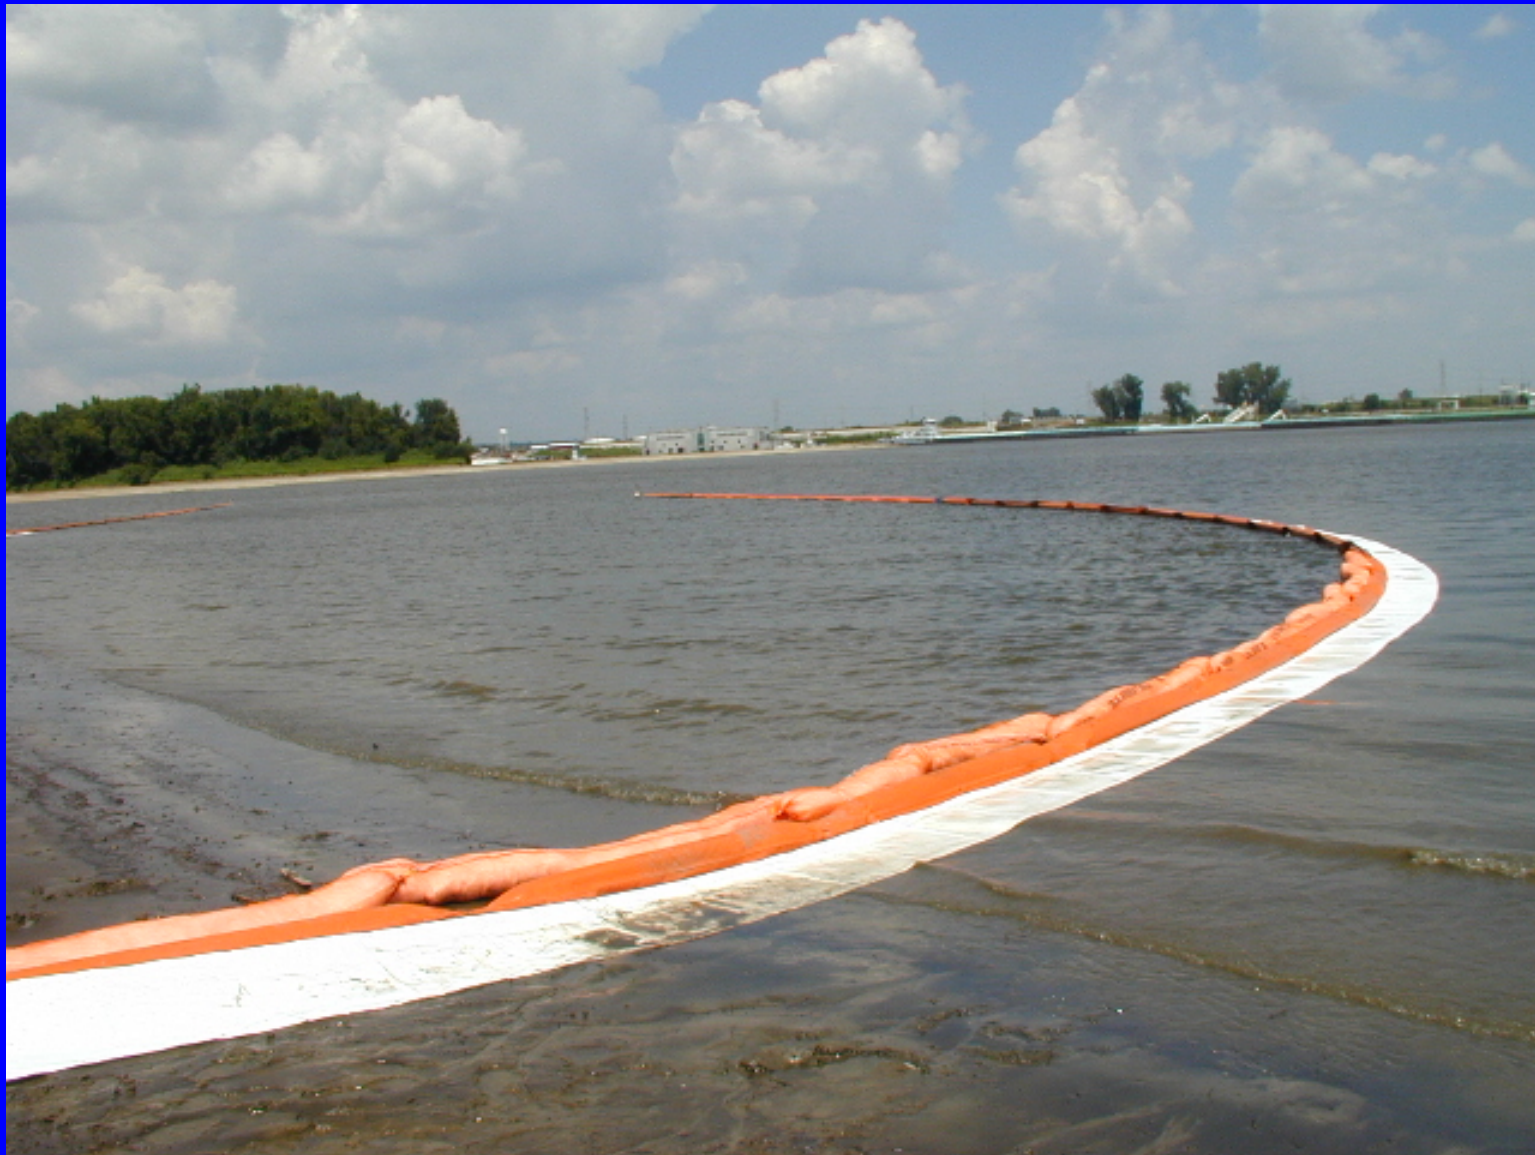
Initial containment of sheen / release - 08/07/03

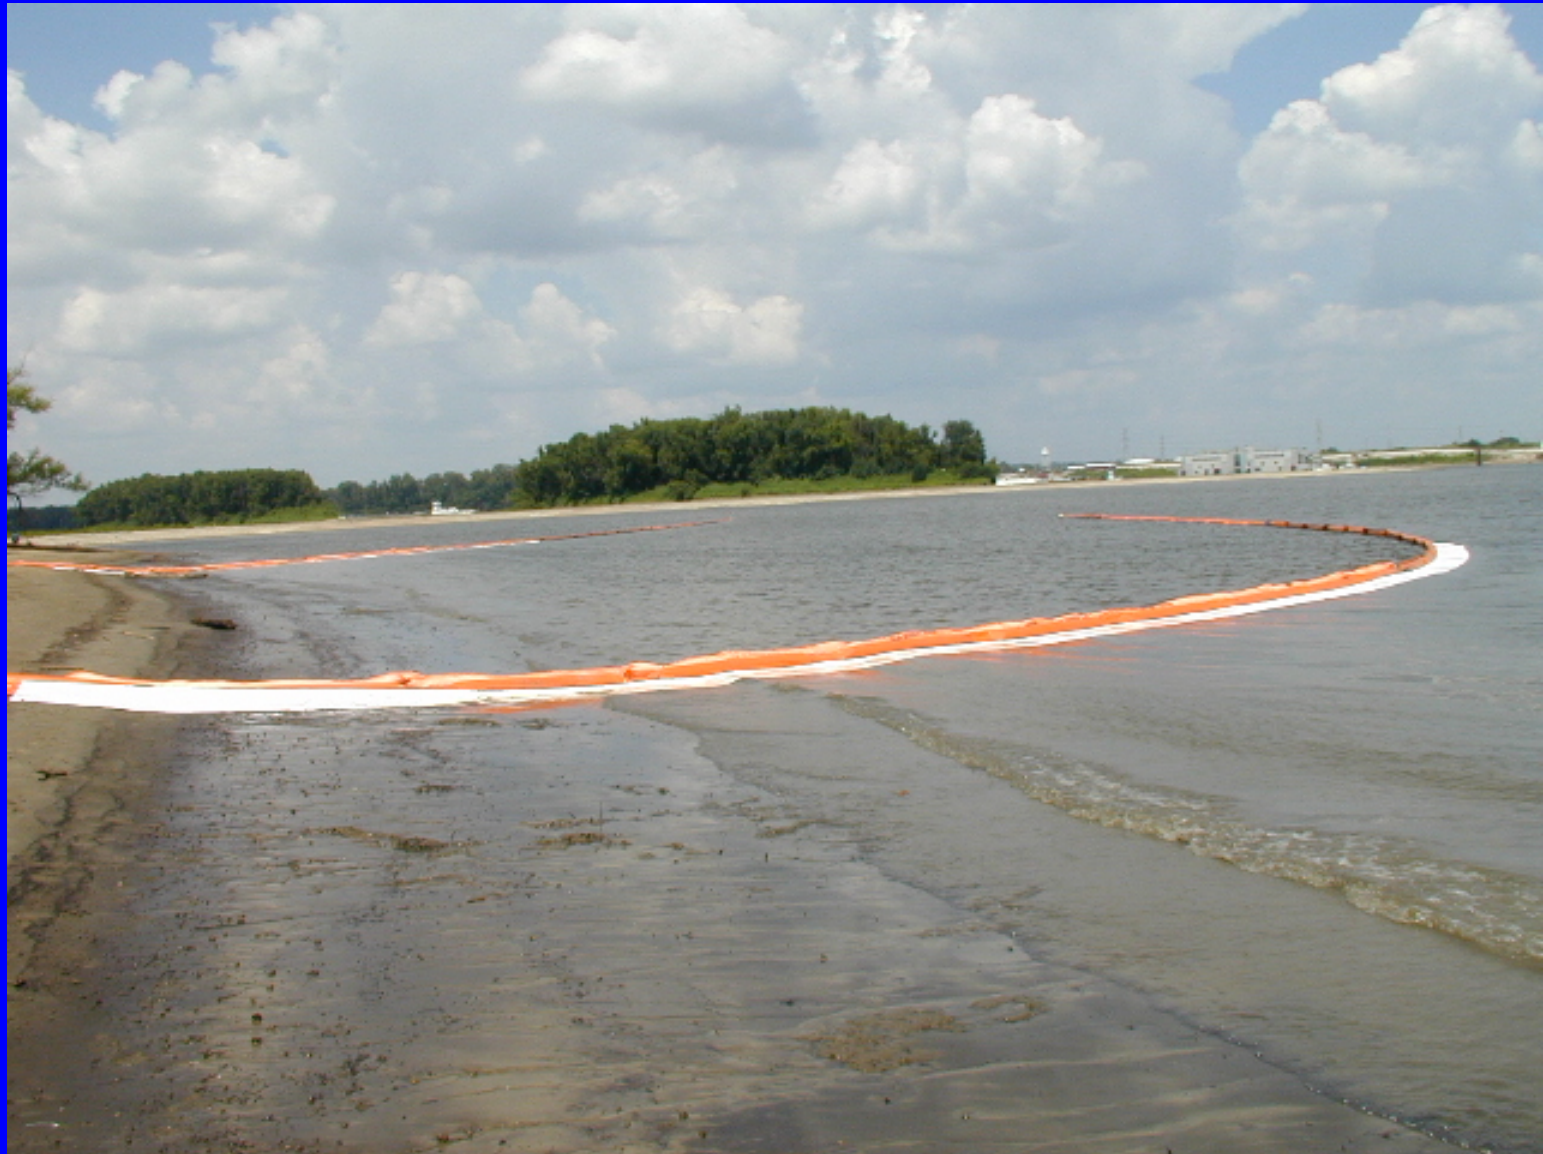
Initial containment of sheen / release - 08/07/03

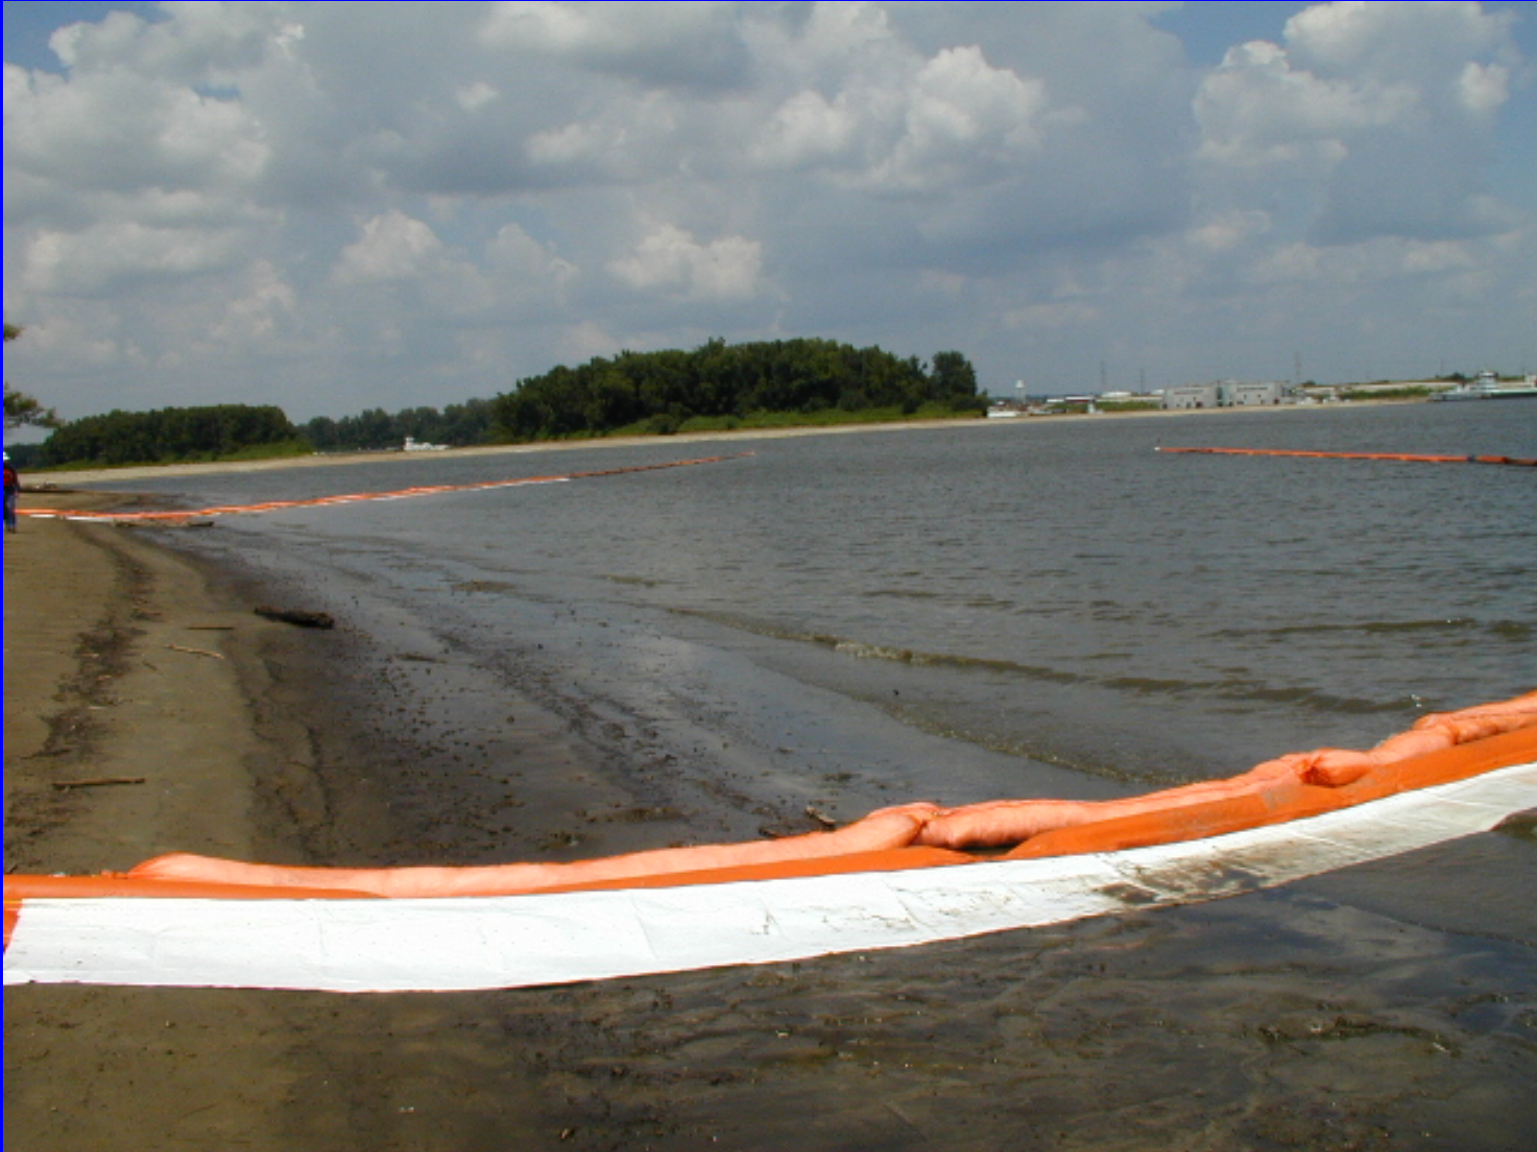
Containment boom - 08/08/03

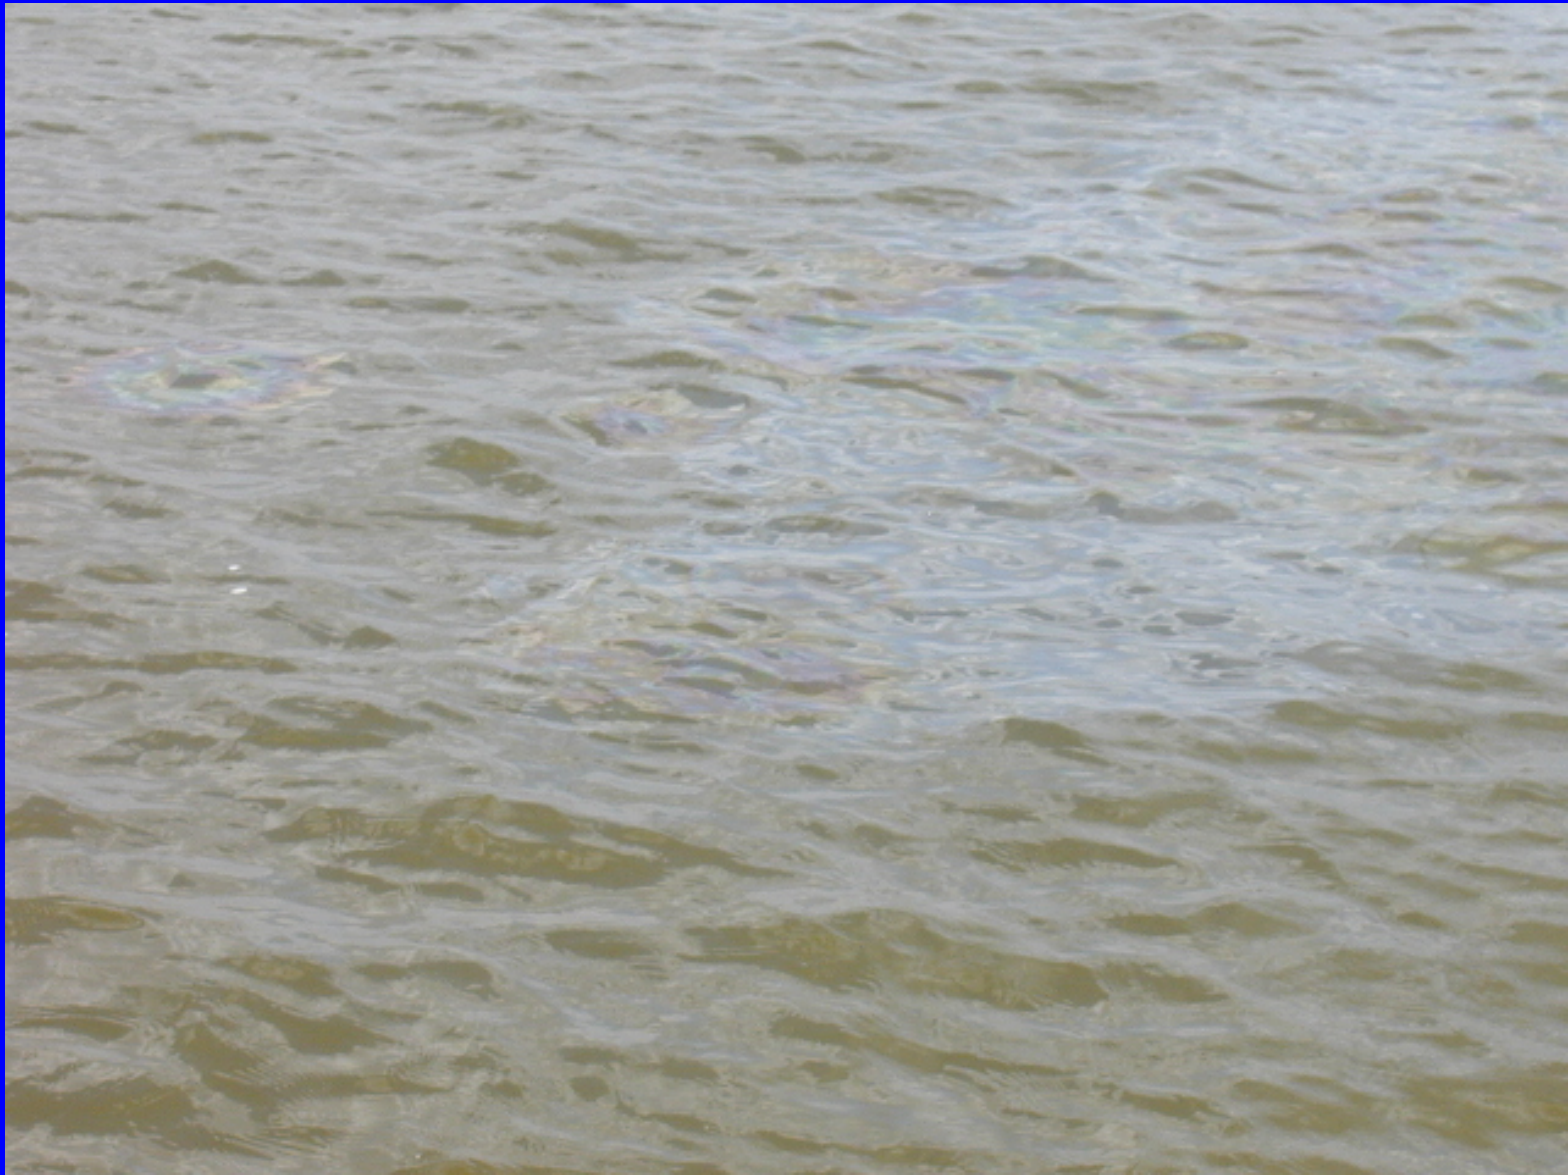
Petroleum sheen at source - 08/06/03

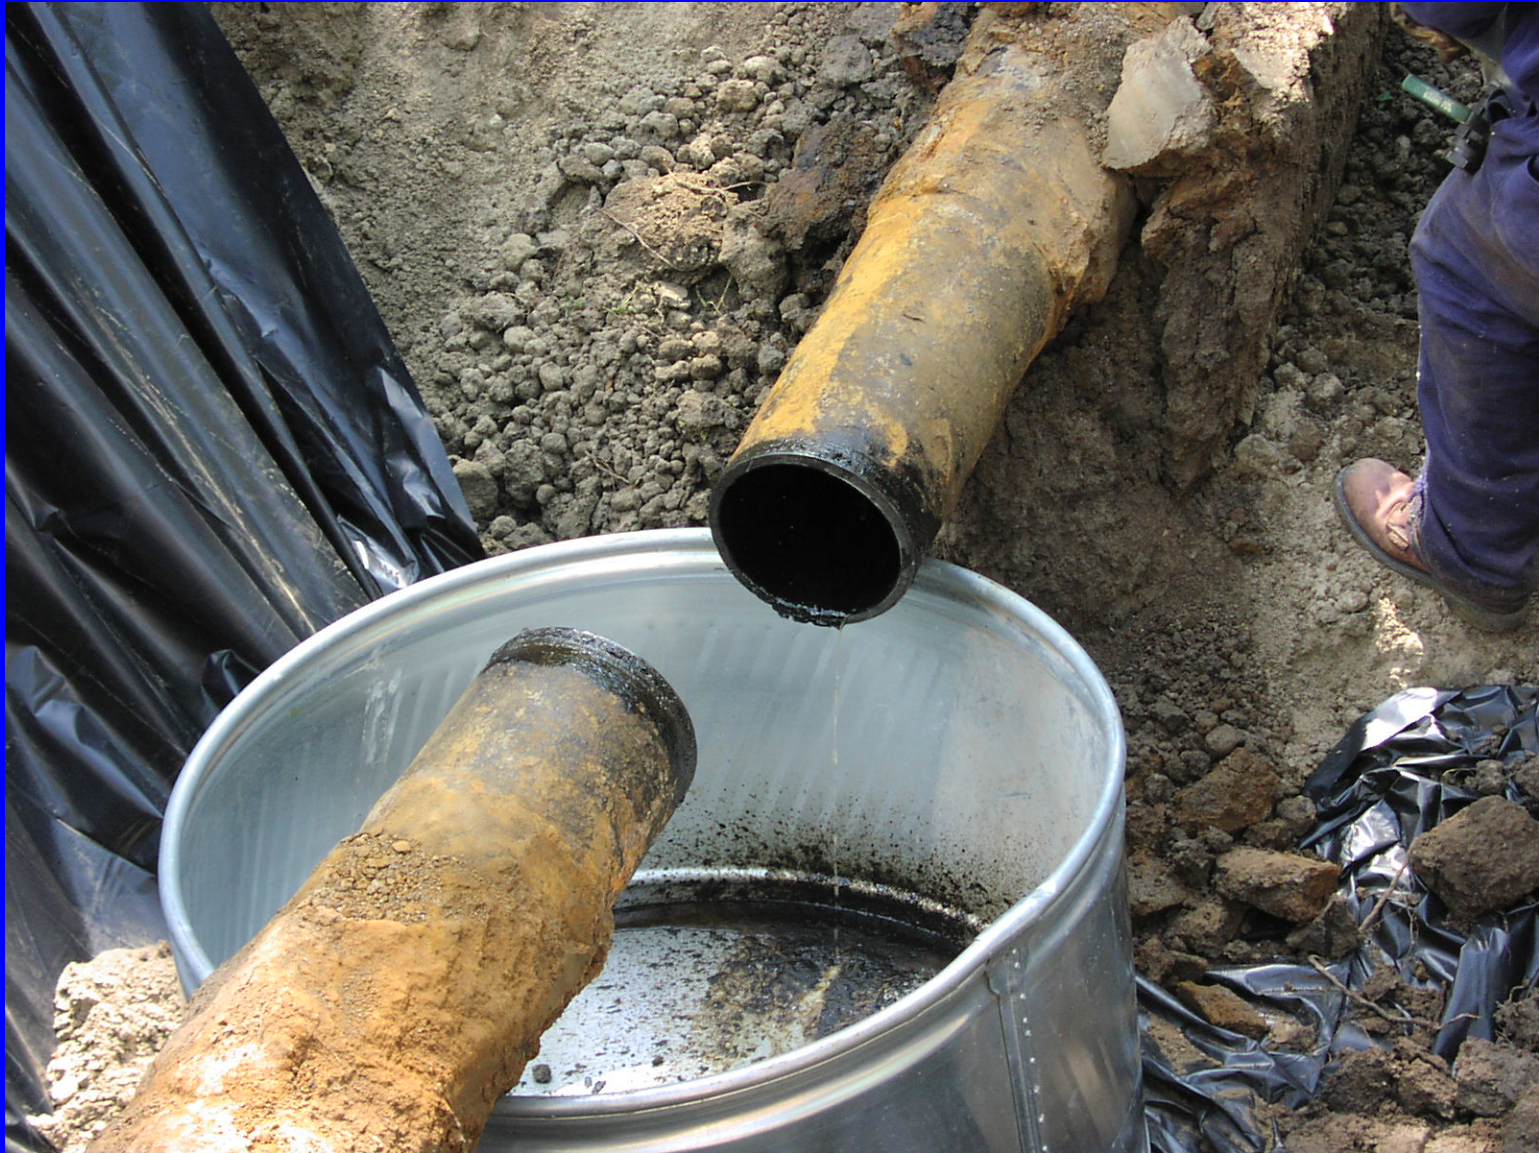
Cutting of south line - 08/09/03

- The south line was cut open on the Missouri side on 08/09/03 so material could be pumped out of the line.
- 400' section of two inch diameter PVC pipe advanced into the south line to suck out remaining oil/water
- Oil/water mix was pumped into a steel tub at the open end of the pipeline and pumped from there into a trailer mounted vacuum tank
- Approximately 30 barrels of crude and 10 barrels of water were recovered from this operation

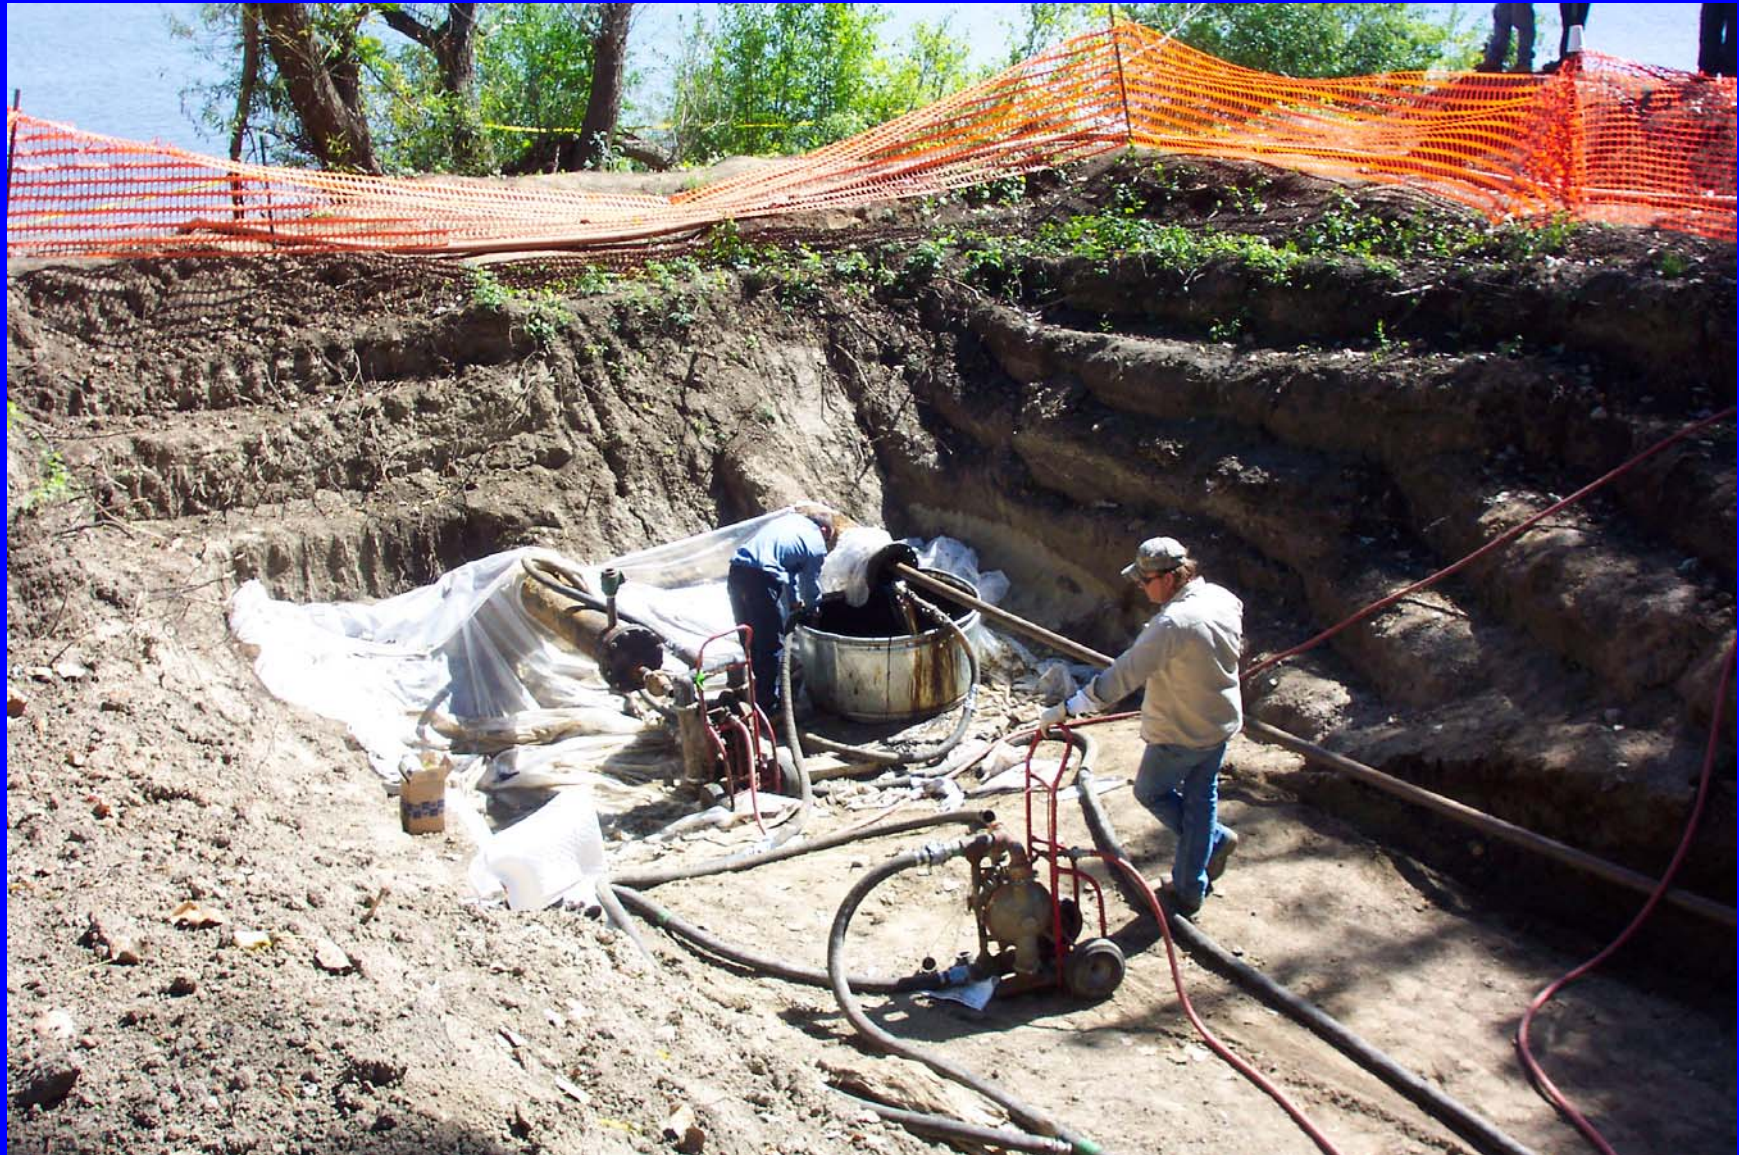
Pumping out remaining crude/water in South Line

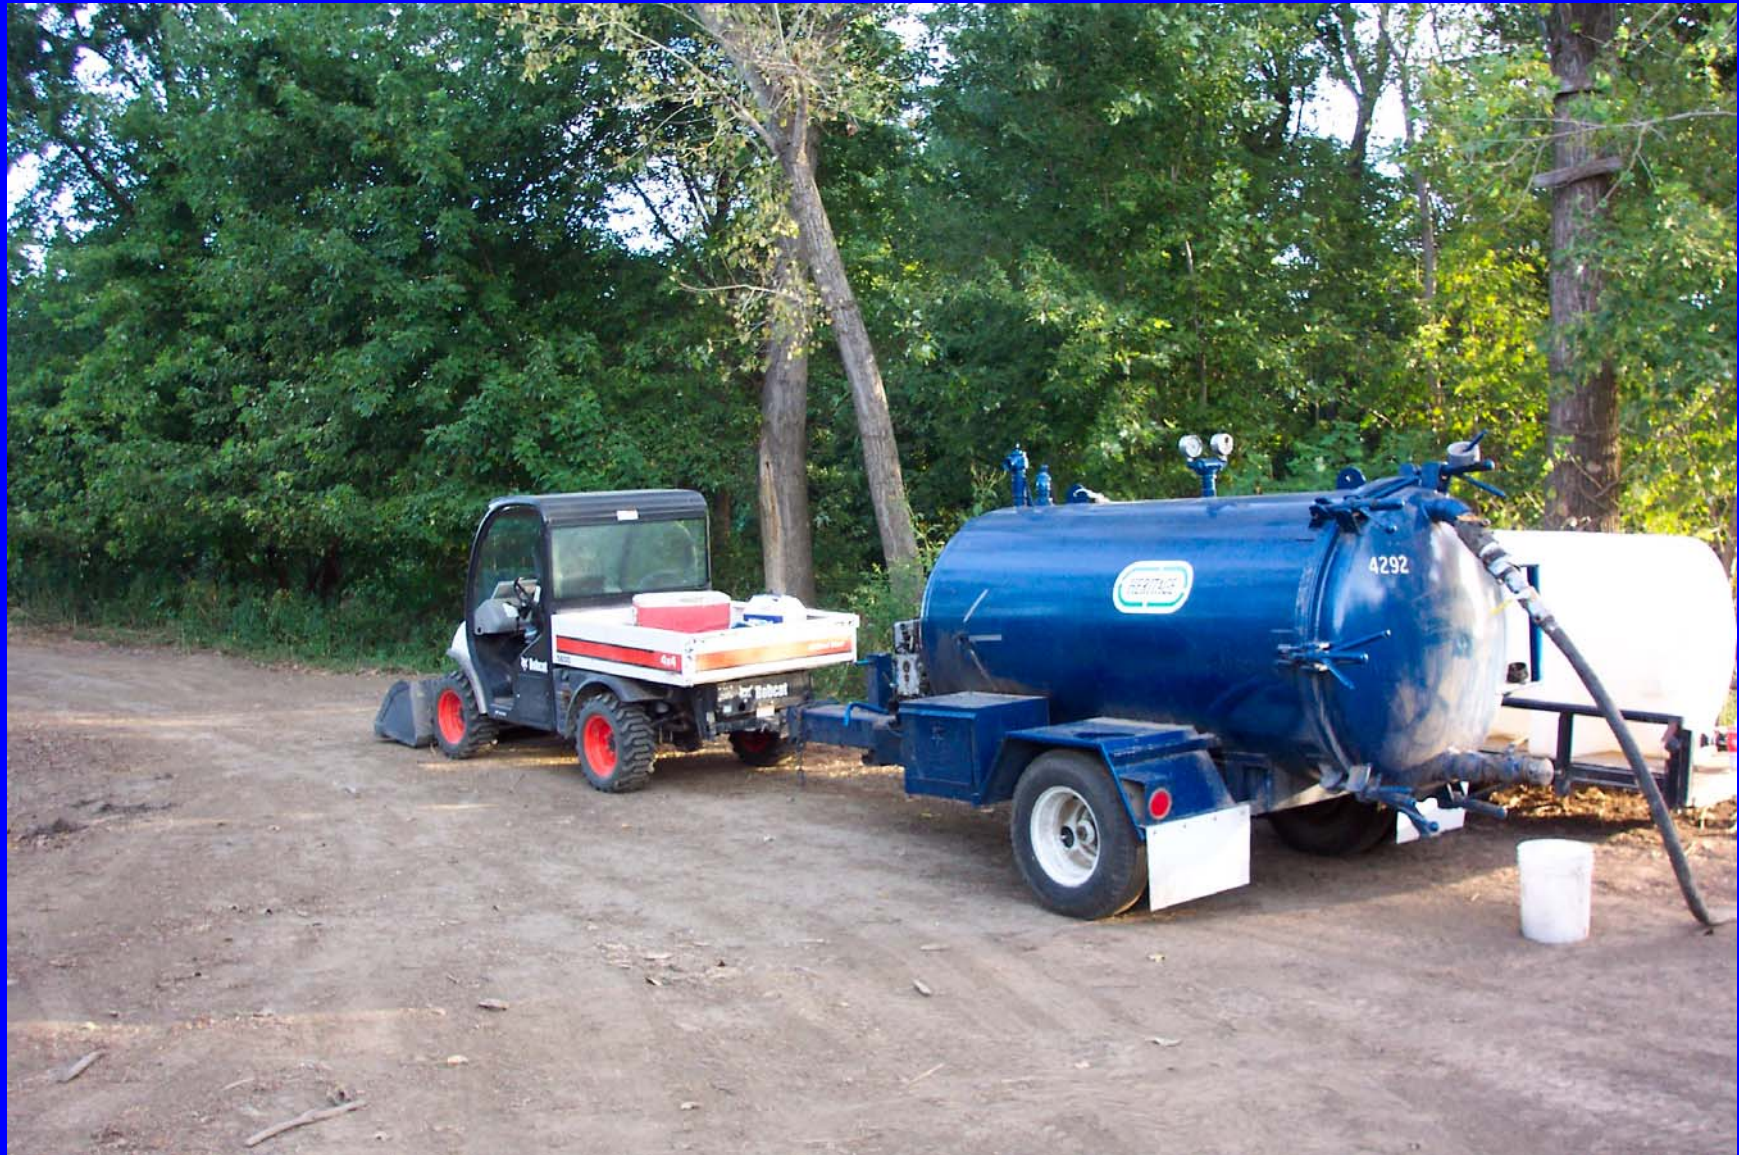
Portable vac tank

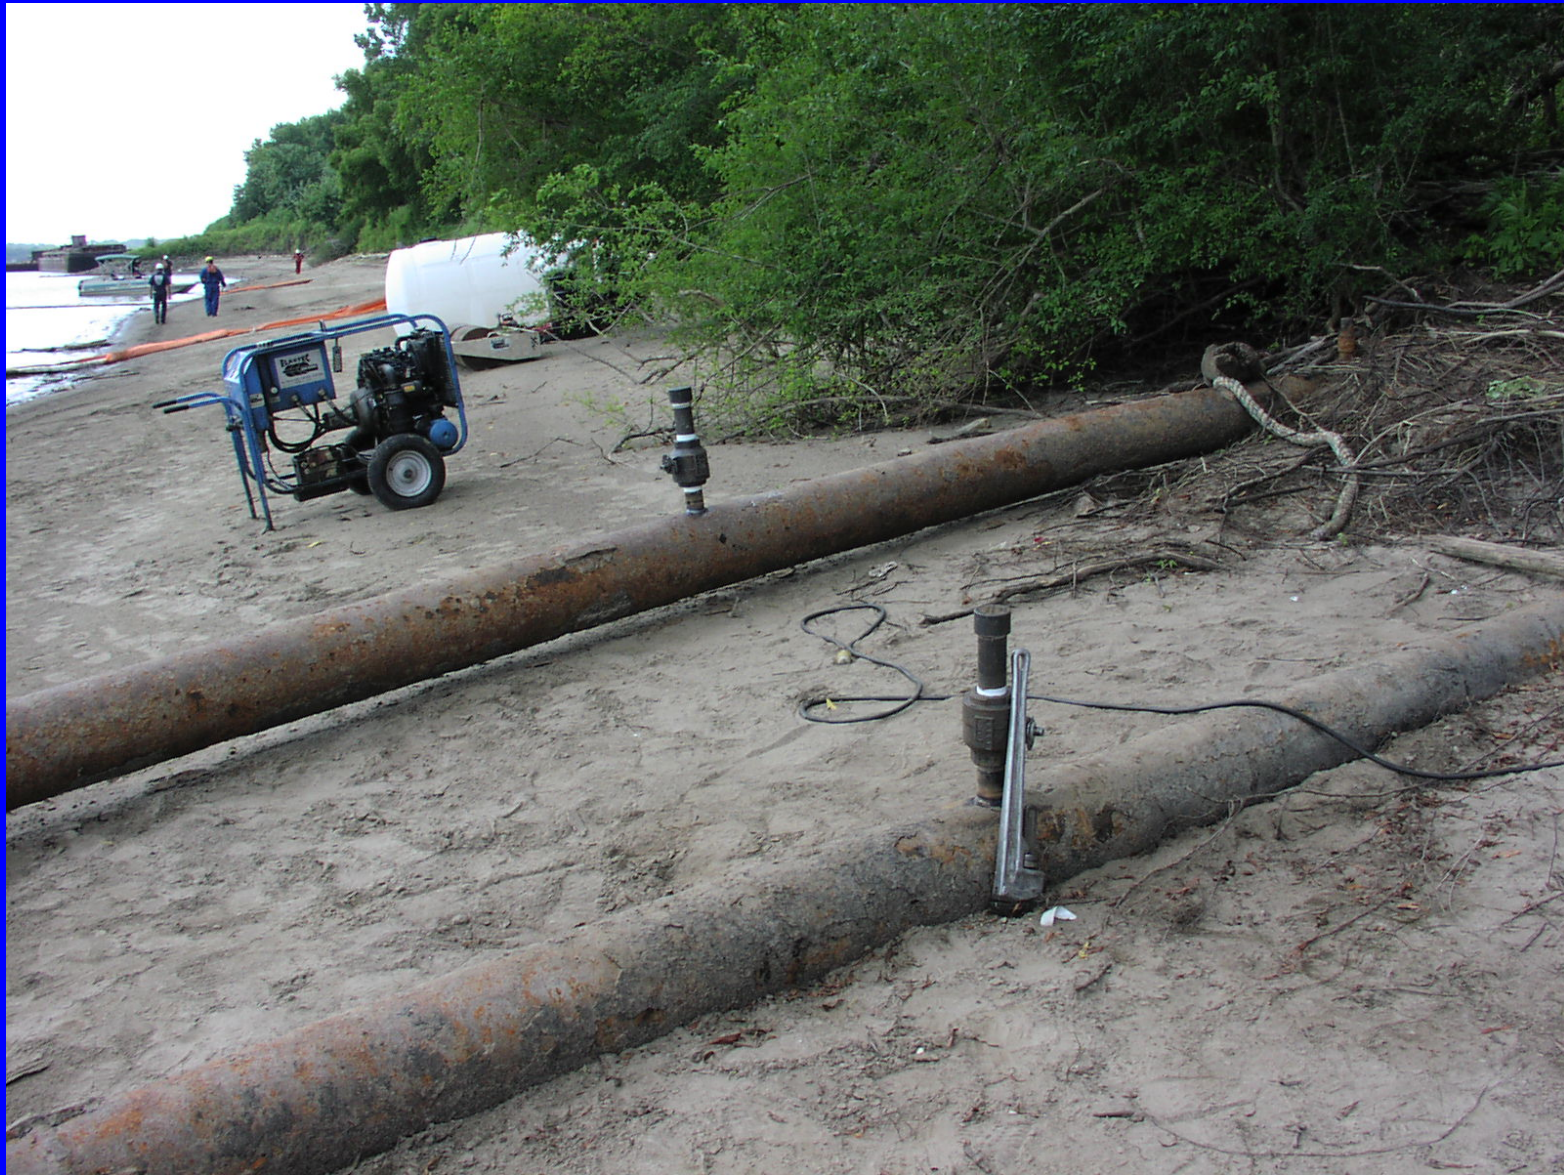
TOR valves installed on lines to bleed off pressure / recover product - 08/08/03
