ConocoPhillips Mississippi River Pipeline Release

August 6 - October 3, 2003

presented by Tim Ganz, former State On-Scene Coordinator,
Missouri Department of Natural Resources
Environmental Emergency Response Section

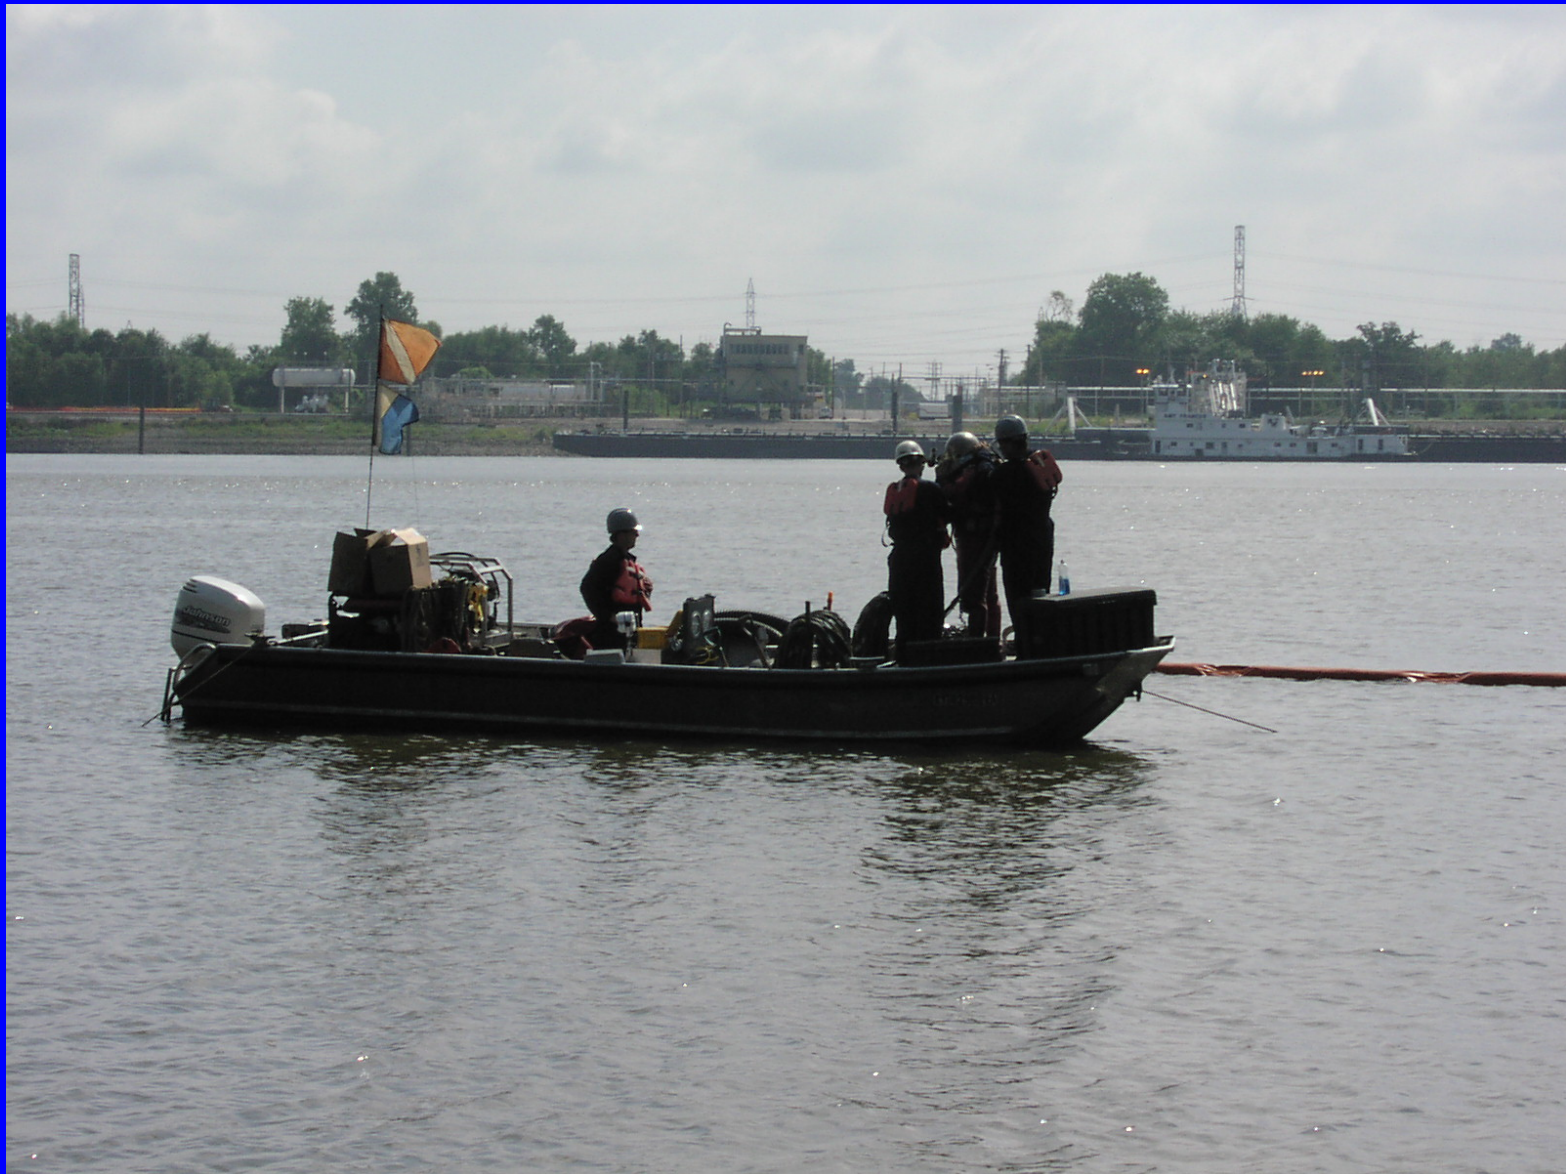
Dive team at source - 08/09/03

- Dive team hired by ConocoPhillips to find the leak and “patch” the line.
- The dive team found the leak and fastened a “sleeve clamp” to the leak area to stop the leak.
- The dive team disturbed the sediments around the south line causing a release of crude oil.

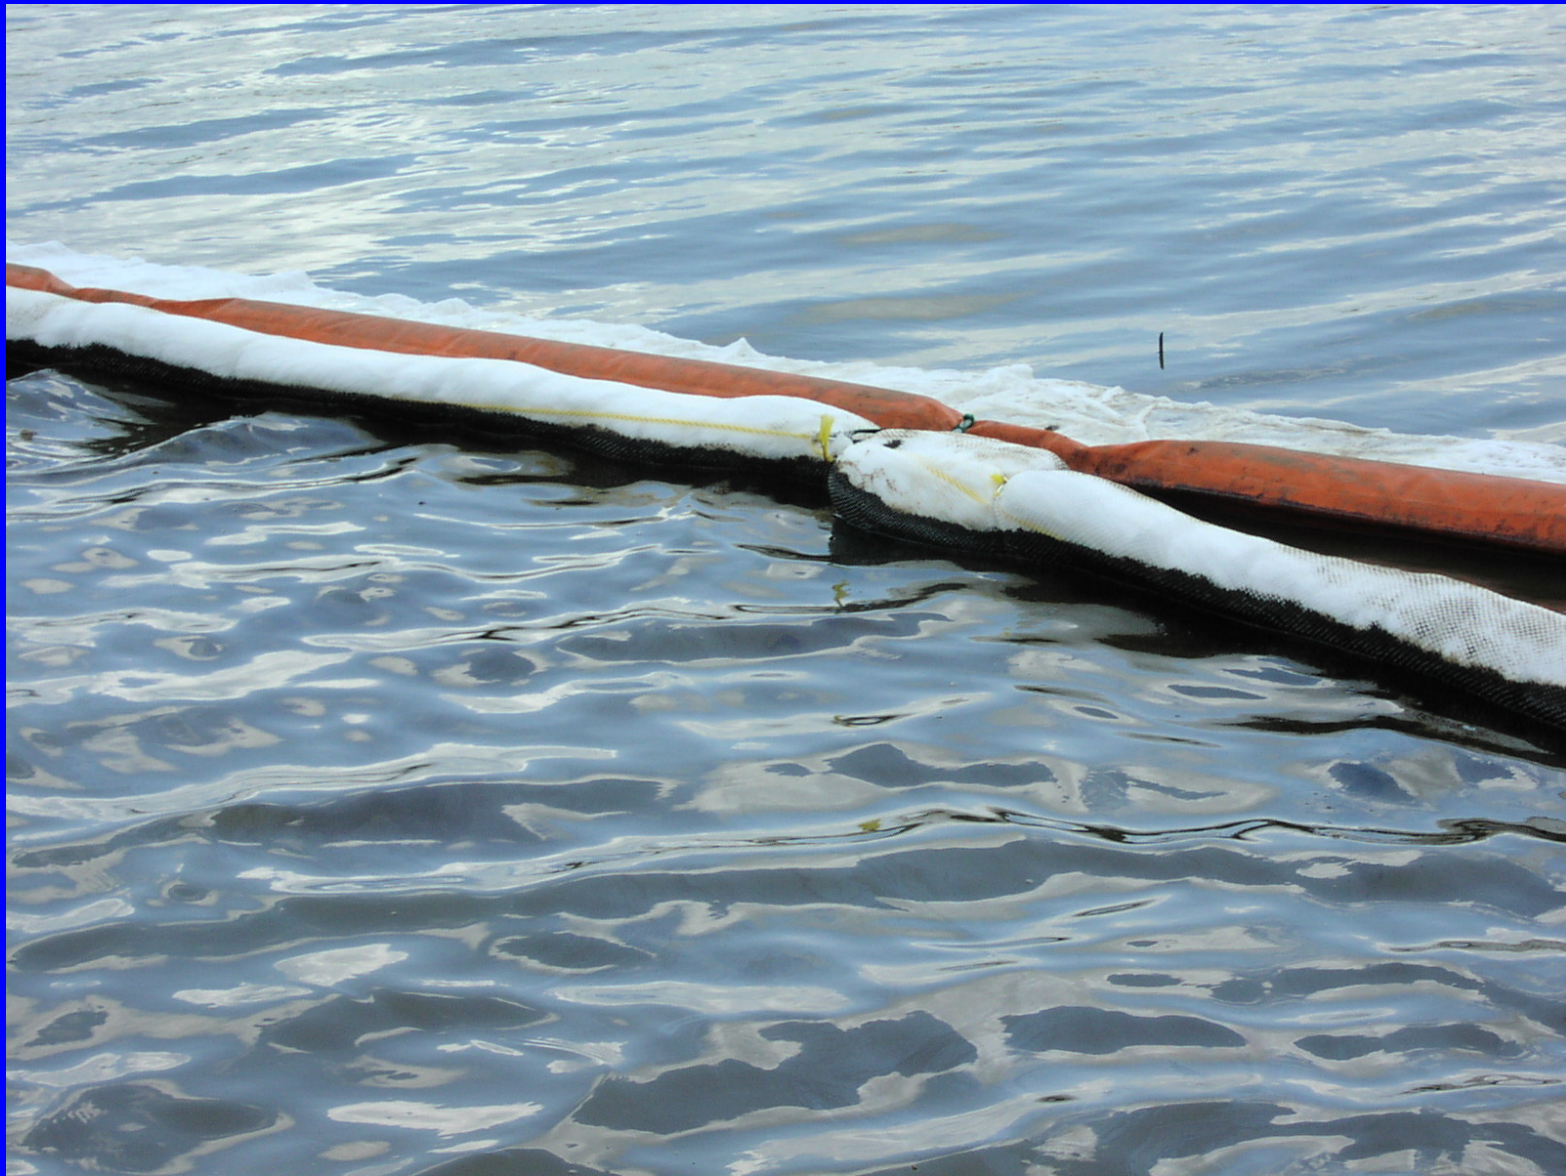
Absorbent boom saturated with crude oil - 08/09/03

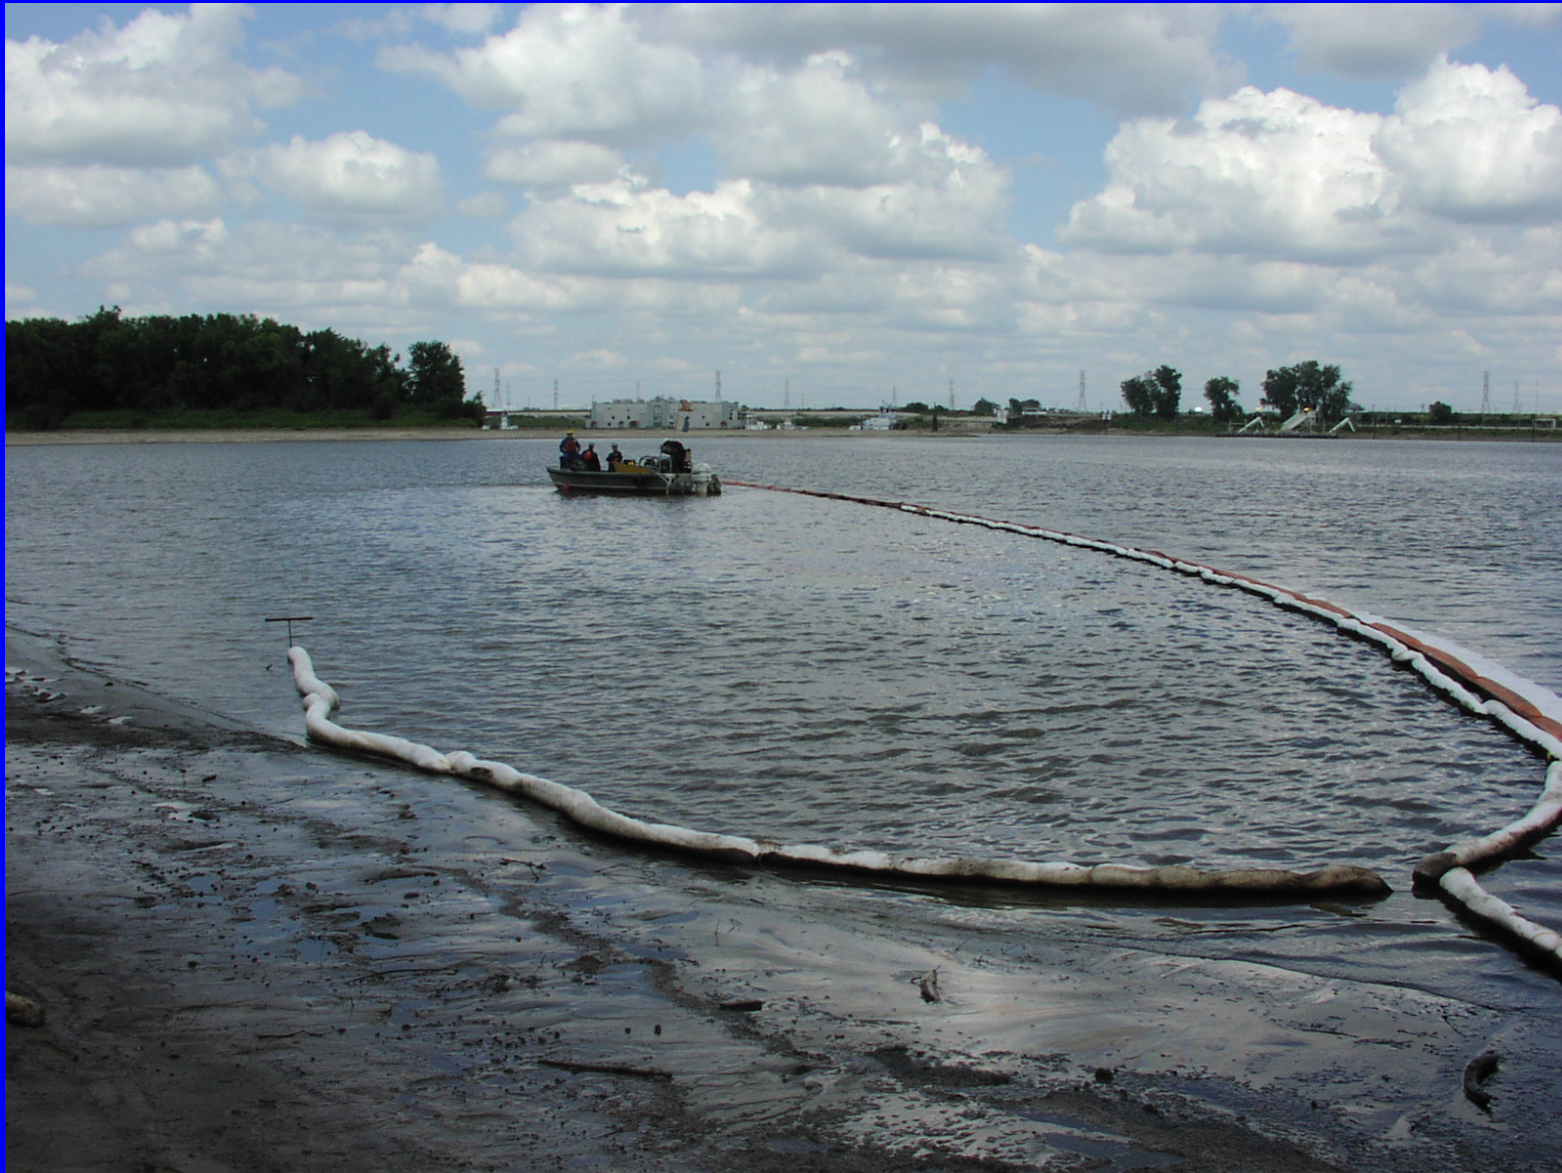
Dive team disturbing contaminated sediments - 08/09/03

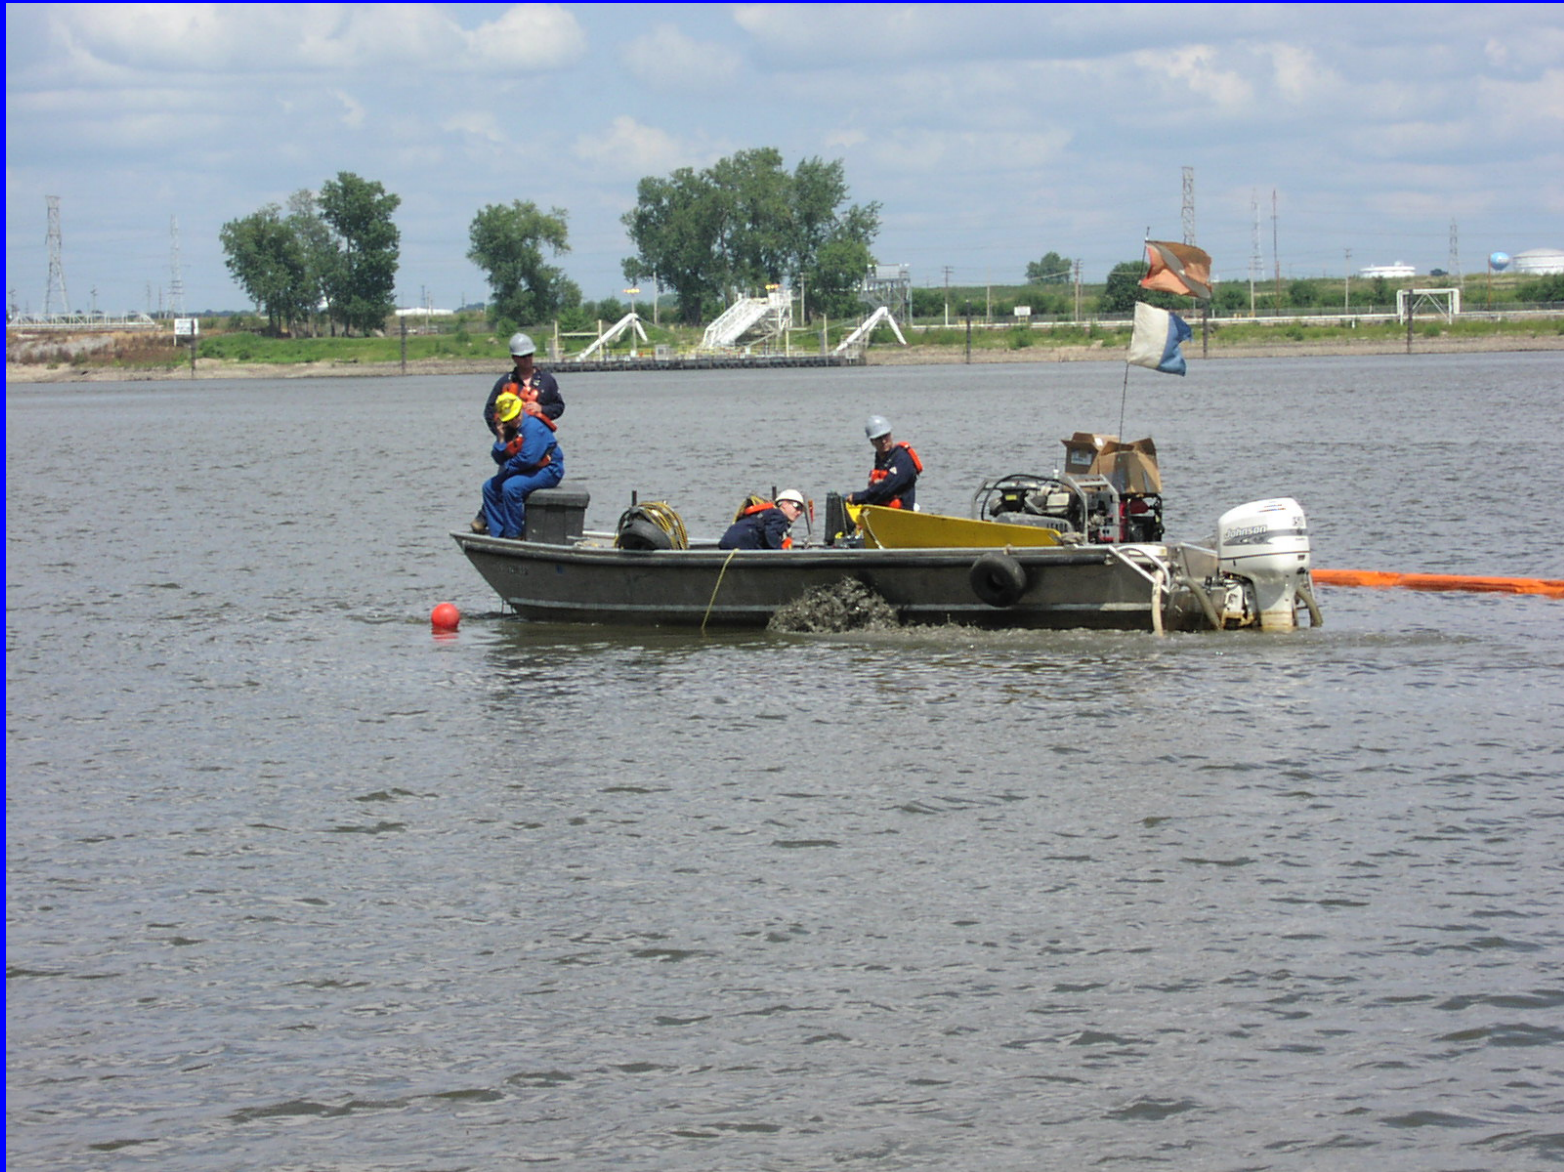
Dive team disturbing contaminated sediments - 08/09/03

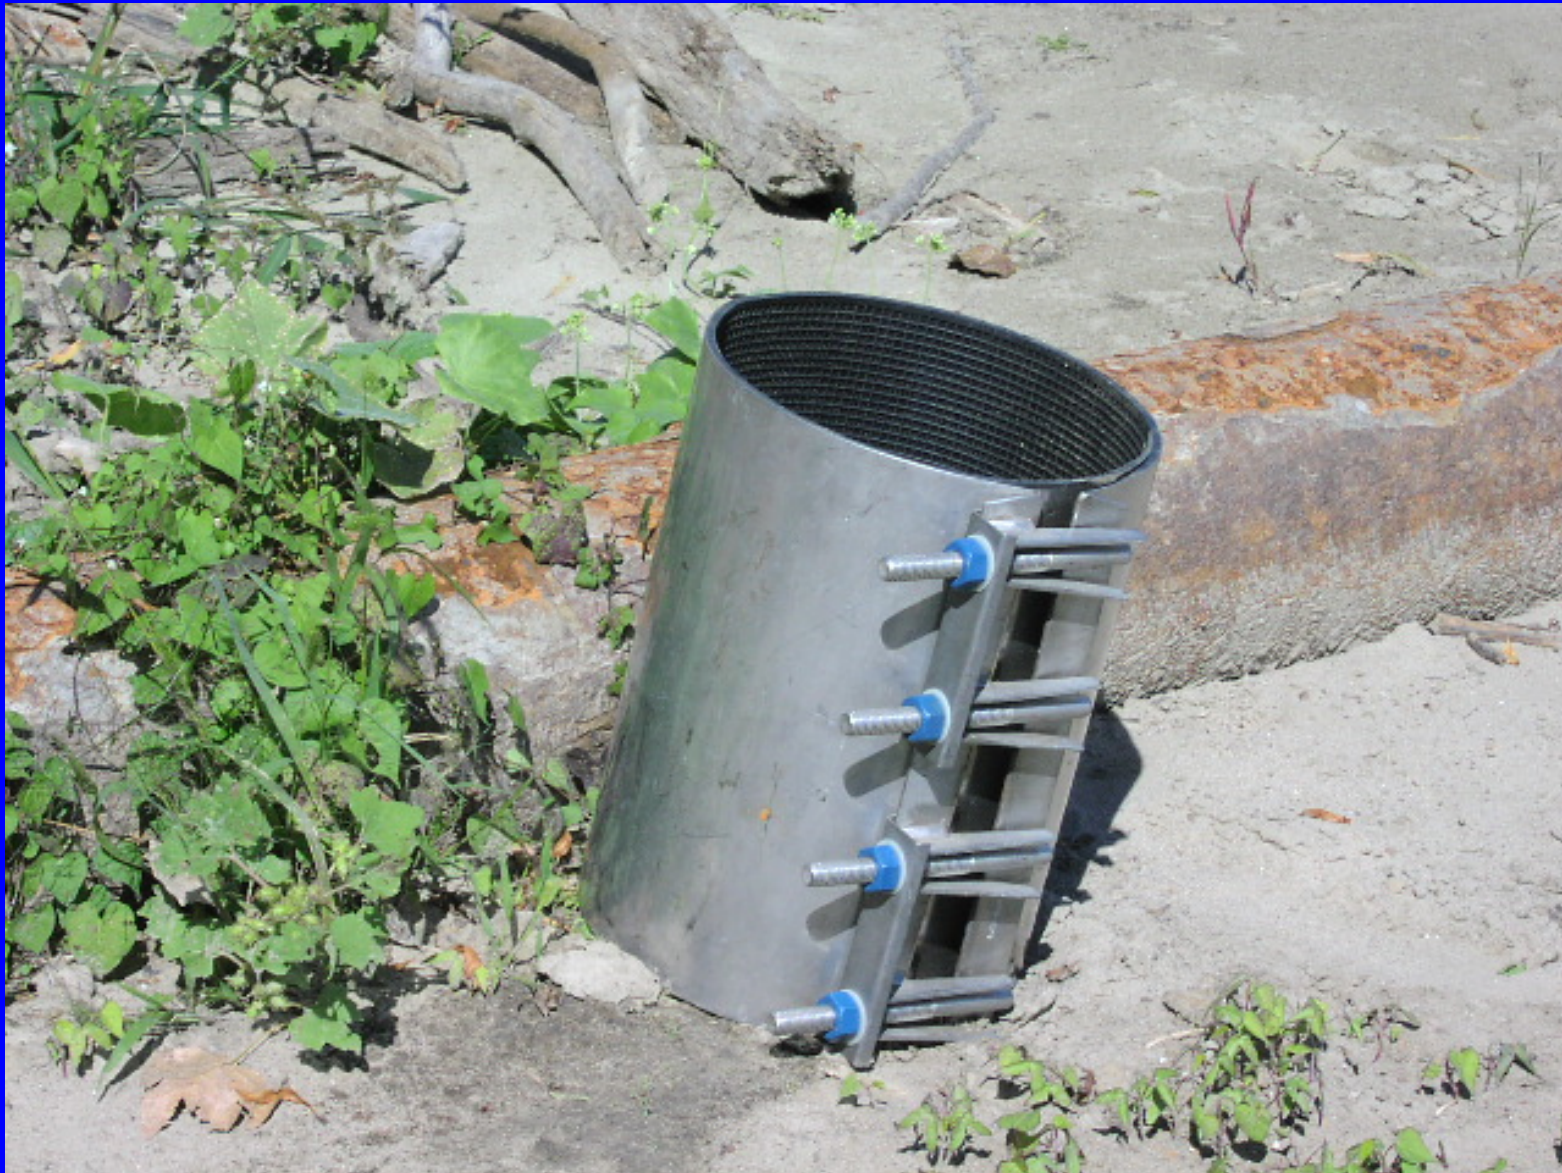
Metal sleeve used to “patch” the leak on the south line

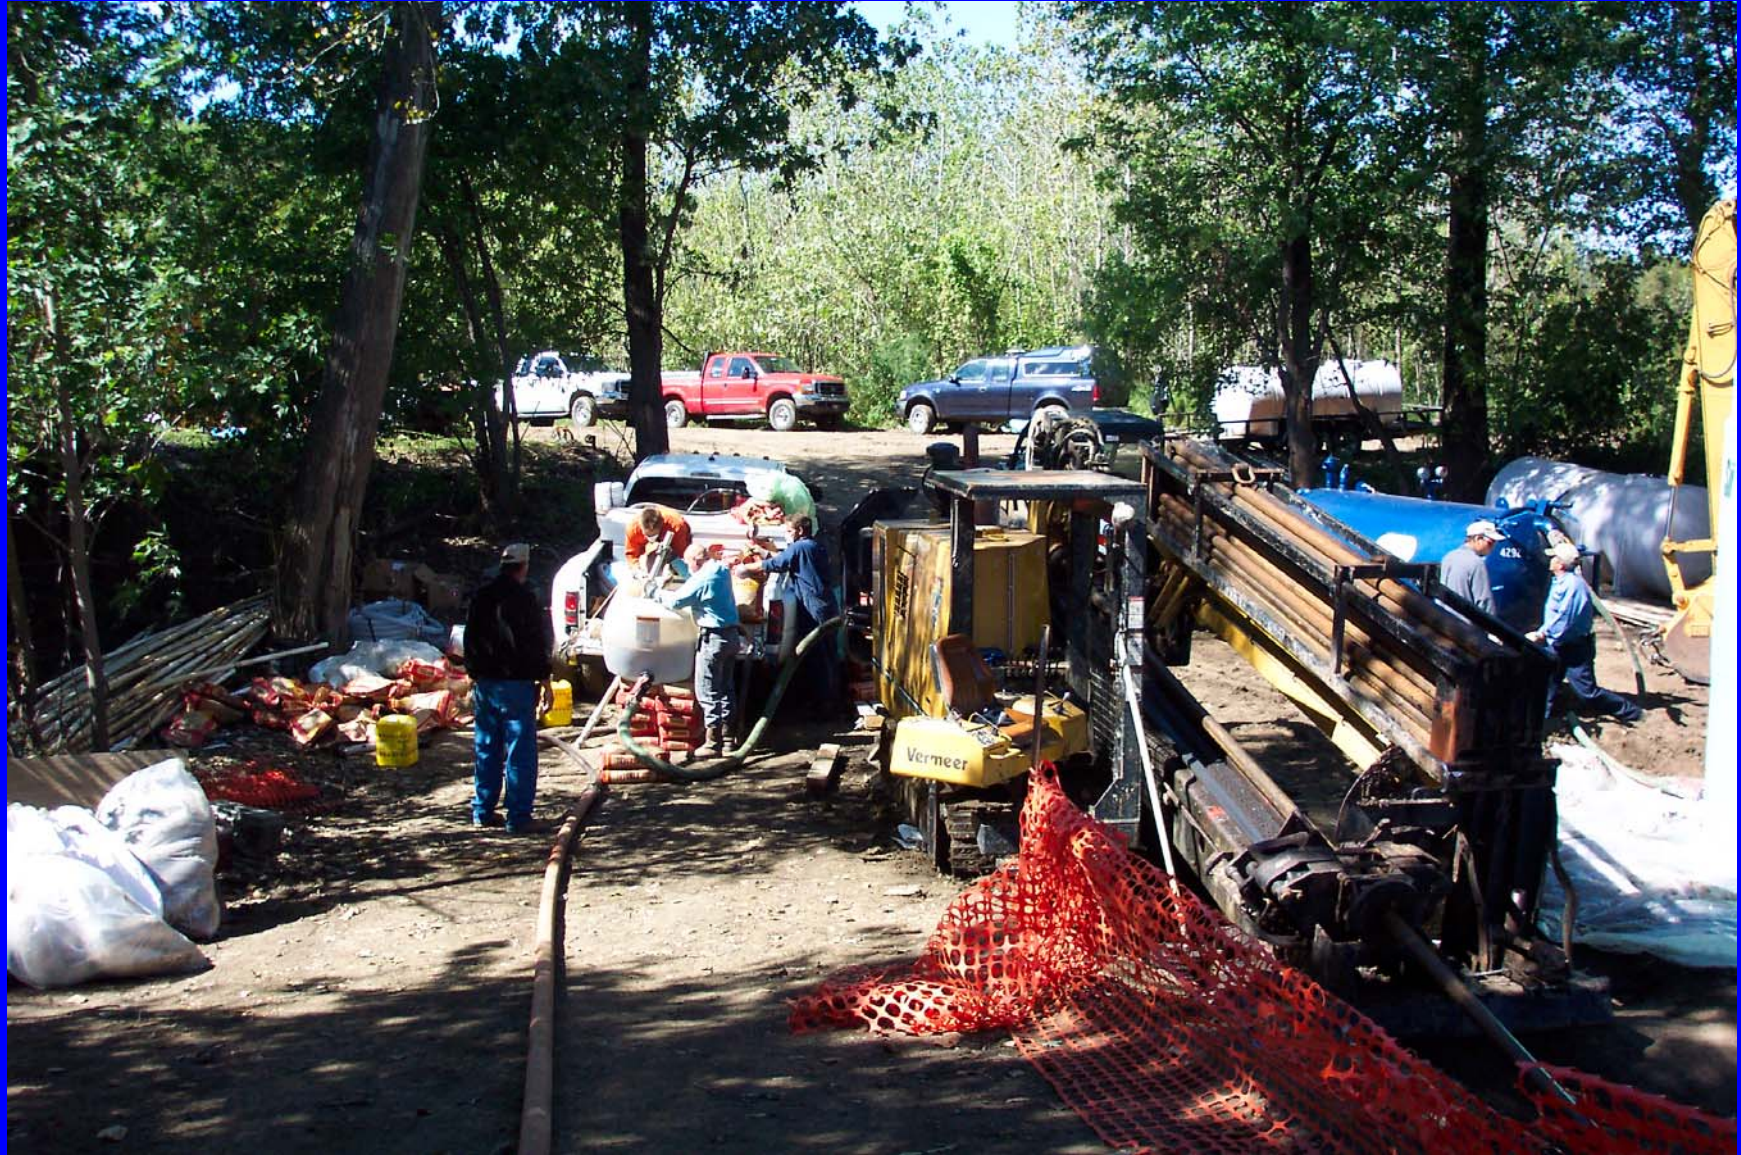
Horizontal drill rig

- Plan is to remove all remaining material from both lines
- Continue pumping out liquids
- Use a horizontal drill rig to insert a “pig” into the south line to “swab” the line
- Cap the severed end of the north line
- Fill both lines with concrete/drilling mud

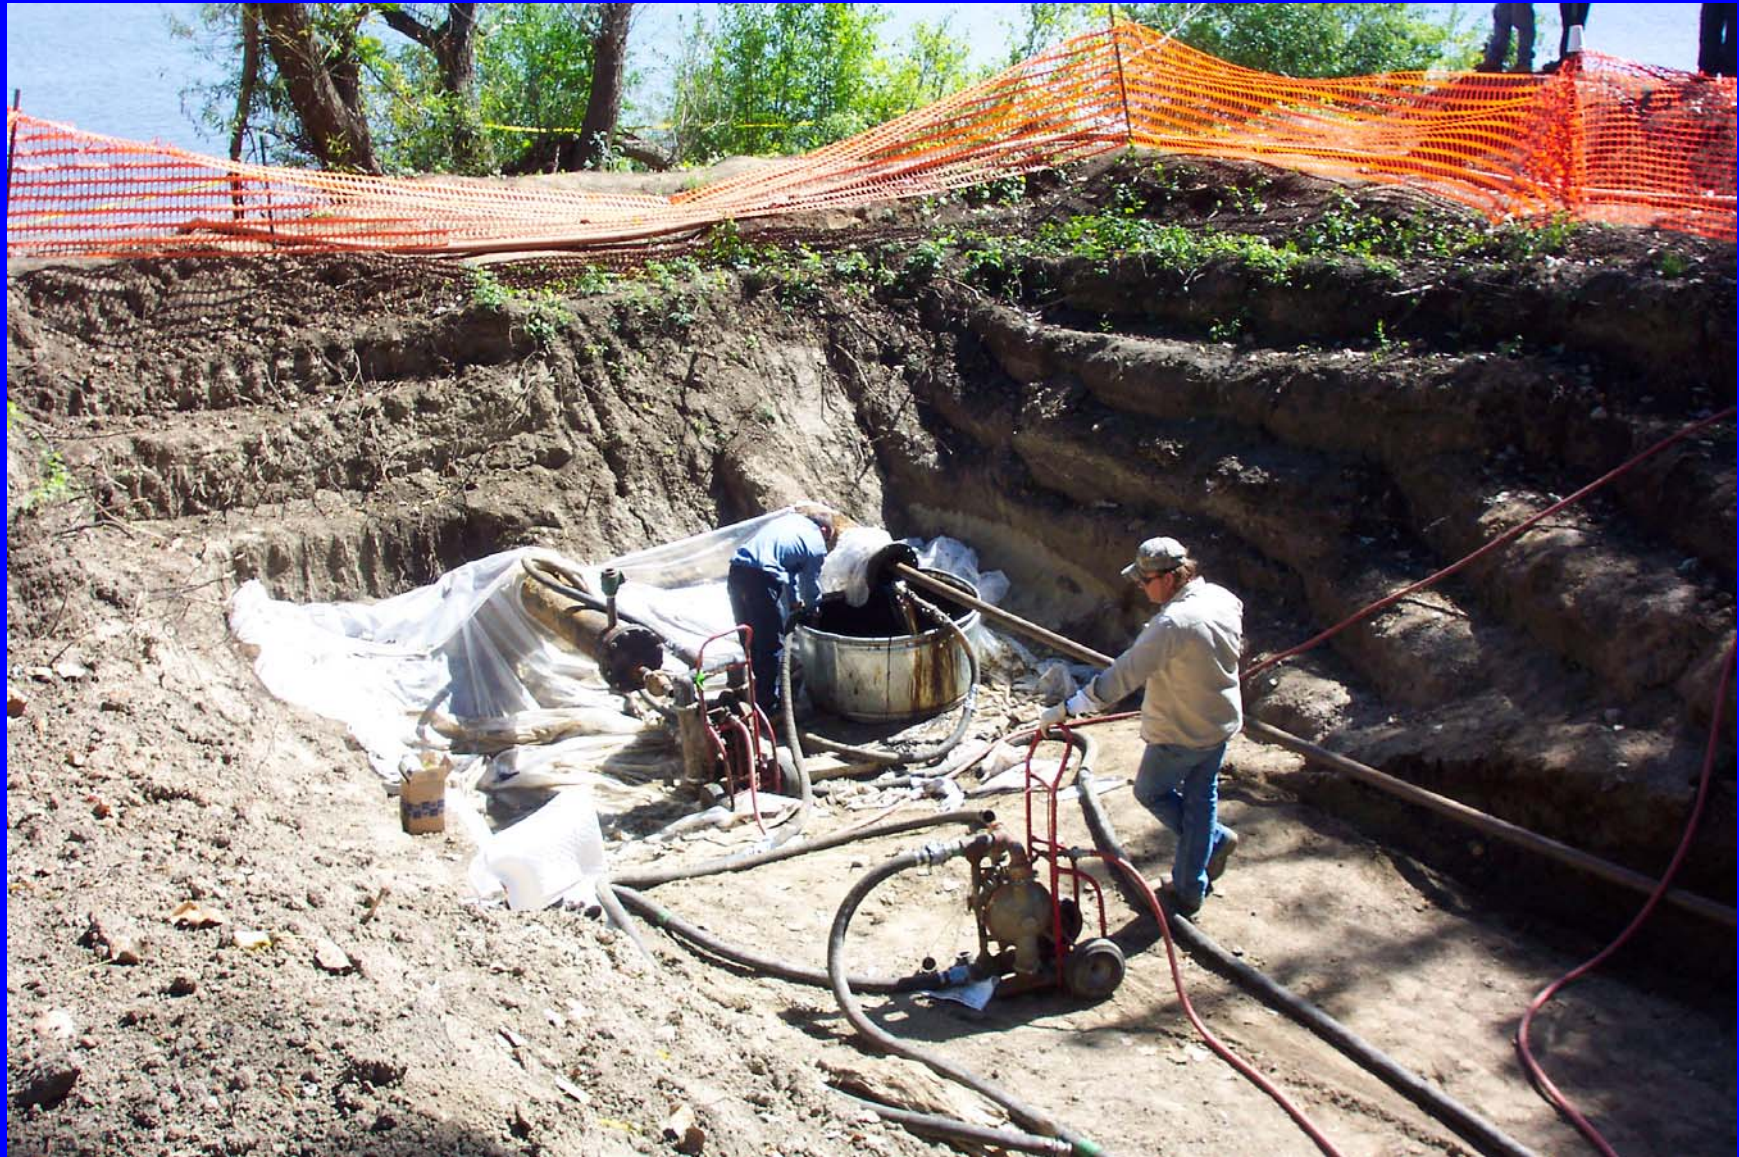
Insertion of drill stem into south line

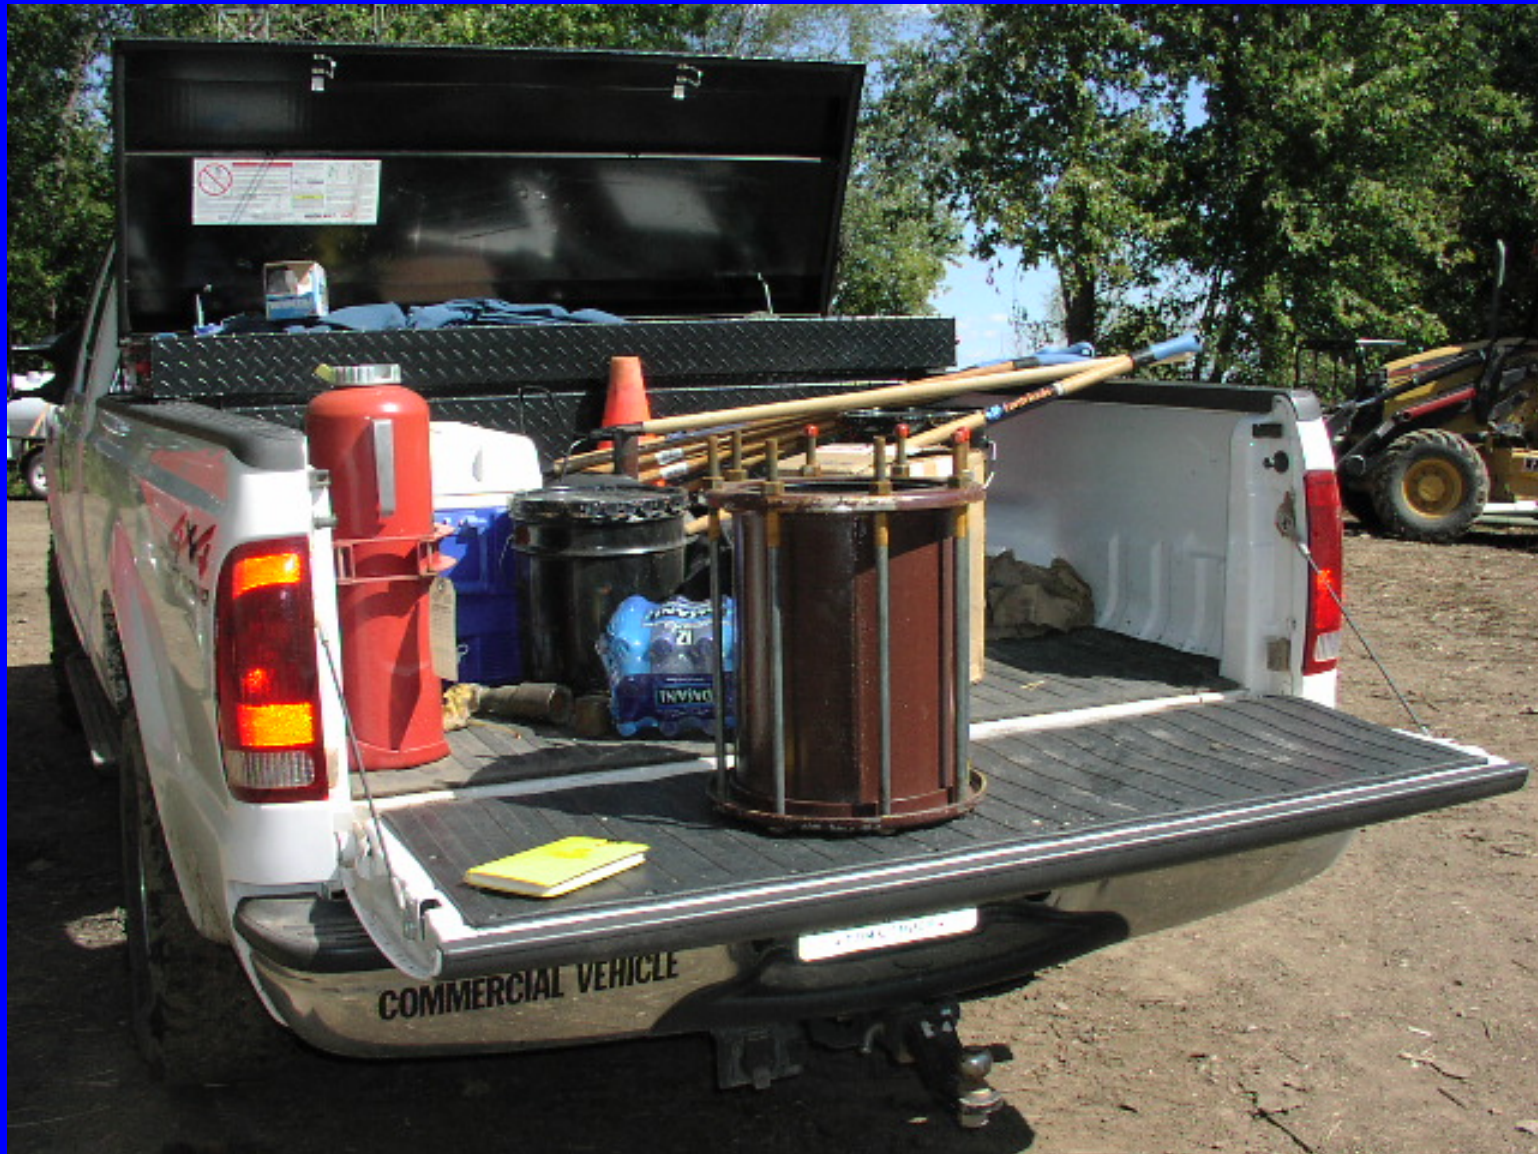
Steel sleeve used to cap the end of the north line

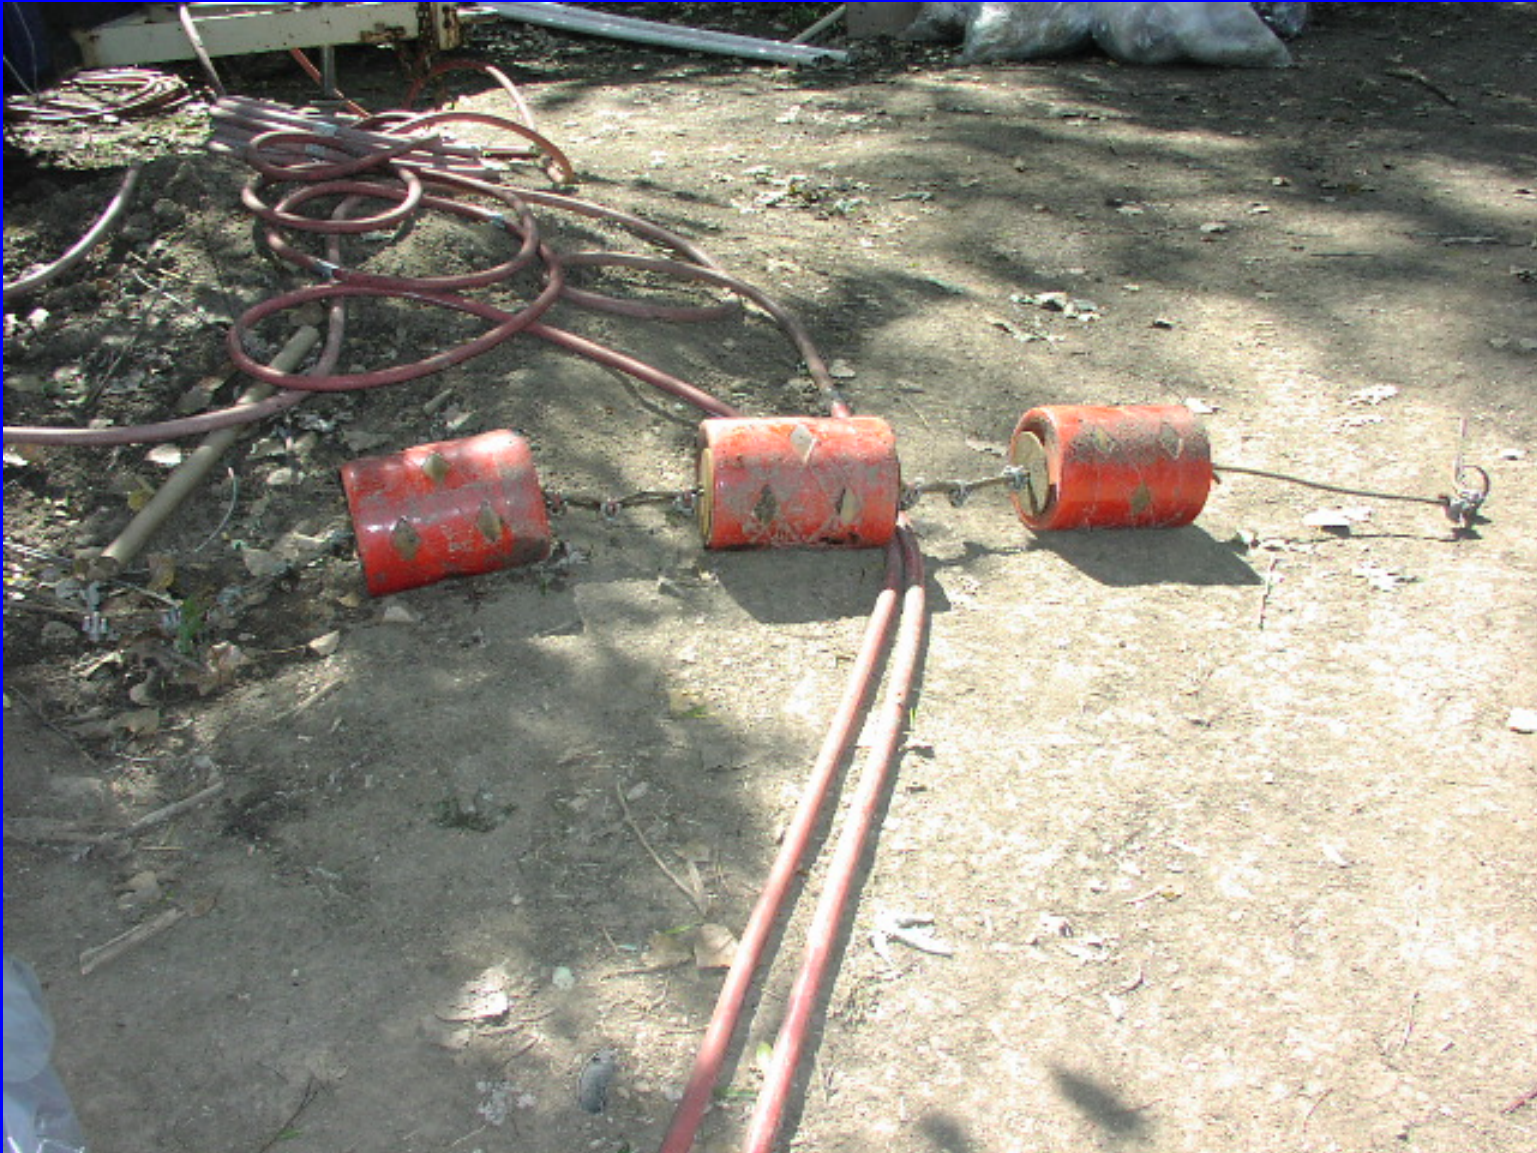
Eight inch diameter pig train

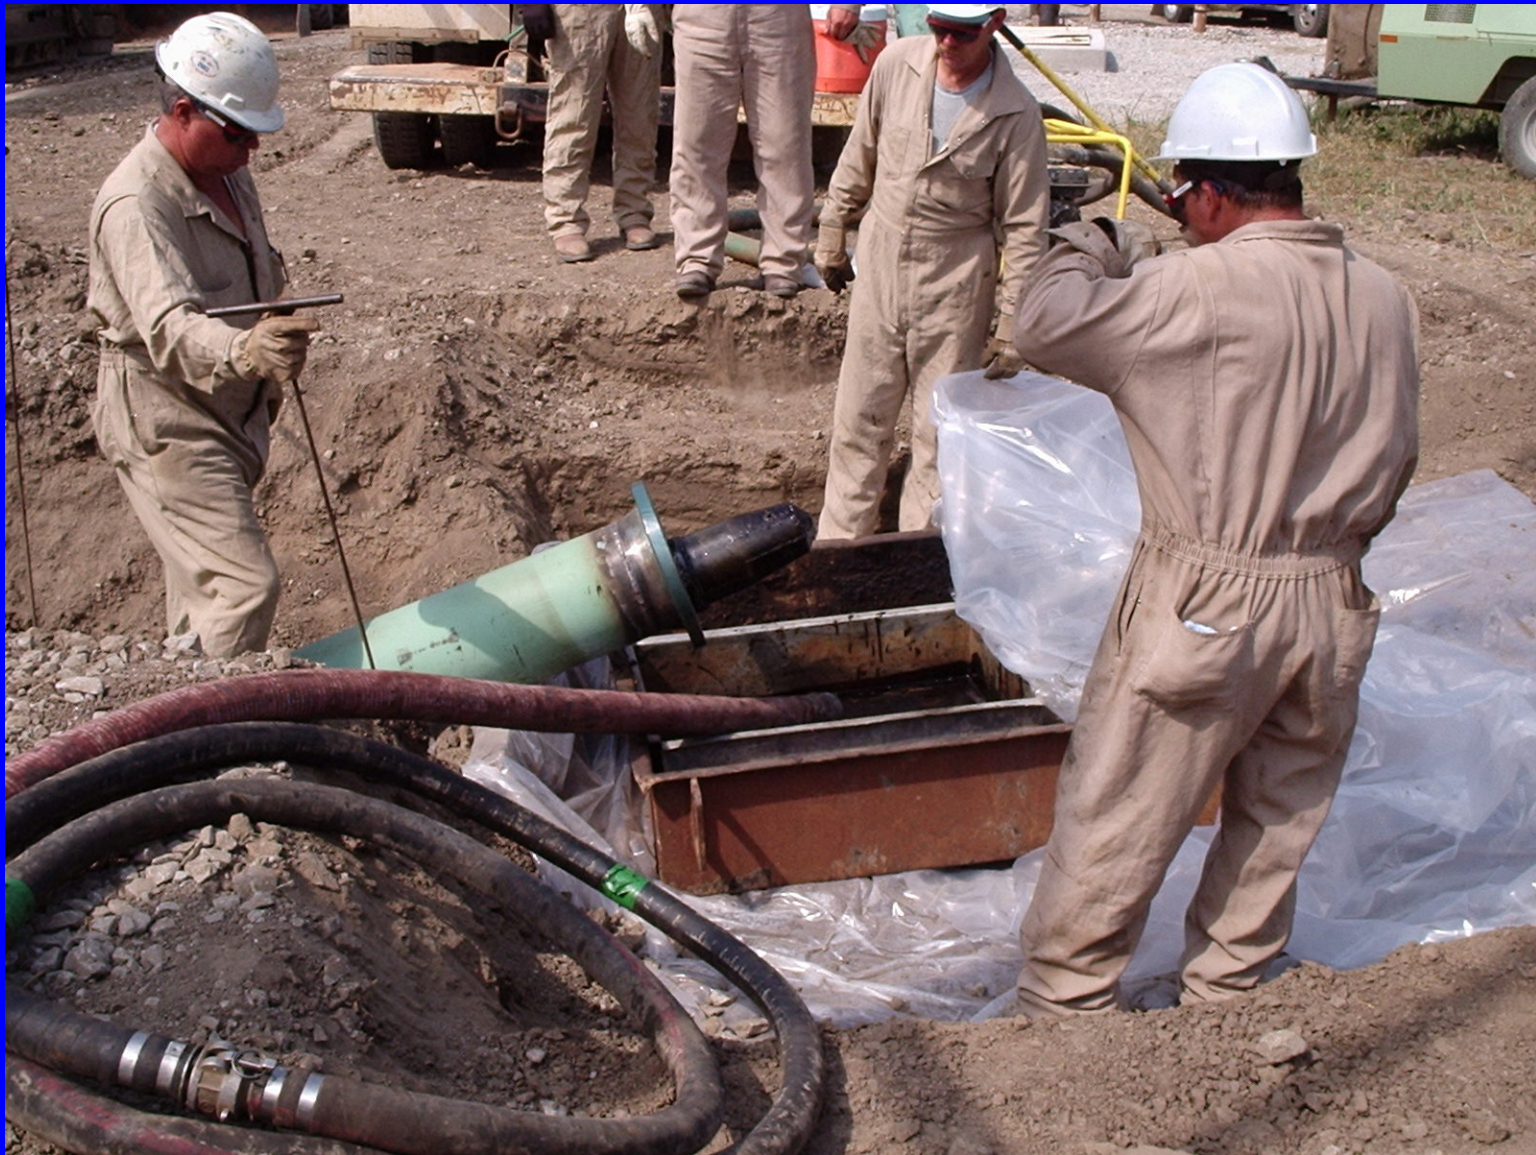
Push-head coming out of south line on Illinois side

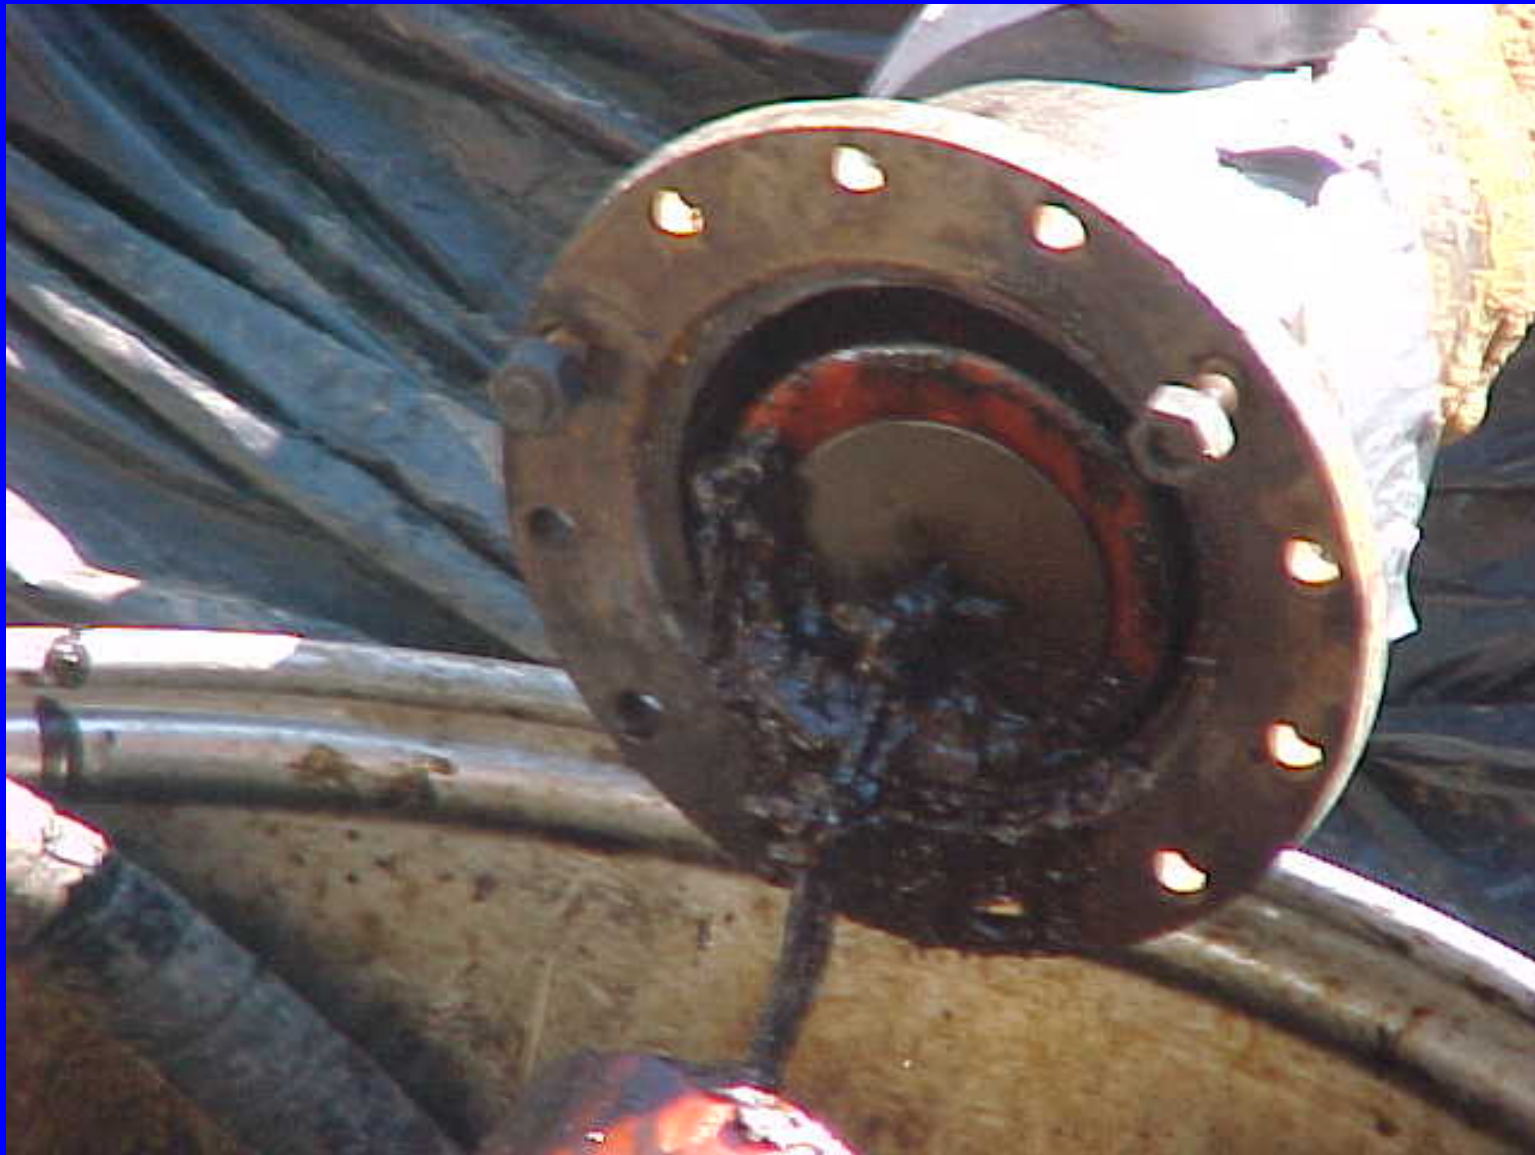
Pig being pulled through the south line, Illinois side -
09/08/03

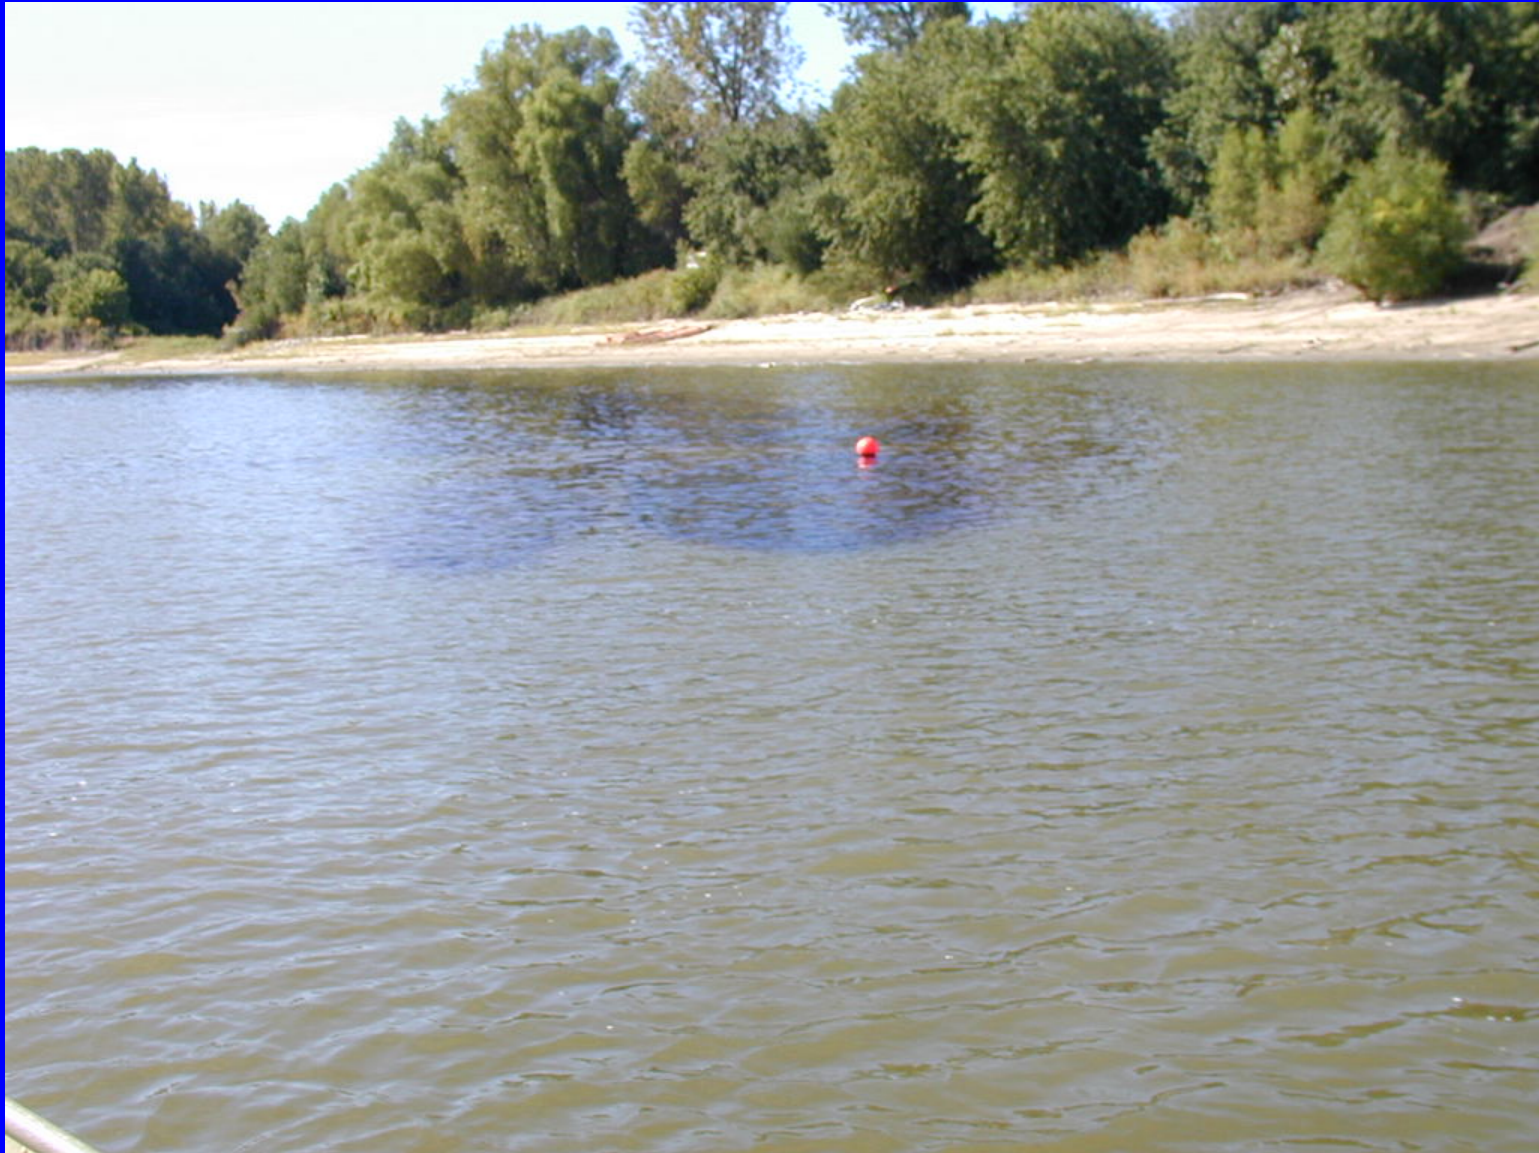
- By September 19, 2003, the south line was ready to be filled with cement/grout
- On September 25, 2003, a cement mixture was introduced into the Illinois side of the south line using a horizontal drill rig and pumps
- Approximately 2,100' of line was filled when a slug of crude oil was noticed in the in the water near the site of the original leak
- The oil was apparently pushed out of hole in the line due to displacement by the concrete mixture

Secondary release of crude oil - 09/25/03
