ConocoPhillips Mississippi River Pipeline Release

August 6 - October 3, 2003

presented by Tim Ganz, former State On-Scene Coordinator,
Missouri Department of Natural Resources
Environmental Emergency Response Section

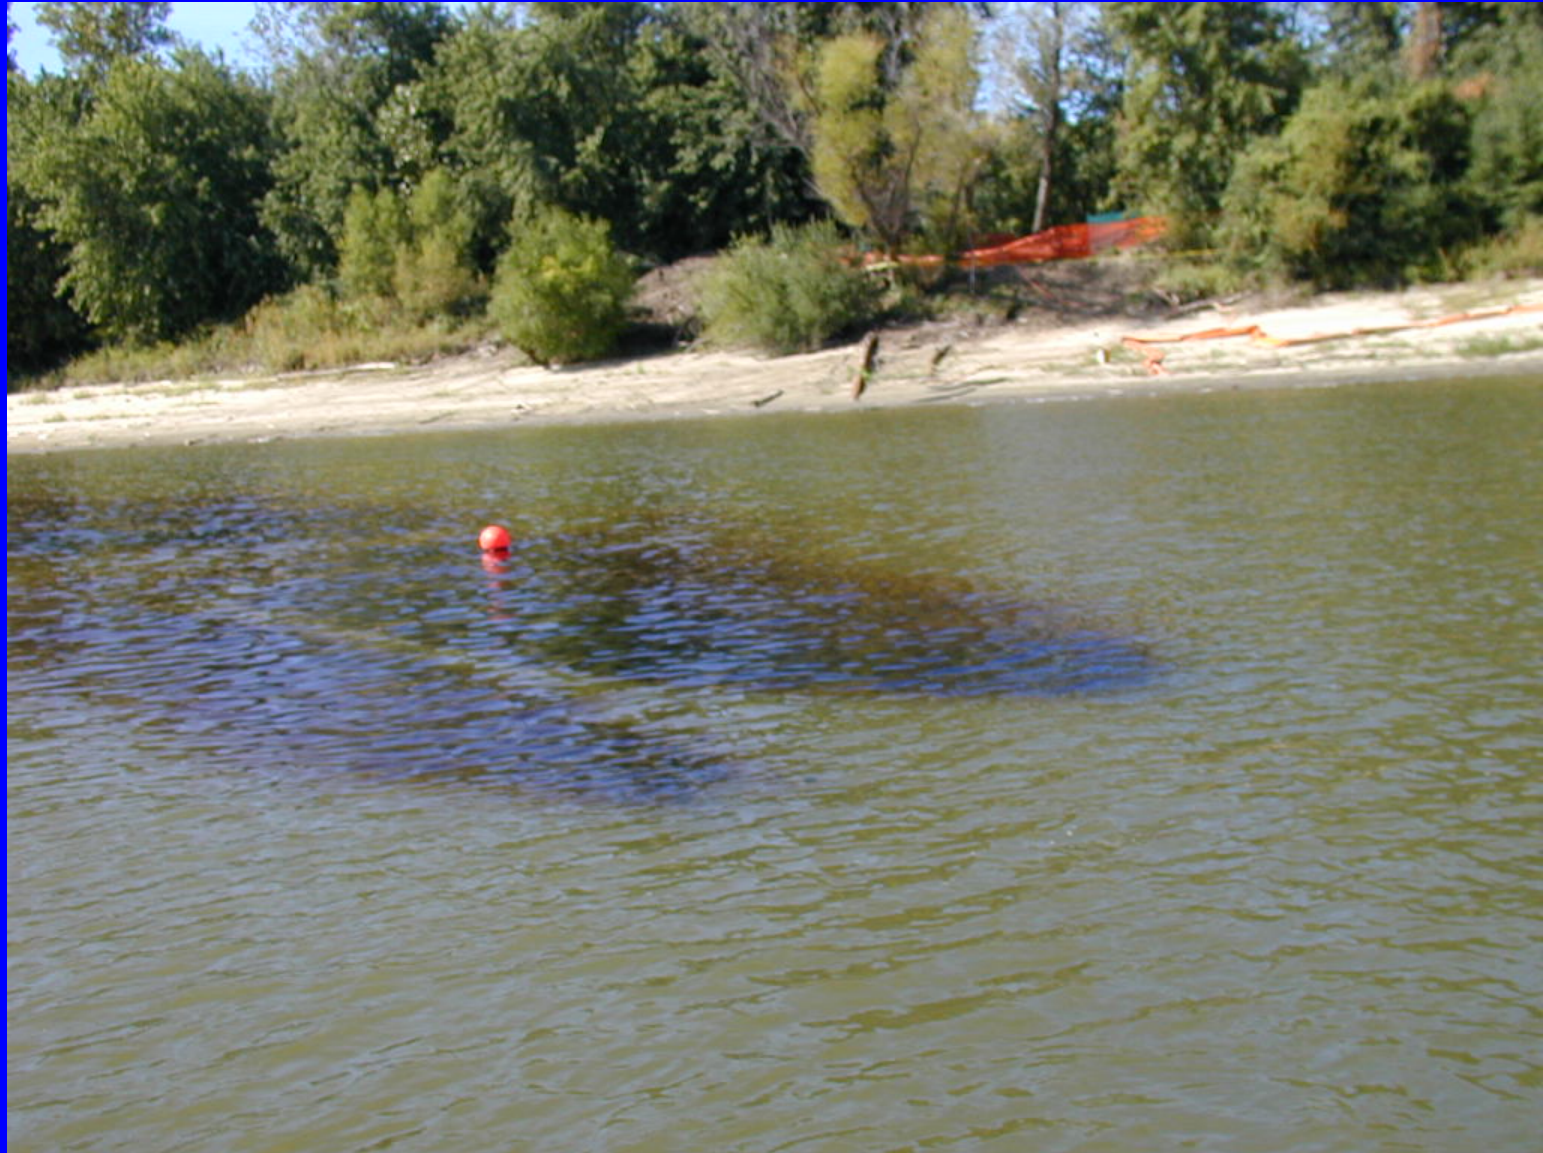
Secondary release of crude oil - 09/25/03

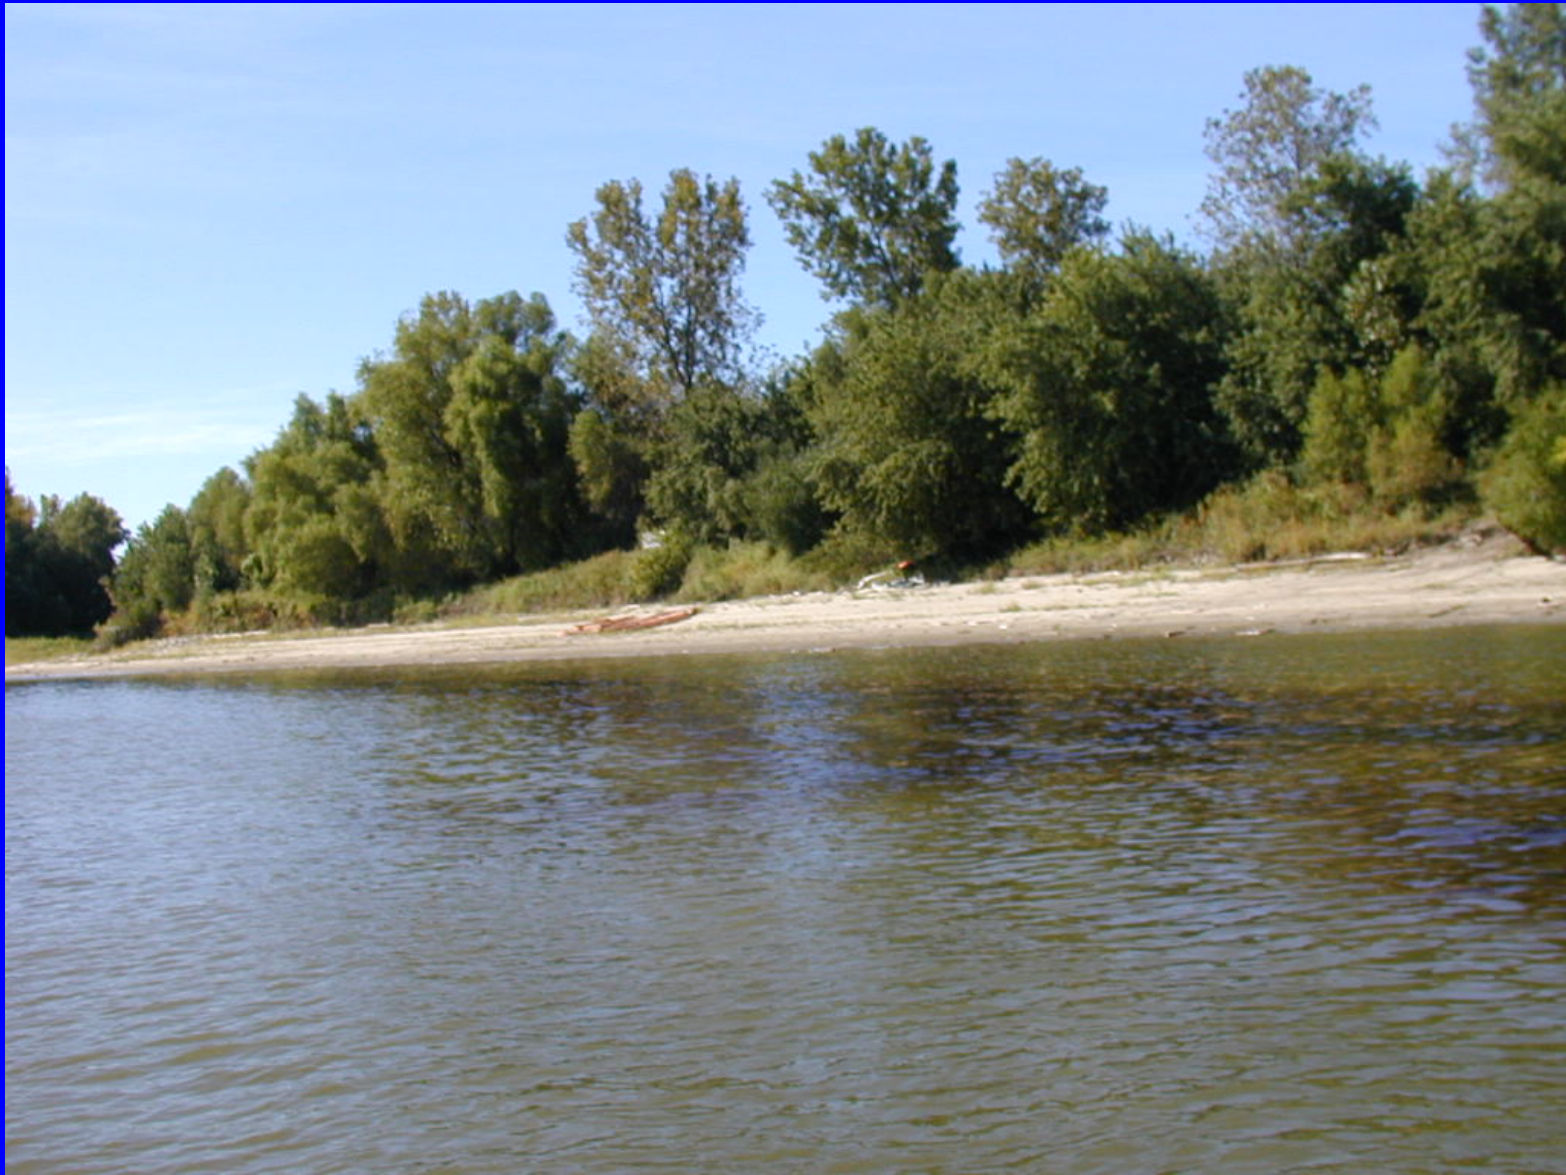
Secondary release of crude oil - 09/25/03

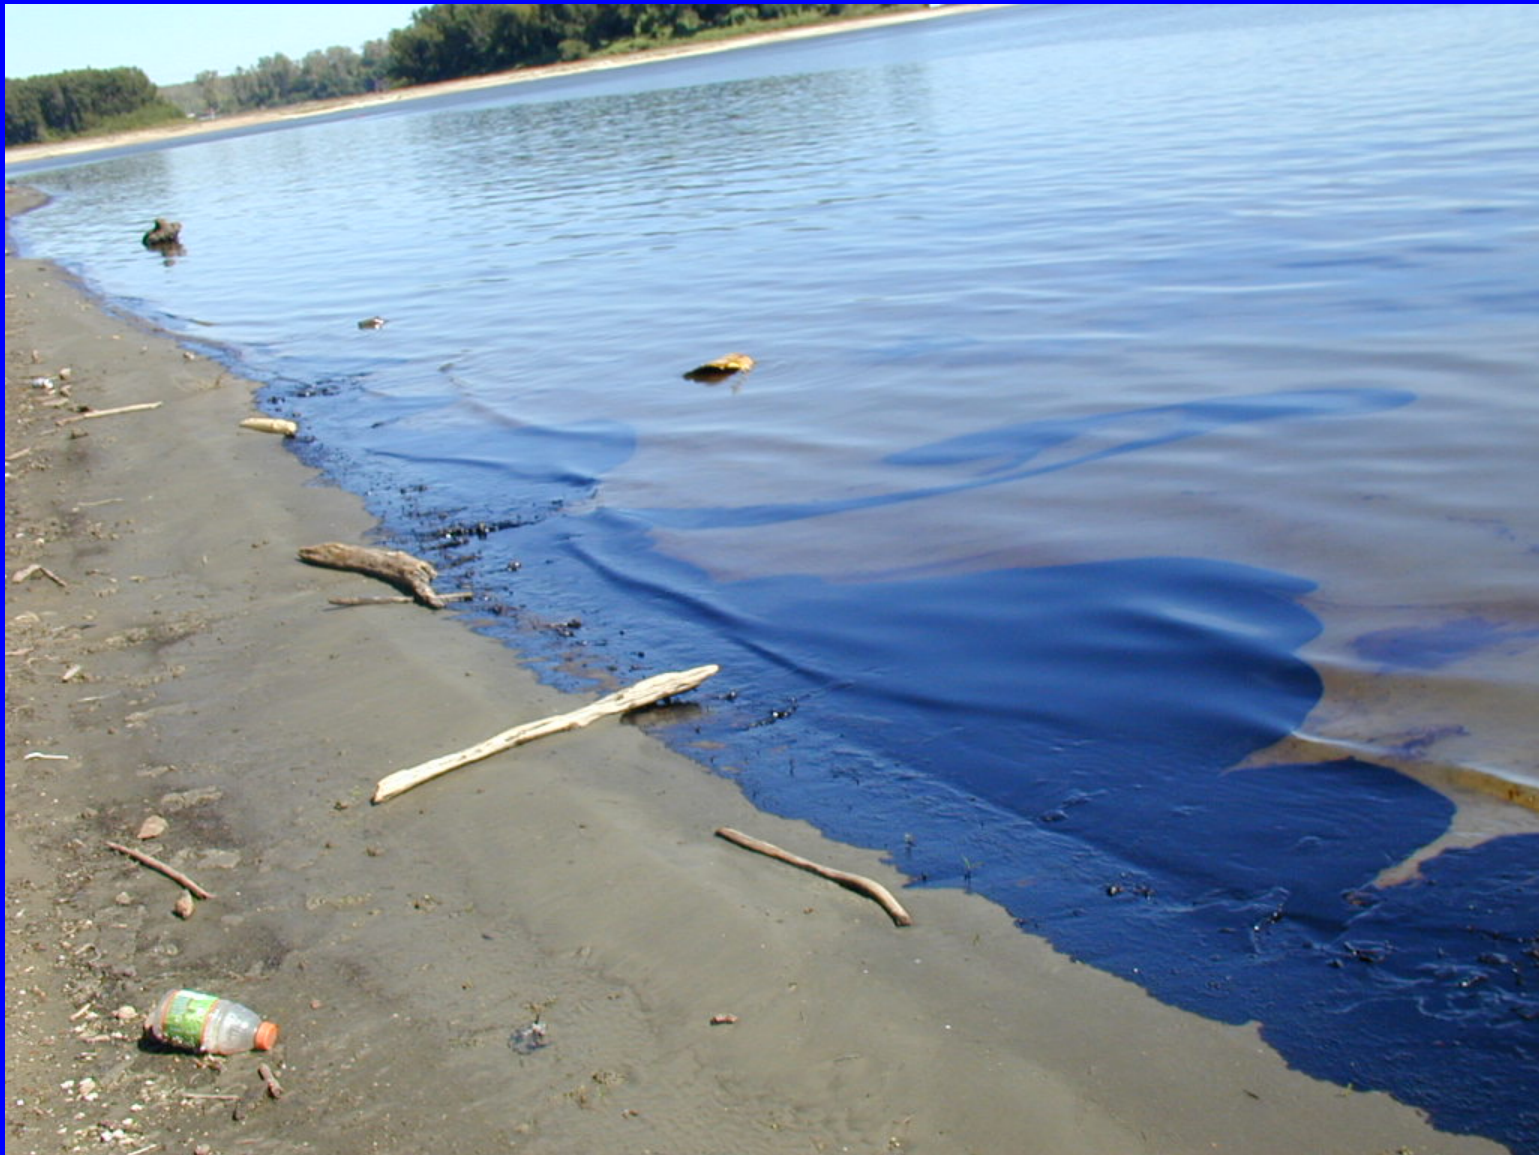
- Oil slick approximately 300 yards in length and 20' in width
- Containment measures took approximately one hour to put in place
- Due to prevailing wind and current conditions the majority of the oil washed up on the Missouri shoreline just downstream from the leak site

Crude oil on beach - 09/25/03

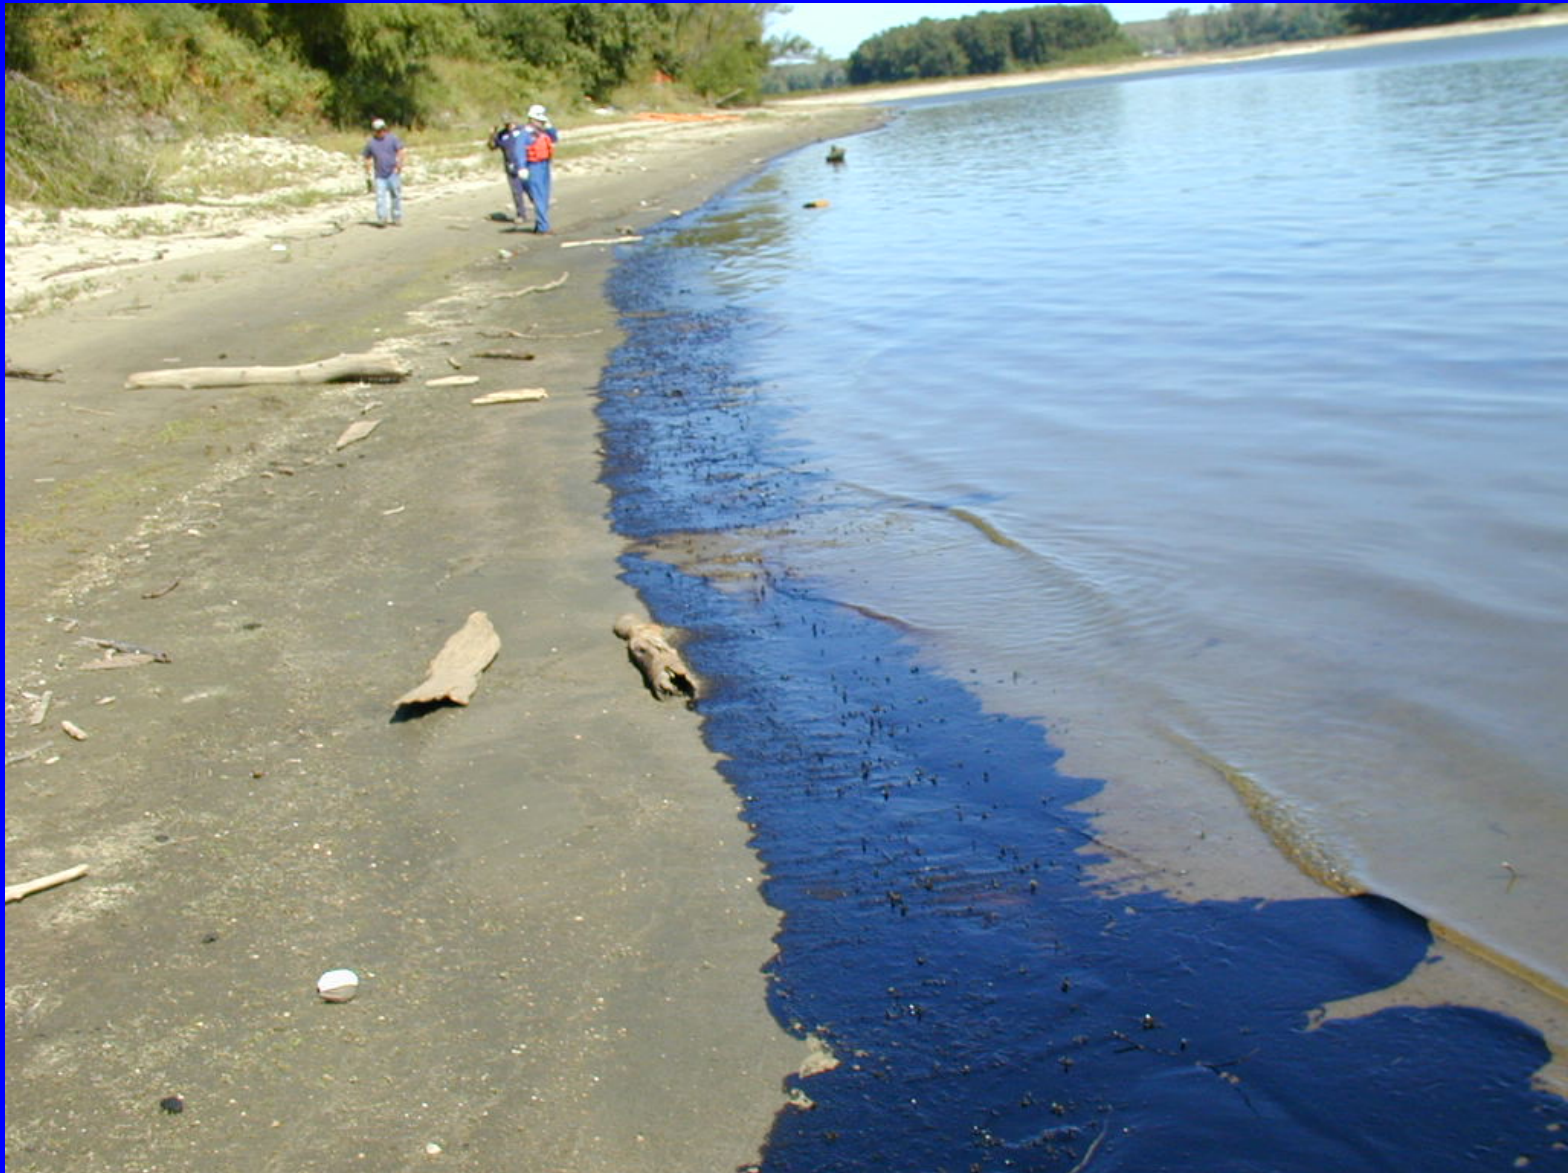
Crude oil on beach - 09/25/03

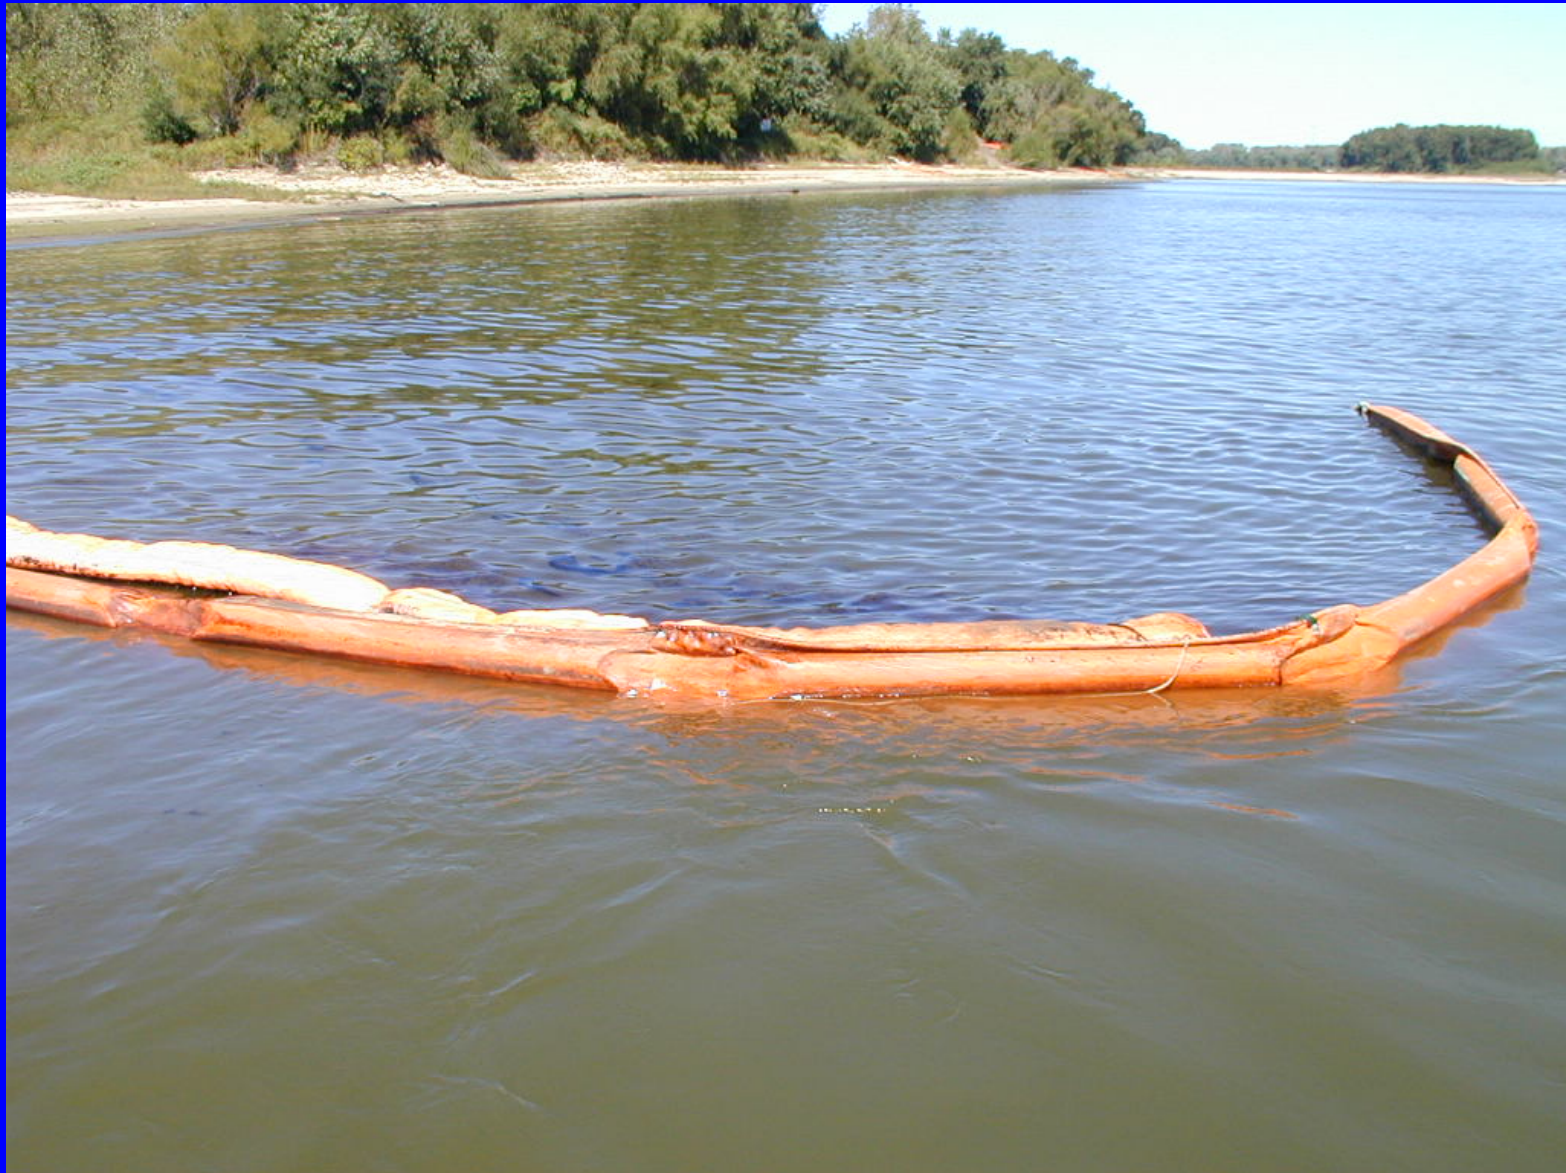
Initial containment boom - 09/25/03

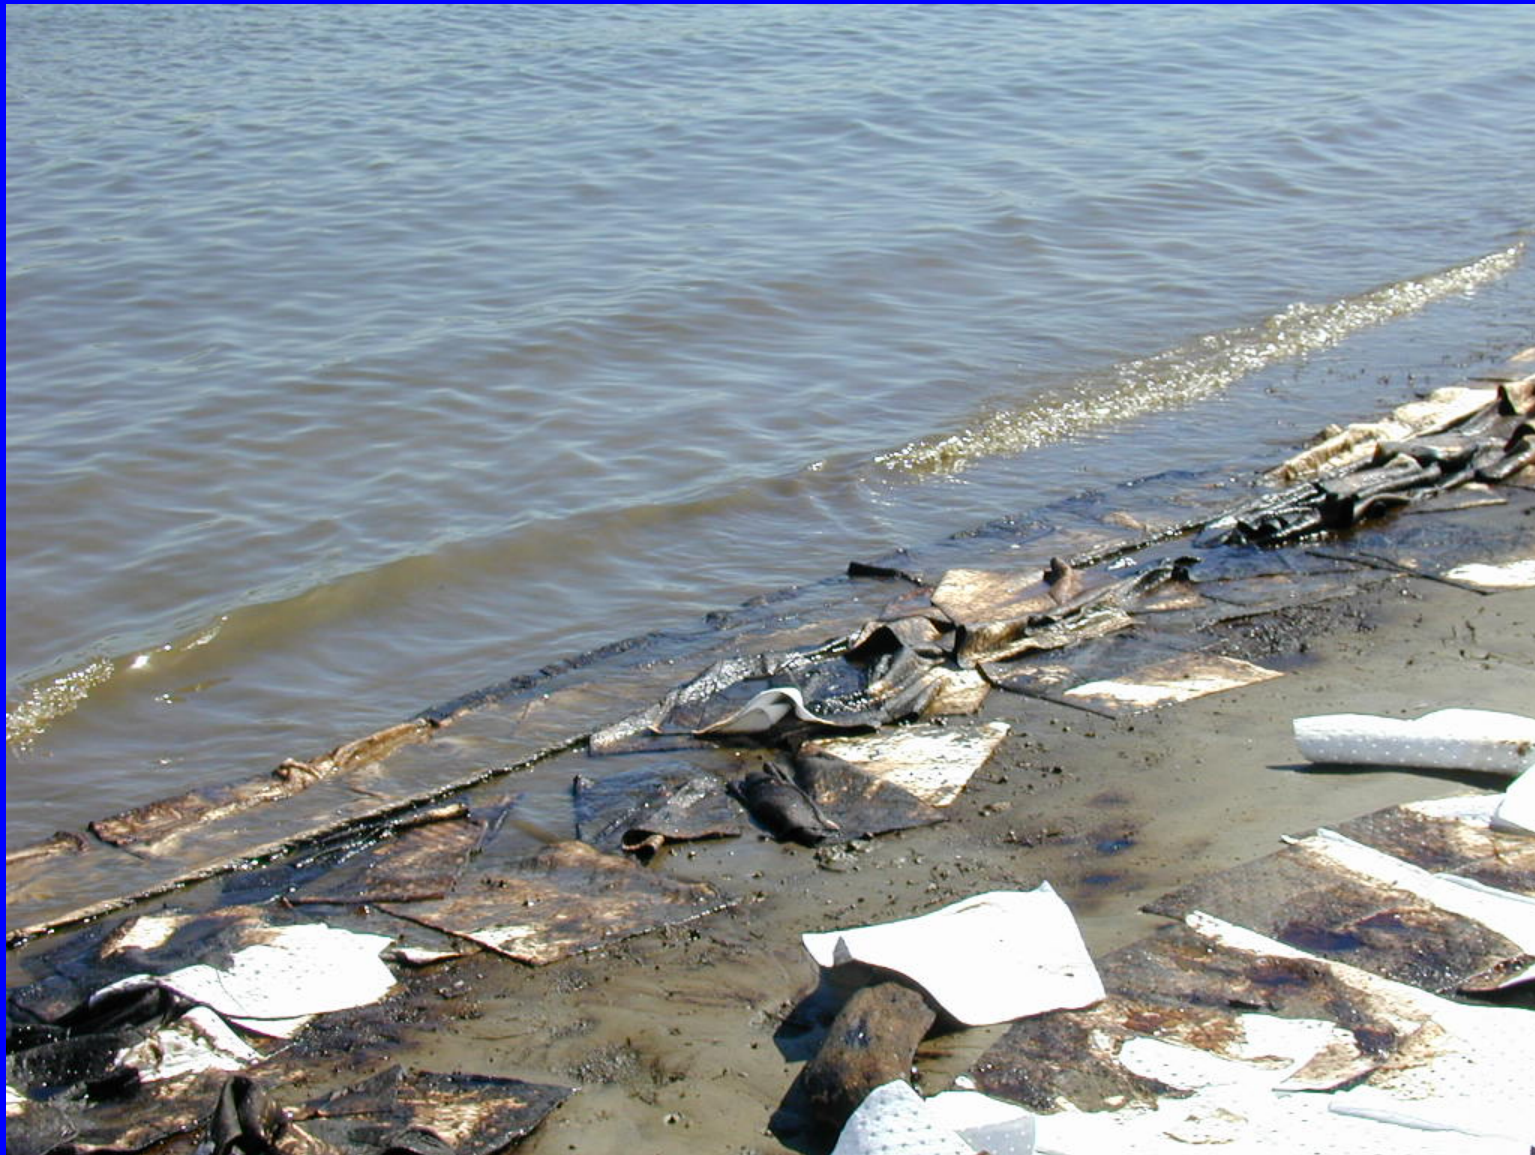
Initial clean up of crude oil - 09/25/03

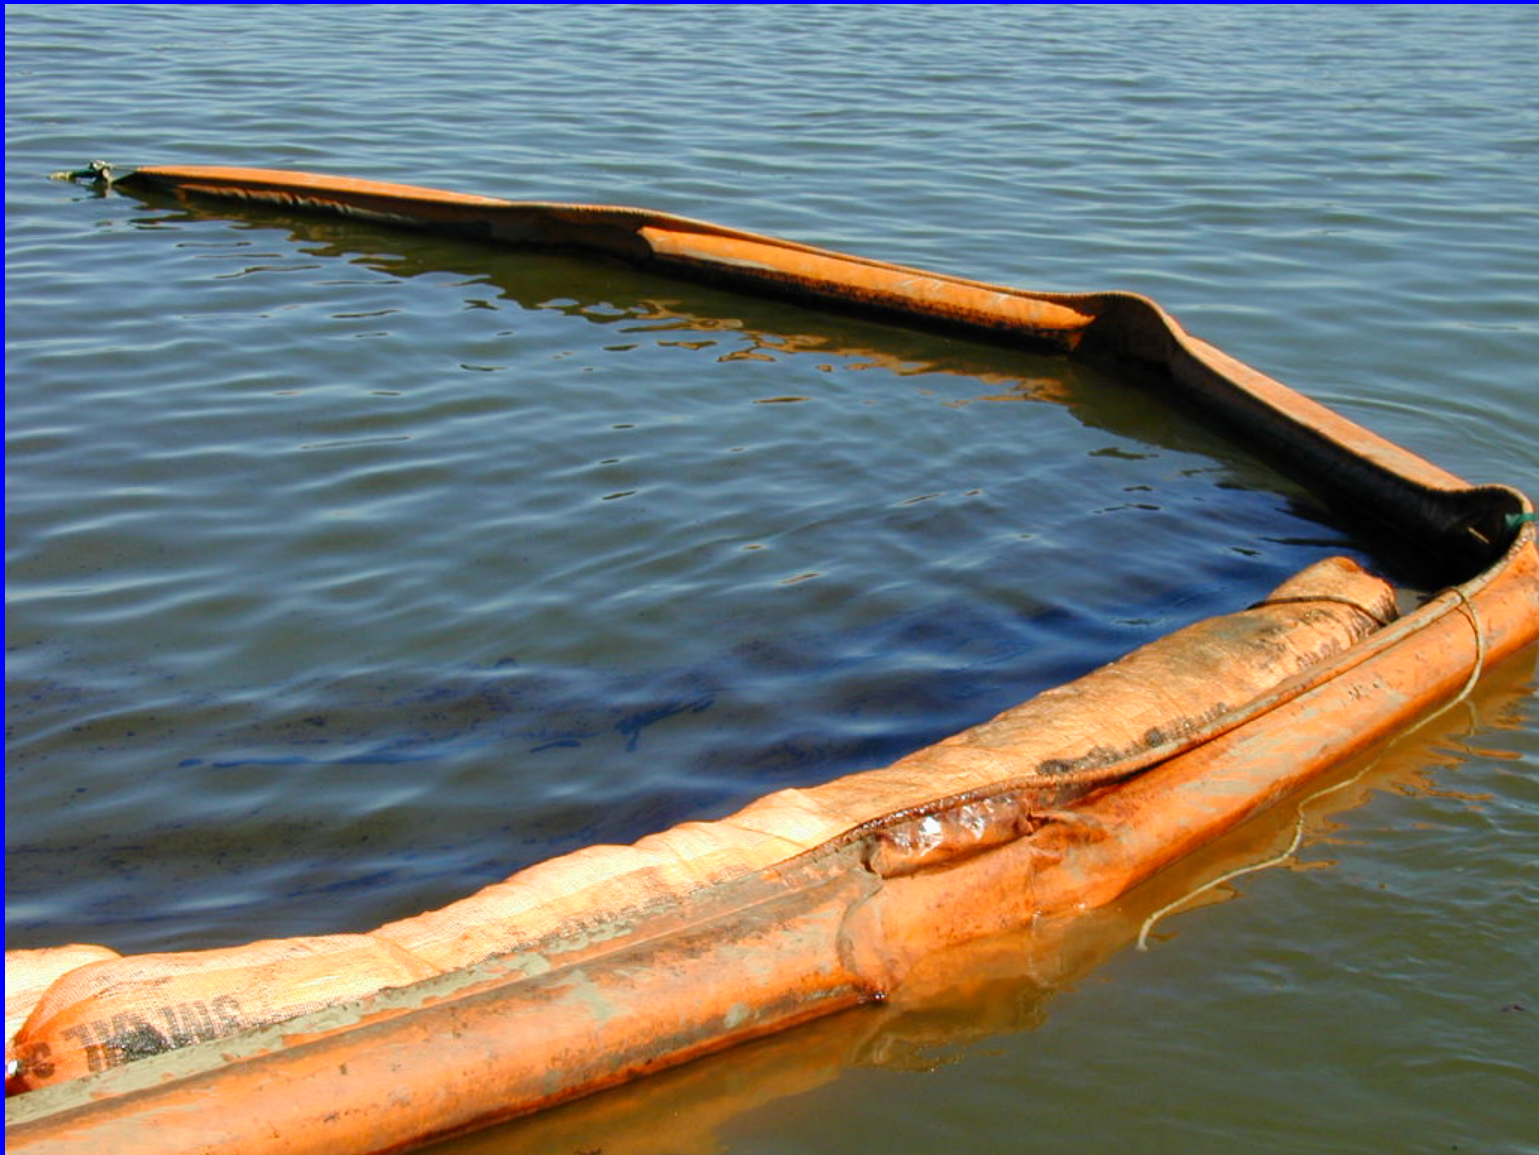
Initial clean up of crude oil - 09/25/03

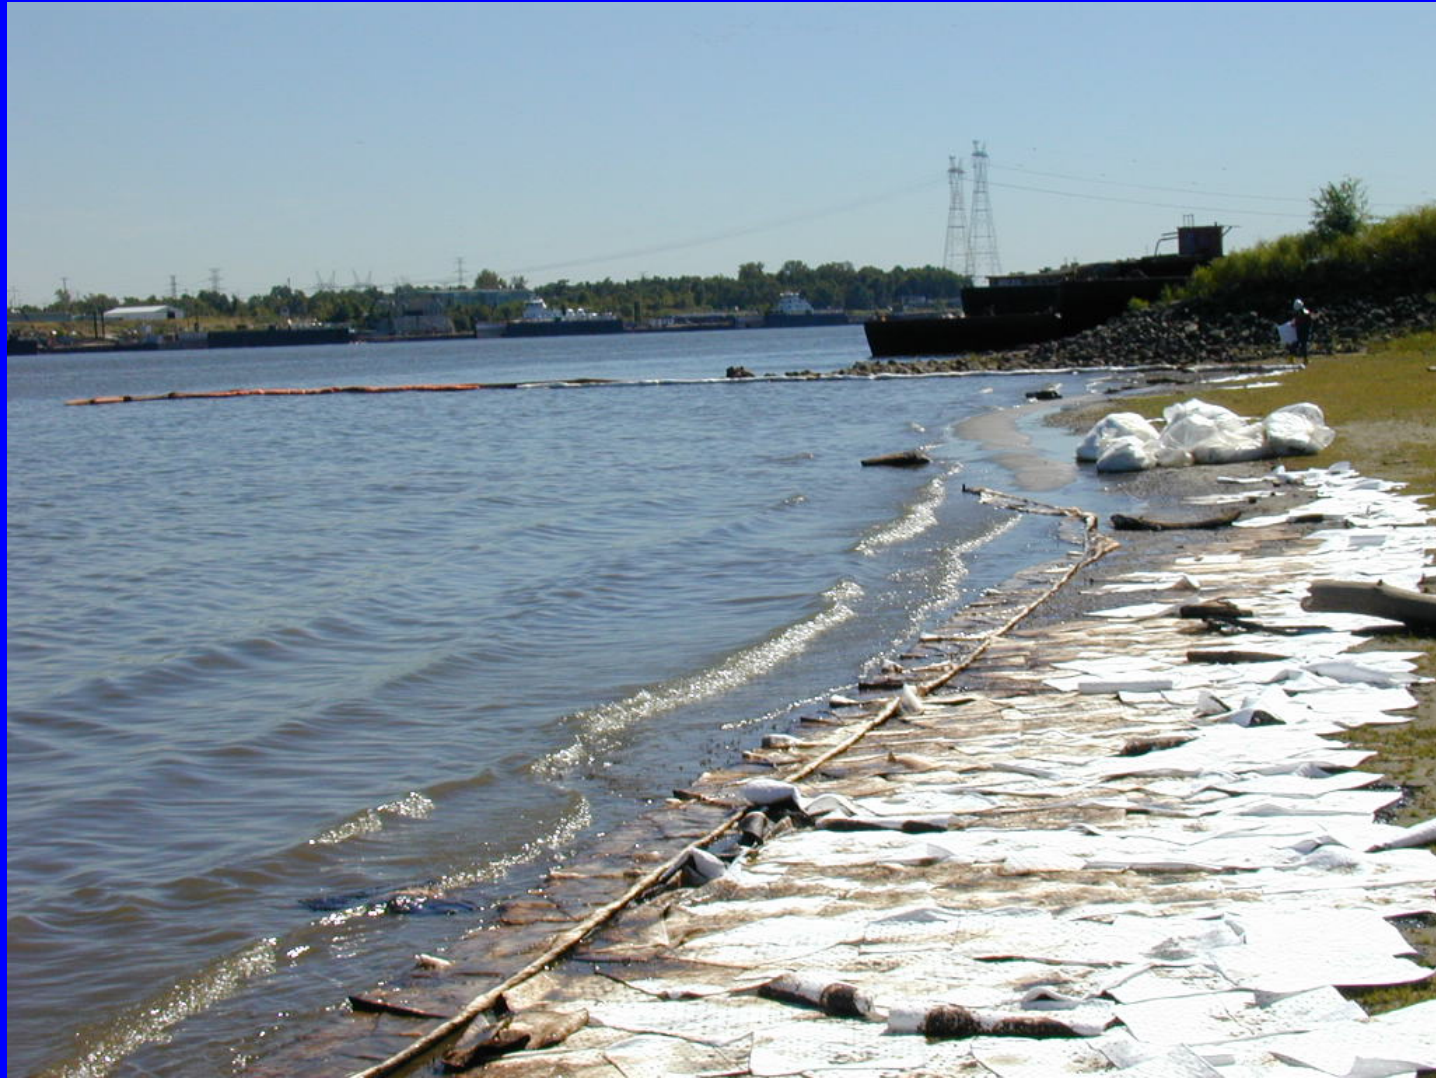
Initial clean up of crude oil - 09/25/03

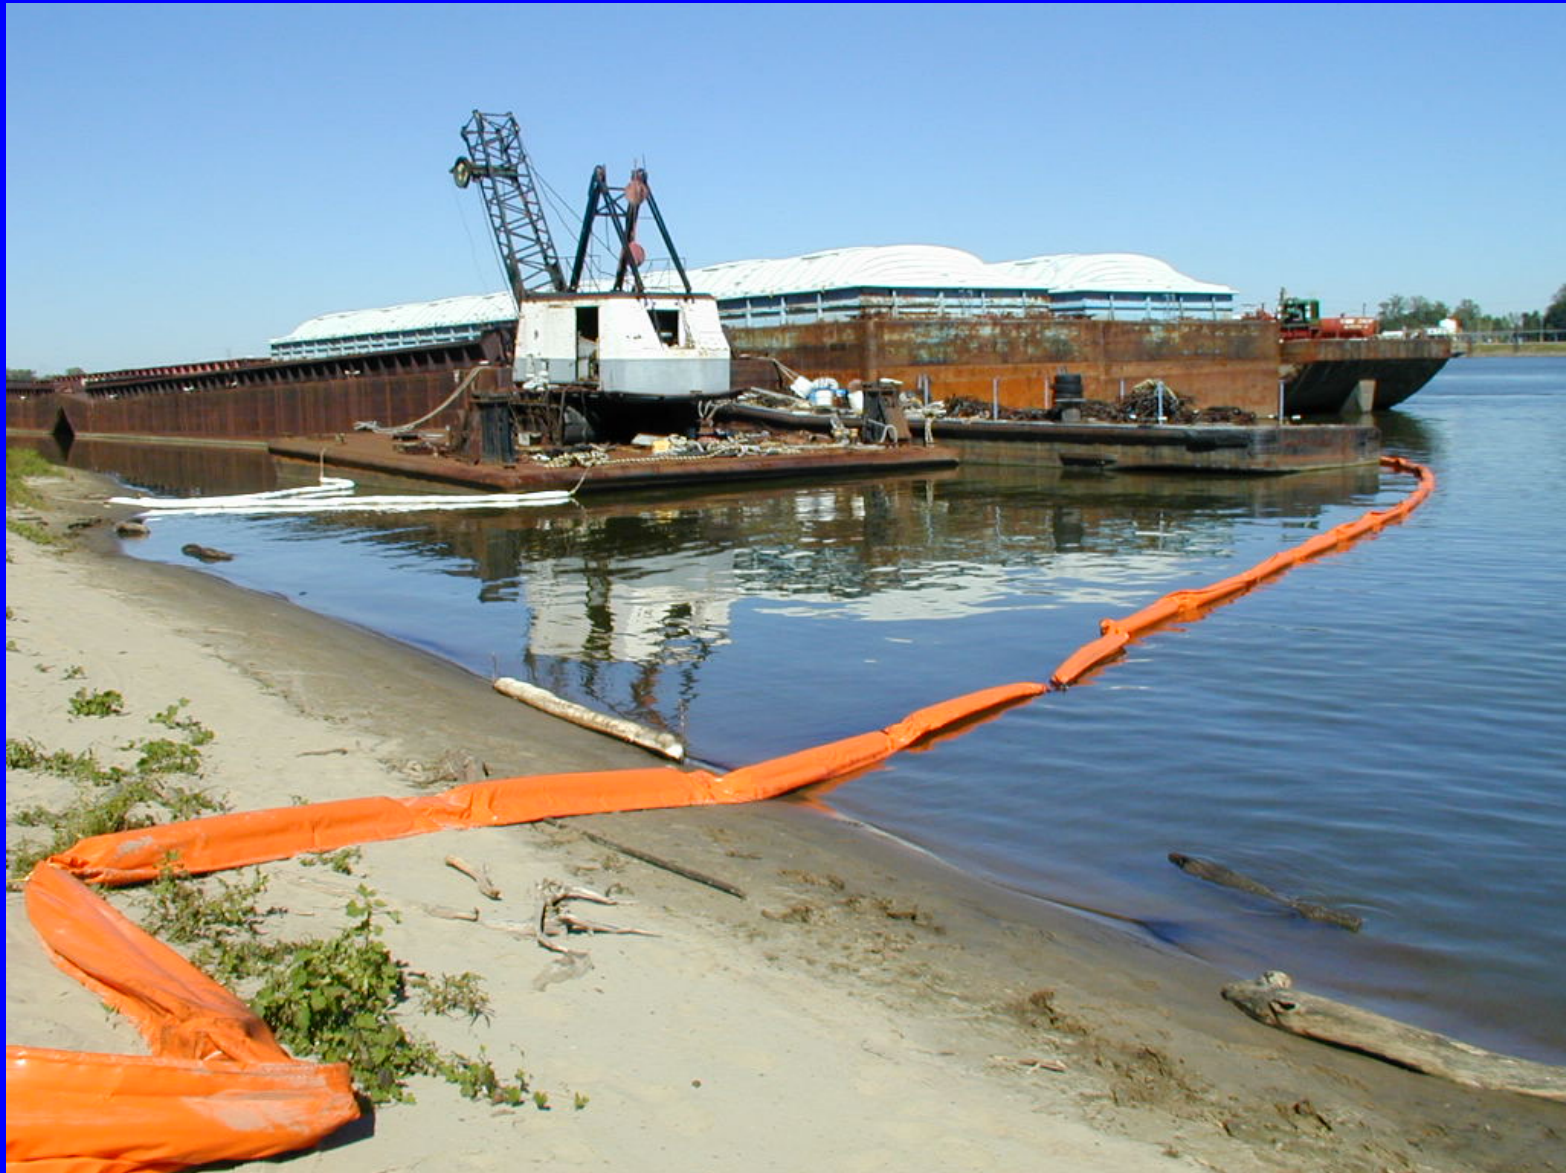
Containment boom deployed around barges - 09/25/03

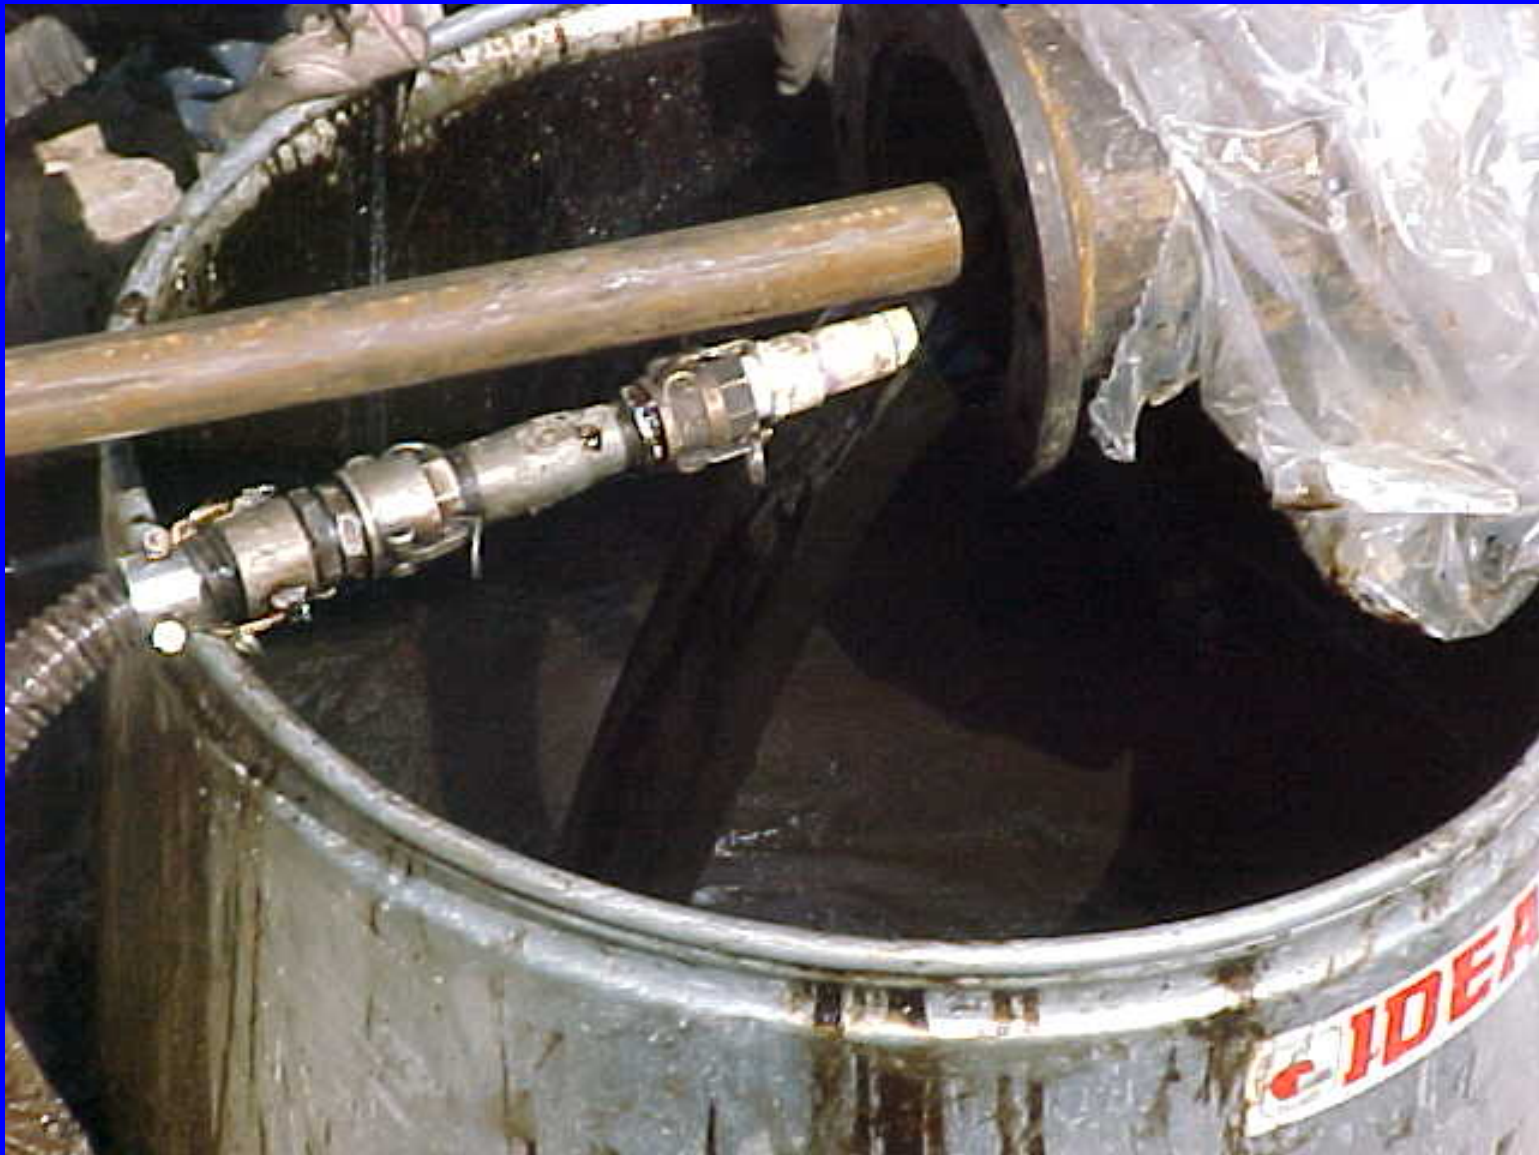
Oil discharging from south pipeline - 09/29/03

- Drilling mud was pumped into the Missouri side of the south line to complete the filling of the line
- An additional 5 barrels of crude were recovered from this process
- Line permanently capped – abandonment complete
- Same process utilized on the north line

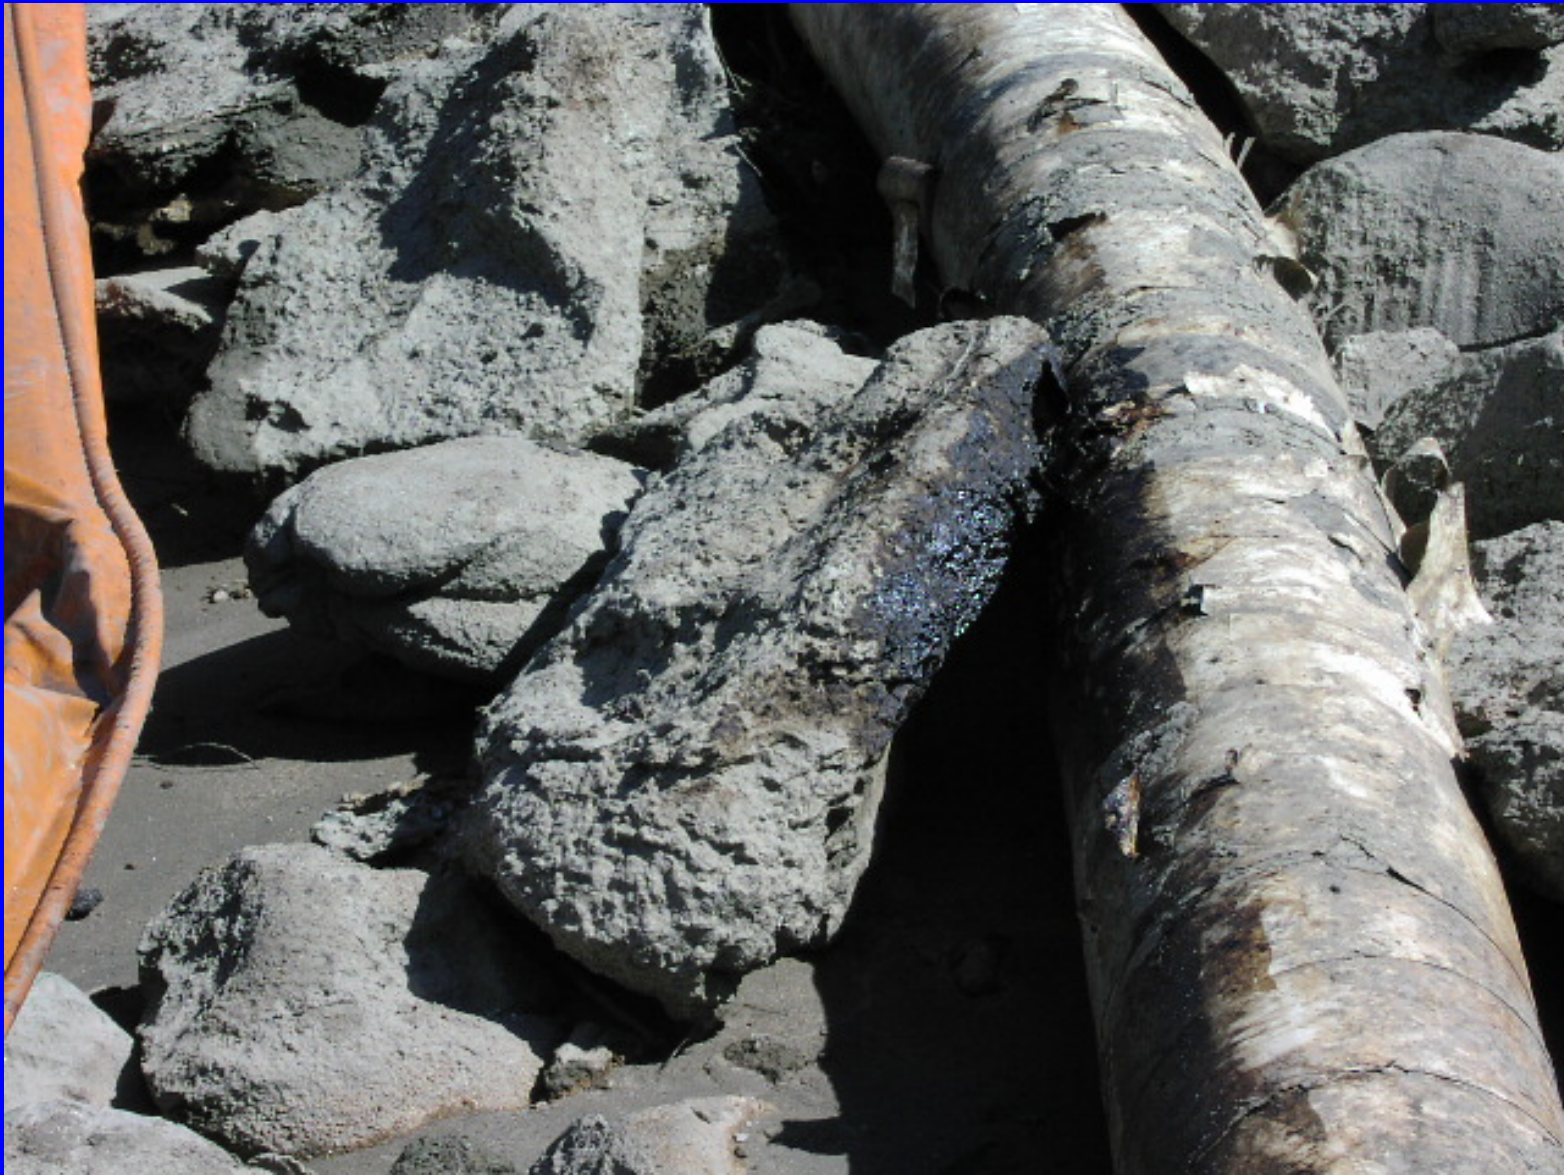
Oil staining on rocks - 09/29/03

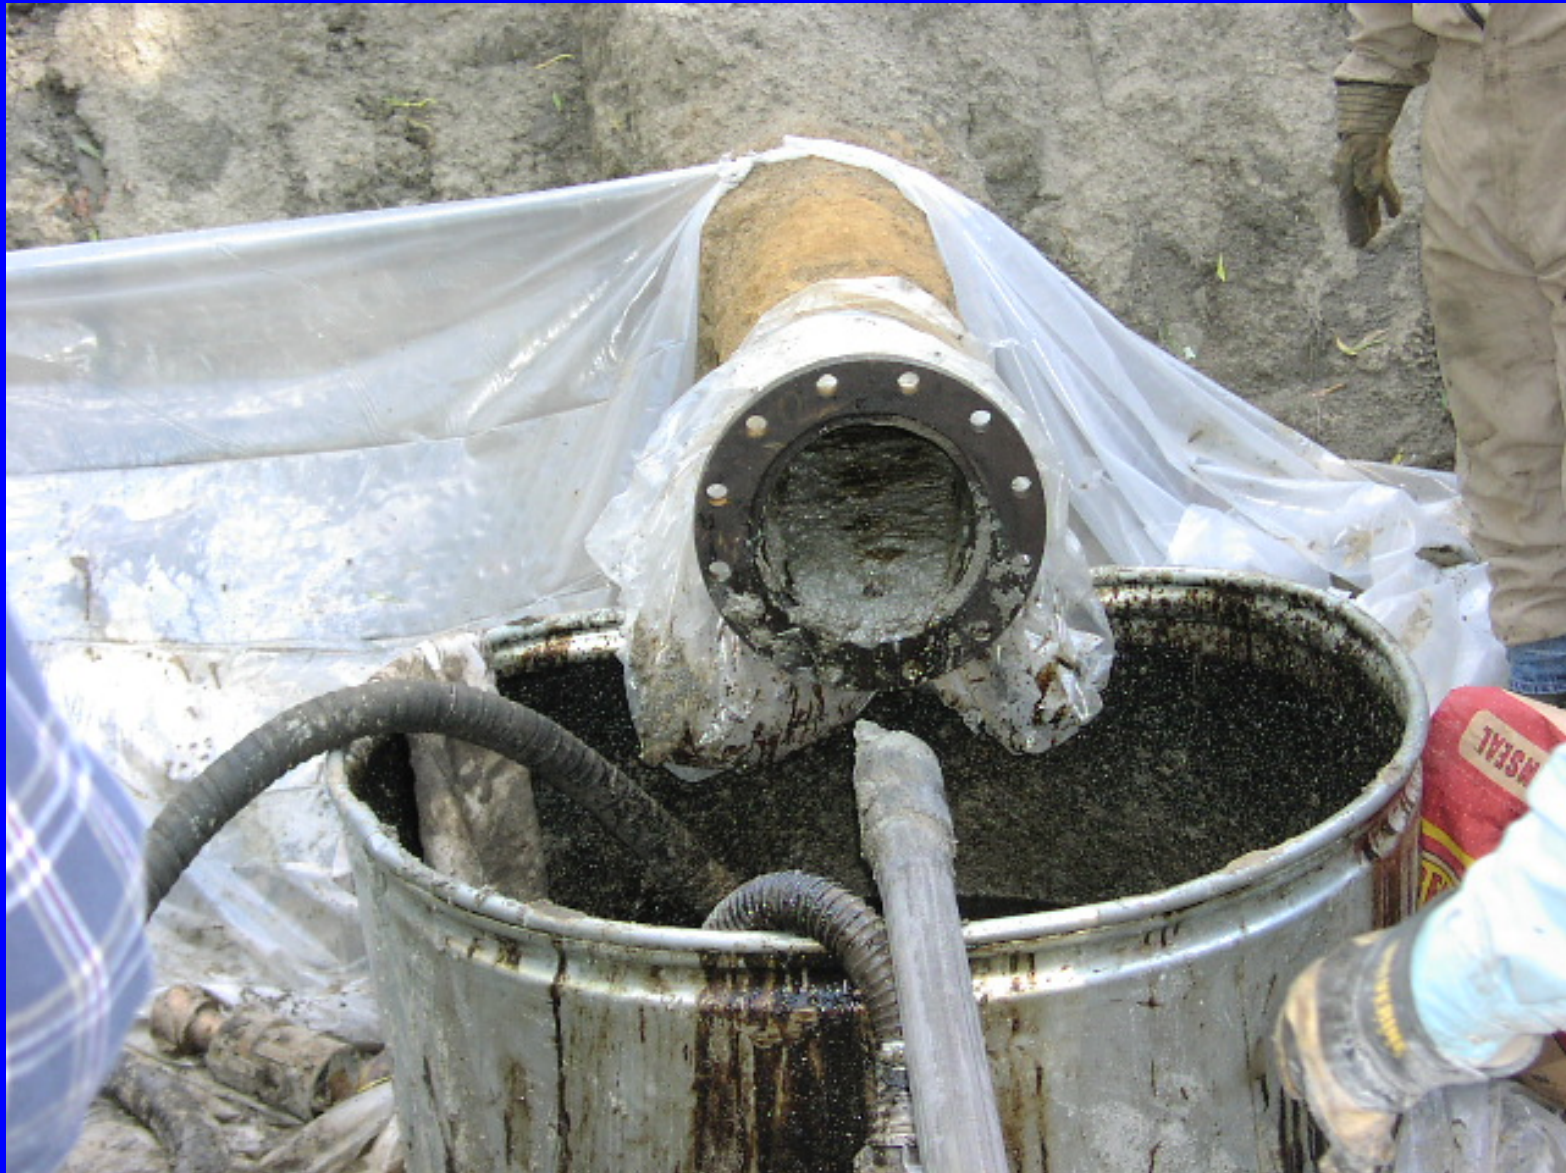
South line filled with drilling mud
