ConocoPhillips Mississippi River Pipeline Release

August 6 - October 3, 2003

presented by Tim Ganz, former State On-Scene Coordinator,
Missouri Department of Natural Resources
Environmental Emergency Response Section

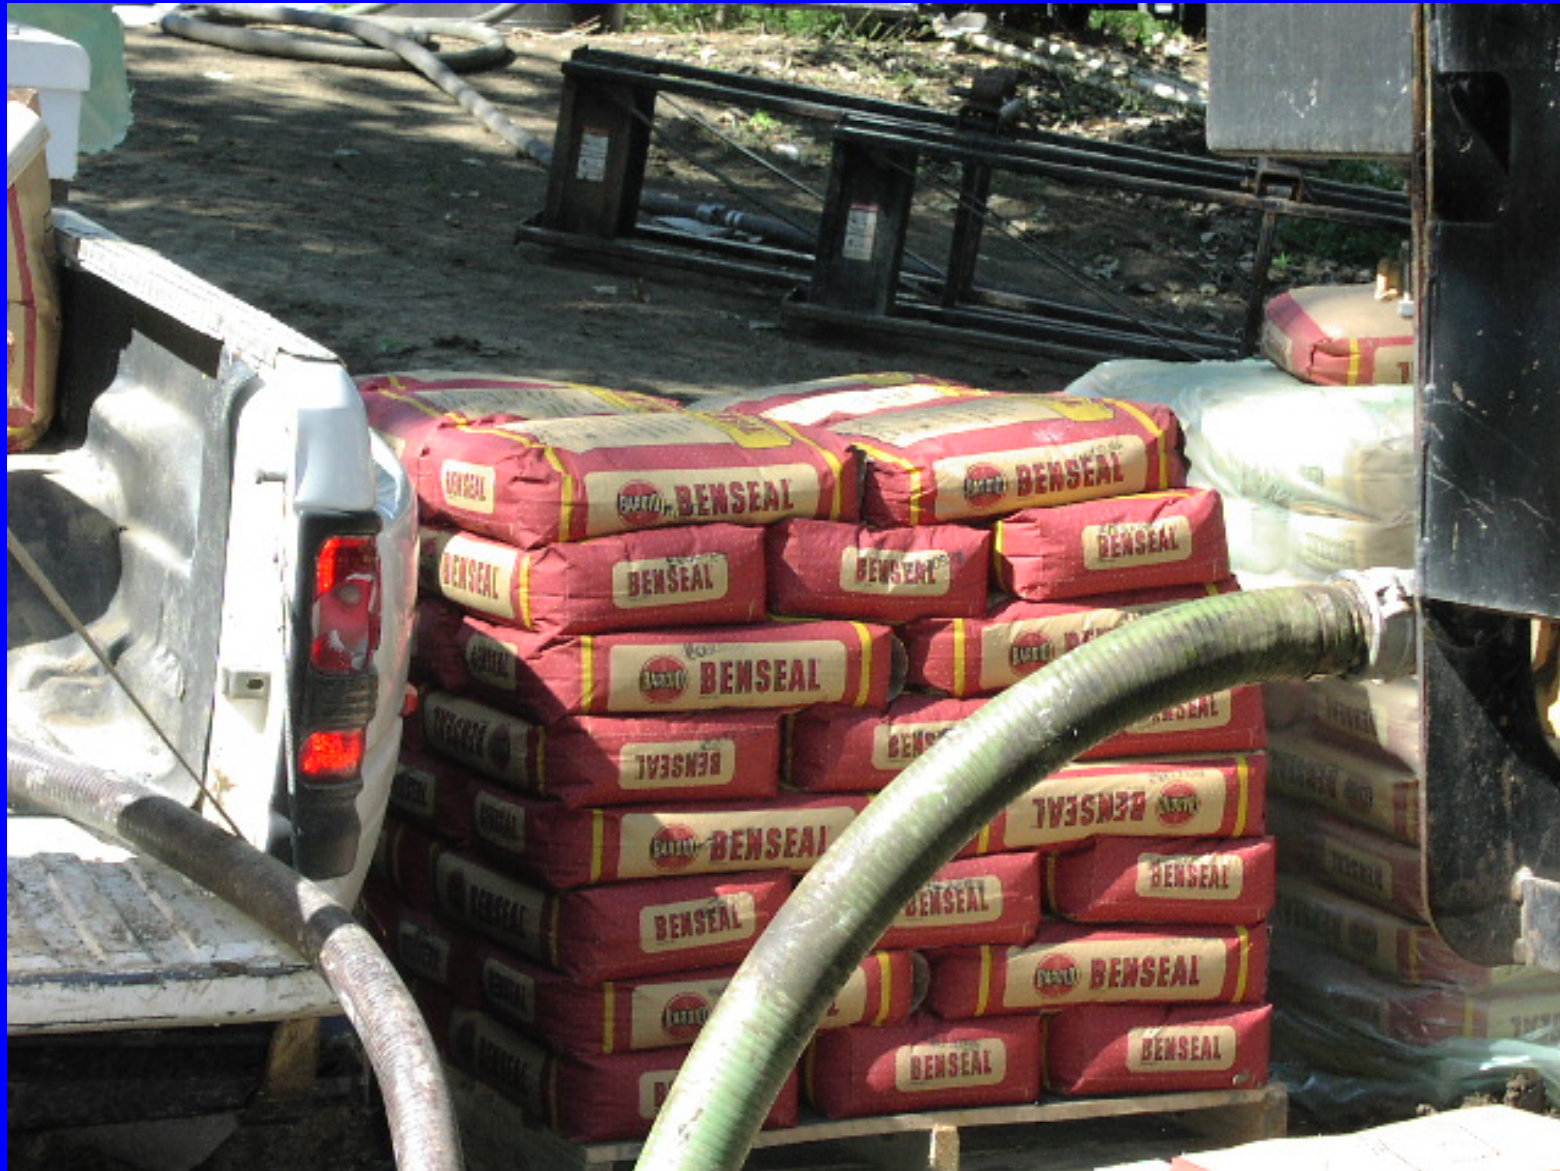
Drilling mud prior to mixing and inserting in the lines

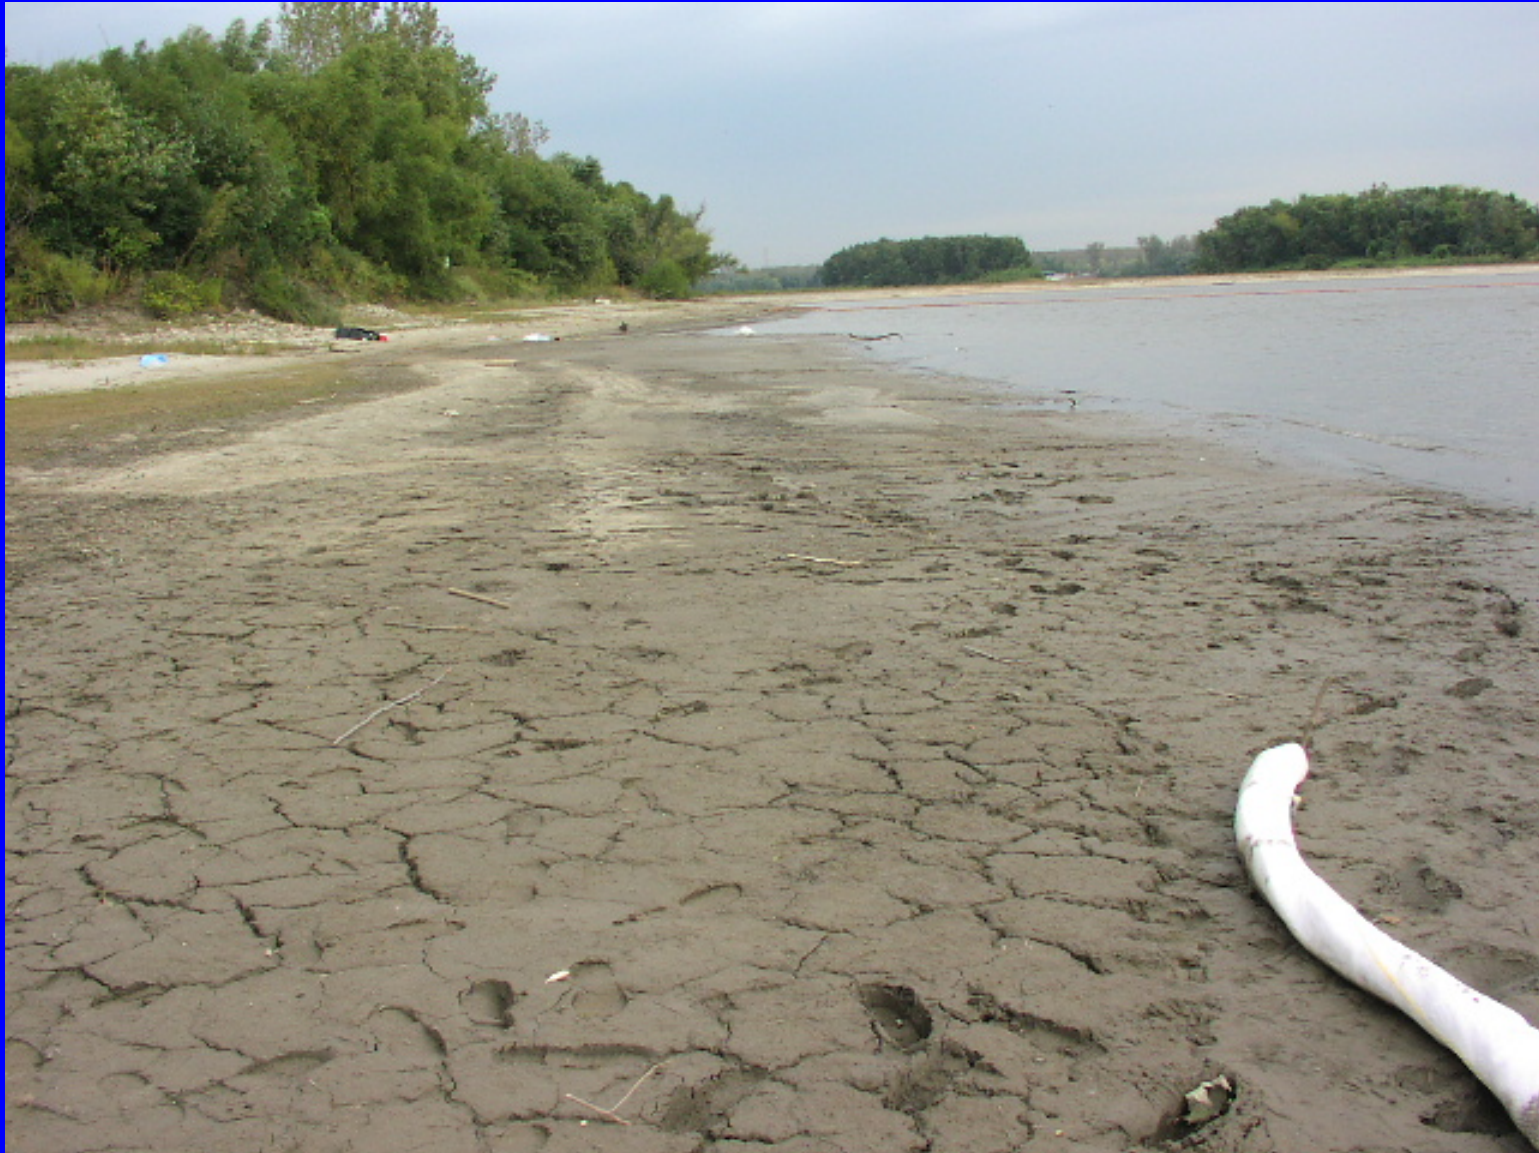
Post clean-up view of beach

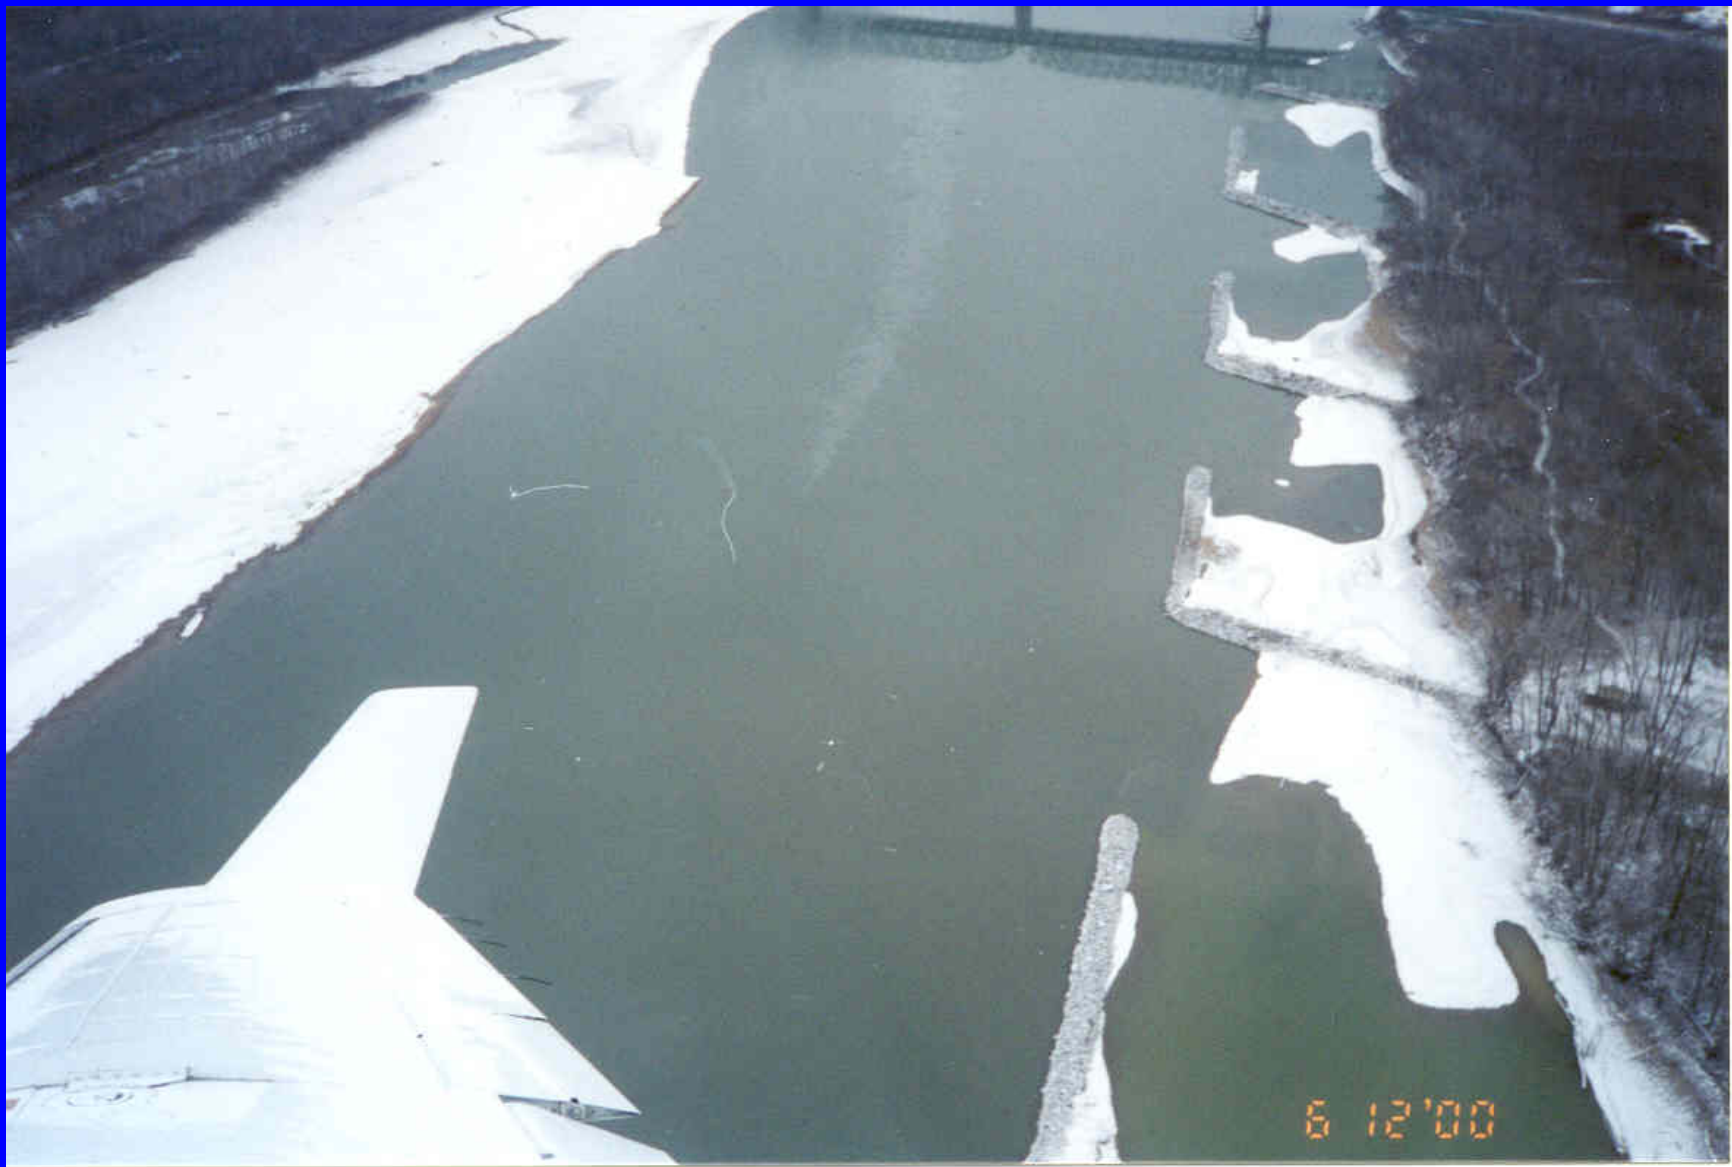
Abandoned Pipeline Leak on the Missouri River – 12/06/00

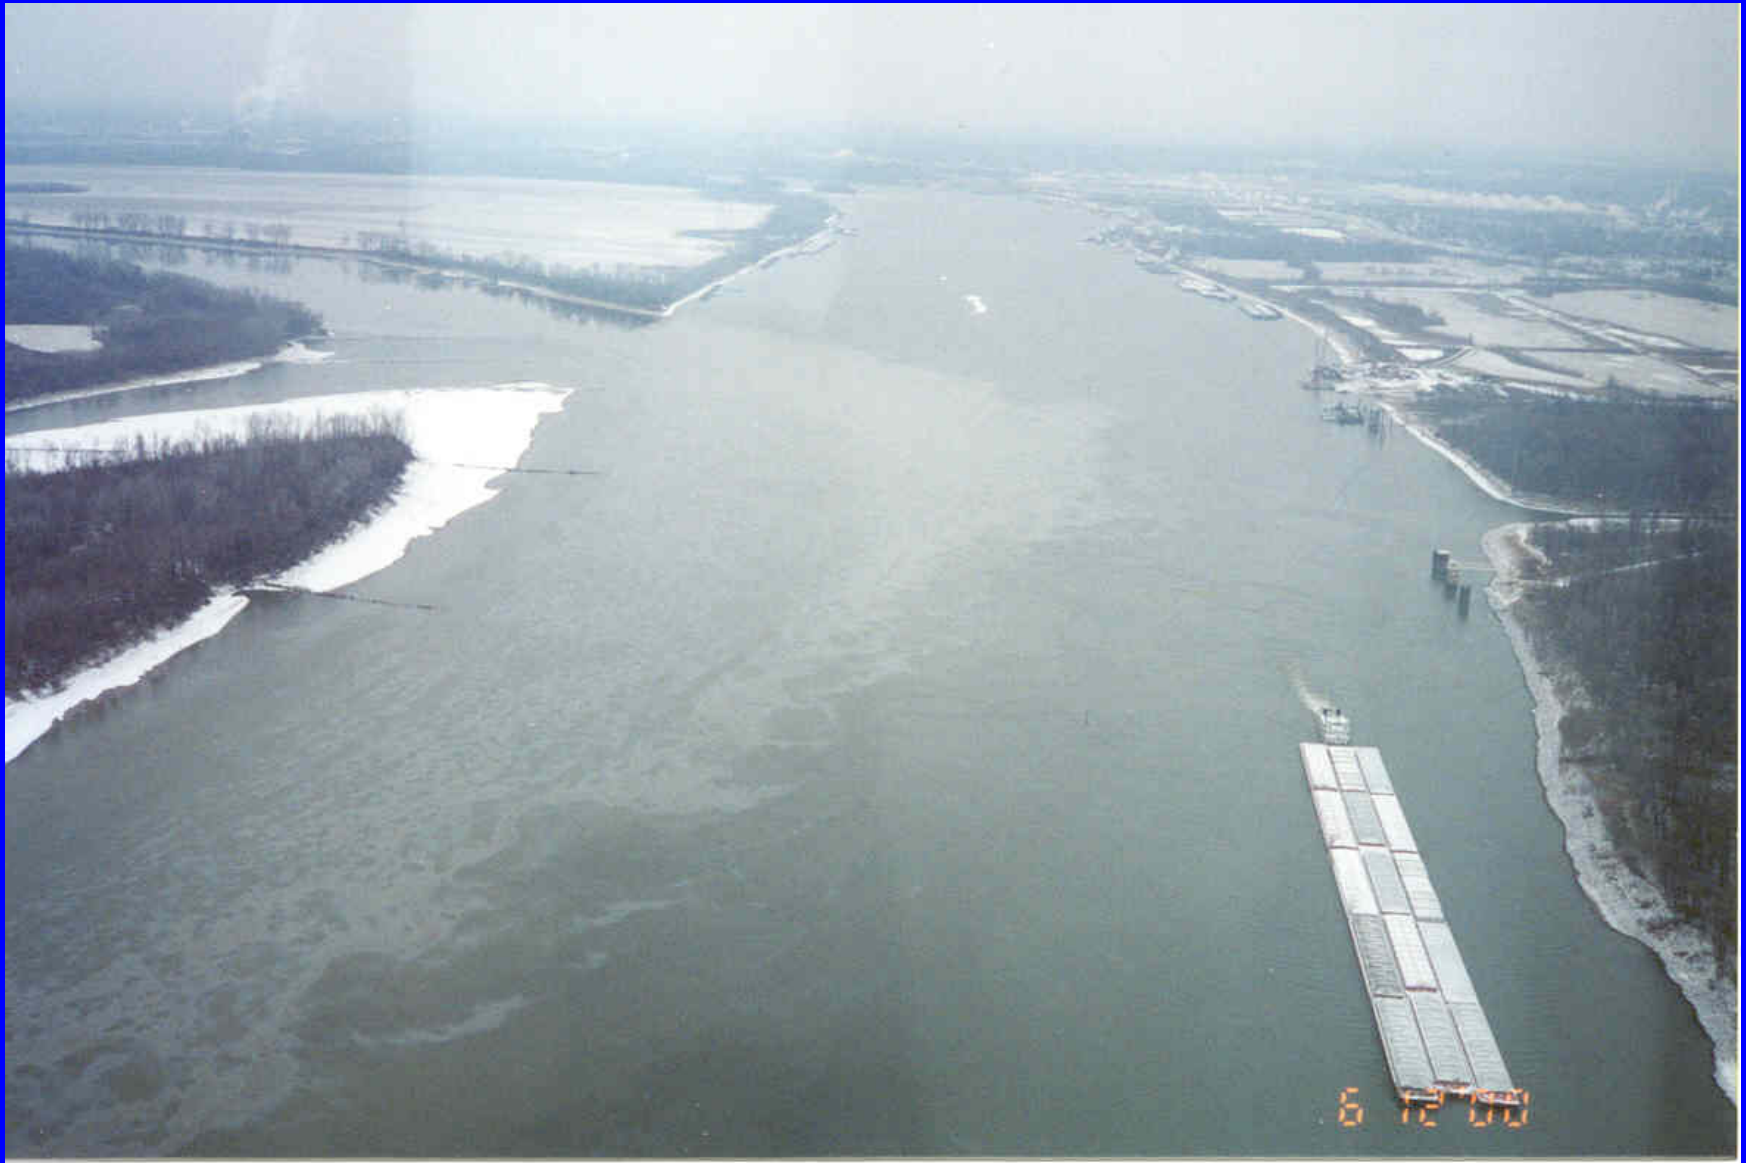
Sheen at confluence of Missouri and Mississippi Rivers
