Minnesota Pollution Control Agency

A Crude Oil In-Situ Burn in a Peat Bog

Enbridge Energy Company

July 4, 2002

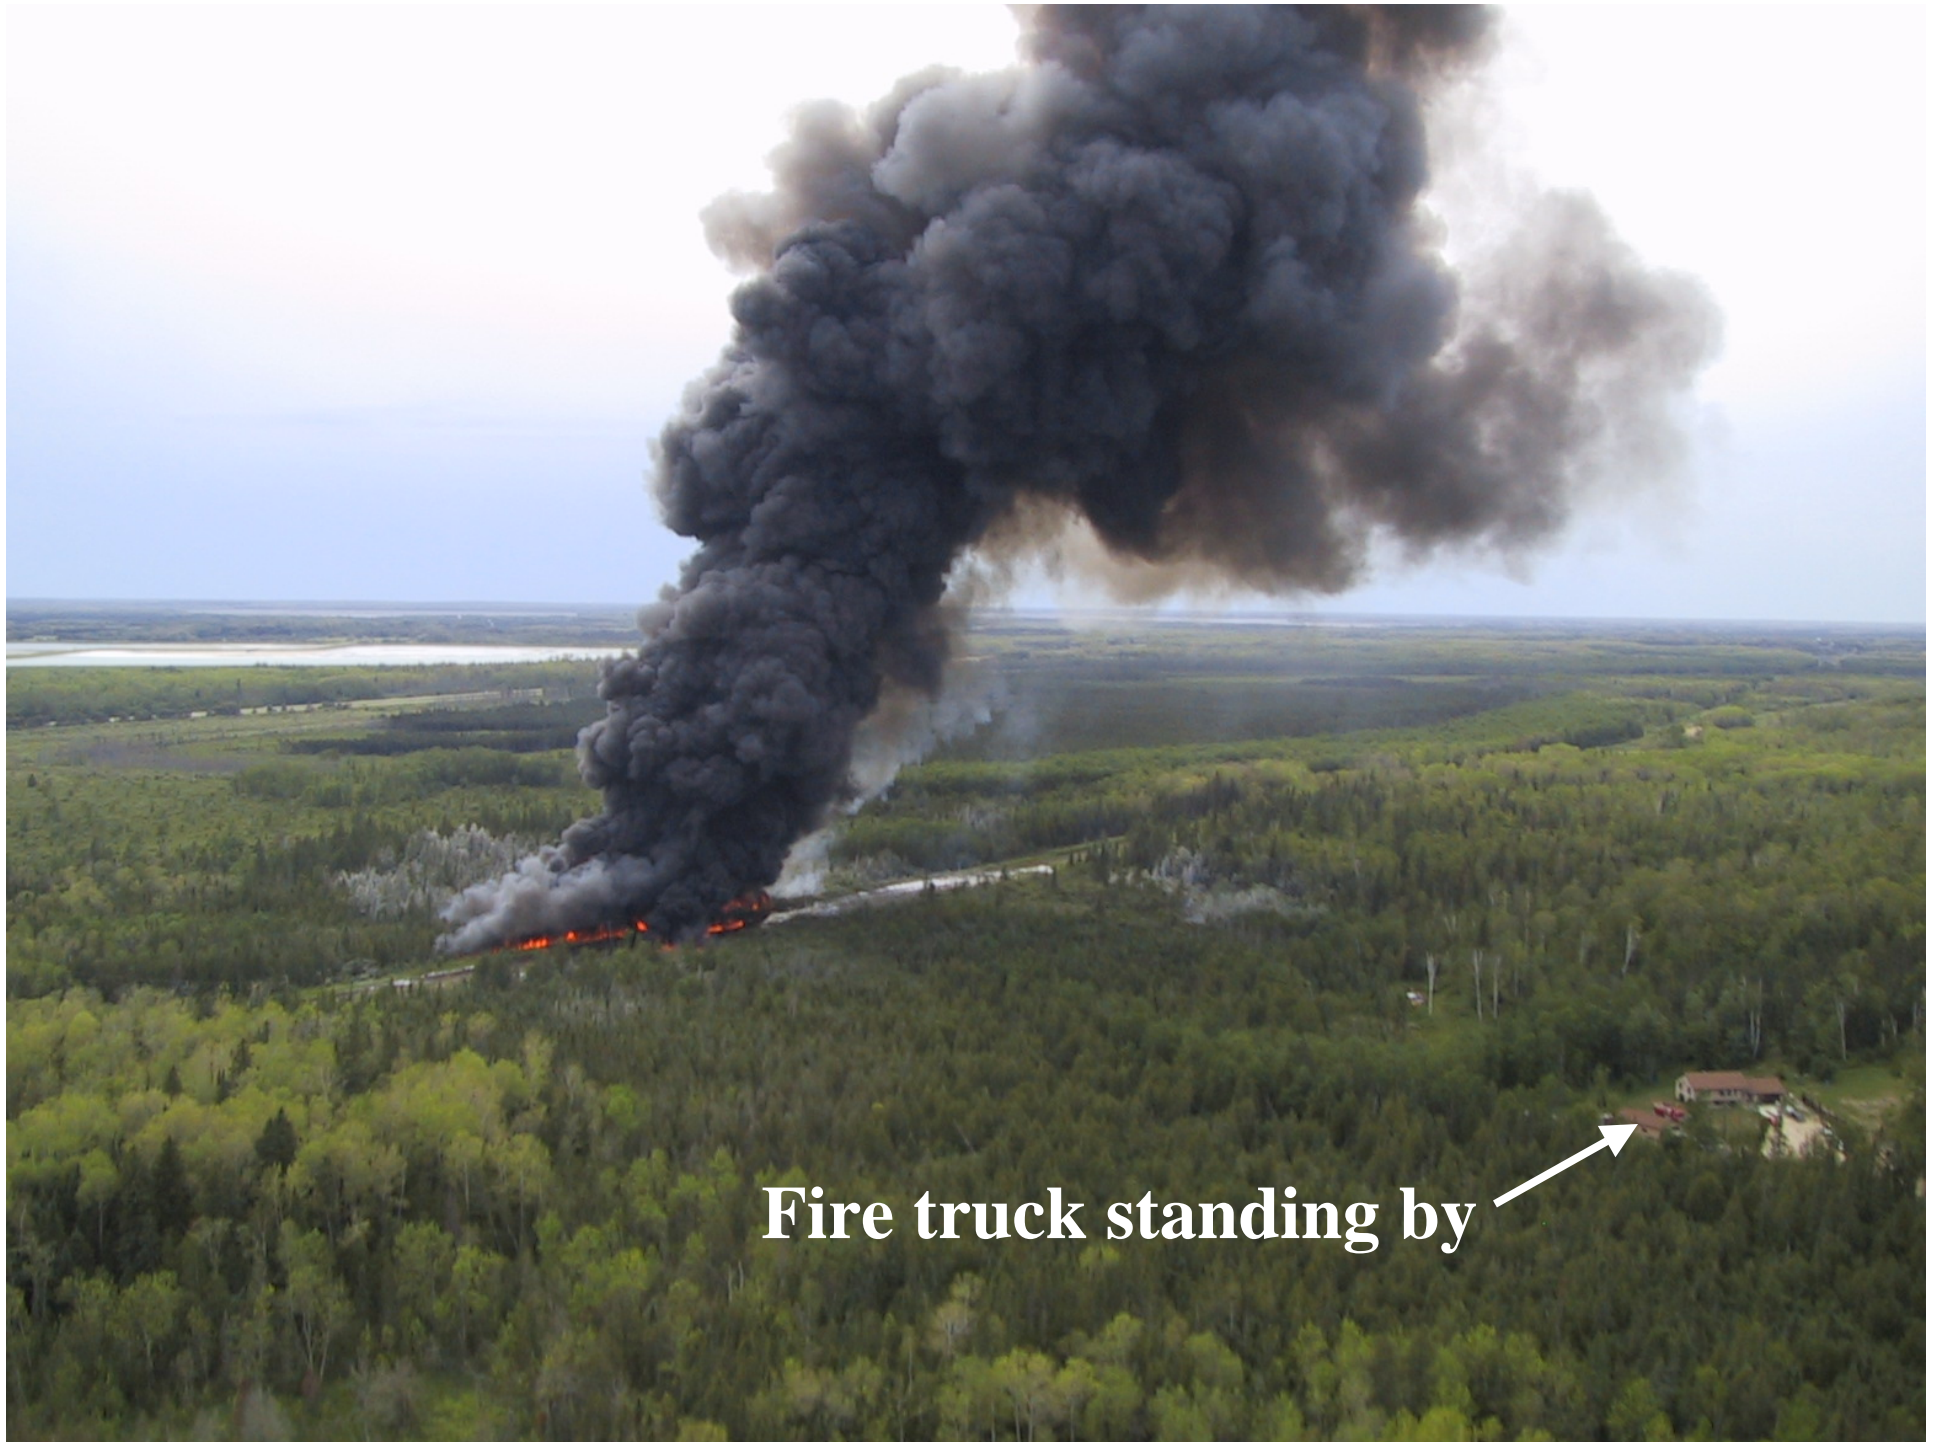
Fire truck standing by

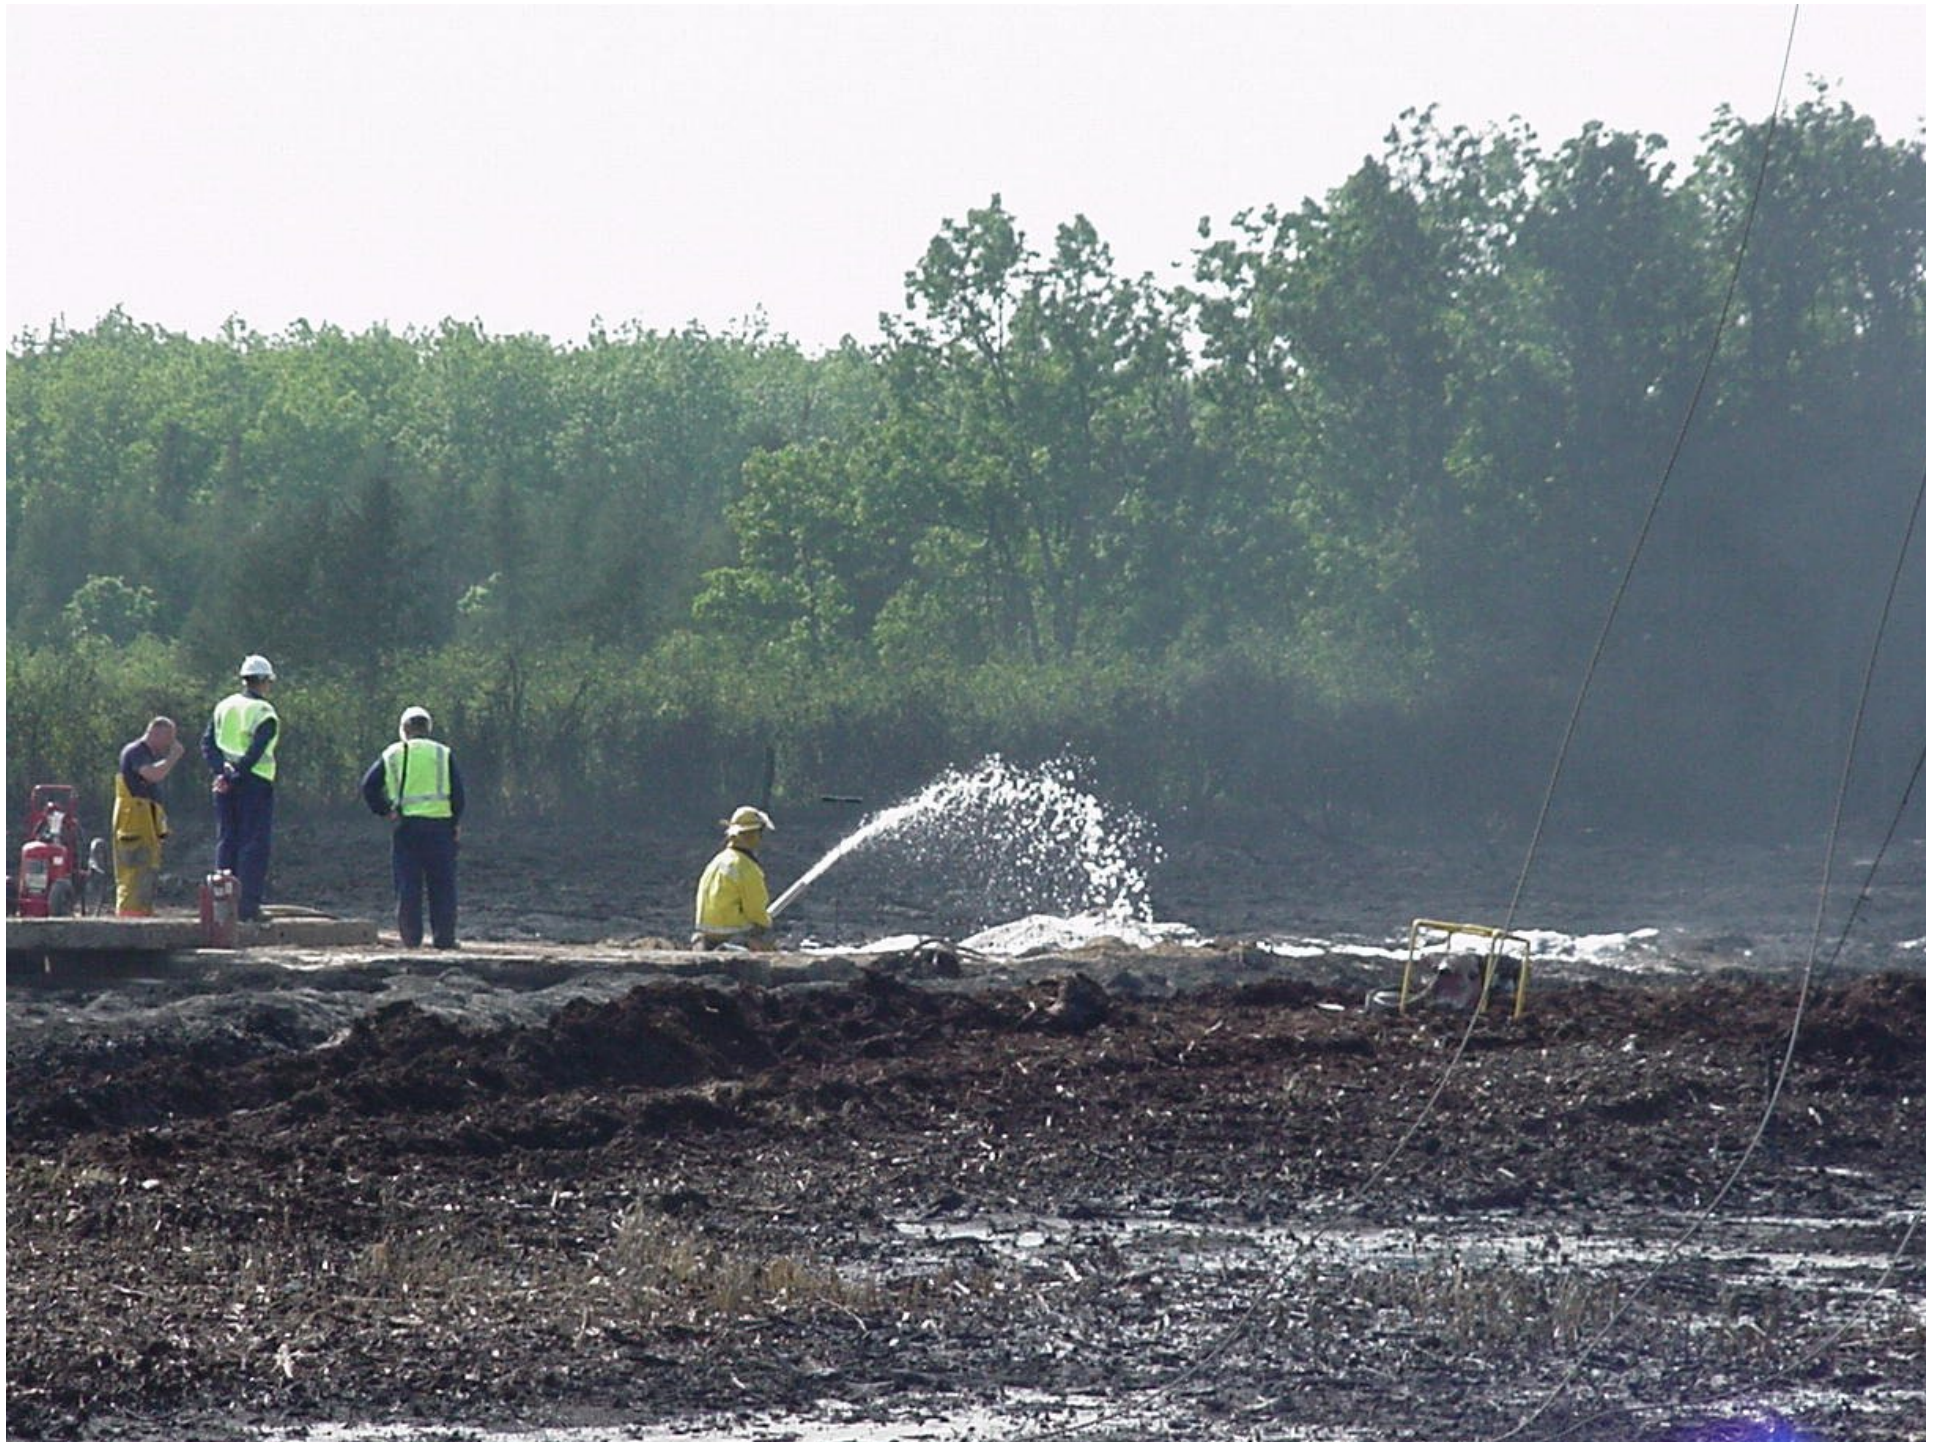
Remaining Fire Extinguished

As the majority of the burn had ended, various “pockets” of product would extinguish but then reignite as product came to the surface. Also, by this time, physical recovery was more efficient.

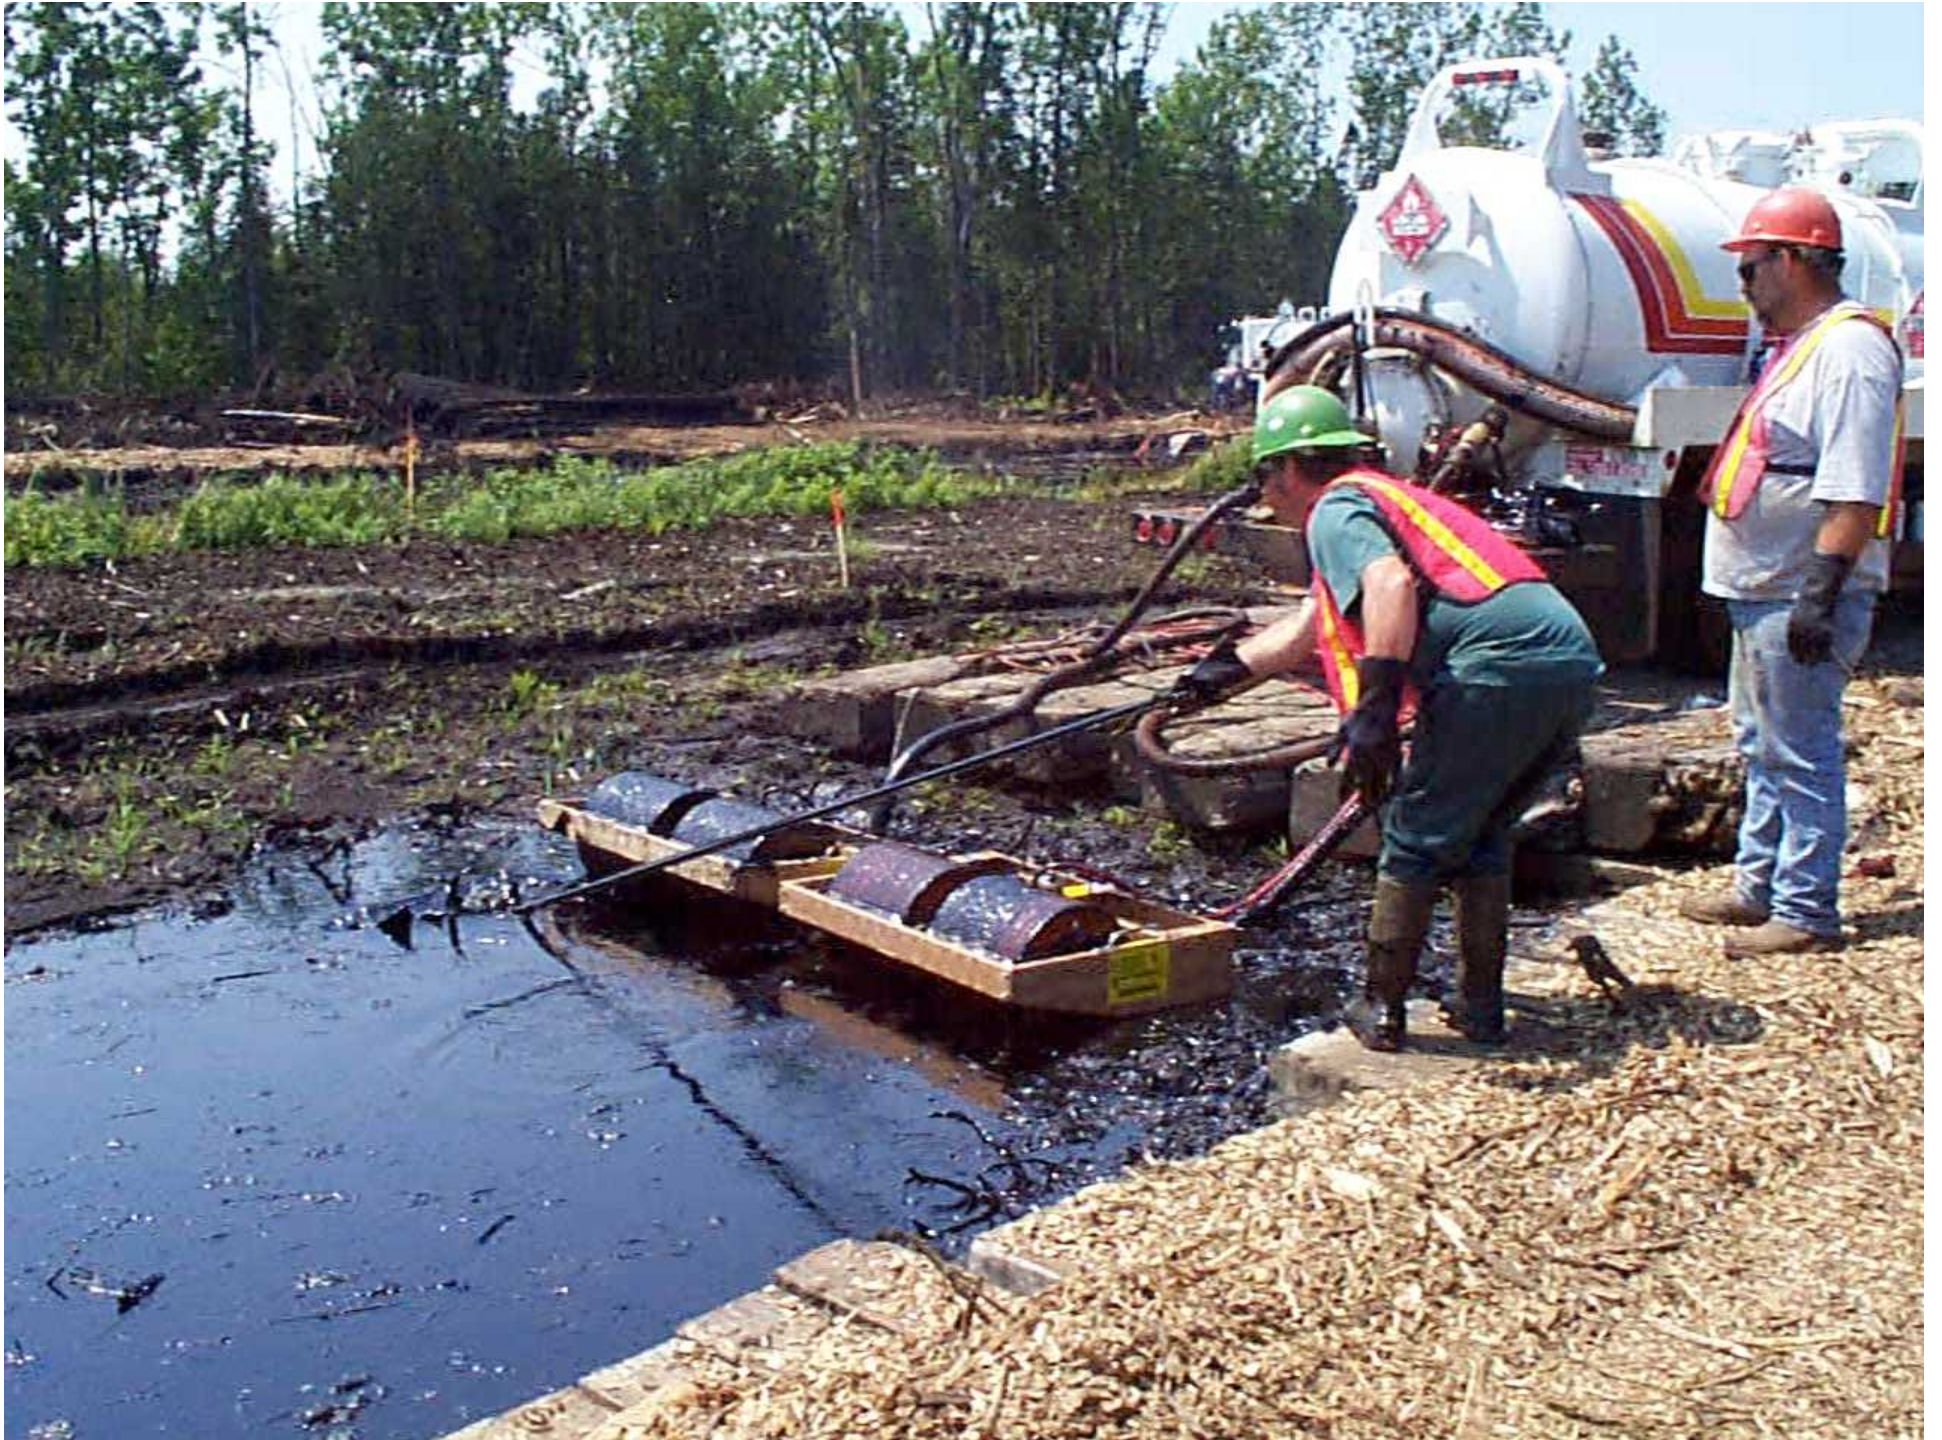
Large reflective eye and decoy wing-flapping birds used to “haze” waterfowl from landing in oil

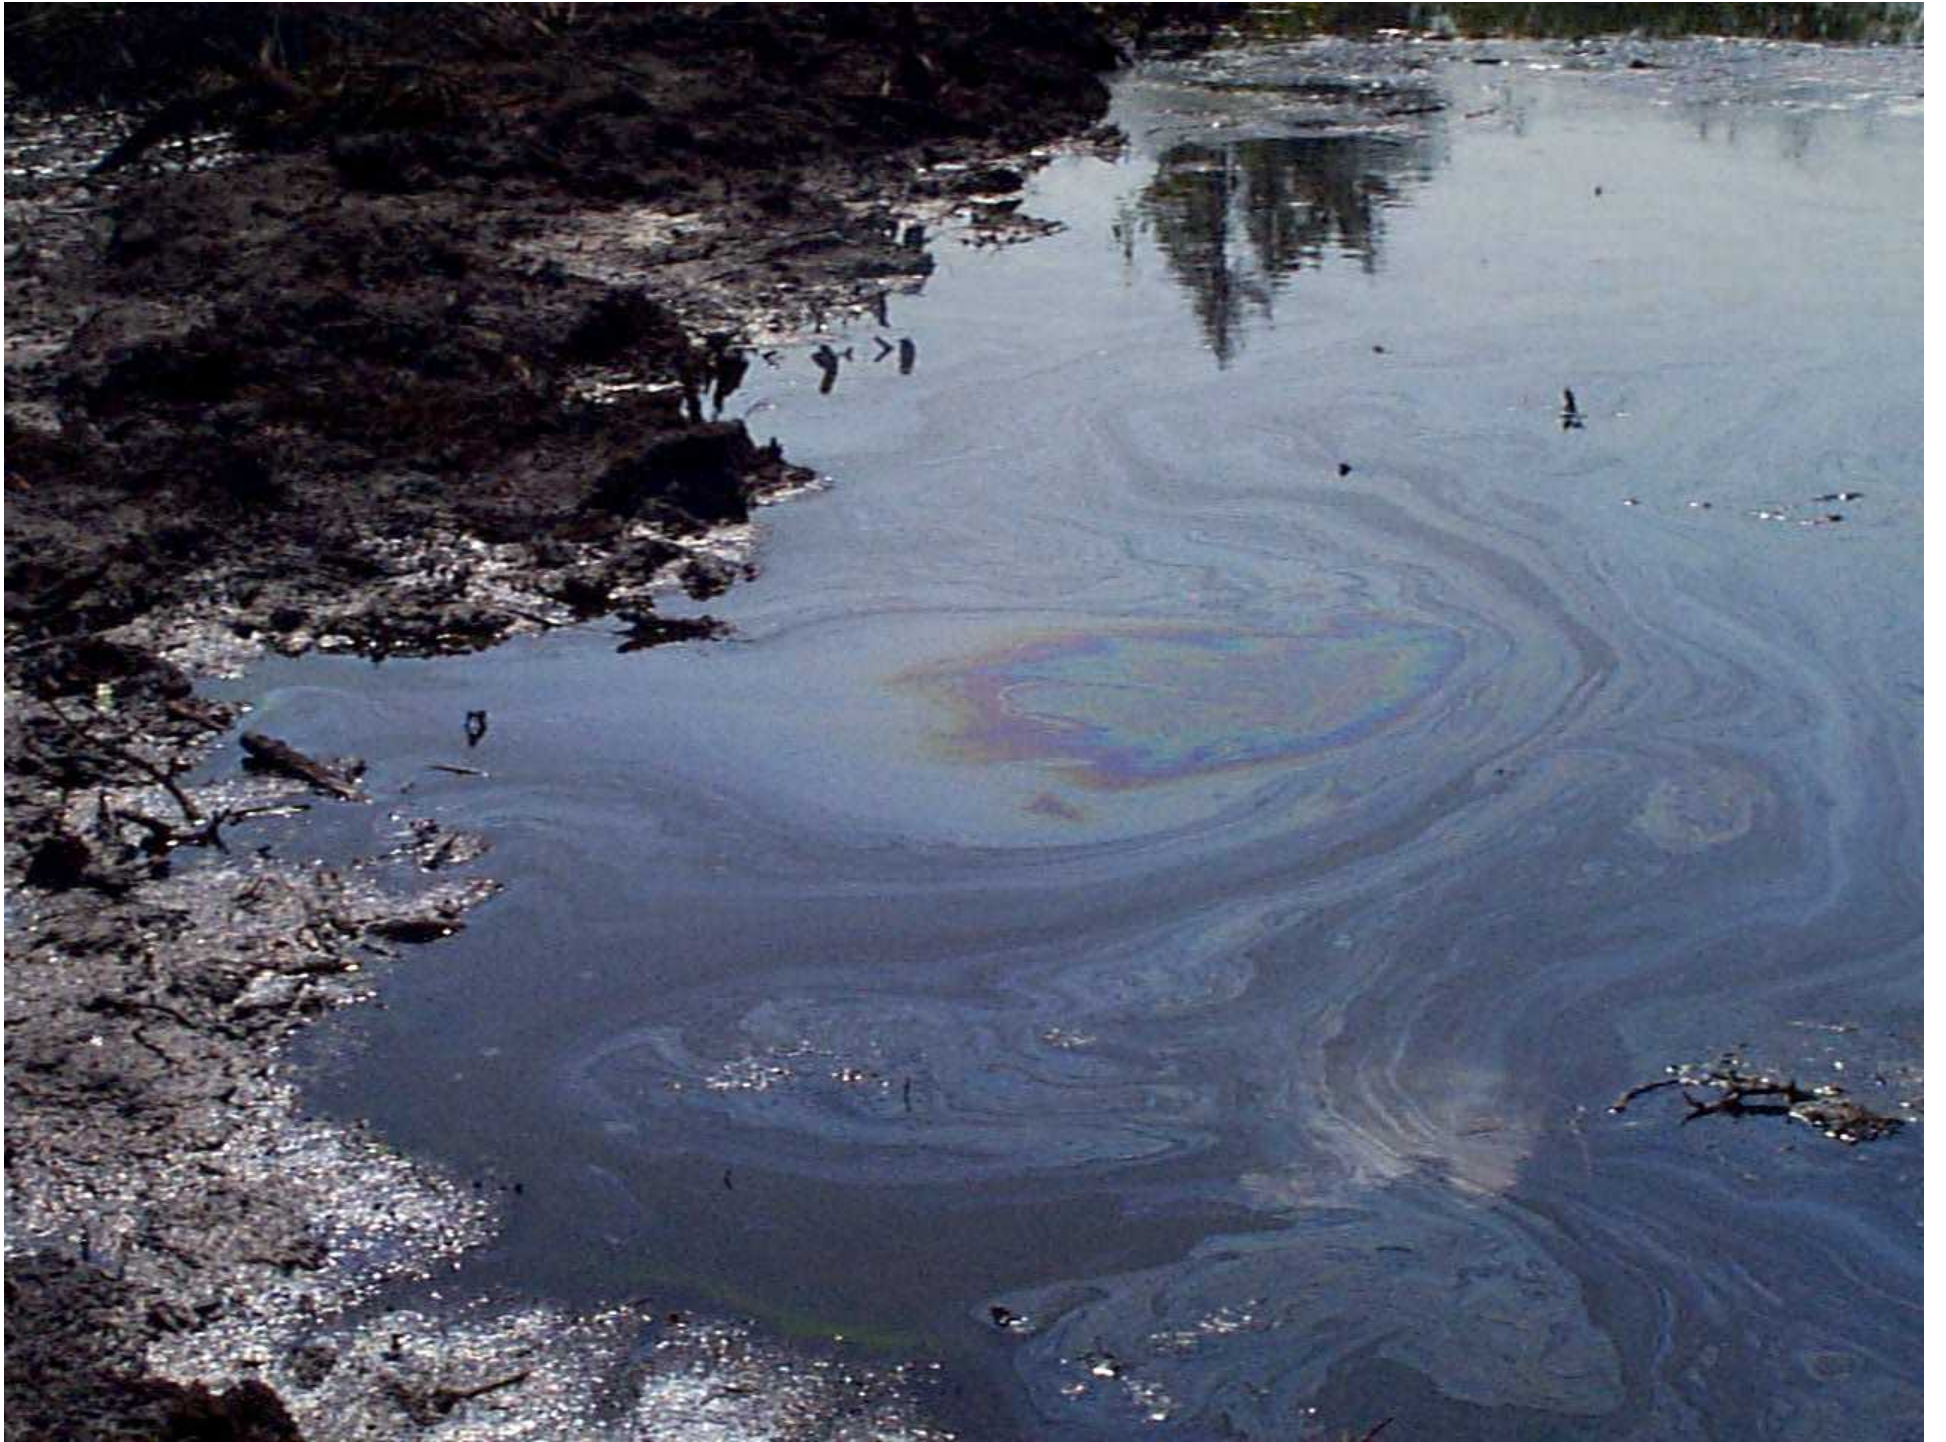
Placing oiled-peat into windrows and hydrating out oil met with limited success

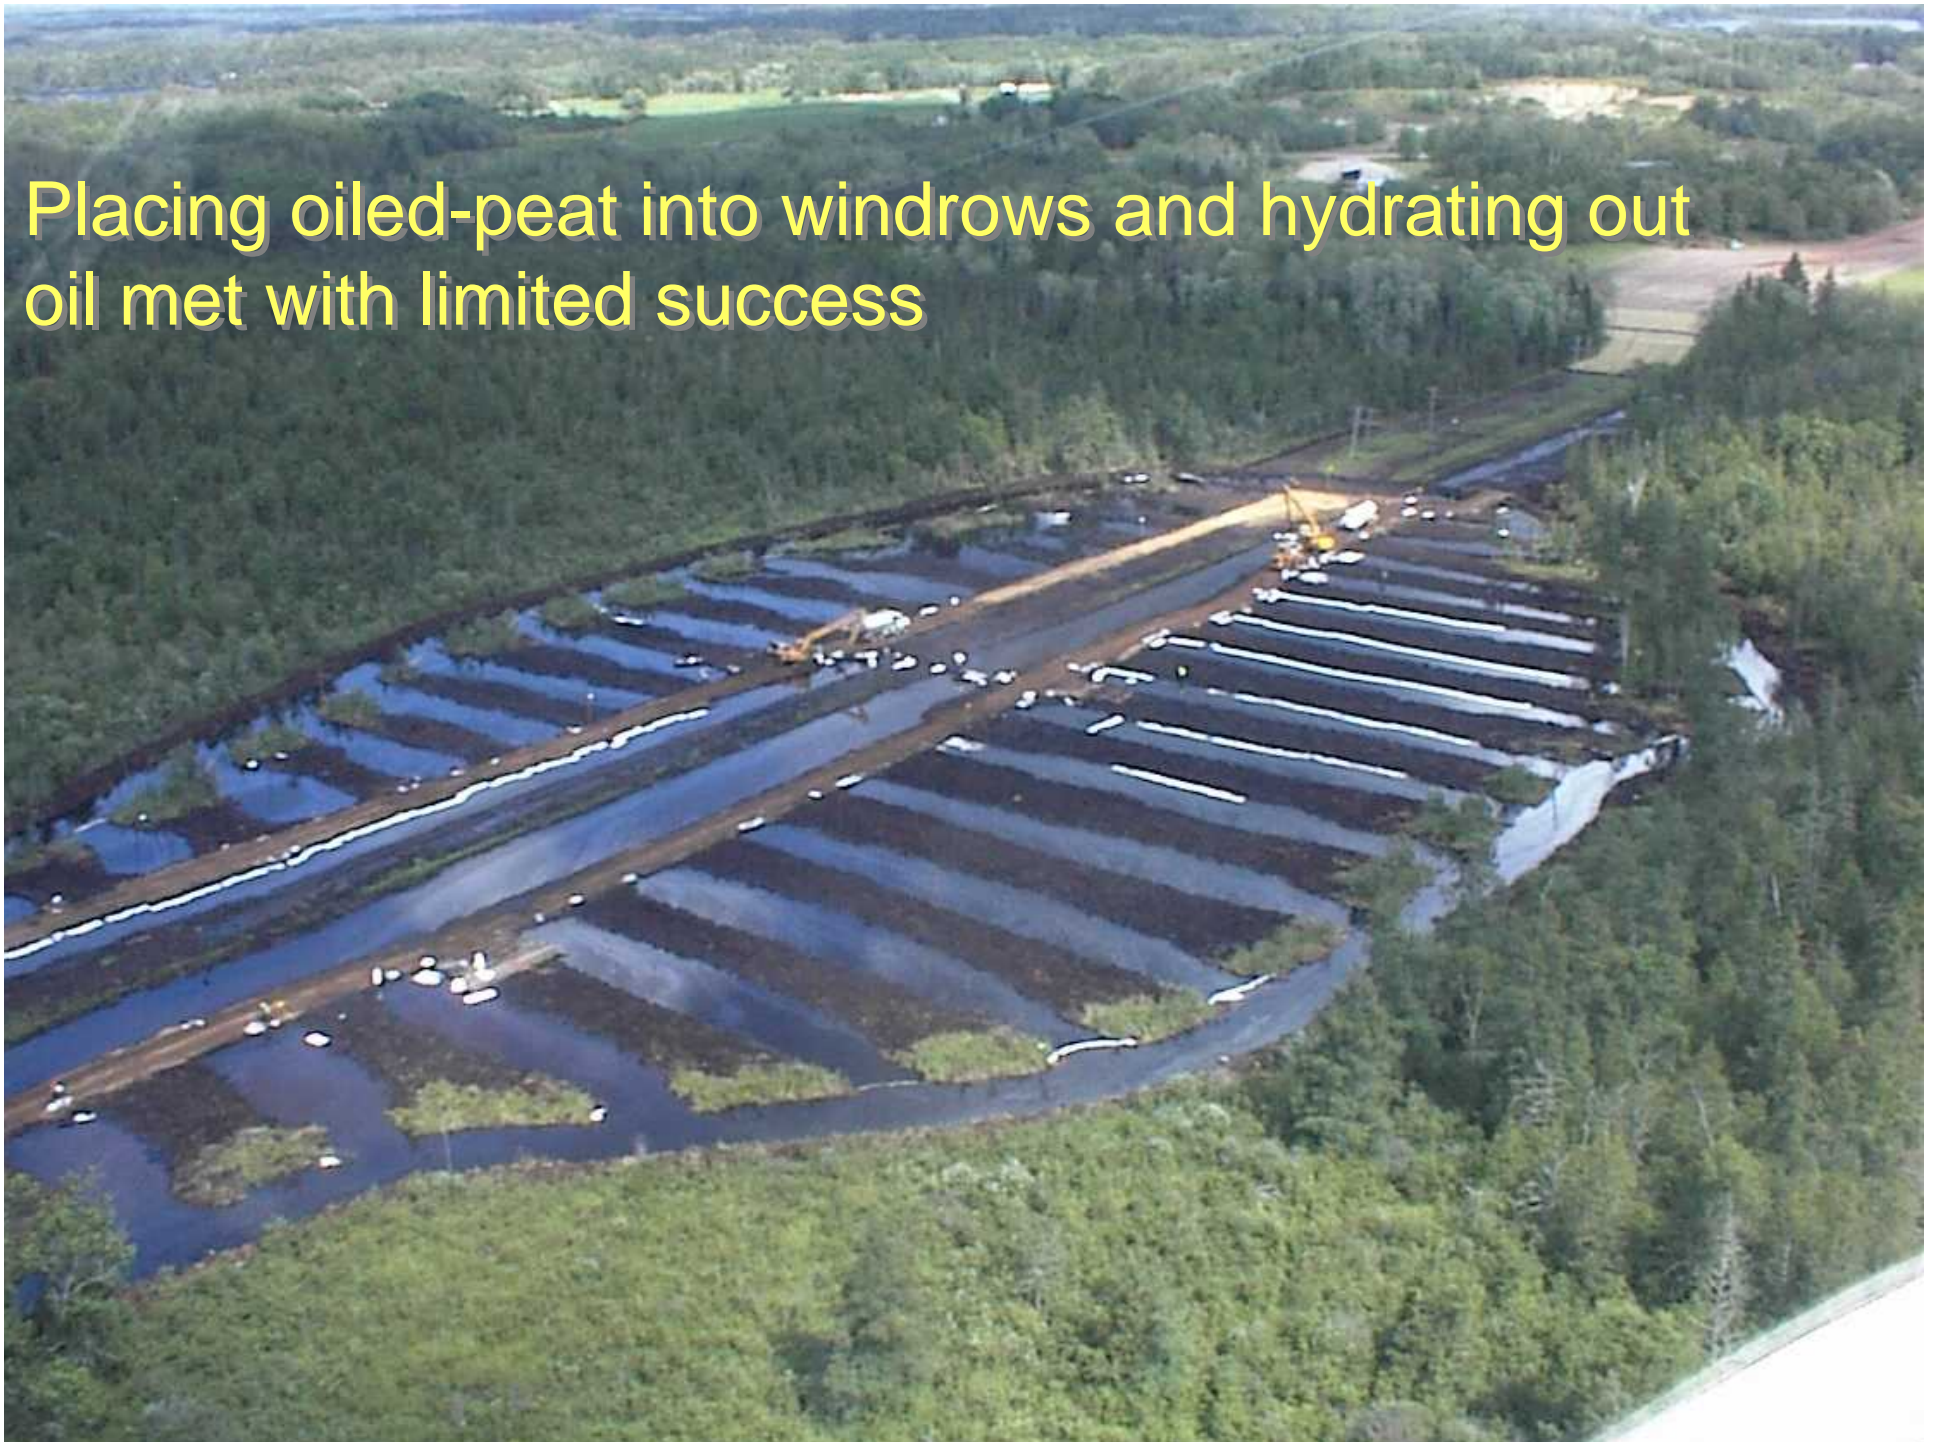
An aerial photograph taken from a high altitude, showing a large dam structure across a river. The dam is a long, narrow, light-colored structure, possibly made of earth or concrete, with a dark, turbulent flow of water passing through its center. The surrounding landscape is a dense forest of green trees, with some patches of brown and yellow, suggesting autumn. In the upper left, there are some buildings and a road. The sky is clear and blue. The perspective is from above, looking down at the dam and the surrounding area. The text "November 1, 2002: field operations suspended" is overlaid in yellow at the top. A date stamp "9.25.2002" is in the bottom right corner.

November 1, 2002: field operations suspended

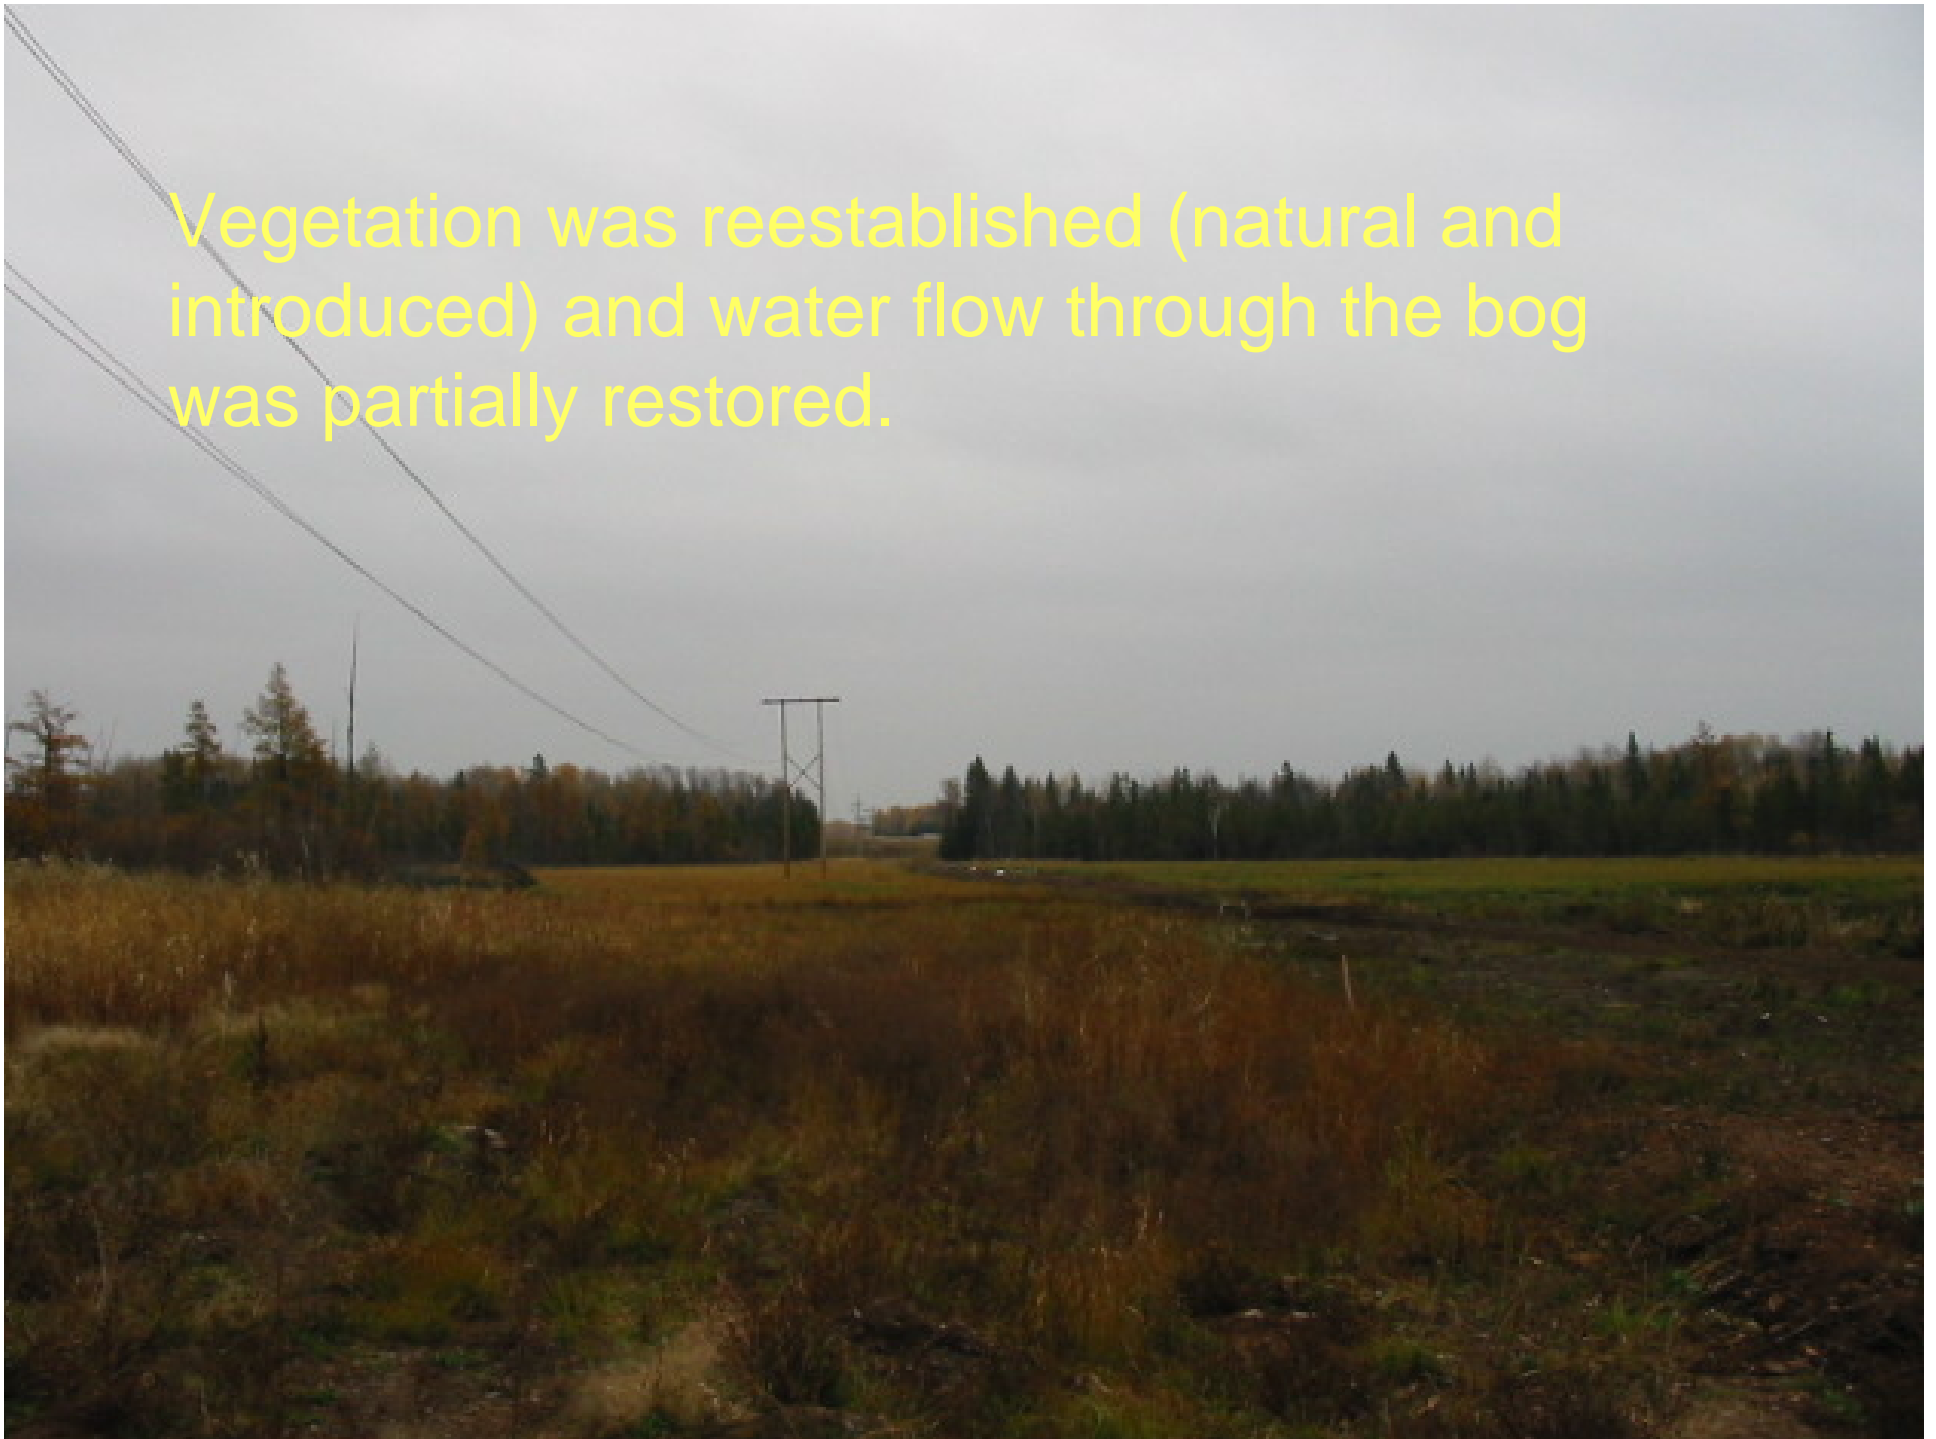
Fall 2003

Vegetation was reestablished (natural and introduced) and water flow through the bog was partially restored.
