CCG/USCG International Joint Marine Contingency Plan for the Great Lakes

Incident Origin

Shoreline Assessment Shoreline Survey

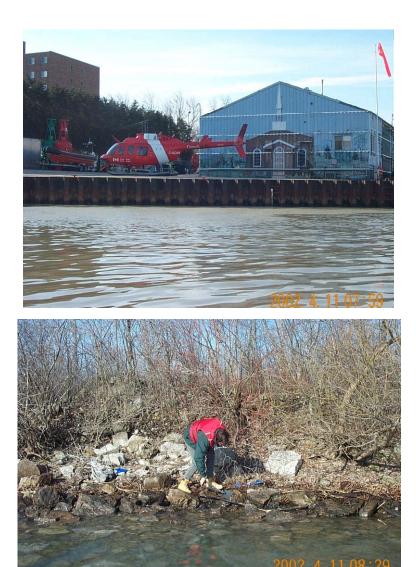
Over 41 km of total shoreline oiled

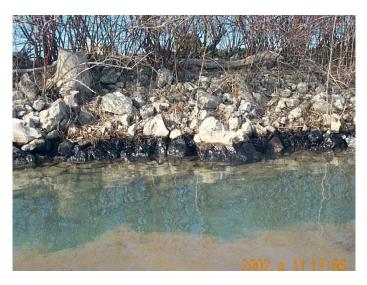
Shoreline Assessment Shoreline Types

➢Rip Rap **≻**Pebble **Cobble Boulder ≻**Sand Fringing Wetland ➢ Mixed Shoreline Shoreline Uses

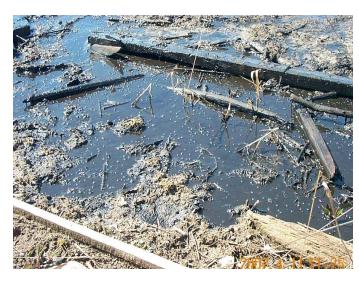
- Approx 18 km of Canadian Shore Oiled, Est 10,000L(2600gal)
- ▶ 0.5 to 1 mm Thick
- 50 75mm from Waterline
- Slightly Weathered
- Pooled Oil (75mm)
- > Oiled Reeds (152mm)
- Stained Rocks
- Sheen

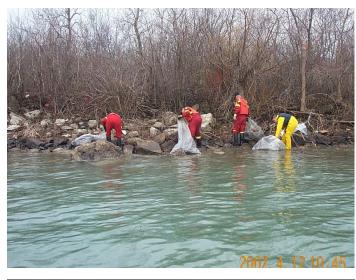
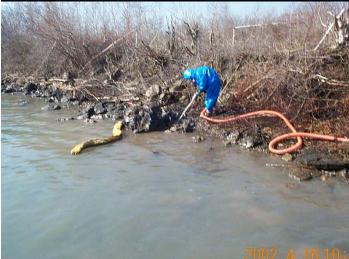
Different Methods According to Shoreline Type

Manual Removal of Oiled Debris

Compressure Wash

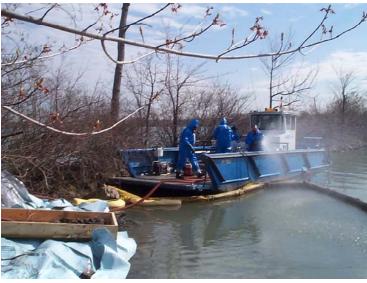
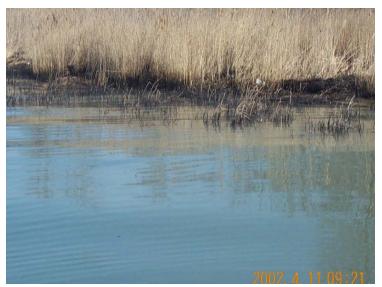
- Flooding (deluge)
- Contained High Pressure Wash
- Cutting of Vegetation/Reed
- Natural Recovery

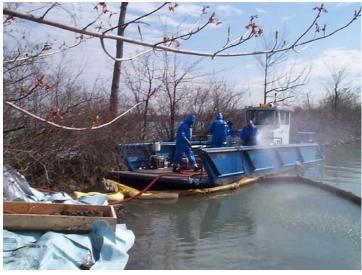
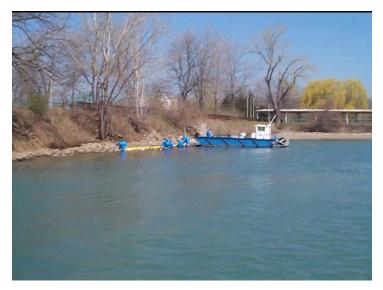
Cleanup Methods & Criteria Criteria

- Different Criteria According to Land Use
- Was Any Oil Product Recoverable
- Was There Potential for Oil to Remobilize

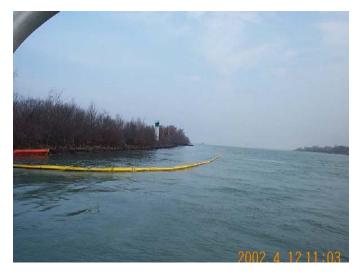
Cleanup Methods & Criteria Criteria

Any Pooled Oil Visible in Water or on Shoreline

- Does Oil Become Visible When Sediments are Mixed/Stirred
- Keeping in Mind More Harm Than Good May Occur in Some Areas

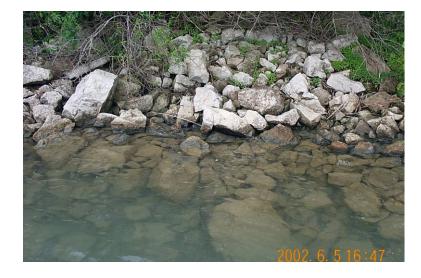
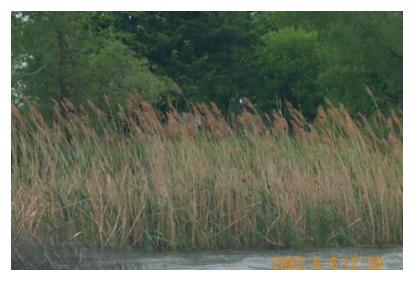
Site Revisit - 1

- area Revisited June 4/02June 6/02
- Video & Photo Documentation
- No Visible impact on shoreline
- New Vegetation Growth
- Wildlife Vibrant on all Shorelines
- Will be Revisiting in Spring of 2003

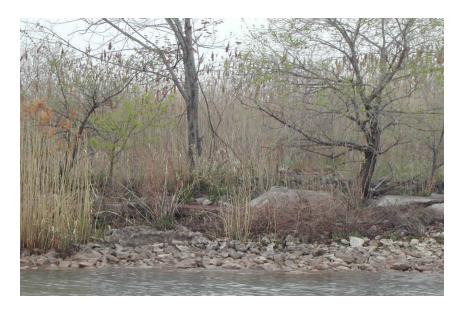
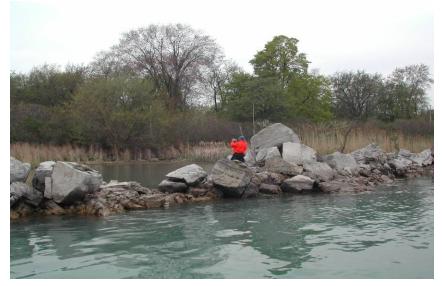
Site Revisit - 2

- area Revisited April 2003
- Video & Photo Documentation
- No Visible impact on shoreline
- New Vegetation Growth
- Wildlife Vibrant on all Shorelines
- Will not be Revisiting
