National Biological Assessment
and Criteria Workshop

RFC 202

Challenges in Selecting Reference Streams in Plains Landscapes: Northeastern Montana

Presented by
Michael W. Suplee,
Montana Dept of Environmental Quality,
Water Quality Standards Section

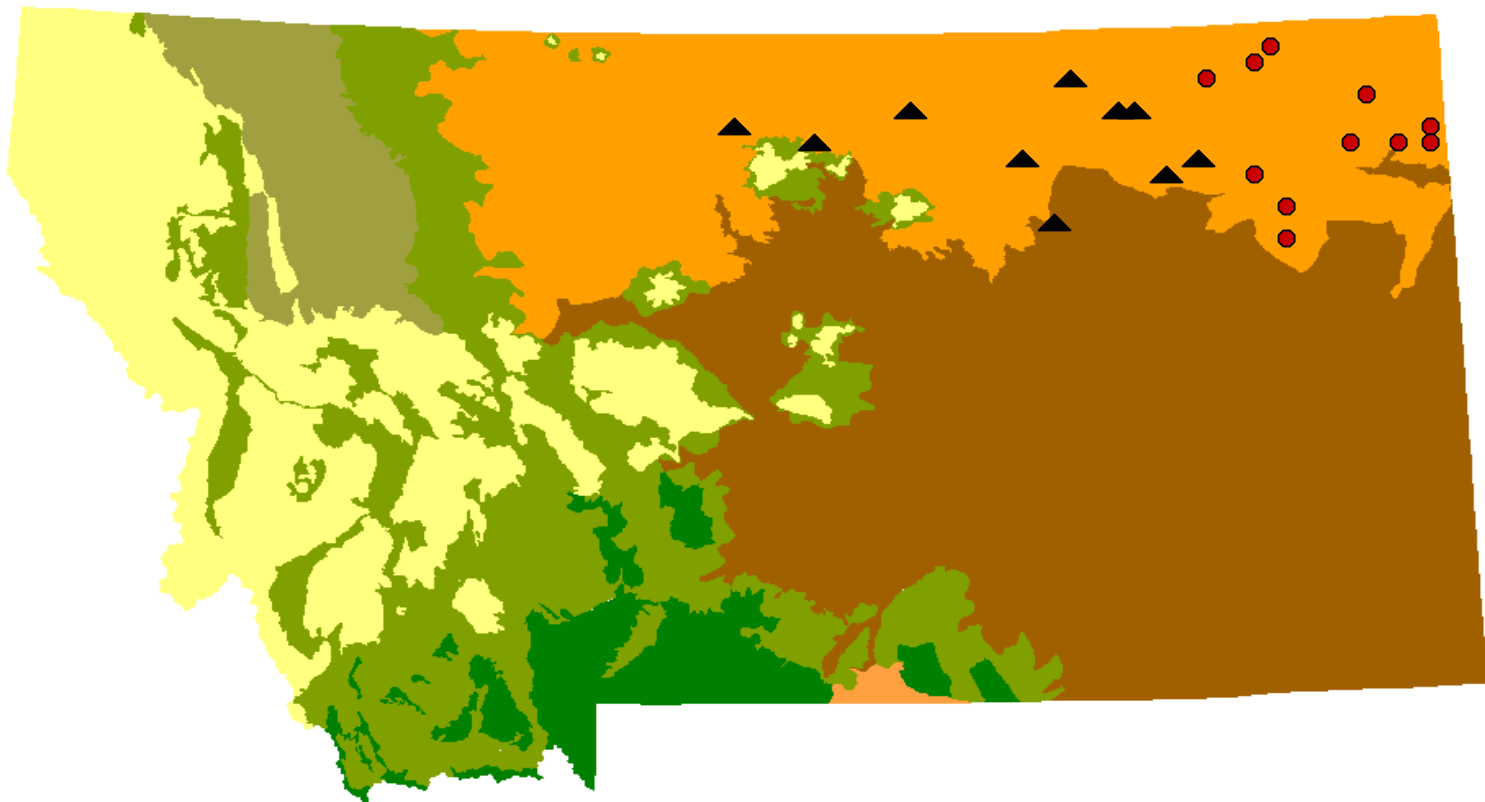
Site Locations

▲ 2001 (3 sites also sampled in 2002)

● 2002

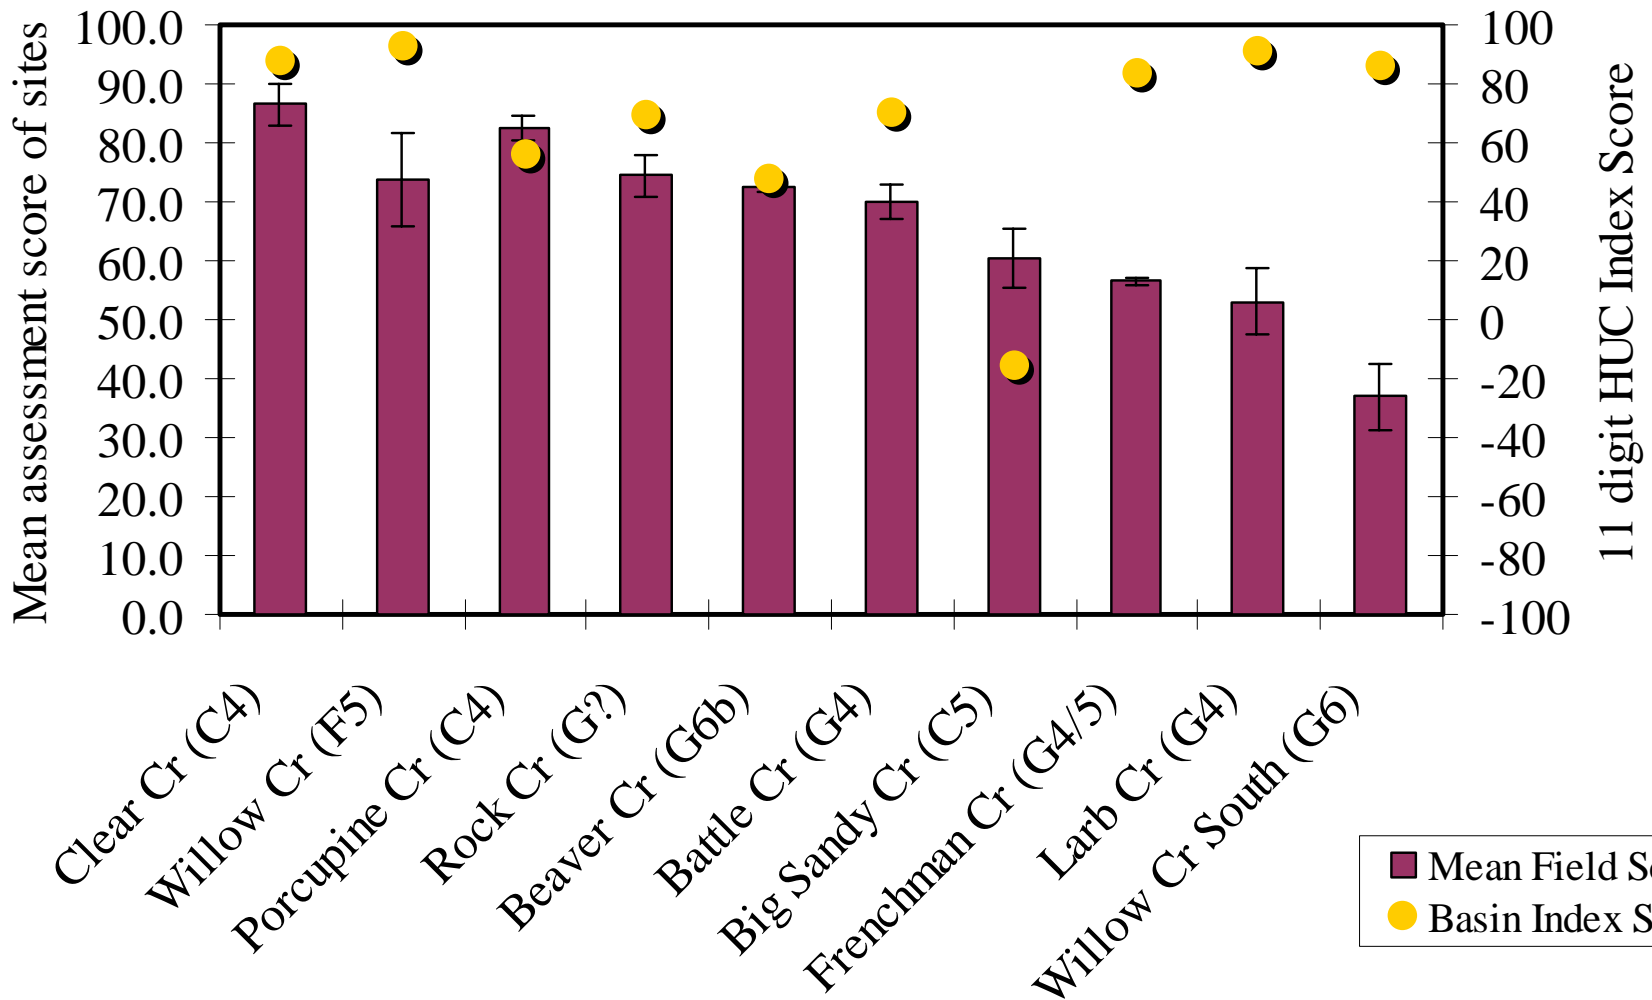
Field Assessments vs. Basin Index Values

(error bars are 1SD of the mean)

- In spite of efforts to the contrary, the study ended up with most sites in the middle range of habitat condition
- Various BPJ approaches to rating individual stream sites provided similar results, however a simple basin-index approach could not predict *a priori* the location of impacted vs. un-impacted sites.

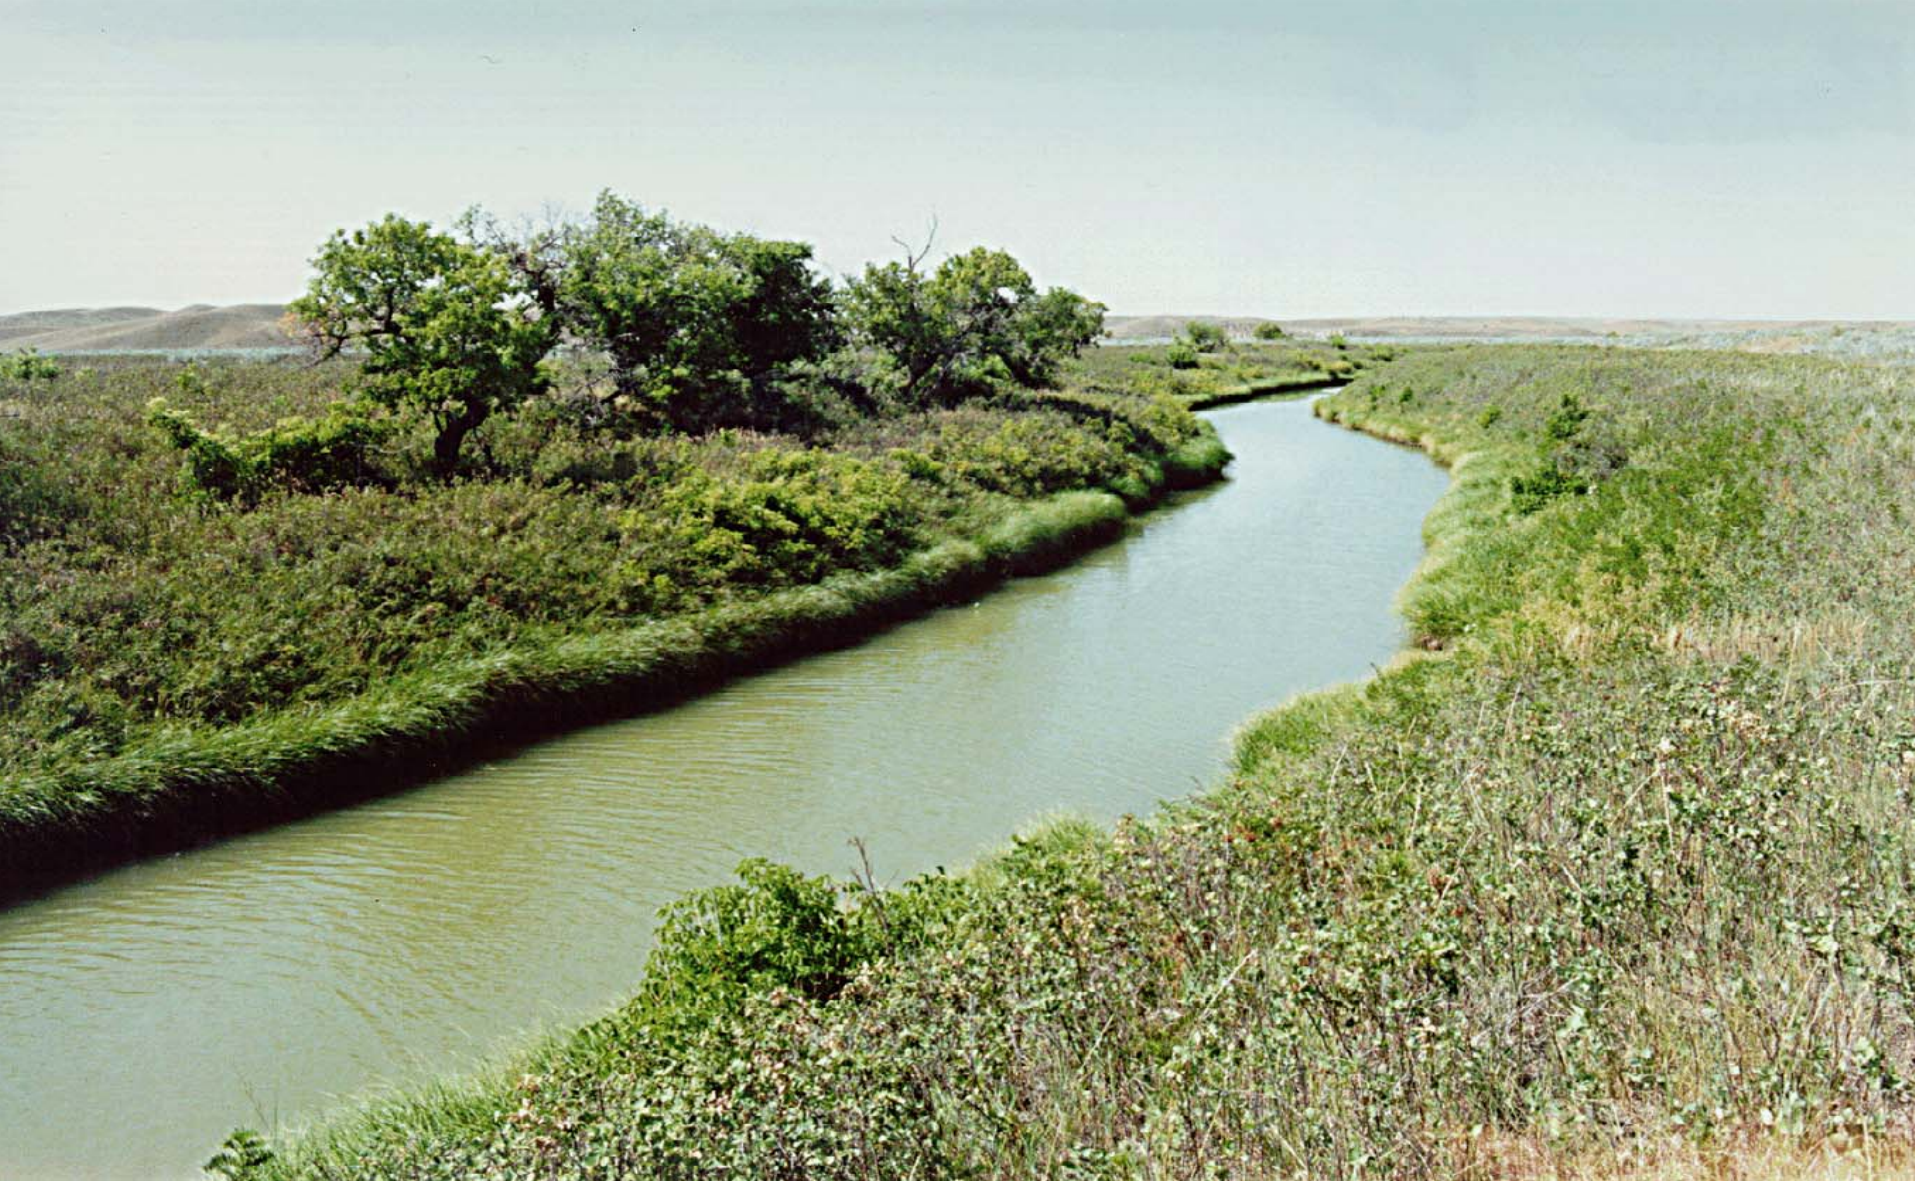
What kind of algae and macrophyte community should we expect?

Plains streams generally had two well defined communities, with little overlap:

1. Phytoplankton community (green pools)
2. Robust, mixed population of macrophytes and filamentous algae, with little or no phytoplankton (clear water pools).

Beaver Creek. Phillips County, MT

- Not all Prairie streams have extensive woody vegetation; careful observation of the old floodplain, stubble, and grazing practices will help elucidate whether this is “natural” or not.
- Divergent aquatic plant populations are likely a result of positive feedback in the aquatic ecosystem; ultimate cause unknown

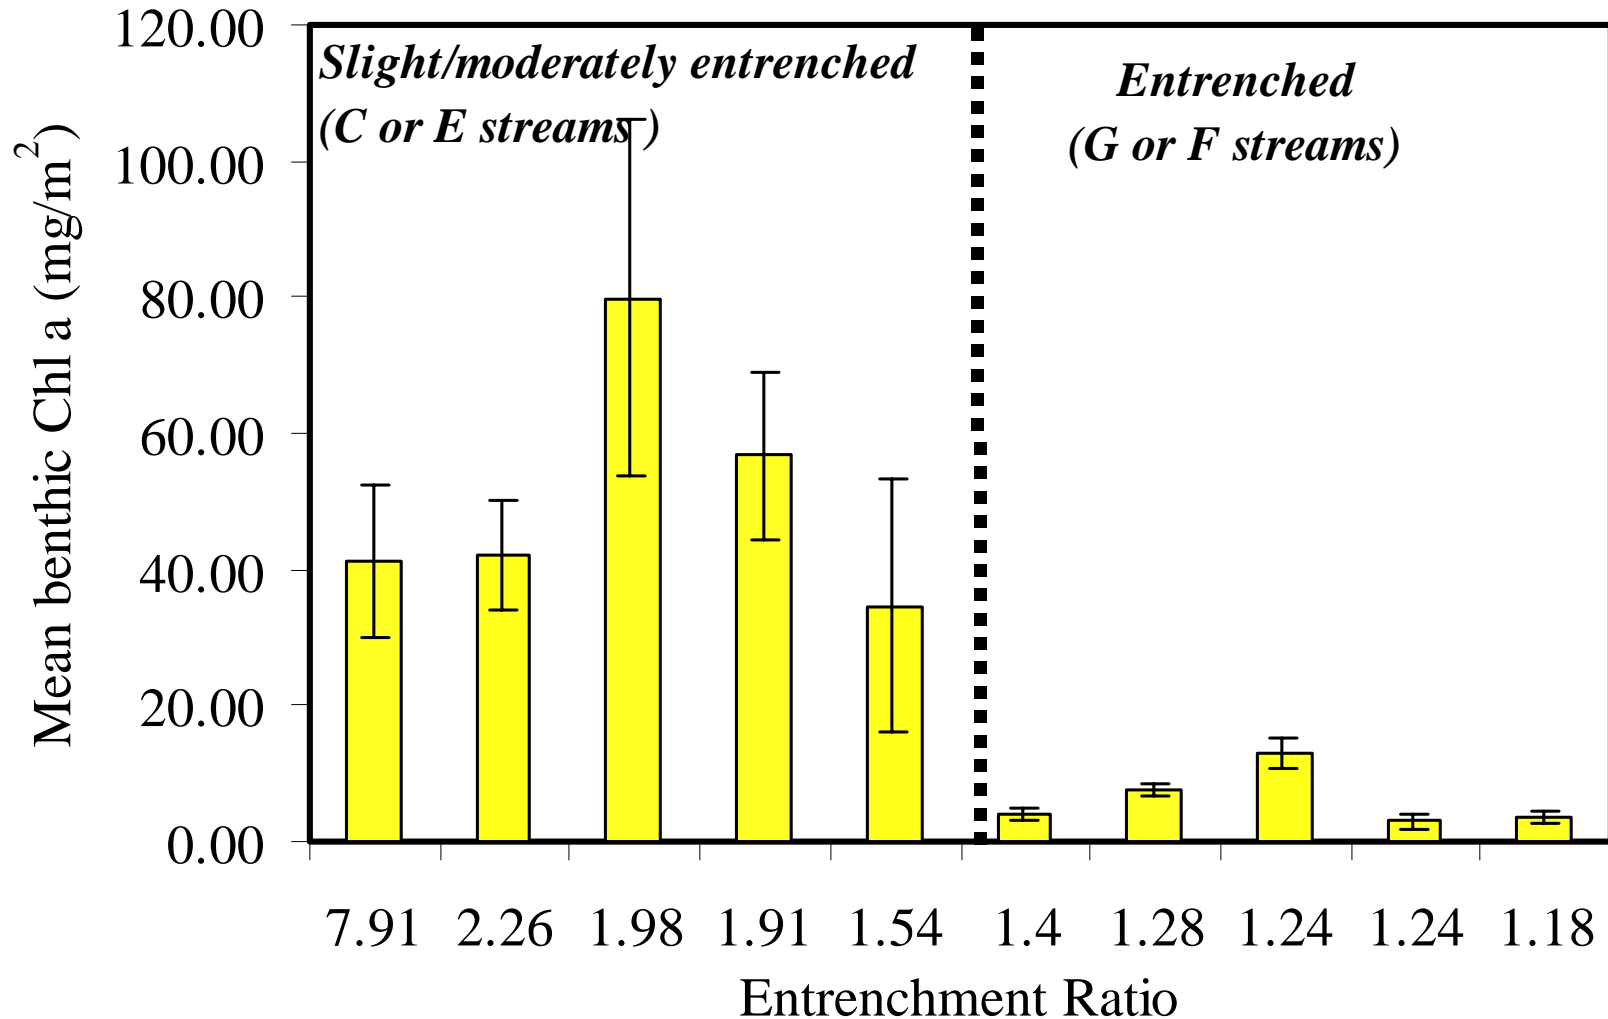
Benthic Chl *a* and Entrenchment Ratio-August 2001

(error bars are 1 SE of the mean, n=11)

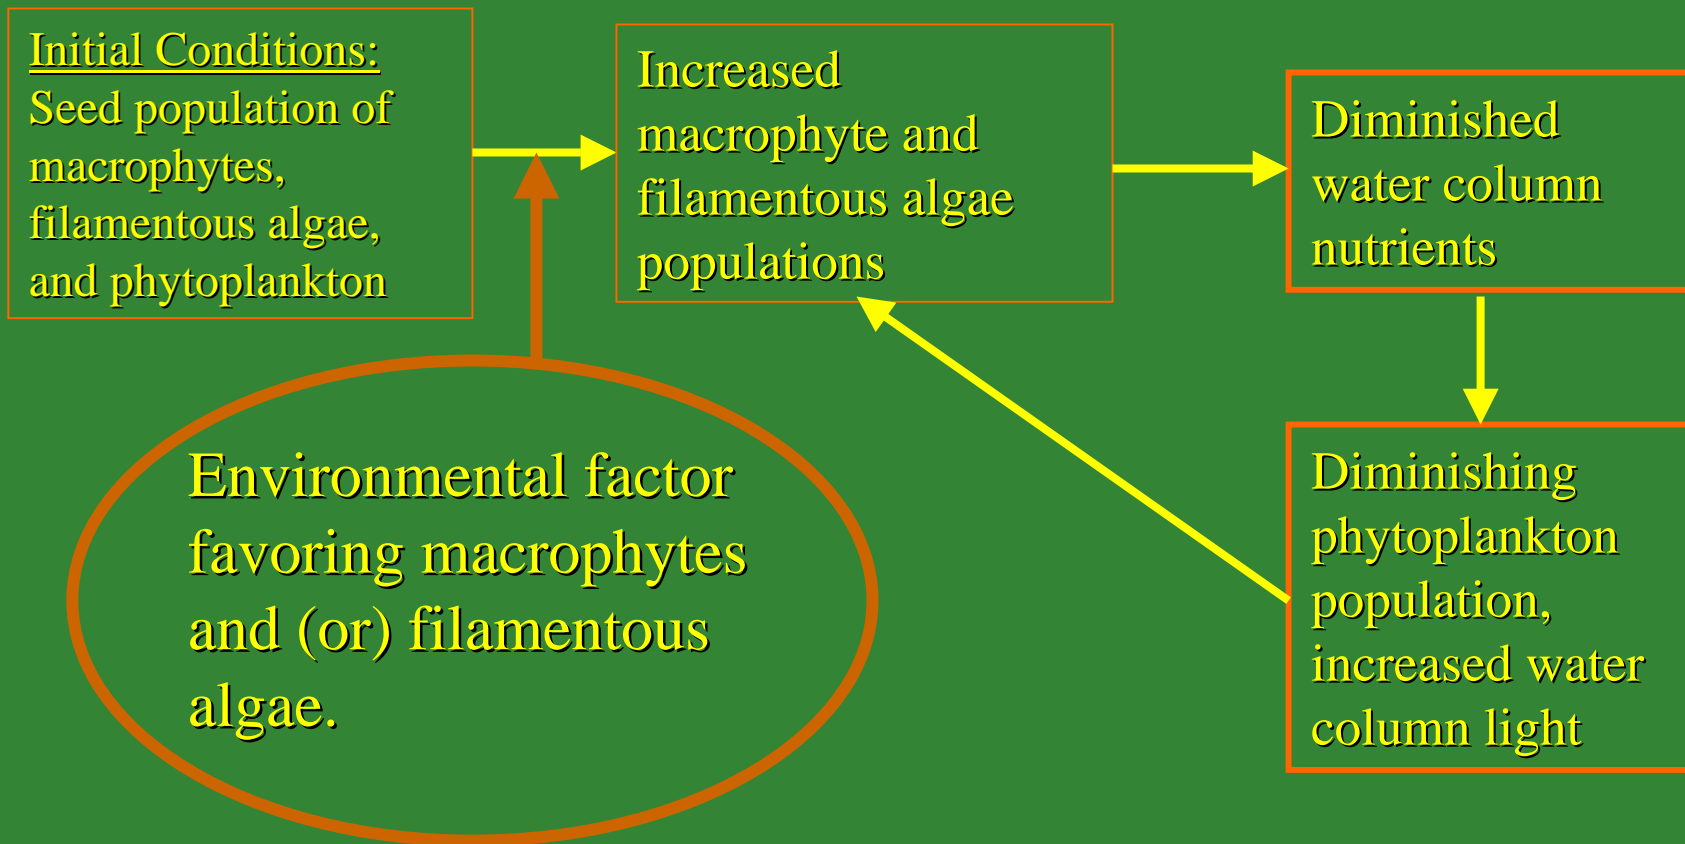
Why do the aquatic plant communities diverge?

- Ultimate cause unclear, proximate cause probably a positive feedback loop.

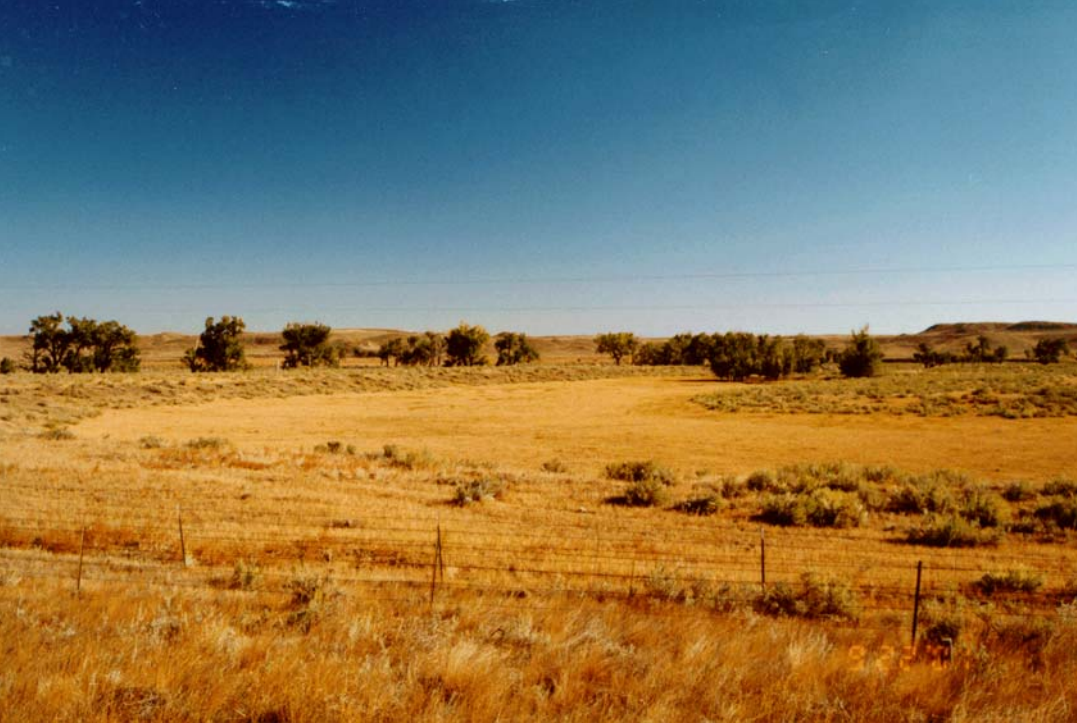
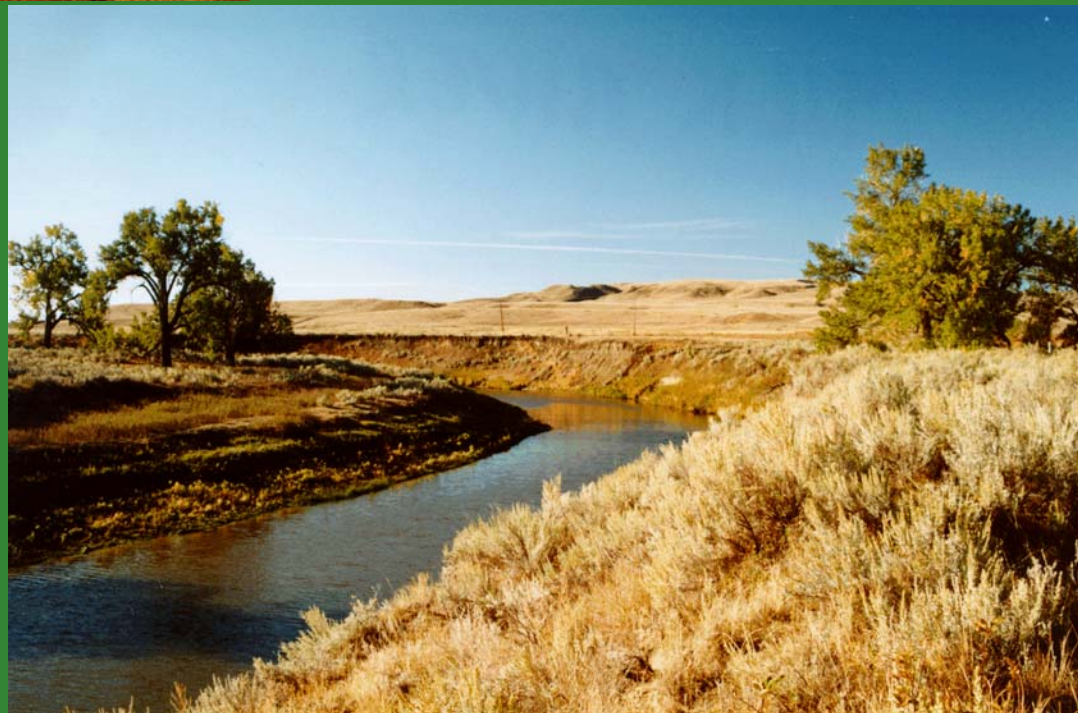
Milk River
abandoned oxbow

Milk River
at present

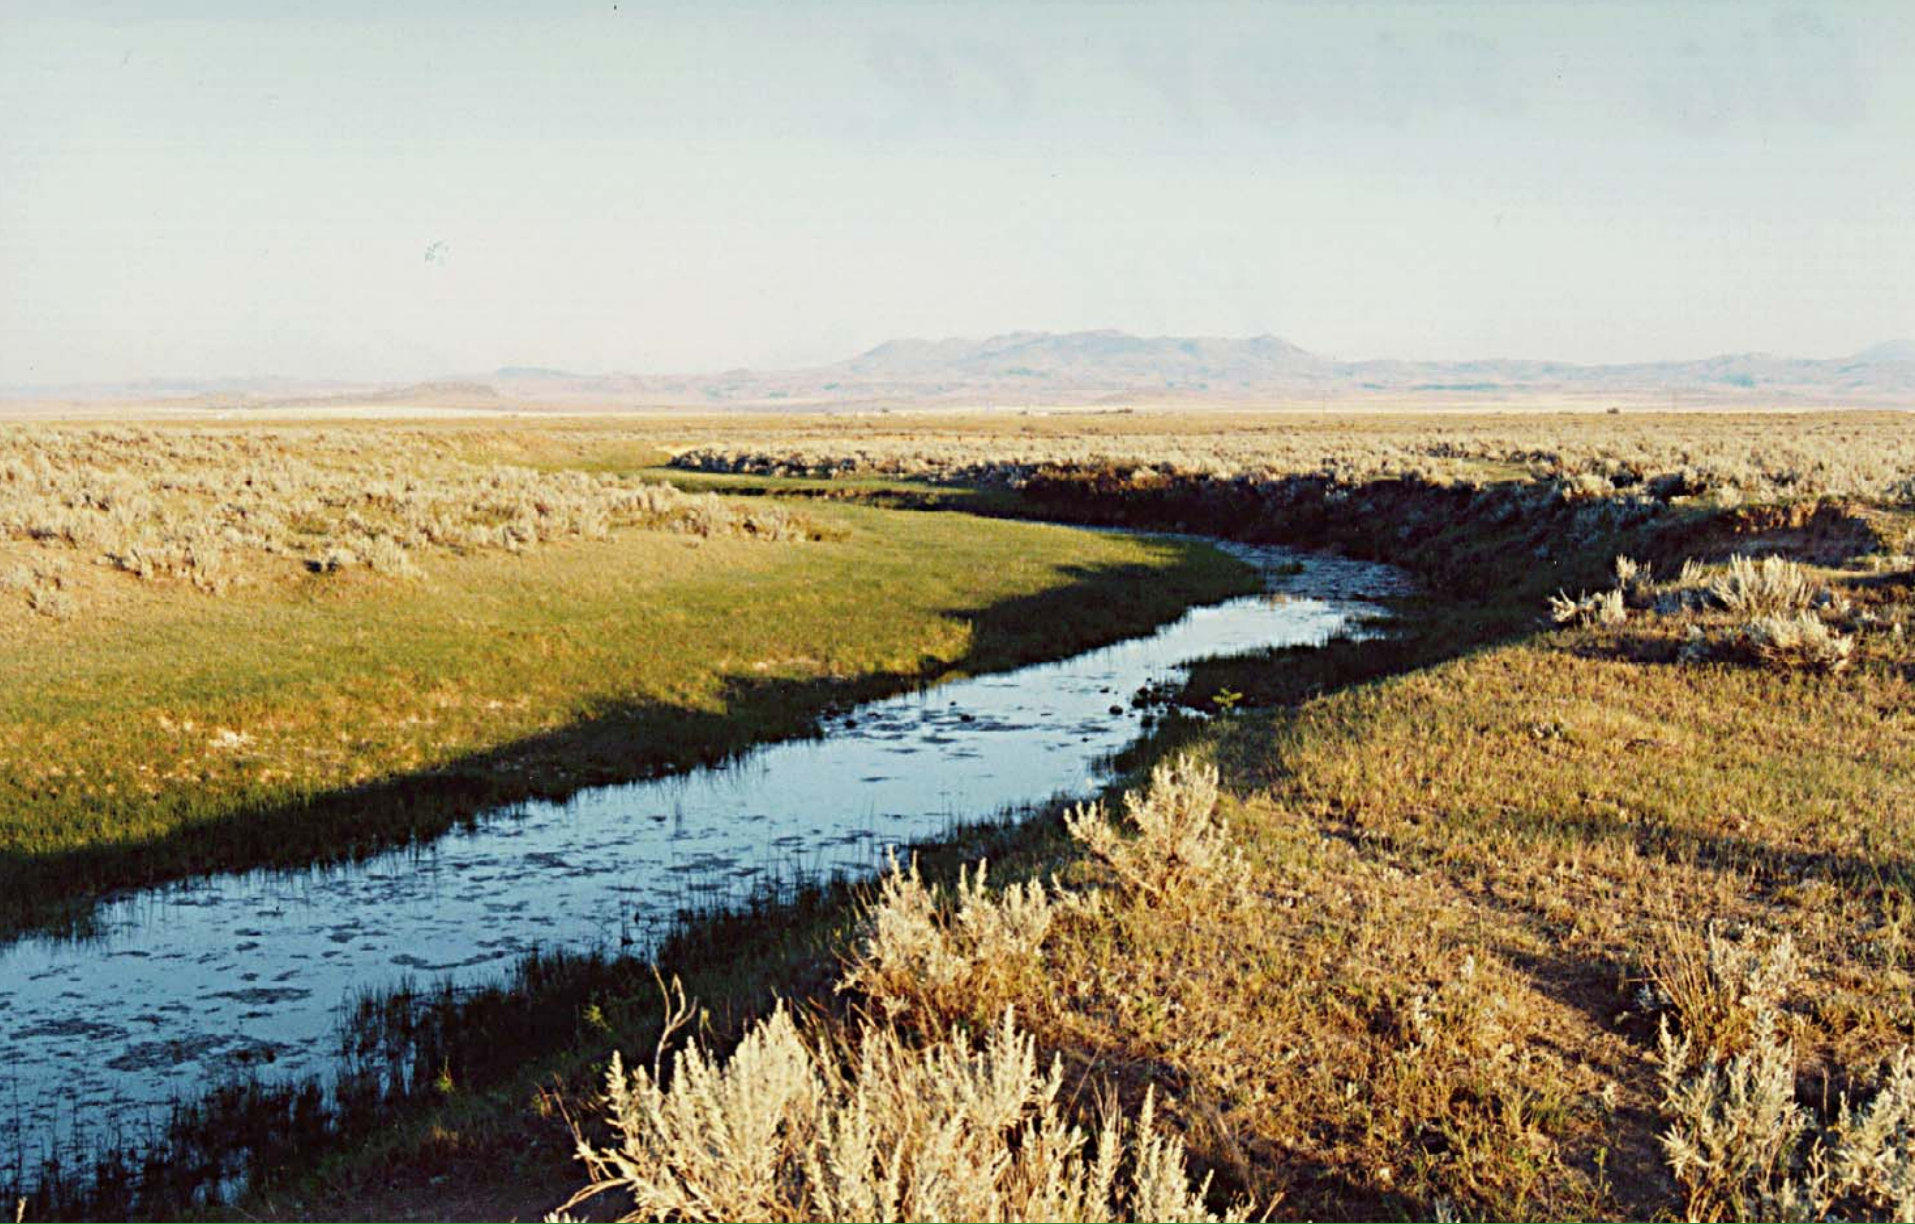
Stream type evolution. From Rosgen 2002

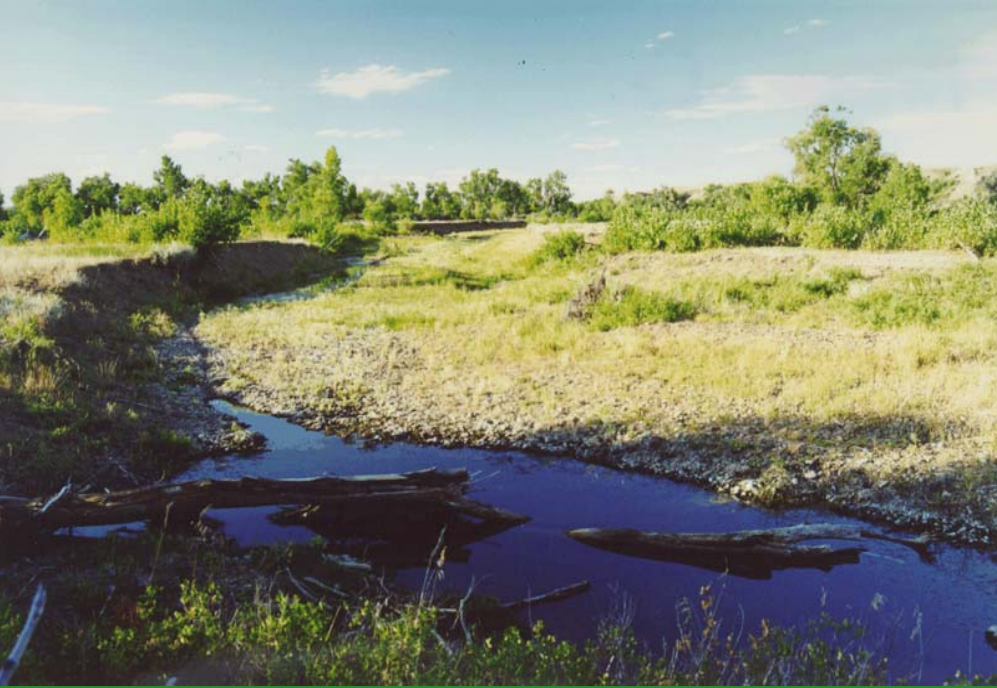
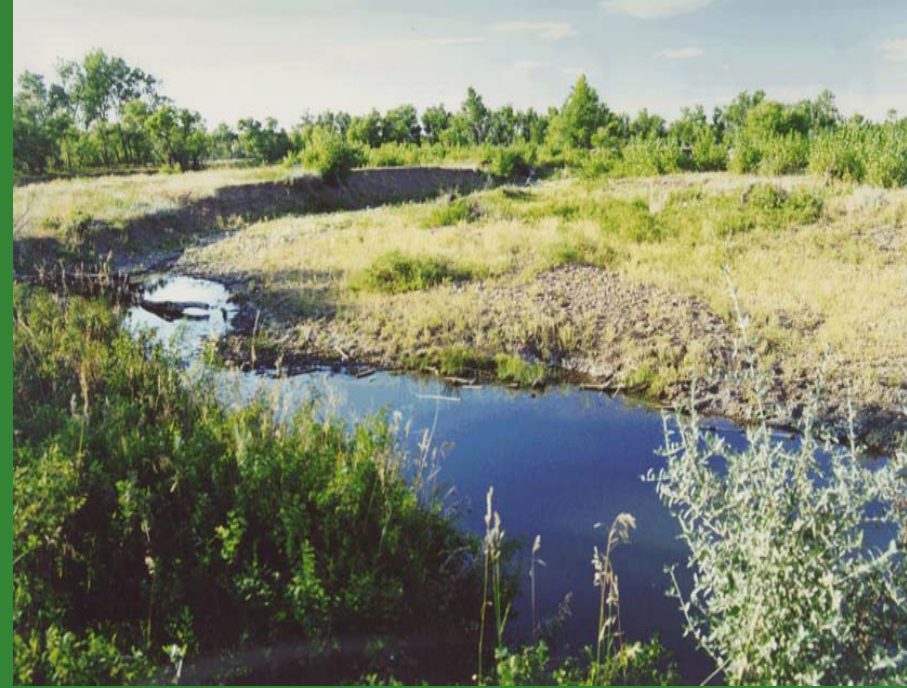
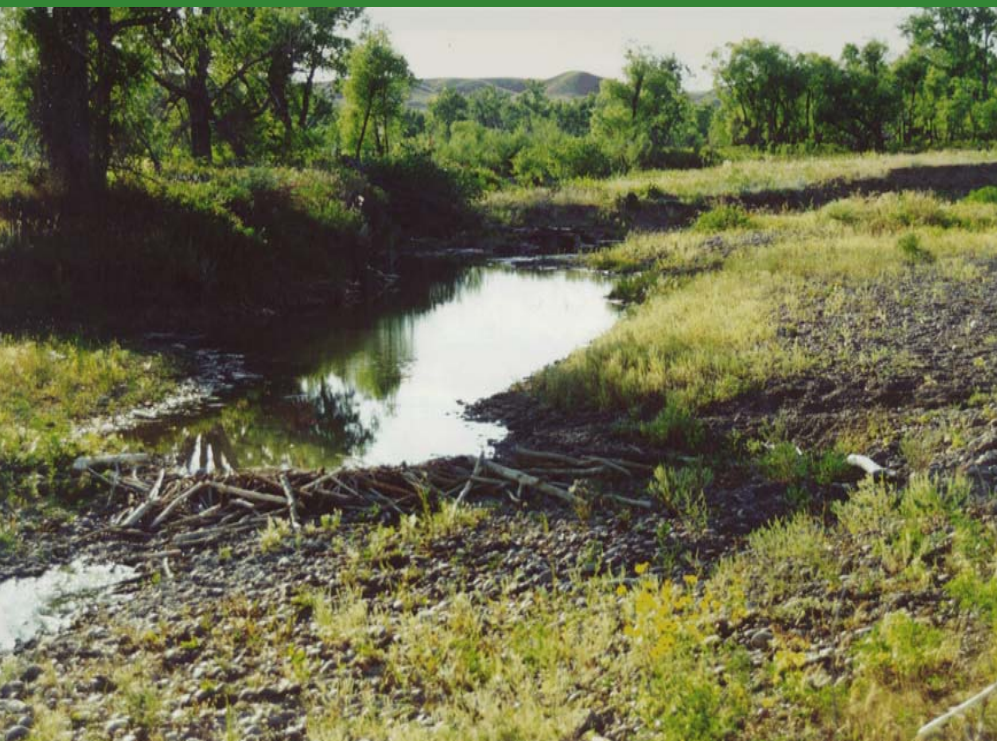
Big Sandy Creek (C6)

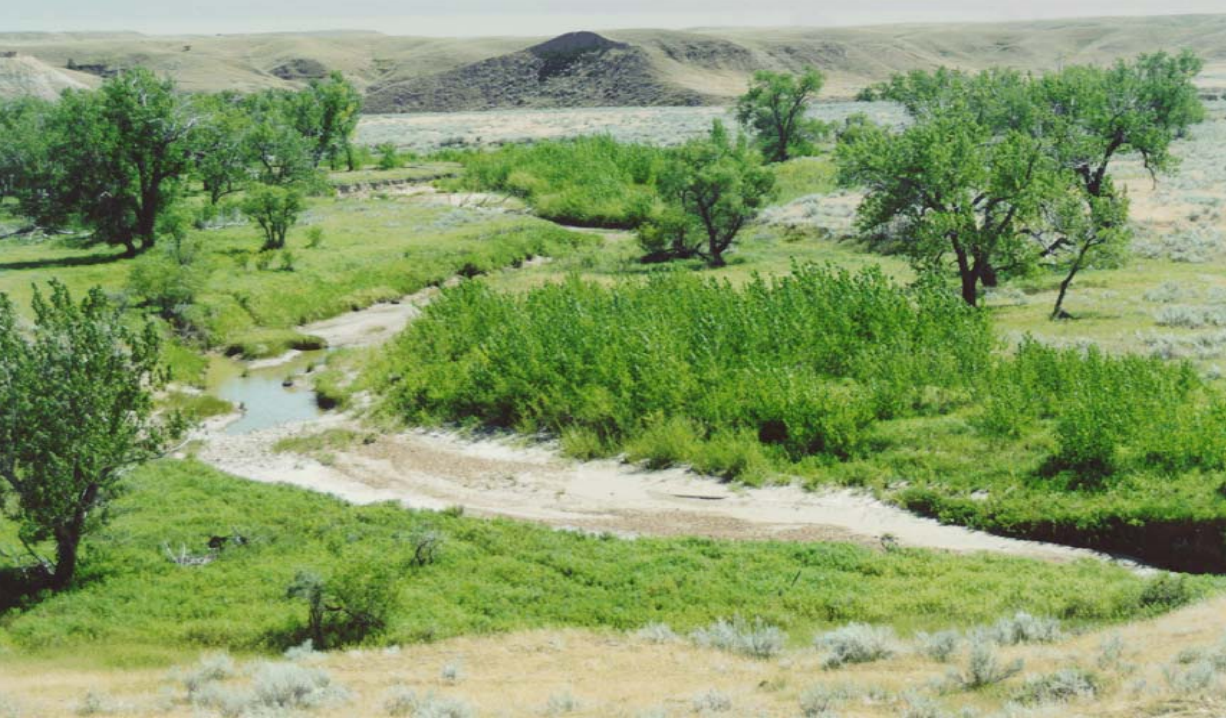
Porcupine Creek (C4)

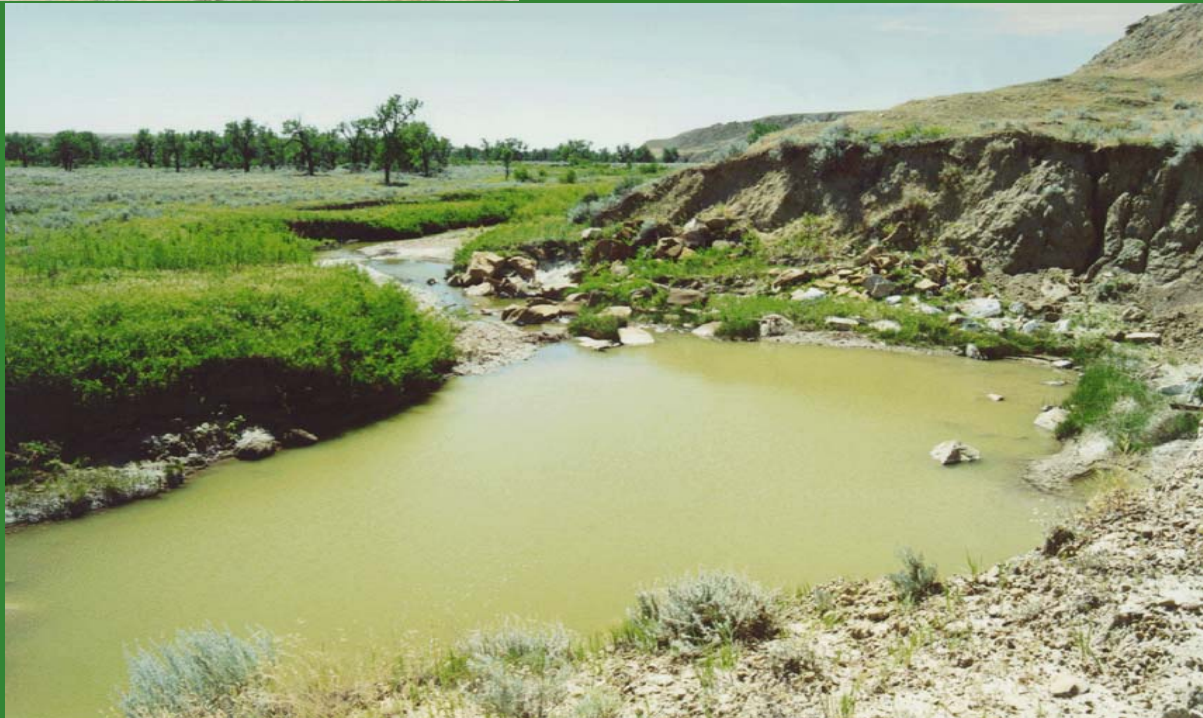
Willow Creek
North (F5)

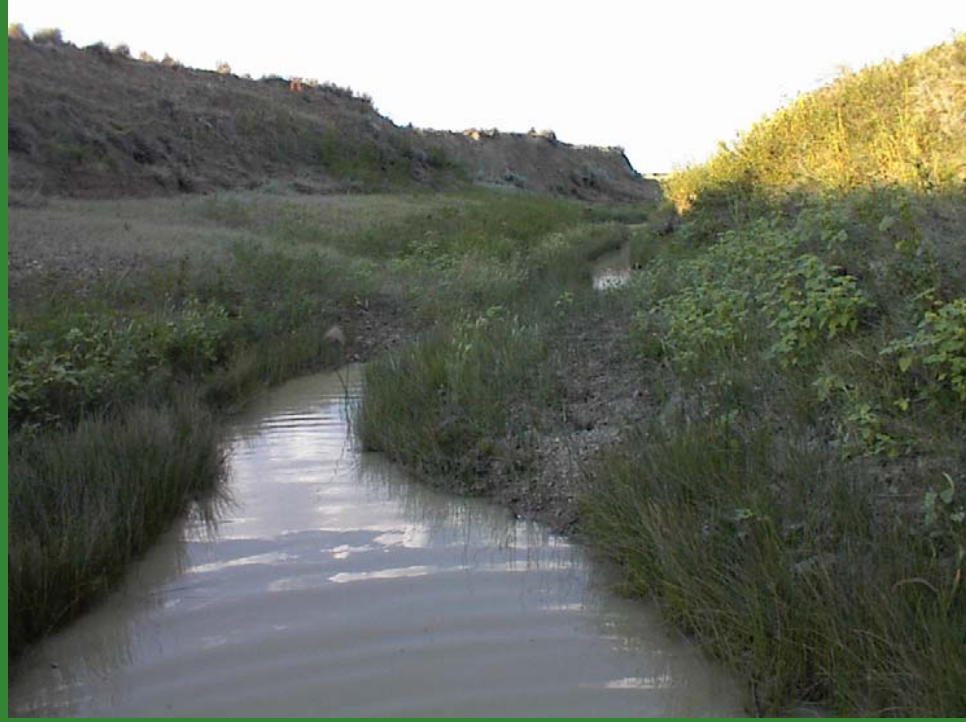
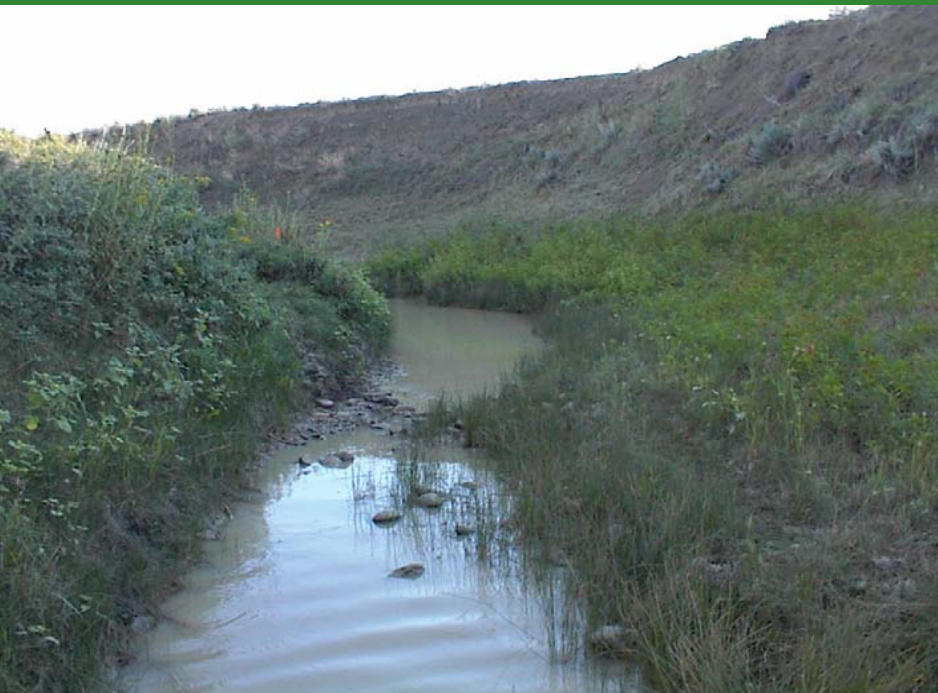
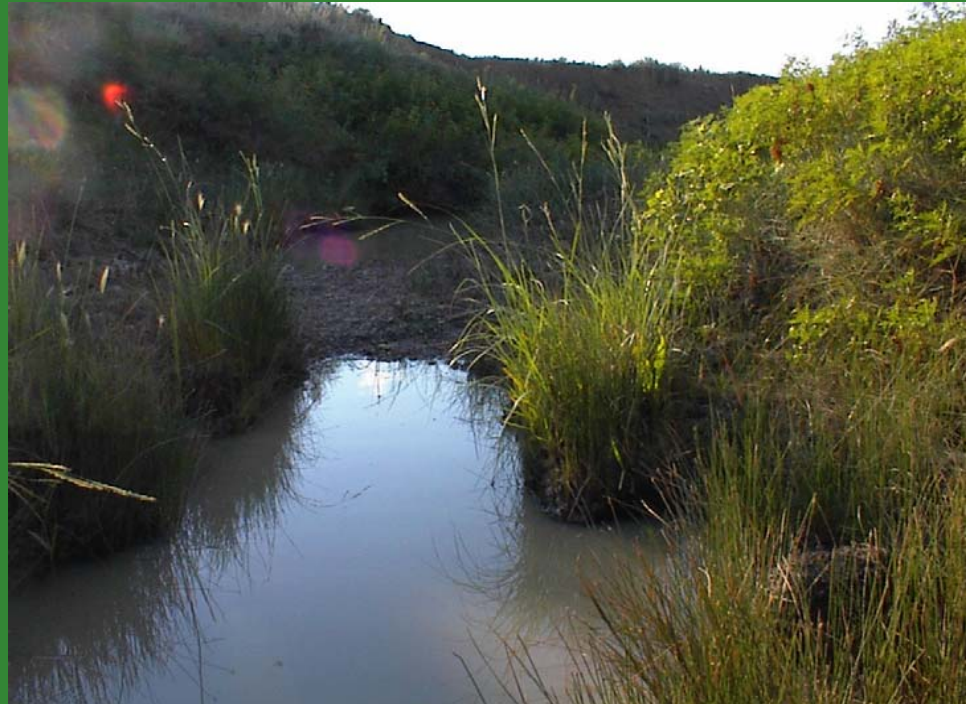
Larb Creek (G4)

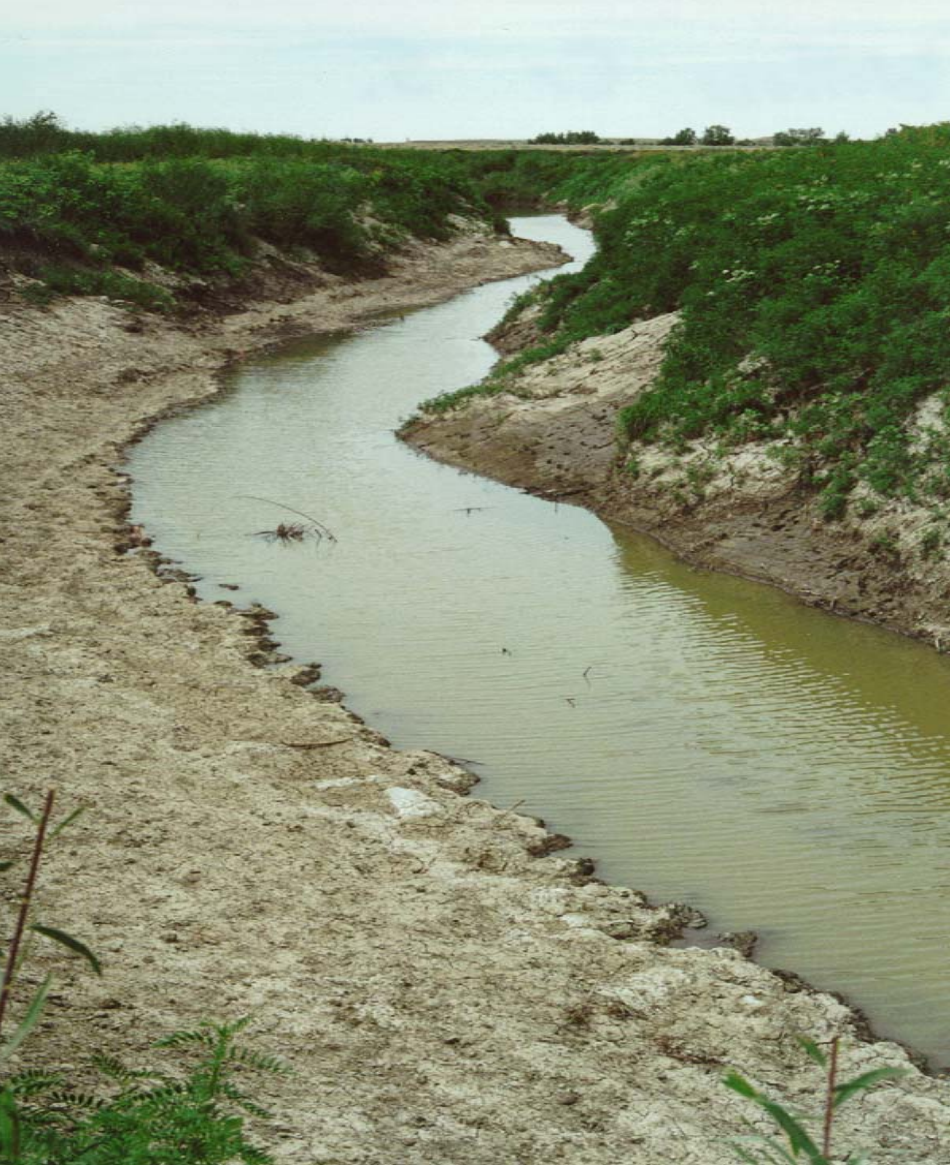
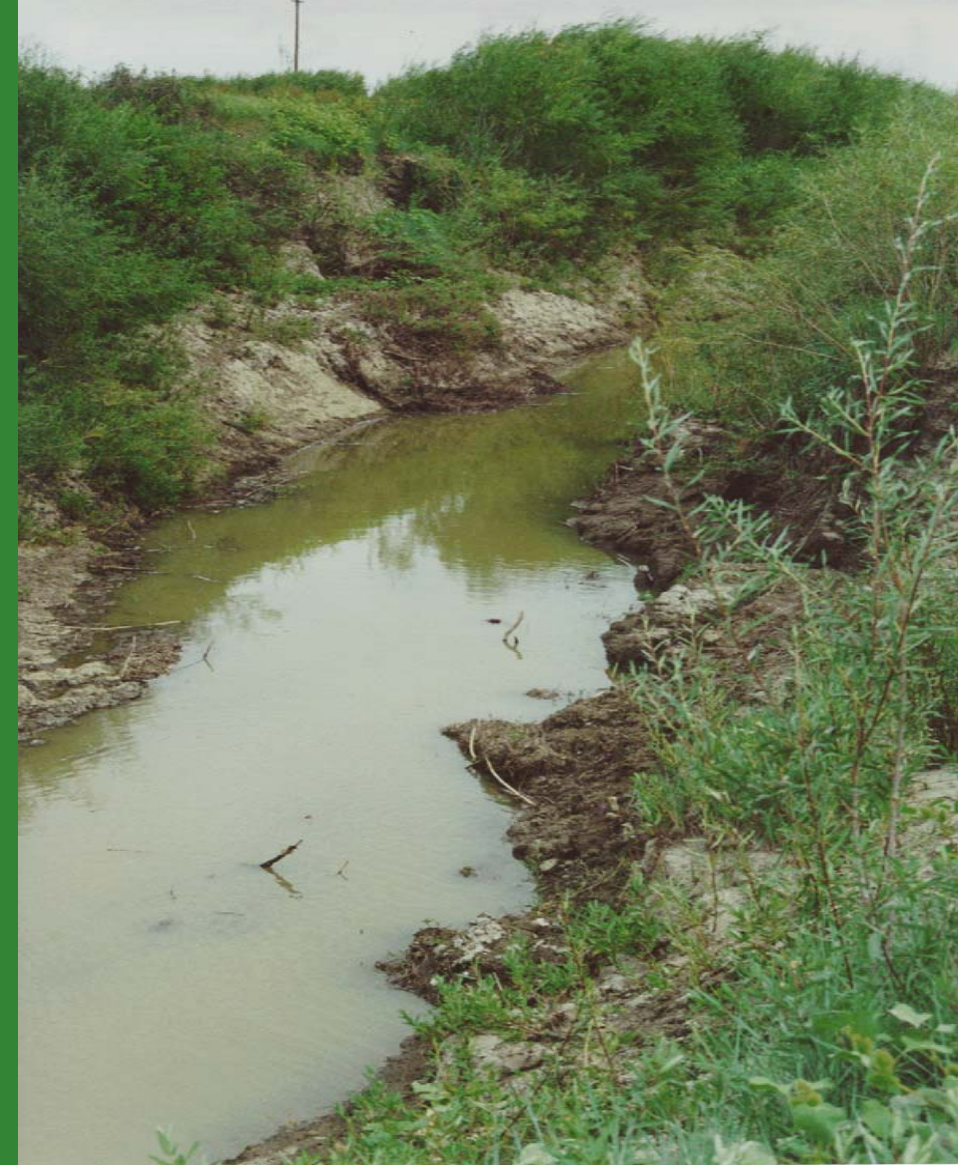
Willow Creek South (G6)

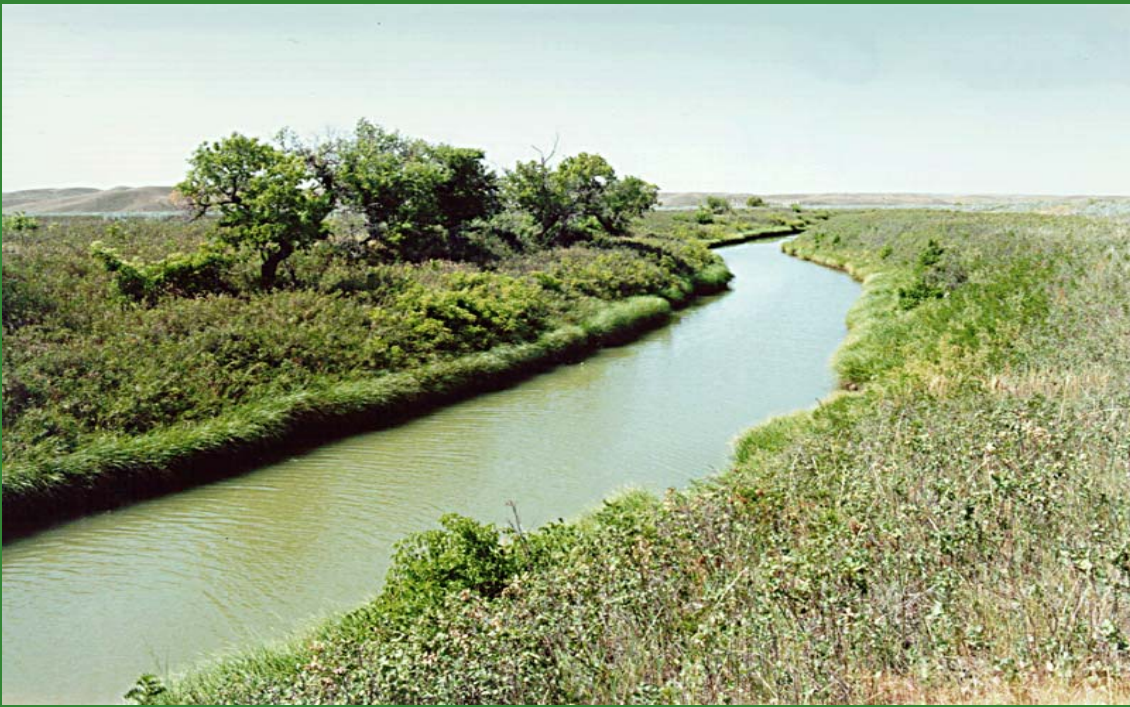
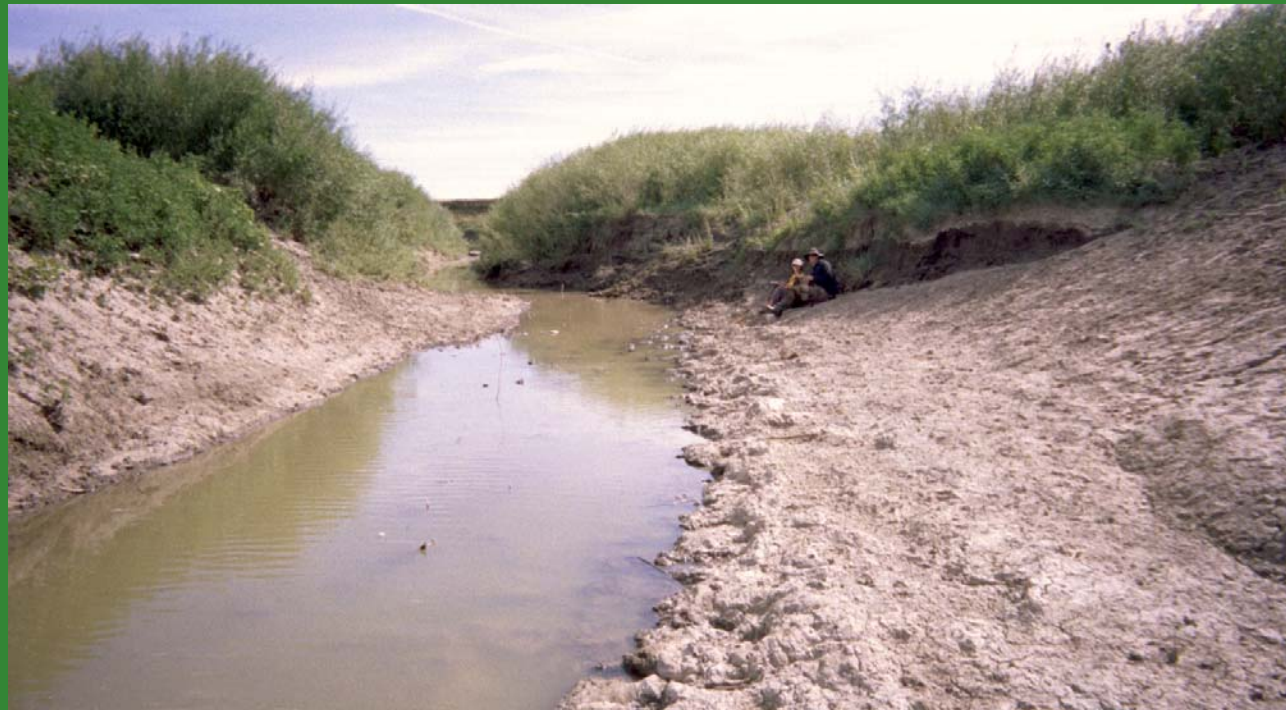
- Entrenched streams are considered unstable, erosive, and in a dynamic state evolving towards more stable stream types.
- 50% of the streams in this study were of this type. They appear to be very common in the Plains of Eastern Montana

Example range
of conditions for
two entrenched
streams

- Want to compare apples to apples
- Prairie streams with well-developed floodplains should probably not be used as “references” for entrenched streams
- Among entrenched streams, there will be streams that will make reasonable reference sites for comparison against impacted, unstable sites.
