North Anna 2 RPV Head CRDM Project

North Anna 2 RPV Head Project

Presentation Outline

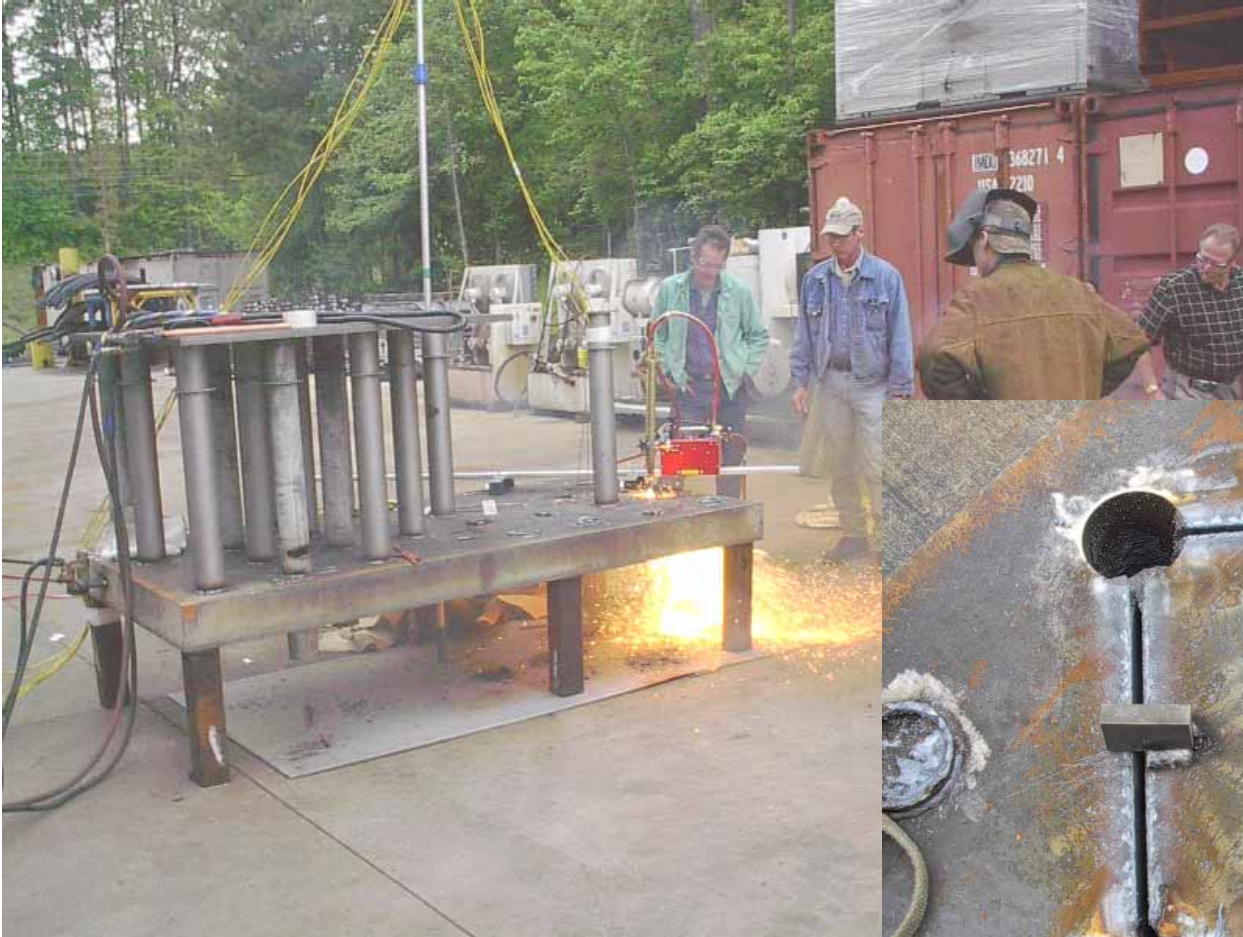
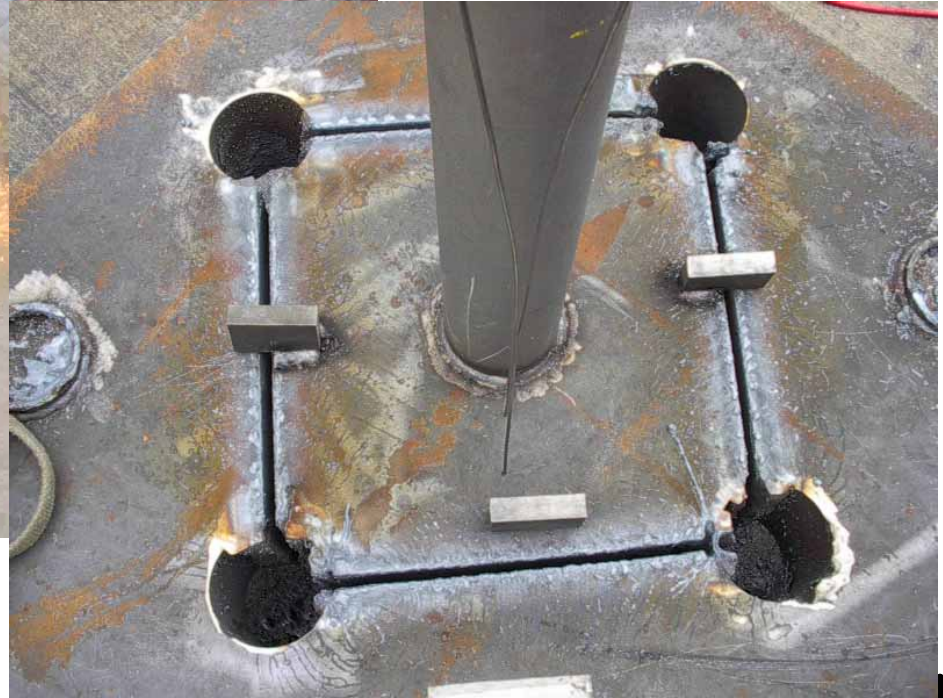
- Project Kick-Off Meeting on 4/1/2003
- Mockup Testing
 - Welding Services built two Mockups, one a simple cutting bar and another a large life-size mockup
 - Several test cuts performed over several days
 - EPRI and utility personnel witnessed simulation of cutting one nozzle from large mockup
 - Mockup results:
 - Temperature ~400°F during tests at 3" from cut line.
 - Determined need for a 3rd mockup to test angled cutting. Test completed satisfactorily on 5/2/2003.

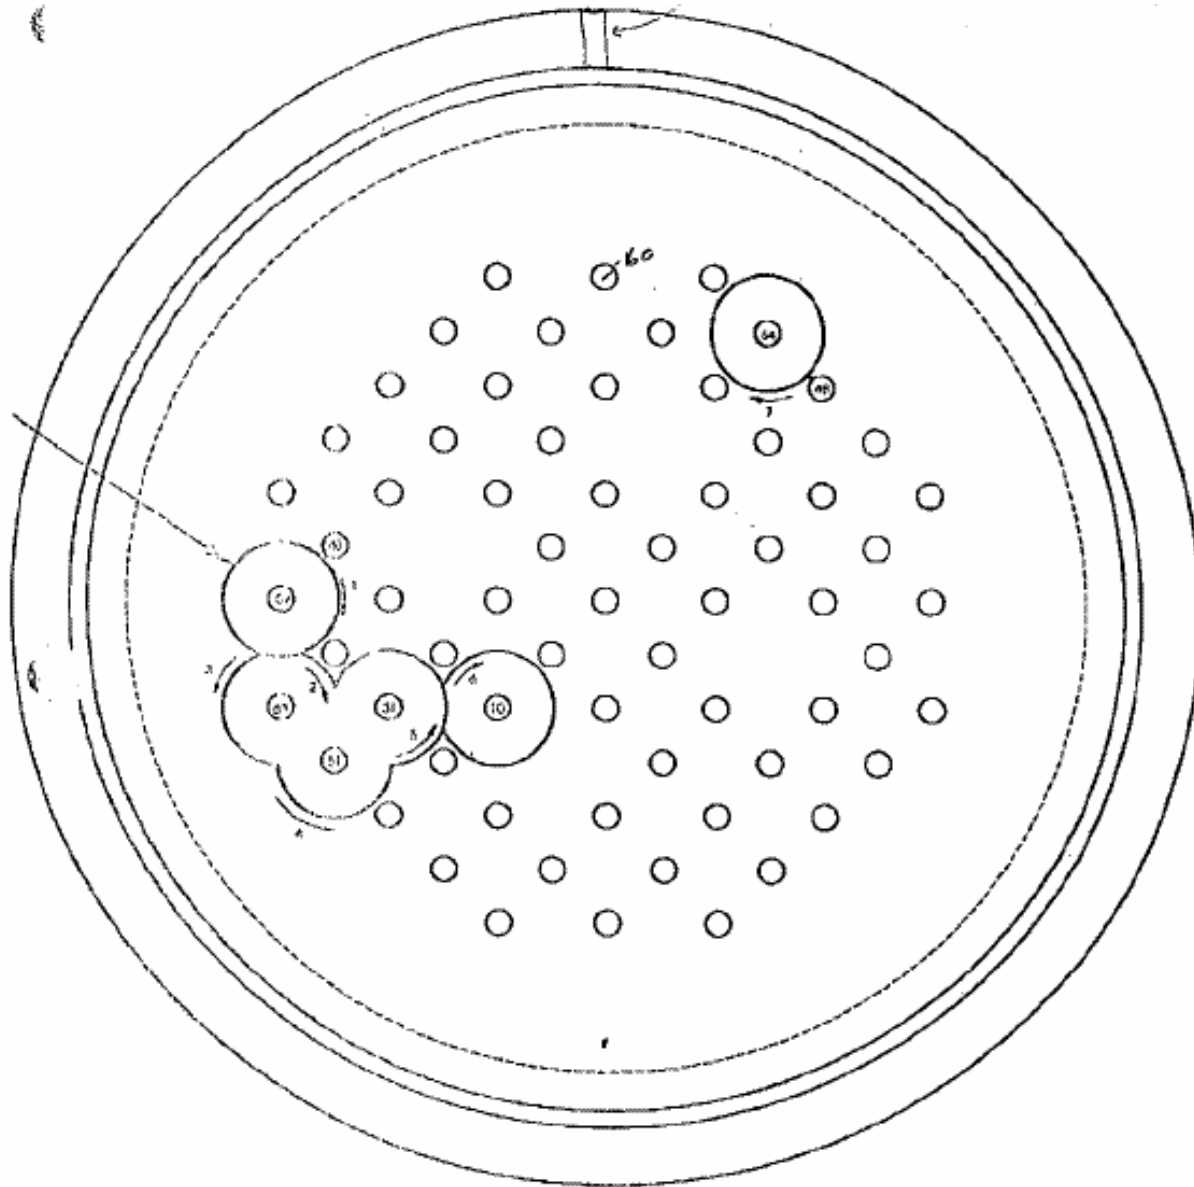
NA-2 Cutting Plan

- Build temporary building over head
- Disassemble Shipping Package
- Build primary containment
- Remove insulation
- Install work platforms and ventilation systems
- Cut six nozzles using an oxy-fuel torch
 - 3 separately and 3 removed as a large block
- Place 4 sections inside secondary containment
 - Section large block into 3 individual nozzles
- Package nozzles for shipment to PNNL
- Demobilize
