Davis-Besse Nuclear Power Station

Reactor Vessel

Incore Monitoring Instrumentation Nozzle Leakage Simulation Results

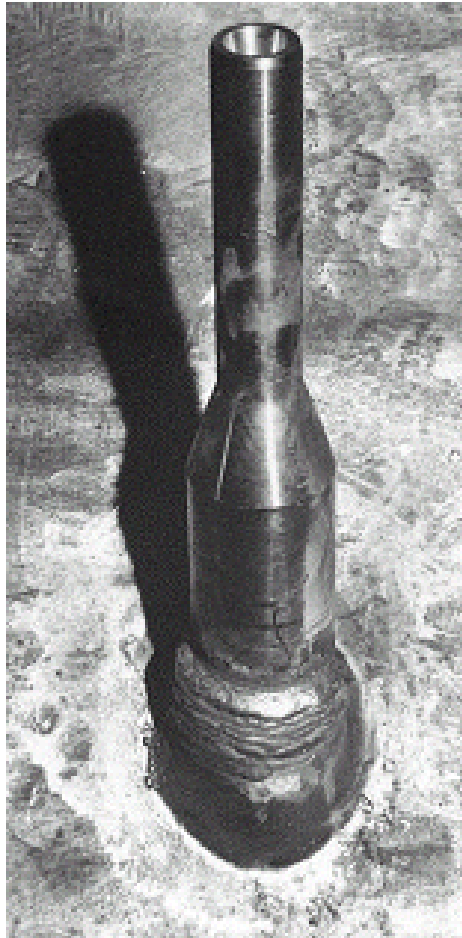
**Modified IMI nozzle
(inside of reactor vessel)**

- Babcock & Wilcox reactor vessel has 52 IMI nozzles
- IMI nozzles are ~ 1 inch in diameter
- Original IMI nozzles fabricated from Alloy 600 material
- J-Groove welds - Alloy 182 (stress relieved)
- IMI nozzles modified (not stressed relieved) following Oconee 1-1972 Hot Functional Testing Failure

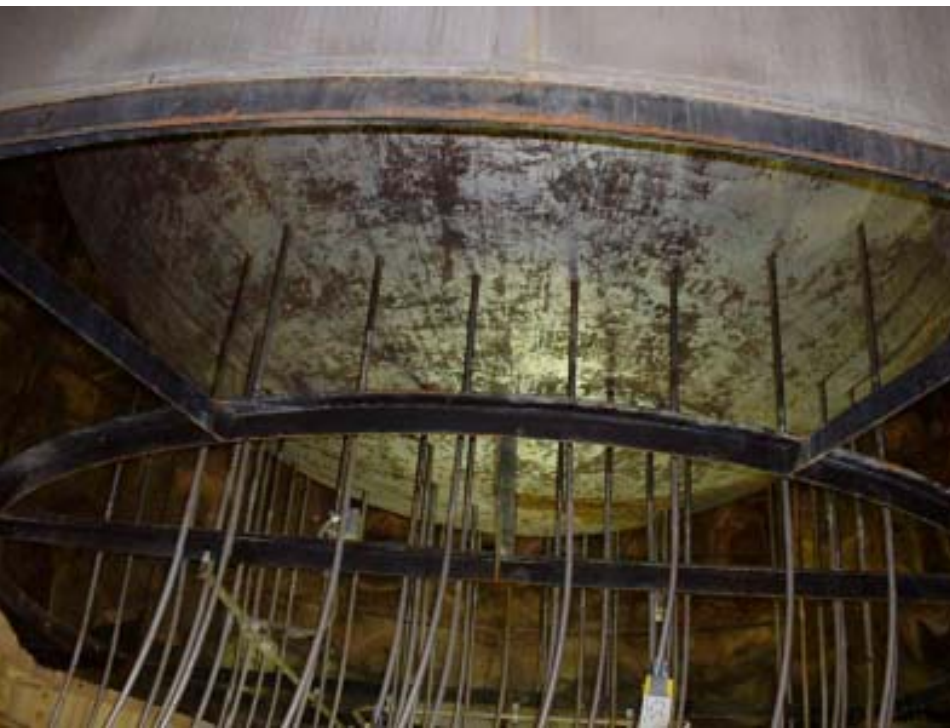
**IMI Nozzles
at Bottom of Reactor Vessel
(Post-cleaning)**

- Boron and rust deposit trails were observed on the sides and bottom of the reactor vessel
- No build-up of boric acid deposits or corrosion products on top of insulation
- No evidence of wastage on bottom of reactor vessel

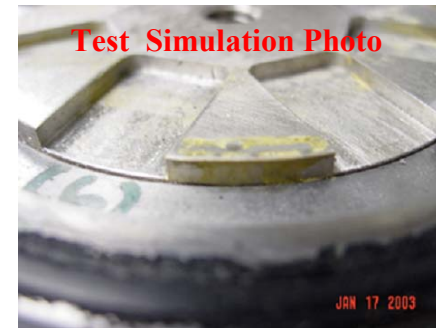
Test #5 (leak rate: 0.0006 gpm)
Crusty yellow deposit buildup
on nozzle wall at annulus discharge

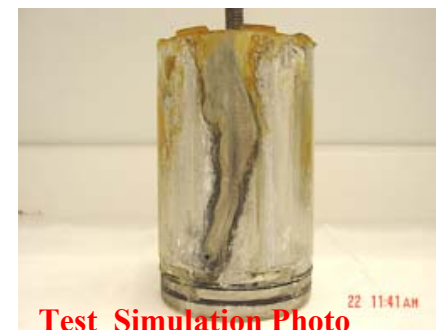
Test #1
(leak rate: 0.015 gpm)
Nozzle OD showing leak path

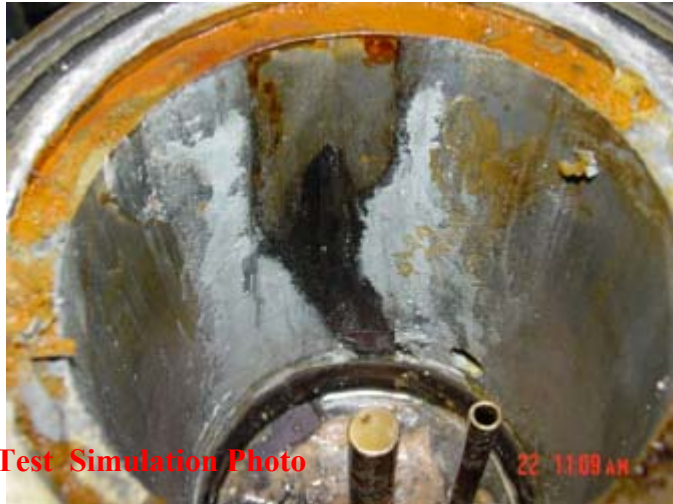
Before cleaning

**Test #1 (leak rate: 0.015 gpm)
Inside of vessel head after removal of
nozzle, showing eroded leak path**

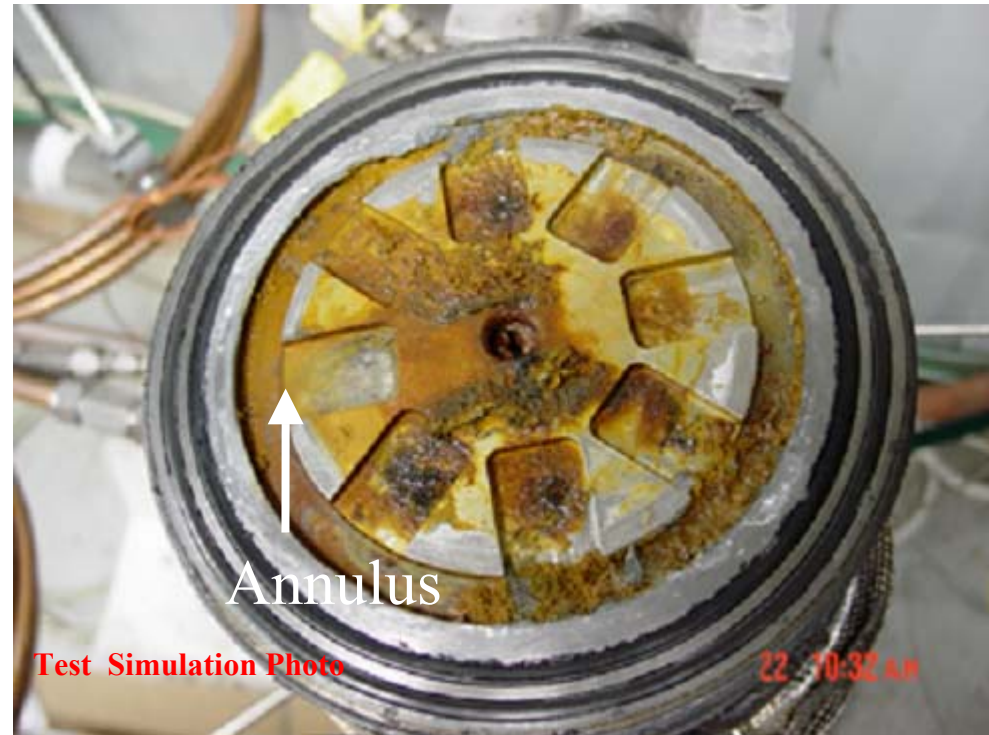
Annulus

**Test #1 (leak rate: 0.015 gpm)
Post test view of nozzle/vessel
head assembly**

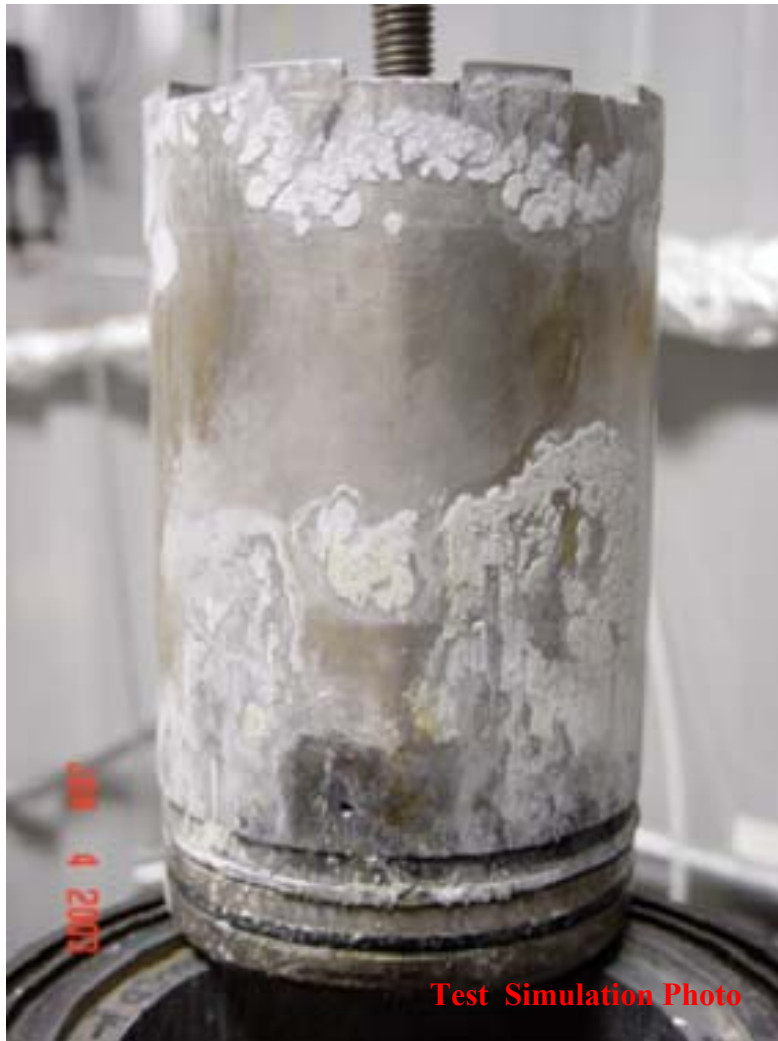
**Test #2 (leak rate: 0.0017 gpm)
Nozzle OD showing buildup
of white deposits**

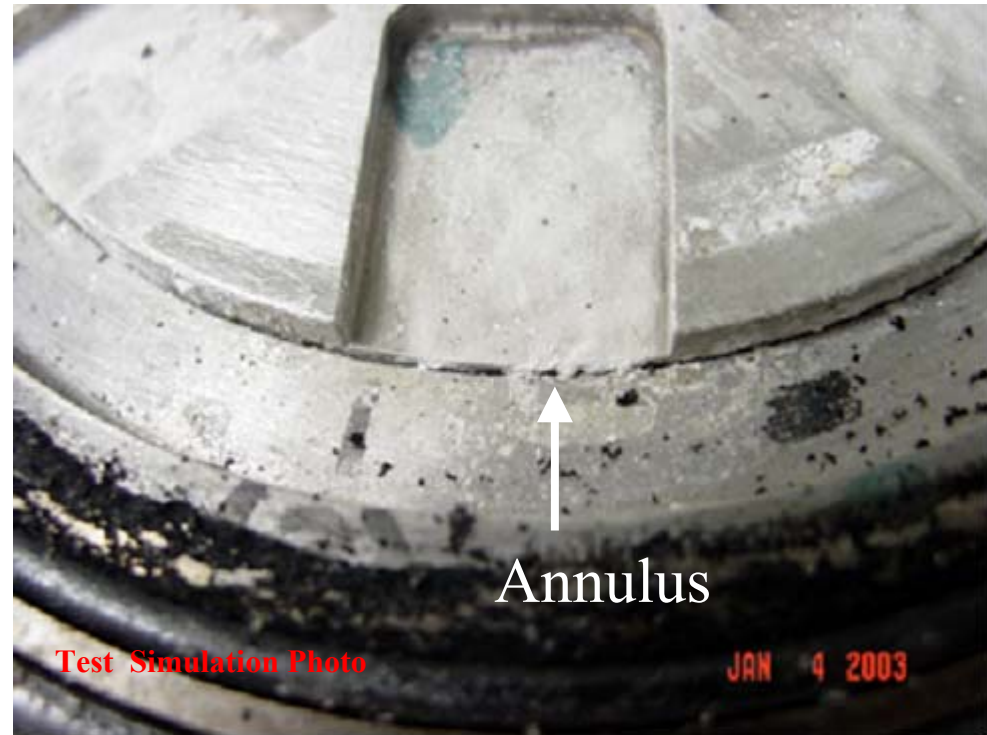
**Test #2 (leak rate: 0.0017 gpm)
Close-up view of head-to-nozzle
annulus showing buildup of white deposits at
exit of annulus**

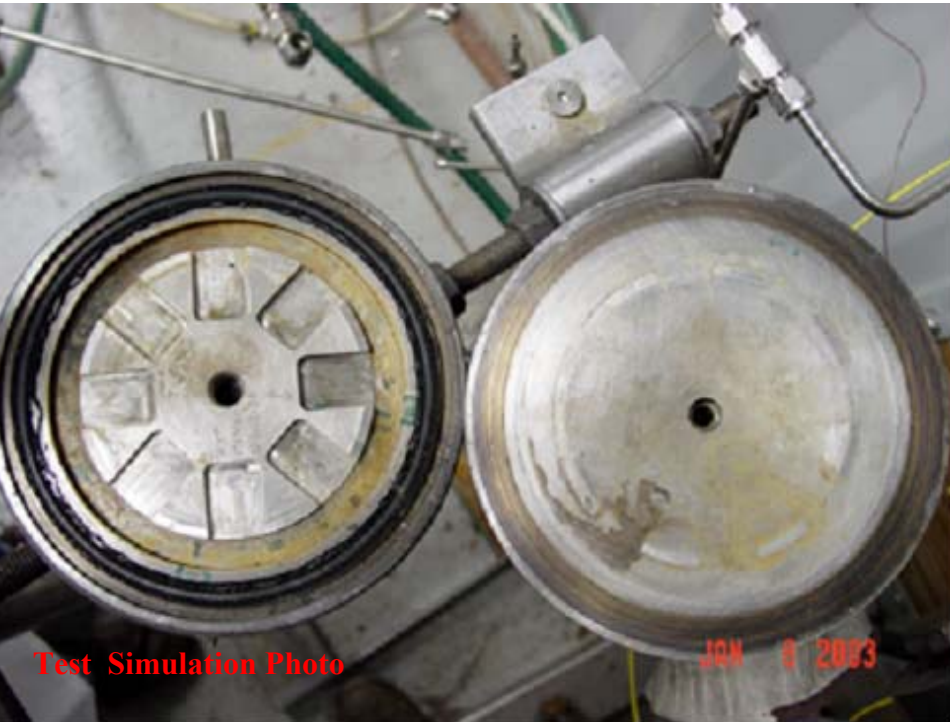
**Test #3 (leak rate: 0.0004 gpm)
Nozzle surface deposits**

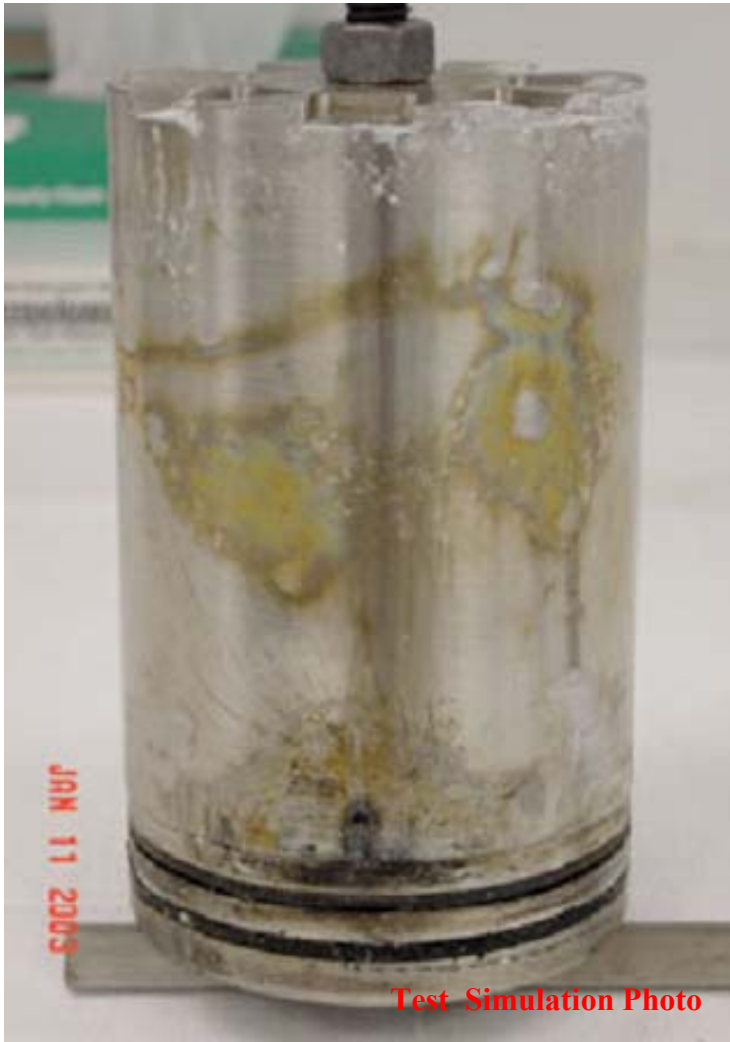
**Test #4 (leak rate: 0.0012 gpm)
Nozzle outer diameter showing buildup
of white deposits at discharge of annulus**

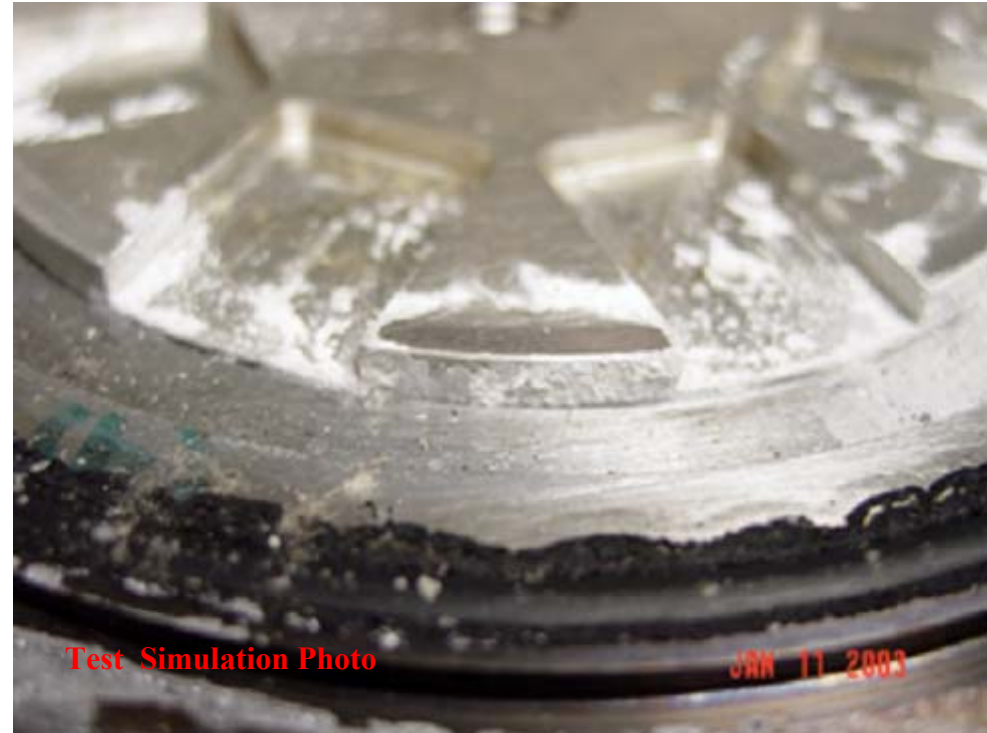
**Test #4 (leak rate: 0.0012 gpm)
Close-up of head-to-nozzle annulus
showing buildup of white deposit
at exit of annulus**

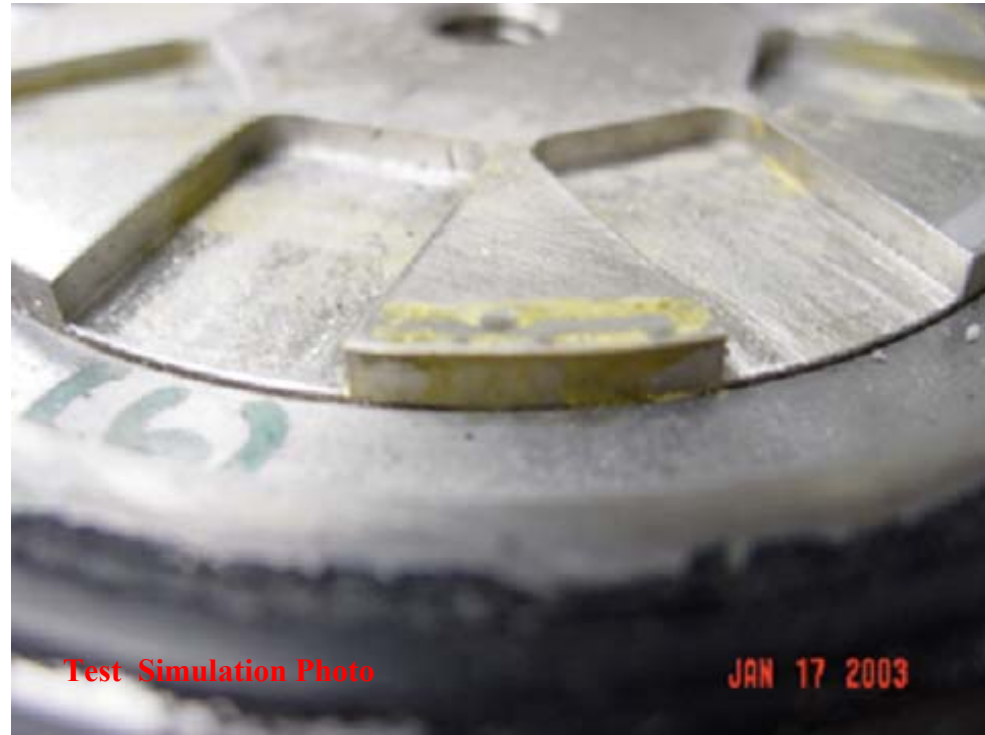
**Test #5 (leak rate: 0.0006 gpm)
Crusty yellow deposit buildup on nozzle
wall at annulus discharge**

- Visible evidence of small leakage would be present on the IMI nozzle even for very small leaks
- Deposits may appear crusty with light yellow coloration
- Significant levels of Lithium (concentrations could reach levels of 15,000 ppm or higher) would be present in the deposit in addition to high Boron levels
