# CFD Analysis Results

# HPI Pump Operating Conditions

# Qualification Testing Results Summary

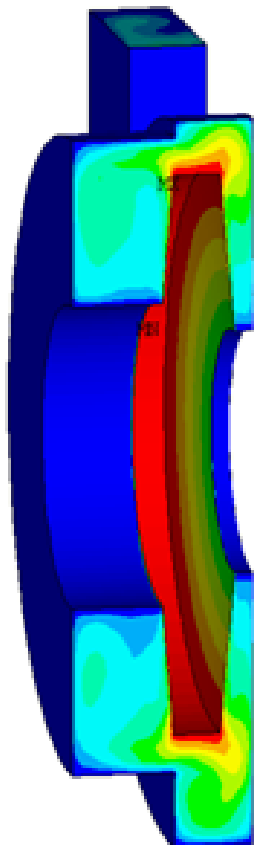
ANSYS 7.0  
 SEP 23 2003  
 15:25:42  
 PLOT NO. 5  
 NODAL SOLUTION  
 STEP=2  
 SUB =1  
 VSUM  
 RSYS=1  
 SMX =1697

0
188.507
377.013
565.52
754.026
942.533
1131
1320
1508
1697

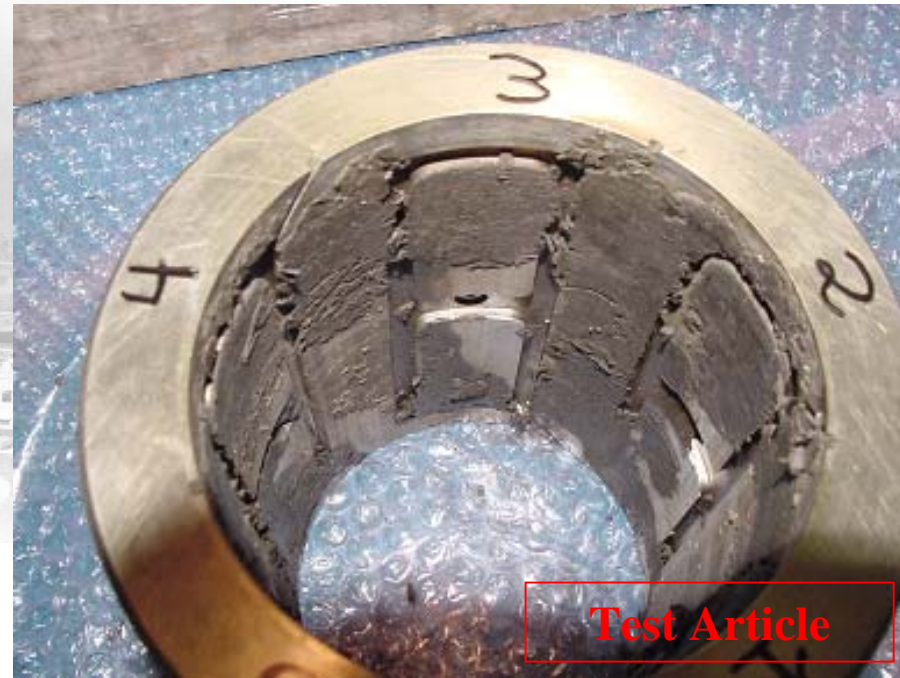
# Hydrostatic Bearing Test Results

**21 Days Testing**

- Hydrostatic Bearing

- Minimal wear on bearing
- Abrasive wear on shaft sleeve
- Bearing flow remained adequate (~ 5% decrease)

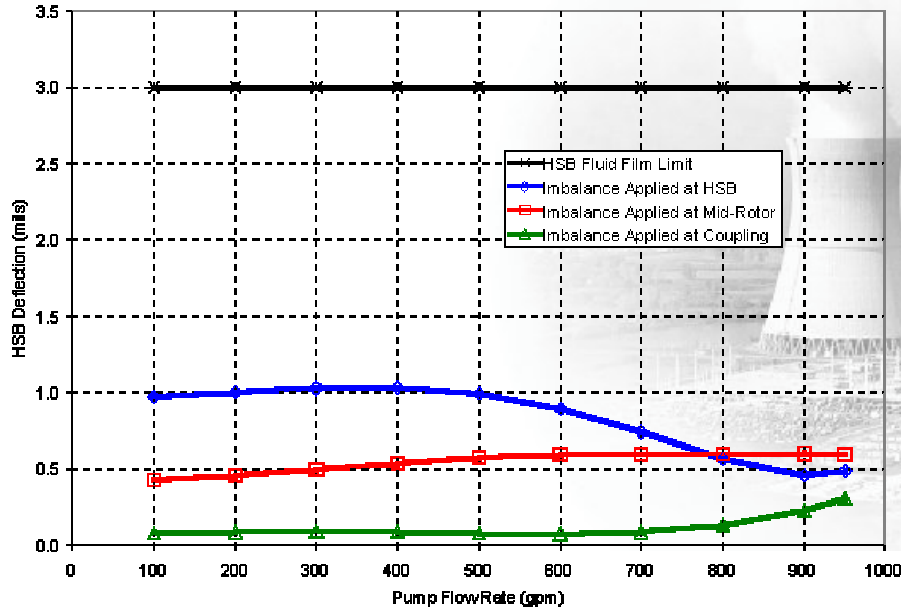
# Forced Response Analysis

**75% Central  
Volute Bushing  
Length**
