Wildfire-Related Floods and Debris Flows in Montana in 2000 and 2001

Water-Resources Investigations Report 03-4319

By Charles Parrett, Susan H. Cannon, and Kenneth L. Pierce

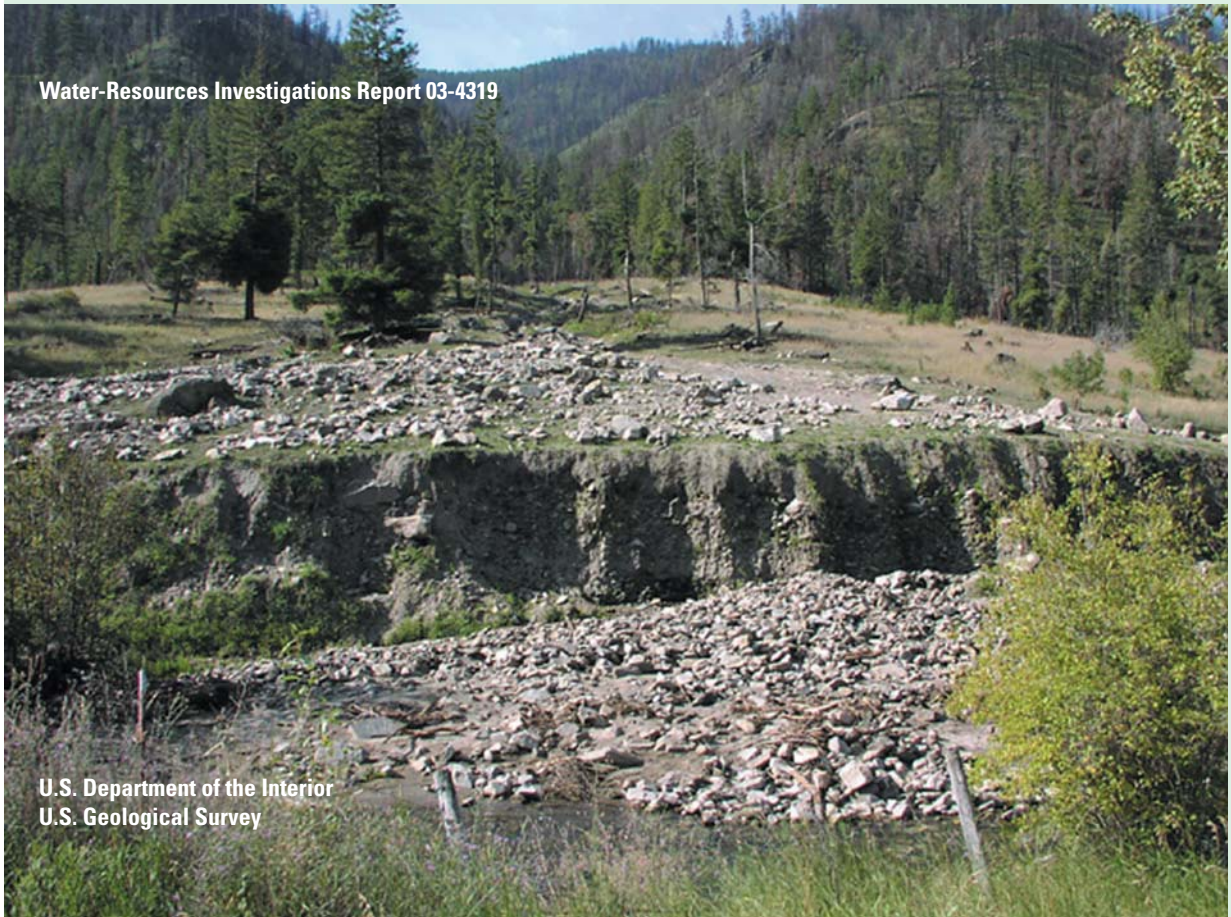
Front cover photograph:

Debris fan from storm event of July 2001 on tributary stream to Skalkaho Creek near Hamilton, Montana. Debris fan overlays ancient, massive debris fan on same stream. Photograph by Richard M. Jones, U.S. Department of Agriculture Forest Service.

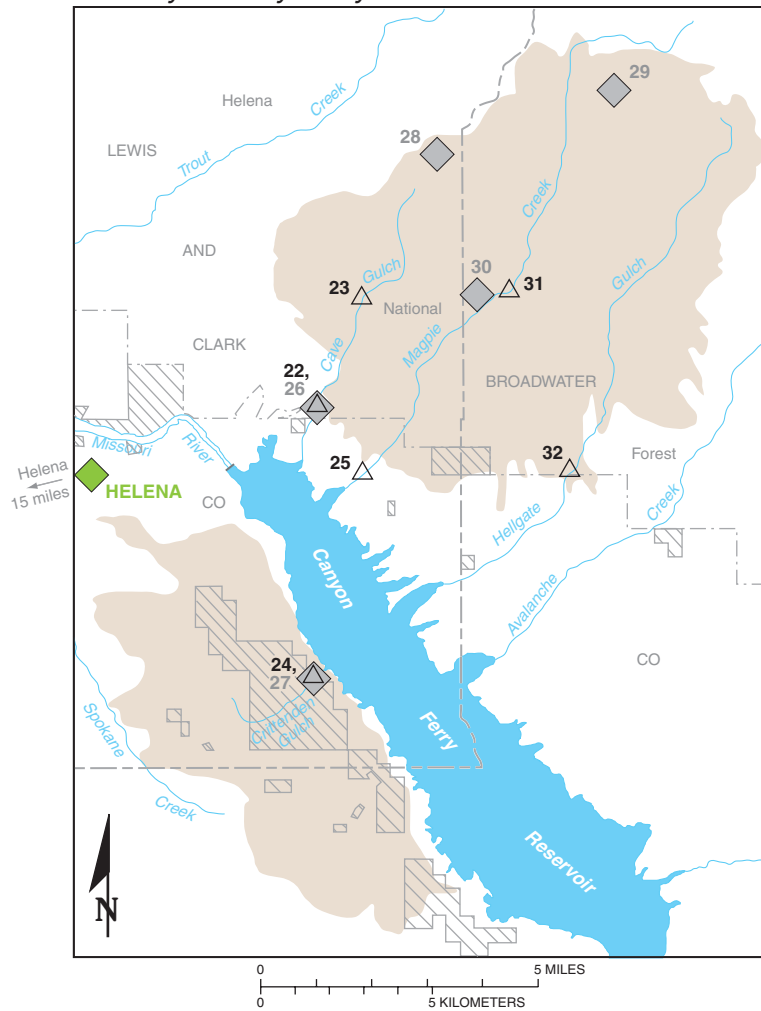
Figure 1. Location of precipitation and streamflow-gaging stations and flood

and debris-flow discharge estimation sites in three burned areas, Montana.

Following the storms in late May, five tipping-bucket rain gages were installed in burned areas (fig. 1A) to better determine future storm intensities. The rain gages were located near the mouths of Cave Gulch (site 26) and Crittenden Gulch (site 27), at a site near the headwaters of Cave Gulch (site 28), and at two sites in the Magpie Creek basin (site 29 in the upper part of the basin and site 30 near the middle of the basin).

Two tipping-bucket rain gages installed in the Ashland burned area in May collected data during the storm of June 30. One, located near the headwaters of Paget Creek (site 33, fig. 1B), recorded 0.56 inch in only 5 minutes and a storm total of 0.95 inch in 30 minutes (table 2). The second gage, located near the southwestern edge of the burned area (site 34, fig. 1B), recorded 0.14 inch in 5 minutes and a storm total of about 0.29 inch in 15 minutes. Neither gage was operable during the July 10 storm. The calculated recurrence intervals for the 5-, 10-, 15-, and 30-minute rain depths at the Paget Creek rain gage (site 33) were 100-500, 25-50, 25, and 10 years, respectively, whereas the calculated recurrence intervals for all depths at Coal Bank Creek (site 34) were less than 2 years. Based on observer reports and inspection of Doppler radar images for the storms, the National Weather Service (Steve Kuhl, National Weather Service, written communication, 2001) estimated that the maximum intensity for the June 30 storm was about 2.0-2.5 inches in 30 minutes and that the maximum intensity for the July 10 storm was about 5 inches in 2 hours in the burned area. The calculated recurrence intervals for these rainfall depths and durations exceed 500 years.

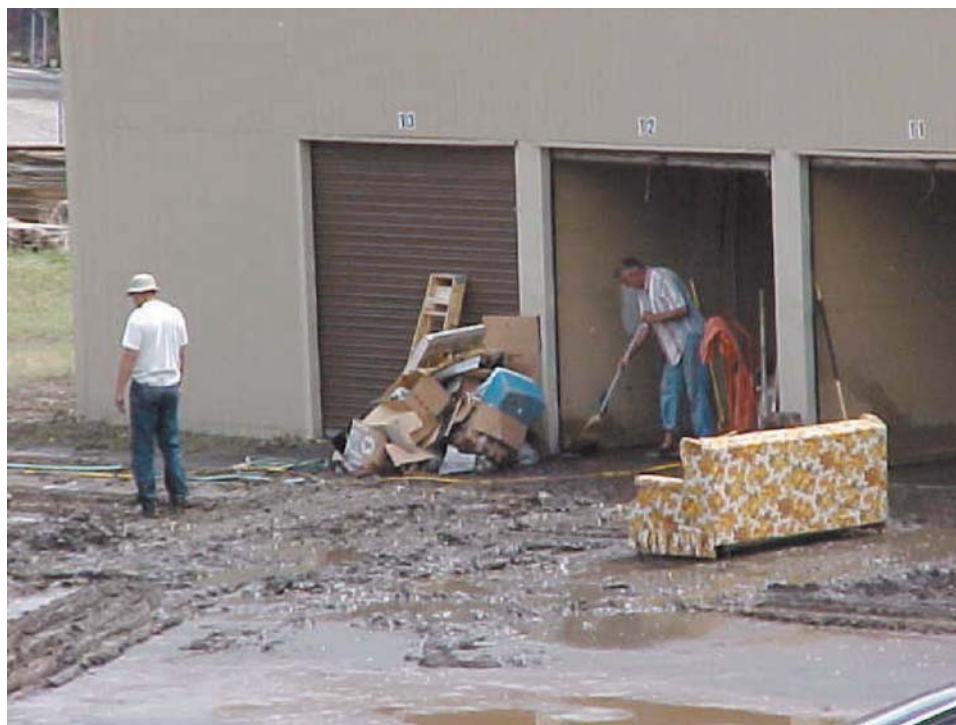
Figure 2. Flooding aftermath from the storm of May 27, 2001, in a storage building constructed in the poorly defined Cave Gulch stream channel, near Helena, Montana.

Beginning in late May 2001, a series of thunderstorms moved generally northeast across the Canyon Ferry area near Helena. On May 27, the first storm caused flooding on Cave Gulch (site 22), which is a small (4.6 square miles drainage area), ephemeral tributary to the northeast side of Canyon Ferry Reservoir. The Cave Gulch drainage basin, which was heavily burned in 2000, also has a mine and several excavated mine-waste settling ponds near the middle of the drainage basin. Prior to the flood of May 27, streamflow in Cave Gulch near its mouth was such a rare occurrence that structures were built in the poorly defined channel. Consequently, flood discharge from the May 27 storm, although relatively small, had nowhere to go but through the structures (fig. 2).

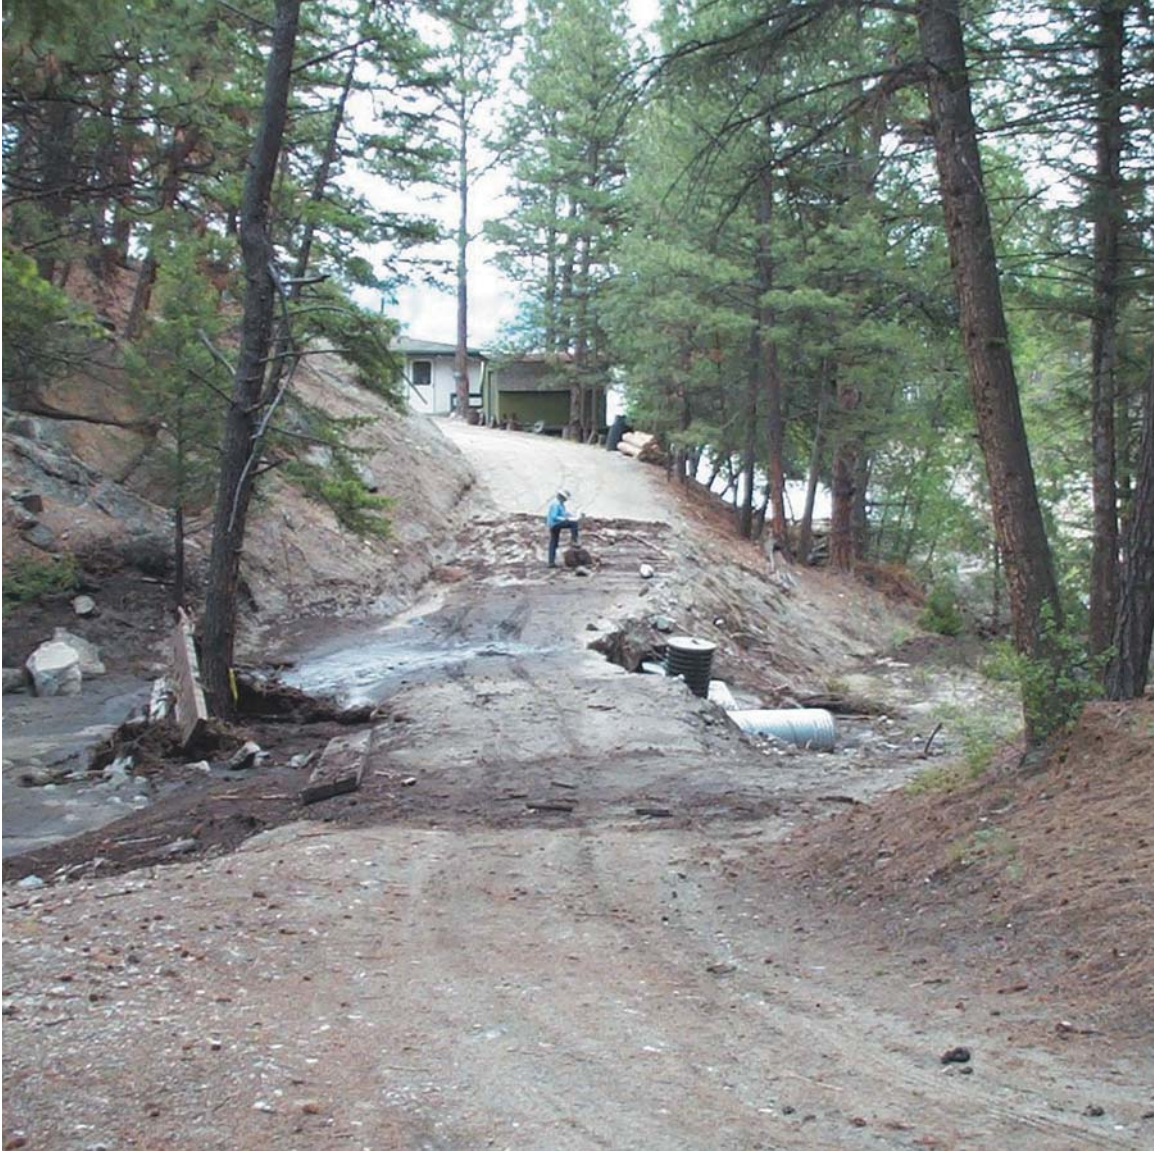
Figure 3. Flood damage on Crittenden Gulch at its mouth, near Helena, Montana. Vertical, corrugated pipe on the downstream side of the road provides access to a septic tank.

The estimated peak discharge on Crittenden Gulch (site 24) following the July 17 storm was calculated to be 1,020 cubic feet per second (table 3). This flood caused further damage to the previously flooded access road on the west side of Canyon Ferry reservoir and completely blocked a culvert on the main road with

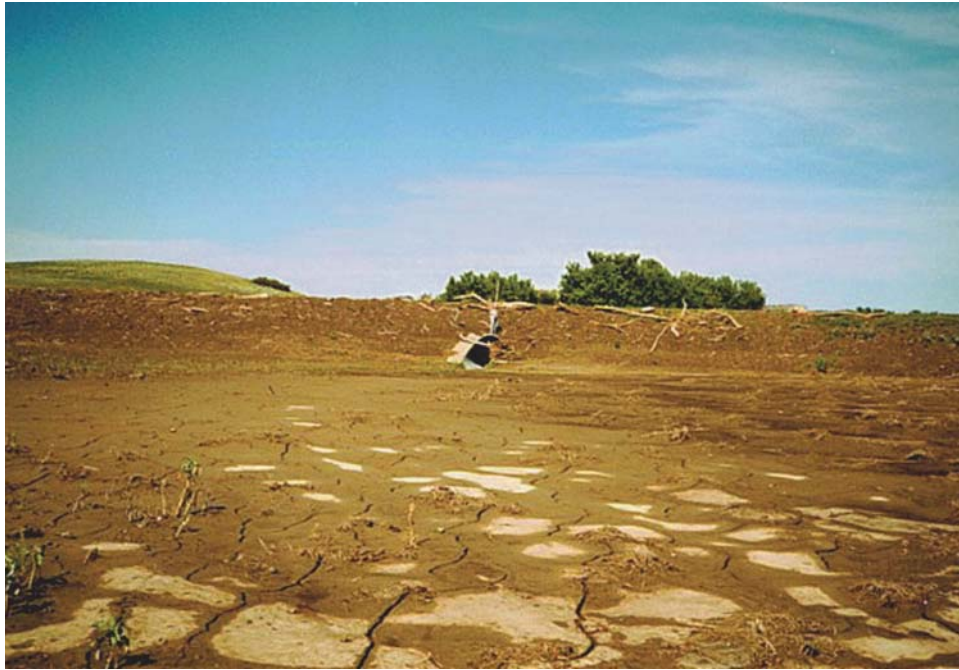
Figure 4. Sediment-laden floodwaters on Brian Creek near Ashland, Montana, overtopped the road and deposited a thick layer of muddy sediment (foreground) and large, woody debris (road embankment in background). Note the person standing on the culvert for scale. View is looking downstream.

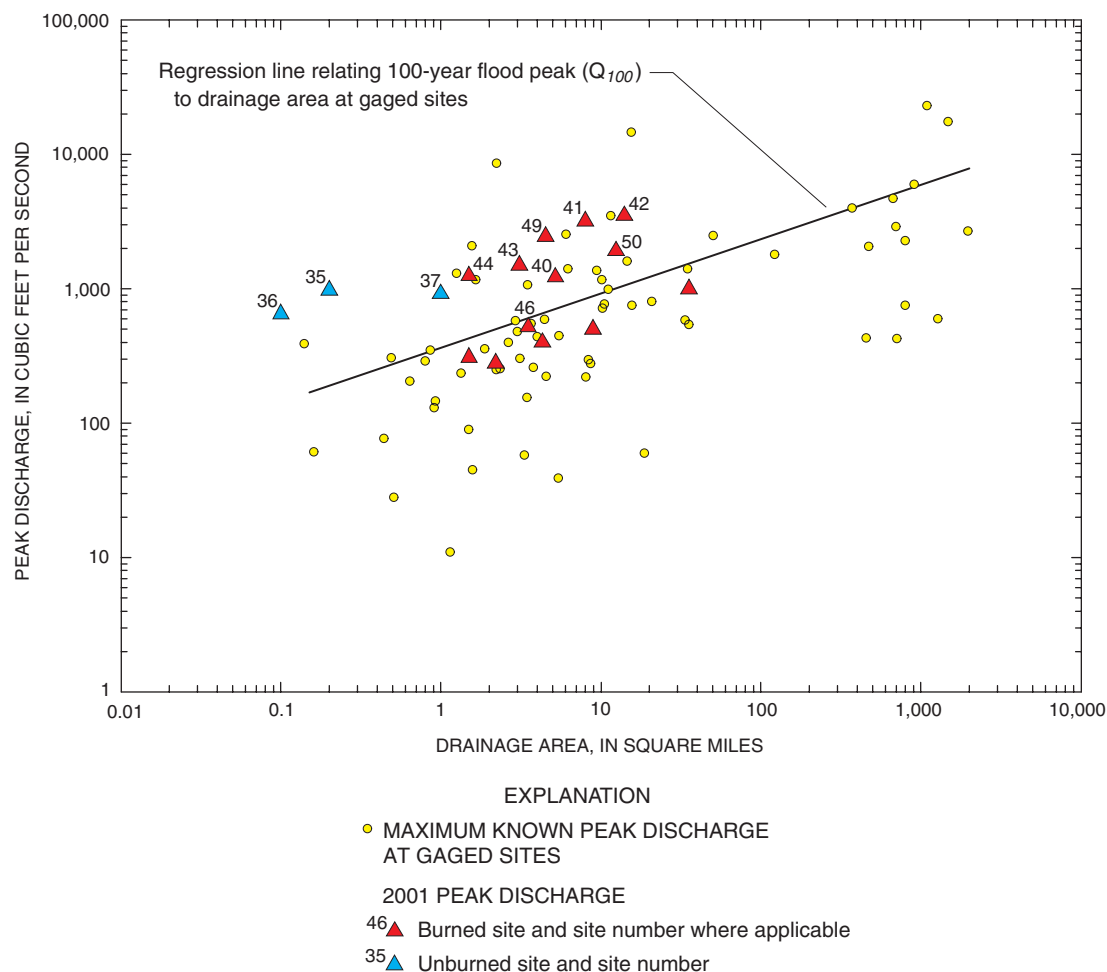
Figure 5. Maximum known peak discharges at gaged sites in the Southeast Plains Region of Montana (Parrett and Johnson, 2004) compared to 2001 peak discharges in the Ashland study area.

Figure 5 shows the relative rarity of the large floods that occurred in the Ashland study area in June and July 2001. This graph shows the maximum known peak discharges at gaged sites in the Southeast Plains Region of Montana (Parrett and Johnson, 2004) and drainage areas, together with calculated peak discharges and drainage areas for the June and July floods in the Ashland study area. Several of the calculated peak discharges in 2001 plot as high or higher than the maximum known discharges at similar-sized gaged sites (sites 35 and 36). Also shown for comparison on figure 5 is a regression line relating 100-year flood peaks (Q_{100}) to drainage area for the gaged sites. Several peak discharges for 2001 in the Ashland study area plot well above the 100-year flood regression line (sites 35, 36, 37, 40, 41, 42, 43, 44, 49, and 50). The regression line in figure 5 is based on only one explanatory variable (drainage area), whereas the regression equations developed by Parrett and Johnson (2004) are based

on more than one explanatory variable. Consequently, one calculated peak discharge for 2001 (First Creek, site 46) plotted below the regression line, even though data in table 3 indicates that the recurrence interval is 100-200 years. The recurrence intervals shown in table 3 are considered to be more reliable than the regression line in figure 5. Finally, figure 5 distinguishes the 2001 peak-discharge sites draining burned areas from those draining unburned areas. Surprisingly, peak discharges for the three sites (sites 35, 36, and 37) draining unburned areas generally plot as high above the regression line as the highest-plotting discharges for sites draining burned areas. This result may indicate that the fire of 2000 had less effect on the 2001 flood peaks in some watersheds than did the pattern and intensity of the storms producing the runoff.

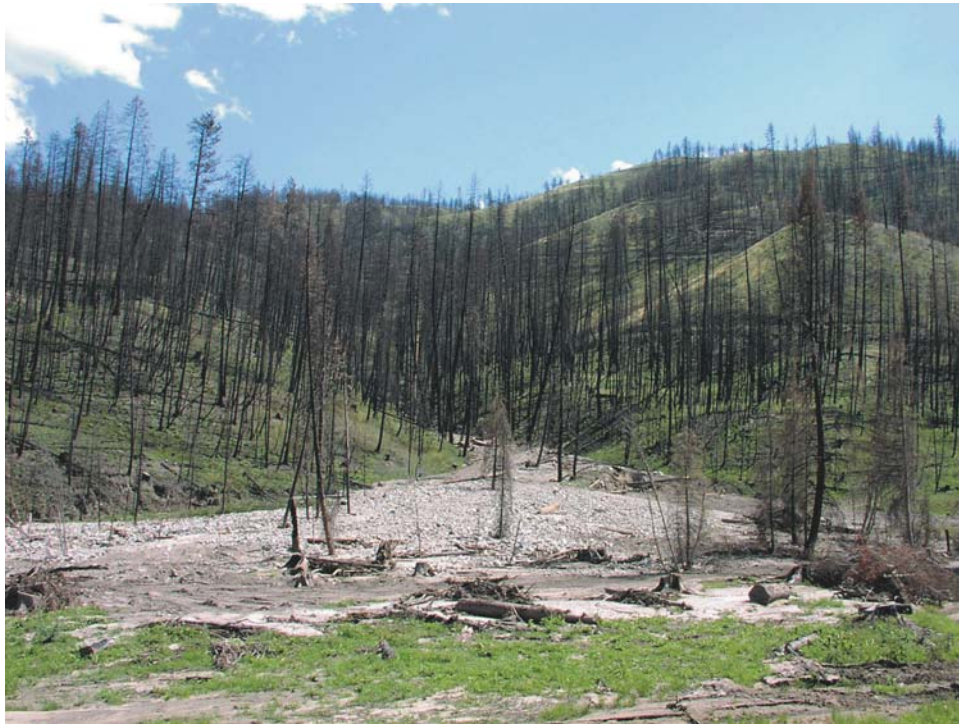
Figure 6. Flood deposits from Laird Creek tributary partly blocked the Laird Creek channel (upstream from site 2) following storms of July 20 and 21, 2001, near Sula, Montana.

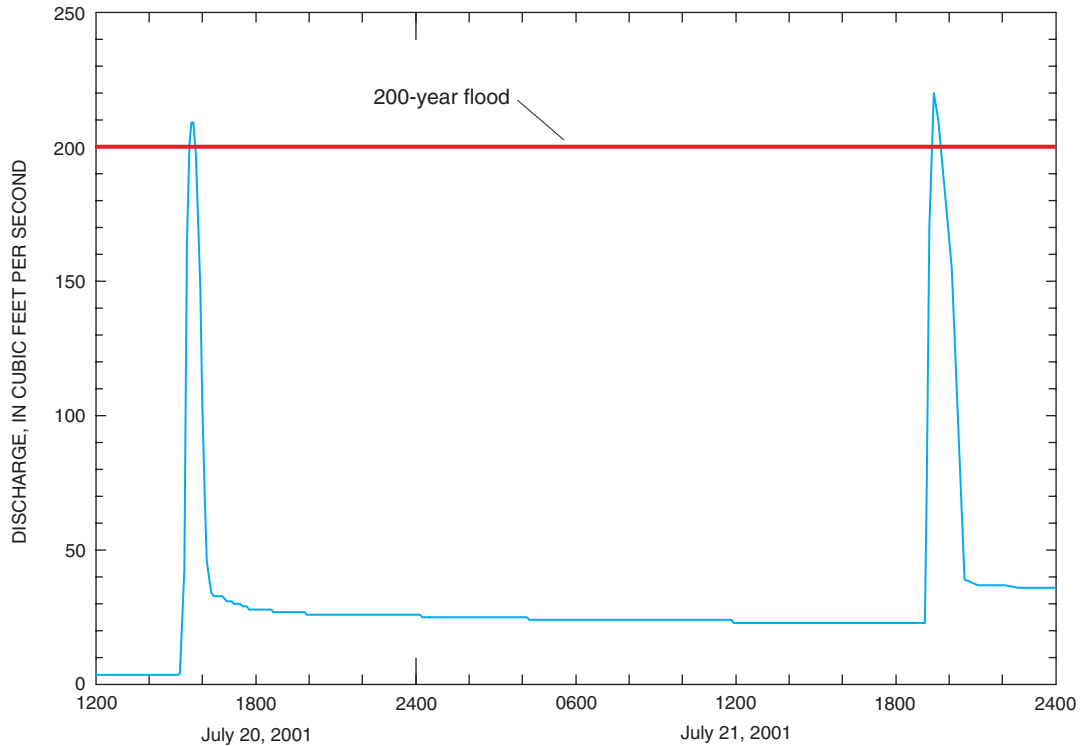
Figure 7. Hydrographs of floods for Laird Creek near Sula, Montana (site 2), July 20 and 21, 2001.

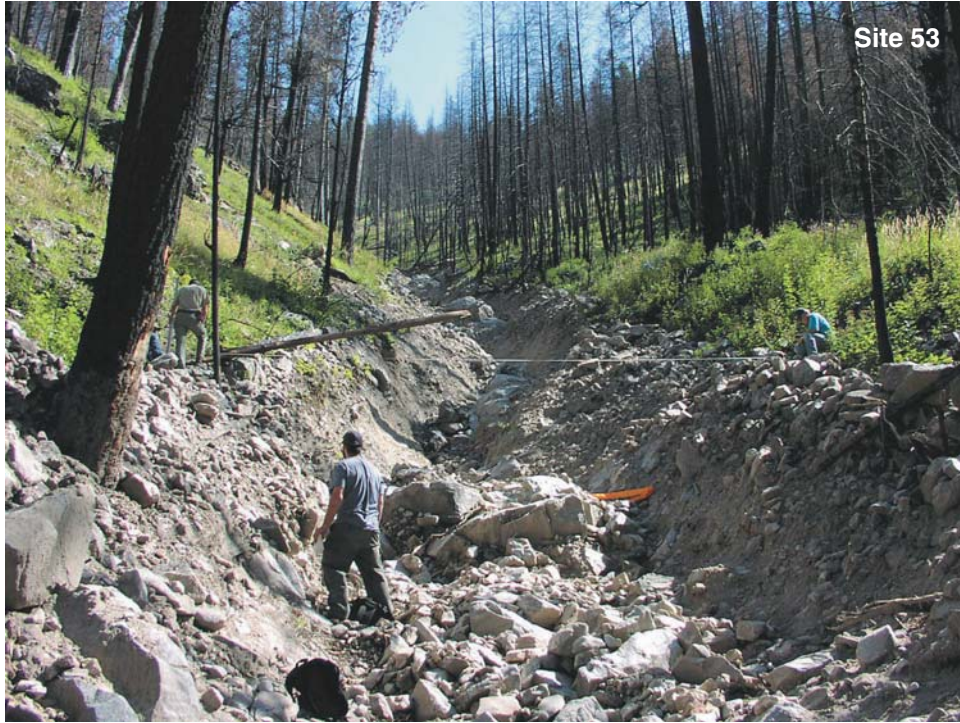
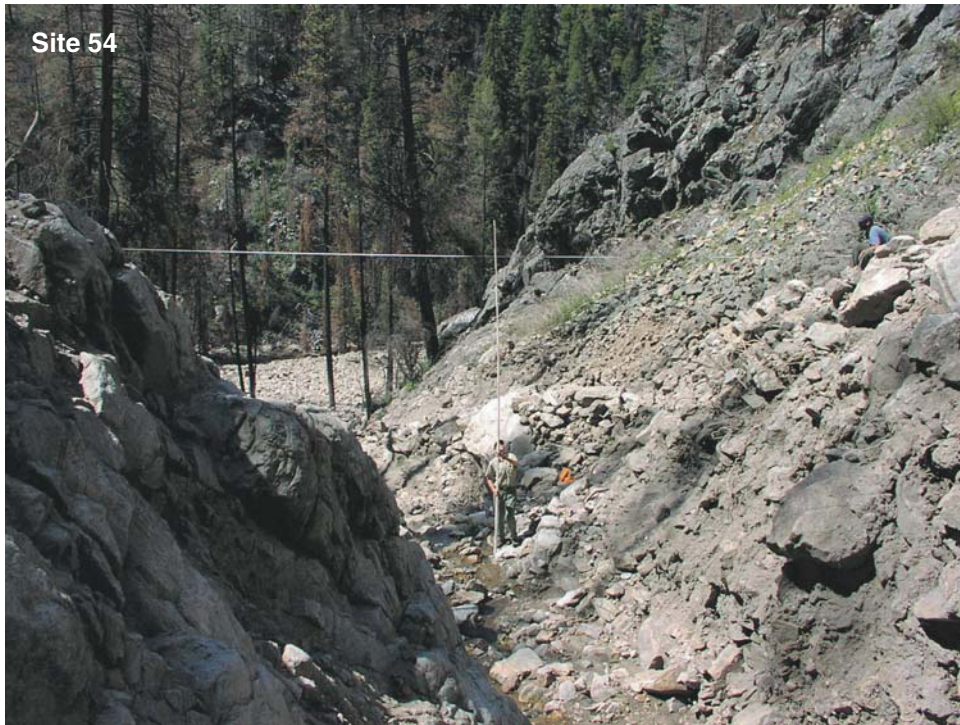
Figure 8. Measuring debris-flow channel section at two unnamed tributaries to Sleeping Child Creek (sites 53 and 54), Montana.

fig. 1) where the erosion and subsequent deposition was especially large (fig. 8). Calculated peak debris-flow discharges ranged from 1,740 to 7,860 cubic feet per second for drainage areas ranging from 0.07 to 0.41 square mile. At one of the largest tributary sites (site 56), flow deposits did not form levees, were generally sorted by size, and did not have any evident fine-grained matrix support. Consequently, the peak discharge at this site was considered to be a hyper-concentrated flow rather than a debris flow (Costa and Jarrett, 1981) and was estimated as a water discharge (table 3).

A single channel cross section encompassing the tops of the debris-flow deposits or scour marks on each side of the channel was surveyed at a location assumed to best represent the break in channel gradient, and equation 1 was used to calculate peak debris-flow discharge. In very steep mountain channels, debris flows may be predominantly supercritical rather than subcritical, and application of equation 1 may yield calculated

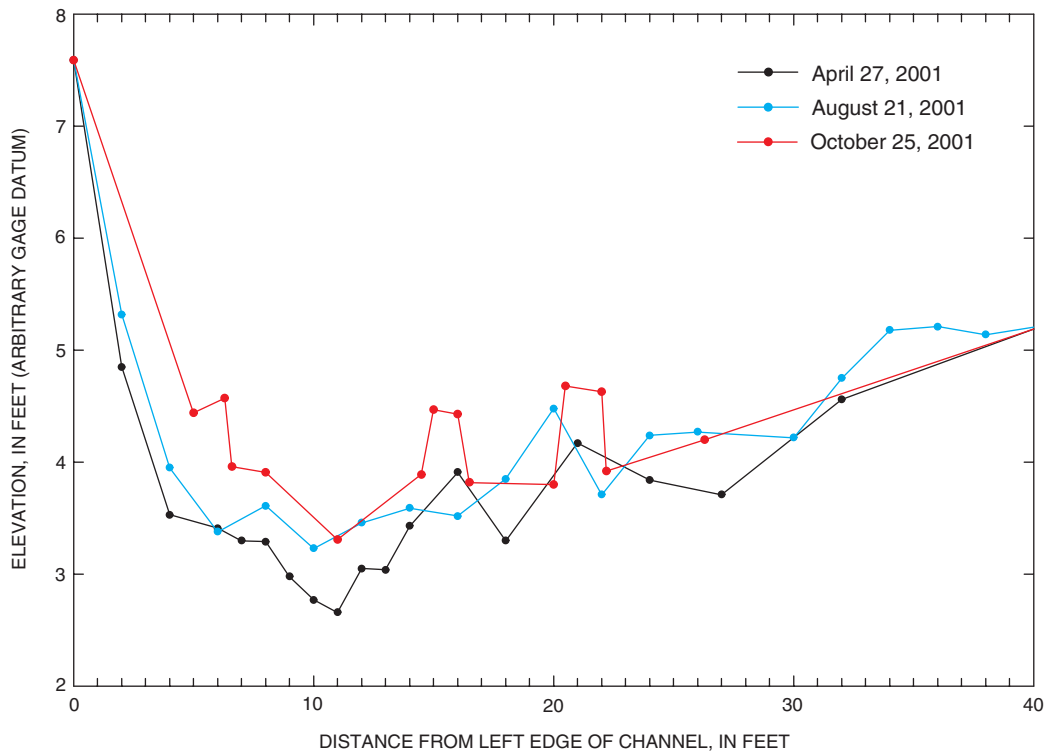
Figure 9. Comparison of surveyed channel cross sections at Sleeping Child Creek near Hamilton, Montana (site 13), before and after debris flows of July 15, 2001.

sequently eroded from the channel. The upstream channel blockages contributed additional sand-sized sediment to Sleeping Child Creek. Figure 9 shows the channel section at site 13 in April 2001 (before the July debris flows), compared to the channel section surveyed in August and again in October 2001. The comparison indicates that the channel aggraded about 0.3 foot from April to August and another 0.2 foot from August to October. Further aggradation may take place as sediment from upstream debris-flow deposits moves downstream, but cyclic variations in runoff also may result in cyclic changes from aggradation to degradation. Overall, given the size of the upstream debris-flow discharges and the several main-channel blockages, the debris flows had a notably small effect on streamflow in Sleeping Child Creek downstream at site 13. Following the large debris flows in July, a continuous-recording streamflow gage was placed at the Sleeping Child Creek gage site (site 13).
