# INACTIVE AND ABANDONED MINE LANDS— Sunset Mine, Snohomish County, Washington

WASHINGTON  
DIVISION OF GEOLOGY  
AND EARTH RESOURCES

Open File Report 2002-4  
September 2002

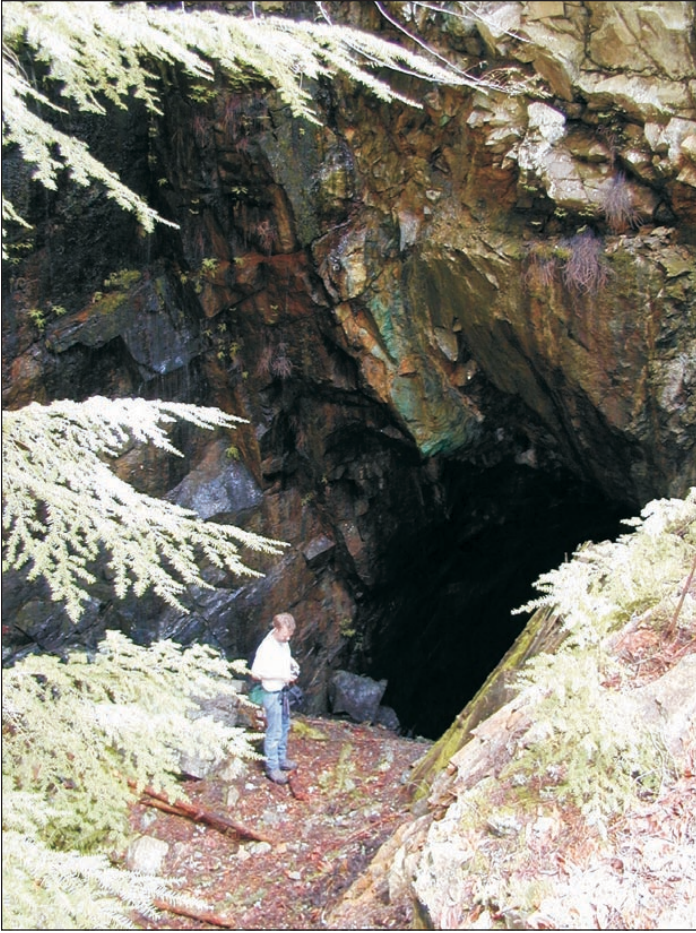
**Figure 4.** Surface entrance to stope 1. Floor dips  $-40$  degrees easterly. Vein material is exposed in overhang.

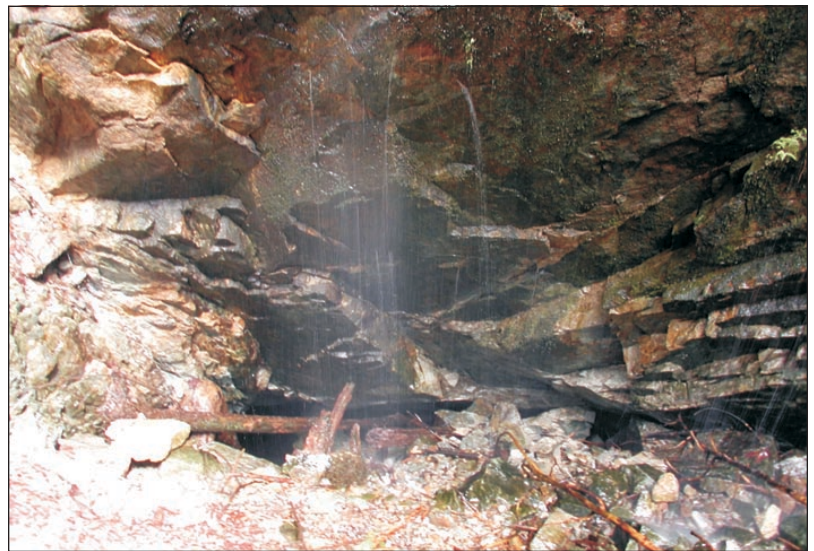
**Figure 6.** A 4 x 4 foot opening above stope 3. The log is approximately 1 foot in diameter.

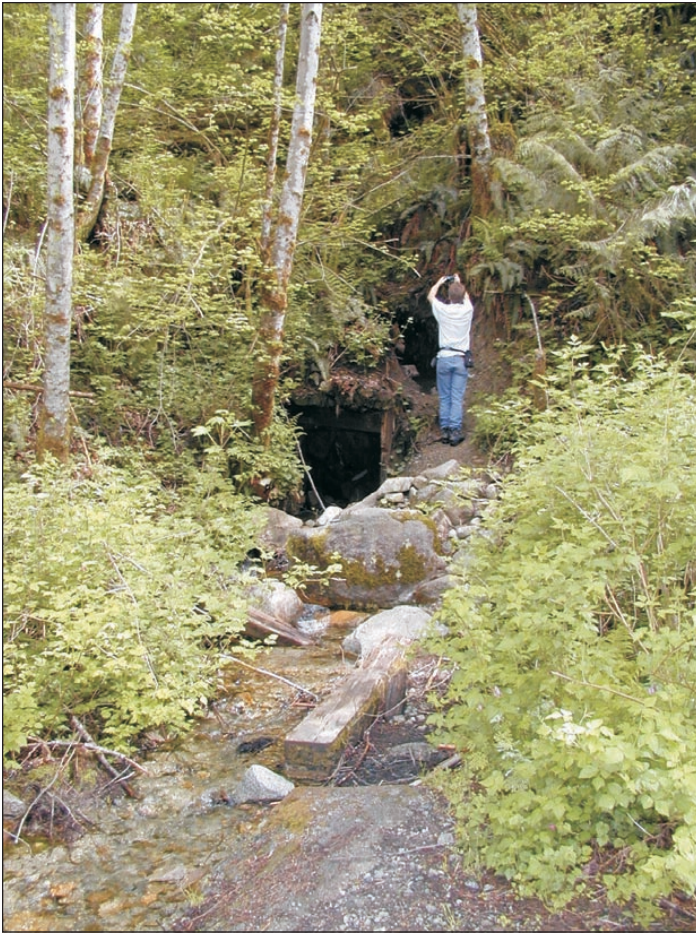
Adit 2 was the main haulage level. It is 1200 feet long and has caved a few feet beyond the portal. All workings below this level are flooded. Adit 2 discharges water at the rate of 150 to 450 gpm depending on the season (Fig. 7). A sample taken at this location meets the requirements for ground water for domestic consumption described in WAC 246-290 (see Table 5).

**Figure 7.** (above left) Main haulage level, adit 2. The tunnel is caved beyond the DGER geologist. A discharge stream is in the foreground.

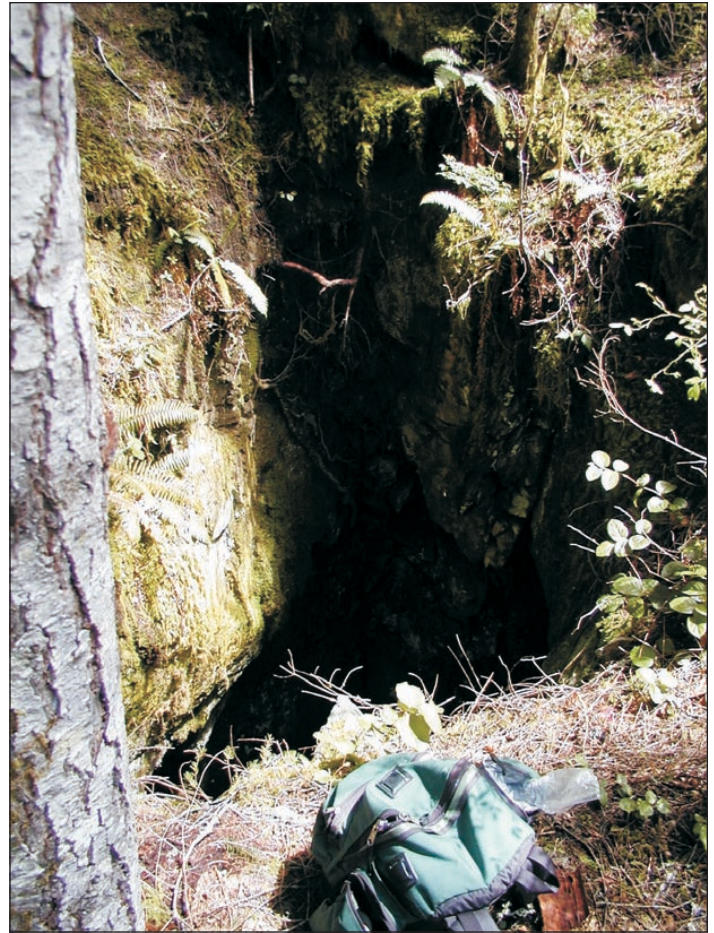
Adit 3 is located a few hundred feet to the west of adit 1 at about the same elevation. The entrance is caved. A ventilation shaft on the adit's centerline is open and unprotected (Fig. 8). It falls 154 feet to the present floor of stope 11. Fifty feet to the west, we encountered another open cut and cavern similar to the

**Figure 8.** (above right) Ventilation raise on the centerline of adit 3. Backpack for scale.

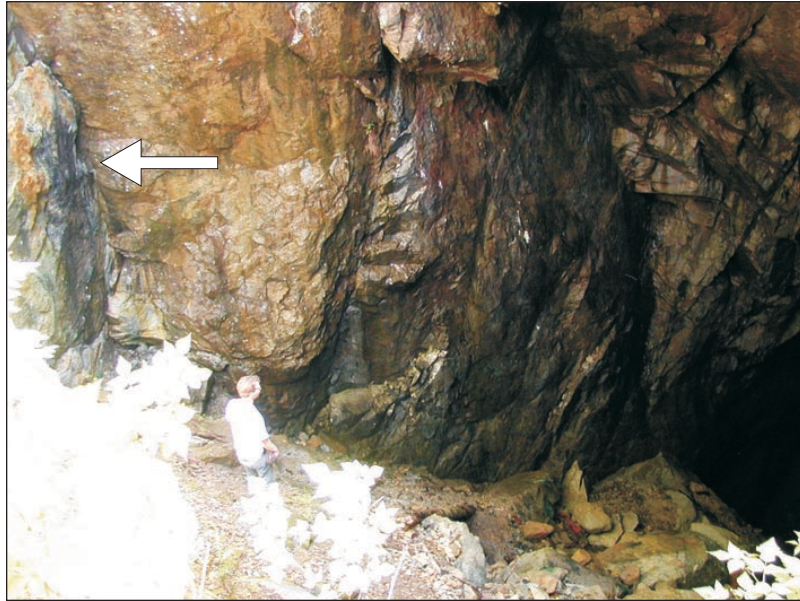
**Figure 10.** Entrance to stope 11. Note the mineralized vein on the wall on the left side of the photo (arrow). View is to the northeast.

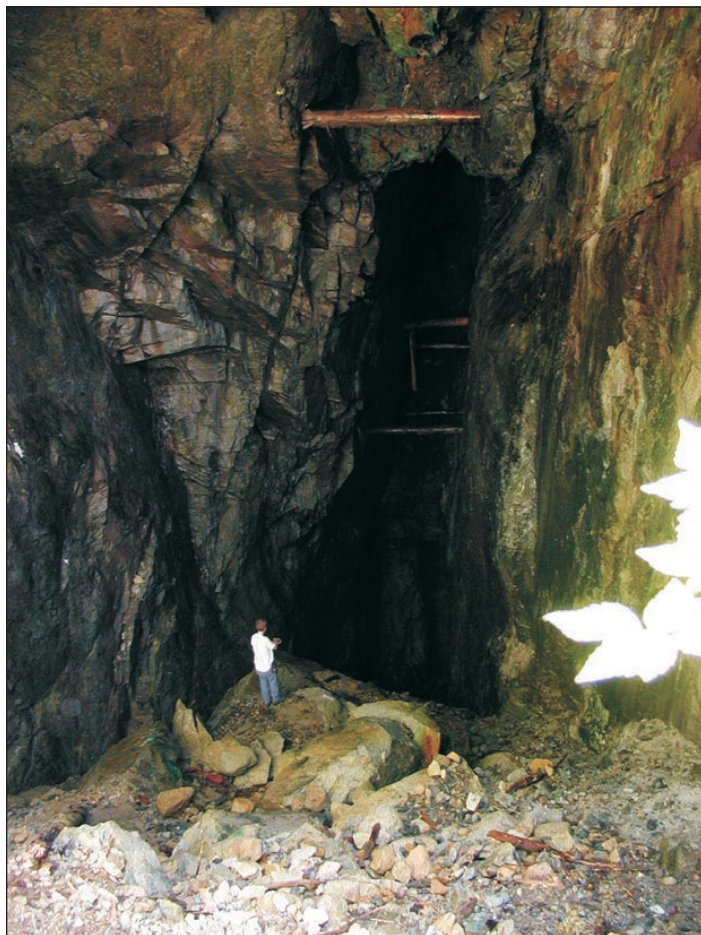
**Figure 11.** Entrance to stope 11 on vein centerline. Note the 1-foot-diameter stulls overhead. The back of the stope is 220 feet distant. View is to the east.

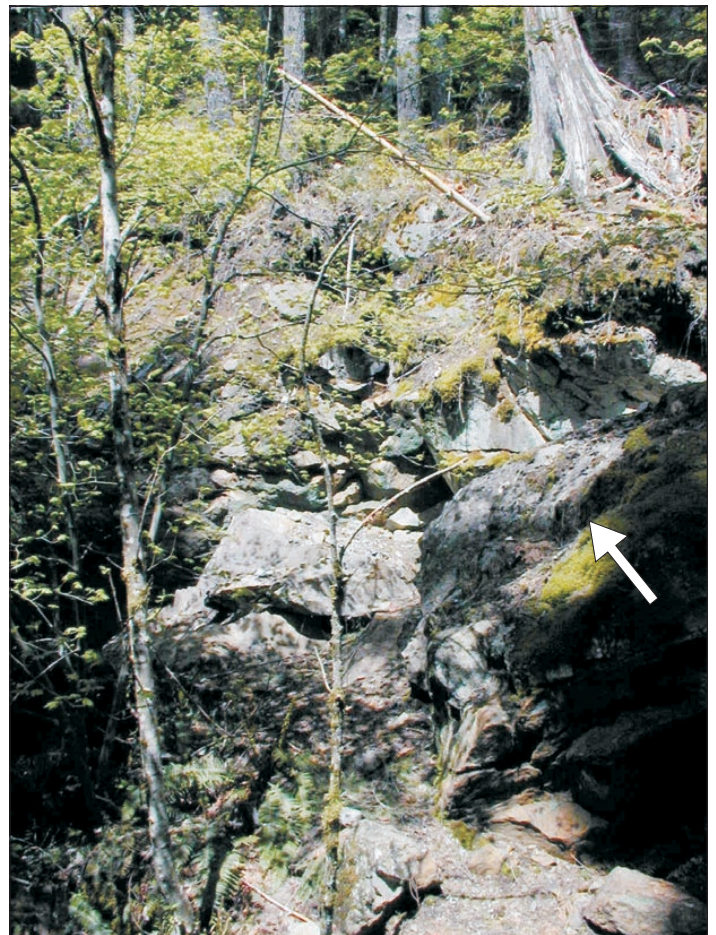
400 feet westerly along the vein. Blocks of mineralized granodiorite the size of small pickups slumped off the hanging wall at some time between November 2000 and May 2002 (Fig. 12).

**Figure 12.** Recent highwall failure (arrow) and subsidence along the vein's western extension.

**Presence of unstable slopes, walls, waste rock, tailings, or impoundments:** The open stopes and surface cuts described in Table 1 create an extreme hazard to human safety. The highwalls, which are vertical, stand 50 to 100 feet above the floor. Blocks of granodiorite continue to spall off the sidewalls of the surface cuts and overhead of the open stopes. The open stopes form caverns 50 to 100 feet high. We estimate the distance between the ground surface and the stope ceilings to be about 15 to 20 feet.

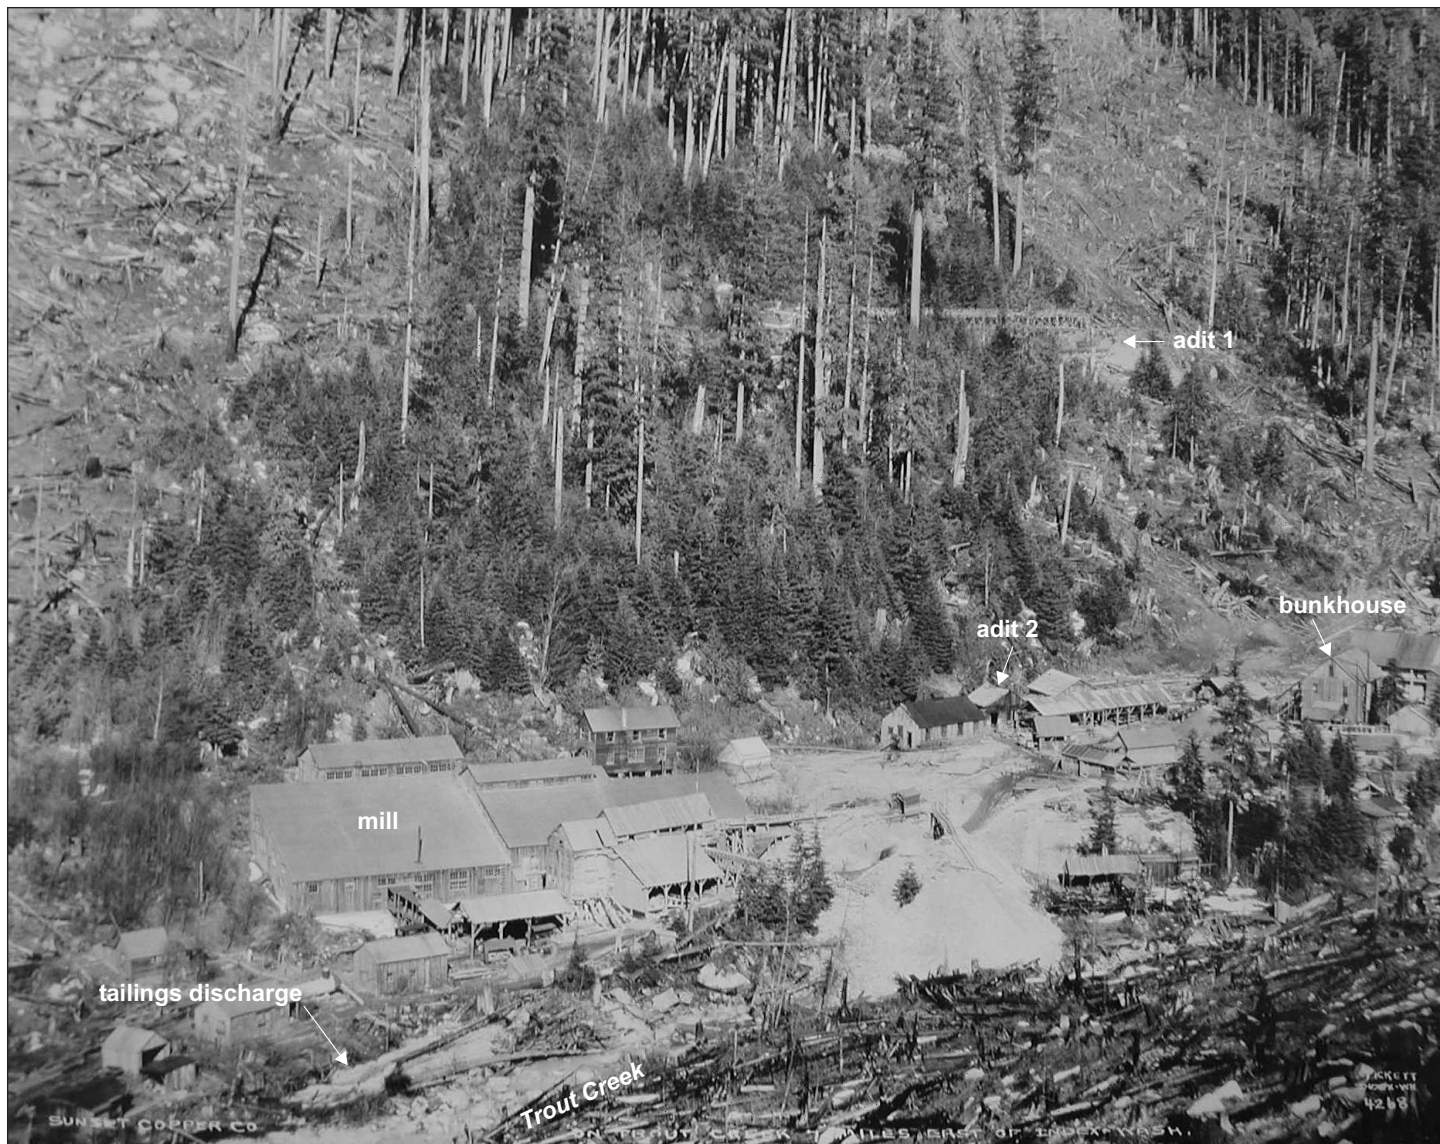
A photo taken in 1929 shows the mill discharging tailings on the north bank of Trout Creek and into the creek itself (Fig. 13). Periodic flooding in Trout Creek has washed any remnant tailings downstream. This

photo was taken at a high point in the Sunset mine's operation and shows a highly self-contained camp with bunkhouse, dining hall, assay office, sawmill, concentrator, blacksmith forge, and shop. Only the concrete mill foundation remains at present (Fig. 14). The site of former bunkhouse and dining hall is overgrown with alder and brush (Fig. 15).

**Figure 13.** Sunset mine and camp operations in 1929. Lee Pickett photo from DGER photo files.

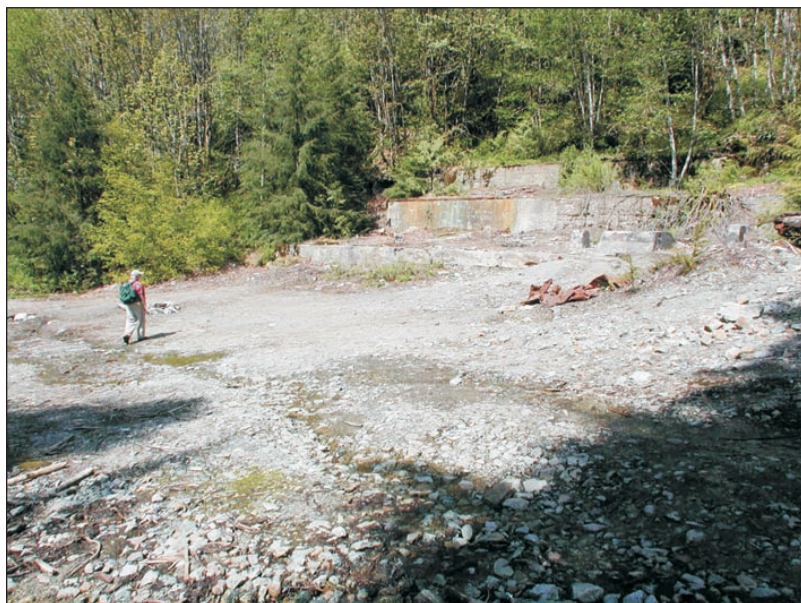
**Figure 14.** Mill foundation. Former waste-rock site in foreground was washed away during Trout Creek flooding. Note machine gun bullet holes in foundation.

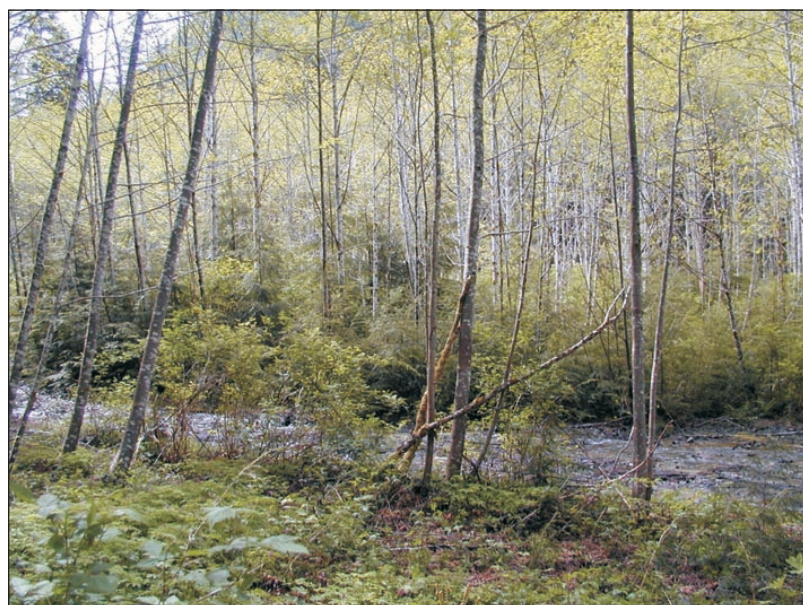
**Reclamation activity:** Mining debris, buildings, and equipment have been removed. Second-growth forest has established a strong presence in formerly logged areas on the claims. Mill tailings and waste rock dumps shown in historical photos near adit 2 and the mill have been inundated at various times by high water in Trout Creek and washed downstream. Brush, red alder, and hemlock have taken hold at the location of former bunkhouses, shop buildings, and mine roads (Fig. 15).

**Figure 15.** Site of former bunkhouse and dining hall. View to the south.
