***ABBREVIATED PRELIMINARY ASSESMENT***

***MONTE CRISTO CONCENTRATOR***

Mt. Baker-Snoqualmie National Forest  
Snohomish County, WA

October 2002

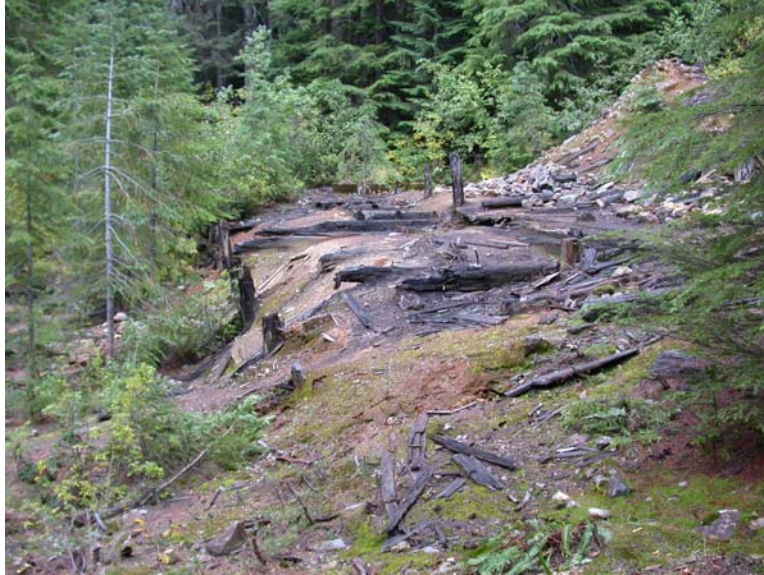
The material at and around the old concentrator facility is highly contaminated. The remains of this facility is heavily visited by tourists and during this assessment, it was apparent that people had been digging into the material at the Site, probably in hopes of finding rock specimens. This area is being promoted for various tourist attractions in several printed sources, of which one is *Discovering Washington's Historic Mines*.

*Side View of The Concentrator Foundation*

concentrator and waste pile with the Niton XRF unit, the proximity of potential waste piles to Glacier Creek, presence of tourists in the area, presence of Bull Trout in Glacier Creek, and EPA's APA Checklist (Appendix A), it is recommended that a Site Inspection (SI) be completed. As part of this inspection, a thorough study of the area to determine the extent of contamination is warranted as well as sampling water from pore spaces of the stream gravels immediately above and below the Site. Sampling of the benthic macroinvertebrates are also required. In addition to testing water samples from the pore spaces of the gravels for the presence of metallic elements, water parameters such as pH, conductivity, turbidity, dissolved oxygen, temperature, total dissolved solids, hardness, and oxygen reduction potential are required. The area should be sampled to determine the presence of waste material, and if present, the potential waste piles should be sampled at depth and a determination of volumes should be calculated. Acid base accounting (ABA) is required if waste material is present besides what had been observed during this assessment. Sediment samples are to be collected from transects of the stream and preferably at depth and analyzed for total as well as for available metals. Surface water samples are also required for analyses of both total and dissolved metal concentrations in Glacier Creek as well as in any other seeps and/or tributaries that may be present in the concentrator area.

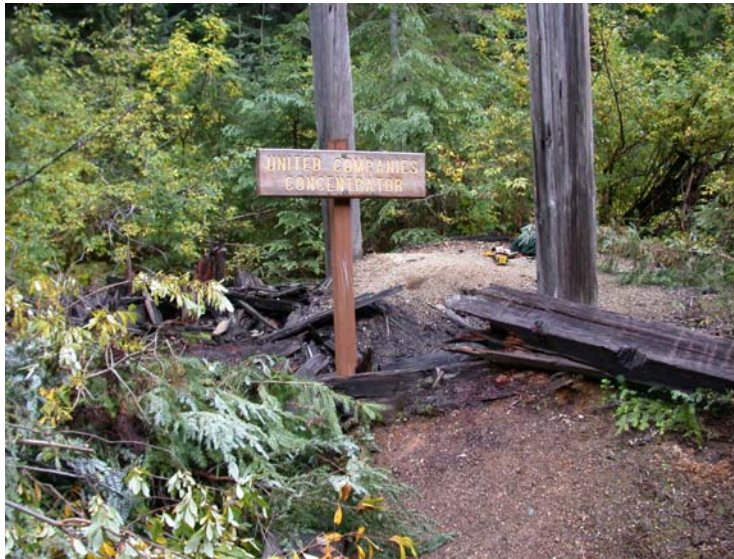
The Site consists of foundations and portions of flooring. It is expected that there may be some tailings/waste material still in the area (an AIM Discovery Form states the presence of 14,000 cy of tailings at the Site), which needs to be verified. The property is heavily overgrown with vegetation in most places. There are no other structures in the area. Access to the Site can be easily accomplished by way of the old Forest Service road except for the last 100 yards. The road and bridge have been washed out by Glacier Creek. Approximately 5 acres are disturbed on the Site.

*Waste Pile Behind Sign*
