ABBREVIATED PRELIMINARY ASSESMENT

KROMONA MINE AND MILLSITE

Mt. Baker-Snoqualmie National Forest
Snohomish County, WA

August, 2003

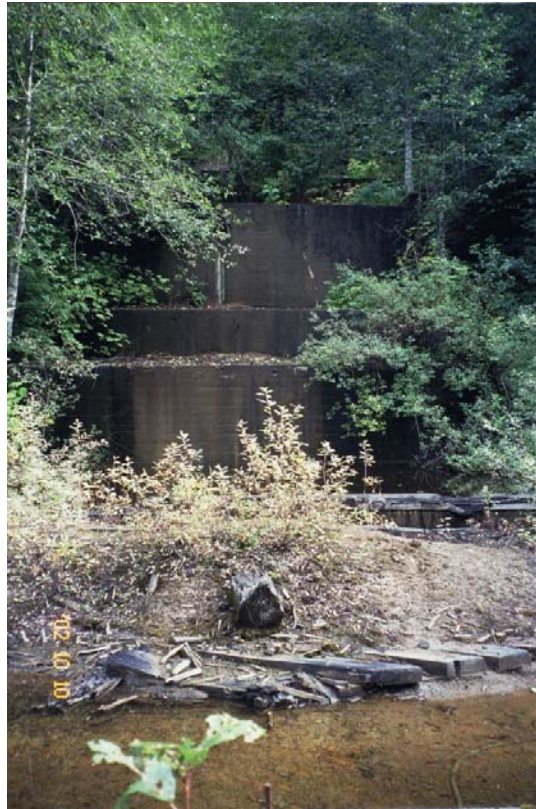
Photo 1. Remains of mill foundation, view to the northeast (photo by G. Graham, 10/10/2002).

<u>Location</u>	<u>Constituent</u>	<u>Result (mg/kg)</u>	<u>PRG (mg/kg)</u>
Mill Foundation	Arsenic*	21,000	1.6
	Copper	63,000	41,000
	Iron	140,000	100,000
Main adit waste dump	Arsenic*	1,500	1.6

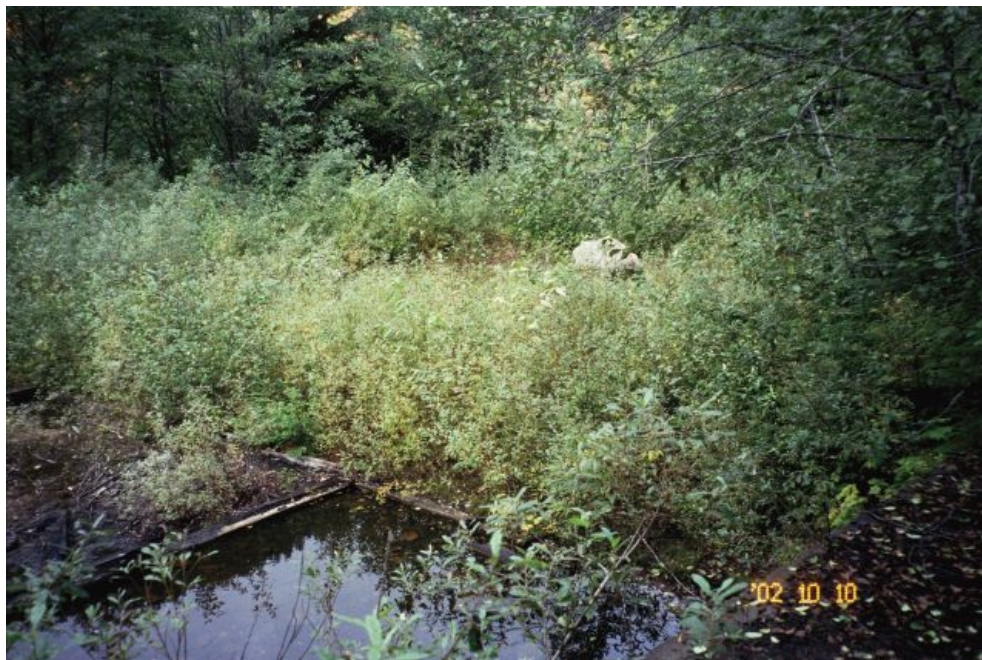
Photo 2. View of probable tailings impoundment from bottom of mill foundation, view to the northwest (photo by G. Graham 10/10/2002).

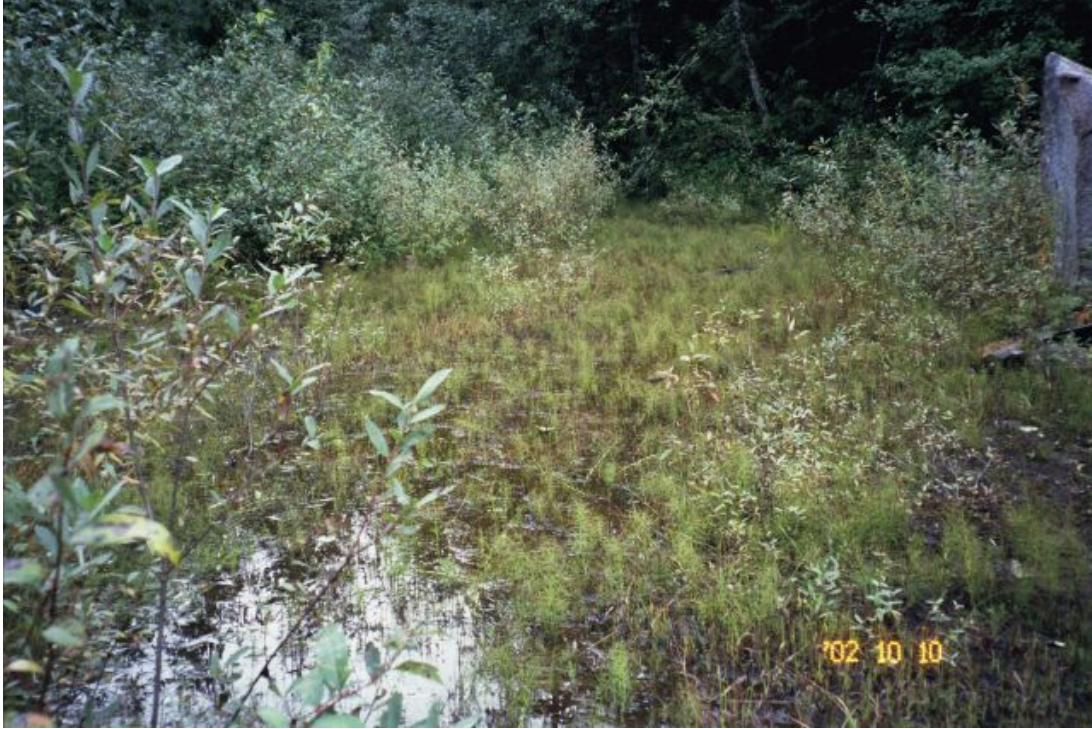
Photo 3. Close up of probable tailings impoundment adjacent to mill foundation, view to the north (photo by G. Graham, 10/10/2002).

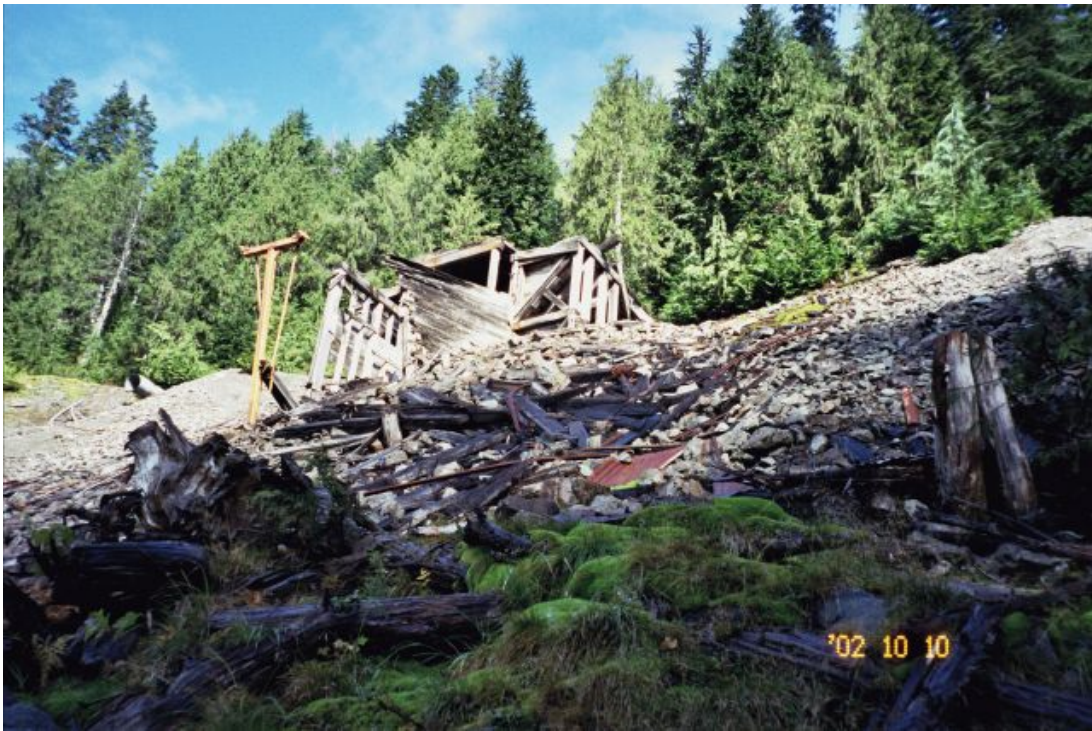
Photo 4. Waste dump for main adit and upper tram station, view to the northeast (photo by G. Graham, 10/10/2002).

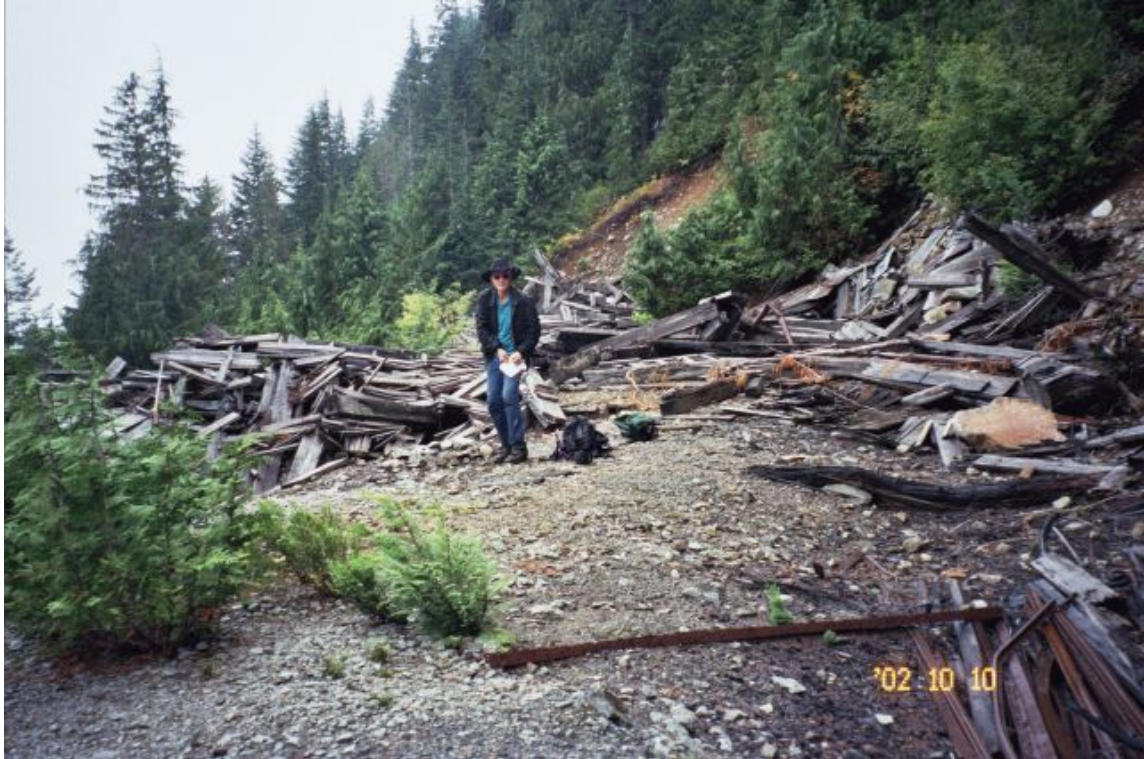
Photo 5. Refuse atop waste dump at main adit/upper tramway terminal where bunkhouse, cookhouse, and workshop were located, view to the northwest (photo by G. Graham, 10/10/2002).

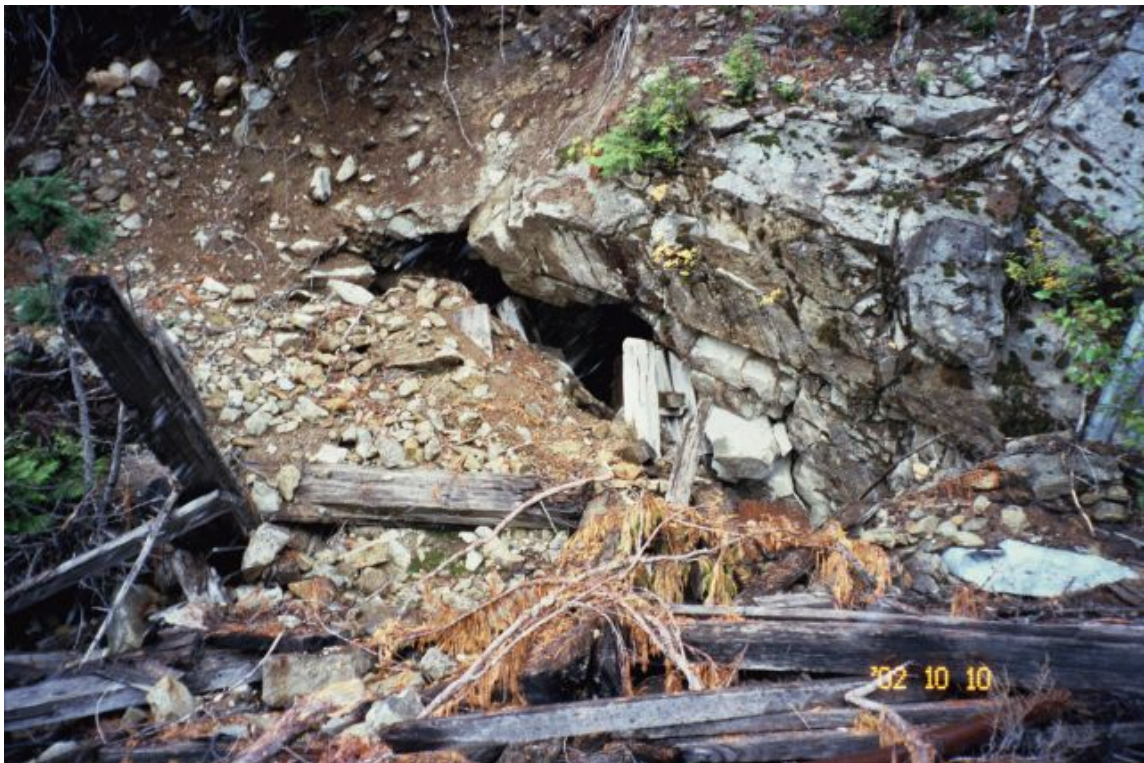
Photo 6. Partially collapsed main adit, view to the northeast (photo by G. Graham, 10/10/2002).

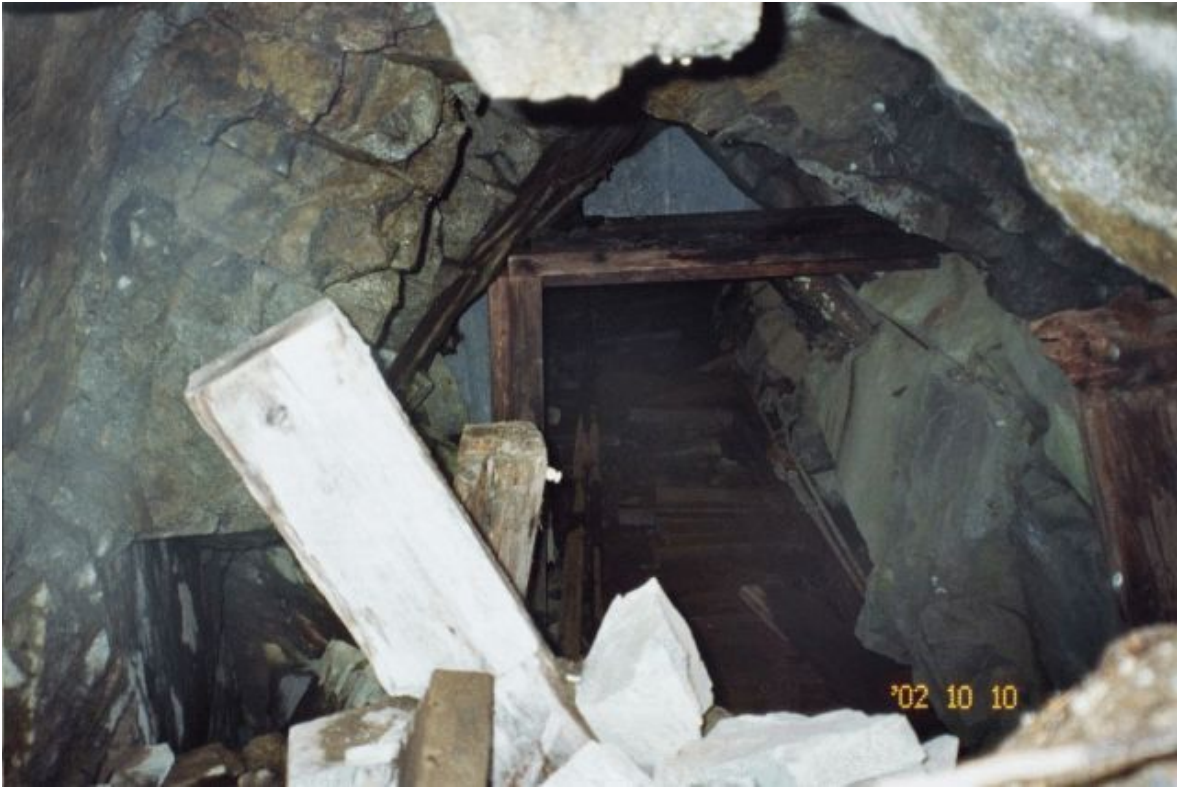
Photo 7. Close-up of main adit at the Kromona mine (photo by G. Graham, 10/10/2002).
