ABBREVIATED PRELIMINARY ASSESMENT SUNSET MINE AND MILLSITE

Mt. Baker-Snoqualmie National Forest Skykomish Ranger District Snohomish County, WA

September, 2003

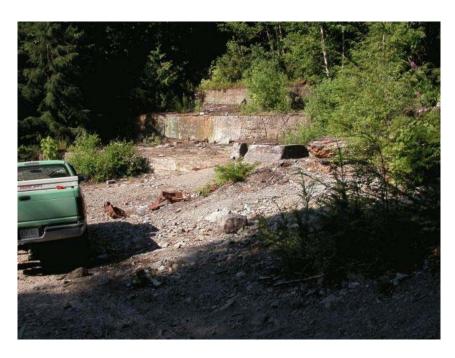
Photo 1. Remains of mill foundation, view to the northwest (photo by G. Graham, 7/30/2003).

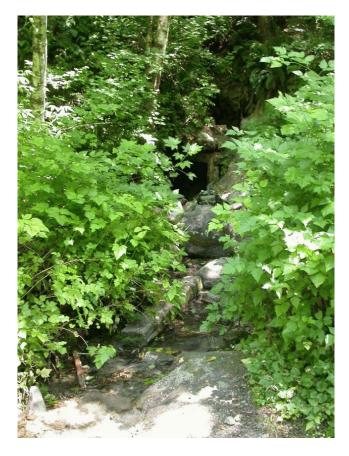
Photo 2. Partially caved Adit 2 which was the main haulage level for the mine. Note discharge stream in the foreground, view to the northeast (photo by G. Graham 7/30/2003).

The standards for arsenic, copper, lead, and zinc are for the dissolved fraction (Table 1A). Samples collected by WA-DNR were analyzed for total metal content and are hence conservative when compared to the State standards. Table 1B lists analytical results for the samples collected by WA-DNR. At the mine, effluent discharging from Adit 2, the main haulage, exceeds state chronic standards for surface waters for copper. In addition, background copper concentrations in Trout Creek noticeably increase downstream of the mine site (Table 1B).

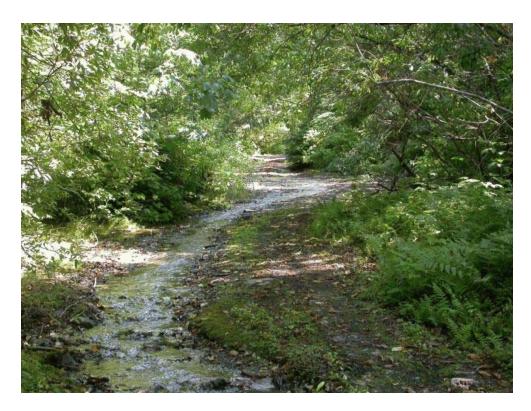
Photo 3. Discharge from Adit 2 on access road en route to Trout Creek, view to the east (photo by G. Graham, $\frac{7}{30}/2003$).

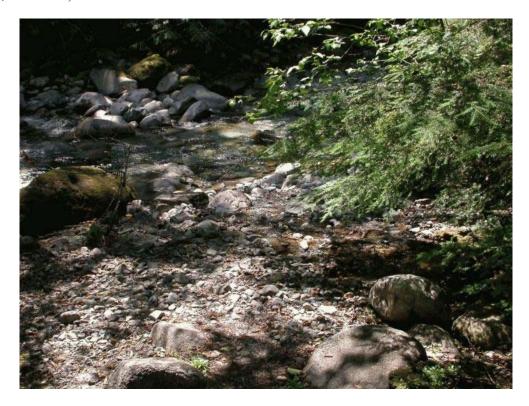
Photo 4. Discharge from Adit 2 entering Trout Creek approximately 500 feet east of the portal, view to the southwest (photo by G. Graham, 7/30/2003).

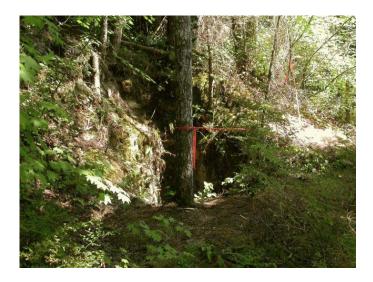
Photo 9. Air shaft open to the surface, view to northwest (photo by G. Graham, 7/30/2003).

The Site poses significant physical hazards to the general public recreating at the Site. Two stopes have collapsed to the surface and there is one ventilation raise open to the surface. Numerous collapse features along strike of the mined out veins suggests continued subsidence may be a problem at the site.

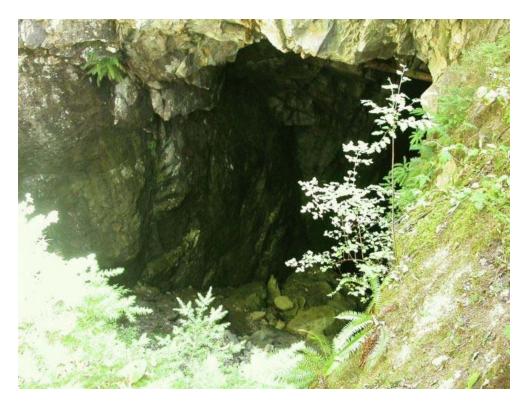
Photo 10. Collapsed Stope 2 open to surface, view to southeast (photo by G. Graham, 7/30/2003).

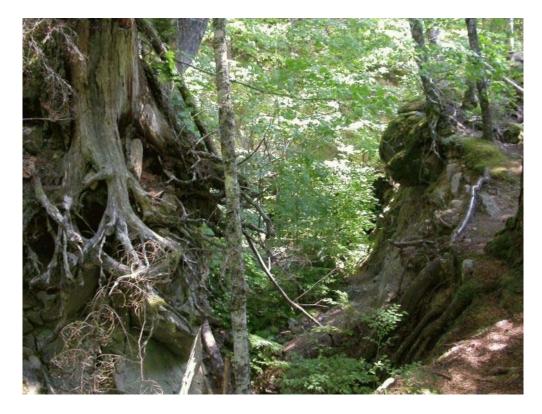
Photo 11. Surface expression of collapsed Stope 2 at surface, view to northwest (photo by G. Graham, 7/30/2003).
