ABBREVIATED PRELIMINARY ASSESSMENT

***Sidney Mine
in the
Monte Cristo Mining District***

Mount Baker-Snoqualmie National Forest
Darrington Ranger District
Snohomish County, WA

September, 2006

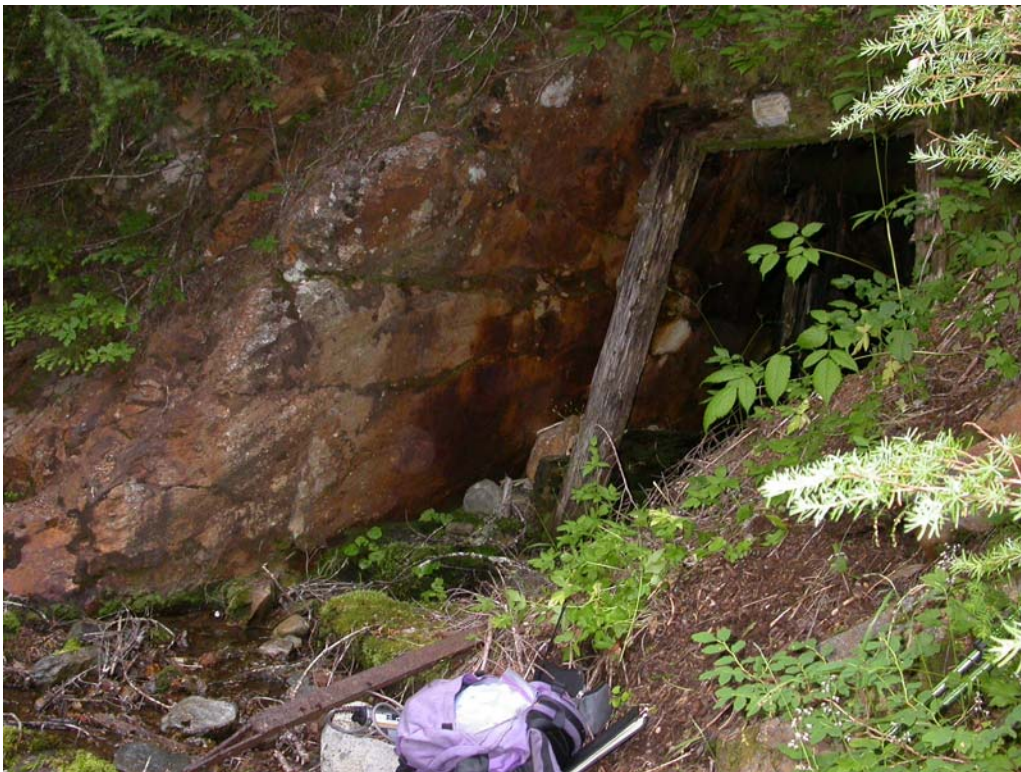
Cover Photo: Portal of the Sidney Mine adit.

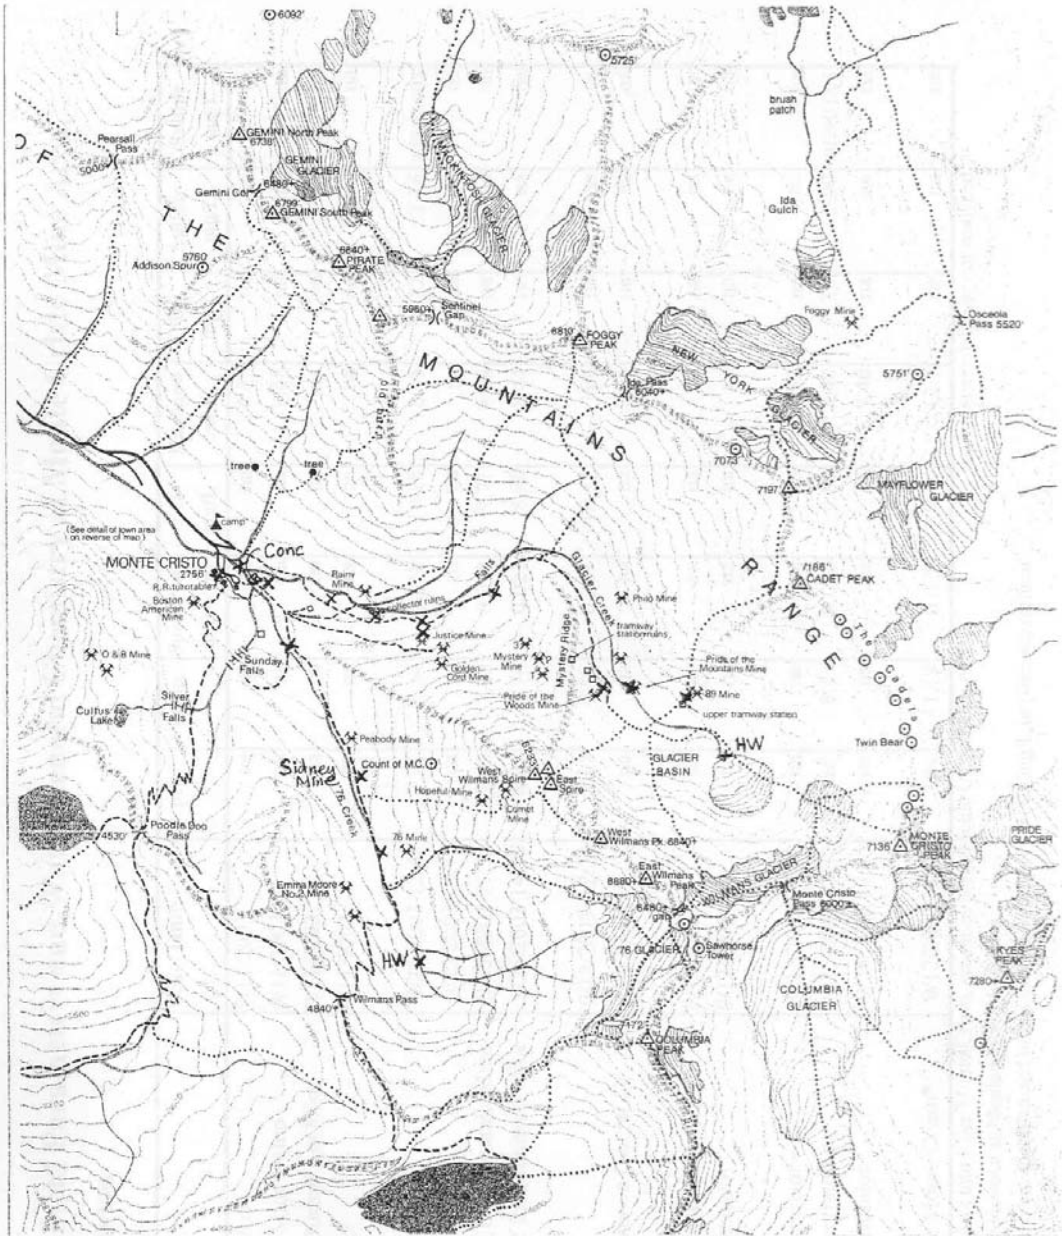
Figure 1. Monte Cristo Mine Area, Snohomish County, Washington
 Figure shows mine locations, sample locations (X), creek headwater locations (HW), concentrator (conc) and general topography. Scale is 1 inch = 1750 feet or 0.3 mile.

X = sample location
 Conc = Concentrator location
 HW = Headwater of creek sample location

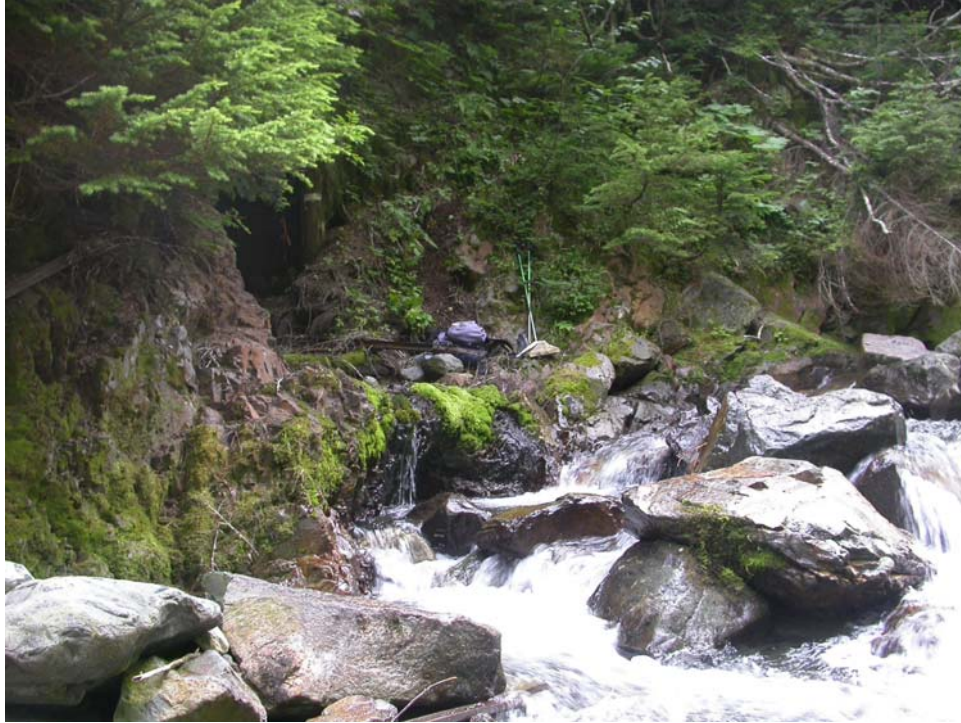
- The mine adit is open at the portal and located immediately adjacent to 76 Creek on the northeast side of the creek (Appendix E-1, Photo1).
- Mine effluent discharges from the adit at approximately 2-3 gallons per minute into 76 Creek (Appendix E-1, Photo 2). The drainage is clear and there is no discoloration of the discharge path substrate.

Photo 1. View along 76 Creek towards the portal of the Sidney Mine. Note mine discharge directly into 76 Creek, view to the southeast (photo by G. Graham, 8/3/2006).

Abandoned or inactive mine workings should be closed to limit potential liability associated with the general public recreating at the Site.

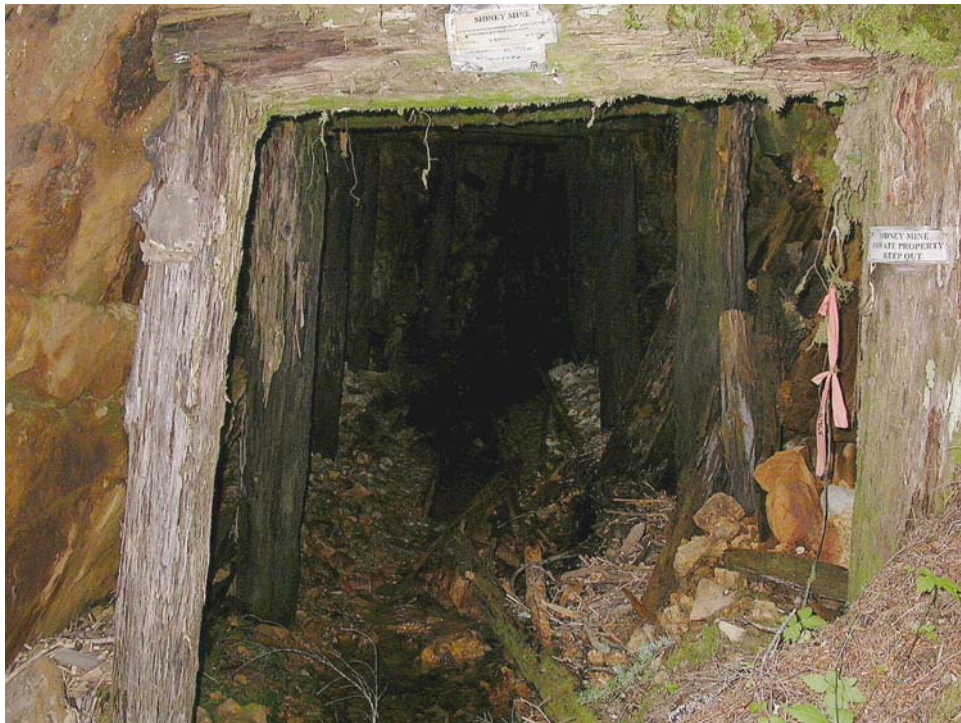
Photo 2. Close-up of mine portal at the Sidney Mine, view to the northeast (photo by G. Graham, 8/3/2006).

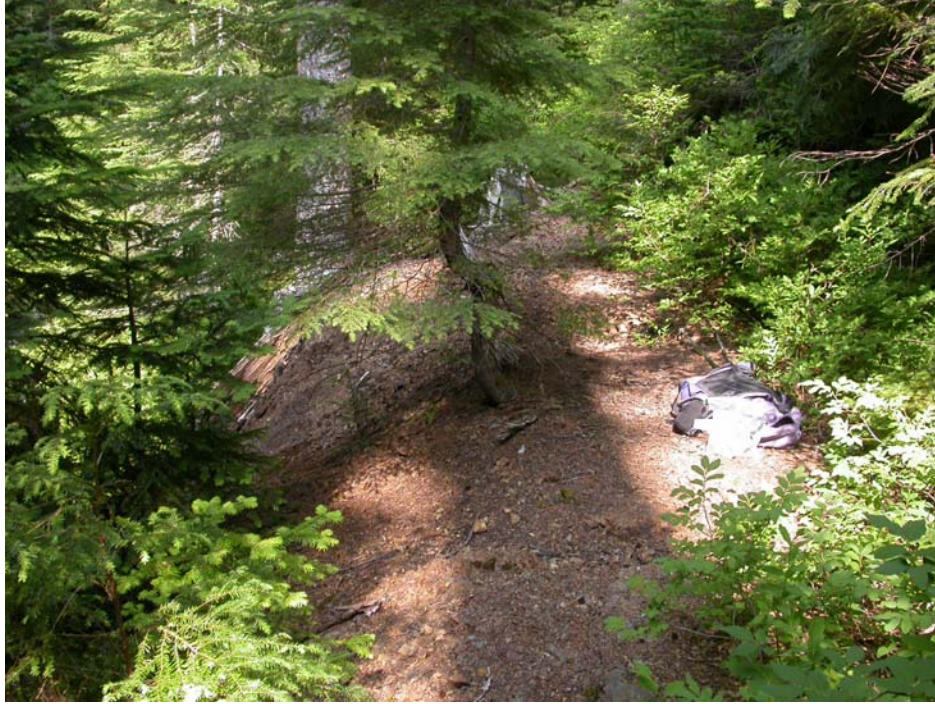
- Waste rock was brought out of the mine on rails and side cast on steep side slopes immediately adjacent to 76 Creek (Appendix E-2, Photos 3 and 4).
- The waste rock dump is fairly well vegetated with shrubs and small trees and is roughly estimated at approximately 200 LCY (Appendix E-2, photos 3 and 4).
- The majority of the waste rock dump at depth comprises ferricrete which forms when waste material has been cemented by iron oxides (Appendix E-3, Photo 5).
- 76 Creek has eroded and will continue to erode waste rock from the toe of the dump (Appendix E-2, Photo 4).
- A significant amount of rails and other mining-related equipment has accumulated in 76 Creek just downstream from the mine (Appendix E-3, Photo 6).

Photo 3. Top of waste rock dump at the Sidney Mine. Waste rock was brought out of the mine on rails and side cast into and immediately adjacent to 76 Creek. Note that shrubs and trees are growing fairly well on the dump, view to the northwest (photo by G. Graham, 8/3/2006).

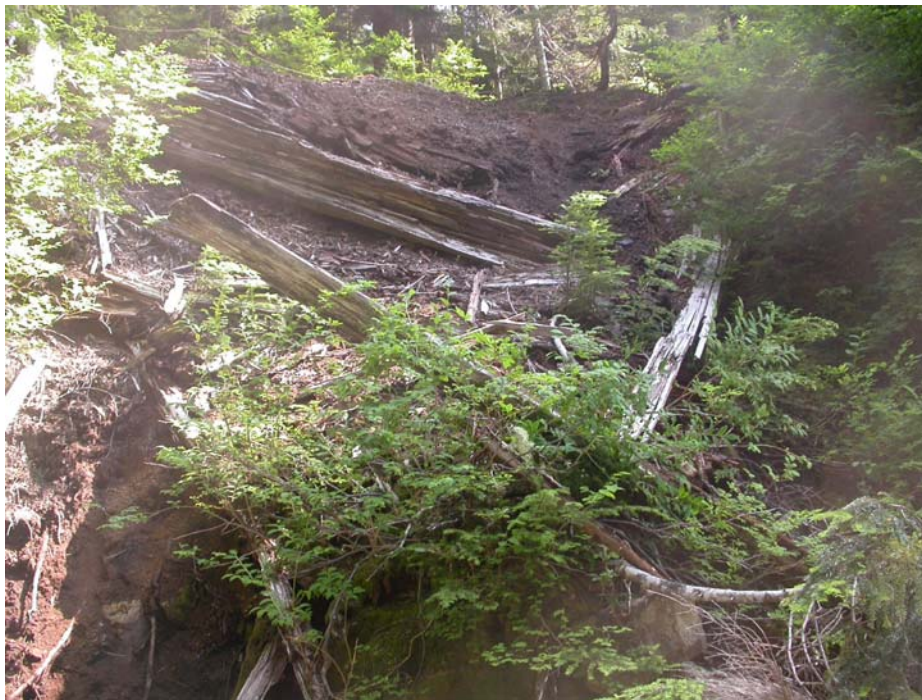
Photo 4. Sidney Mine waste rock dump as viewed from 76 Creek looking towards Photo 3. Note slumping of material as a result of 76 Creek eroding into the toe of the dump, view to the northeast (photo by G. Graham, 8/3/2006).

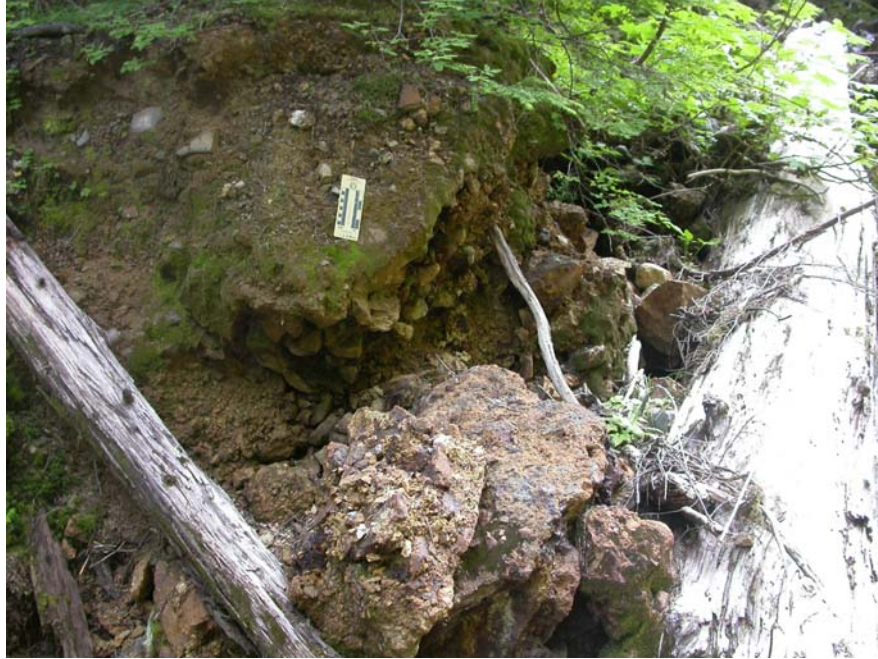
Photo 5. The majority of the Sidney mine waste dump comprises ferricrete which forms when waste material has been cemented with iron oxides into rock, view to the southeast (photo by G. Graham, 8/3/2006).

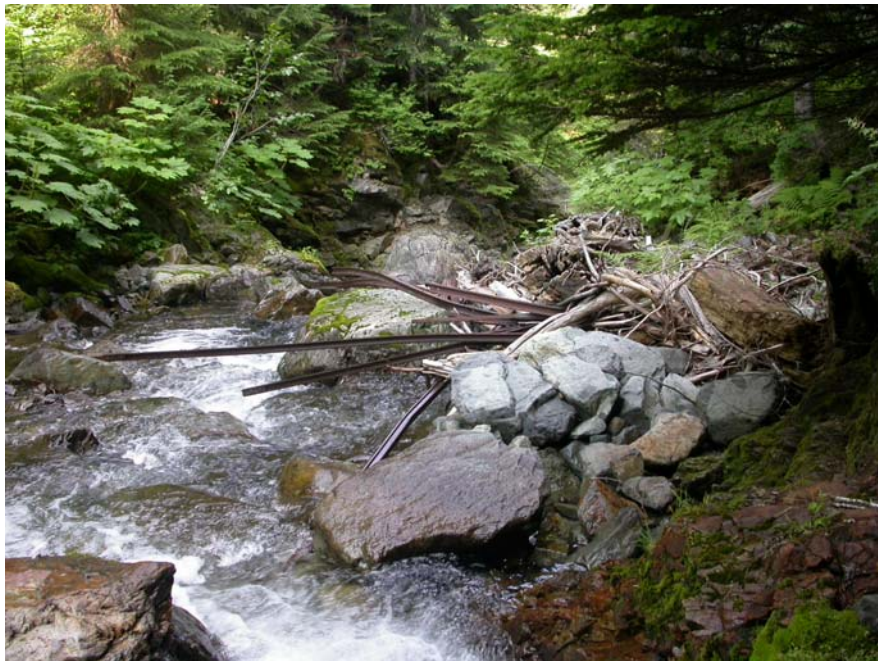
Photo 6. Rails and other mining debris from the Sidney Mine located in 76 Creek immediately downstream of the adit and waste rock dump, view to the northwest (photo by G. Graham, 8/3/2006).
