North Anna 2 RPV Head Non Destructive and Destructive examinations

RPV Head Working Group

March 22, 2004

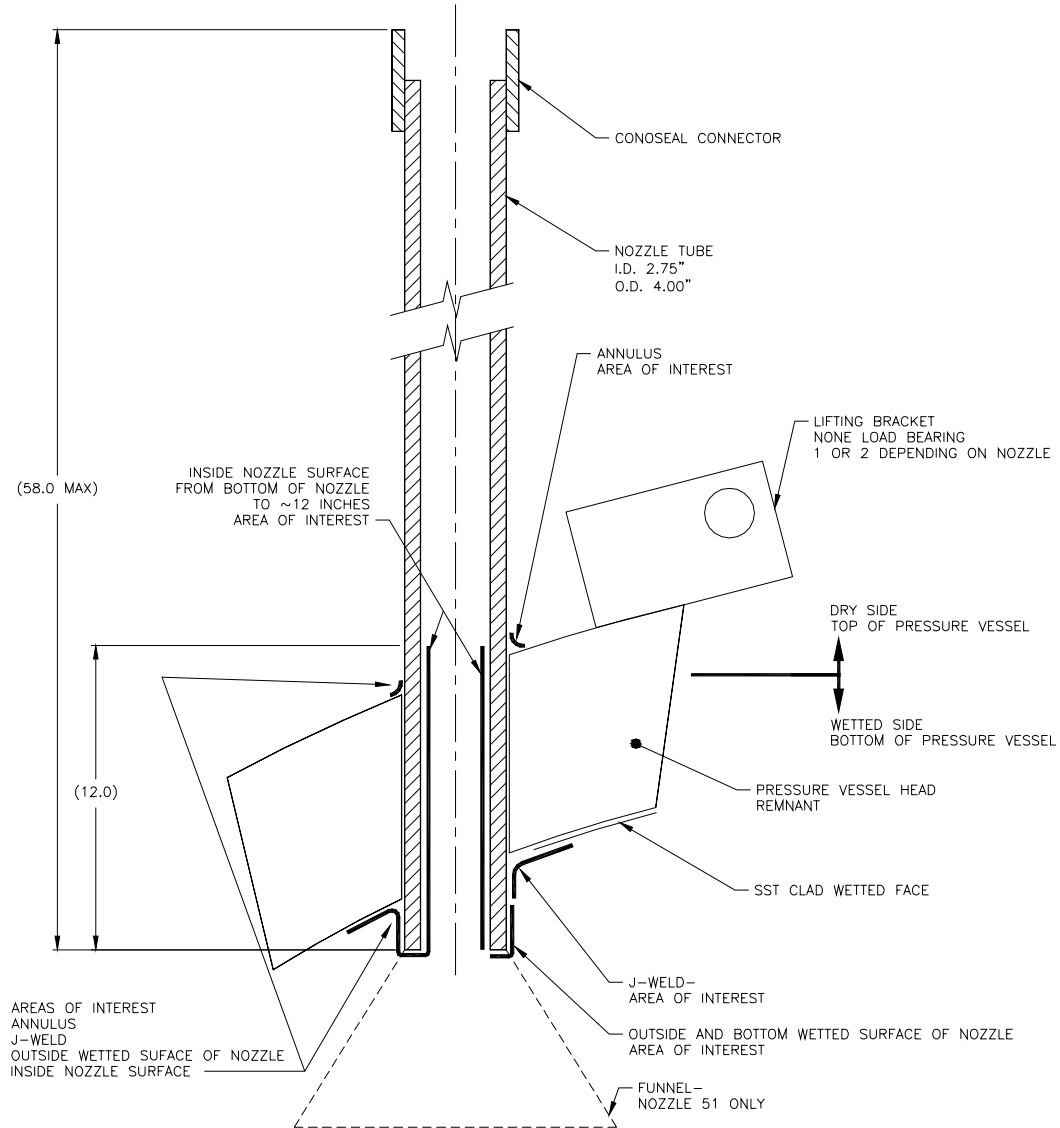
Areas of Interest

CRDM Penetrations Preparations

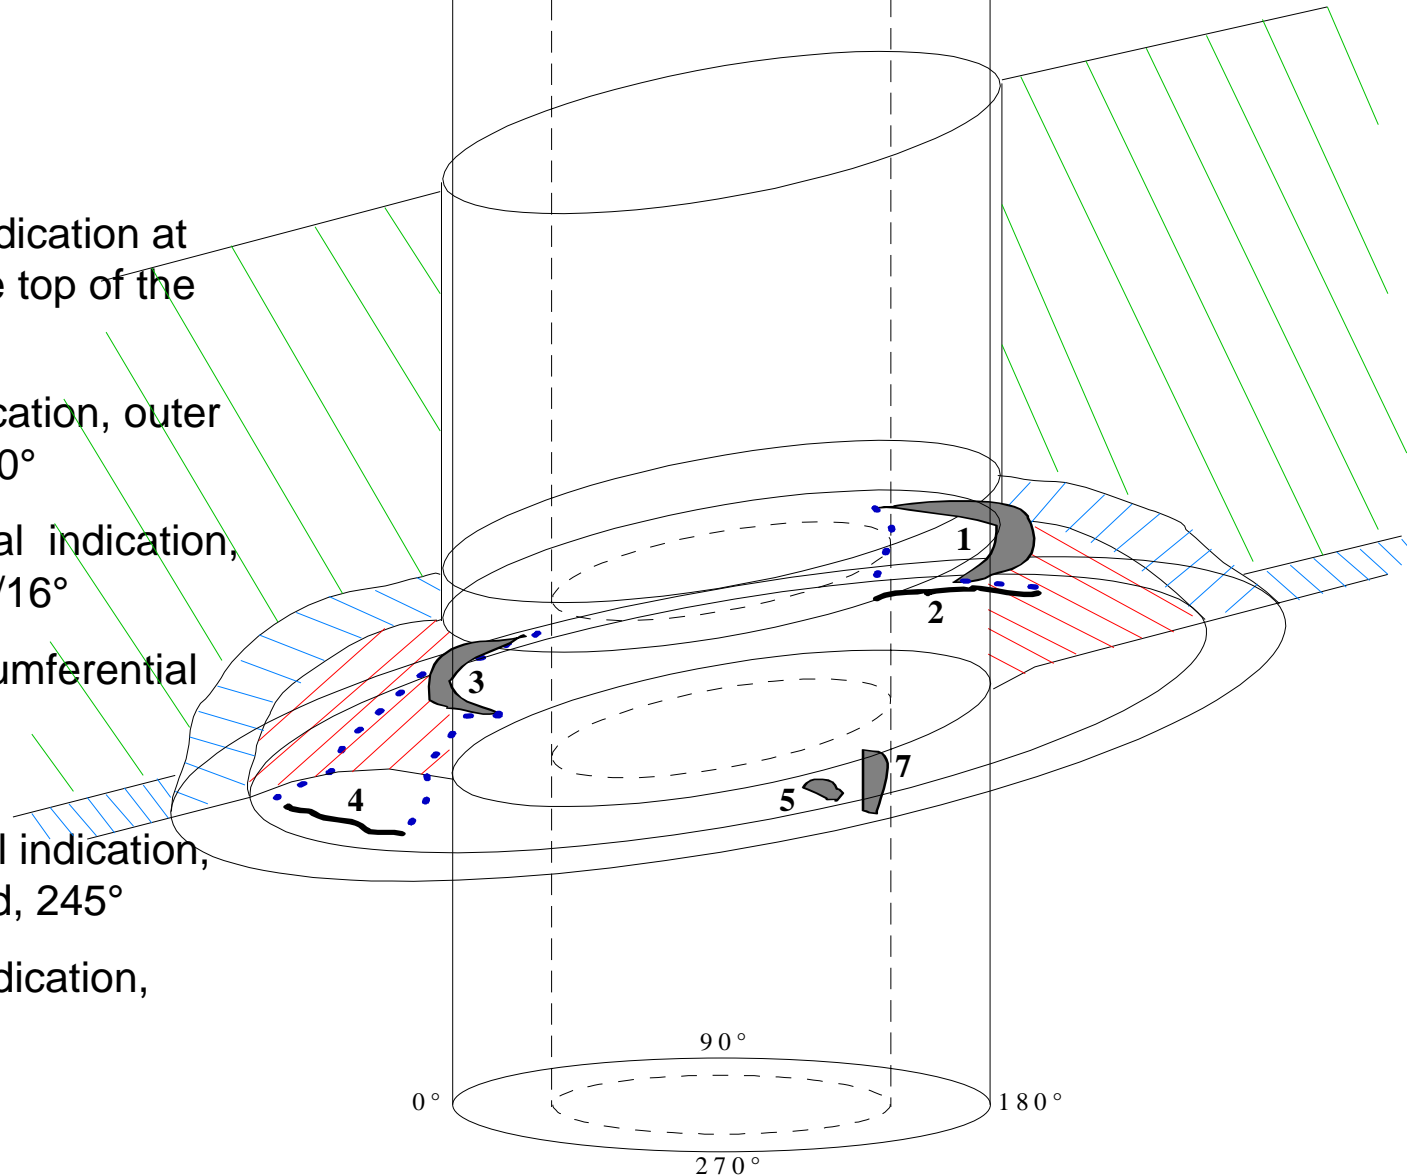
Penetration 54:

Visual : no leak

UT 1: circumferential indication at the nozzle OD, near the top of the weld, 119/198°

ET 2: weld surface indication, outer half of the weld, 115/140°

UT 3: OD circumferential indication, middle of the weld, 344/16°

ET 4: weld surface circumferential indication, outer portion of the weld, 333/353°

ET 5: weld surface axial indication, outer portion of the weld, 245°

ET 7: axial nozzle ID indication, below the weld, 200°

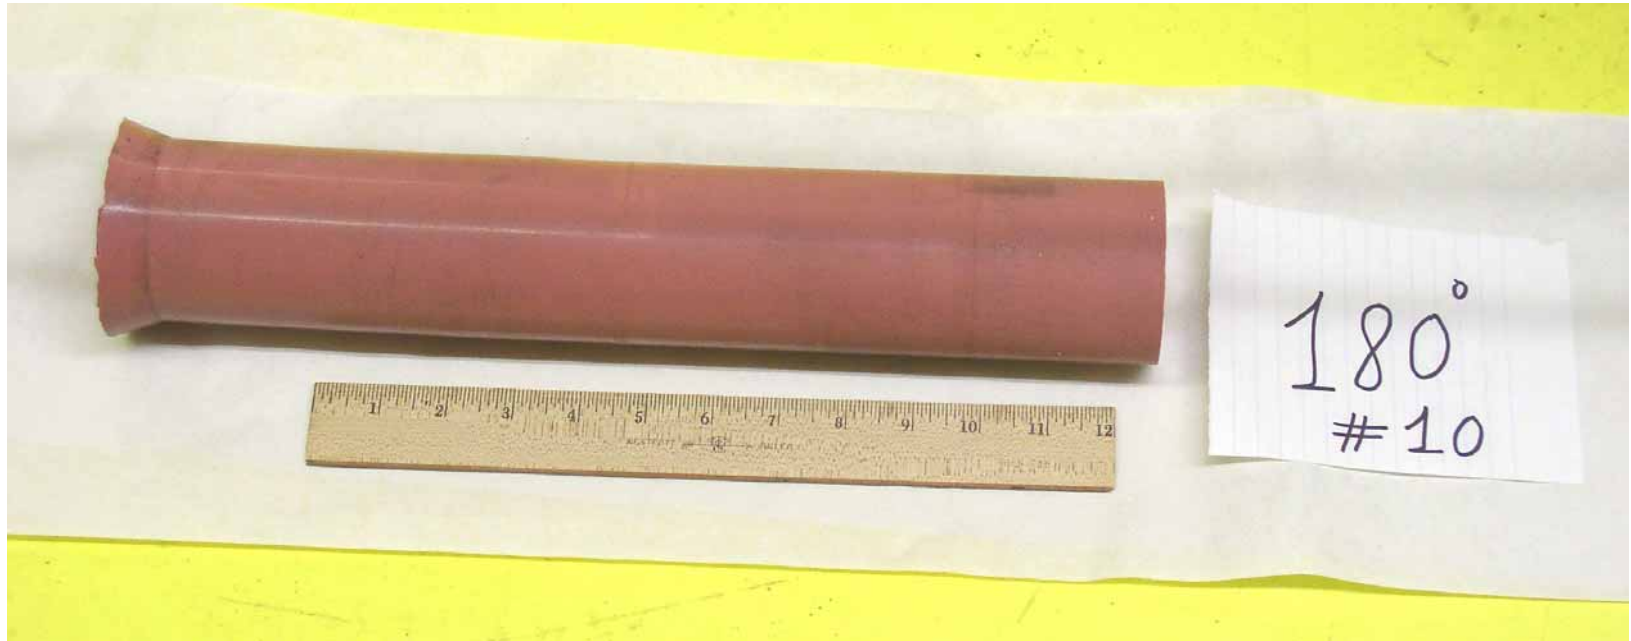
Finished Mold

- Provides information on inside features such as:
 - Deformation and ovality that could be used for residual stress calculations from assembly and welding operations
 - Surface defects such as machine marks (possibly even surface cracks)
- Allows correlation of penetration geometry with spatial position
- Highly accurate molds (micron level)
