Expanded Site Inspection Report

**Palestine Light, Heat and Power Company Site
Palestine, Anderson County, Texas
TXD981912421**

**Texas Commission on Environmental Quality
Superfund Site Discovery and Assessment Program
Austin, Texas**

June 2004

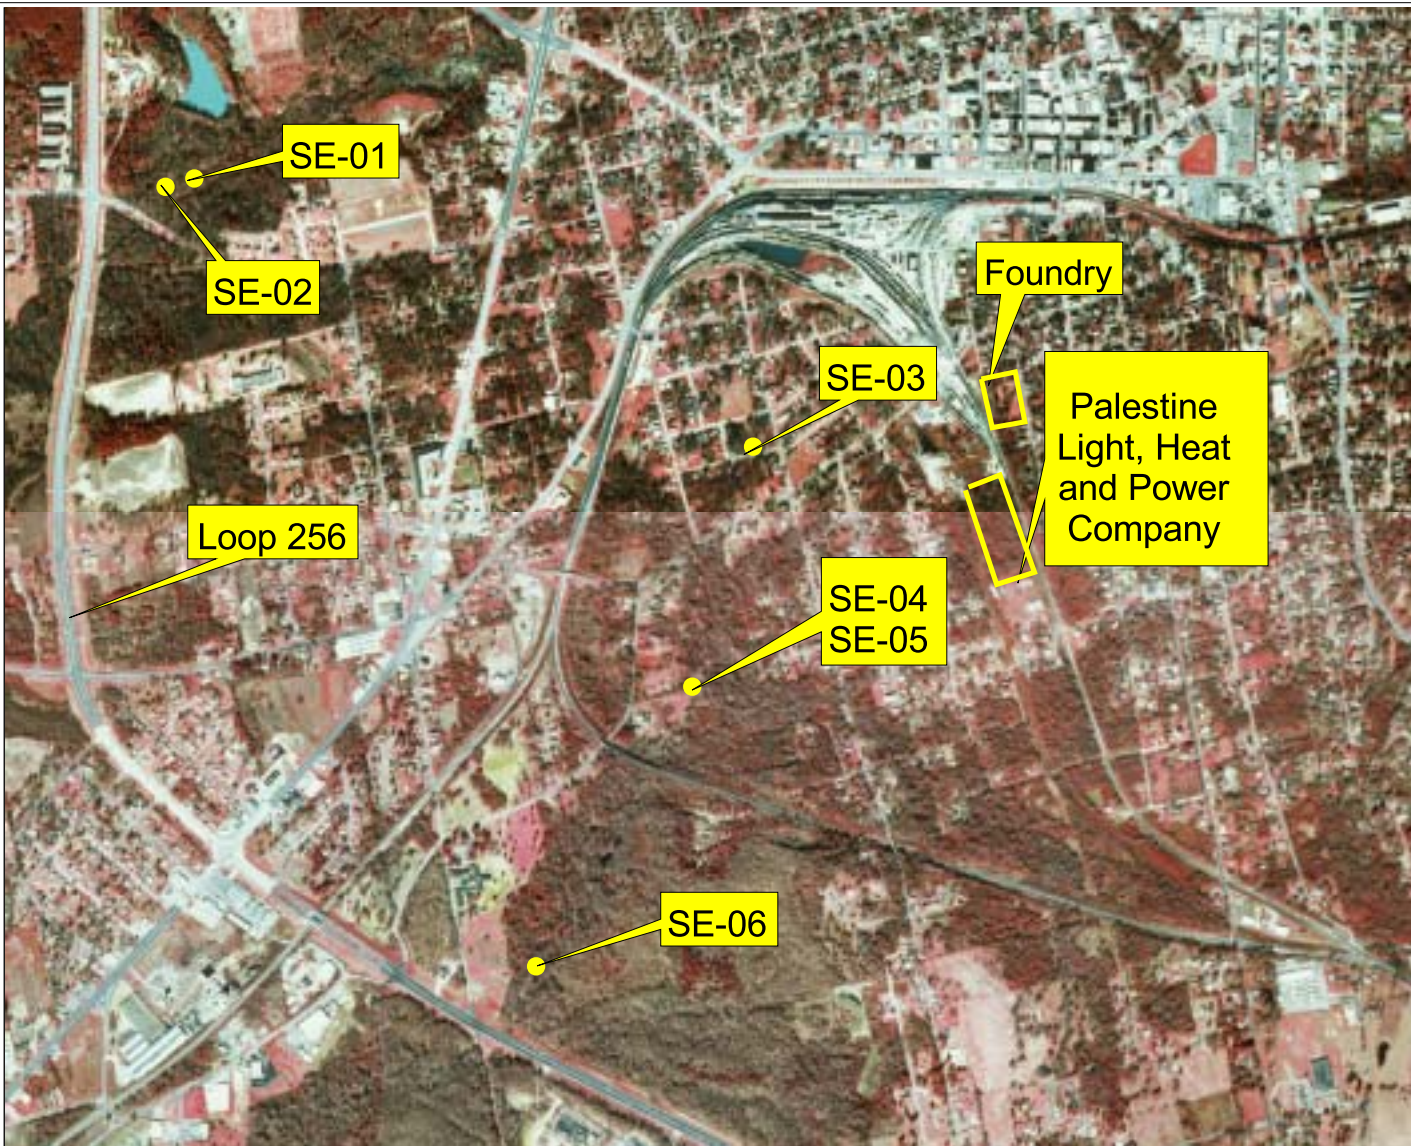
**Sediment Sample
Location Map**

Four (4) sediment samples including a duplicate were collected from Town Creek to substantiate the release of hazardous substances along the surface water migratory pathway and to assess potential receptor targets. Selected sample locations are shown in Figure 4.

Sediment sample SE-03 was a grab sample collected at "0-4" deep along Town Creek north of Giraud Street using a clean, dedicated stainless steel bowl and spoon. Sample locations are shown in Figure 4. Sampling conditions encountered and depth were documented in the Field Log Book at each sample location (Ref. 28, p. 73).

Sediment samples SE-04 and SE-05 (duplicate sample) were grab samples collected from 0"-6" deep from Town Creek, access from 1504 West Reagan Street using a clean, dedicated stainless steel bowl and spoon. Sample locations are shown in Figure 4. Sampling conditions encountered and sample depth were documented in the Field Log Book at each sample location (Ref. 28, p. 75).
