Screening Site Inspection Report

**Palestine Light, Heat and Power Company Site
Palestine, Anderson County, Texas
TXD981912421**

**Texas Commission on Environmental Quality
Superfund Site Discovery and Assessment Program
Austin, Texas**

November 2003

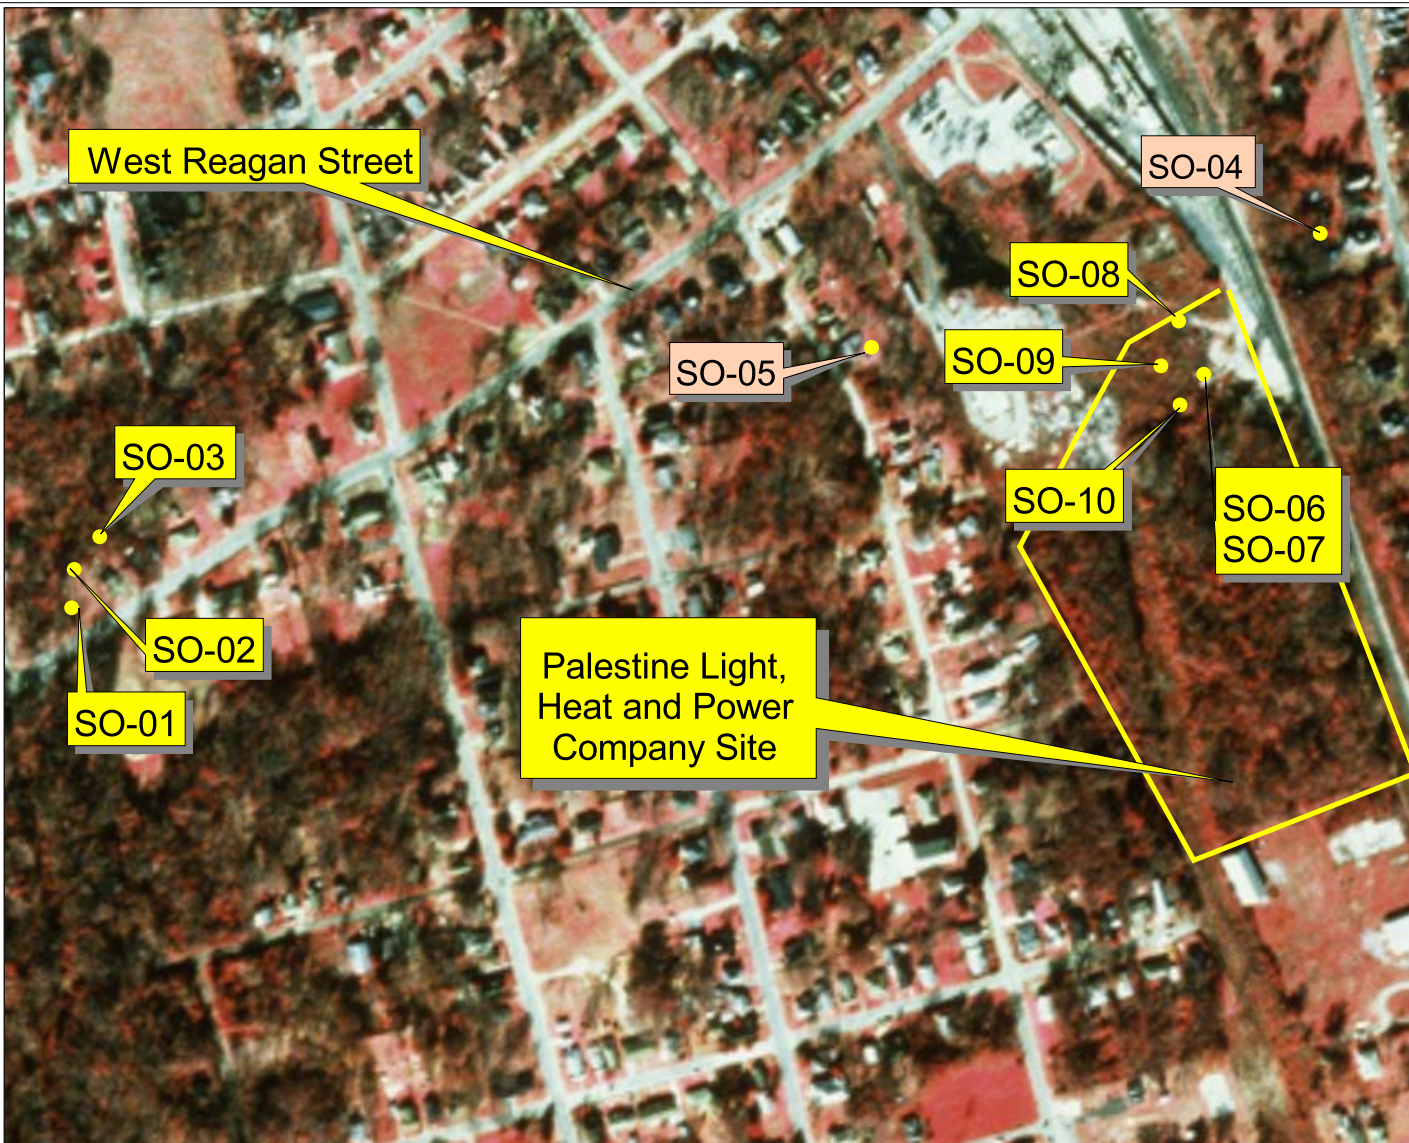
Source samples SO-6 through SO-10 were all grab samples collected 3"- 6" deep from the soils located adjacent to a potential source area (contaminated soil) using a clean dedicated stainless steel spoon and bowl. Sample locations are shown in Figure 3. A Global Positioning Satellite (GPS) instrument was used to record the geographic coordinates at each sample location. Sample locations were selected at the lowest area visibly observed adjacent to the potential source area where surface water would normally accumulate (Ref. 6, pp. 45-51).

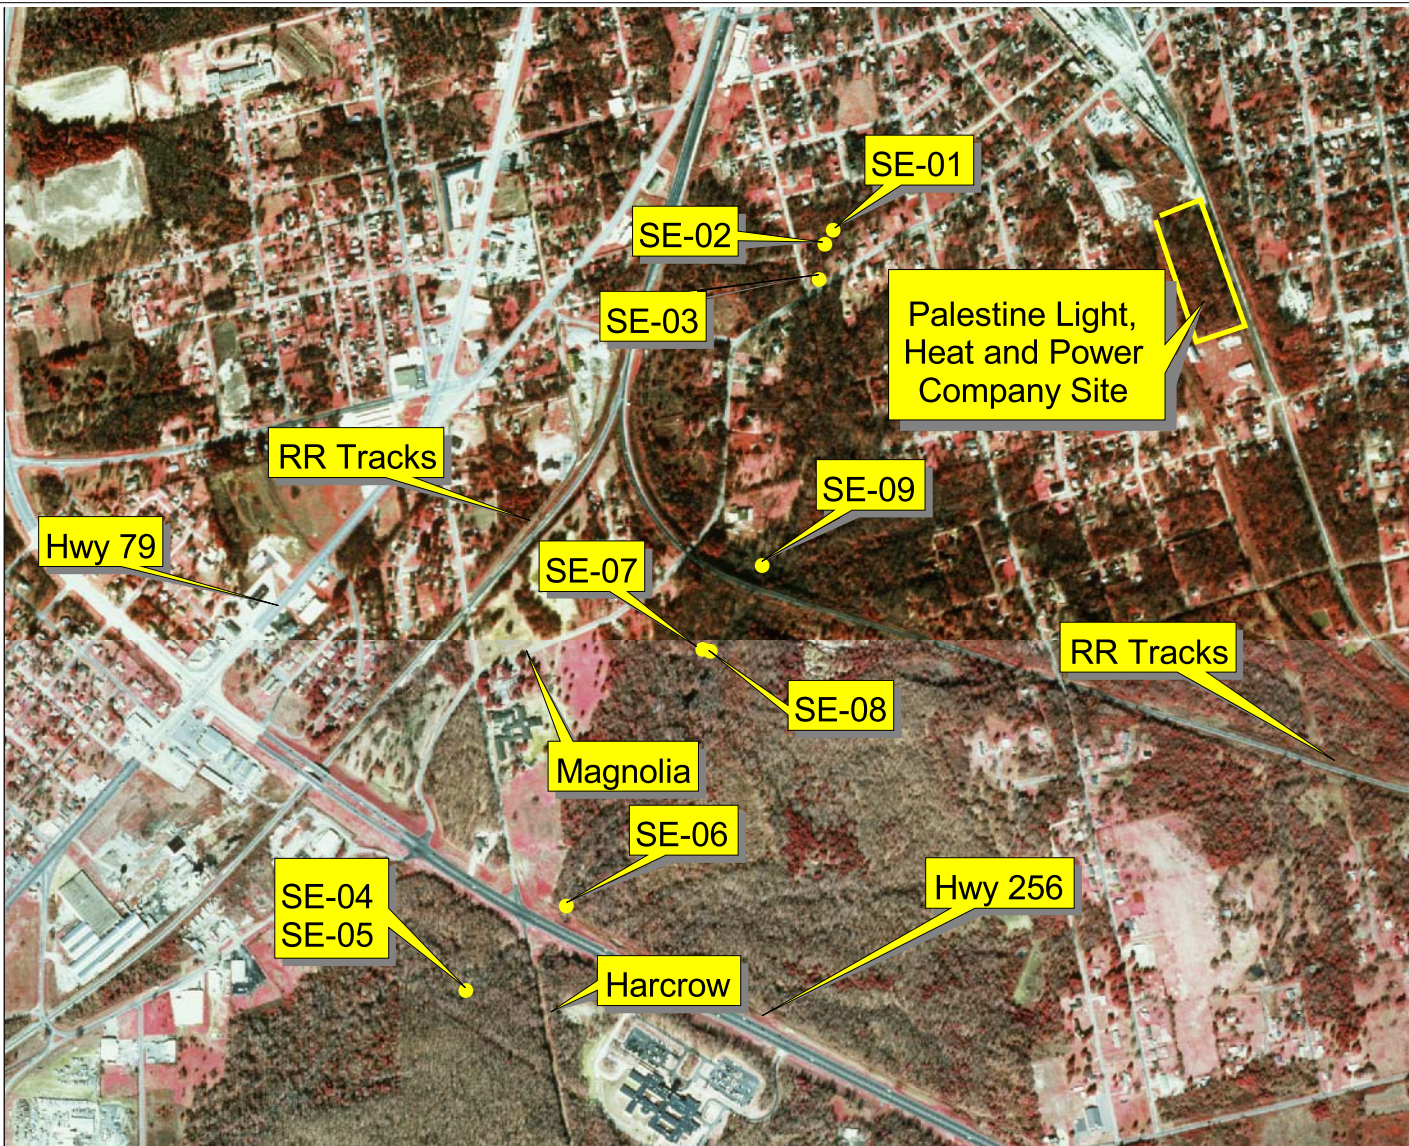
**Sediment Sample
Location Map**

Sediment samples SE-04 and SE-05 (duplicate sample) were grab samples collected from 3"-5" deep from the most downstream location, south of Highway 256 using a clean, dedicated stainless steel bowl and spoon. Sample locations are shown in Figure 4. Sampling conditions encountered and sample depth were documented in the Field Log Book at each sample location (Ref. 6, p. 17).

Sediment sample SE-07 was a grab sample collected at 4"-6" deep along Town Creek at the PPE to the PFO1A wetland using a clean, dedicated stainless steel bowl and spoon. Sample locations are shown in Figure 4. Sampling conditions encountered and depth were documented in the Field Log Book at each sample location (Ref. 6, p. 21).

Sediment sample SE-08 was a grab sample collected at 6"-8" deep along Town Creek at the PPE to the PFO1A wetland using a clean, dedicated stainless steel bowl and spoon. Sample locations are shown in Figure 4. Sampling conditions encountered and depth were documented in the Field Log Book at each sample location (Ref. 6, p. 23).

PFO1A wetland using a clean, dedicated stainless steel bowl and spoon. Sample locations are shown in Figure 4. Sampling conditions encountered and depth were documented in the Field Log Book at each sample location (Ref. 6, p. 25).

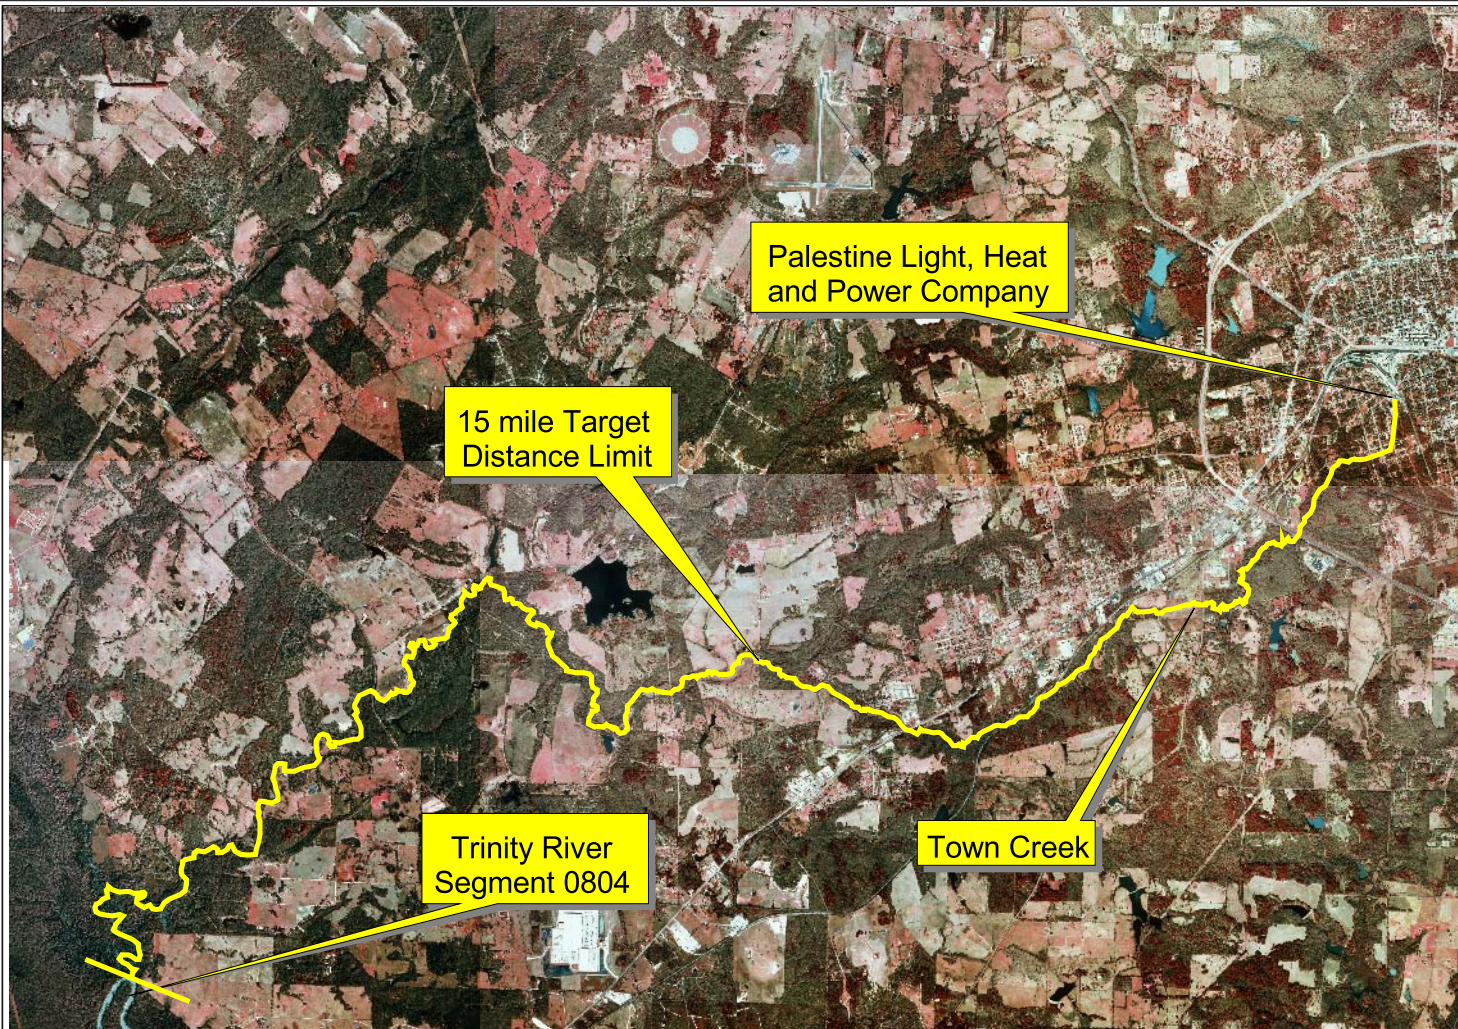
**Surface Water
Pathway Map**

The base data used is the NW and NE SW Palestine, the SW and SE NW Palestine, SE Tennessee Colony, and the NE Long Lake Digital Orthophoto Quadrangles (DOQs) which is a digital version of an aerial photograph. This DOQ was produced by the TCEQ using USGS guidelines. UTM NAD 83 Zone 15
