2 Background on Tornadoes and History of the Storm

This chapter presents both a history of the May 3, 1999, tornadoes as they affected Oklahoma and Kansas and insight into the interaction between a tornado and a populated area. The Fujita scale for classifying tornado damage is presented in this chapter. A discussion on tornadoes and tornado damage is also included.

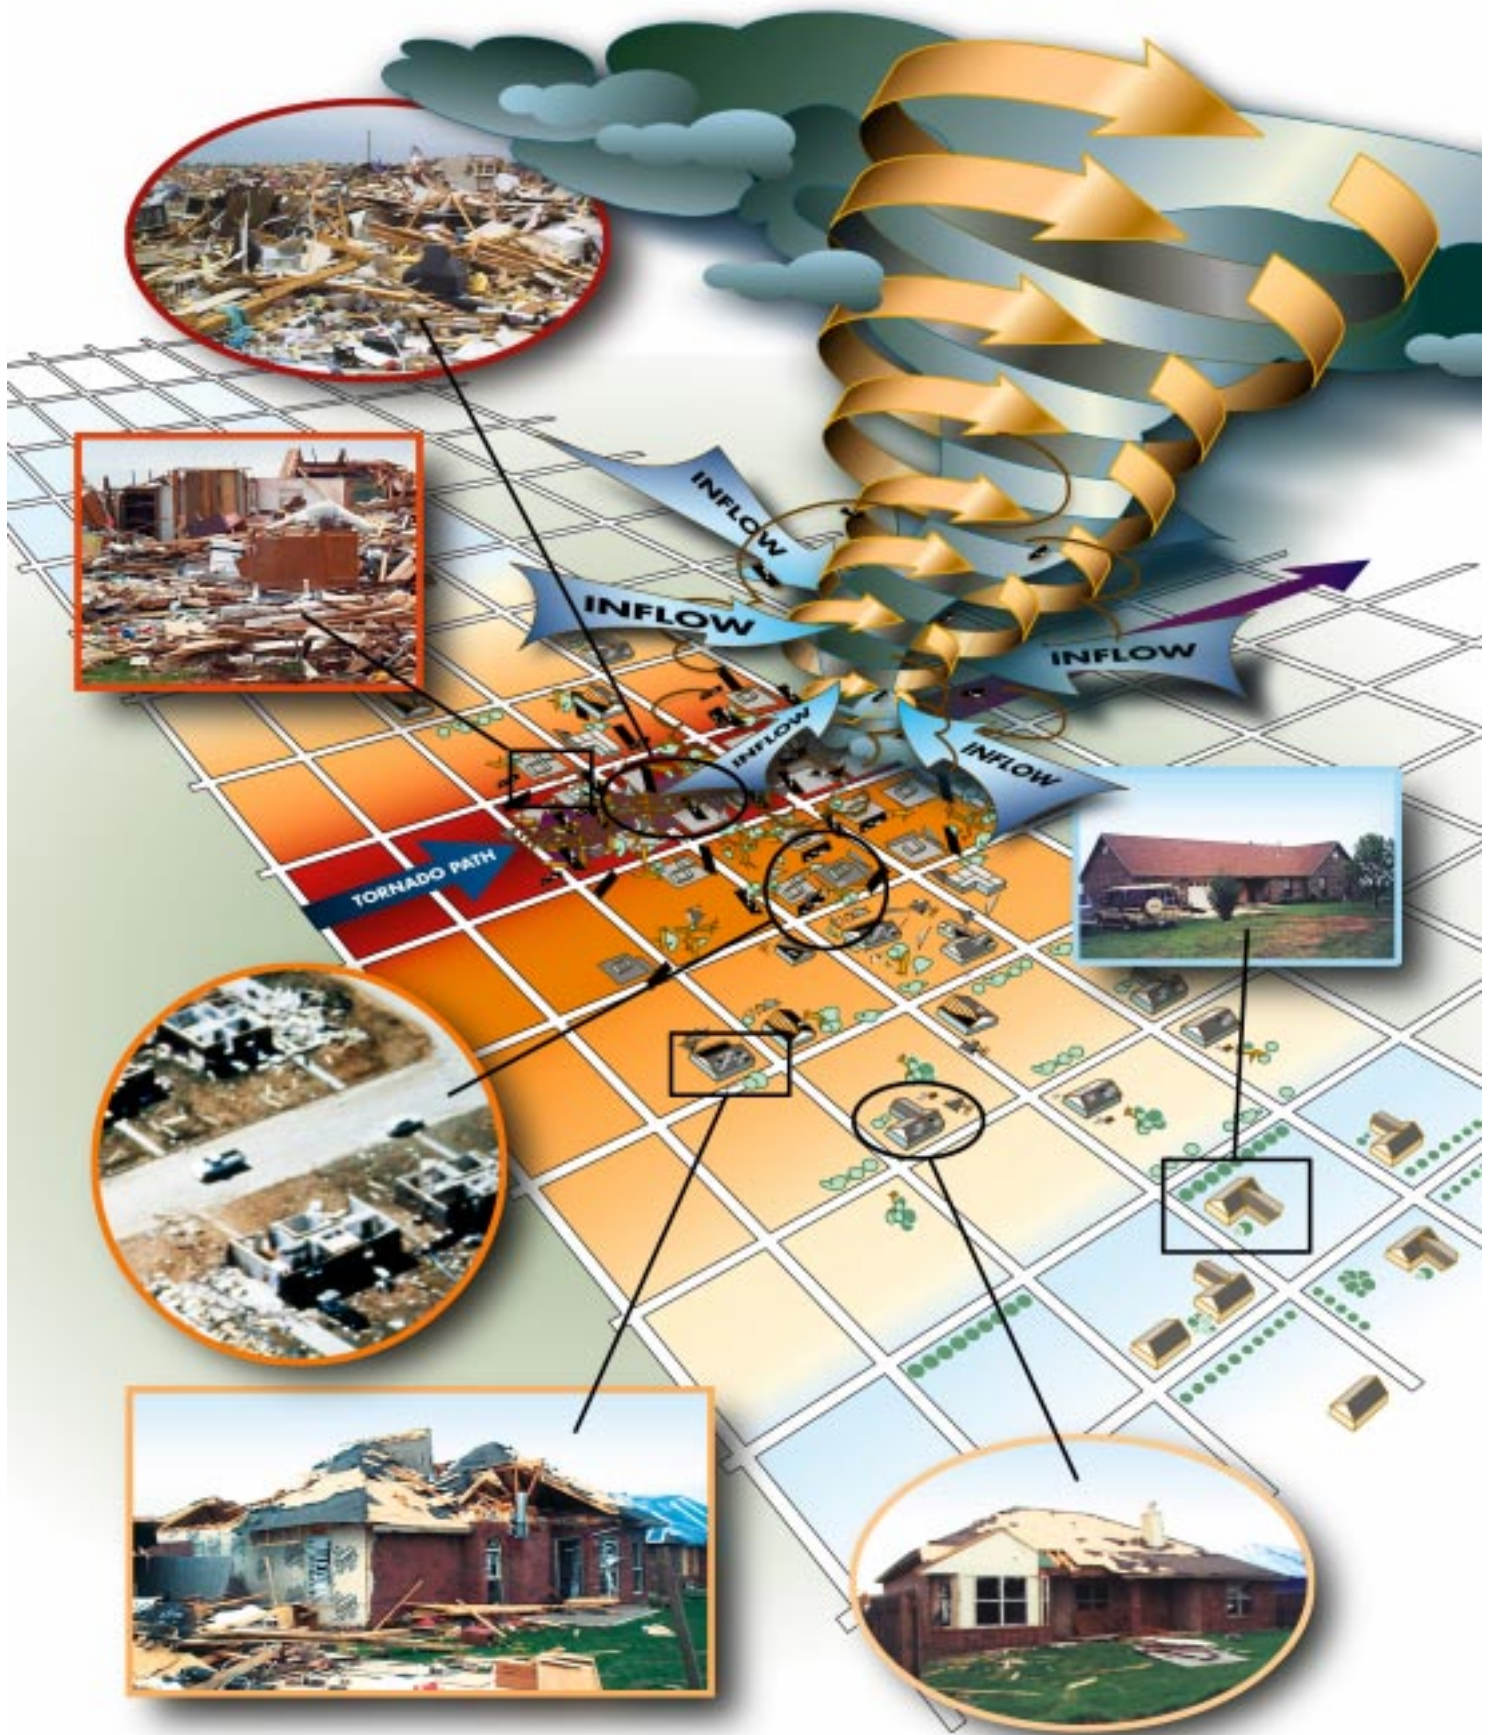
Figure 2-2: Impact of a

Impact of a Violent Tornado

Managing Risk	Damage Color Code	Description of Damage
<p>The Threat to Property and Personal Safety Can Be Minimized Through Compliance With Up-To-Date Model Building Codes and Engineering Standards</p>		Some damage can be seen to poorly maintained roofs. Unsecured light-weight objects, such as trash cans, are displaced.
		Minor damage to roofs and broken windows occur. Larger and heavier objects become displaced. Minor damage to trees and landscaping can be observed.
<p>Property and Personal Protection Can Be Improved Through Wind Hazard Mitigation Techniques Not Normally Required by Current Building Codes</p>		Roofs are damaged, including the loss of shingles and some sheathing. Manufactured homes, on nonpermanent foundations can be shifted off their foundations. Trees and landscaping either snap or are blown over. Medium-sized debris becomes airborne, damaging other structures.
		Roofs and some walls, especially unreinforced masonry, are torn from structures. Small ancillary buildings are often destroyed. Manufactured homes on nonpermanent foundations can be overturned. Some trees are uprooted.

<p>Personal Protection Can Only Be Achieved Through Use of a Specially Designed Extreme Wind Refuge Area, Shelter, or Safe Room</p>		Well constructed homes, as well as manufactured homes, are destroyed, and some structures are lifted off their foundations. Automobile-sized debris is displaced and often tumbles. Trees are often uprooted and blown over.
		Strong frame houses and engineered buildings are lifted from their foundations or are significantly damaged or destroyed. Automobile-sized debris is moved significant distances. Trees are uprooted and splintered.

Figure 2-2 shows the types of damage that can be caused by a violent tornado similar to the one that passed through the Oklahoma City Metroplex on May 3, 1999. In general, as shown in the figure, the severity of the damage varies with distance from the vortex. Note, however, that the rotation of a tornado can cause winds flowing into the vortex on one side to be greater than those on other sides. As a result, it is not uncommon for the area of damage on one side of the tornado to be more extensive. Figure 2-2 reflects this situation.

In a violent tornado, the most severe damage occurs in the area directly affected by the vortex (the area shaded dark red [dark gray] in Figure 2-2).

Typically, in this area, all buildings are destroyed and trees are uprooted, debarked, and splintered. In the immediately adjacent area, shaded orange [medium gray] in the figure, buildings may also be destroyed, but others may suffer less severe damage, such as the loss of exterior walls, the roof structure, or both. Even when buildings in this area lose their exterior walls and roof, interior rooms may survive. In the outer portion of this area, further from the vortex, damage to buildings affects primarily roofs and windows. Roof damage ranges from loss of the entire roof structure to the loss of all or part of the roof sheathing or roof coverings. Typically, most or all of the windows in buildings in this area will be broken by windborne debris. In the area shaded yellow [light gray], damage is again primarily to roofs and windows. However, roof damage is lighter, and although windborne debris damage still occurs here, not all windows are broken. Damage to buildings in the outer fringe of this area is even lighter. Beyond this area, where the figure shows blue shading, buildings typically suffer no damage.
