Results of Soil Sampling Along the Middle Rio Grande, 2006 Report

U.S. Department of the Interior
Bureau of Reclamation
Technical Service Center
Environmental Services Division
Fisheries and Wildlife Resources Group
Denver, Colorado

December 2007

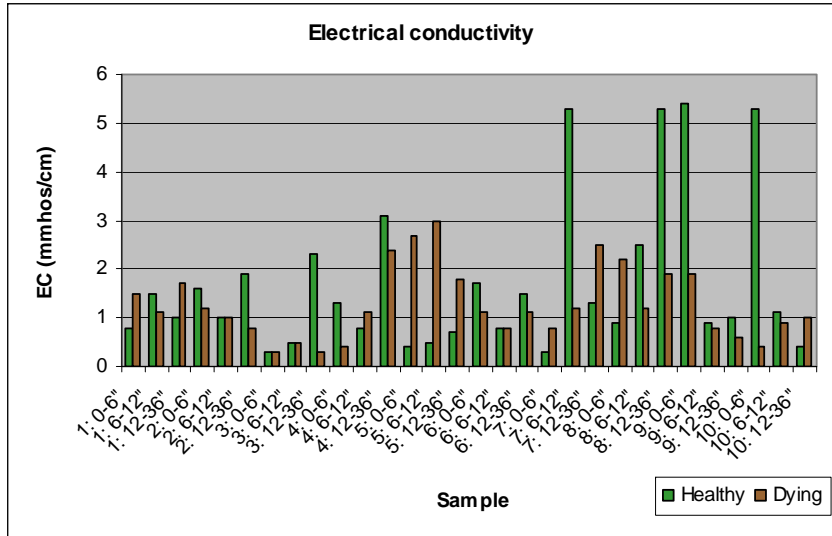
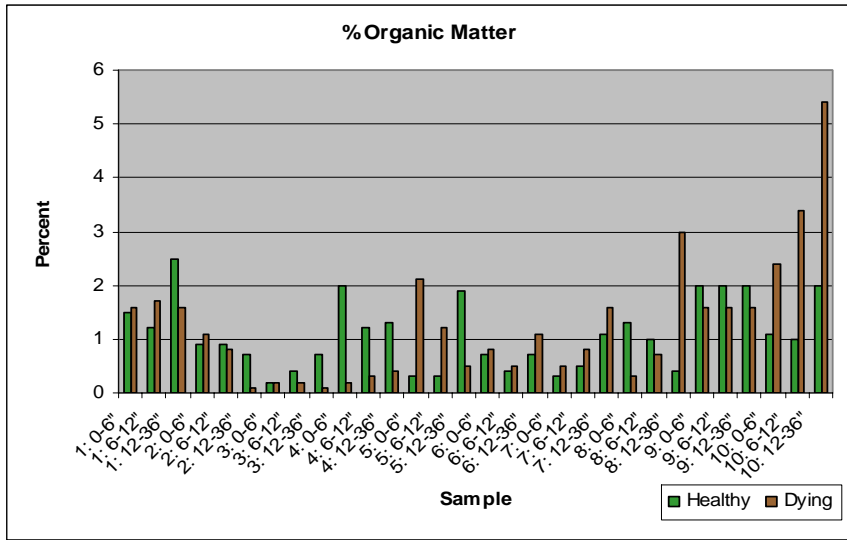
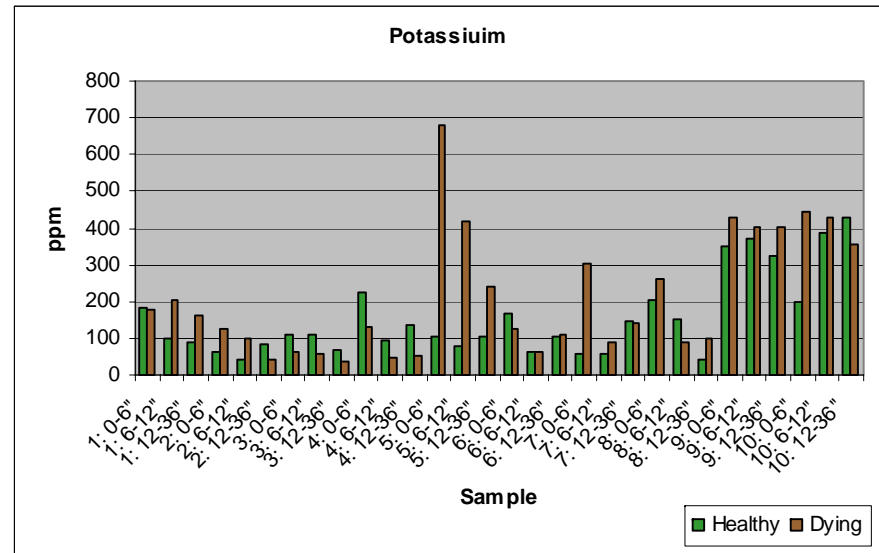
Sample Comparisons of Each Parameter

The laboratory results of the soil analyses are shown in Appendix A. Note that three of the values are highlighted; two in the $\text{NO}_3\text{-N}$ test results and one in the P test results. These values were outliers that were removed from statistical analysis. A series of graphs in Appendix B shows comparisons between plots with healthy and dying vegetation by sample for each parameter.

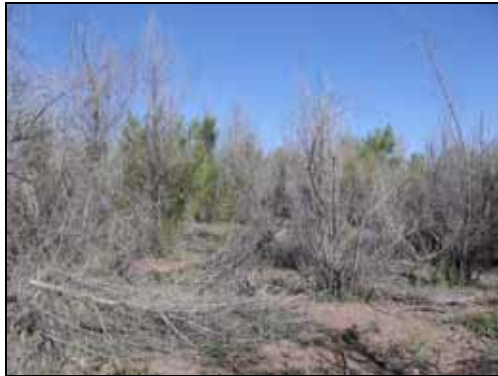
SS05D-Dying

- **Use a smaller diameter auger and collect more samples to form a composite sample at each plot site.** Sample SS05D had outlier values within the NO-N₃ and P test results. It was noted that this site showed signs of heavy cattle grazing (Table 1). It is possible that there was a concentration of urine in the sample, causing a huge spike in the amount of N and P collected. To avoid this spot variability, more samples (e.g., 5 to 10) could be collected using an auger with a 1 inch diameter. These samples could then be combined to a) make one composite
