**Monitoring Changes to Wetland and Riparian  
Vegetation Resulting from the February 13th,  
2005 Flood Event, Upper Gila River, Arizona**

**An Assessment Report  
from the National  
Wetlands Inventory  
Program**

December 2006

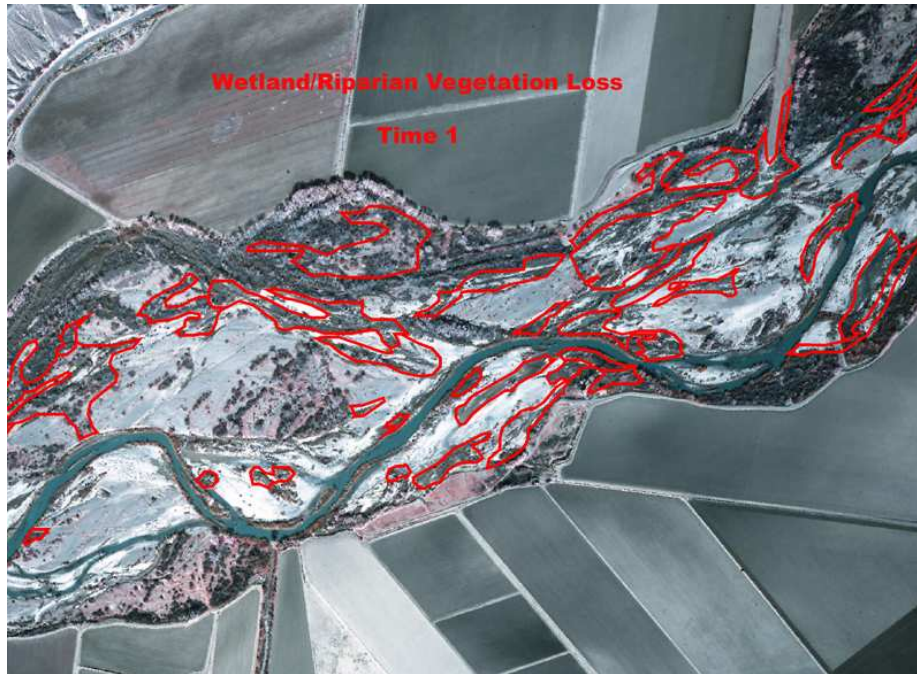
Figure 2. Upper Gila River floodplain, near Solomon, AZ, before (above) and after (below) the February 2005 flood. The areas outlined in red show the condition of the habitat at Time 1 for the areas altered by flooding prior to Time 2; the red areas on the lower photo show the absence of vegetation in these areas at Time 2. CIR aerial photography, 1:15,840 scale, January 18, 2005 (upper), May 19, 2005 (lower).

According to streamflow data there has not been a flood of this magnitude (February 2005 flood) since January 1995 (Appendix B.). This process has allowed the robust establishment of emergent and shrub wetland vegetation in/along the river channel and within older river channel scars. The imagery shows that these communities exhibited more of an impact from the flood waters (Figure 2.).

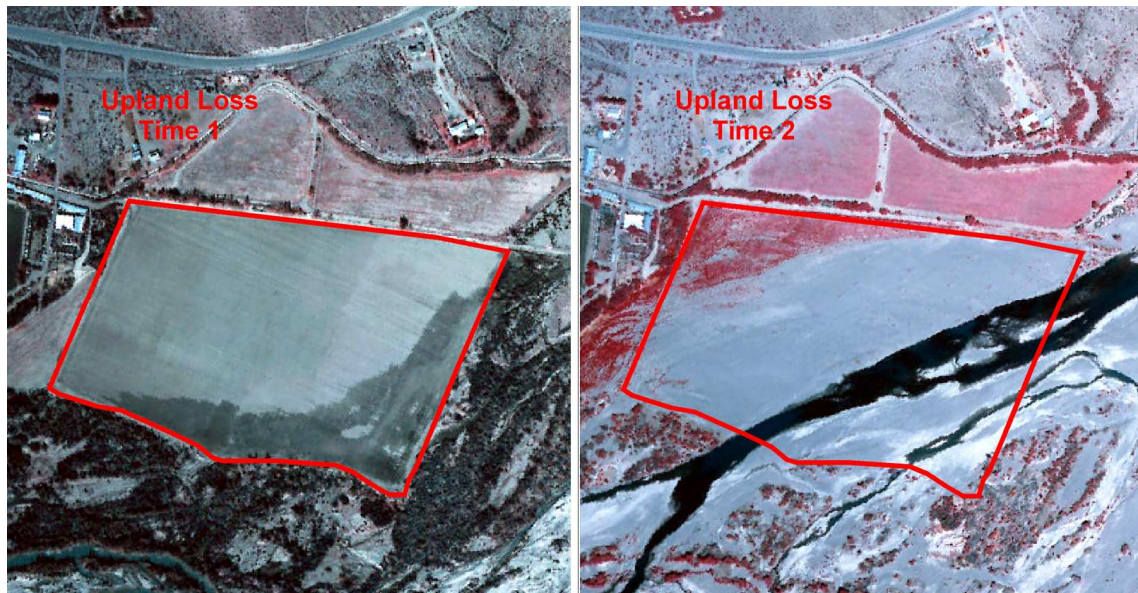
Figure 4. Upper Gila River floodplain, near Sanchez, AZ. Example of upland agriculture lost to channel change, as a result of the flood. CIR aerial photography, 1:15,840 scale, January 18, 2005 (left), May 19, 2005 (right).

There were two major areas of extensive erosional loss of uplands to riverine or unvegetated wetlands totaling 87.6 acres. Major losses occurred near Sanchez, Arizona (Figure 4.) and at a gravel mine within the floodplain, near Thatcher, Arizona, where tailings areas, levees and unpaved roads were washed away.
