Impact of Landslides and Innovative Landslide-Mitigation Measures on the Natural Environment

Robert L. Schuster and Lynn M. Highland

Geologic Hazards Team, U.S. Geological Survey, Denver, Colorado, U.S.A.

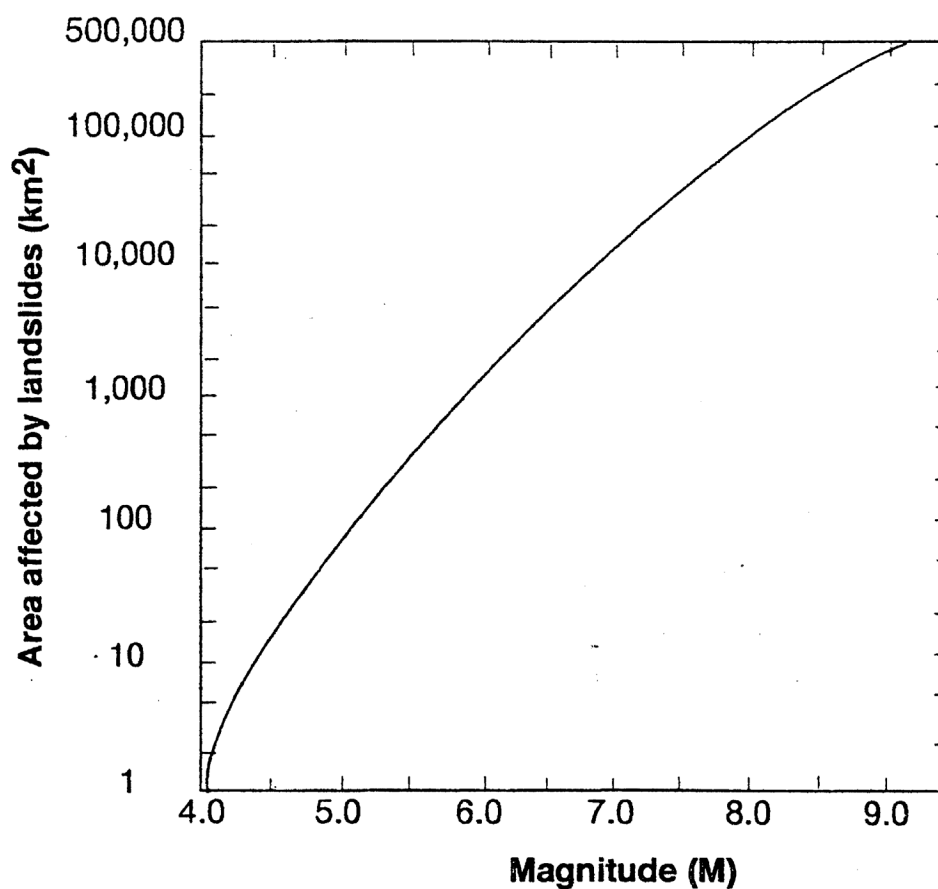
Fig. 1. Area affected by landslides triggered by earthquakes of different magnitudes (after Keefer, 1984)

The world's largest landslides are prehistoric, but their remains are displayed as significant morphologic features on the Earth's surface. Most very large landslides have been triggered by earthquakes or volcanic eruptions. In a study of 40 major historic earthquakes, Keefer (1984) has shown that landslides can be triggered over an area as large as 500,000 km² by a M=9.2 earthquake (Fig. 1).

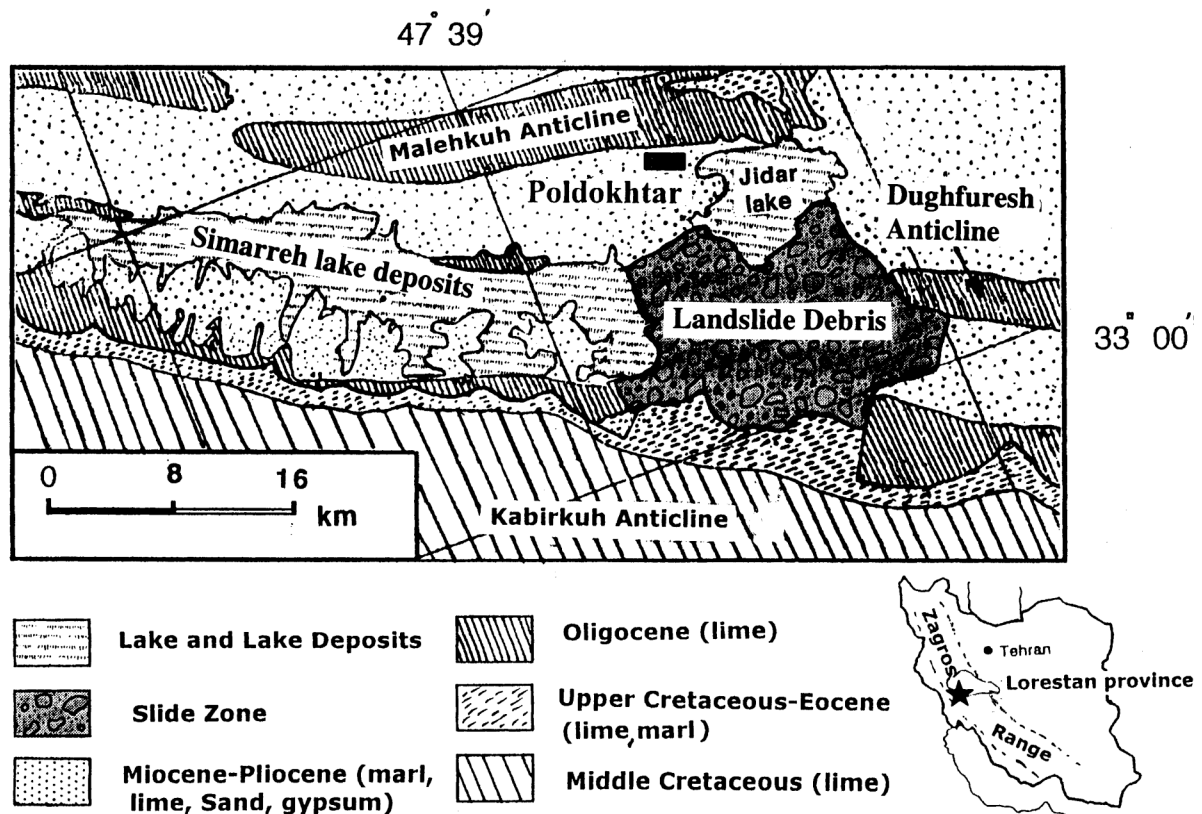
Fig. 2. Geologic map of the prehistoric Simareh (Seimareh, Saidmarreh) landslide in southwestern Iran, showing 40-km-long Simarreh Lake, which has been filled by lacustrine sediments to form a large dissected plain. Note that smaller Jaidar Lake was also impounded by the landslide and has also since been filled by sediment. Location of landslide within Iran is indicated on index map by star. (After Shoaei and Ghayoumian, 2000.)

Another huge prehistoric landslide that was probably earthquake-induced is the Simareh landslide in southwest Iran (Fig. 2) (Harrison and Falcon, 1938; Watson and Wright, 1969). Composed of limestone debris, this landslide, which occurred about 10,000-11,000 yrs B.P. (Watson and Wright, 1969; Ambraseys and Melville, 1982) has a surface area of 166 km² and an estimated volume of 24-32 km³, making it one of the world's largest subaerial landslides (Shoaei and Ghayoumian, 2000).

The aforementioned Simareh landslide in Iran provides the world's outstanding example of large-scale deposition of lacustrine sediment behind a landslide dam. Another excellent example was provided by the 1941 Tsao-Ling landslide dam on the Chin-Shui-Chi (river), central Taiwan, where 50 m of lacustrine sediments deposited in the impoundment caused severe siting problems for a proposed hydroelectric project planned for the bed of the lake after failure of the natural dam (Chang, 1984). The 1941 Tsao-Ling landslide also changed the gradient of the Chin-Shui-Chi. After failure of the natural dam, the gradient of the river bed upstream from the knickpoint was 1.1 percent, whereas downstream it was 7.6 percent. Interestingly, another major landslide formed a new natural dam at the site in 1999. Man-made remedial measures preserved this dam so that there now is a permanent impoundment at the site (Schuster and Throner, 2000).

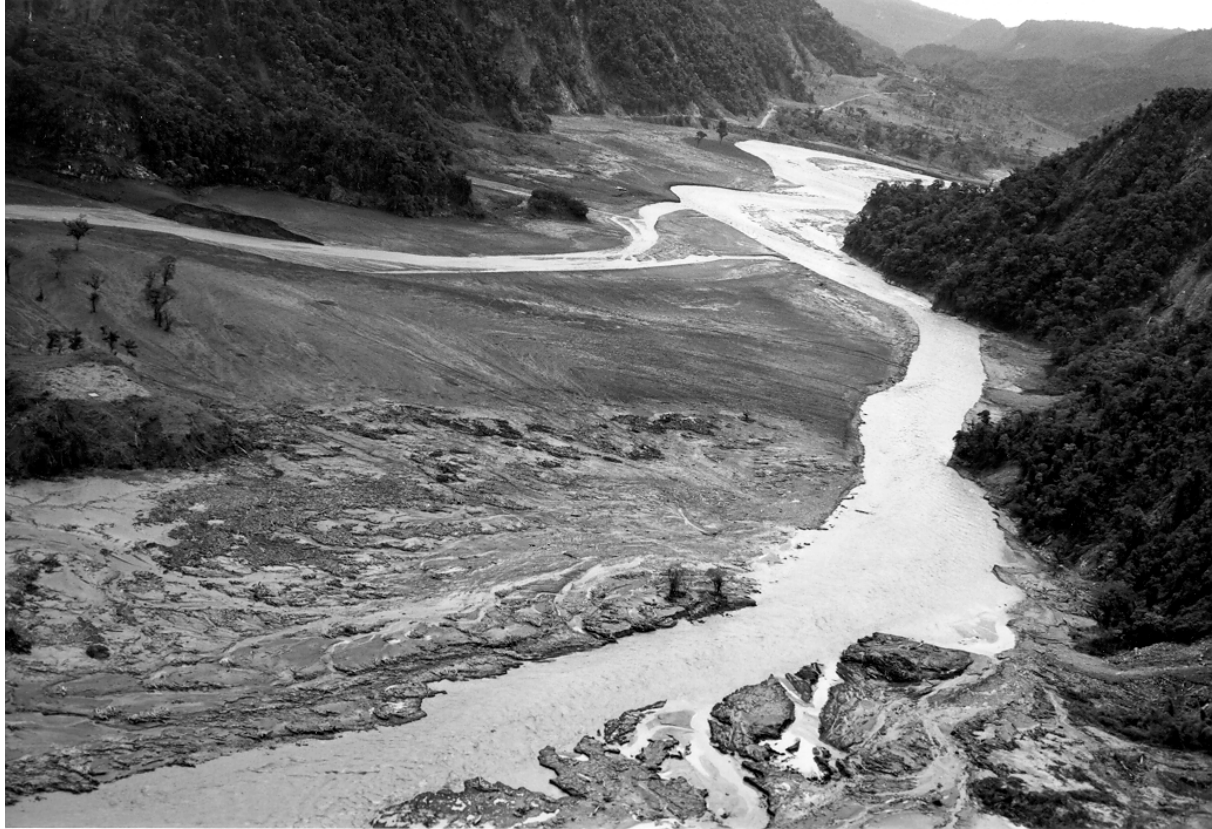
Fig. 3. Looking downstream at the confluence of the Malo River (flowing from the left) with the Coca River, northeastern Ecuador, following debris-flow activity induced by the 1987 Reventador earthquakes. A debris flow issuing from the Malo River during the night of 5 March 1987 formed a short-lived dam of the Coca River, resulting in deposition of ~15 m of sediment in the Coca channel (Nieto et al., 1991).

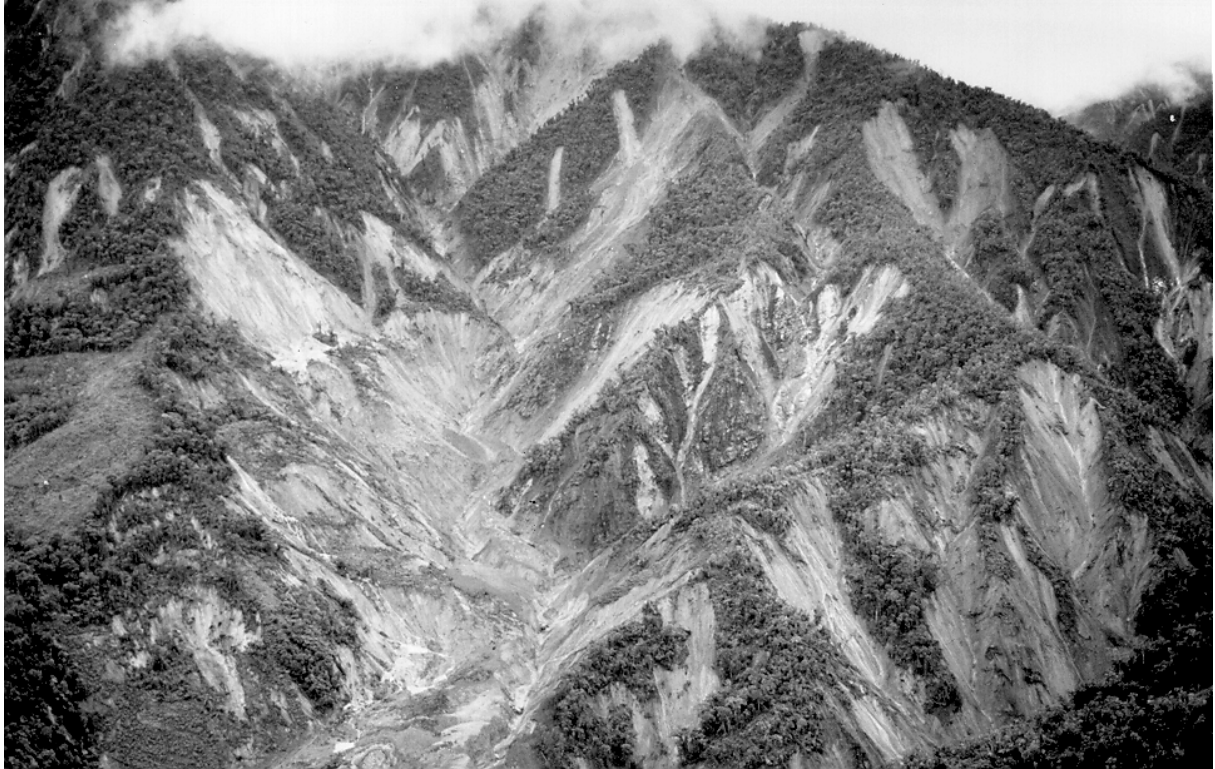
Fig. 4. Destruction of vegetative cover on the valley walls of the upper San Vicente River, southwestern Colombia, by slides, debris avalanches, and debris flows triggered by the 1994 Paez earthquake.

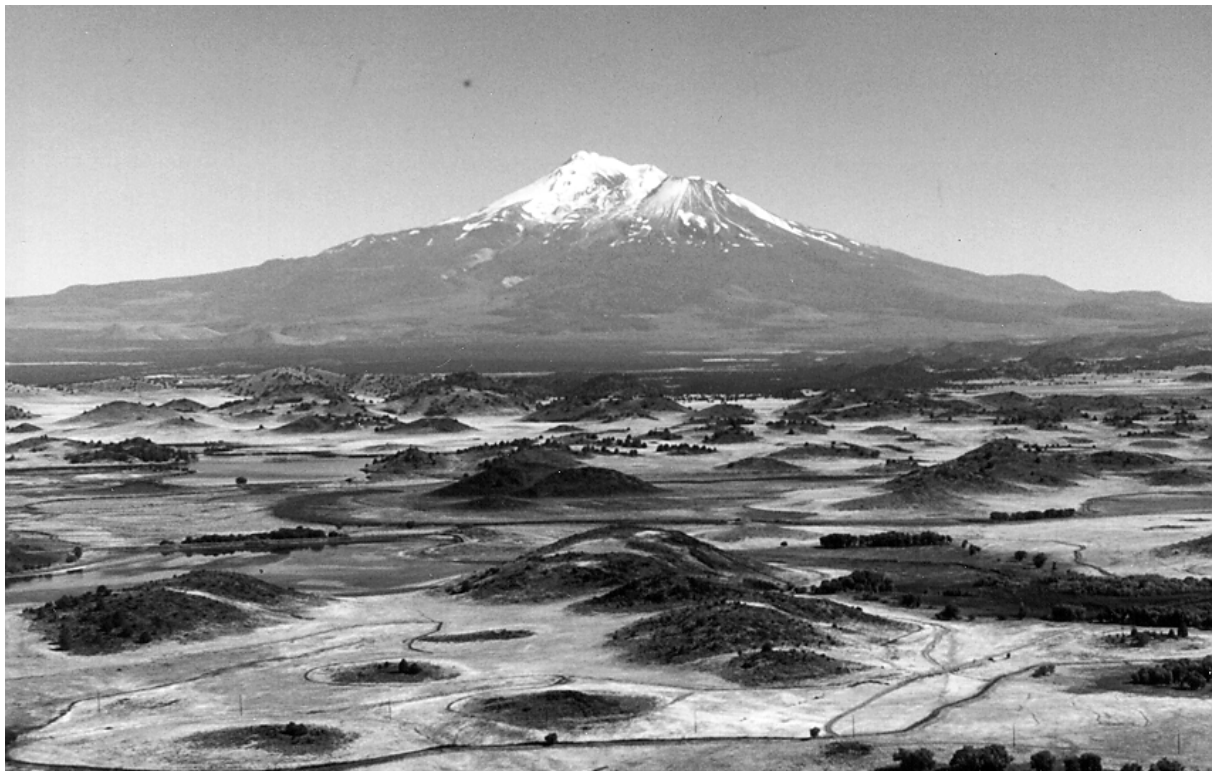
Fig. 5. Aerial oblique view to the south of the ancestral Mount Shasta, California, debris avalanche (foreground and middle distance). (Photo by D.R. Crandell, U.S. Geological Survey.)

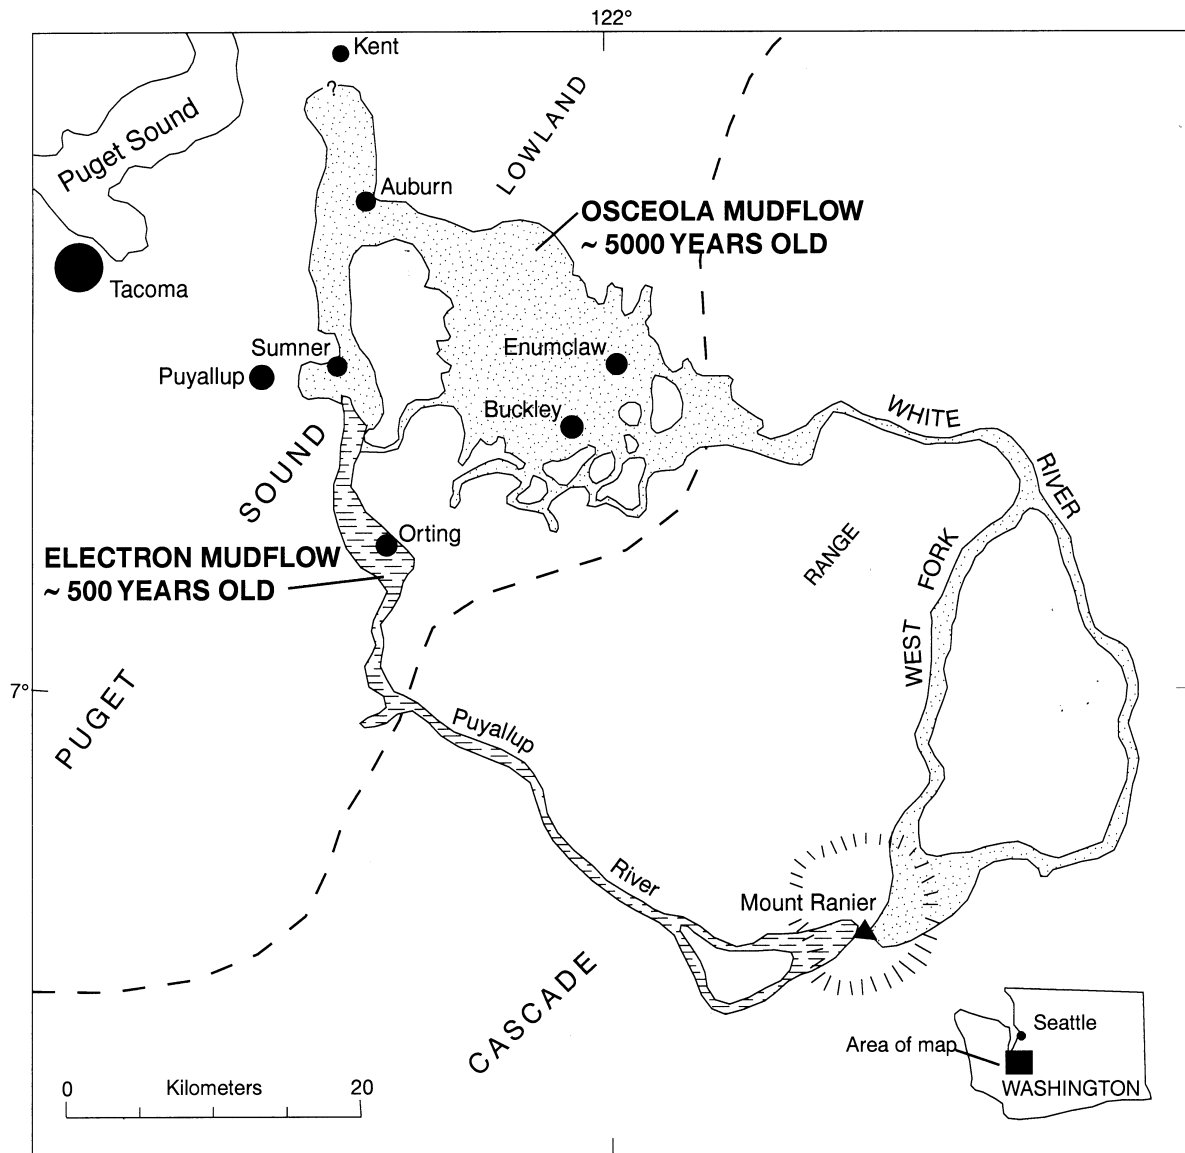
Fig. 6. Map showing area covered by two large debris flows that extended from Mount Rainier, Washington State, U.S.A., onto the Puget Lowland during the Holocene (after Crandell, 1971).

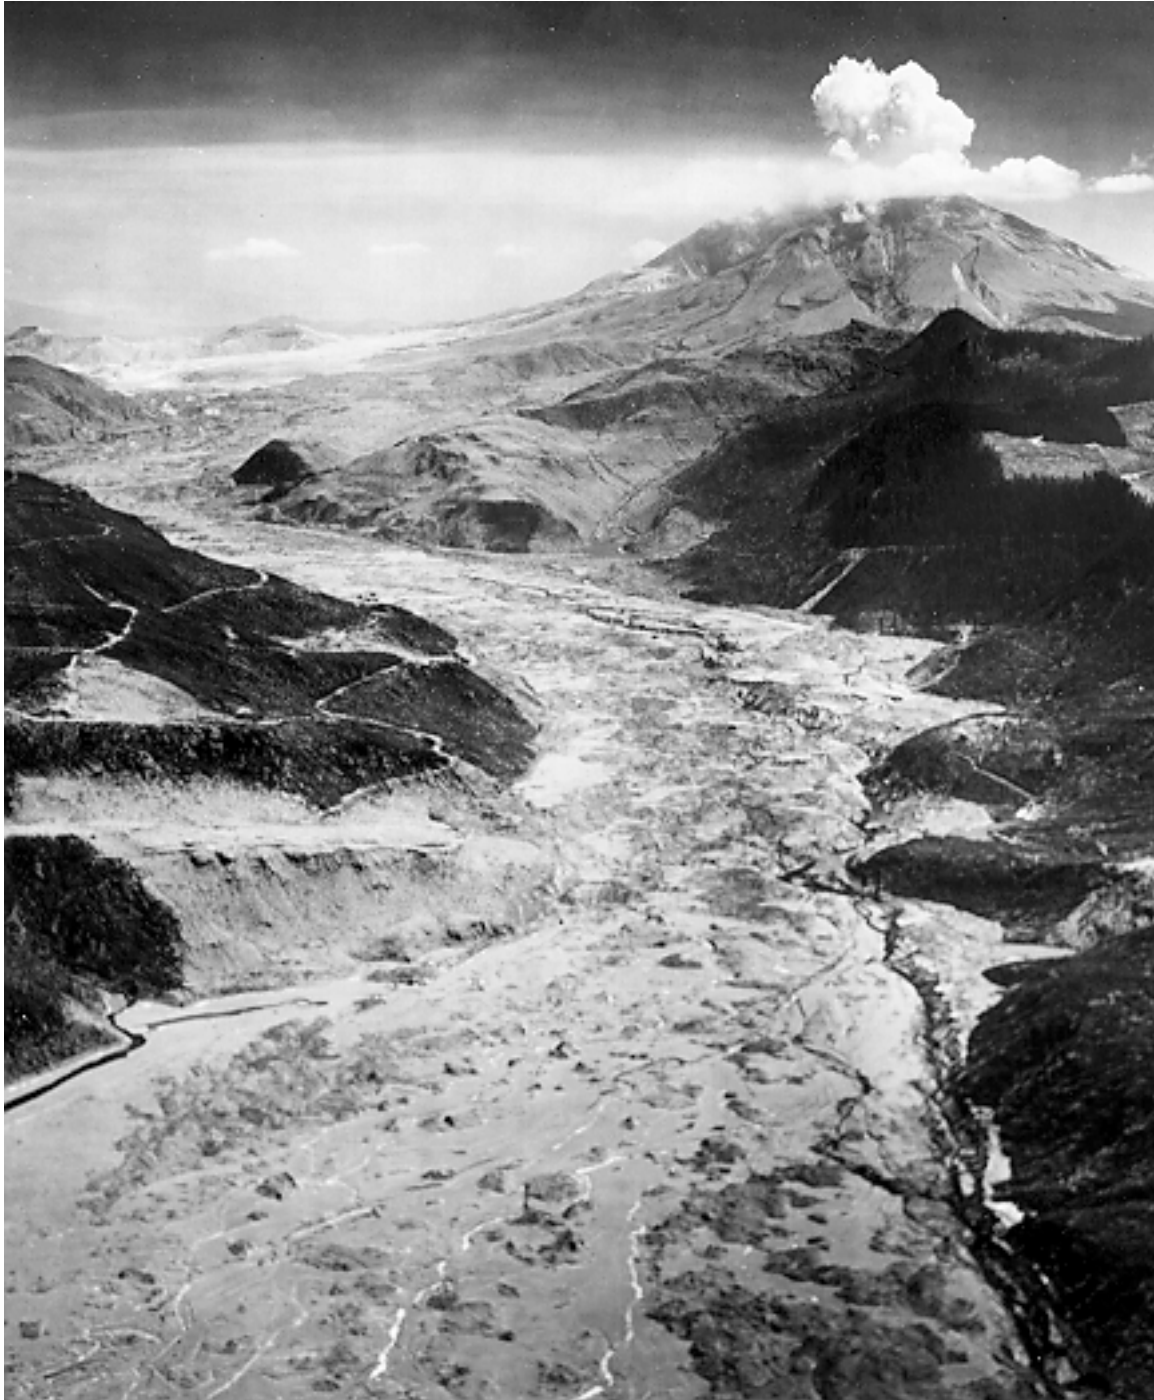
Fig. 7. Debris avalanche in the upper valley of the North Fork Toutle River, southwestern Washington State, U.S.A. View is to the east toward the devastated cone of Mount St. Helens. (May 1980 photo by Austin Post, U.S. Geological Survey.)

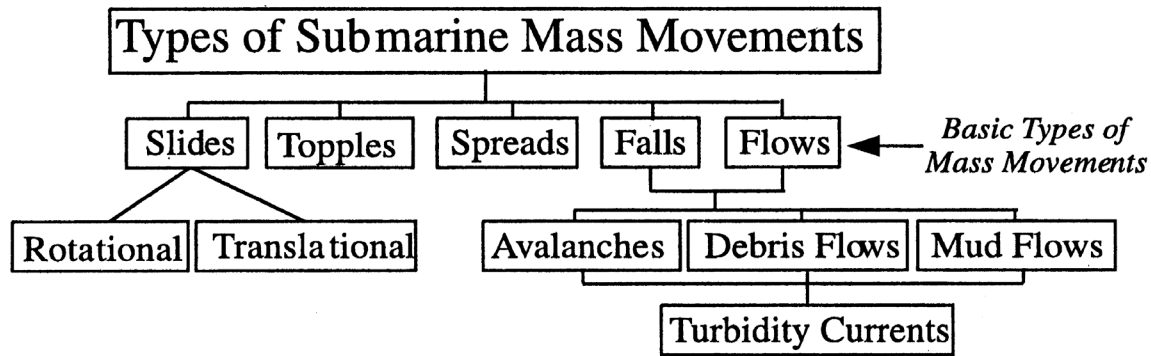
Fig. 8. Classification of submarine mass movements (Locat and Lee, 2002).

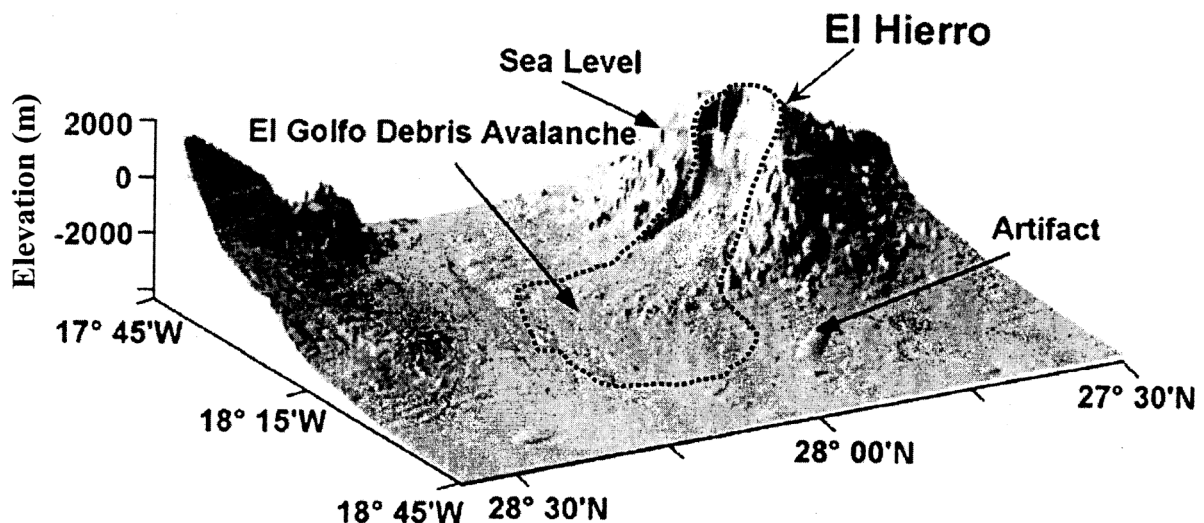
Fig. 9. El Golfo subaerial and submarine debris avalanche from El Hierro Island, Canary Islands, Spain. (From Locat and Lee (2002) after Urgeles et al. (1997).)

Volcanic islands can be the sources of huge submarine landslides. Major rock and debris avalanches are reported around many volcanic islands (e.g., Elsworth and Voight, 1995; Voight and Ellsworth, 1997). An excellent example is provided by El Hierro, a small island in the volcanic Canary Island group, which served as the source of two major Pleistocene submarine landslides: the El Golfo debris avalanche and the Canary debris flow (Urgeles et al., 1997). The El Golfo debris avalanche originated subaerially on the western flank of the island of El Hierro and has an associated 150-km^3 rock-debris deposit with an area of $2,600 \text{ km}^2$ in the sea at the base of the volcanic slope (Fig. 9). The Canary debris flow, which dislocated some 400 km^3 of volcanic material, resulted from a separate failure that originated at a depth between 3200 and 3700 m on the submarine slope of El Hierro island.

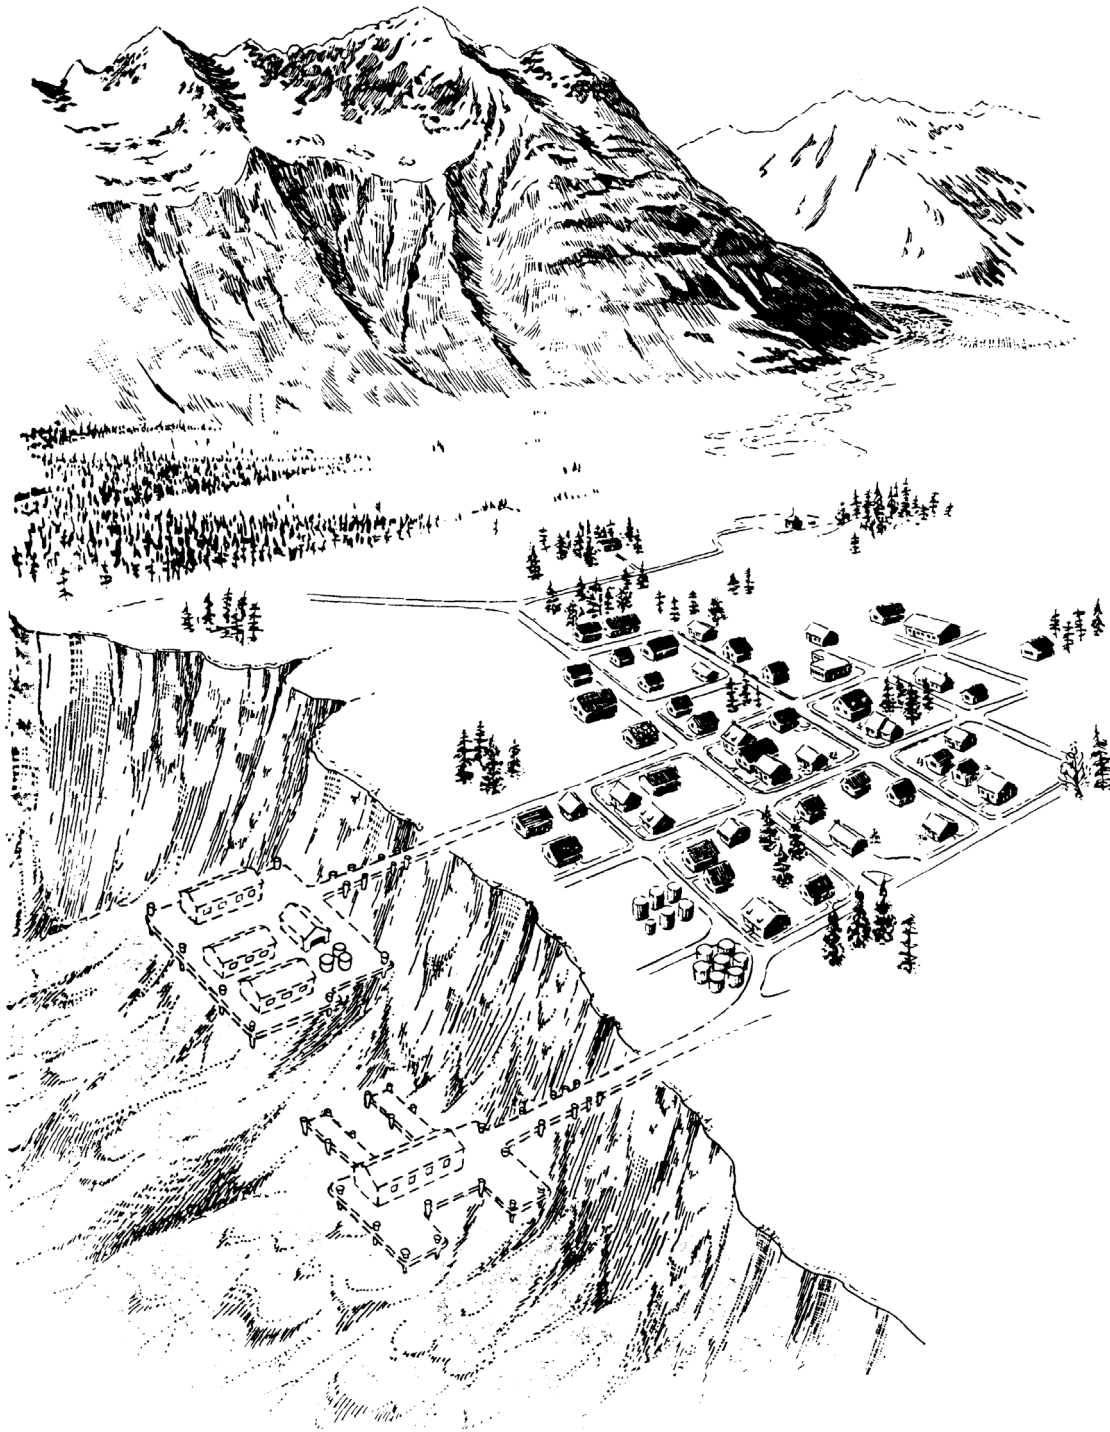
Fig. 10. Destruction of shoreline and port facilities at Valdez, Alaska, by a submarine landslide triggered by the March 1964 Alaska earthquake (Coulter and Migliaccio, 1966). Dashed lines indicate dock area destroyed by the slide. (Drawing by David Laneville, U.S. Geological Survey.)

Although not as large as the above prehistoric examples, a few historic submarine landslides have been documented (Hampton et al., 1996). For example, the 1964 Alaska earthquake resulted in catastrophic failure of the steep submerged shore of the town of Valdez, Alaska (Coulter and Migliaccio, 1966). The submarine landslide then retrogressed beyond the shoreline, submerging areas of coastal land and harbor facilities. Almost 75 million m³ of the shoreline of Valdez Harbor disappeared into the sea (Fig. 10). Accompanying these and similar submarine landslides are the dangerous tsunamis, or giant ocean waves, that spread outward from the landslide area and travel at high speeds for great distances. These waves strike coastal areas with disastrous results to mankind, flora, and fauna, alike. A submarine landslide in 1888 in the harbor of Trondheim, Norway (Andresen and Bjerrum, 1967), and a 1975 landslide in Kitimat Arm, British Columbia, Canada (Prior et al., 1982), exhibited similar sequences of offshore initiation, retrogression inland, and tsunami generation.

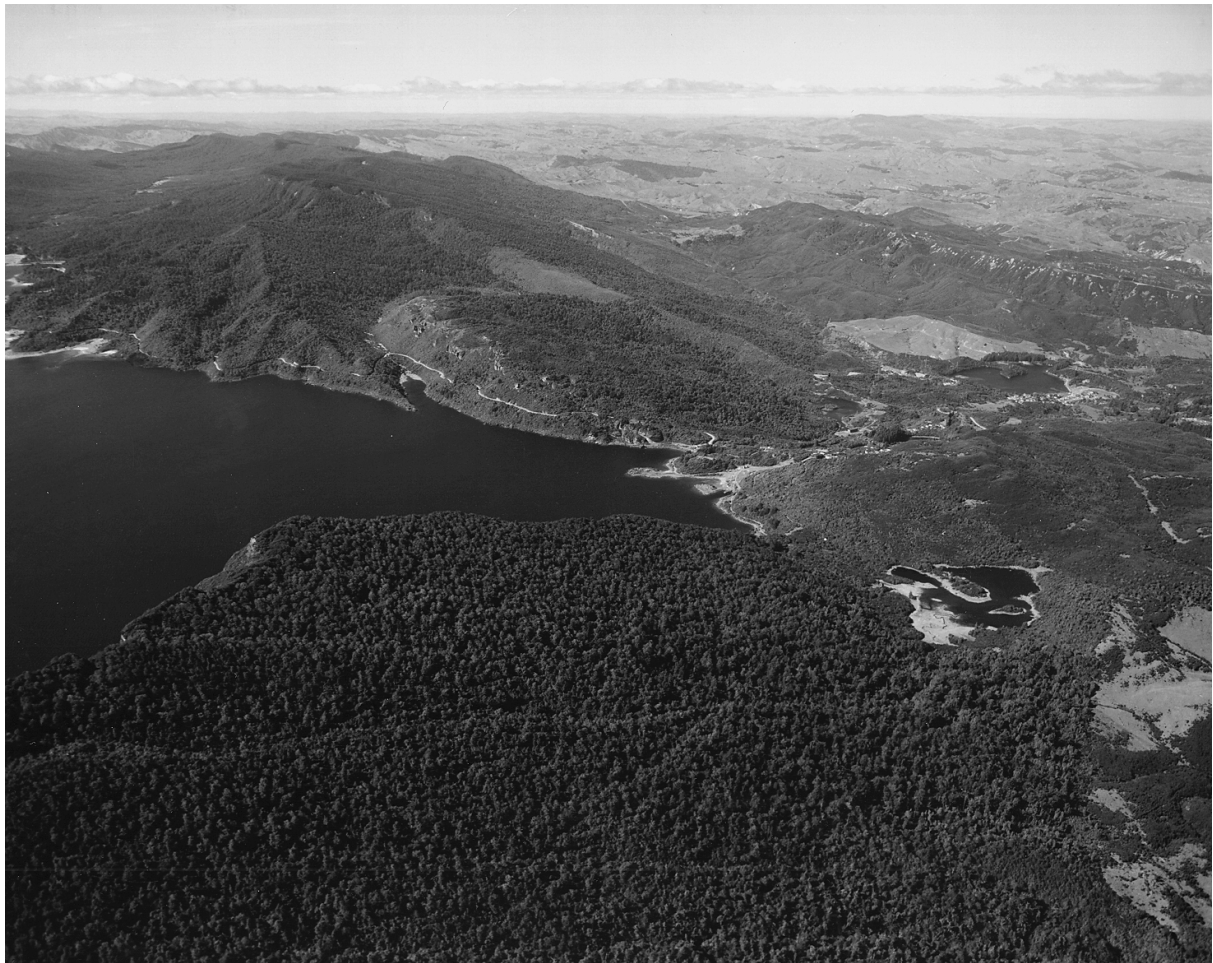
Fig. 11. Oblique aerial view of landslide-dammed, 56-km² Lake Waikaremoana, New Zealand. The outlet of the lake is at the center of the photo. (Photo by Lloyd Homer, Institute of Geological and Nuclear Sciences, Ltd., New Zealand.)

An outstanding example of a landslide-dammed lake that exists as a long-term geologic feature is Lake Waikaremoana on the North Island of New Zealand (Fig. 11). This 250-m-deep lake with an area of 56 km² is a remarkable natural feature that owes its survival to the erosion-resistant nature of the Tertiary sandstones and siltstones in the landslide dam (Read et al., 1992; Riley and Read, 1992). The lake has reduced the upstream gradient of the Waikaretaheke River to zero for about 15 km. Because the incoming river carries little sediment, Lake Waikaremoana has not been noticeably reduced in size or volume by sediment deposition.

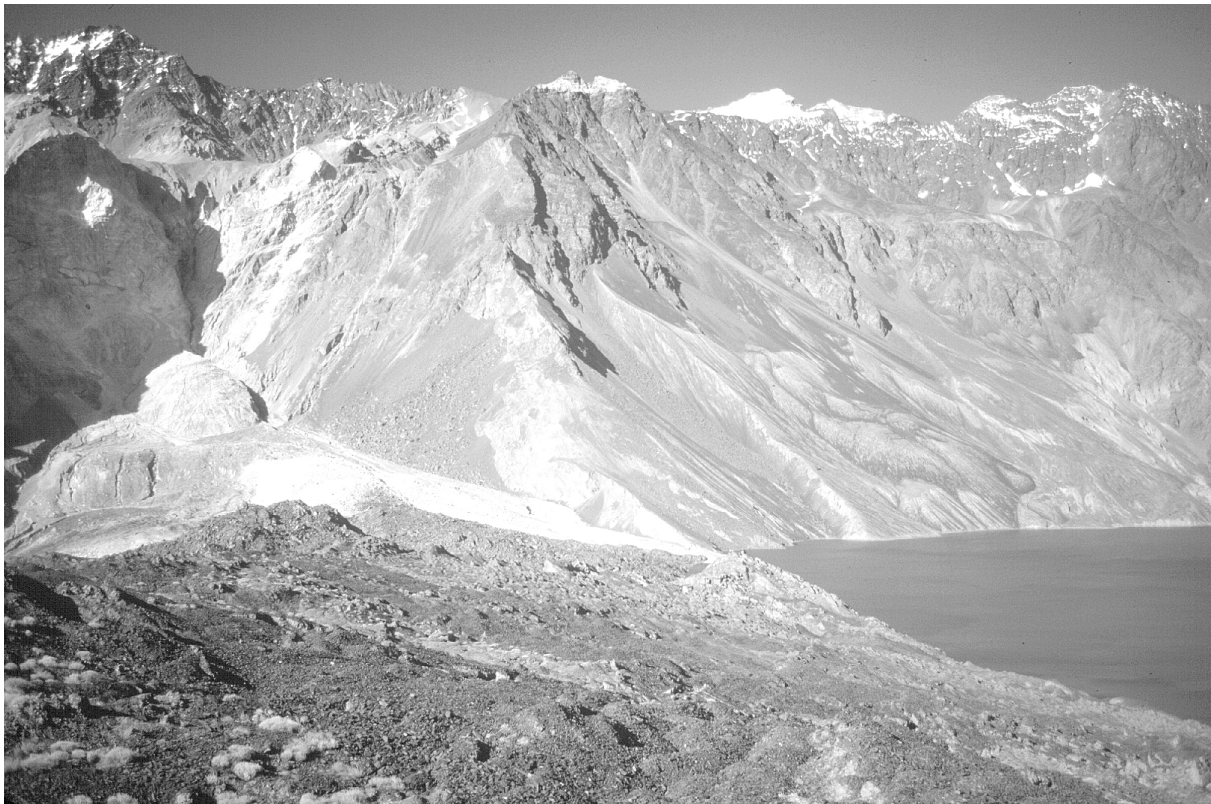
Fig. 12. View of Usoi landslide dam (foreground) and downstream (west) end of Lake Sarez., southeastern Tajikistan. Source area of the landslide is in the distance at the far left. (Photo by S. F. Cunha, Humboldt State University, Humboldt, California.)

The world’s largest and highest historic landslide dam was formed by the earthquake-triggered Usoi rock slide–rock avalanche, which dammed the Murgab River in the Pamir Mountains of southeastern Tajikistan in 1911 (Gaziev, 1984; Alford and Schuster, 2000; Hanisch, 2002; Schuster, 2002). The resulting 600-m-high dam impounds 53-km-long, 550-m deep Lake Sarez (Fig. 12). This natural dam is twice as high as Nurek Dam (also in Tajikistan), the world’s highest man-made dam. The dam has not been overtopped; inflow from the Murgab River and outflow (seepage) through the dam, in the form of several large outlet springs, appear to be in equilibrium. Thus, this landslide dam will continue to have a major effect on the long-term gradient of the Murgab River.

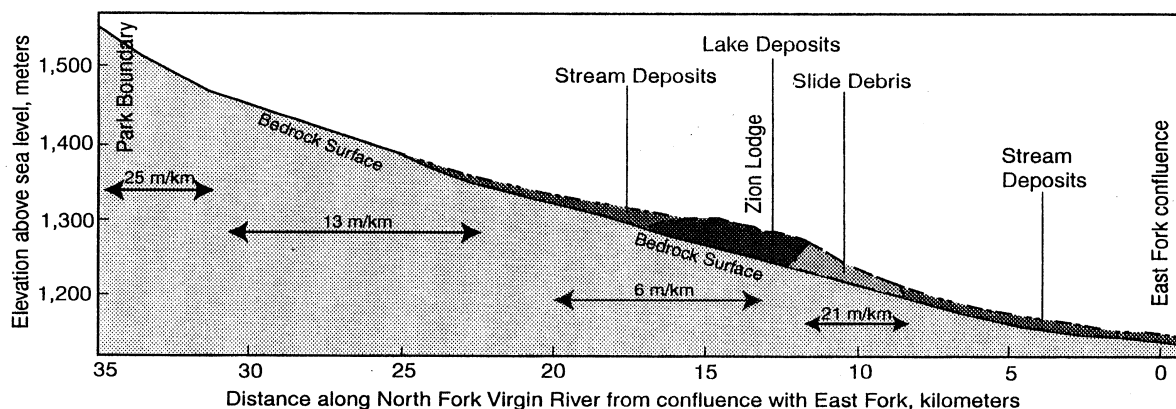
Fig. 13. Profile of the North Fork of the Virgin River, Zion National Park, Utah, U.S.A., showing the long-term effect of landslide damming on the stream gradient (after Hamilton, 1992).

Similar long-term effects on stream gradient of lacustrine deposition behind a landslide dam can be noted for the North Fork of the Virgin River in Zion National Park Utah, where a large slide mass that formed "*several thousand years ago*" impounded a lake 5 km long and nearly 1 km wide (Grater, 1945, p. 116). The impoundment lasted long enough before the natural dam failed to allow deposition of a large amount of lacustrine sediment, much of which still exists (Fig. 13).

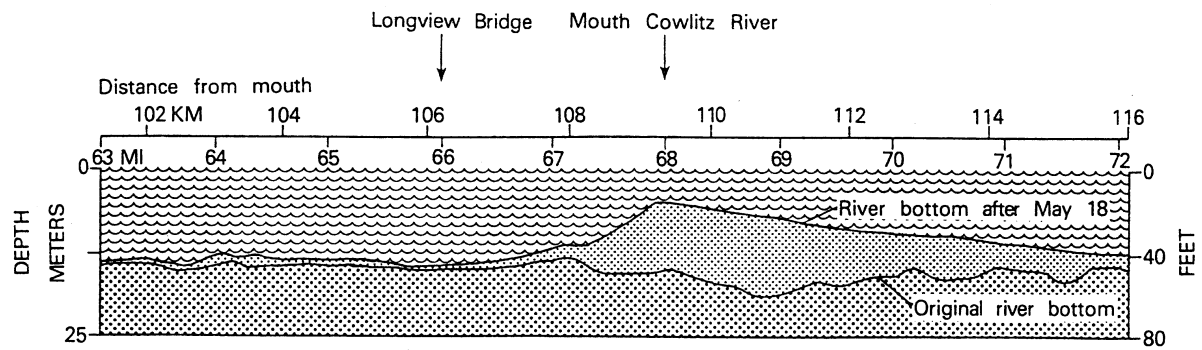
Fig. 14. Longitudinal profile of the bottom of the Columbia River where sediment resulting from the 18 May 1980 mudflows entered from the Cowlitz River. Note that most of the sediment was deflected upstream (Schuster, 1989; modified from Bechly, 1980).

As an outstanding example, remobilization of the already-saturated surface of the 1980 Mount St. Helens debris avalanche formed large debris/mud flows, which continued downstream 95 km beyond the distal margin of the debris avalanche (Janda et al., 1981; Schuster, 1981, 1989). The huge flows filled and permanently modified the channels of the Toutle and Cowlitz Rivers, and continued into the much larger Columbia River, which was partially dammed by the sediment (Fig. 14). Between June 1980 and May 1981, ~ 45 million m^3 of sediment were dredged from the Cowlitz and lower Toutle Rivers to restore the original stream channel (U.S. Army Corps of Engineers, 1984). An additional 34 million m^3 of

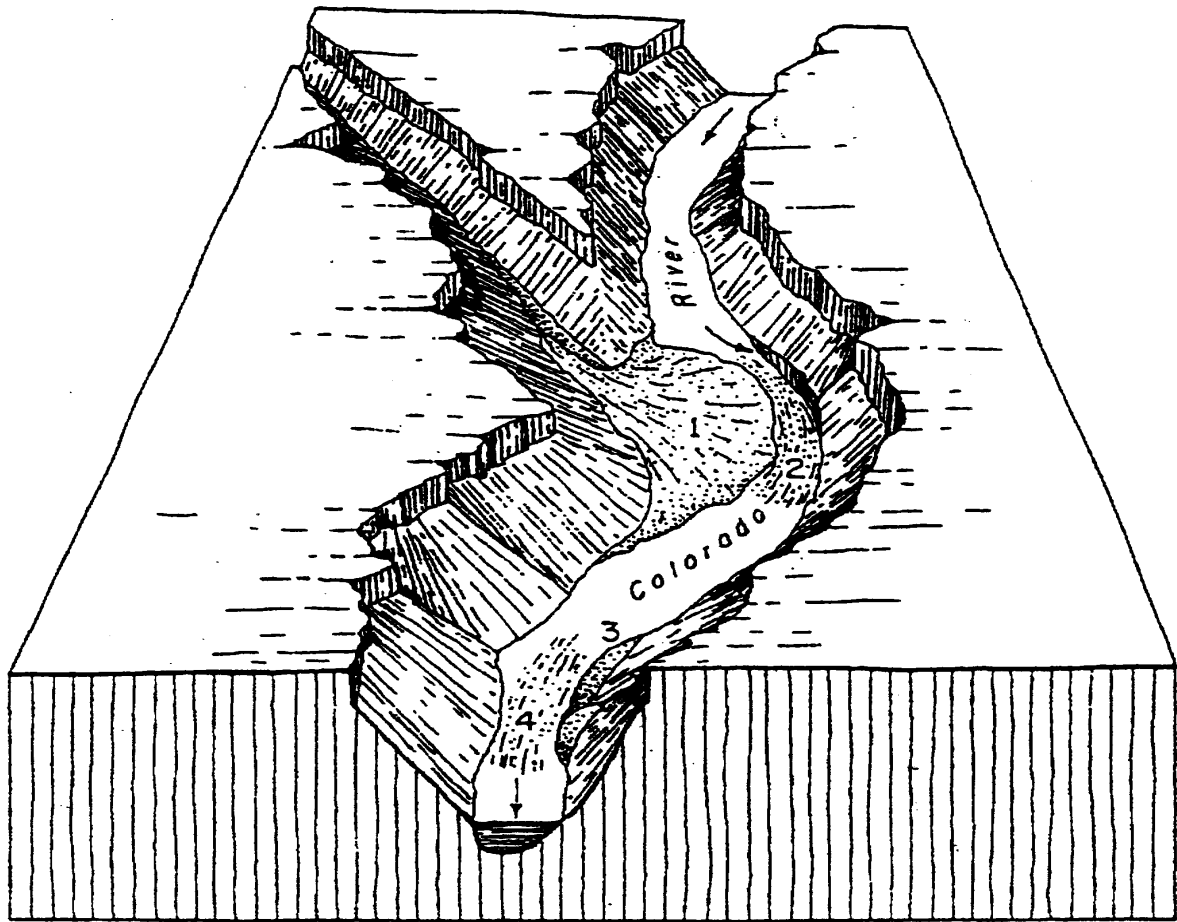
- 1 Tributary debris fan
- 2 Rapid controlled by large immobile boulders
- 3 Debris bar (synonymous with "island" or "rock garden")
- 4 Riffle or rapid caused by debris bar

Some tributary debris flows have been large enough to have temporarily dammed the Colorado River in the Grand Canyon, resulting in long-term morphologic effects in the river channel. An example is the fan at the mouth of the tributary Prospect Canyon, which dammed the river about 3,000 yrs ago, and has partially dammed it twice since (Fig. 16) (Webb et al., 1996). The Colorado River in the Grand Canyon was also dammed by large, prehistoric, rotational landslides that were as much as 600 m high and covered a surface area of as much as 16 km² (Savage et al., 2003). The river was forced to reroute around the landslide debris and excavate new channels.

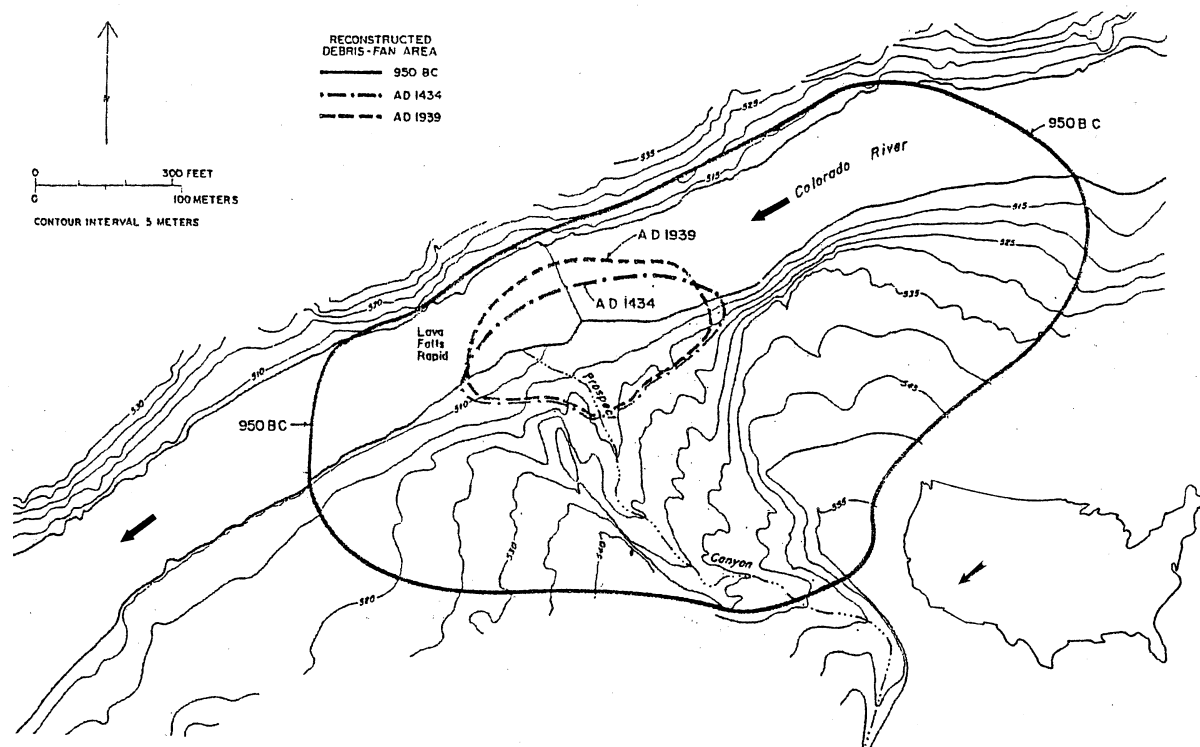
Fig. 16. Debris fans deposited by Holocene debris flows from Prospect Canyon into the Grand Canyon of the Colorado River, Arizona (Webb et al., 1996).

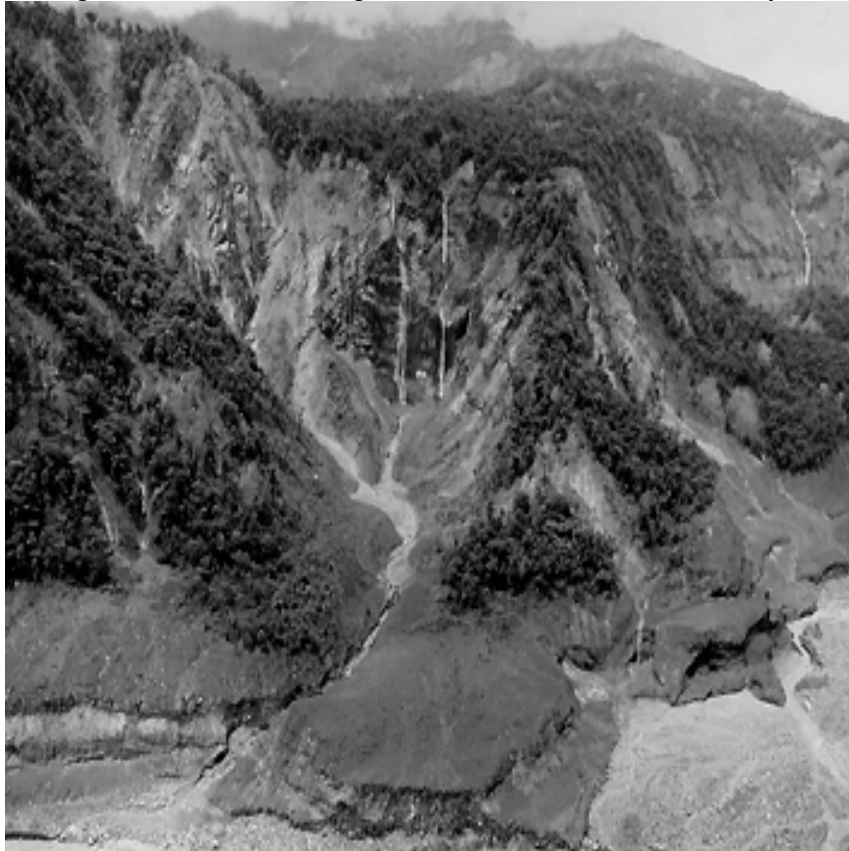
Fig. 17. Aerial view of the northeast valley wall of the Malo River, northeast Ecuador, showing extreme denudation of slopes due to slips/avalanches/flows triggered by the 1987 Reventador earthquakes.

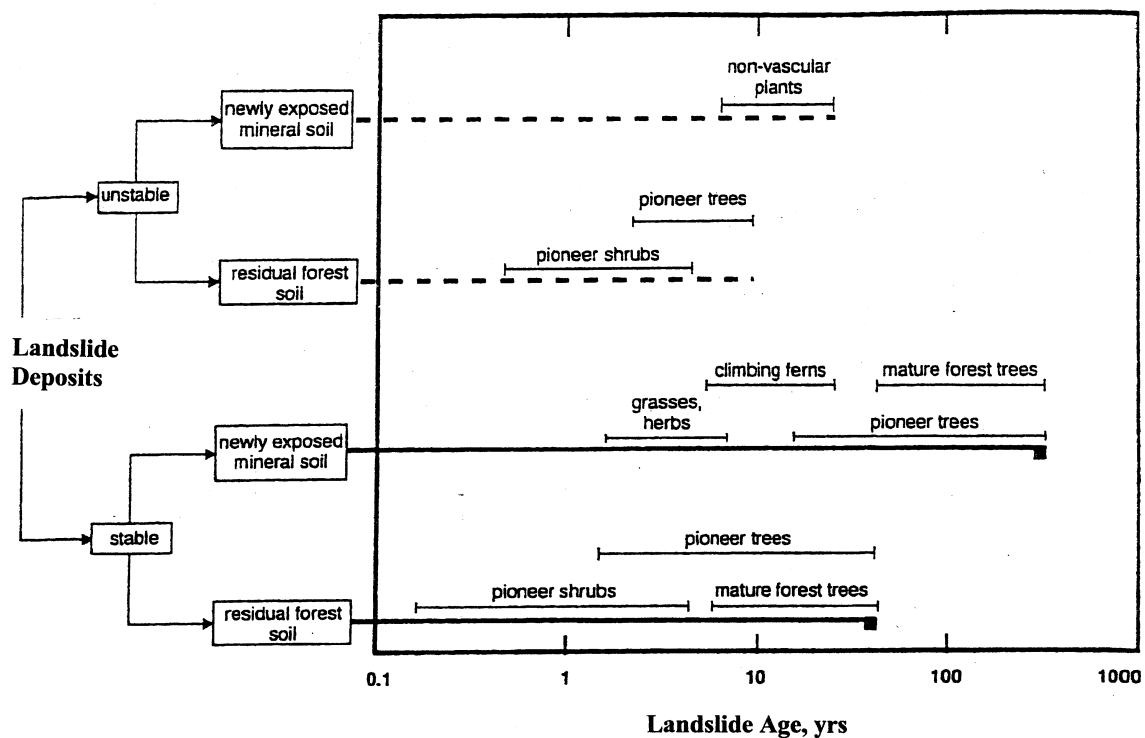
Fig. 19. Proposed plant succession on landslides in the Luquillo Mountains, Puerto Rico (Walker et al., 1996). On unstable soils, erosion constantly resets succession (dashed lines). On stable soils, filled squares indicate ages at which pre-landslide vegetation may re-establish.

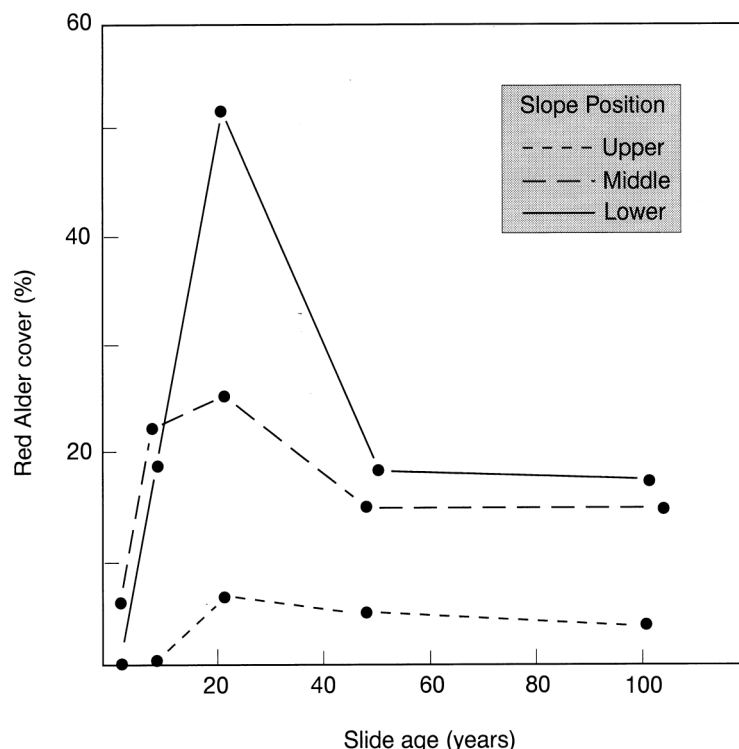
Fig. 20. Cover of landslide-damaged land by red alder as a function of landslide age and slope position, Queen Charlotte Islands, British Columbia, Canada (after Smith et al., 1986).

deposited on, or mixed with, the original soil. Two major trends in vegetative development on slide surfaces were observed, one dominated by red alder (Fig. 20) and one by conifers (Fig. 21). The alder was dominant on the lower parts of the slides, while conifers dominated on the middle and upper parts.

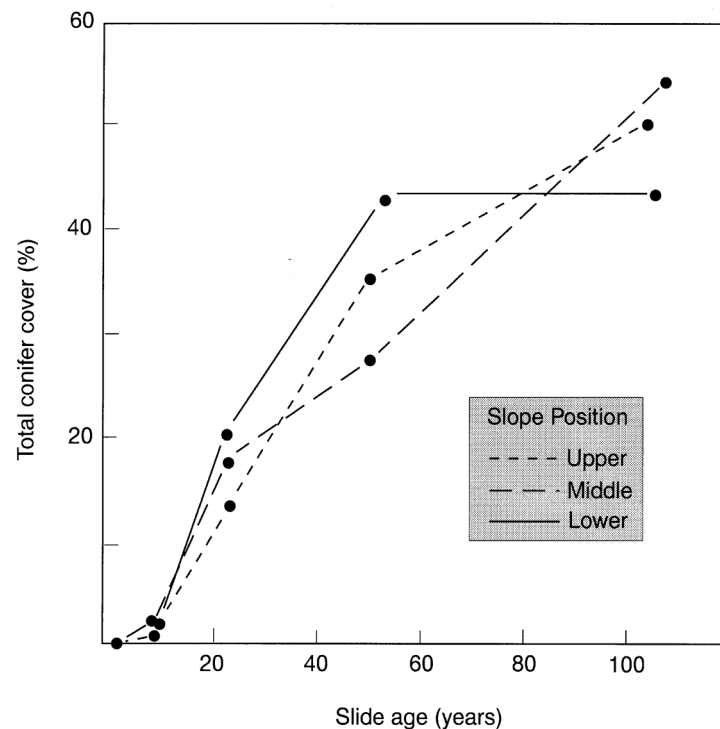
Fig. 21. Cover of landslide-damaged land by coniferous trees as a function of landslide age and slope position, Queen Charlotte Islands, British Columbia, Canada (after Smith et al., 1986).

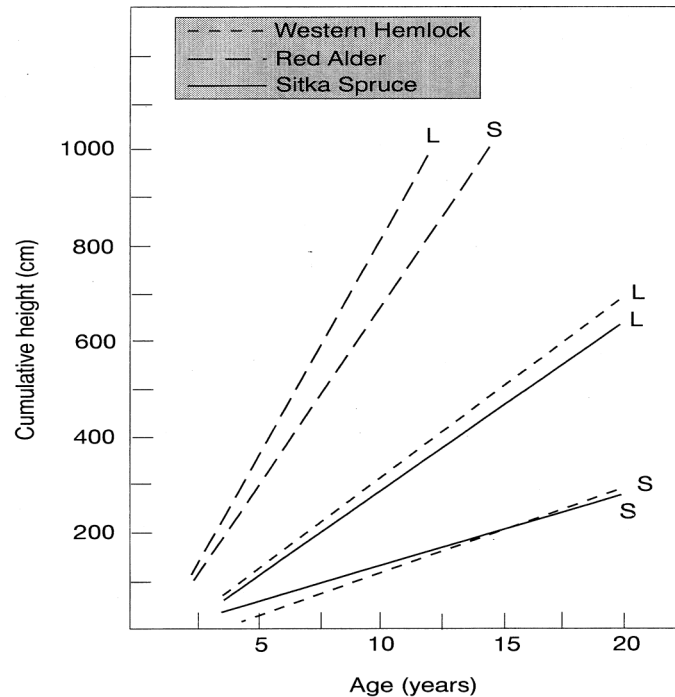
Fig. 22. Early height growth of red alder, western hemlock, and Sitka spruce in landslide (S) and logged (L) areas, Queen Charlotte Islands, British Columbia, Canada (after Smith et al., 1986).
