Impact of Landslides and Innovative Landslide-Mitigation Measures on the Natural Environment

Robert L. Schuster and Lynn M. Highland

Geologic Hazards Team, U.S. Geological Survey, Denver, Colorado, U.S.A.

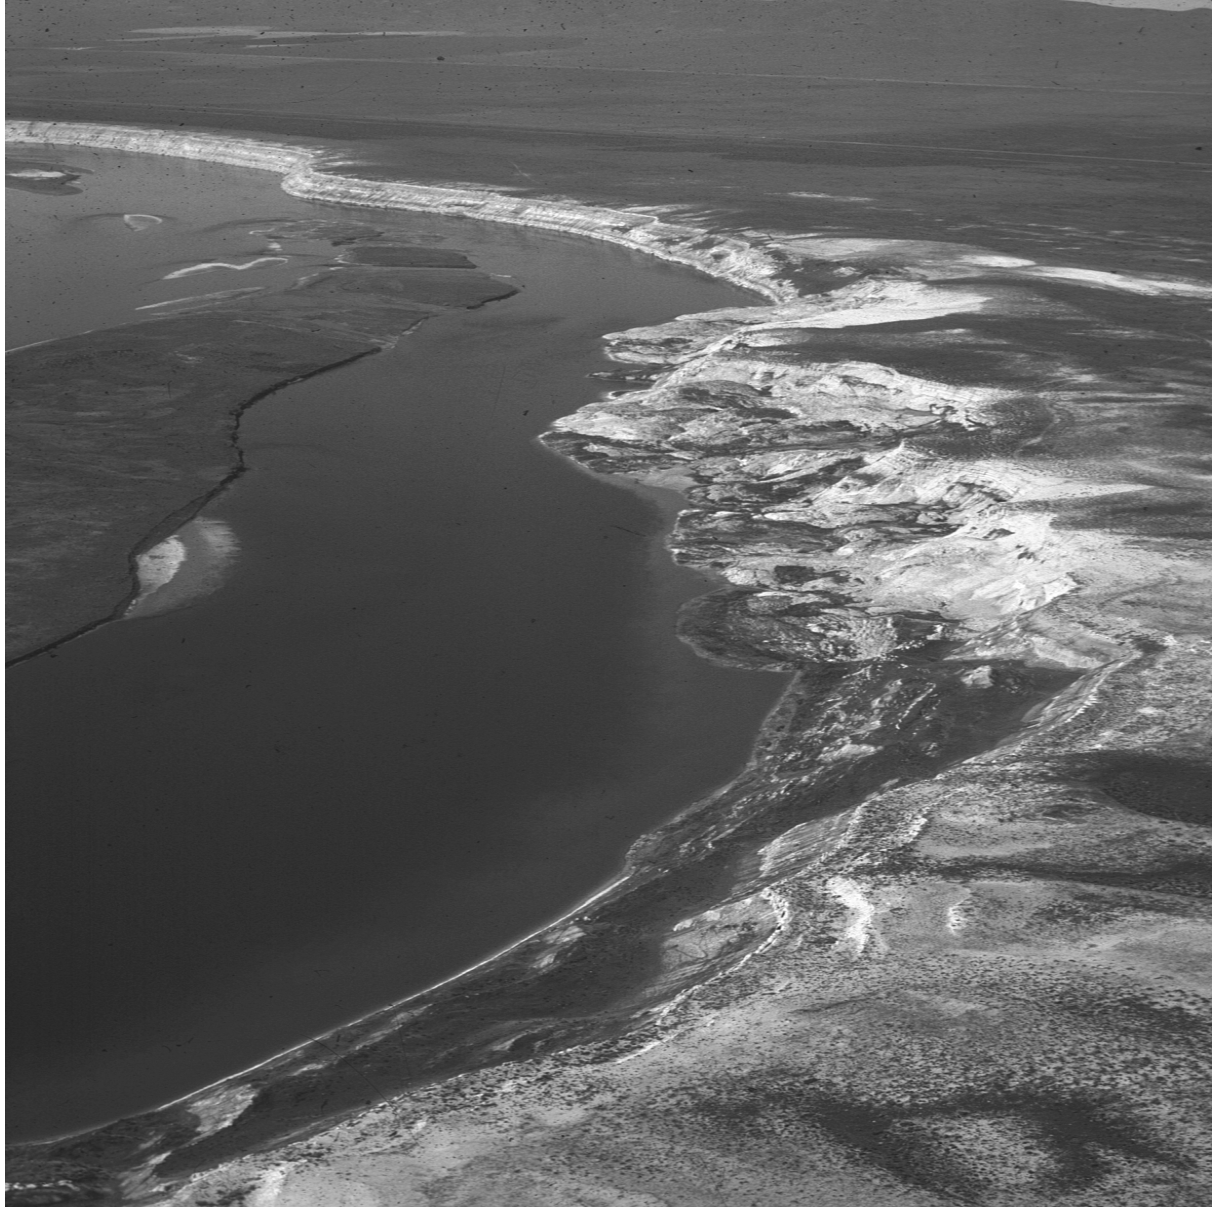
Fig. 23. Irrigation-caused landslides have badly damaged salmonid spawning grounds in the last free-flowing stretch of the Columbia River in the United States (Schuster, 1989).

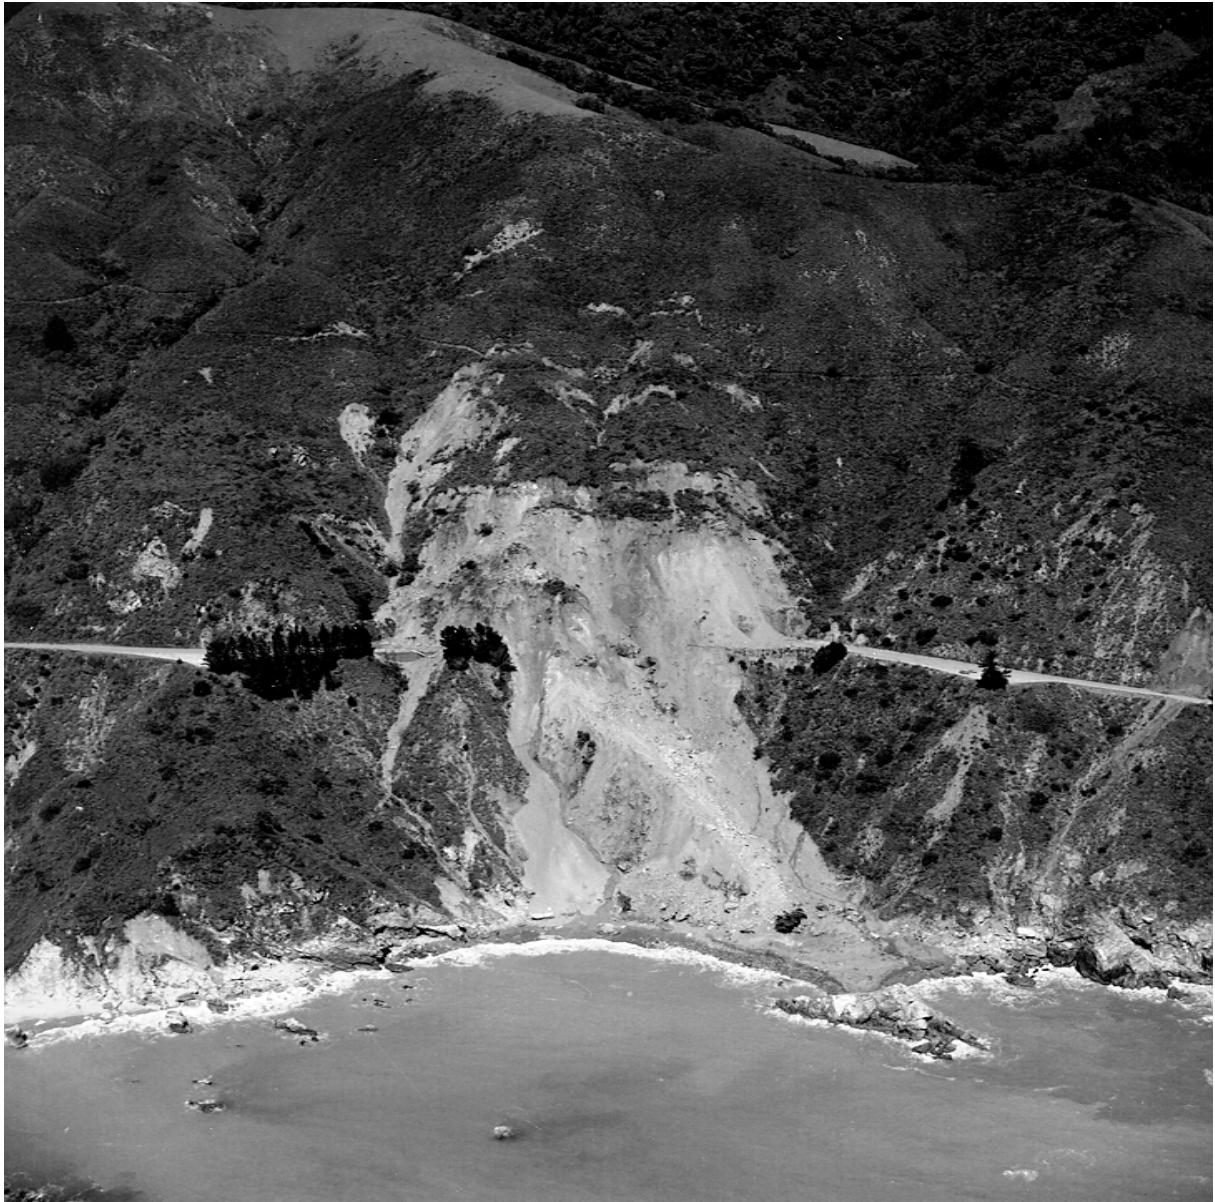
Fig. 24. Aerial view of the 1983 McWay landslide, Big Sur Coast, California. By reaching tidewater, this slide impacted marine organisms, both flora and fauna. (Photo by Lynn Harrison, California Department of Transportation.)

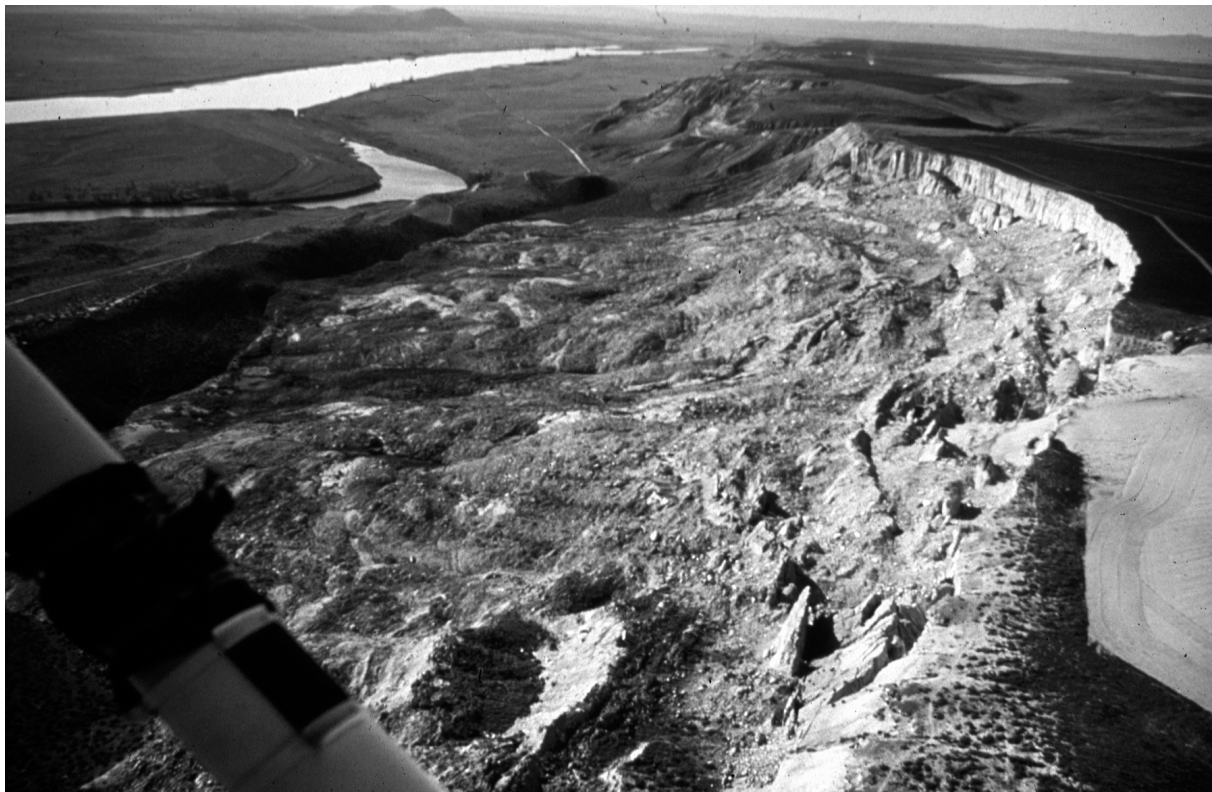
Fig. 25. April 1981 aerial oblique view of the 12-million-m³, irrigation-induced Savage Island landslide on the Columbia River, south-central Washington State, U.S.A. In the spring of 1981, hundreds of baby cliff swallows were killed when their nests in the 25-m-high main scarp were destroyed because of catastrophic headward recession of the landslide to the location shown.

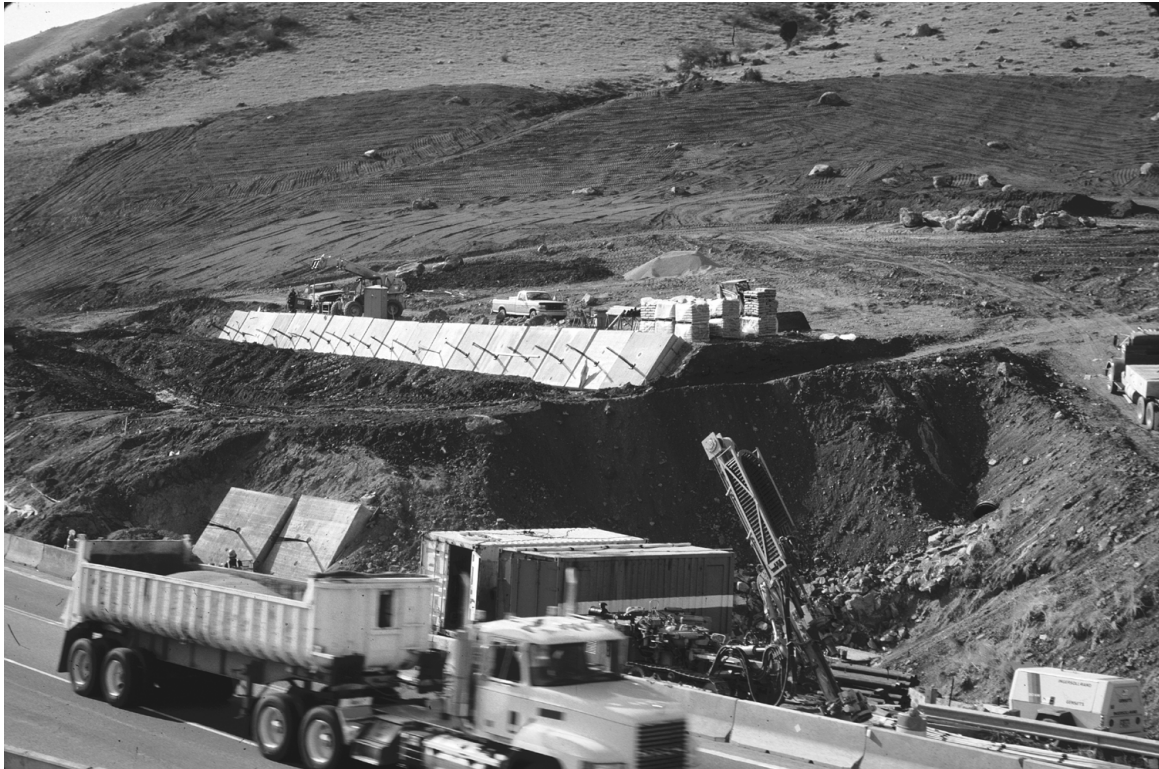
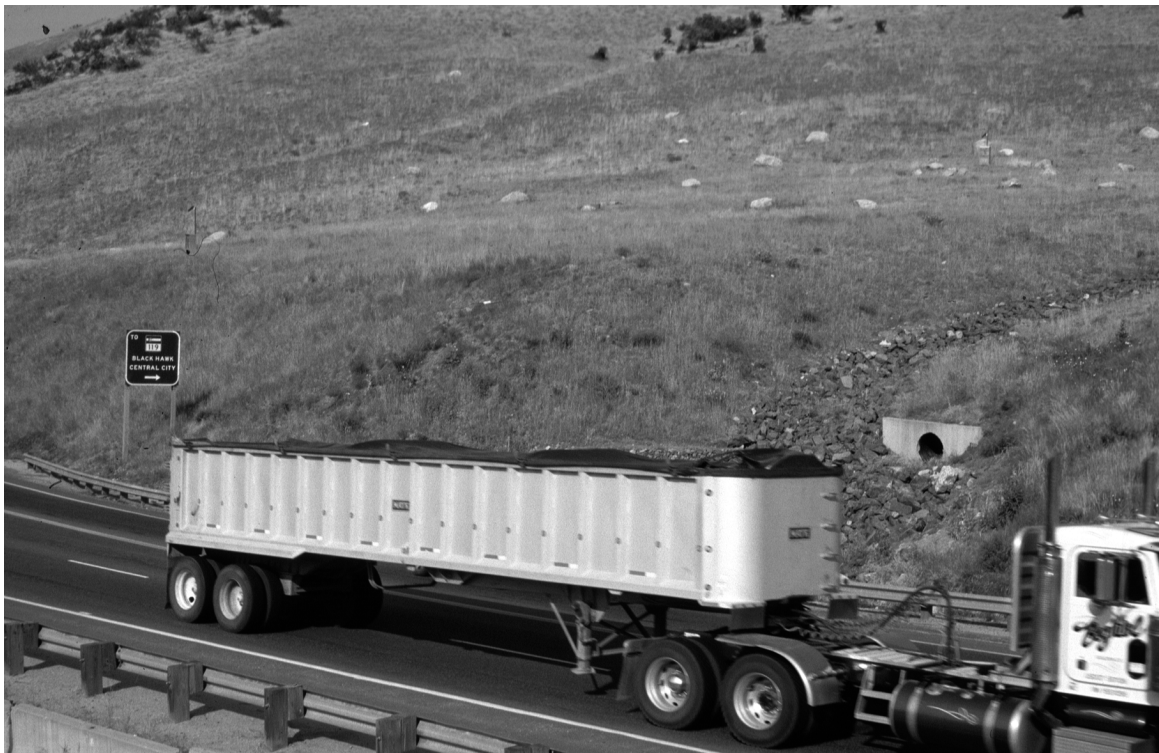
Fig. 26. Environmentally-friendly stabilization of a cut slope on Colorado State Highway 93 in Golden, Colorado, U.S.A. (A) Installation of 3m x 3m reinforced-concrete “face plates” tied to a system of rock anchors (photo: March 1994). The final rock-anchor system consisted of three rows of anchors with a total of 40 anchors and face plates. (B) Post-construction view of same site (photo: July 2003). Anchors and plates have been hidden by a soil fill, which has been planted with native grass.
