1. Riparian Corridor Revegetation

Restoration Actions
within the San Luis Obispo Creek Watershed

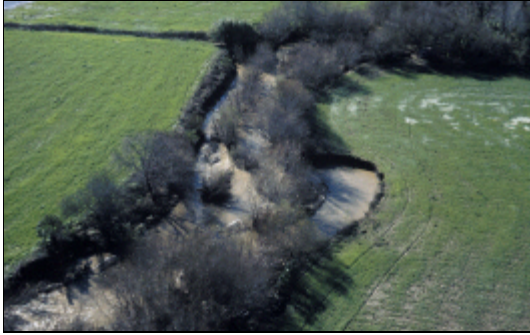
Site SL-3-1R

Figure 3. Photograph of Project Site SL-3-1R.

Problems: Bank failure at this site is the result of past vegetation removal that has left an insufficient vegetation buffer. While some willow is colonizing the site, the single layer of vegetation is insufficient to withstand high winter flows. Much of the erosion is caused by return flow of water during frequent

floods. Secondary deficiencies on this site include the absence of overhead canopy and lack of a vegetative filter strip to catch sediment from overland run-off. This site would benefit from additional vegetation to help cool water temperatures and act as an enhanced vegetative filter strip.

Project Description: The focus of this project is to stabilize the banks with vegetation including willow material. A riparian buffer strip of at least 25 feet on each bank would protect the site from the frequent flooding and filter run-off from the agriculture operation.

The project will consist of reshaping and revegetation of approximately 100 feet of the north bank and vegetation enhancement over an additional 300 feet of bank. A vegetated corridor of 25 feet on each bank will be established. The total restoration area will measure approximately ¼ acre. Willow material will be used to stabilize the reshaped bank by post planting or through a bio-engineered approach. Exotic species of vegetation will be removed as part of the project and will be monitored during the monitoring period.

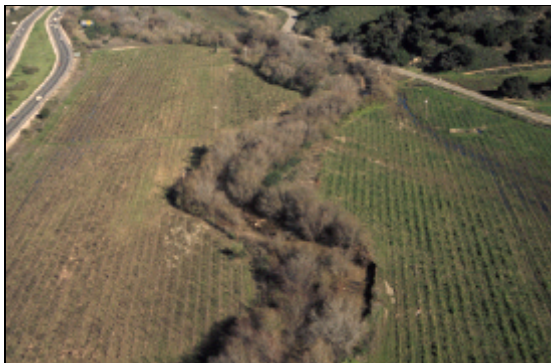
Site SL-4-1R

Figure 4. Photograph of Project Site SL-4-1R.

Problems: Sections of this reach have been artificially straightened and protected with concrete riprap that has led to channel incision, bank erosion, and degradation of riparian vegetation. These factors contribute to sedimentation of fish habitats. Frequent flooding also contributes sediment as the water returns to the creek. Much of

this site is in stable condition however and enhancing the vegetation diversity while repairing the damaged areas would be a positive step toward establishing a long reach of high quality fish and wildlife habitat.

Project Description: Restoration activities center on establishment of a continuous vegetated corridor planted with large canopy tree species. This would provide shade to cool the water and add stability to the creek banks. Trees will also be a source of woody debris that would enhance instream fish habitat.

Several sections through this project site are lacking native riparian vegetation and contribute to bank erosion and collapse. The gaps in vegetation are overgrown with exotic weeds that prevent re-establishment of a healthy riparian corridor. The goal of this project is to enhance current gaps in the riparian corridor by removing exotic species and planting native plants in a riparian buffer strip. The enhanced vegetation buffer will also help filter sediment from returning flood waters. Approximately 1,100 feet of stream bank will be enhanced on the project site.

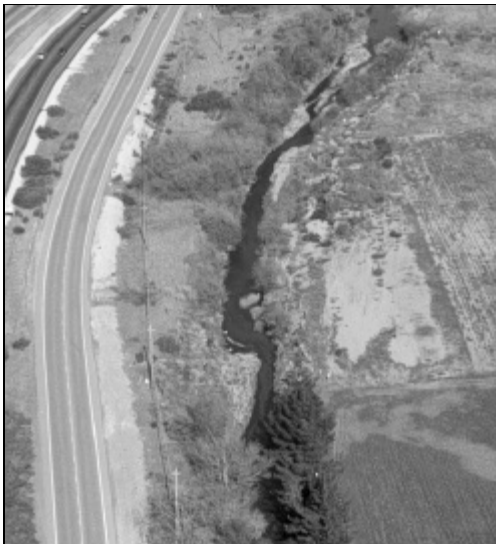
Site SL-6-1R

Figure 5. Photograph of Project Site SL-6-1R.

Problems: This site exhibits several problems that are common in the San Luis Obispo Creek watershed. Riparian vegetation on this site is highly degraded, leaving banks vulnerable to erosion. Fine sediment from eroding banks settles downstream and contributes to degradation of fish spawning gravels. Degraded riparian vegetation also decreases the in-stream cover that provides fish with safe havens and velocity breaks. In addition, exposed oil pipelines divert water into banks and pose a potential for oil spills. The “San Luis Obispo Creek Steelhead Trout Inventory and

Investigation: 1995”(Land Conservancy, 1995) identified this reach of the Creek as having the poorest in-stream shelter rating on the main stem of San Luis Obispo Creek.

Secondary problems include the lack of overhead canopy. These factors contribute to elevated water temperatures and poor fisheries habitat. Summertime temperatures at this site have been measured in the 70°F range (Coastal Resources Institute, 1994). High water temperatures affect local trout fisheries because steelhead have difficulty extracting oxygen from water at temperatures above 70°F.

Project Description: This reach of San Luis Obispo Creek will be revegetated with native riparian species. Banks will be stabilized with willow material and may include a vegetation based structural element. Work will focus on the south bank and consist of a continuous corridor approximately 40 feet wide. Total restoration area is approximately 1.6 acres. Some bank re-sloping may be necessary that will require permits from applicable agencies. Prior to implementation, this site will require closer hydrologic inspection to determine the preferred methods for stabilizing eroded banks.

Habitat such as deep pools and instream cover are lacking at this site. Due to the flow velocity along this reach, even during low flow periods, there is an opportunity to establish pools and instream cover through the installation of fish habitat devices such as boulders.

Exposed oil pipelines at this site represent a significant threat to the riparian corridor as they are occasionally active and are subject to washout during high water flows. Exposed pipelines should be re-buried or otherwise removed from the active channel as part of this project. The current pipeline owner (Tosco) has expressed interest in a cooperative project on this site. The LCSLOC is working with Tosco to solve the problem. Tosco would be responsible for costs related to the pipe re-burial or removal and repair of the immediate construction area. Trustee Council funds would be expended for areas immediately upstream and downstream of the pipeline location. The Trustee Council will not spend restoration funds to reposition oil pipelines as part of the proposed project.
