# Streamflow Losses through Karst Features in the Upper Peace River Hydrologic Area, Polk County, Florida, May 2002 to May 2003

## Introduction

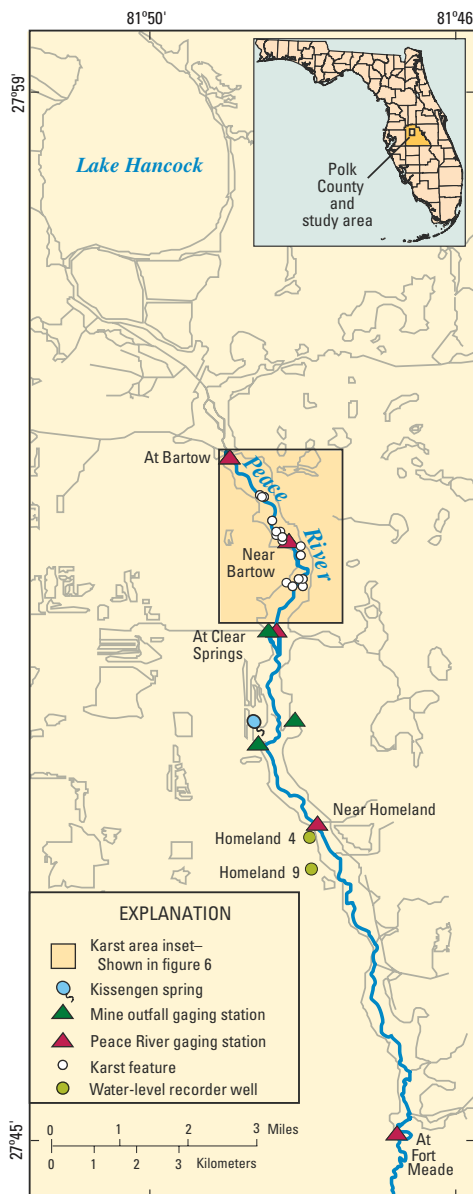
**Figure 1.** Upper Peace River Hydrologic Area, Polk County, Florida.

fractures—the largest is 26 feet long and spans the riverbed. The spatial distribution of the karst features is shown in figure 1. Vertically, these features are present at the contact between the Peace River and Arcadia Formations. The largest karst feature mapped is the catacombs, which is located in the flood plain (fig. 6). This feature is composed of numerous interconnected horizontal and vertical fractures that show evidence of scouring by moving water; some of the openings are large enough for a person to enter. Numerous smaller features also are found in the channel and the flood plain.

Preliminary analysis of the differences between the stage of the Peace River and head in the aquifers in the Upper Peace River Hydrologic Area was based on data from an existing pair of wells (Homeland 4 and Homeland 9) located within 1 mile of the Peace River near the Homeland gaging station (fig. 1). The wells penetrate the intermediate aquifer system and the Upper Floridan aquifer, respectively, and are the only available monitor wells located in close proximity to the river. The head difference between these two aquifers indicates recharge conditions and is relatively constant at about 4 ft (fig. 11). Water-level hydrographs show that the stage of the Peace River near the Homeland gaging station was higher than the heads in the aquifers, indicating the potential for the river to be a losing stream (fig. 11). The difference

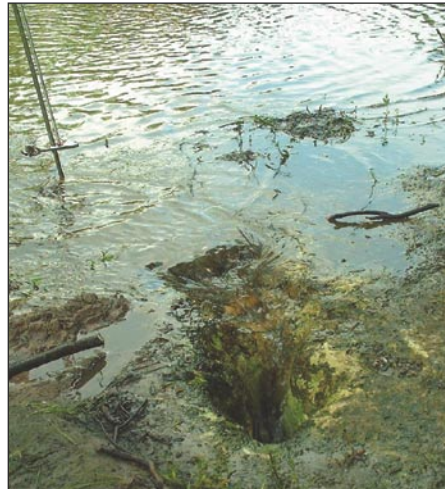
**Figure 2.** Fricano fracture.

Locations, surface orientations, and dimensions of prominent karst features were measured in mid-May 2002 when reaches of the river were dry. Examples of features are shown in the photographs. Fricano fracture (fig. 2) is a coalescing group of vertical pipes; Midway sink (fig. 3) is a collapsing sinkhole with small fractures near the base; Dover sink (fig. 4) at the base of the outcrop is located at the end of a 200-ft-long distributary in the flood plain; and the crevasses (fig. 5) includes multiple

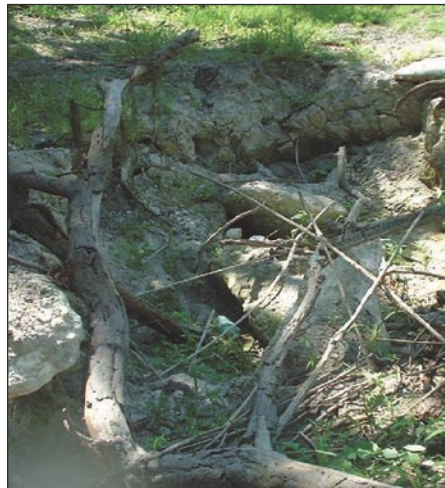
**Figure 3.** Midway sink.

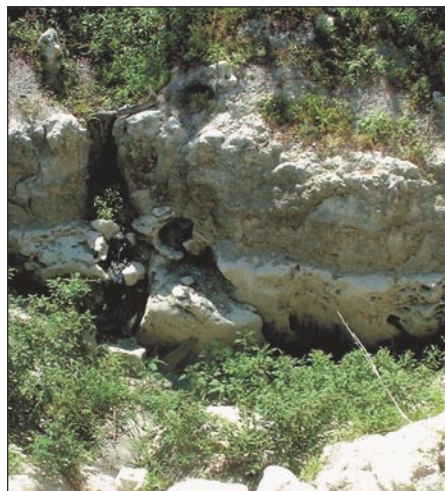
**Figure 4.** Dover sink.

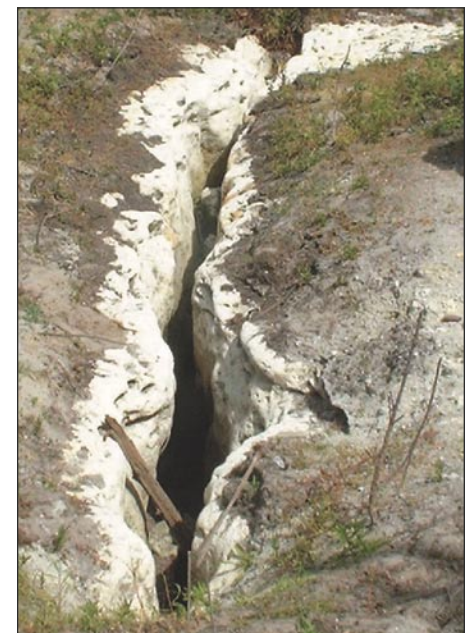
**Figure 5.** The crevasses.

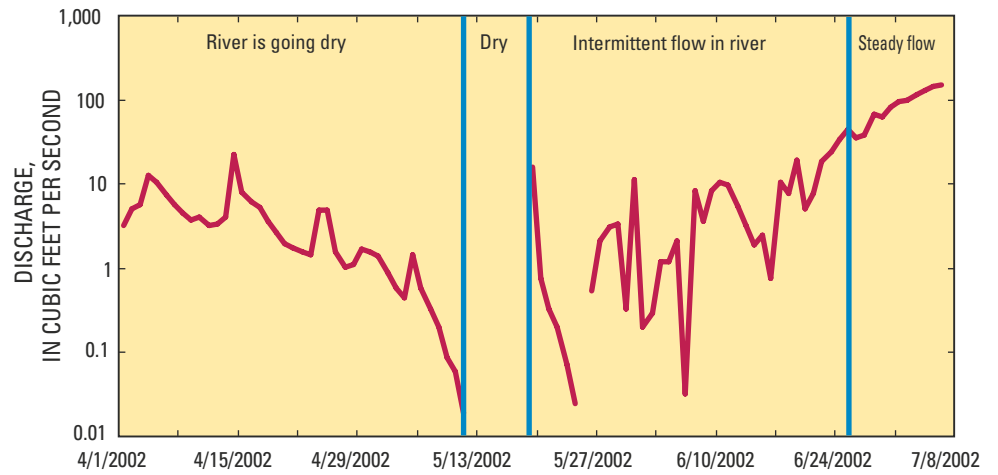
Figure 7. Streamflow hydrograph for the Peace River at Bartow gaging station.

The Peace River ceased flowing at the Bartow gaging station on May 12, 2002. Intermittent flow in the river was observed between May 19 and June 25 with the commencement of summer rain, and steady flow resumed again in late June 2002 as the frequency of summer storms increased (fig. 7). During the period of intermittent flow, surface water was lost to the ground-water system via karst features downstream from the Bartow gaging station; the length of the

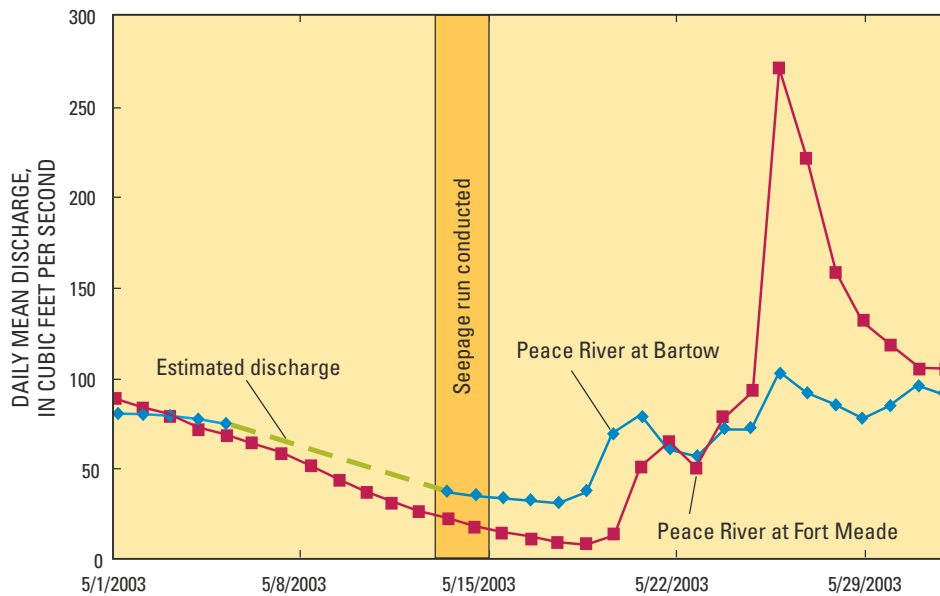
**Figure 8.** Streamflow hydrographs for the Peace River at Bartow and at Fort Meade gaging stations, May 2003.

A seepage run was conducted on May 13 to 14, 2003, at the end of the dry season. The daily mean discharge at the Bartow station (upper end) and the Fort Meade station (lower end) fell 2 and 8 ft<sup>3</sup>/s, respectively (fig. 8). The seepage run was designed to quantify gains and losses to the river during a steady-state period, representing low ground-water levels. To maintain steady-state conditions of surface-water flow, the control structures were not adjusted during the seepage run. The discharge measurements were made using either a standard (type AA) or a pygmy current meter and standard USGS streamflow measuring techniques. Synoptic measurements of streamflow were made at 21 cross sec-

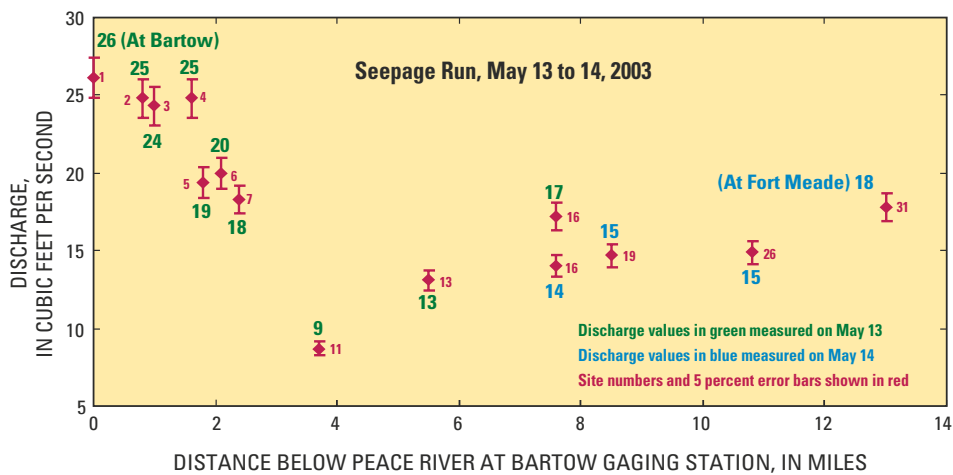
**Figure 10.** Peace River site numbers, discharge, and error bars for data collected during the seepage run conducted May 13 to 14, 2003.

During the May 2003 seepage run (fig. 10), decreasing streamflow was assumed to reflect seepage to the ground-water system. The error bars provided a way to separate measurement error from changes in stream flow. The inherent error in a “fair” discharge measurement in a natural river environment is estimated at  $\pm 5$  percent (Rantz and others, 1982). Changes in discharge greater than the range span by the error bars were accepted as net changes. Losses were insignificant (less than  $2 \text{ ft}^3/\text{s}$ ) between sites 1 and 2. No losses were measured between sites 2 and 4. Streamflow losses equaling  $6 \text{ ft}^3/\text{s}$  were measured between sites 4 and 5. Streamflow losses equaling  $10 \text{ ft}^3/\text{s}$  were measured between sites 7 and 11. The Clear Springs station (site 11) had the lowest discharge during the seepage run. Three mine outfalls and a drainage ditch contributed  $7 \text{ ft}^3/\text{s}$  of inflow to the Peace River between the Clear Springs (site 11) and Homeland (site 16) stations. Two tributaries contributed  $3 \text{ ft}^3/\text{s}$  of inflow to the Peace River between sites

26 and 31. Streamflow losses primarily occur along the reach between the Bartow

and Clear Springs stations, corresponding to locations of prominent karst features (fig. 9 and 10).

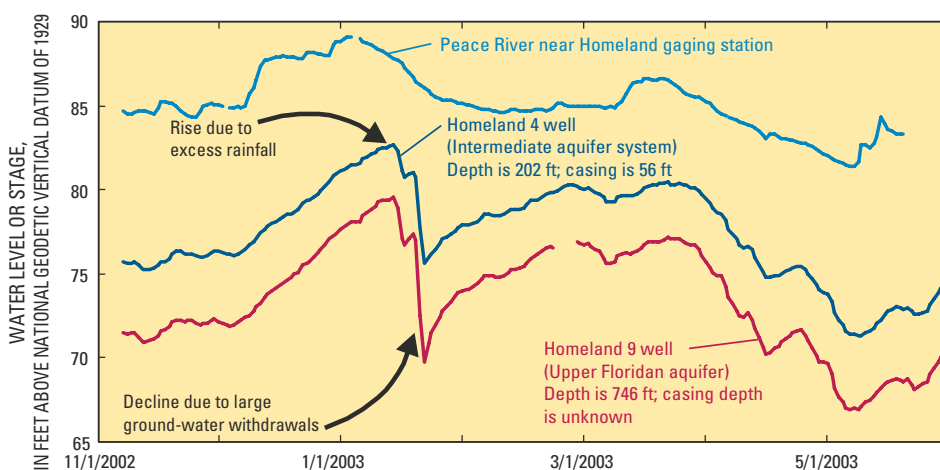
**Figure 11.** Surface-water stage and ground-water level hydrographs for Peace River near Homeland gaging station and Homeland 4 and 9 wells (November 2002 through May 2003).

between the river stage and the head in the intermediate aquifer system is smaller during the wet season and larger during the dry season, ranging from about 5 to 12 ft (fig. 11). The El Niño-Southern Oscillation condition resulted in above-normal rainfall that was reflected on hydrographs as steeply rising water levels in December 2002 (fig. 11). The dramatic drop in water levels on January 24 to 25, 2003, resulted from large ground-water withdrawals associated with frost and freeze protection of crops (fig. 11).
