## **Erosion and Sediment Delivery Following Removal of Forest Roads**

Mary Ann Madej

## ABSTRACT

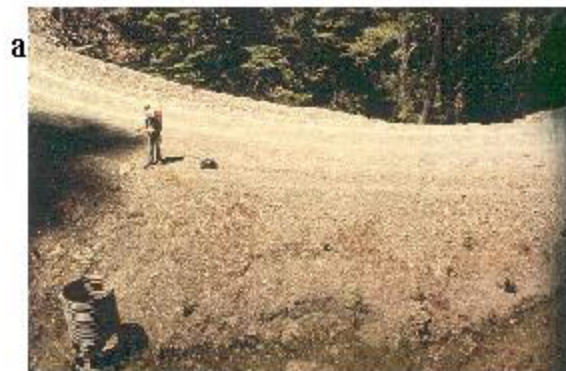
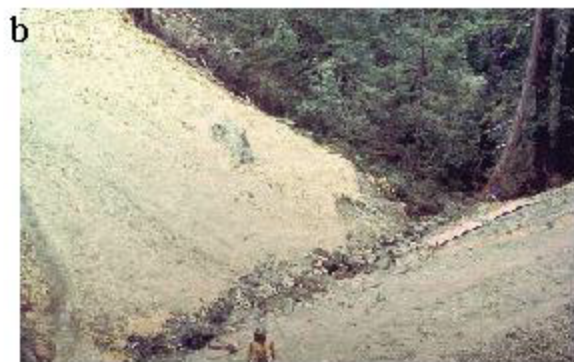
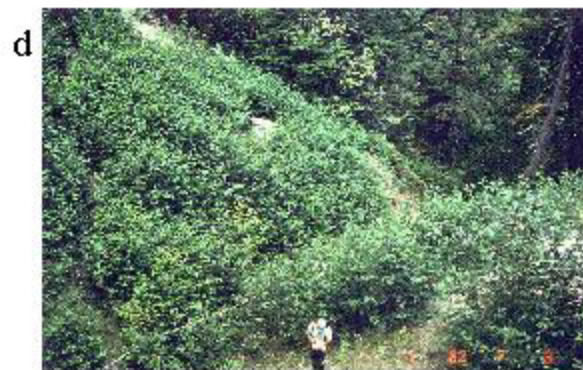
Figure 2. Typical stream channel excavation. a) Abandoned logging road with intact culvert before treatment. b) Immediately following stream crossing excavation. In this case, rock armor and check dams were installed on the channel bed to prevent downcutting. c) Less than one year later, revegetation of the streambanks is well underway. d) Three years after treatment, alders have revegetated most of the ground disturbed during treatment.

The first step in treating forest roads was to map the geomorphic and hydrologic features of the road and adjacent hillslopes. Erosion features, drainage structures, the stream network, and the location of all roads, skid trails, seeps, and springs were identified on enlarged aerial photographs at a scale of 1:1200. Following the mapping phase, road removal treatments were designed and implemented. In the early 1980's, road treatment work focused on removing culverts and pulling back road fill from streambanks (Figure 2a-d). In some cases, newly excavated stream channels were protected with check dams or large rocks (Figure 2b). The crossing excavations surveyed in this study varied from 100 to 7500 m<sup>3</sup> in volume, and averaged about 1000 m<sup>3</sup>. Stream gradients of excavated stream crossings ranged from 1 to 50 percent.

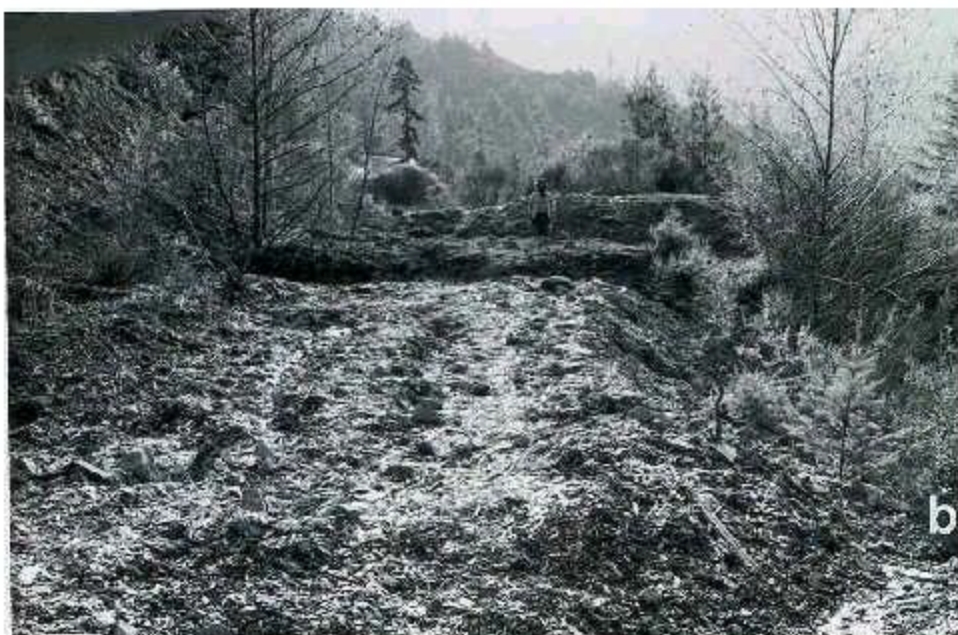
Figure 4. An example of the least intensive road rehabilitation technique. a) Abandoned logging road before treatment. b) The road surface is decompacted, and ditches are constructed perpendicular to the road alignment to drain the road. The road bench and road fill remain in place.

On road reaches between stream crossings, a variety of techniques were used, which varied in the amount of earth moving involved (Figure 3a-d). Treatments in the early 1980's decompacted the road surface and constructed drains perpendicular to the road alignment to dewater the inboard ditch (a technique referred to as "ripped and drained"). Typically, 200 to 500 m<sup>3</sup> of road fill were moved for every kilometer of road treated with this method. This approach is the least intensive treatment (Figure 3b). Following this treatment, the roads were mulched with straw and seeded and replanted with native vegetation (Figure 4a and b).

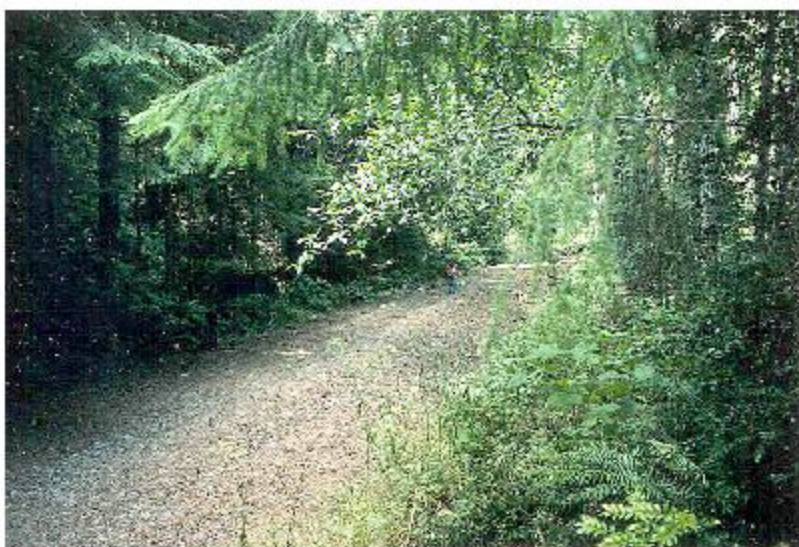
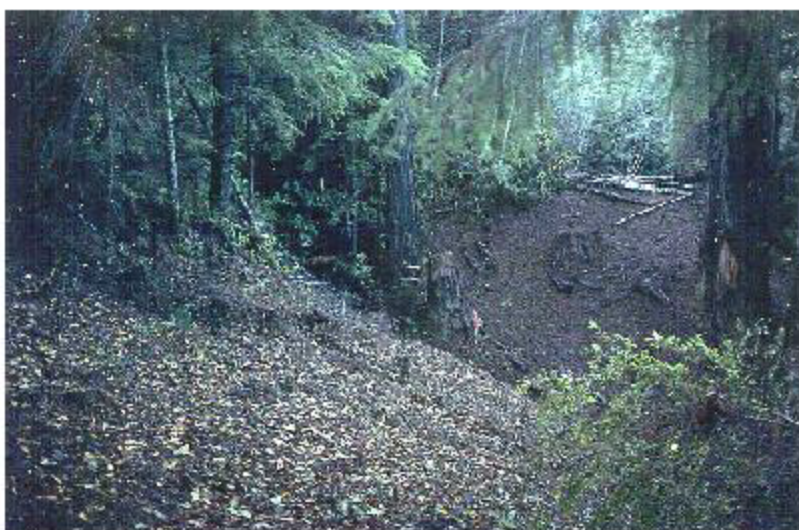
Figure 5. An example of the most intensive road rehabilitation technique. a) Abandoned logging road before treatment. b) The road bench is obliterated and the hillslope is recontoured (total outsloping of the road bench, and total excavation of the stream channel). Stumps uncovered during excavation indicate the location and elevation of the original hillslopes.

As the program progressed, park geologists began to use more intensive treatment methods, which included partially outsloping the road surface by excavating fill from the outboard edge of the road and placing the material in the inboard ditch at the base of the cutbank (Figure 3c). This technique required more earth moving (1000 to 2000 m<sup>3</sup>/km of treated road). By the 1990's, geologists commonly prescribed complete recontouring of the road bench (total outslope), in which the cutbank was covered by excavated fill, original topsoil from the outboard edge of the road was replaced on the road bench where possible, stream channels were excavated to the original channel bed elevation, streambanks were extensively reshaped and the road bench was fully recontoured (Figures 3d, 5a and b). Total outsloping involved moving an average of 6000 m<sup>3</sup>/km of treated road. Channel armoring was seldom used in this phase, but trees felled during road treatment were later placed in the stream channels and on the treated road surface. On some road segments, excavated road fill was removed from the road bench and transported to a more stable location, and this technique is termed export outslope (Figure 3e). The locations where the road spoils were placed are called fill sites. Export outsloping involved the greatest amount of earth moving (15,000 to 20,000 m<sup>3</sup>/km of treated road). Because surface erosion is not considered to be a major sediment source (Kveton *et al.*, 1983), and natural revegetation is

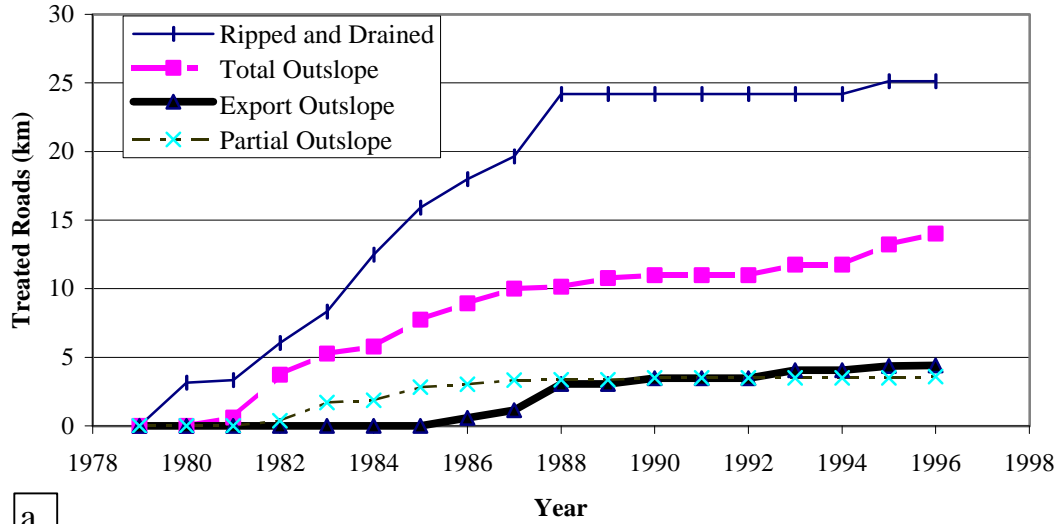
a

Figure 6a. Cumulative length of sampled roads by date and method of treatment.

**Cumulative Length of Road Treated by Date and Method**

The cumulative length of road treated by the different methods is shown in Figure 6a. Most roads that were ripped and drained were treated prior to 1988, and most export outcropping occurred after 1988. This means that most minimally treated roads were subject to more storms than roads which had more intense levels of treatment. A greater length of road was treated in early years, when treatments were still being refined. Due to budget constraints and more intensive treatment in later years, fewer road segments were treated in more recent years. Figure 6b shows the cumulative length of road treated by hillslope position. More lower hillslope roads were treated in the first few years of the restoration program than roads in upper and middle hillslope positions, and overall more lower hillslope roads were treated. The implications of these interactions among date of treatment, treatment method and hillslope position will be discussed more fully later.

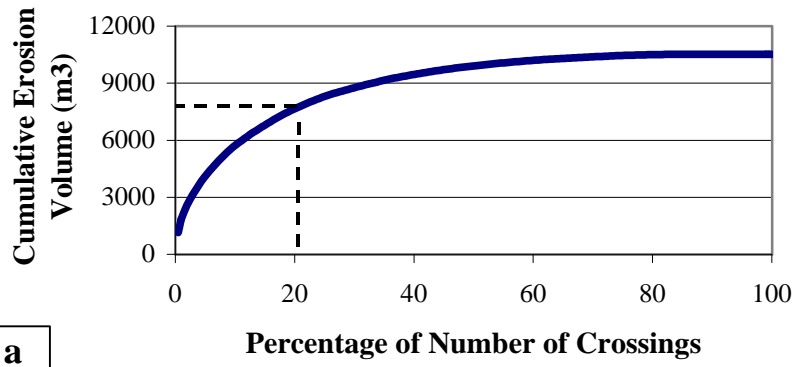
Figure 7a. Cumulative plot of total erosion from excavated stream crossings. Twenty percent of the crossings accounted for 73% of the total erosion.

### Cumulative Erosion Volumes from Crossings

Most excavated stream crossings produced very little sediment. (Crossings which had debris torrents originating upslope and off-site of the crossing excavation were not included in this analysis because the purpose was to look at the effectiveness of the road treatment itself). Twenty percent of the excavated stream crossings produced 73 percent of the total volume eroded from stream crossings (Figure 5a). Klein (1987) and Bloom (1998) suggest that most channel erosion occurs in the first few floods following treatment, and later adjustments of the channel form are smaller in magnitude. Virtually all the road fill eroded from the treated channels was transported off site by the time the crossings were inventoried.
