CHAPTER 13

A Conservator's Perspective

BERNARD RABIN

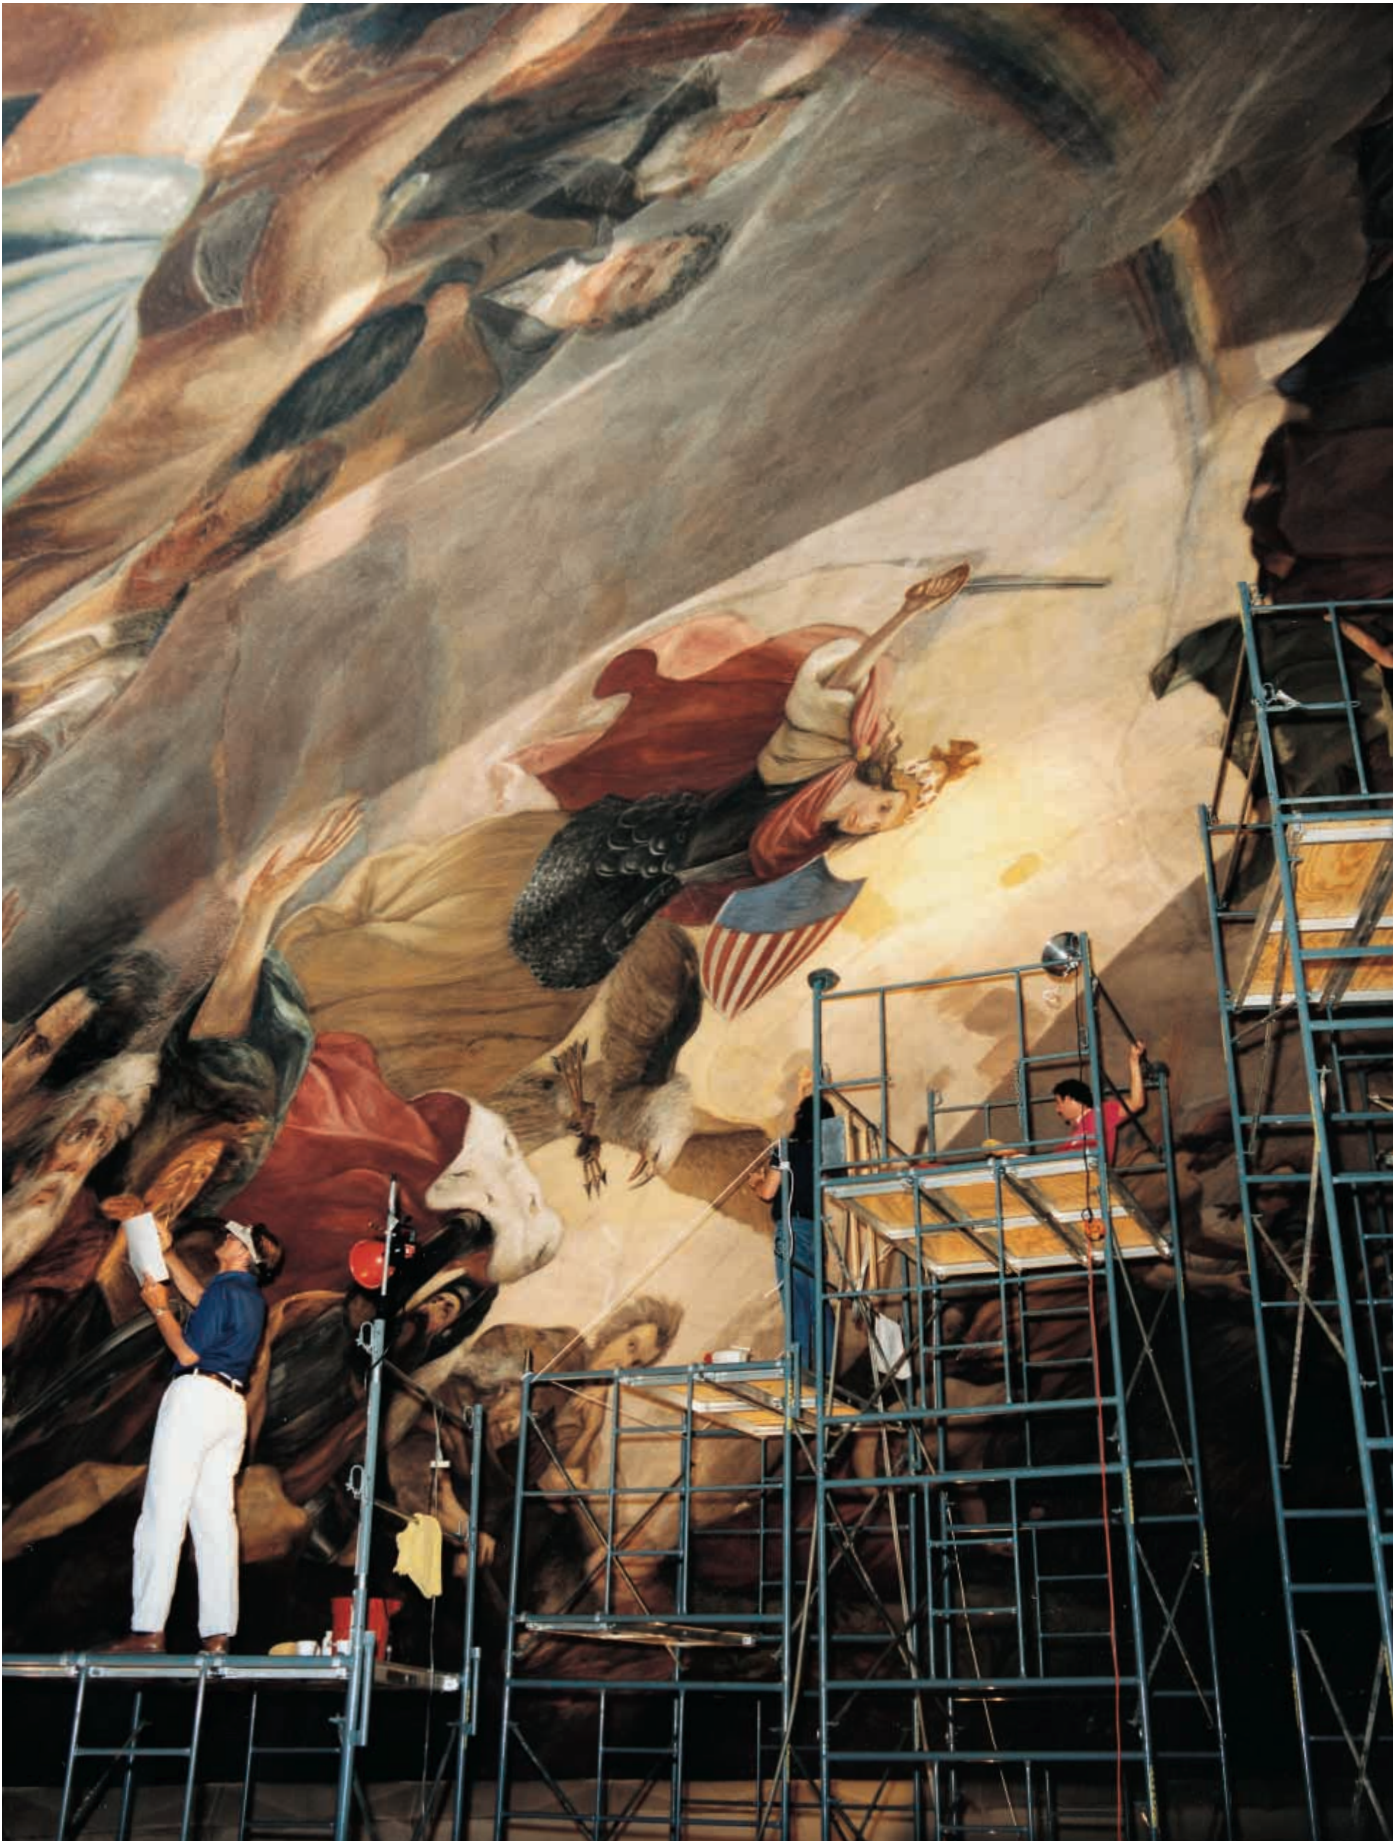
Fig. 13-4. Rolling scaffolds atop the fixed scaffold. *The conservators could reach all parts of the curved canopy from the platforms at varying heights.*

On the platform at the top of the fixed scaffold, smaller rolling scaffolds were provided to enable my team, which consisted of Larry Keck, Constance S. Silver, Perry Hurt, and Todd Overturf, to reach all levels of the concave canopy (fig. 13-4). Because there is no plumbing at the top of the dome, special pumps and drains were designed so that the murals could be cleaned with water.
