CHAPTER 15

The Process of Change in the Brumidi Corridors

CHRISTIANA CUNNINGHAM-ADAMS AND GEORGE W. ADAMS

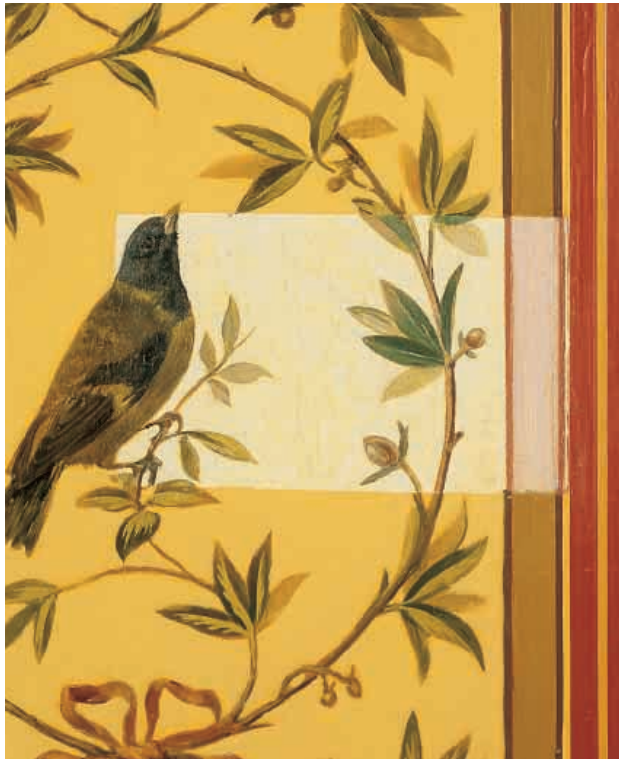
Fig. 15-2. Test removal of overpaint. *In comparison with the overpainted areas, the original painting is higher in quality, with the details of the black-headed grosbeak and vine delicately and accurately painted on a white background.*

were looking at was not the original but extensive inexpert repainting (fig. 15-2). We discussed our suspicions with Barbara Wolanin, Curator for the Architect of the Capitol, and were subsequently contracted by that office in 1993 to undertake a one-year technical study of the corridor decoration.

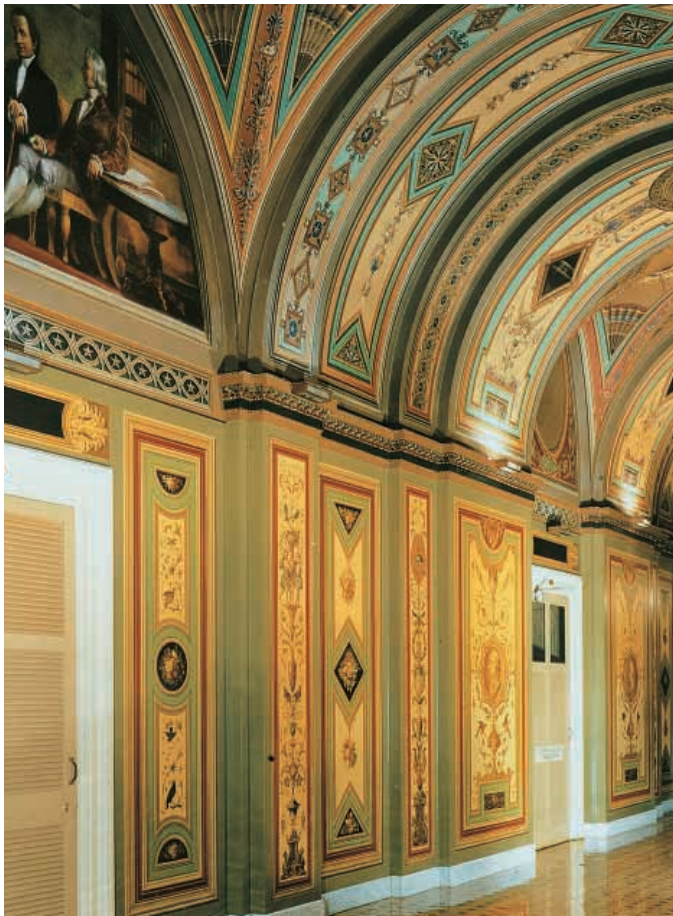
Fig. 15–3. Section of the North Corridor. *Overpainting over the years darkened and coarsened the original decoration of the walls, leaving the borders a murky green and the background fields yellow.*

The 1993 study confirmed that the unsettling qualities that distract from the extraordinary beauty of the Brumidi Corridors are the result of changes made subsequent to their creation (fig. 15-3). We discovered that the original paintings lay essentially intact buried under repainted layers,

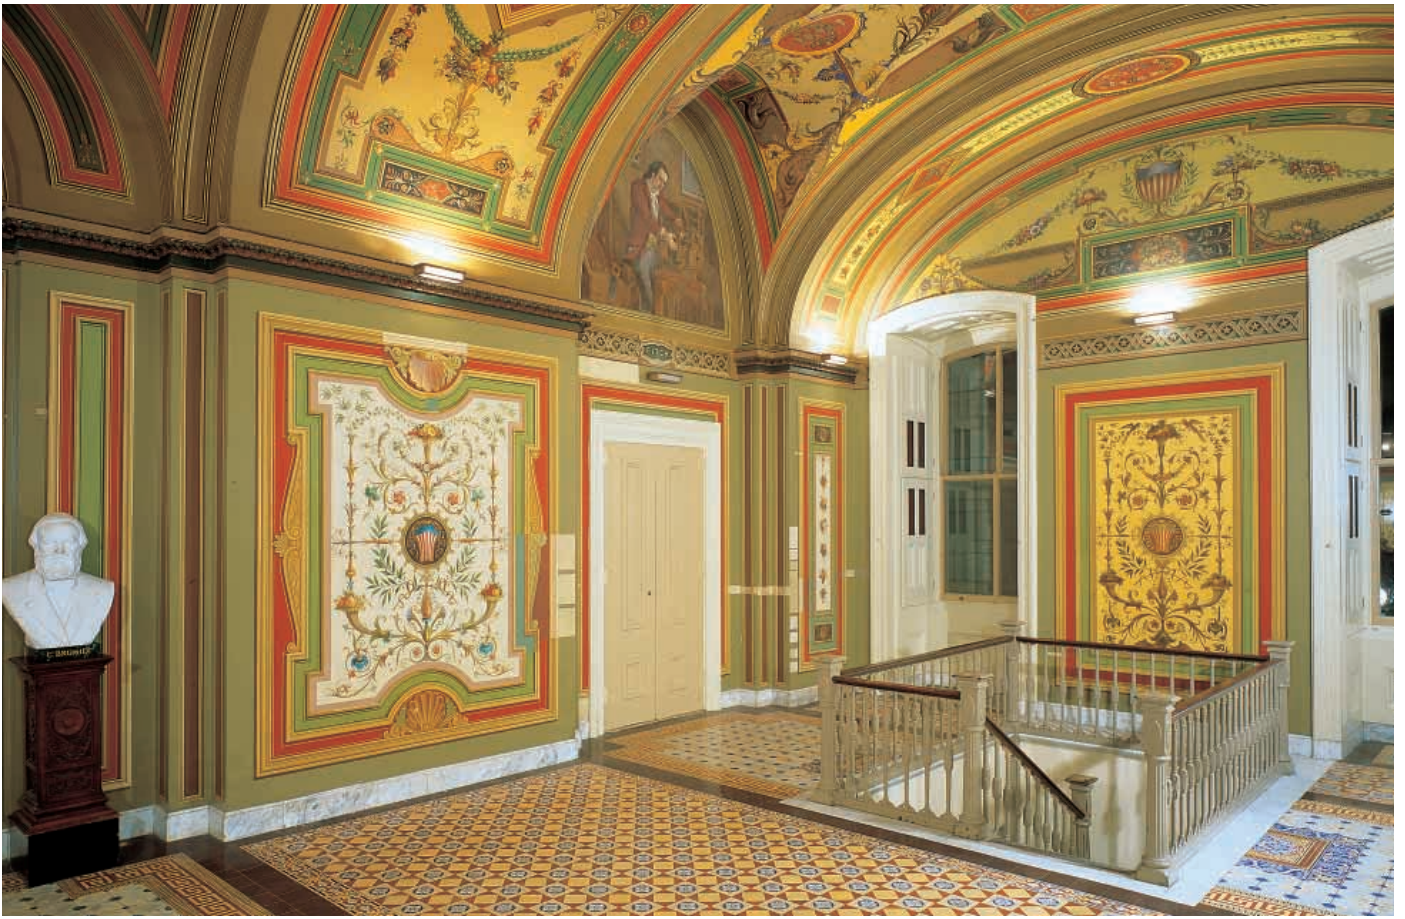
Fig. 15–5. Patent Corridor with two conserved panels.

Exposure of the first large sections of original paint layers in the initial phase of the corridor restoration produced bright, limpid colors that dramatically contrast with the untreated panel to the right.

the ten-year project was begun with a pilot phase funded for 1996. In the initial phase of the project, the large sections of original surface that were uncovered fulfilled the promise of our research (fig. 15–5) and provided the final confirmation of our hypothesis of the process of change. The metamorphosis we had slowly unraveled proved to be an exemplary case study of the gradual transformation sometimes imposed on a work of art that can camouflage the artist’s intent and take the art out of its proper place in time and art history.

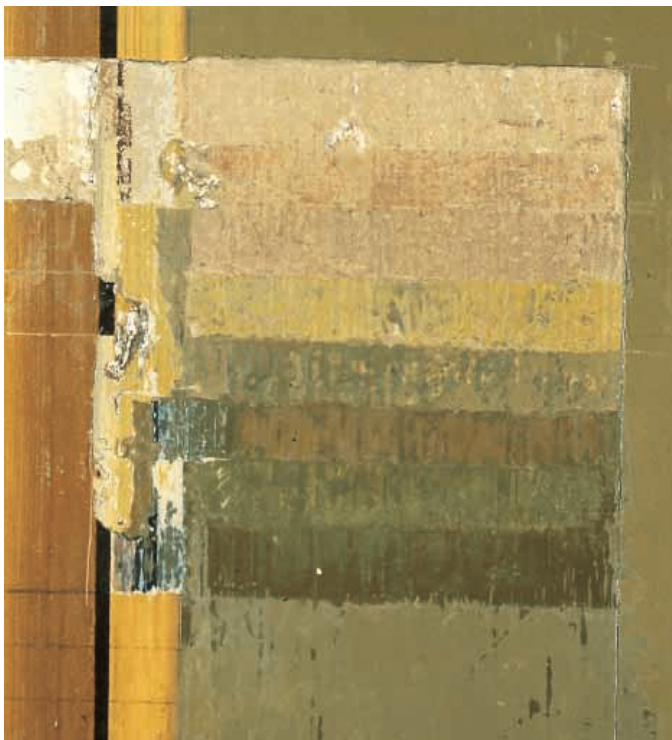
Fig. 15–6. Test window showing the gradual color shift in overpaint. This scala through layers of overpaint at the edge of the trompe l'oeil molding shows nine major paint layers. They shift from the lowest, original, layer of stony light gray to muddy green.

paint layers step by step) (fig. 15–6) confirms what one would expect: there was no sudden, dramatic change of color, but rather a gradual process of drift, which varied in different areas. For example, in the northern end of the Main Corridor, the wall panel surrounds are presently a chocolate color. Visually, this region now seems utterly unconnected to the adjacent North Corridor, but it originally had the same colors as the North and West Corridors.

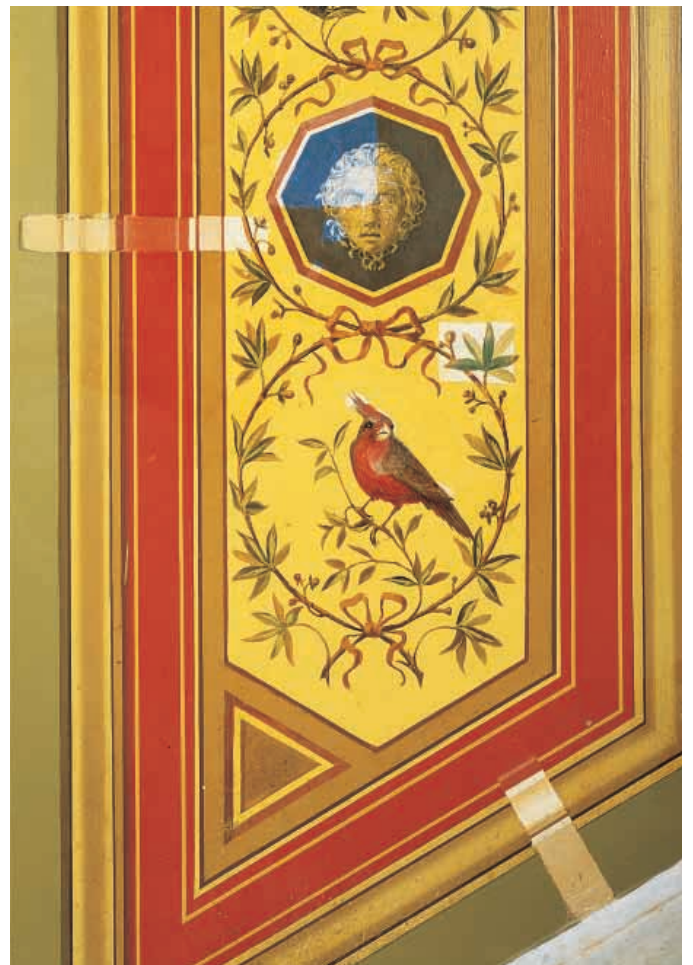
Fig. 15–8. Panel in main corridor with early test windows. *The discovery of the much lighter colors and delicate details showed the value of uncovering Brumidi’s original designs.*

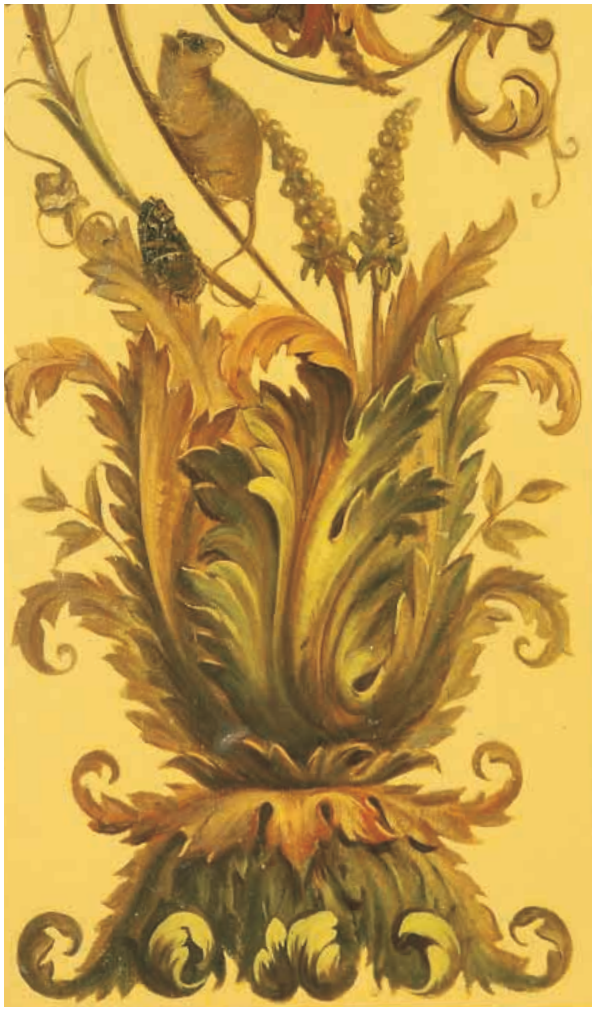
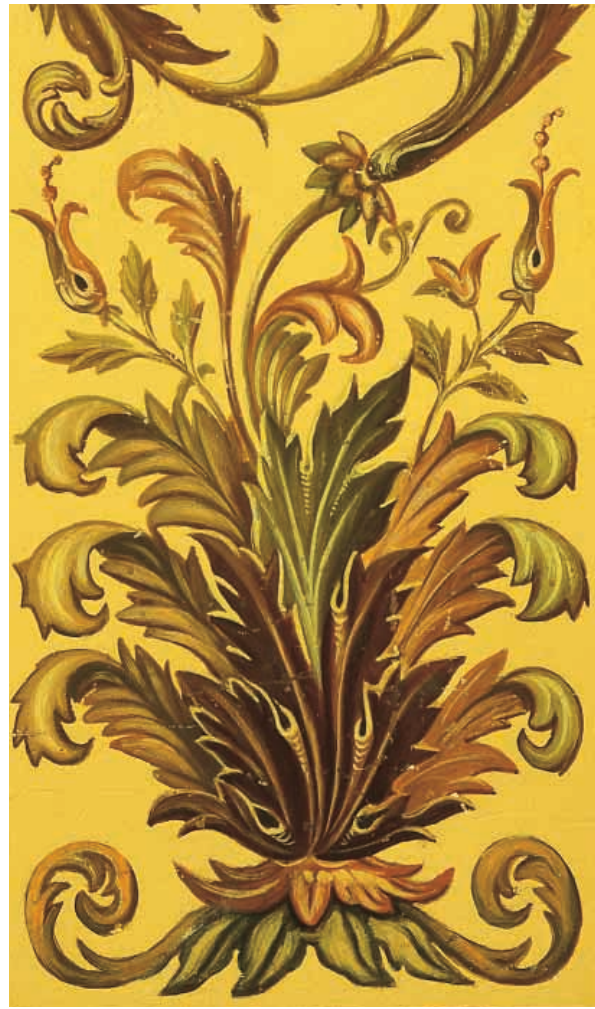
Fig. 15-9. Comparison of overpainted acanthus leaves. *In the corridors, the acanthus leaves range from three-dimensional forms that appear to be growing (left) to crude and flat outlines resulting from heavy-handed overpainting.*

On the overpainted surfaces, the stylistic drift can be seen in samples of acanthus, which appear frequently in the corridors. The drift is so conspicuous throughout the Senate wing that the painted acanthus leaves can be used as an indicator of the amount of change that has occurred in any section of the hallways since that section was first painted (fig. 15-9).

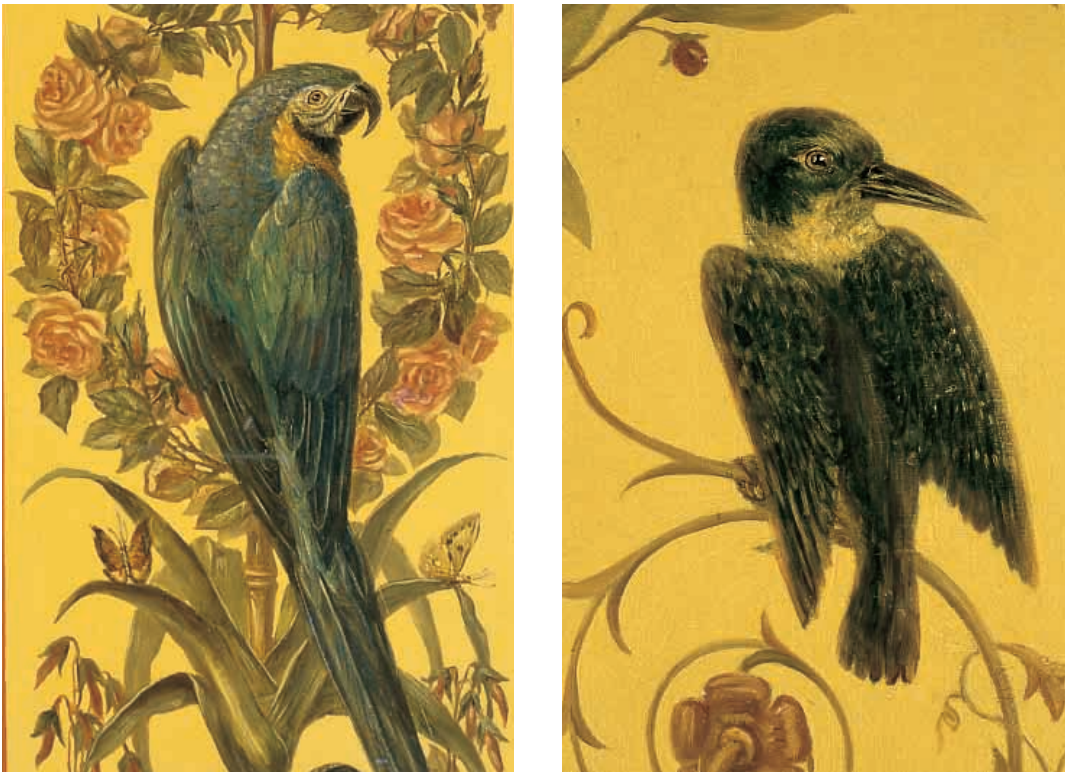
Fig. 15–10. Varied conditions of overpainted birds. *The original birds of the corridors, such as the blue macaw at left, were painted with the accuracy of good ornithological illustration of the period. In areas subject to damage, birds have “mutated” through repainting. The belted kingfisher, for example, has lost its distinctive crest and gained a sparrow’s tail.*

A study of the birds of the Brumidi Corridors also offers insight into changes in the decorative scheme because each was intended to portray accurately a creature whose actual appearance is known to us. The birds obviously were painted with skill and with the intent to be faithful to nature; therefore, even though painted by different hands and at different times, they can be used to measure the degree of stylistic change. The corridors can be seen as an ecosystem in which the natural processes of evolution, interbreeding, and genetic leaps

remain active as a result of overpainting. Generally the birds show a tendency toward the appearance of their corridor neighbors, as if by cross-species interbreeding; natural forces seem to encourage shrinking and coarsening of appendages and outline; occasionally a grand mutation occurs. Just as DNA divergence forms a measure of evolutionary distance, the divergence of these birds from their natural models forms a good measure of the degree of overpainting that has been applied to them and probably, therefore, to the surrounding decoration (fig. 15-10). In the first phase of the restoration in 1996, panels decorated with daisies and roses were restored to reveal a wide variety of more colorful flowers such as hydrangea, poppies, hibiscus, and morning glories; the daisies and roses painted over them in the 1930s repainting reflect the American tastes of that period (fig. 15-11).

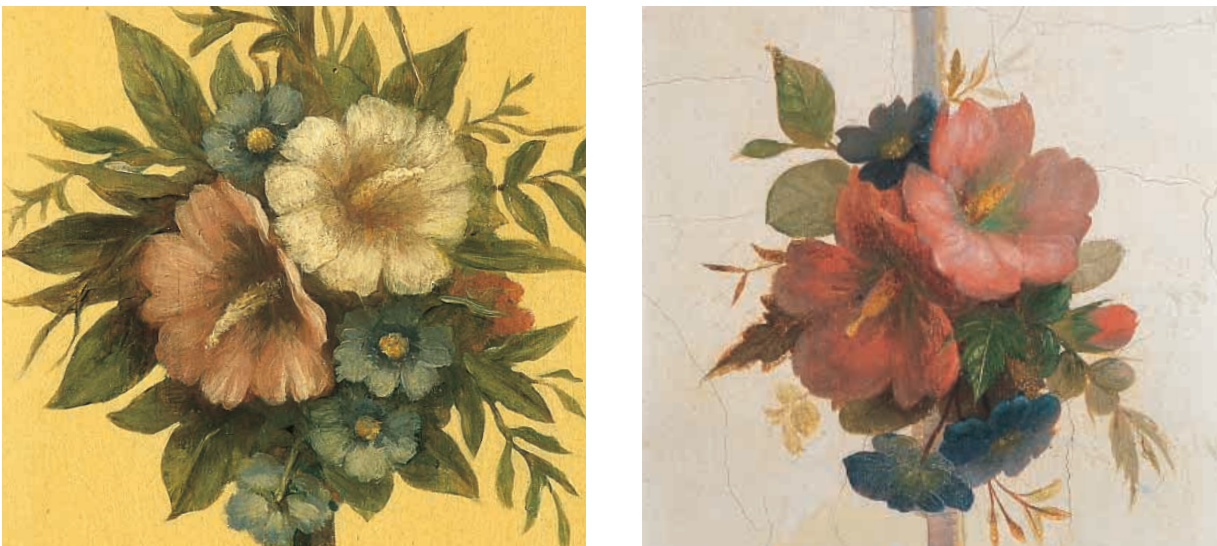
Fig. 15–11. Details of floral panel before and after conservation. *The heavy oil overpainting of the uppermost layer (left) showed stiff, leaden flowers of unspecific character. Underneath them were found delicate and brilliant morning glories, poppies, and hibiscus (right) on the original paint layer, which needed only minor repair.*

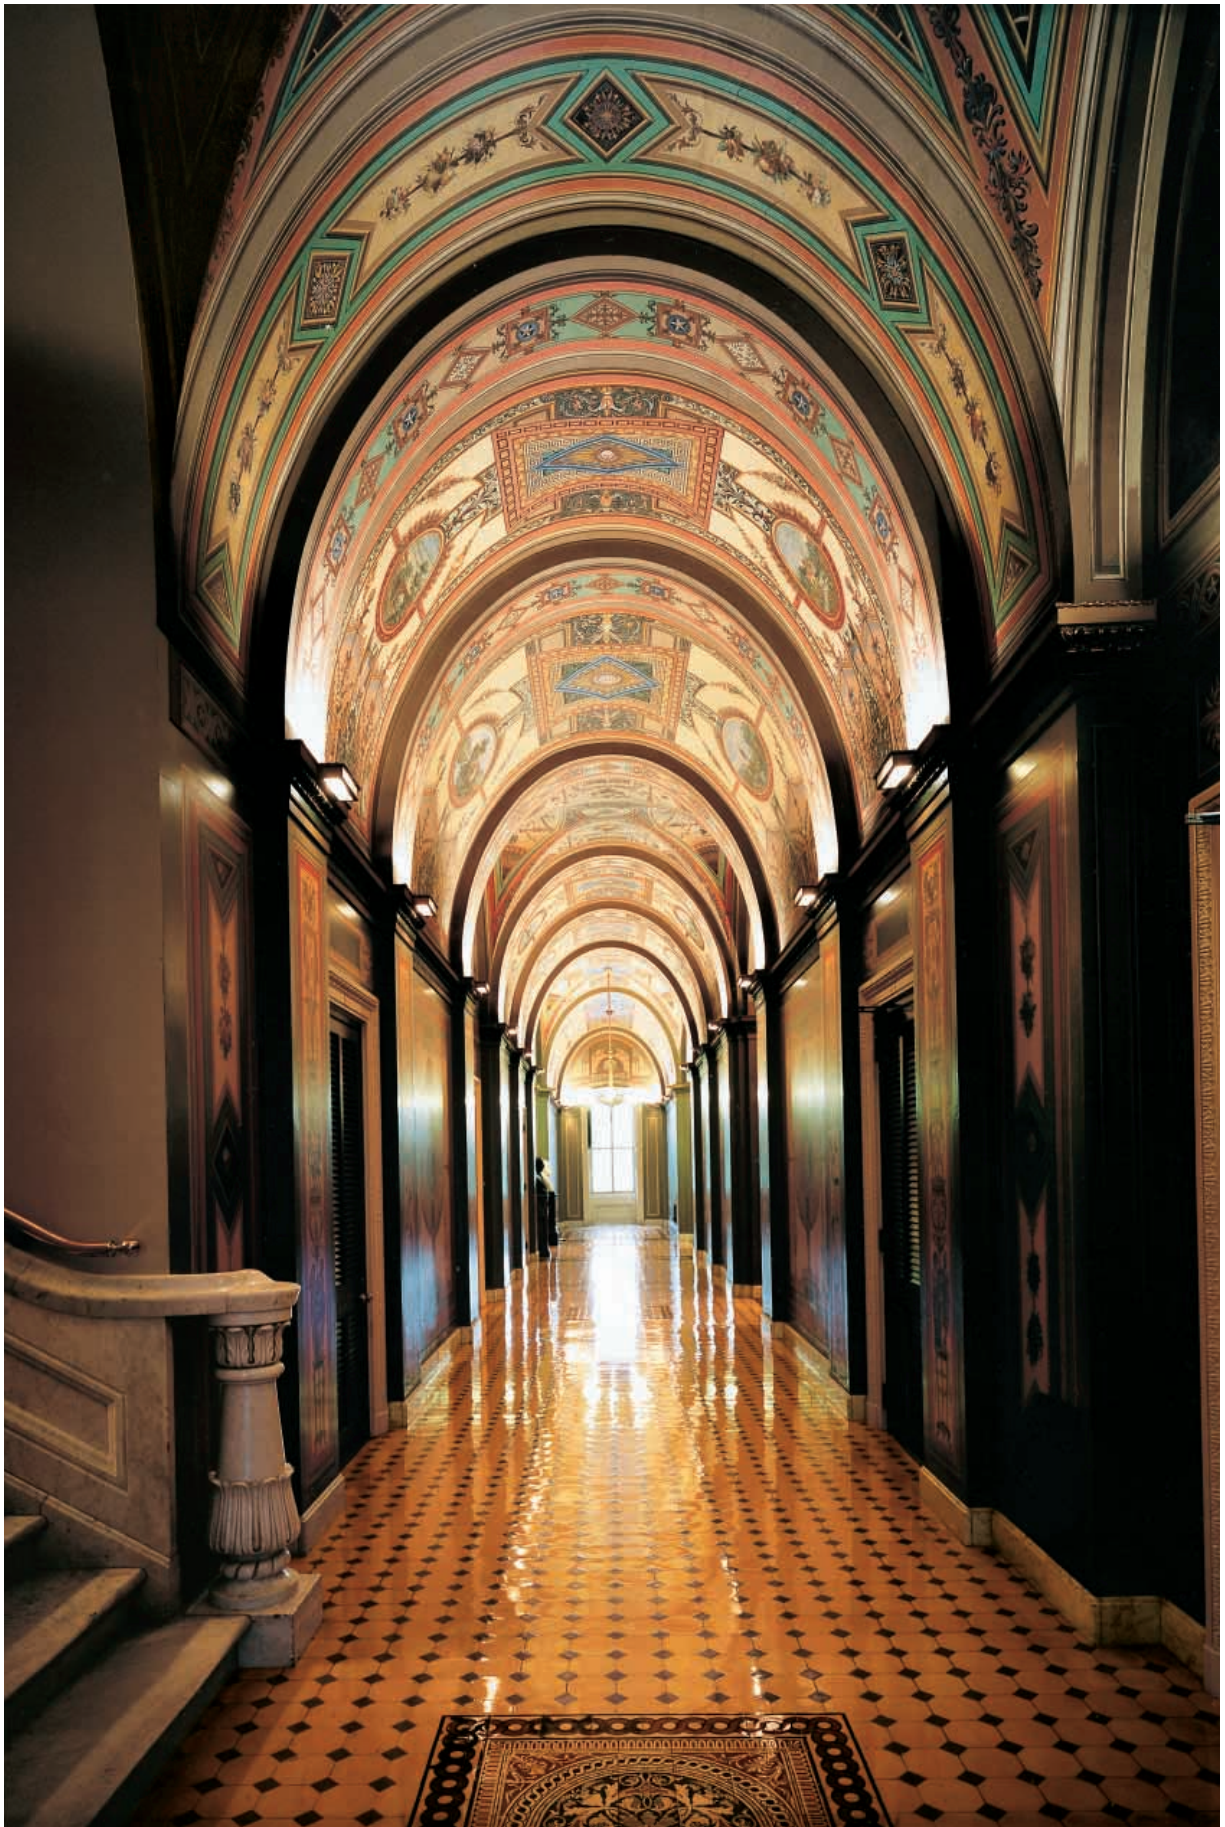
Fig. 15–12. Effect of modern lighting. *The light reflecting ten times brighter on the ceiling of the corridors than on the walls exaggerates the visual separation of the two elements.*

In the course of time, at least two major renovations of the corridor lighting system were made. The first was the introduction of electric lighting; the second was a renovation of the electrical system the 1960s, a period when reflected lighting was gaining popularity. These changes were undoubtedly necessary, and they achieved appropriate overall light levels. But they brought with them some unfortunate results—in particular, a large imbalance between the illumination of the ceiling and the illumination of the walls (fig. 15–12). This imbalance severely disrupts the original visual unity of the ceilings and walls and makes the cornice a harsh dividing line between the surfaces, compounding the effect of the changes in palette and execution medium on the walls.
