Examination Of The Nondestructive Evaluation Of Composite Gas Cylinders

FINAL REPORT

September 2002

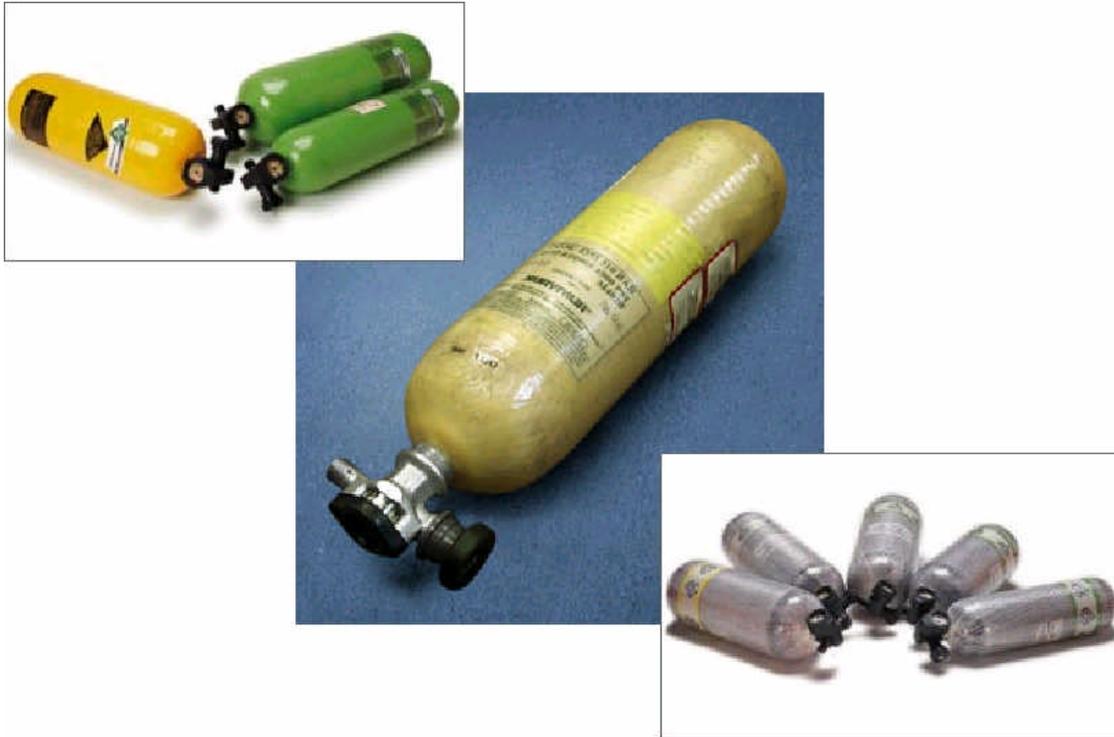
Figure 2-1. Compressed gas cylinders: fiberglass (upper left), Kevlar (center), and carbon-wrapped (lower right). Fiberglass and carbon cylinders were used for the initial feasibility study; Kevlar cylinders, although not used during this phase of study, were acquired for follow-on work.

Currently the requalification and recertification process for composite wrapped gas cylinders (Figure 2-1) requires hydrostatic testing followed up with a visual examination, repeated every three years up to a maximum of 15 years.

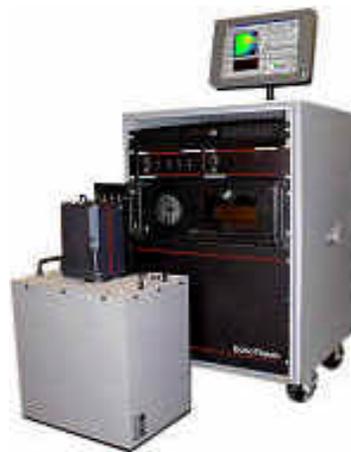
Figure 3-9. The EchoTherm NDT system used to inspect the composite cylinders.

The inspection was performed using the EchoTherm32 NDT system (Figure 3-9) and a InSb FPA IR camera operating at 60

Hz in the 3-5 mm spectral range. A thin layer of black washable paint was applied to the outer surface to increase optical absorption and IR emissivity of the sample surface.

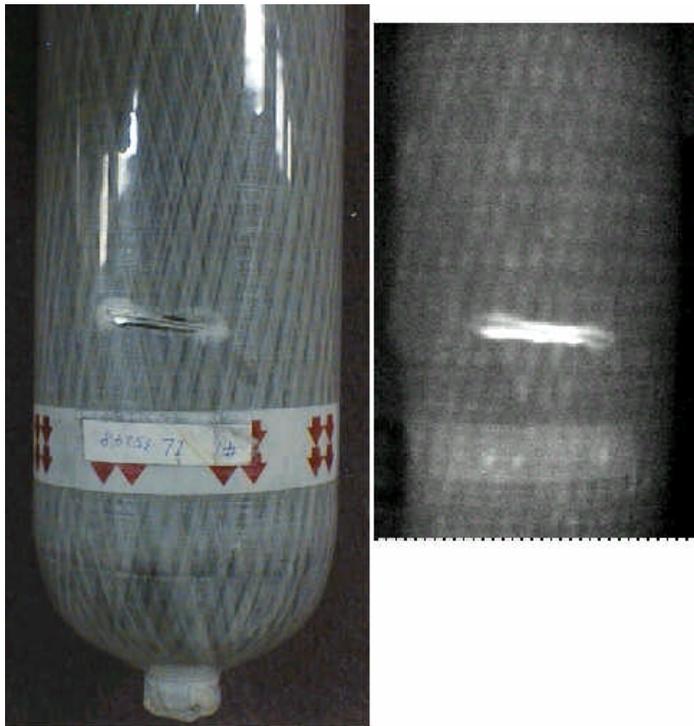
Figure 4-3. Visual and thermographic pictures of Cylinder 1 (IL35248), illustrating the visibility of the impact damage on the composite cylinder.

The thermography feasibility studies were able to demonstrate surface and sub-surface flaw detection, as illustrated in Figures 4-3 through 4-5, which show both the conventional visual and the corresponding thermographic image of damaged cylinders.

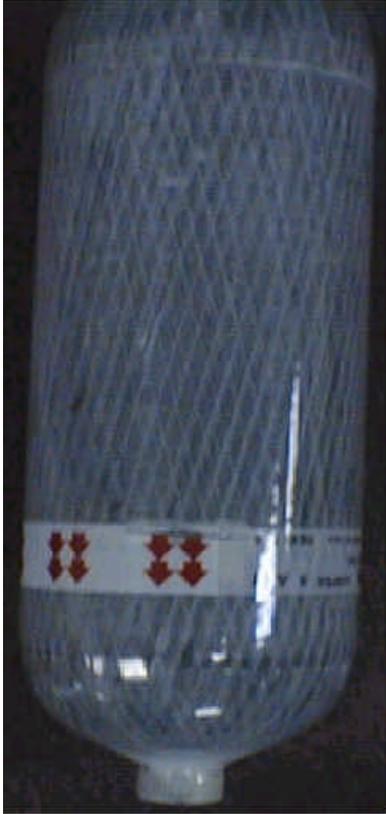
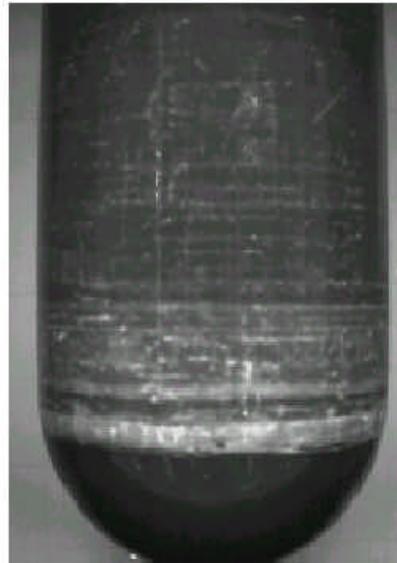
Figure 4-4. Comparing visible and thermographic indications of impact damage in Cylinder 3 (IL35250). In contrast with the thermograph of Cylinder 1, which has a similar severe impact anomaly, the impact damage in Cylinder 3 is not as clearly visible as in Cylinder 1.

Interestingly, thermography was not able to detect the clearly visible impact damage on Cylinder 3 (Figure 4-4), while it was able to detect a similar level of impact damage in Cylinder 1 (Figure 4-3). The impact damage in Cylinder 3 was not as extensive as that in Cylinder 1, but was nonetheless severe. While acoustic emission testing did recommend scrapping Cylinder 3, thermographic testing would likely have passed the cylinder. In future studies, NTIAC suggests that both cylinders be burst tested to determine if the damage in Cylinder 3 would be sufficient to be condemned.

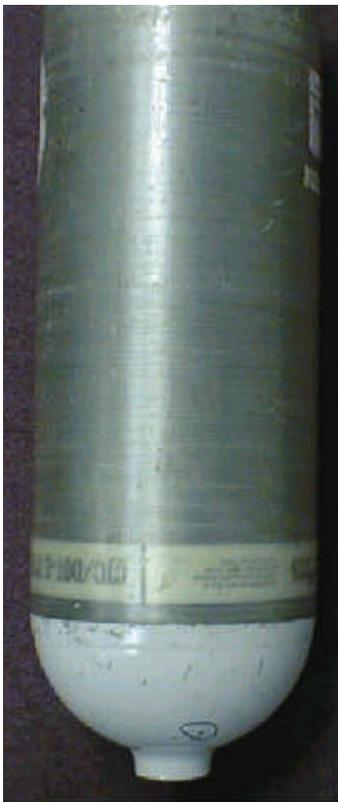
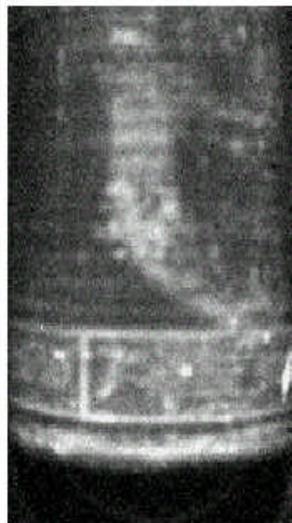
Figure 4-5. Comparing visual and thermographic images of one of the retired fiberglass cylinders. Although no damage is apparent in the conventional image, the thermograph clearly shows a sub-surface anomaly in the cylinder that would otherwise have escaped detection.

The thermographic feasibility studies were also able to demonstrate detection of sub-surface anomalies, as illustrated in Figure 4-5. Although thermographic techniques were not able to achieve 100% penetration of the composite, NTIAC recommends that thermography be included in the follow-on work.

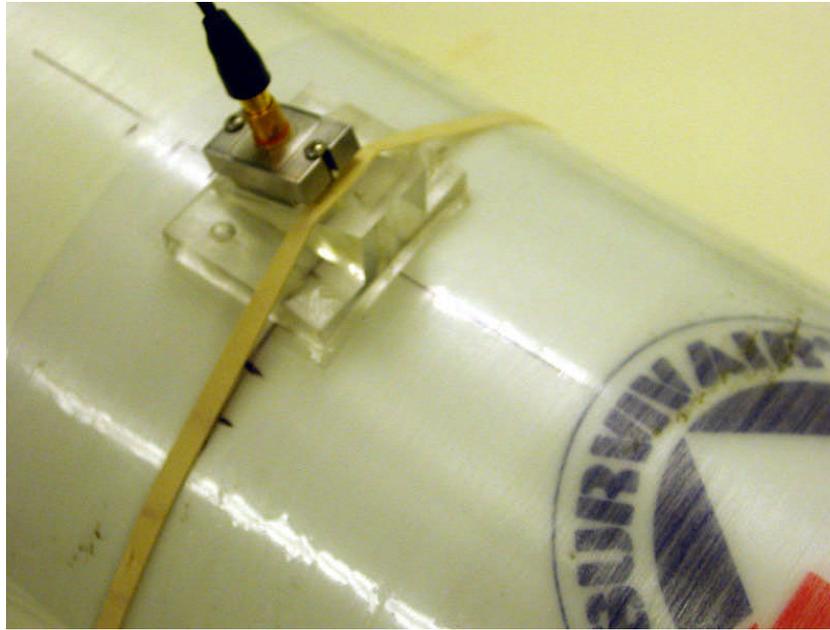
Figure 4-6. Close-up picture of the angle beam wedge on tank

The original intent of the ultrasonics feasibility study conducted by Don Bray Engineering was to excite L_{CR} waves using the probe arrangement as shown by the angle beam wedge on the fiberglass tank (Figure 3-10 and Figure 4-6). The wedges were machined based on an assumed wave speed, which ultimately proved incorrect. As a result, an alternative approach was employed, in which a single source transducer with a pencil receiver looking at the wave patterns along radial lines from the source. This is a normal, longitudinal wave 5.0 MHz, $\frac{1}{4}$ inch diameter source probe with a 20 MHz pencil probe as the receiver (Figures 4-7 and 4-8). The plan was to trace the arrivals along radial lines from the source, which would allow for the examination of the ultrasonic properties of the tanks.
