1.0 INTRODUCTION

In response the RSPA contracted the Nondestructive Testing Information Analysis Center (NTIAC) to quantitatively evaluate three common methods of cylinder inspection: visual testing (VT), eddy current testing (ET), and ultrasonic testing (UT). Conducting an extensive round-robin testing procedure, NTIAC evaluated the performance of each technique in terms of its accuracy and reliability in detecting flaws in the neck and shoulder region of the cylinder. This report is a summary of our findings and concludes with a recommendation to the RSPA on a testing technique and procedure.

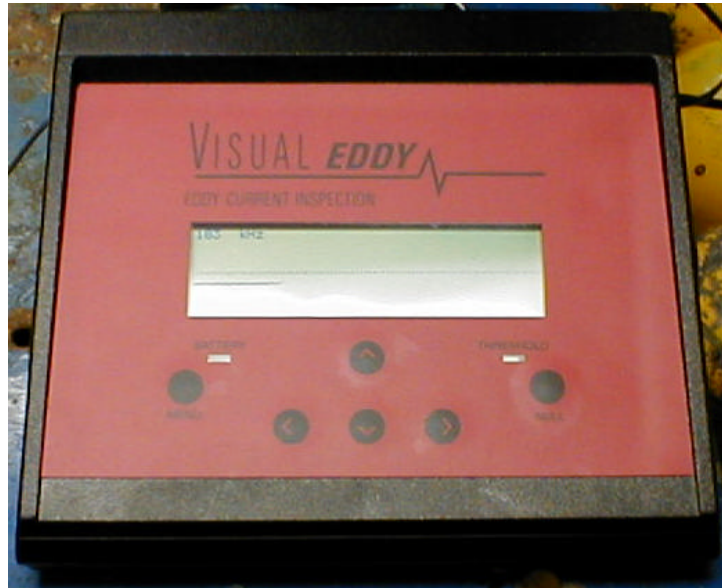
Figure 2-4. Eddy Current Equipment used in the Project. This is one of several systems that are commercially available for eddy current inspection of thread regions. The authors, the RSPA and the DOT do not endorse any specific system manufacturer.

equipment used for this investigation is shown in Figures 2-4 and 2-5.

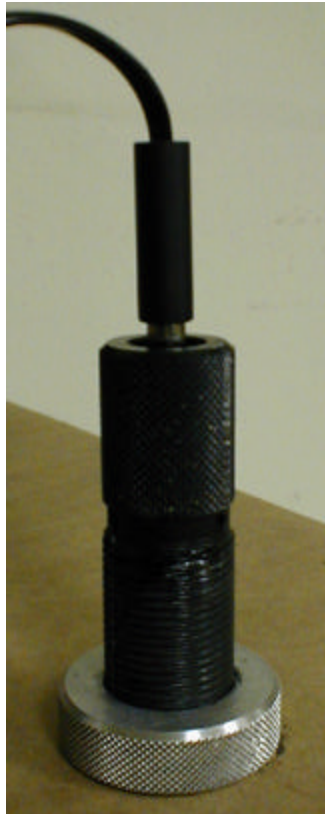
Figure 2-5. Closeup of an Eddy Current Probe Threaded onto the Calibration Block

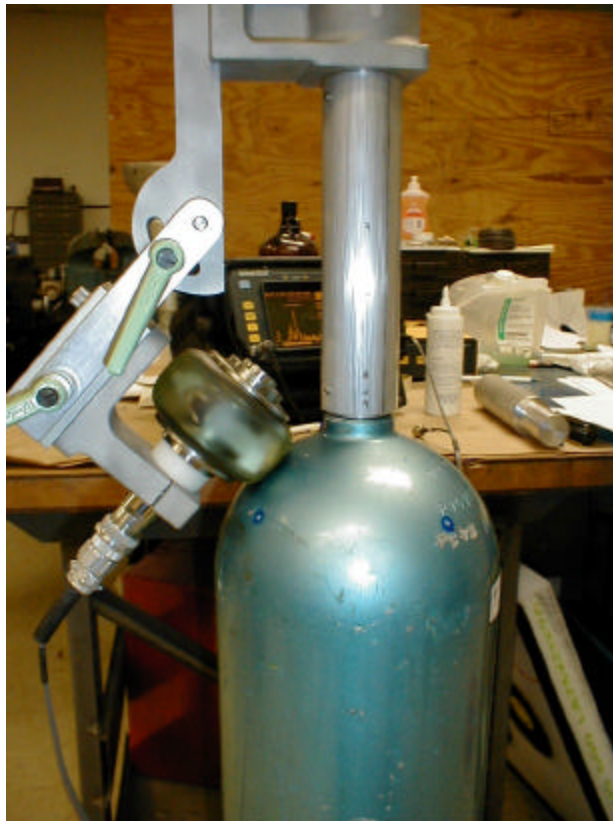
Figure 2-7. Example of a UT Inspection In Progress

The system NTIAC used for this project sends the ultrasonic shear waves energy around the shoulders of the cylinder, which has the effect that the system is actually “looking” forward (i.e., clockwise) from its transducer position by approximately 90°. By looking at the shoulder, the ultrasonic system has the potential to detect a crack at the earliest stage, since it is looking primarily at the position most frequently observed as the site of crack initiation. In contrast, both VT and ET primarily inspect the threads in the neck of the cylinder, although VT inspectors are trained to inspect deeper into the bottle as well. As a side-effect of inspecting from the shoulders rather than the neck, UT inspection is not examining threaded neck of the cylinder for the size of a crack as do VT and ET, but rather detect SLC in the shoulder of the cylinder. The UT inspectors must have higher level of training to produce accurate flaw profile. A picture of the UT inspection “arm” is shown in Figure 2-6, and its placement and use on a SCBA bottle is shown in Figure 2-7.

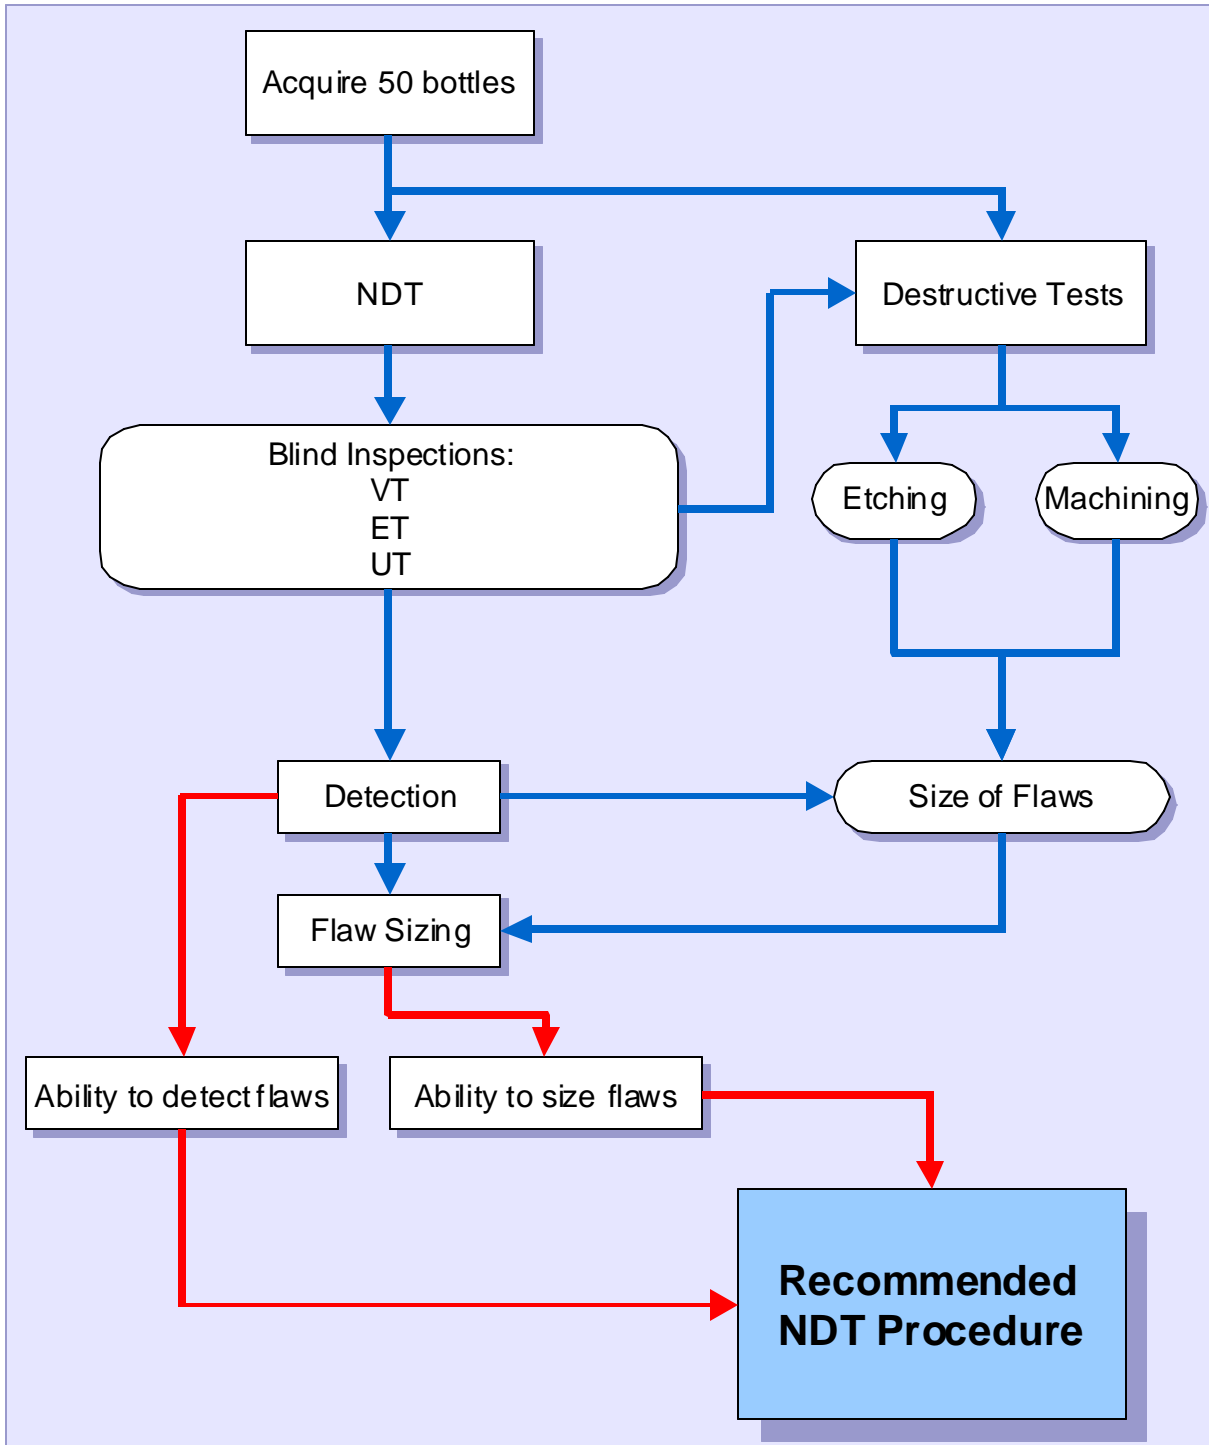
Figure 3-1. Illustration of the Test Progression Used in the Project

The original outline of the testing procedure is illustrated in Figure 3-1. To initiate the project NTIAC arranged to have 51 cylinders¹ shipped from Luxfer's California and North Carolina facilities for the test population. These cylinders varied in their age and condition, having been used in the field for some time prior to being "condemned" by an inspector and sent back to Luxfer. The cylinders were to be first inspected via the three methods of NDT, after which destructive testing would be used to gauge their results.

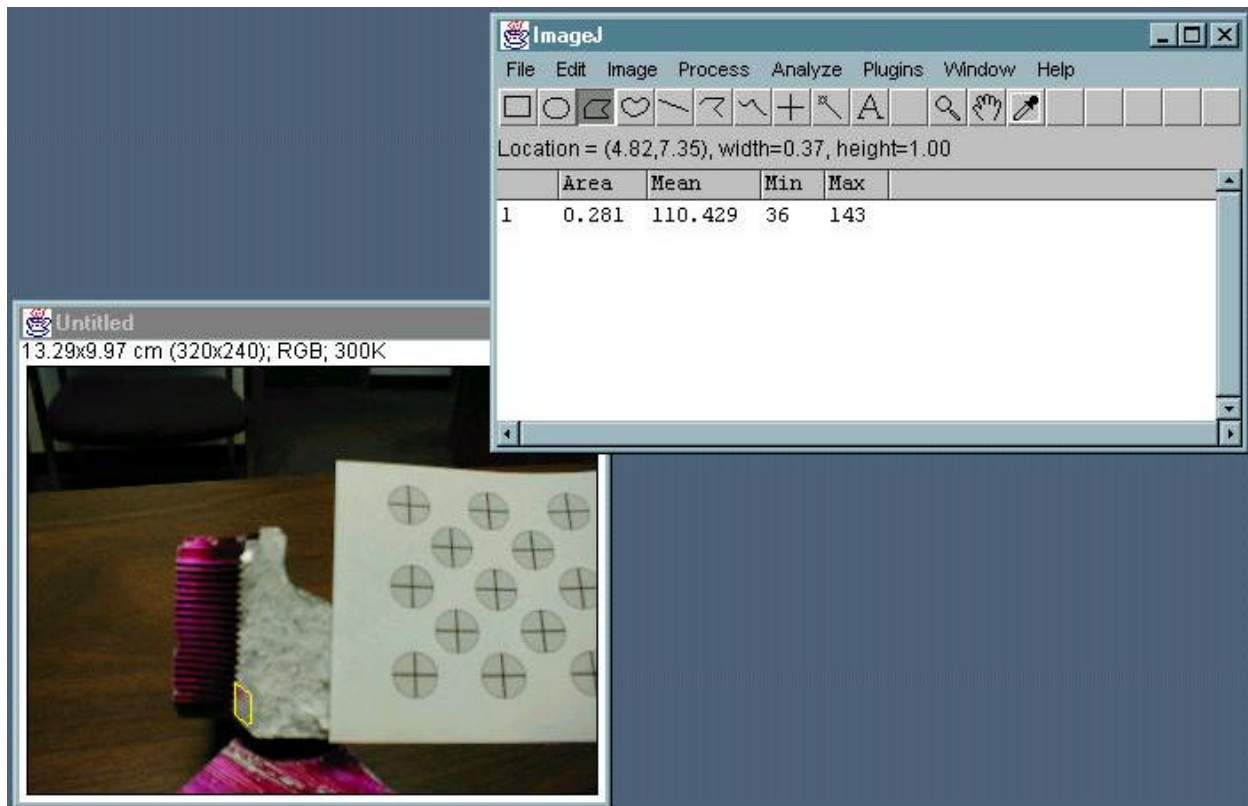
Figure 3-5. Screen Shot of the Java Application ImageJ Produced by NIH, being used to Find the Cross-sectional Area of a Crack in a SCUBA Tank

When a picture of the crack face is calibrated to a known physical dimension, ImageJ can be used to analyze regions of the image in various ways. As an example, Figure 3-5 shows a screen shot of ImageJ being used to find the cross-sectional area of a crack face.

In each of the pictures, a grid pattern was included to assist in calibration within ImageJ. Each of the circles seen in the crack image in Figure 3-5 is of a known diameter of 1.00 centimeters. The calibration procedure is then to measure the diameter of a circle in the picture's horizontal and the vertical directions in order to correct for the picture's aspect ratio. The extent of the crack was determined visually, but for purposes of verifying repeatability, the extent of the crack face shown in Figure 3-6 was determined by additionally plotting a grayscale profile of the crack. The crack's deepest point of penetration into the aluminum was measured visually in ImageJ at approximately 0.50 centimeters: the profile plot of Figure 3-6 estimates this extent at 0.48 centimeters. Thus, visually determining the extent of the crack was seen to agree quite well with the alternative procedure.

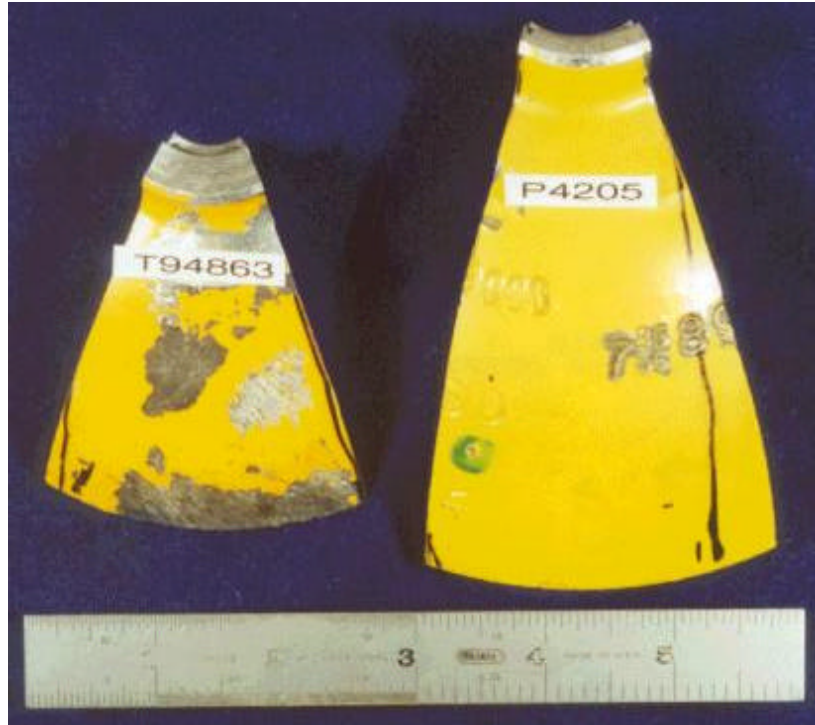
Figure 3-9. Photographs of Cylinder Sample T94863 and P4205 Showing a) the OD Surface and b) the ID Surface

2. The yellow paint on the cylinders, shown in Figure 3-9, was stripped from the OD surface.
3. The two cylinder samples, T94863 (Sample A) and P4205 (Sample B), were EDM-machined. The EDM setup is shown in Figure 3-10.

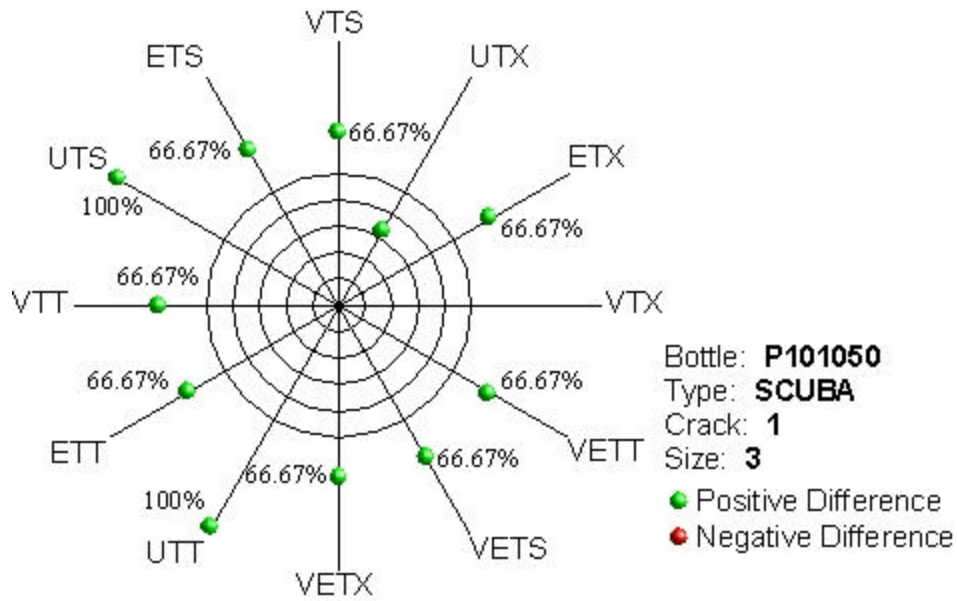
Figure 4-5. Reported Flaw Size for the First Crack in SCUBA Bottle P101050 for Each Inspection

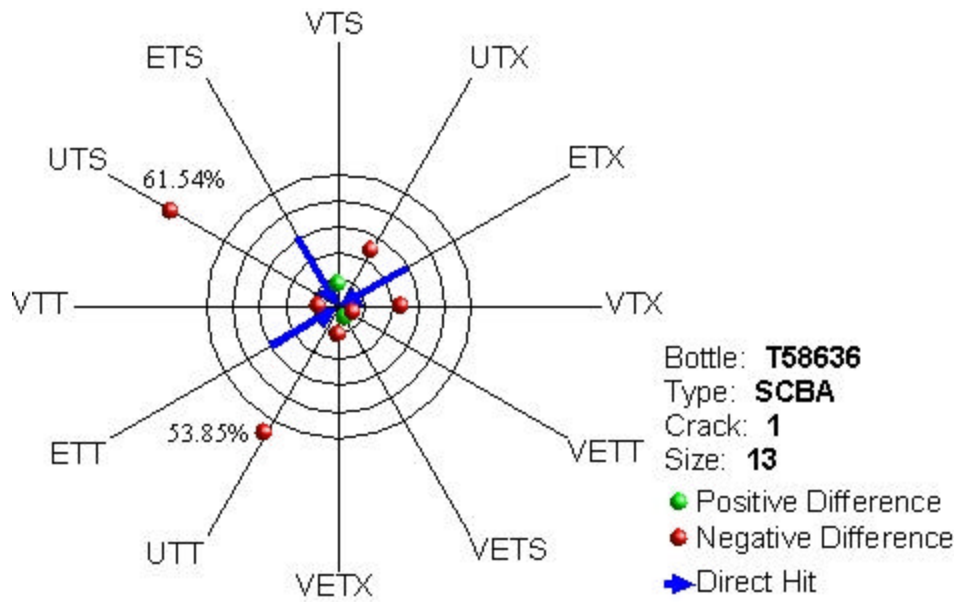
Figure 4-9. Reported Flaw Size for the First Crack in SCBA Bottle T58636 for Each Inspection

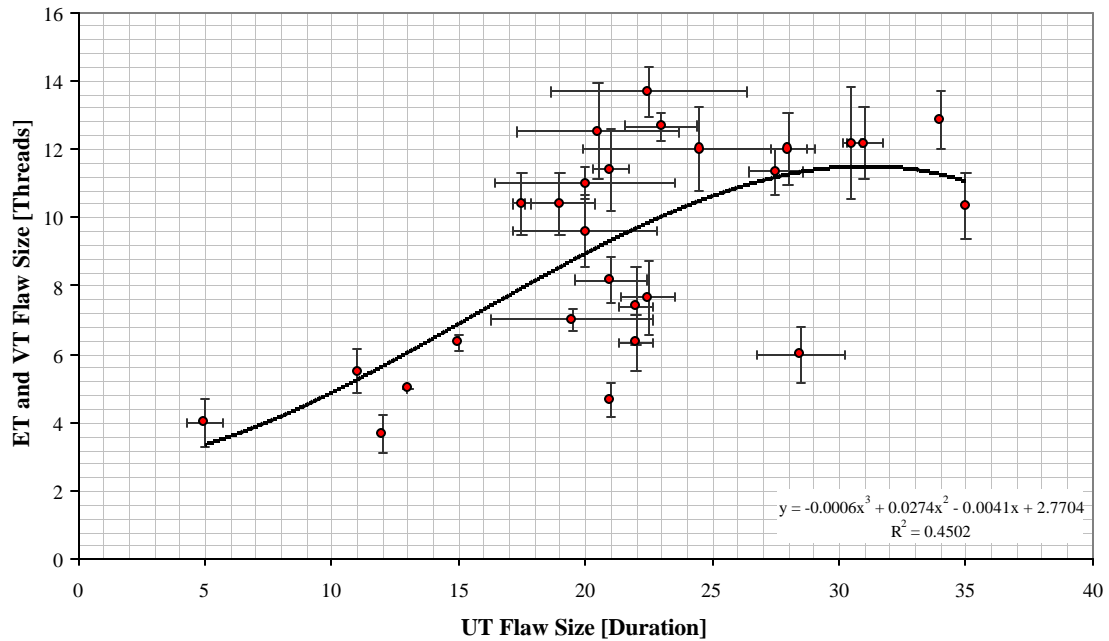
Figure 4-15. Production of the UT Calibration Curve

Based upon this plot, a trendline was produced that most closely approximated the data. This line is then used as the translation between duration and thread size, and was found to be of the form $y = -0.0006x^3 + 0.0274x^2 - 0.0041x + 2.7704$, in which x is the flaw size in signal duration reported by the UT inspector, and y is the corresponding flaw size in threads for the same flaw. Since the other methods do not count fractions of threads, in the final stage of calibration y is taken as an integer.

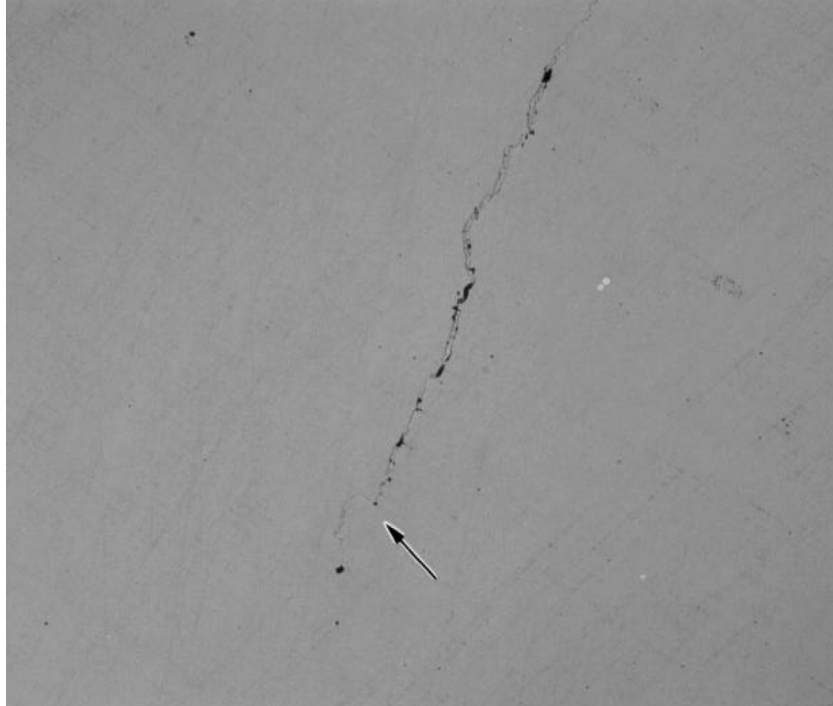
Figure 4-16. Photomicrographs of the a) Apparent Crack Tip at 0.490-inch from Bore ID and b) Crack Tip Region at 0.665-inch from Bore ID for Wafer A5.

BLA's determination of crack depths is found in Tables 4-6 and 4-7 for T94863 and P4205, respectively. Columns six and seven define the crack position and crack depth. BLA observed that the actual crack tip sometimes exceeded the observed continuous crack at low magnifications. On some wafers, such as wafer A5, the continuous crack stopped at about 0.490-inch deep. However, this was not the crack tip. The crack tip was actually at 0.711-inch deep. Discontinuous, tight cracks extended beyond the continuous crack. Figure 4-16 shows the apparent crack tip at 0.490-inch deep and discontinuous cracking at 0.665-inch deep.

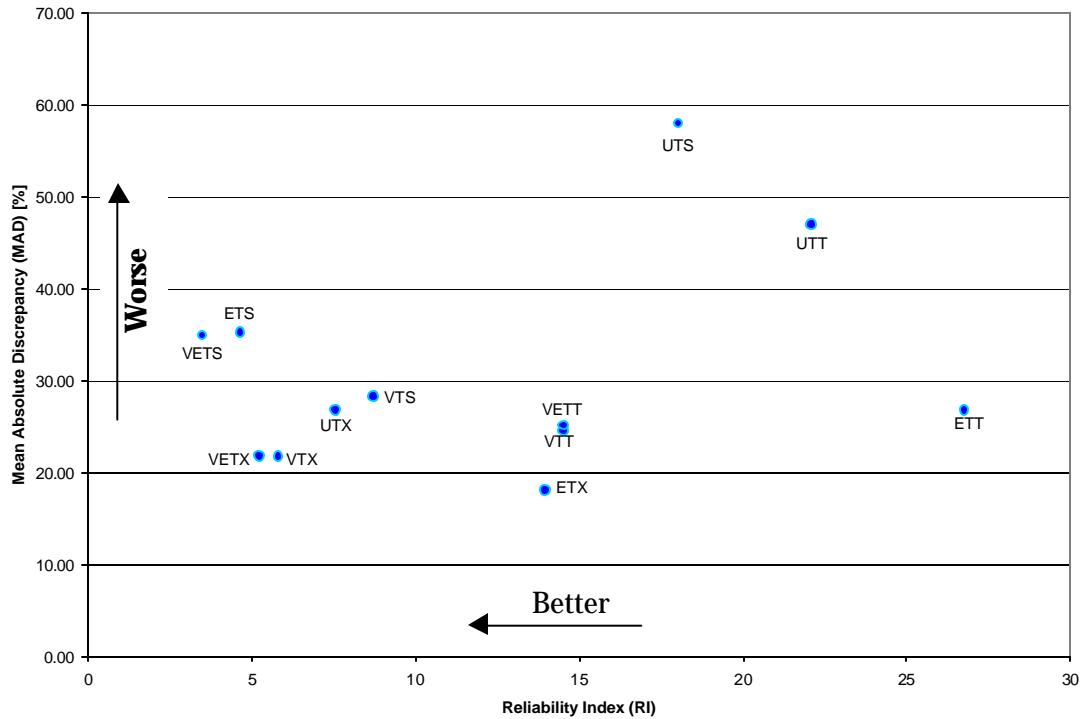
Figure 5-1. Summary of the Test Results, Plotting Each Technique's Mean Absolute Discrepancy (MAD) Against its Reliability Index (RI). An ideal technique would be plotted at the origin (0,0), representing a technique that has no false calls and that perfectly sizes every flaw it detects.

Based upon the results compiled by NTIAC as part of this project, our recommendation is to adopt the combined visual and eddy current testing (designated VET) as the standard for inspection of aluminum gas cylinders. Figure 5-1 provides a graphical summary of the overall results of the project; Figure 5-2 illustrates the averages across technique and skill level respectively.
