SAFETY ALERT

Sherwood has received three reports involving Sherwood TV 5861 valves in which the bonnet, upper stem and hand wheel assembly reportedly ejected from the valve body on the first filling event of the cylinder in which the valve was installed. Sherwood’s initial investigation has revealed that the bonnet thread strength may have been compromised.

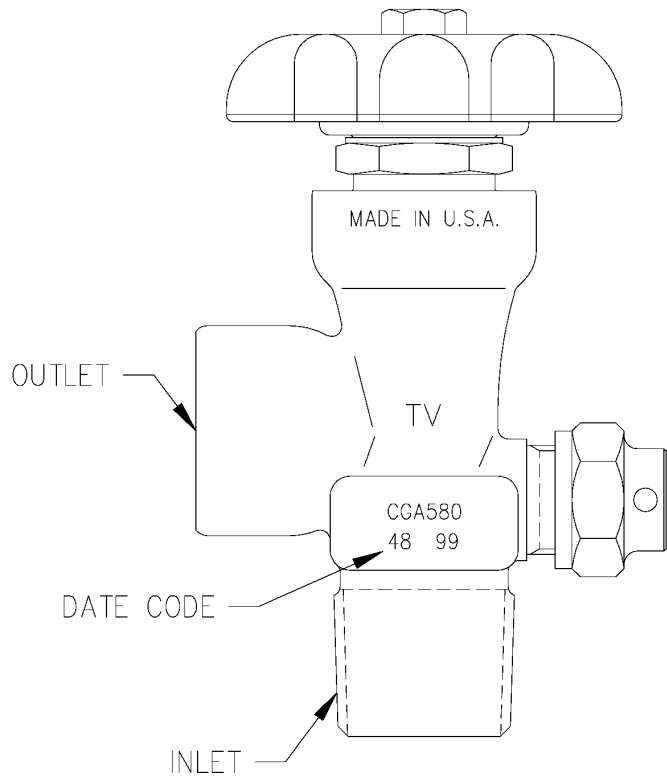
Illustration No. 1

In the interest of safety we are requesting that our customers quarantine the following valves (part numbers listed below) with the date code of **48-99 and 03-00** (location of date code on Illustration No 1).

Sherwood will repair or replace quarantined valves as warranted.

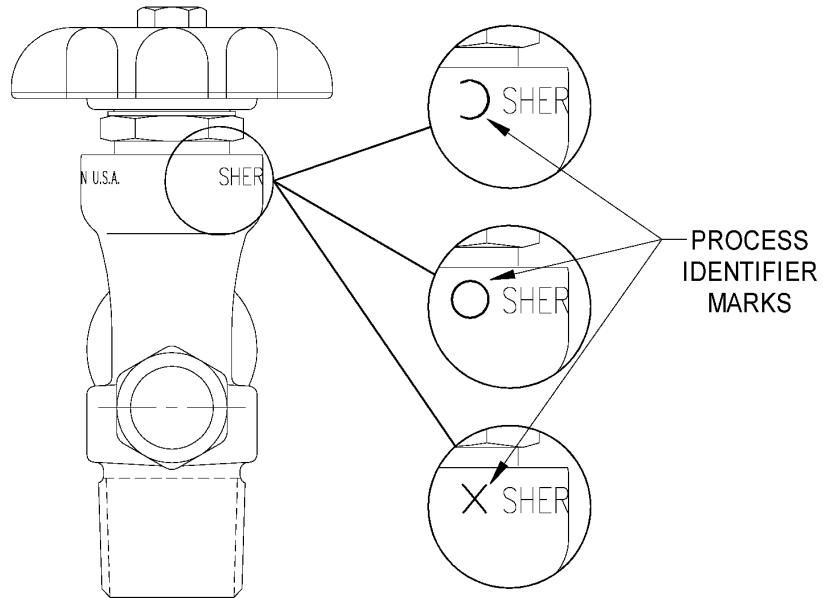
Illustration No. 2

Sherwood does not believe that the reported phenomenon involves TV series valves listed above with a manufacturing process identifier mark “) “ ; “O” or “X” and it is **NOT** necessary to quarantine TV series valves listed above with the specified date codes which have the manufacturing process identifier and of “) “ ; “O” or “X” (Illustration No. 2).
