Non-Coal Mining Near Miss Accident Involving Acetylene Cylinder

Incident Description

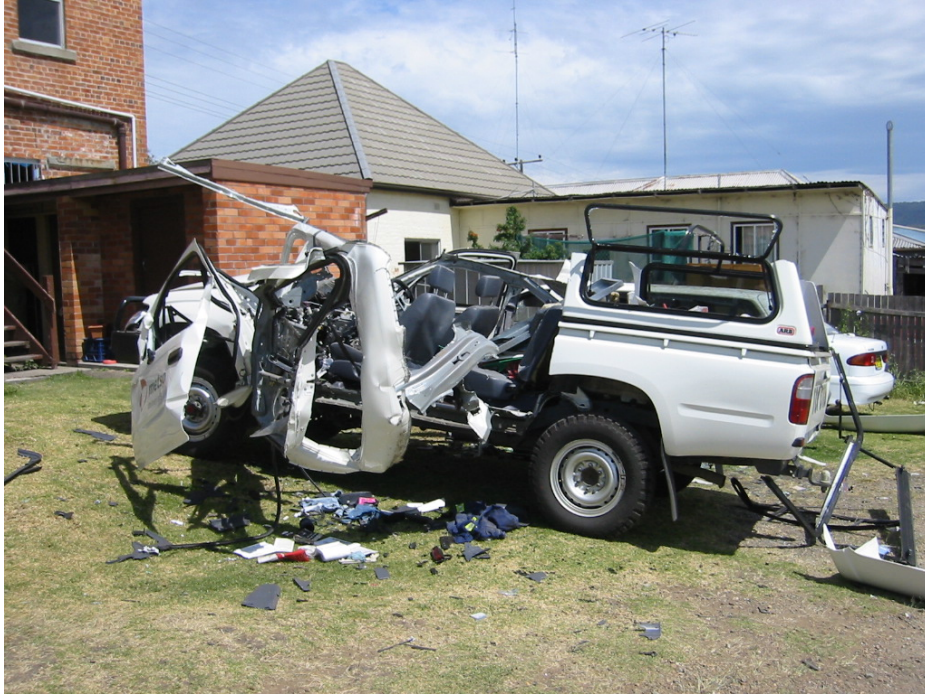
- This incident happened on Monday the 29th of September 2003. A fitter with a work van left an E size Oxygen and Acetylene cylinder on the back seat of a Toyota dual cab over the weekend. The Acetylene cylinder valve was not fully closed and a leak occurred.
- Over the weekend the Acetylene accumulated in the van. On Monday morning the fitter approached the van and opened the door, a large explosion took place. The ignition may have been caused by either the internal light circuitry, the automatic door control, mobile phone which was on the front seat of the van, or lighting a cigarette. The fitter was also a smoker. He has damage to his ear drums and facial damage. As you can see by the attached photo he was very lucky. Don't let safety be something you learn by accident.

**Compressed and liquid gas cylinders shall be secured in a safe manner.
30 CFR 77.208 (d)**

Materials that can create hazards if accidentally liberated from their containers shall be stored in a manner that minimizes the danger. (Never store cylinders in an enclosed vehicle or area.) 30 CFR 77.208 (b)
