Flood of June 2003 in Southwest-Central Florida

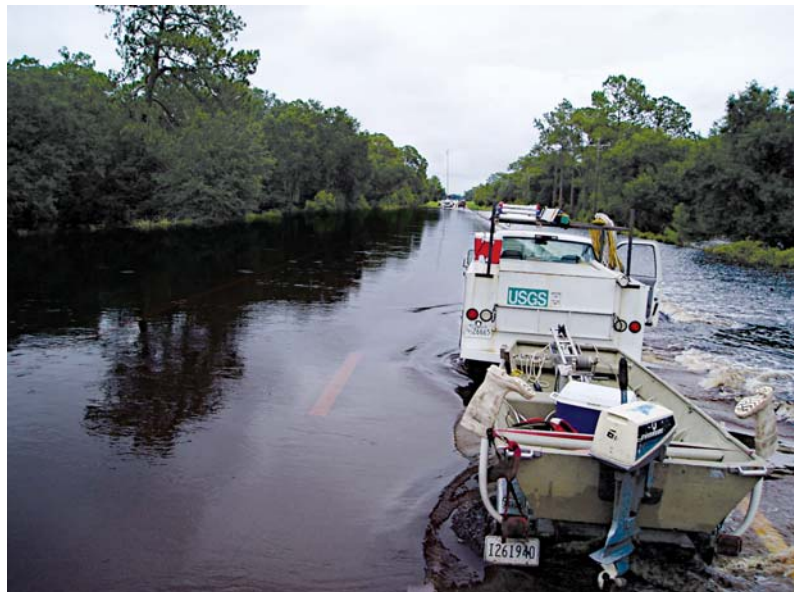
Figure 3—View of road overflow at discharge of 9,900 ft³/s in Horse Creek near Arcadia (site 2, fig. 1, table 1) on June 23, 2003.

discharge for Horse Creek near Arcadia (site 2, fig. 1, table 1) was observed overflowing the road by USGS field crews (fig. 3). The peak discharge of 11,000 ft³/s was the second highest flow recorded since 1950 and the highest since Hurricane Donna in 1960.

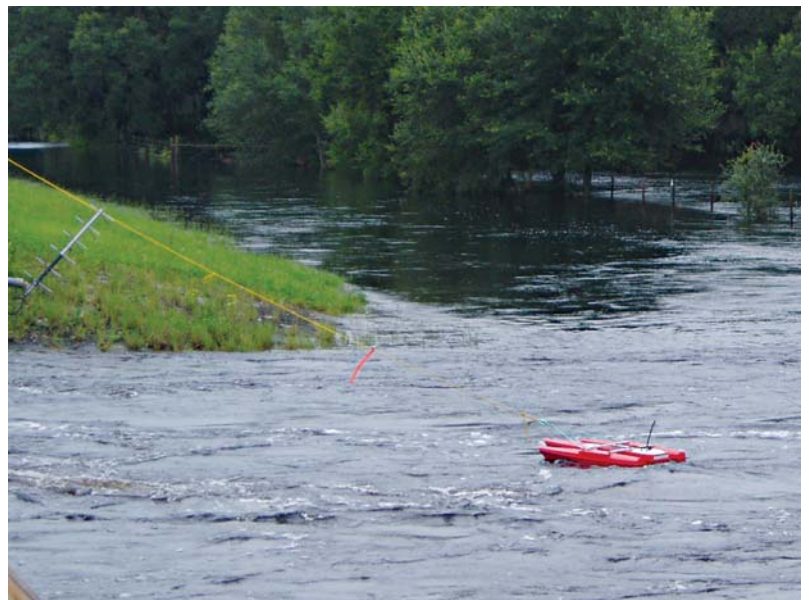
Figure 4—View of Big Slough Canal near Myakka City (site 7, fig. 1, table 1). Discharge measurement being made using a tethered boat and acoustic doppler current profiler.

At Big Slough Canal near Myakka City (site 7, fig. 1, table 1), a discharge of 7,180 ft³/s was the highest recorded since 1992 and second highest for the period of record. Flow measurements at site 7 were made using an acoustic doppler current profiler on a tethered

boat (fig. 4). Flooding continued downstream and was most severe in the City of North Port, where the Big Slough Canal overflowed its banks at Tropicaire Boulevard (fig. 5; site 8, fig. 1, table 1). The peak discharge of 4,950 ft³/s was the highest recorded for the period of record at site 8.
