ACOUSTIC DETECTION OF ROLLER BEARING DEFECTS: PHASE II, FIELD TEST

1. AGENCY USE ONLY (Leave blank)		2. REPORT DATE August 2003	3. REPORT TYPE AND DATES COVERED FRA, Nov.-Dec. 1996	
4. TITLE AND SUBTITLE Acoustic Detection of Railcar Roller Bearing Defects: Phase II, Field Test Report			5. FUNDING NUMBERS DTFR53-93-C-00001, Task Order 111

9. SPONSORING/MONITORING AGENCY NAME(S) AND ADDRESS(ES) U.S. Department of Transportation Federal Railroad Administration Office of Research and Development 1120 Vermont Avenue, NW Washington, D.C. 20590			10. SPONSORING/MONITORING AGENCY REPORT NUMBER DOT/FRA/ORD-00/06.II

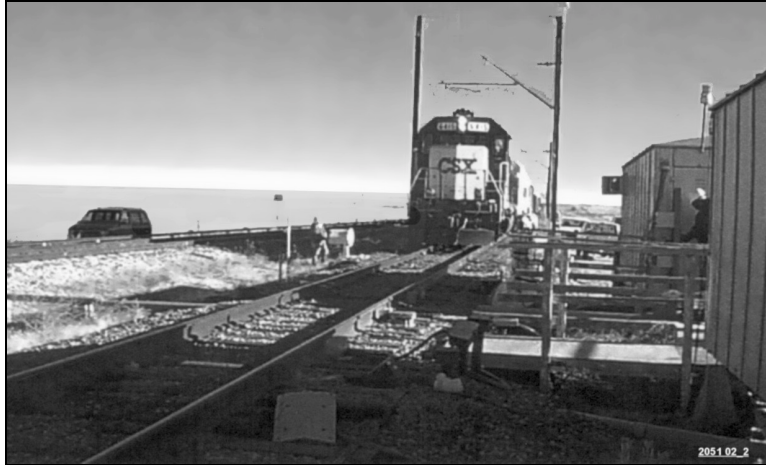
Figure 2. Wayside Test Site

Testing was conducted at TTC on the Railroad Test Track (RTT) at the existing Hot Bearing Detector (HBD) test farm (Station 14). This location is equipped with two bungalows with 100 VAC power and telephone services. The track section at Station 14 is tangent with a grade of 0.26 percent. Figure 2 shows the test site.

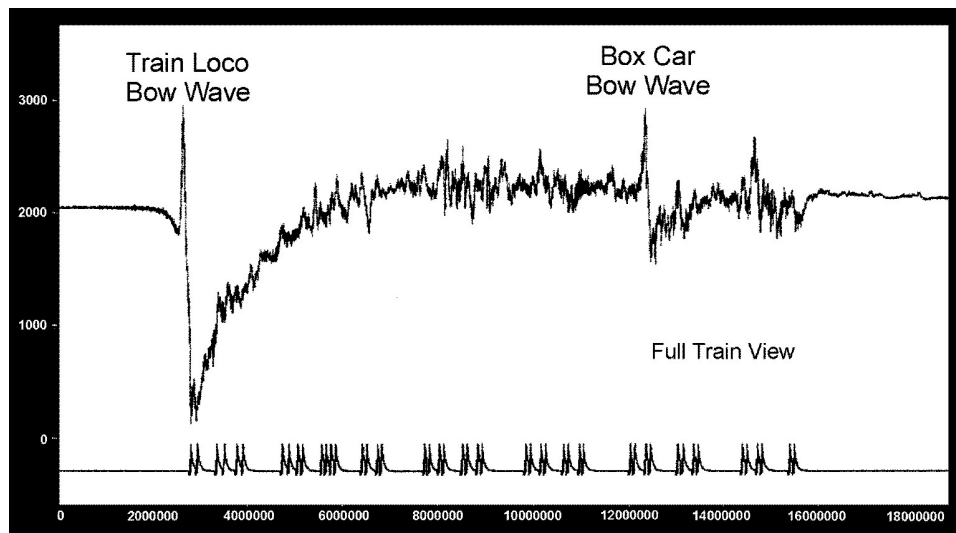
Early in the first half of the test on November 18, 1996, a large pressure wave was shown to be preceding the lead locomotive, and to a lesser extent at the leading edge of each hopper car that trailed a flat car. The effect of these pressure or “bow” waves is exaggerated in Figure 6. The air pressure in the wave caused a large offset to each of the 12 microphones as it passed. The frequency content of the wave was less than 2 Hz.

Figure 6. Exaggerated Illustration of Bow Wave Effect

To reduce the effect of the bow waves on the test data, filtering was obtained for some of the microphones to do high frequency passing (above 8 Hz), and thus to filter out the low frequency offset. There were not enough channels of filtering to accommodate all the microphones, so the bow wave effect was digitally filtered as part of the post test data processing. This effect was overlooked in test preparations.

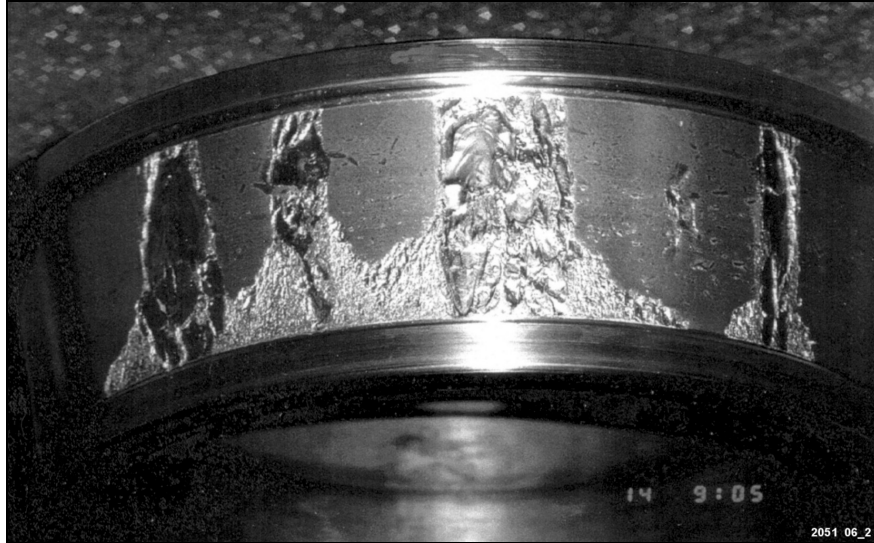
Figure 8. Large Cone Defect in Bearing from Axle 19 of Test Run 24

In addition to the acoustic data, each CD also contains photographs of the defective test bearings. Two of the bearings are shown in detail in Figures 7 and 8. The bearings have large spalls on the cup and cone raceways, respectively. The bearing with the cone spalls (Figure 8) is also one of the test bearings operating with a spun cone. The frequency content of the types of defects shown in these two figures is given in Figures 9 through 11.

Figure 14 is an expanded view of the data from bearing 19 on car 5. This bearing contains the severely damaged cone shown in Figure 8. Figure 15 shows the low-frequency content of the time signature in Figure 14. It contains two or three dominant peaks. As before, the peak at 3.8 Hz corresponds to the rotational rate (4.6 Hz) of the bearing at the 30 mph running speed. The second peak at 61 Hz comes directly from the cone defect repetition rate at the same speed. In this spectra there is also a minor peak at 15 Hz. Since this bearing also contains a spun cone defect, this anomalous peak may be associated with that defect, as well as other possible internal component damage.

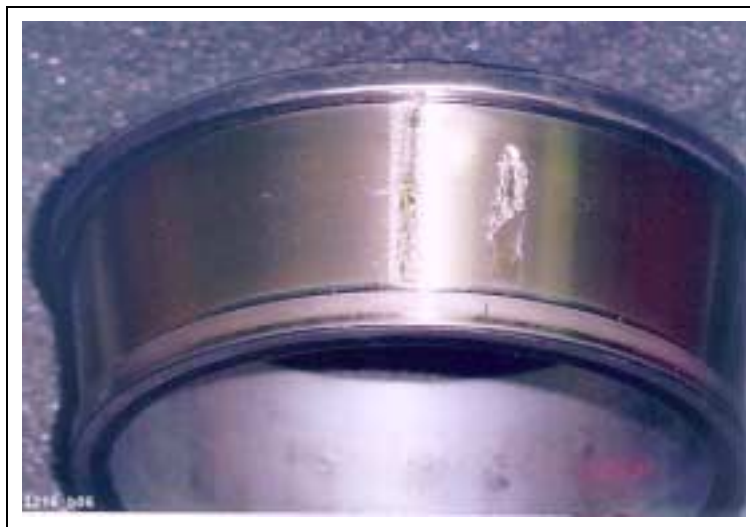
B6.

BEARING #30	CLASS F “MULTIPLE CONE SPALL” SERIAL # 31401	
CONE	Inside	Race	Many small spalls	Fig. B6
		Rollers	No Defects Observed	
	Field Side	Race	One line spall and other spalls	Fig. B7
		Rollers	No Defects Observed	
CUP	Inside	Loaded Zone	No Defects Observed	
		Not Under-Load	No Defects Observed	
	Field Side	Loaded Zone	No Defects Observed	
		Not Under-Load	No Defects Observed	
		BEARING #31	CLASS F “MYSTERY” SERIAL # 1041	
CONE	Inside	Race	Multiple repaired spalls	Fig. B17
		Rollers	Broken	Fig. B17
	Field Side	Race	No Defects Observed	
		Rollers	No Defects Observed	
CUP	Inside	Loaded Zone	Multiple Spalls, color shows excessive heat	Fig. B16
		Not Under-Load	No Defects Observed	
	Field Side	Loaded Zone	Multiple Spalls	Fig. B15
		Not Under-Load	No Defects Observed	
		BEARING #32	CLASS F “MULTIPLE CUP SPALL” SERIAL # 34576	
CONE	Inside	Race	No Defects Observed	
		Rollers	No Defects Observed	
	Field Side	Race	No Defects Observed

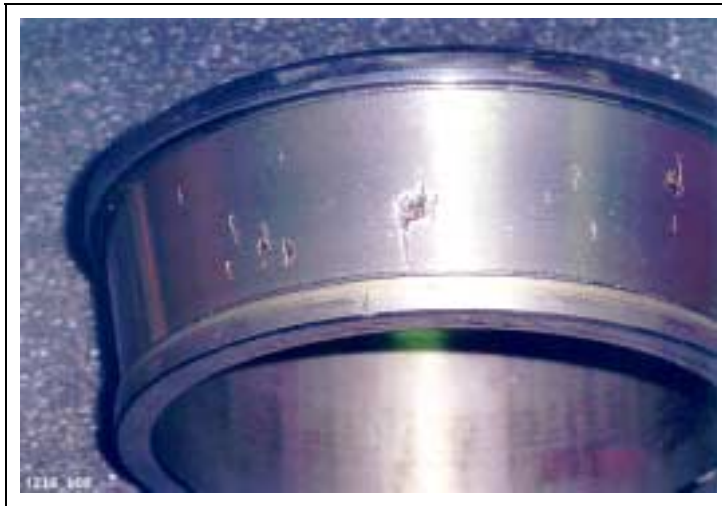
B8.

Rollers	No Defects Observed	
CUP	Inside	Loaded Zone	No Defects Observed	
		Not Under-Load	No Defects Observed	
	Field Side	Loaded Zone	Multiple spalls, large	Fig. B8
		Not Under-Load	No Defects Observed

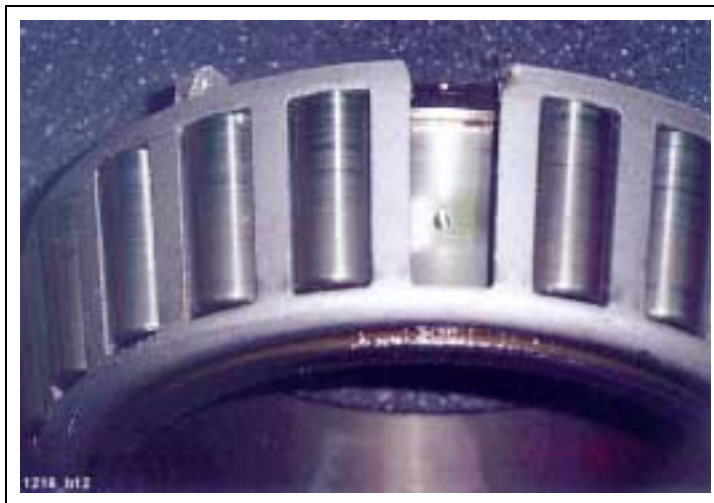
B11.

BEARING #7	CLASS F E "SINGLE CONE SPALL" SERIAL # 34593	
CONE	Inside	Race	Single ½" line spall manufactured by grinding	Fig. B11
		Rollers	No Defects Observed	
	Field Side	Race	No Defects Observed	
		Rollers	No Defects Observed	
CUP	Inside	Loaded Zone	No Defects Observed	
		Not Under-Load	Single small repaired spall	Fig. B10
	Field Side	Loaded Zone	No Defects Observed	
		Not Under-Load	No Defects Observed	
		BEARING #9	CLASS E "BROKEN ROLLER" SERIAL # 83622	
CONE	Inside	Race	No Defects Observed	
		Rollers	No Defects Observed	
	Field Side	Race	No Defects Observed	
		Rollers	Single ½" flat manufactured by grinding	Fig. B14
CUP	Inside	Loaded Zone	No Defects Observed	
		Not Under-Load	No Defects Observed	
	Field Side	Loaded Zone	No Defects Observed	
		Not Under-Load	No Defects Observed	
		BEARING #11	CLASS E "WATER ETCH" SERIAL # X-167	
CONE	Inside	Race	Three very small spalls	Fig. B22
		Rollers	Three each have very small spalls

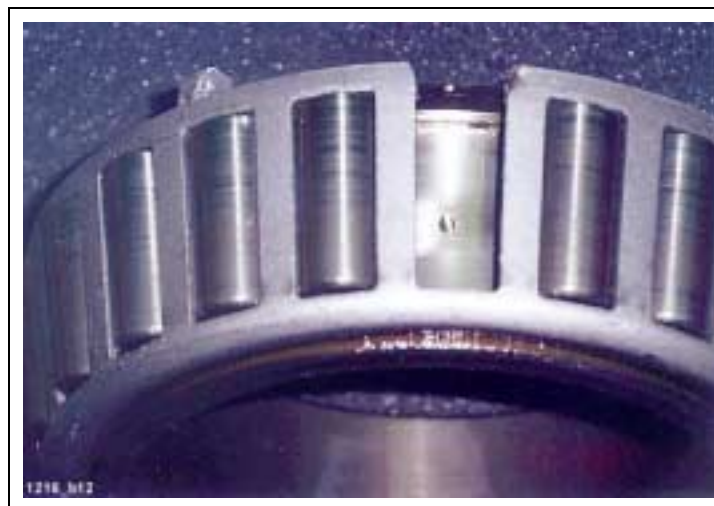
B12.

BEARING #14	CLASS F "SPUN CONE" SERIAL # 10915	
CONE	Inside	Race	Single 1/16 inch repaired spall	Fig. B12
		Rollers	No Defects Observed	
	Field Side	Race	No Defects Observed	
		Rollers	No Defects Observed	
CUP	Inside	Loaded Zone	No Defects Observed	
		Not Under-Load	No Defects Observed	
	Field Side	Loaded Zone	No Defects Observed	
		Not Under-Load	No Defects Observed	
		BEARING #15	CLASS F "SPUN CONE" SERIAL # 61405	
CONE	Inside	Race	Repaired non-condemnable, six each	Fig. B4
		Rollers	No Defects Observed	
	Field Side	Race	Six large spalls	Fig. B1
		Rollers	Steel flakes in grease	Fig. B23
CUP	Inside	Loaded Zone	No Defects Observed	
		Not Under-Load	No Defects Observed	
	Field Side	Loaded Zone	No Defects Observed	
		Not Under-Load	No Defects Observed	
		Spacer Ring	Worn	Fig. B5
		BEARING #18	CLASS E "SPUN CONE" SERIAL # 18A	
CONE	Inside	Race	No Defects Observed	
		Rollers	No Defects Observed	
	Field Side	Race	No Defects Observed

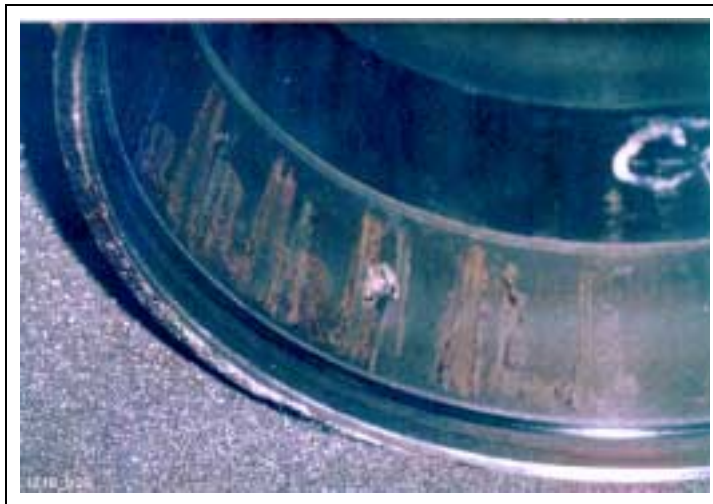
B29.

Rollers	No Defects Observed	
CUP	Inside	Loaded Zone	Spalls, 1 severe, 3 less than or equal to 1/2"	Fig. B30
		Not Under-Load	Water etched, single 1/2" spall	Fig. B29
	Field Side	Loaded Zone	Single line spall	Fig. B31
		Not Under-Load	No Defects Observed

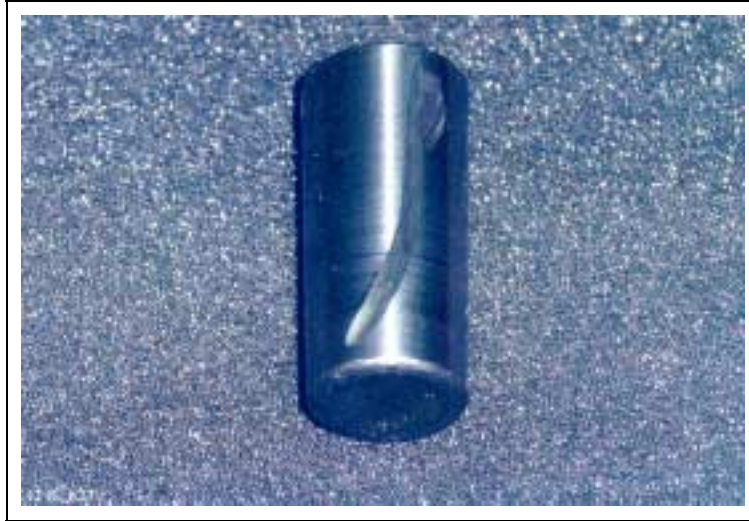
B37.

BEARING #19	CLASS E “SPUN CONE” SERIAL # 83333	
CONE	Inside	Race	No Defects Observed	
		Rollers	No Defects Observed	
	Field Side	Race	No Defects Observed	
		Rollers	No Defects Observed	
CUP	Inside	Loaded Zone	No Defects Observed	
		Not Under-Load	No Defects Observed	
	Field Side	Loaded Zone	No Defects Observed	
		Not Under-Load	No Defects Observed	
		BEARING #22	CLASS F “WATER ETCH” SERIAL # 85882	
CONE	Inside	Race	Minor water etching	Fig. B13
		Rollers	Minor water etching	
	Field Side	Race	Minor water etching	Fig. B41, B42
		Rollers	Minor water etching	Fig. B40
CUP	Inside	Loaded Zone	Minor water etching	Fig. B39
		Not Under-Load	Minor water etching	
	Field Side	Loaded Zone	Minor water etching	Fig. B38
		Not Under-Load	Minor water etching	
		BEARING #24	CLASS F “Broken Roller” SERIAL # 39164	
CONE	Inside	Race	No Defects Observed	
		Rollers	No Defects Observed	
	Field Side	Race	No Defects Observed	
		Rollers	Single defect manufactured by grinding	Fig. B37

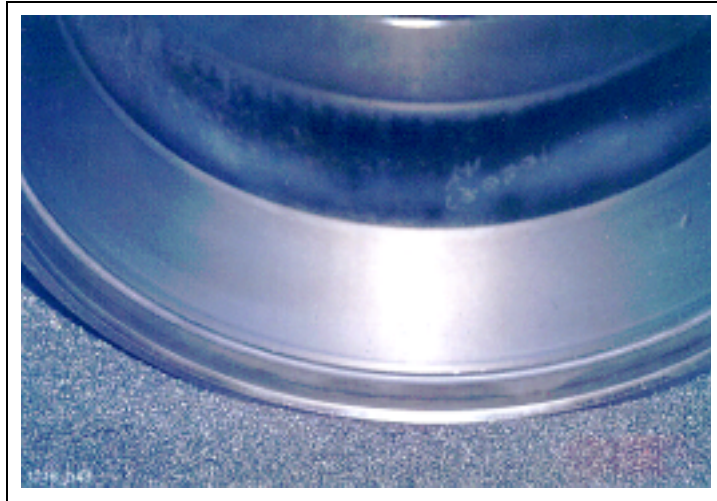
B43.

Rollers	No Defects Observed	
CUP	Inside	Loaded Zone	No Defects Observed	
		Not Under-Load	No Defects Observed	
	Field Side	Loaded Zone	No Defects Observed	
		Not Under-Load	Small Repaired Spall	Fig. B43

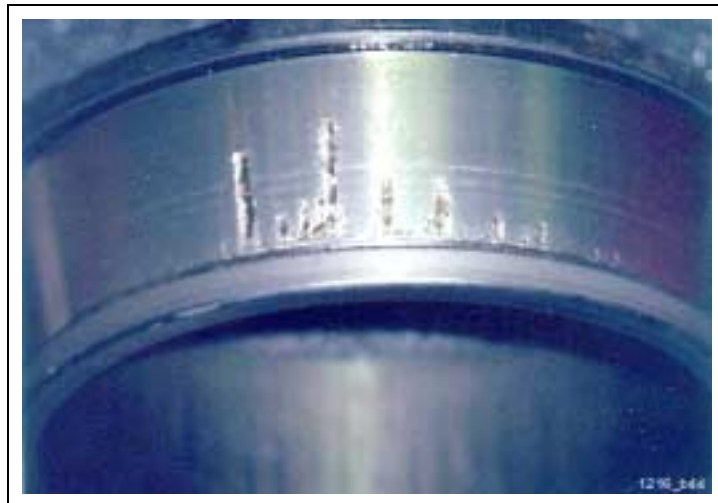
B44.

BEARING #26	CLASS E “MULTIPLE CONE SPALL” SERIAL # 54871	
CONE	Inside	Race	Multiple spalls	Fig. B44
		Rollers	No Defects Observed	
	Field Side	Race	No Defects Observed	
		Rollers	No Defects Observed	
CUP	Inside	Loaded Zone	No Defects Observed	
		Not Under-Load	No Defects Observed	
	Field Side	Loaded Zone	No Defects Observed	
		Not Under-Load	No Defects Observed	
		BEARING #27	CLASS E “MYSTERY” SERIAL # 18-T	
CONE	Inside	Race	No Defects Observed	
		Rollers	Several spalls	Fig. B36
	Field Side	Race	Three small line spalls	Fig. B34, B35
		Rollers	No Defects Observed, rollers are brown	
CUP	Inside	Loaded Zone	Many small dents	Fig. B32
		Not Under-Load	Many small dents	
	Field Side	Loaded Zone	Brinnell	Fig. B33
		Not Under-Load	No Defects Observed	
		BEARING #28	CLASS E “MULTIPLE CUP SPALL” SERIAL # 54900	
CONE	Inside	Race	No Defects Observed	
		Rollers	No Defects Observed	
	Field Side	Race	No Defects Observed	
		Rollers	No Defects Observed
