U.S. Department
of Transportation
**Federal Railroad
Administration**

Passenger Rail Train-to-Train Impact Test Volume I: Overview and Selected Results

DOT/FRA/ORD-03/17.1

Final Report
July 2003

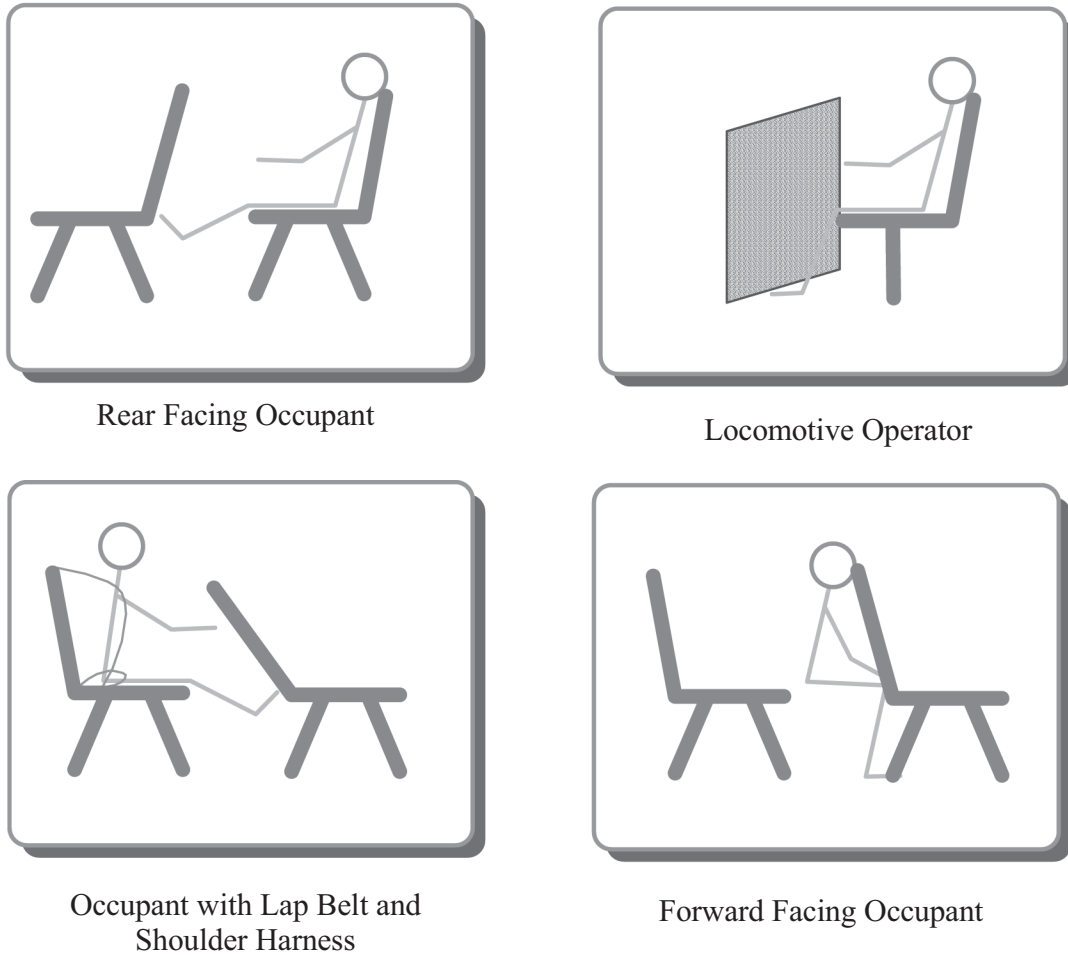
Figure 4. Schematic of Forward Facing Commuter Passenger Seat, Rear Facing Commuter Passenger Seat, Forward Facing Inter-City Passenger Seat, and Locomotive Operator’s Interior Experiments

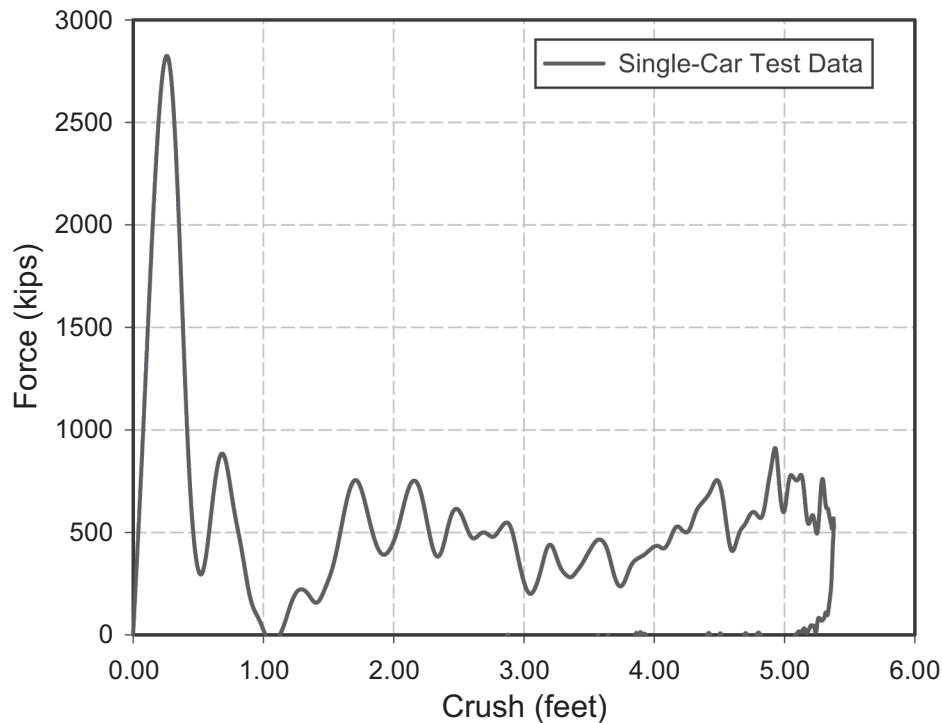
Figure 5 shows the force/crush characteristics developed from measurements made during impact tests of a single passenger car into a fixed barrier [14]. This curve has high initial peak load followed by significantly lower loads, which are approximately constant, for continued crush.

Figure 5. Force/Crush Characteristic Developed from Single-Car Test Measurements

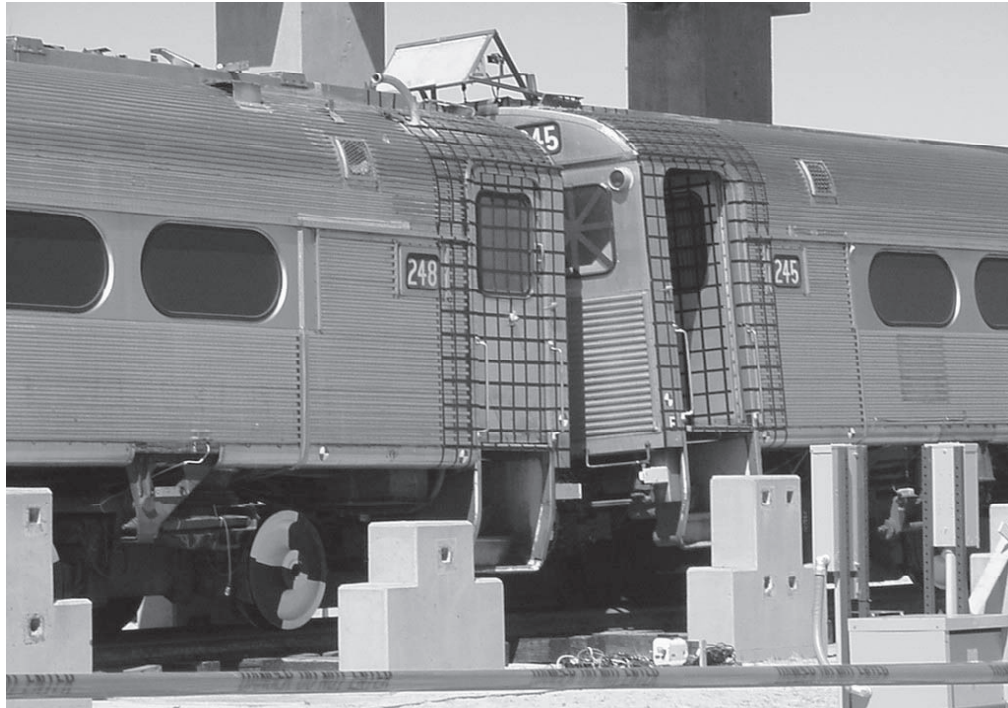
front truck of the trailing car to drop. Figure 6 shows the coupled connection between the two cars at their final lateral displacement.

Figure 6. Sawtooth Lateral Buckling of Coupled Cars Observed in Two-Car Test

Once the cars are misaligned, the high longitudinal force acting on one car exerts a significant lateral component on an adjacent car. Consequently, the train will continue to buckle out into a relatively large amplitude zigzag pattern if there is sufficient energy from the collision. Depending on the severity, this mode may progress until the cars have side-to-side impacts. Sawtooth buckling, zigzag buckling, and side-to-side impacts due to zigzag buckling have been observed in accidents [9, 22, 23]. The progression of the cars from in-line, to the sawtooth lateral buckling pattern, then to the zigzag pattern has been simulated [4] with computational models.

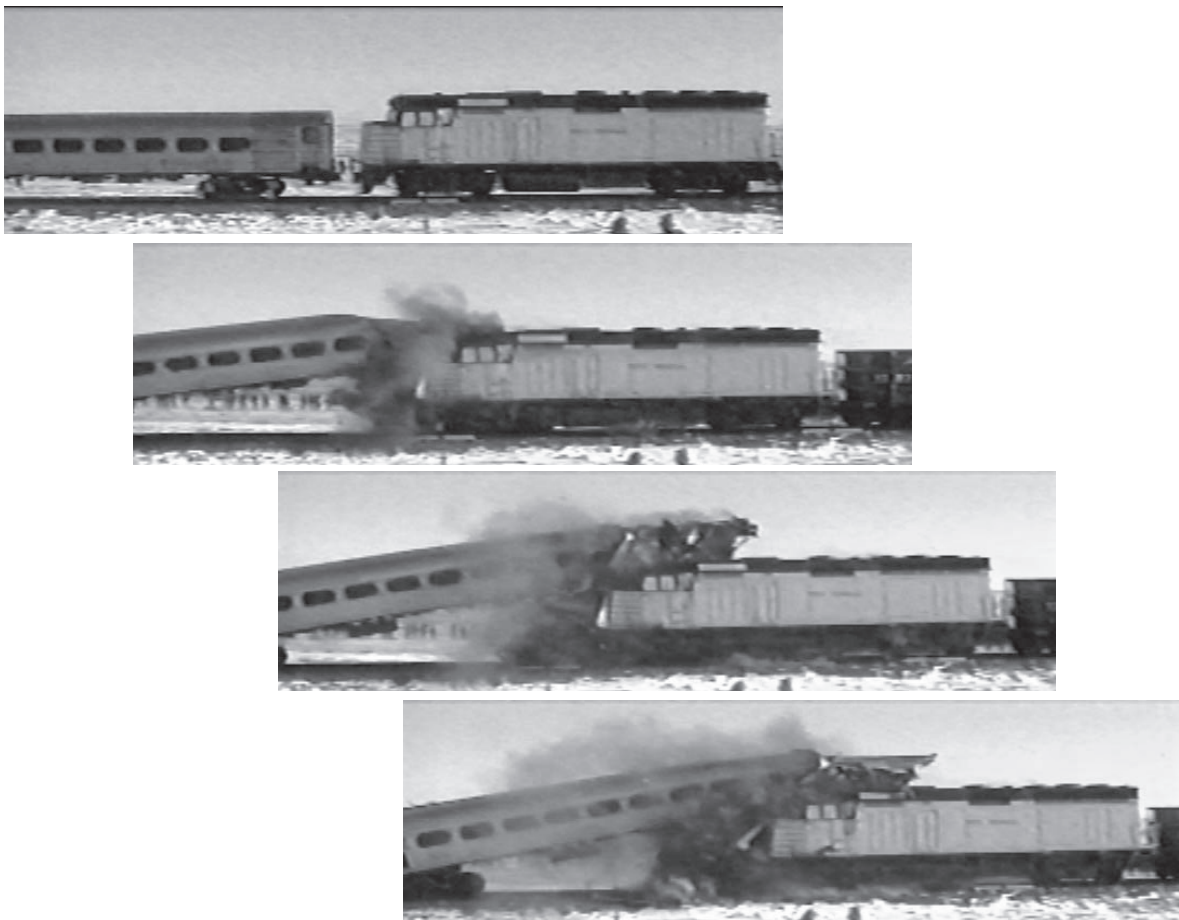
During the train-to-train impact test, the leading cab car overrode the stationary locomotive and sustained approximately 20 feet of crush of the underframe. In addition, the cab car started to deflect to its left as it overrode the locomotive. There was relatively little damage to the stationary locomotive, other than a modest amount of crush of the windshield. A portion of the cab car roof penetrated the locomotive through the windshield on the conductor's side. There was essentially no damage to the three coach cars and locomotive trailing the impacted cab car, or to the two ballasted freight cars trailing the impacted locomotive. Figure 7 shows the interaction of the colliding cab car and locomotive in a series of frames taken from high-speed video recorded during the test.

Figure 7. Override of Locomotive by Cab Car, Observed in Train-to-Train Test

Override during the train-to-train test was initiated by the failure mode of the underframe of the cab car, i.e., the cab car underframe essentially formed a ramp as it crushed. Such behavior was also observed during the single car and two car tests, where the end of the car was seen to rise

approximately 6 inches during both tests. In the single car and two car tests, the end frame of the cab car remained in a fixed position against the wall, while the deformations of the underframe cause the end of the car immediately behind it to rise. Override continued in the train-to-train test due to the vertical offset of the longitudinal forces acting on the impacting end and the trailing end of the cab car. The impacting end rose vertically with the initial deformation of the cab car, while the trailing end remained near its initial height. The offset in longitudinal loads at each end of the cab car caused a pitching moment allowing the cab car to continue climbing the locomotive.

The initiation of lateral deflection was caused by the interaction of the couplers of the cab car and locomotive. The couplers by-passed each other on impact, forming a small laterally oriented ramp. The lateral displacement of the end of the cab car continued to grow during the impact, due to the lateral offset in the longitudinal forces acting at each end of the cab car.

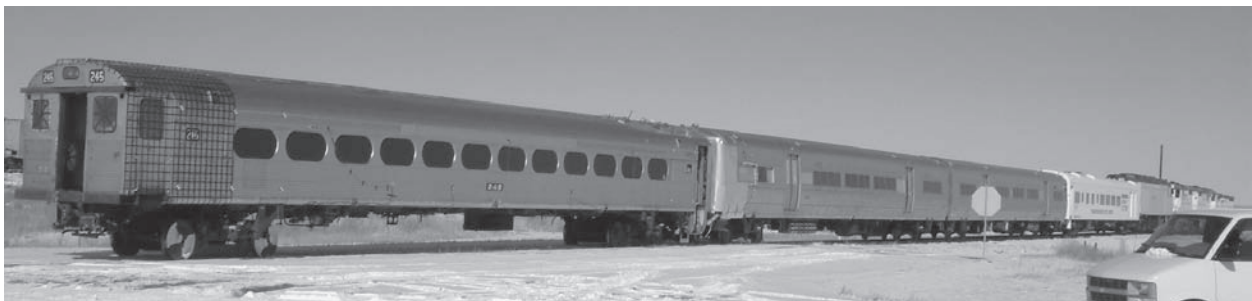
The cab car-led train was made up of a Budd Pioneer cab car, two Budd M1 cars, the T7 track geometry-measuring car, built by St. Louis Car, and a GM/EMD F40PH. The locomotive-led train was made up of a GM/EMD F40PH, and two ballasted open-top hopper cars. It had been originally planned to use four M1 cars in the initially moving consist, and not use the T7 car. T7 was substituted for two M1 cars because of difficulties in shipping the M1 cars from Long Island Railroad to TTC. As used in the test, the T7 car weighs nearly as much as two M1 cars. Figure 8 shows the initially moving cab car-led train just prior to the test.

Figure 8. Cab Car-Led Consist from Train-to-Train Test, Prior to Test

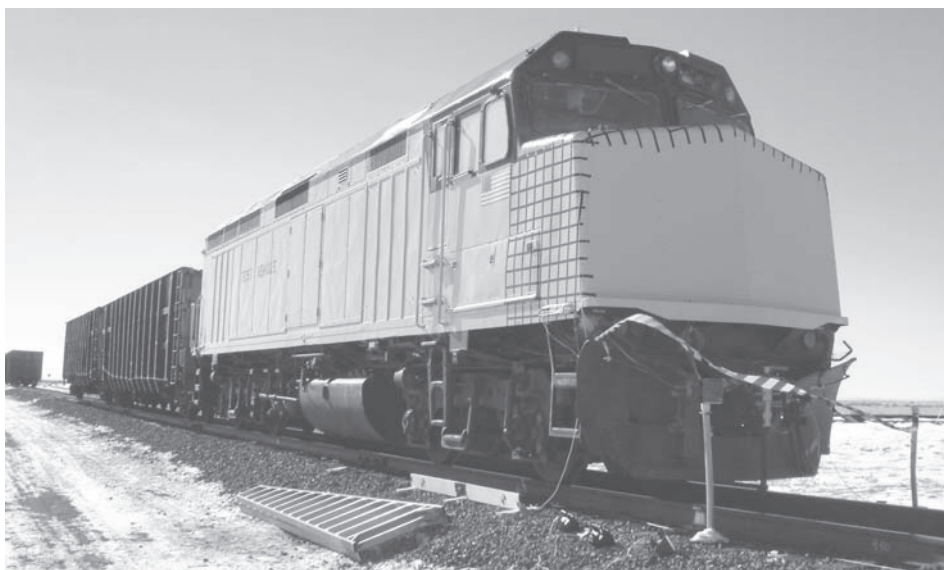
The end structure of the locomotive was modified to comply with the current Association of American Railroad (AAR) S-580 Standard. The collision posts and front sheet of the short hood were replaced. The locomotive structural design was adapted from the design for locomotives supplied to the Metra commuter railroad provided by GM/EMD. The new front sheet did not include details such as cutouts for lights. Figure 10 shows the locomotive on the test track shortly before the test, along with the two ballasted open-top hopper cars.

Figure 10. Locomotive-Led Consist from Train-to-Train Test, Prior to Test

The stationary locomotive used in the testing is a General Motors F40PH. These locomotives were designed and build after 1974. Additionally, the colliding end of the stationary locomotive was modified to bring the structure up to the current Locomotive Crashworthiness Requirement S-580 of the Association of American Railroads Safety & Operations Department Manual of Standards and Recommended Practices. This involved modifying forward facing sheeting on the short hood and collision posts with a different material having a greater thickness.

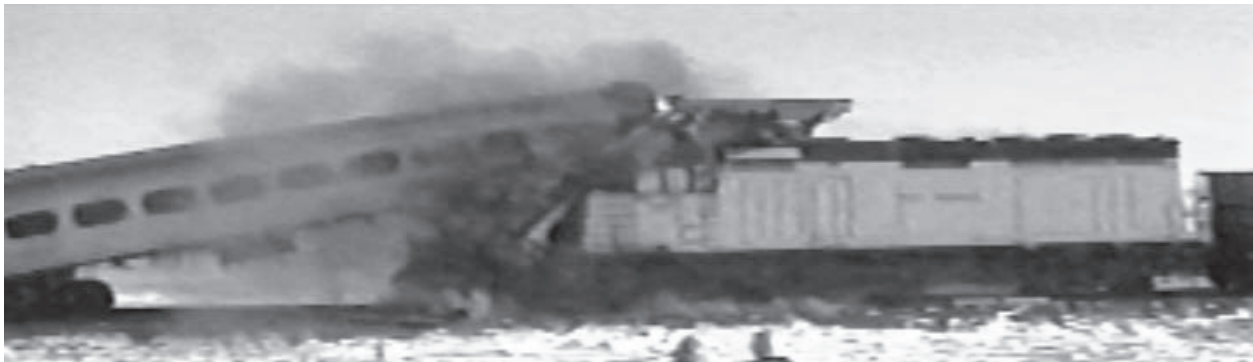
The duration of the test, from initial impact until both trains stopped, was approximately 8 seconds. Immediately after the initial impact, the cab car led train began to slow down, while the locomotive-led train began to move. After approximately 0.2 second and 18 feet of crush of the cab car underframe, the cab car started to override the short hood of the locomotive; the cab car then briefly impacted the window structure of the locomotive at about 0.6 second, crushing the underframe by an additional 2 feet, and finally rode up onto the roof of the locomotive cab after about 0.7 second. About 2 seconds after initial impact, both trains were moving at the same speed – approximately 15 mph. Subsequently, the cab car led train began to slow down at a greater rate than the locomotive-led train, and the cab car fell off the locomotive and the trains separated approximately 6.5 seconds after initial contact. Eventually, both trains came to a stop approximately 8 seconds after the initial impact. Figure 11 shows the cab car at approximately 0.75 second, the time of maximum override.

Figure 11. Frame Showing Cab Car at Maximum Override of Locomotive

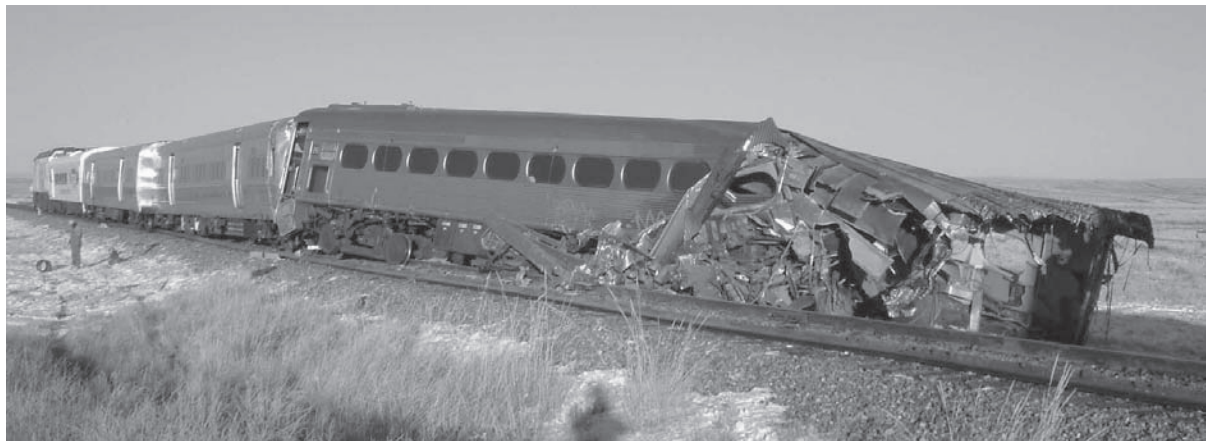
After the impact, there was approximately 22 feet of crush of the underframe and right sidewall of the cab car. Most of the roof and the left side wall of the cab car remained. The end frame of the car was pushed underneath, and ended up near the center of the car. The lead truck, separated from the cab car during the impact, was beside the remaining left sidewall at the crushed end of the cab car. The coupler and draft gear from the lead end of the cab car ended up underneath the lead axle of the lead truck of the first coach car. Figure 13 shows the cab car led consist immediately after the test.

Figure 13. Cab Car-Led Consist from Train-to-Train Test, After Test

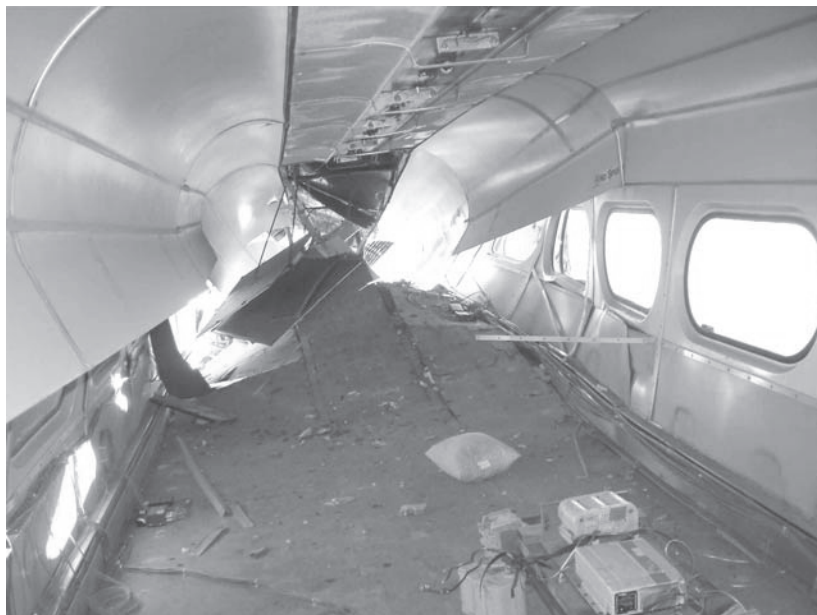
the cab car. The floor is pushed upward, owing to the end crush of the cab car; interior wall and roof panels have broken loose and intruded into the occupant space. Seats are presumed lost in the area where the floor is pushed up and the roof is coming down.

Figure 14. Interior of Cab Car, Looking Toward Crushed End-Led Consist from Train-to-Train Test, After Test

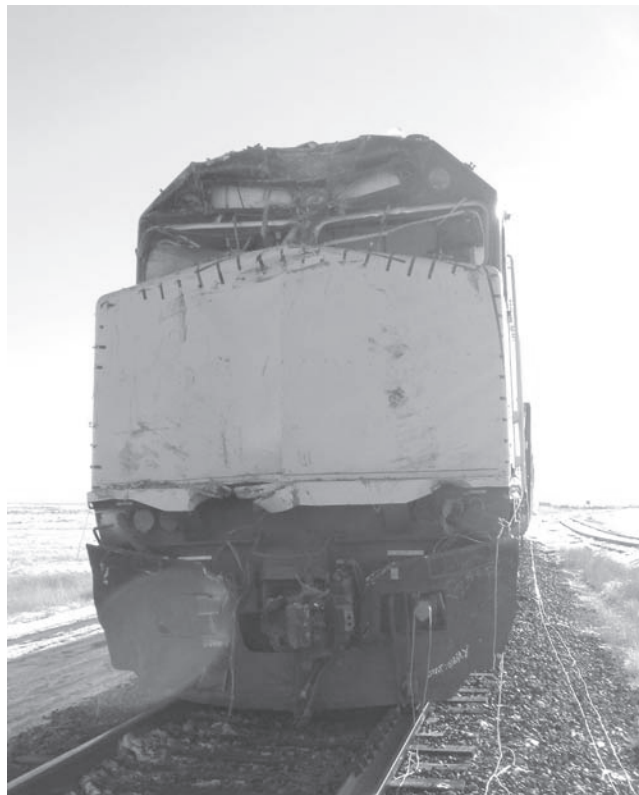
The impacted locomotive sustained a relatively small amount of damage. The coupler was pushed to the left and the left side and bottom of the bellmouth were broken. The short skirt on the underside of the anti-climber was dented on the right side, although the anti-climber itself remained essentially intact. There were a number of small dents in the front face of the short hood, especially near the top-center. The center pillar of the windshield was pushed back, and the conductor's side window was pushed into the operator's cab. The operator's side window remained partially in its frame. Both windows were crazed: each remained as a single sheet, but with substantial amounts of spall. The roof was dented above the center pillar of the windshield. Figure 15 shows the short hood end of the impacted locomotive after the test.

Figure 15. Impacted Locomotive, After Test

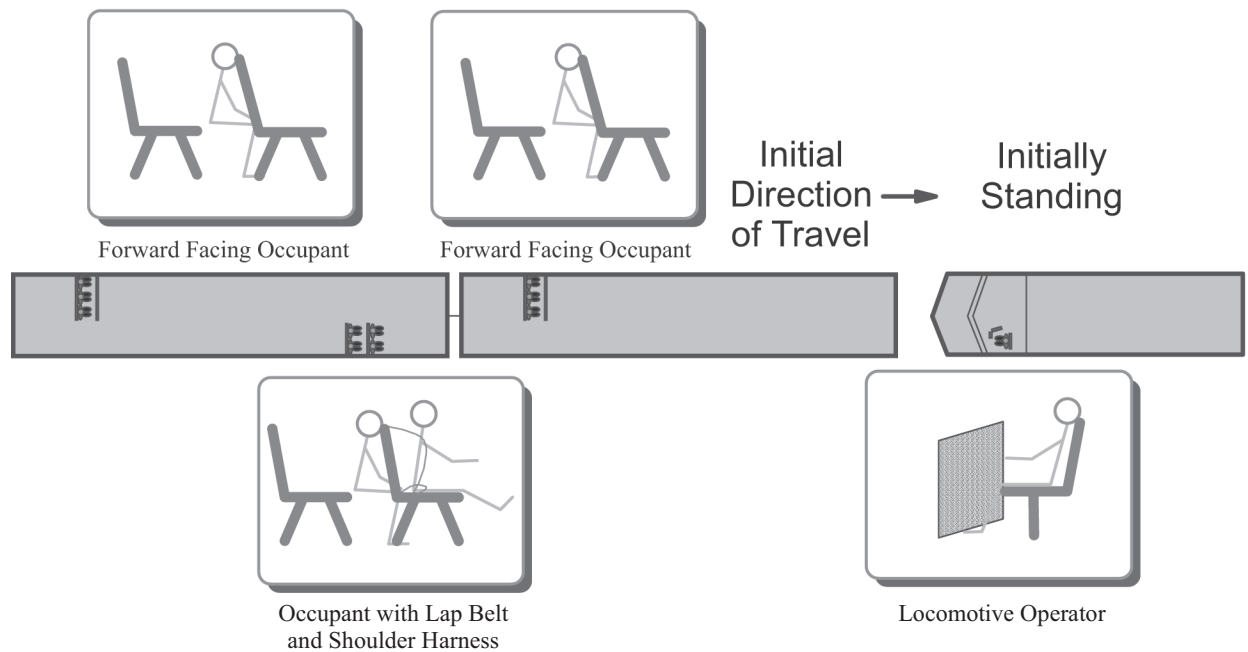
Figure 16 shows the locations of the interior experiments inside the locomotive, cab car, and first coach car.

Figure 16. Locations of Interior Experiments

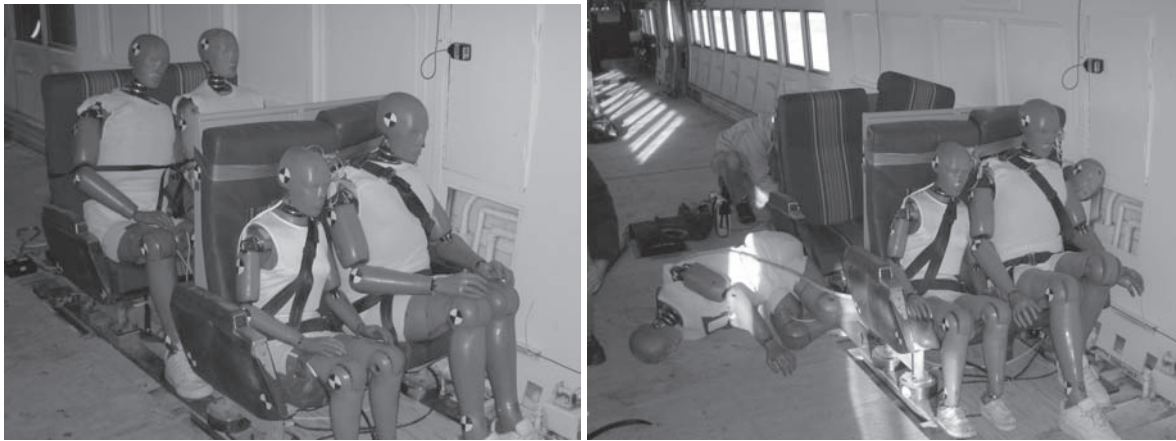
Both dummies in the trailing row were of 95th percentile male stature. During the test, the dummy in the trailing row inboard seat fell into the aisle, and the head of the dummy in the outboard seat wedged in between the wall and the side of the seat ahead. The test dummies in the forward seat remained in their seats. None of the NHTSA injury criteria threshold values was exceeded in this experiment.

Figure 19. Test Dummies in Inter-City Passenger Seats in Cab Car, Before and After Test

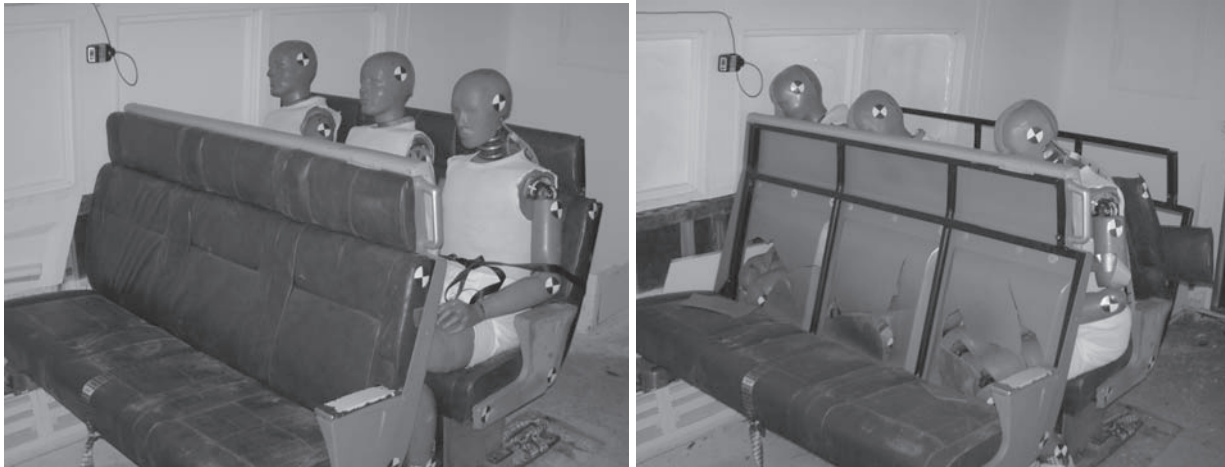
Figure 20 shows the test dummies in the forward-facing rows of three-position commuter seat in the trailing end of the first coach car behind the cab car, before and after the test. The arrangement of this experiment was the same as the arrangement of the experiment in the cab car; the inboard and center test dummies were Hybrid II test dummies with 50th percentile male stature, while the outboard test dummy was a Hybrid III test dummy with a 50th percentile male stature. The dummy in the inboard seat exceeded the injury criteria value for the neck load. Like the experiment in the cab car, review of the high-speed movies taken during the test does show that the heads did rise over the seatbacks during the test, with the chests impacting the top of the seat backs.

Figure 20. Test Dummies Three-Person Seats in Trailing Car, Before and After Test

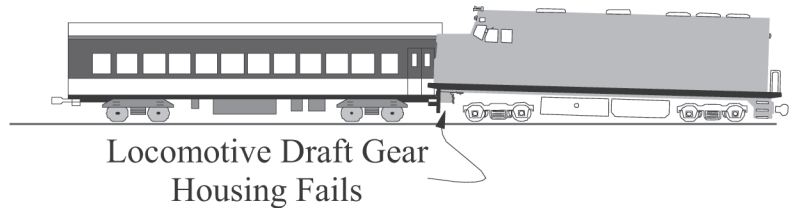
Locomotive Overrides Cab Car

A relatively minor change in initial conditions may have allowed the locomotive to override the cab car. The estimated maximum load that the locomotive's draft gear housing can support [27], approximately 3000 kips, is close to the load required to initiate crush of the cab car underframe at 2750 kips. If the load required to shear the locomotive's draft gear housing had been somewhat lower than estimated, then the locomotive would have overridden the cab car.

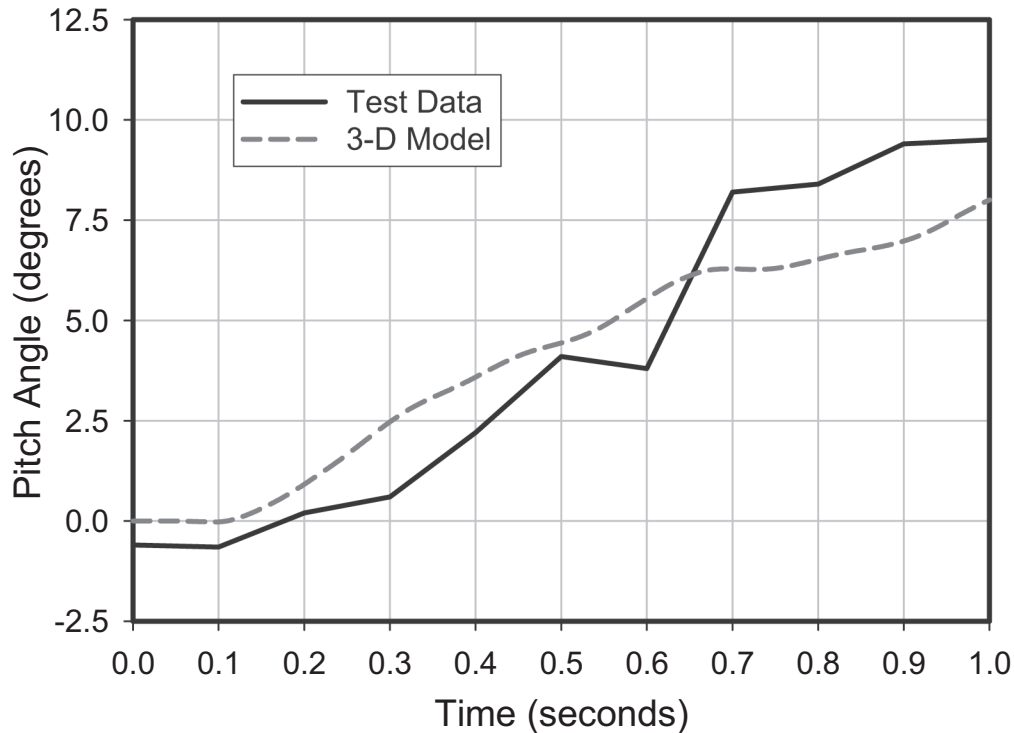
Figure 25 shows the pitch angle of the cab car as measured during the test and as evaluated with the three-dimensional model. Up to 0.6 second there is close agreement between the model predictions and the test measurements. During the tests, from approximately 0.6 second to 0.7 second, the cab car rode up the window structure of the locomotive onto its roof. The model uses heuristic elements to represent the short hood, window structure, and roof of the locomotive.

Figure 25. Pitch Time-History of Cab Car, Test Measurement and Three-Dimensional Model Predictions

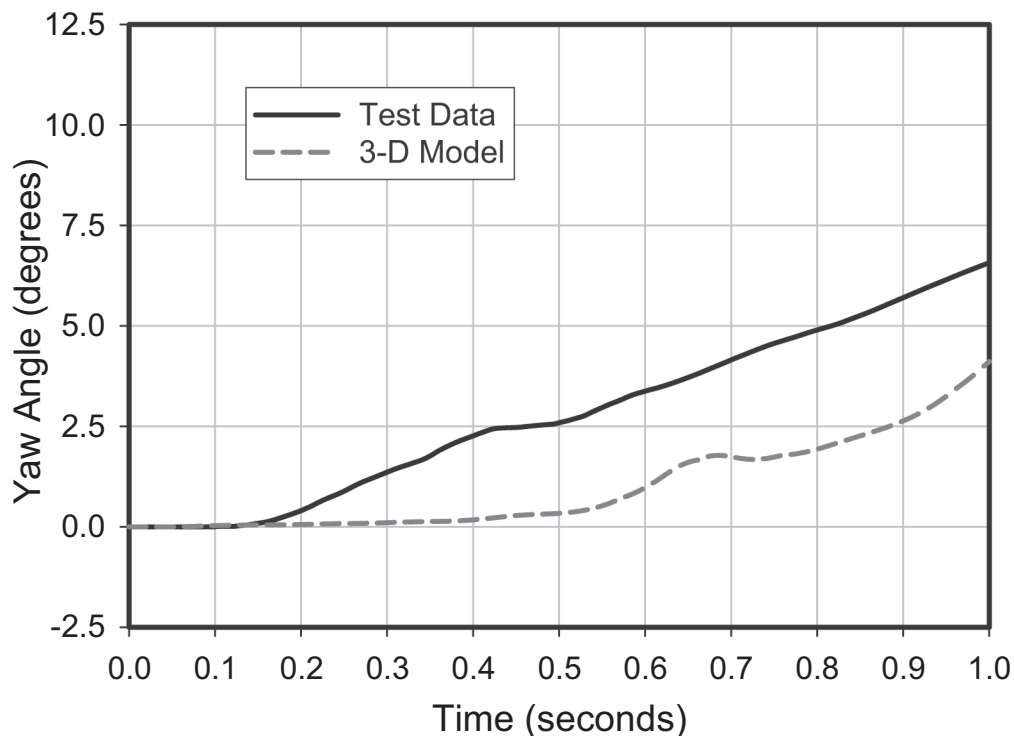
Figure 27 shows the yaw angle of the cab car as measured during the test and as evaluated with the three-dimensional model. The model results are delayed compared with the test predictions, but are otherwise close. The jog seen in both the test data and the model predictions at approximately 2.5 degrees yaw is associated with the transition from sawtooth lateral buckling to large displacement lateral buckling. The approach used in the model is similar to a perturbation analysis for stability: the model requires an initial perturbation. This perturbation reflects the natural differences in lateral displacements between cars due to the cars response to the track. This perturbation is only present between the locomotive and the cab car. Including perturbations between the coach cars would likely bring the timing of the yaw time-history into closer agreement with the test data.

Figure 27. Yaw Angle Time-History of Cab Car, Test Measurement and Three-Dimensional Model Predictions

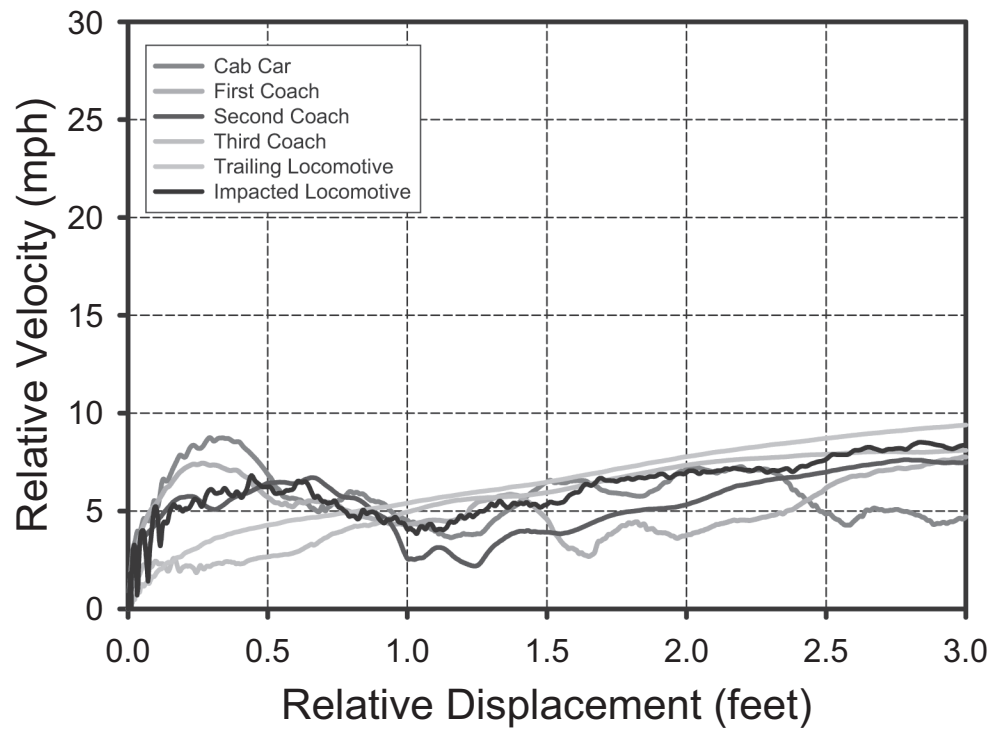
Figure 29 shows the three-dimensional model results and train-to-train test results for the secondary impact velocities for all of the cars in the cab car led consist, and the impacted locomotive.

Figure 29. Secondary Impact Velocities, Cab Car Led Train and Impacted Locomotive, Train-to-Train Test

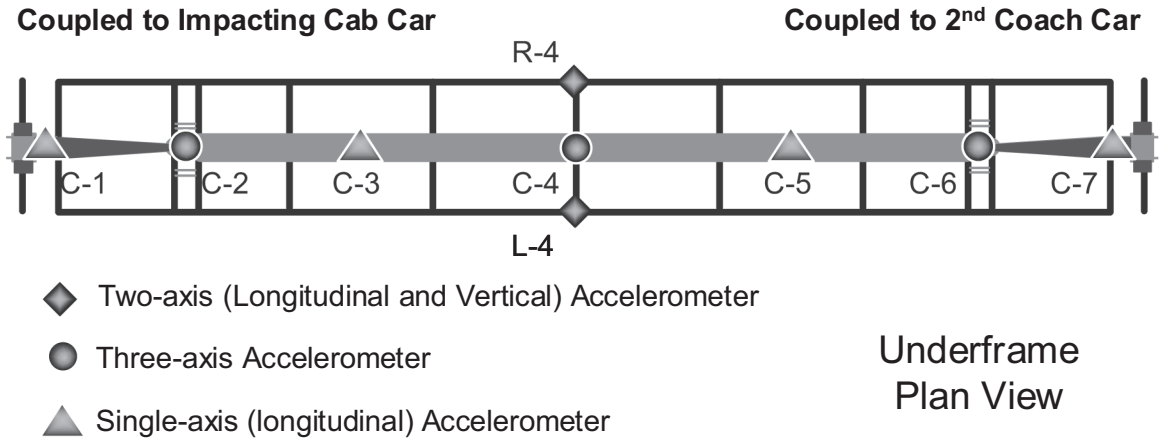
Figure A-3. Schematic Layout of 1st Coach Car Accelerometer Locations

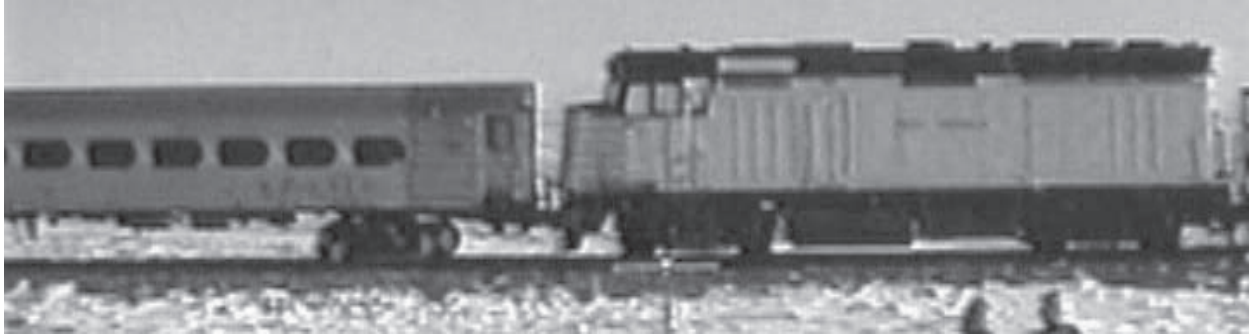
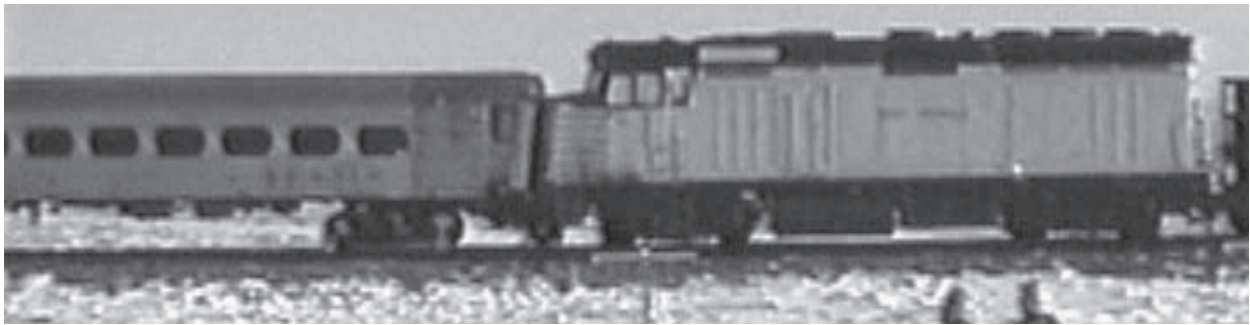
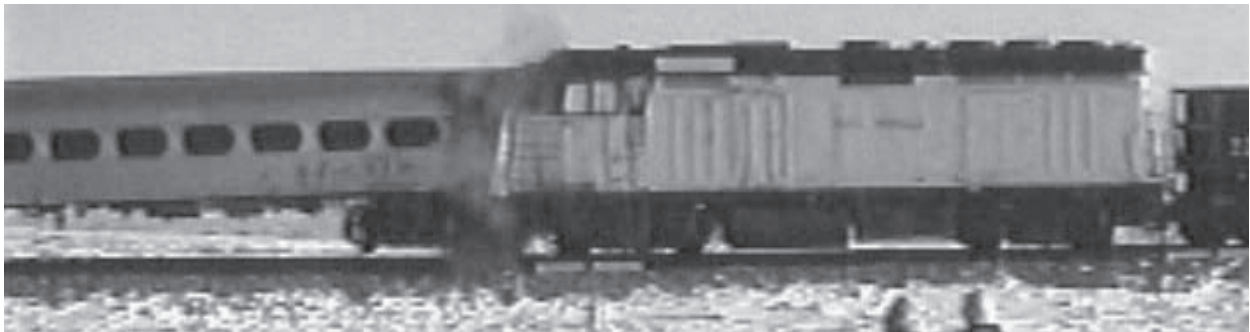
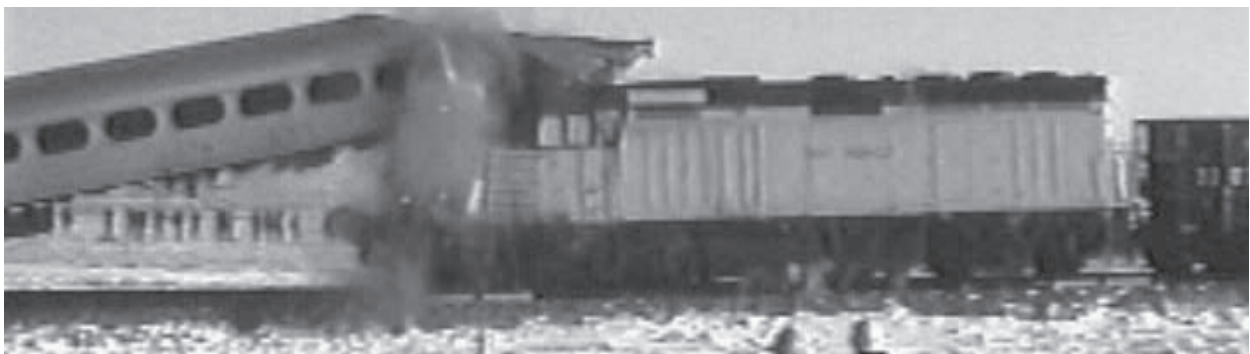
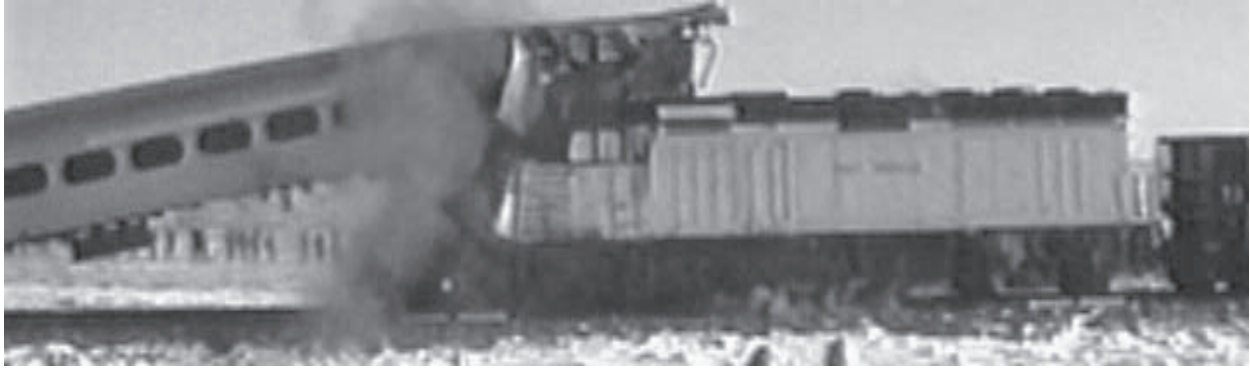
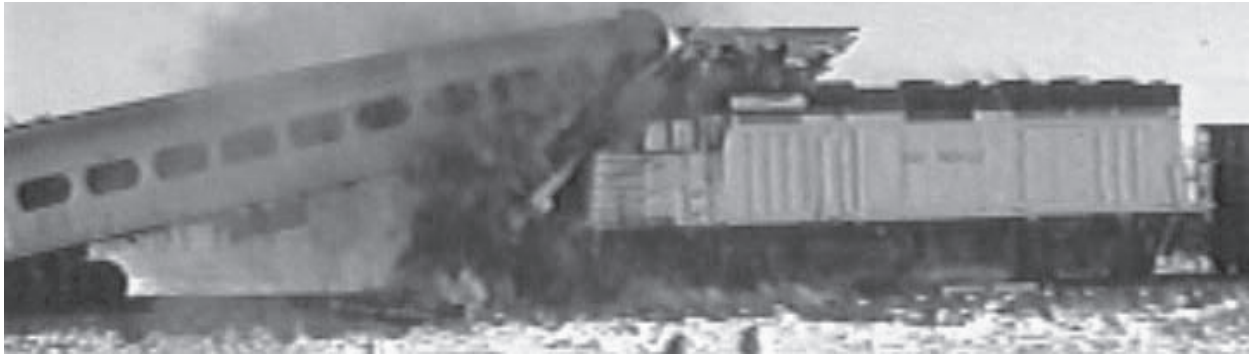
1. Initial contact, between the couplers of the cab car and locomotive
2. Cab car initially pitches down a small amount up to when the maximum force is reached. Shortly after, the carbody starts to pitch up as the crush continues. Similar behavior was observed in the single car and two-car impact tests [14, 17].
3. Cab car is crushed approximately six feet, about the same amount of crush as in single-car and two-car tests [14, 17]. The carbody is pitched upward in this photograph.
4. Cab car body bolster fails and the front end of the carbody folds downward.
5. Maximum cab car vertical displacement
6. Maximum relative longitudinal displacement of the cab car and locomotive, and maximum crush of the cab car and locomotive.

1. Initial contact

2. Cab car initially pitches down

3. Cab Car crushed approximately same amount as in single-car and two-car impact tests

4. Cab car body folds downward

5. Maximum vertical displacement of cab car

6. Maximum crush

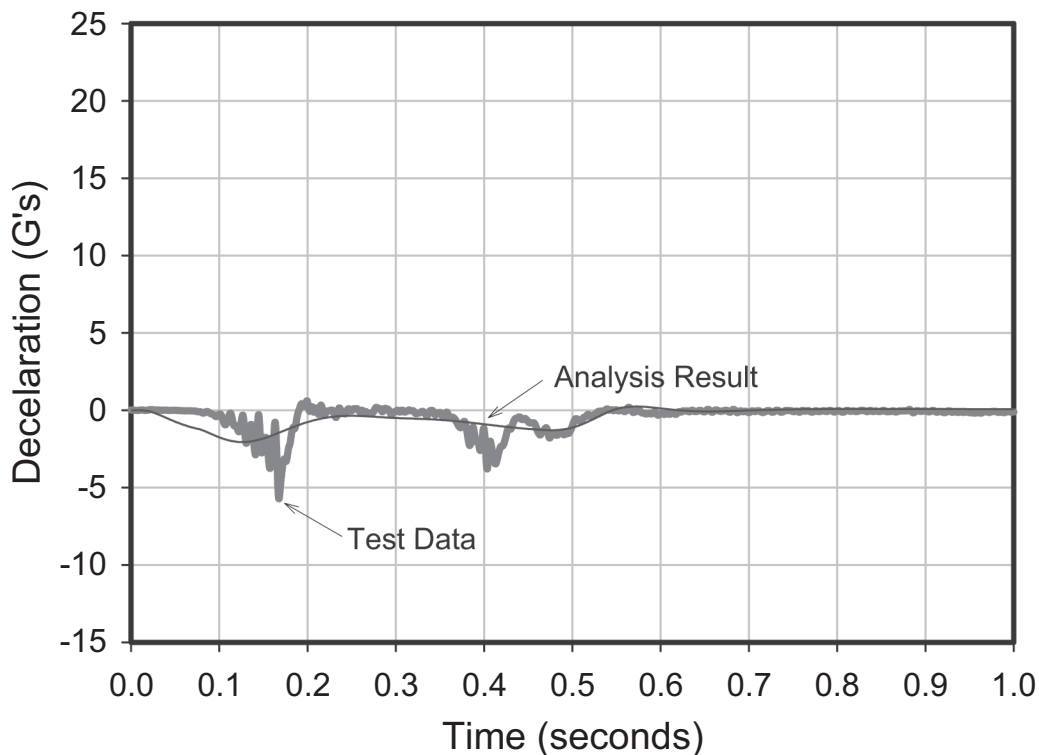
Figure C-7. Longitudinal Deceleration Time-History of Second Freight Car, Test Measurement, Single-Dimensional Model, and Three-Dimensional Model Predictions

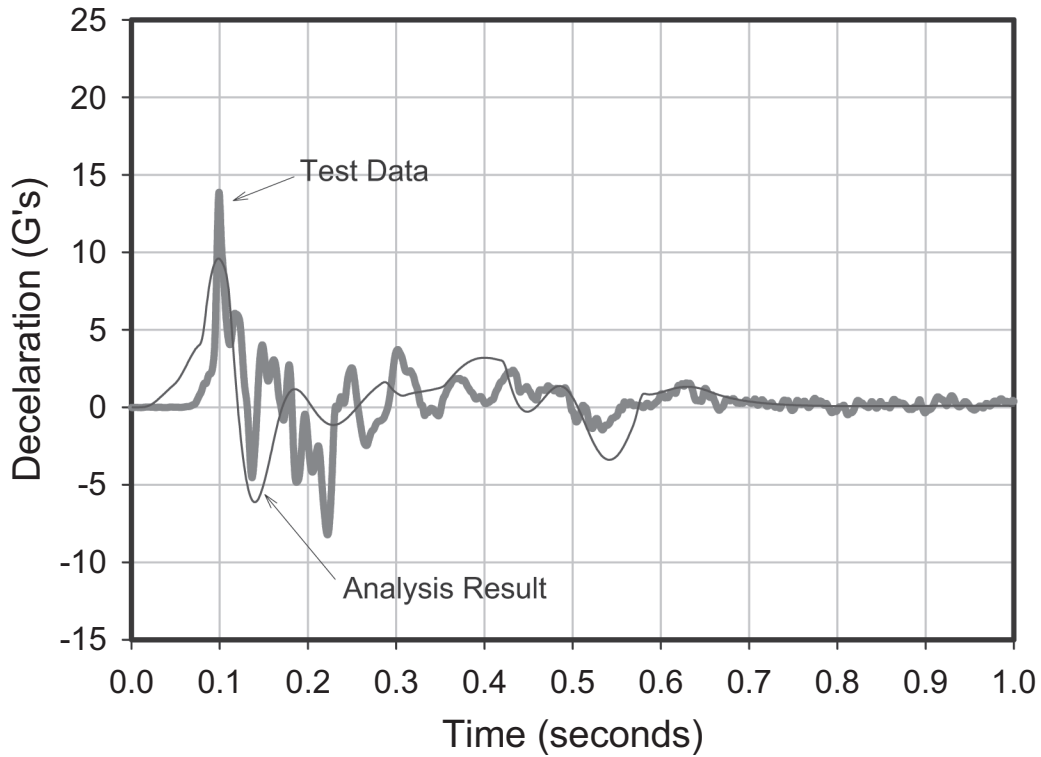
Figure C-12. Longitudinal Deceleration Time-History of Second Coach Car, Test Measurement, Single-Dimensional Model, and Three-Dimensional Model Predictions

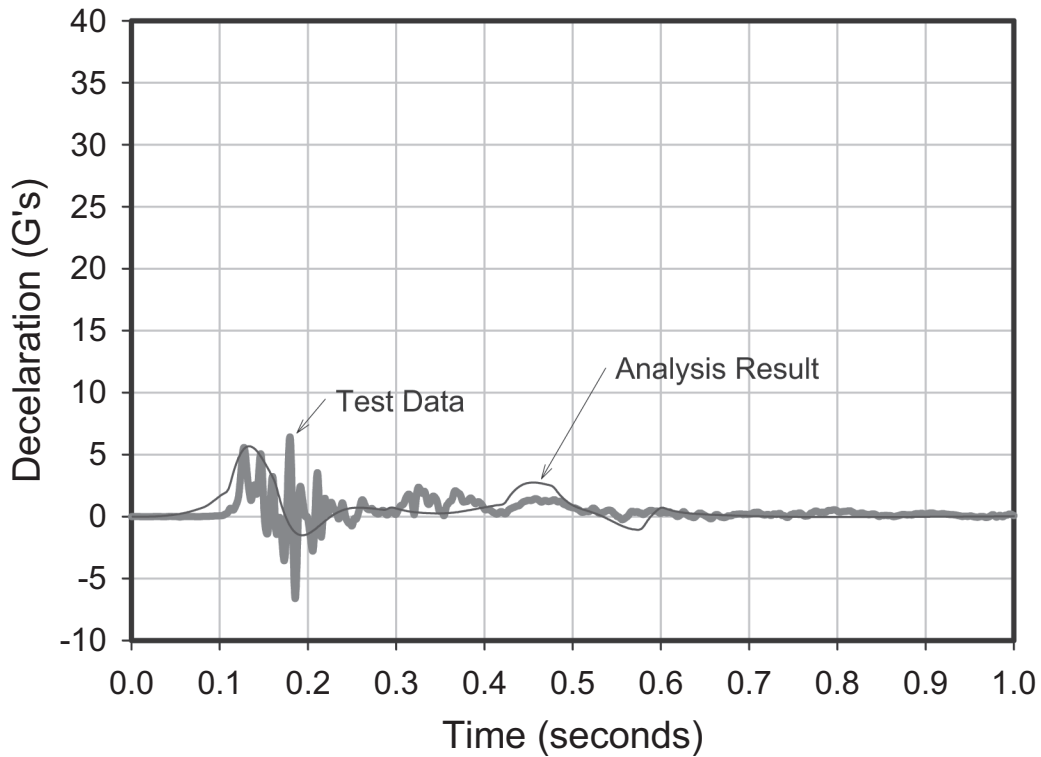
Figure C-13. Longitudinal Deceleration Time-History of Third Coach Car, Test Measurement, Single-Dimensional Model, and Three-Dimensional Model Predictions

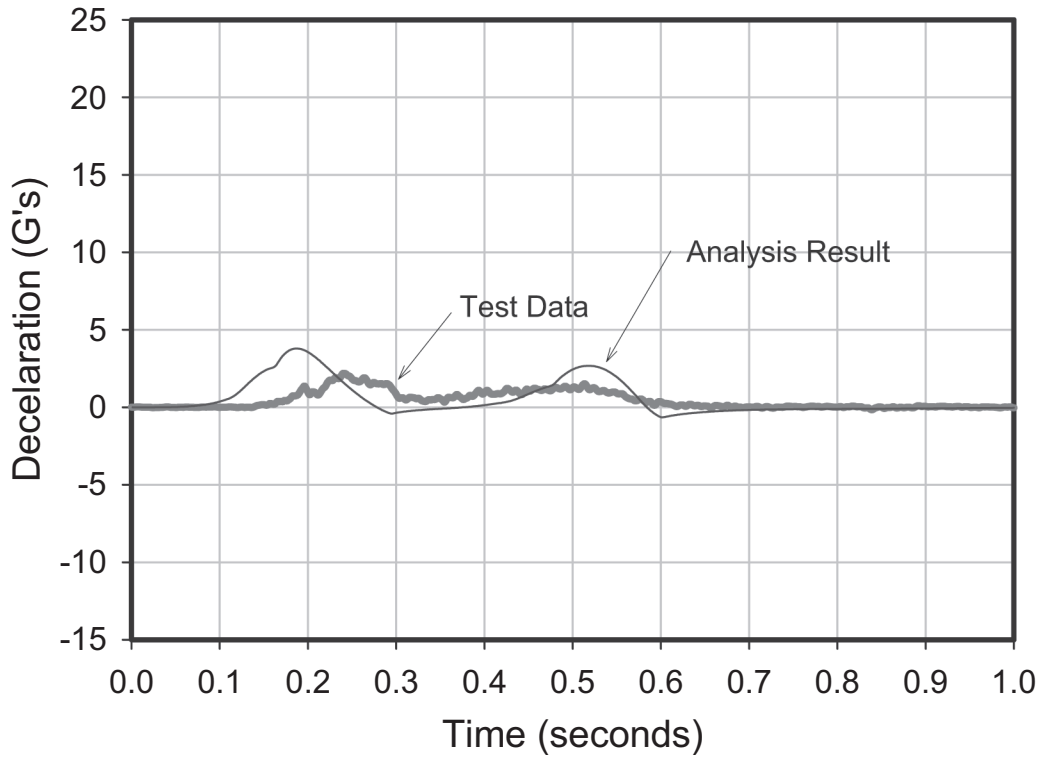
Figure C-14. Longitudinal Deceleration Time-History of Trailing Locomotive, Test Measurement, Single-Dimensional Model, and Three-Dimensional Model Predictions
