U.S. Department  
of Transportation

**Federal Railroad  
Administration**

# Investigation of Cracks in Acela Coach Car Brake Discs: Test and Analysis Volume I - Final Report

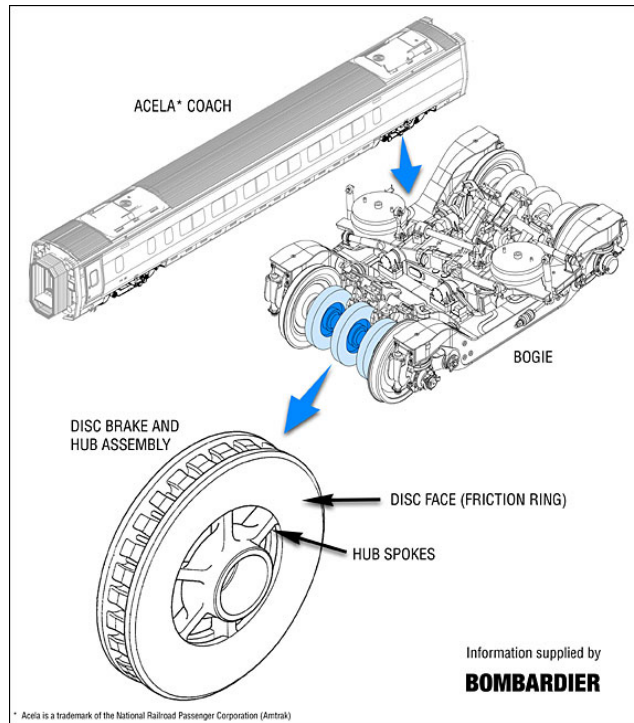
**Figure 1.1. Typical Acela Coach, Bogie and Brake Disc**

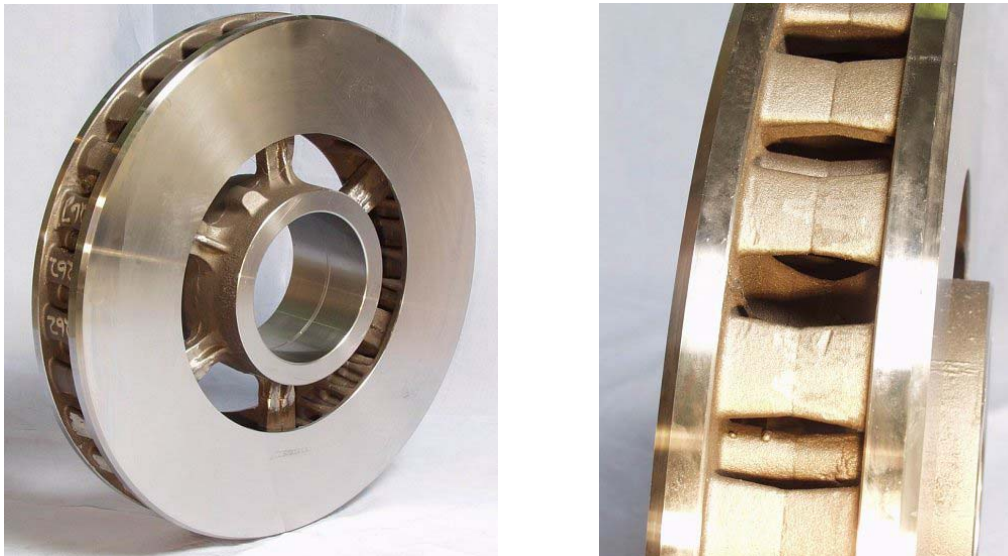
**Figure 1.2. WABTEC/SAB-WABCO Supplied Brake Disc**

Figure 1.1 provides a drawing of the WABTEC/SAB-WABCO supplied disc, including an indication of its location on an Acela coach car; Figure 1.2 shows photographs of this disc. During braking of the Acela trainset, three sets of calipers each force a set of brake pads to make contact with the large friction ring on both sides of the three brake discs installed on each axle.

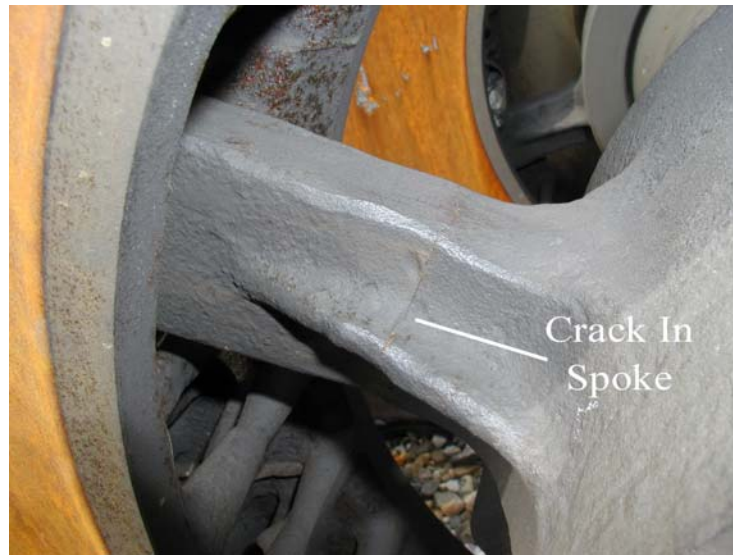
**Figure 1.3. Example of a Crack in Spoke of WABTEC/SAB-WABCO Supplied Brake Disc Used on Acela Coach Car**

The brake discs are considered a monoblock design, one in which the disc is made from a one-piece casting as opposed to designs that have the friction ring bolted to the hub. Figure 1.3 illustrates an example of a crack identified during the inspections. Many cracks observed on the brake discs were in a location corresponding to discontinuities found on the surface of some spokes arising from a mold parting line. As can be seen by considering the crack shown in Figure 1.3, crack propagation through each of the spokes joining the friction ring to the hub of the disc would lead to a situation in which no rigid connection exists between the braking surface of the disc and the hub, and therefore the axle itself. Not only would this result in an elimination of contribution to braking effort from this disc, it could also result in significant damage caused to the truck, therefore presenting a potential derailment scenario, should a portion of the disc separate from the axle. This situation would be exacerbated by the high speeds associated with the operation of the Acela fleet. Although inspections revealed individual spokes in which cracks had propagated completely through the material, exhibiting signs of corrosion, which indicated that cracks have propagated for a significant period of time, *no* disc within the fleet had the braking surface separate from the hub.

investigation revealed that cracks developed due to a progression of bending fatigue that originated along a decarburized surface layer. The report states: “Although the decarburized surface layer provided a site for fatigue initiation, the root cause of the cracking is the level of bending stresses at the crack sites.”

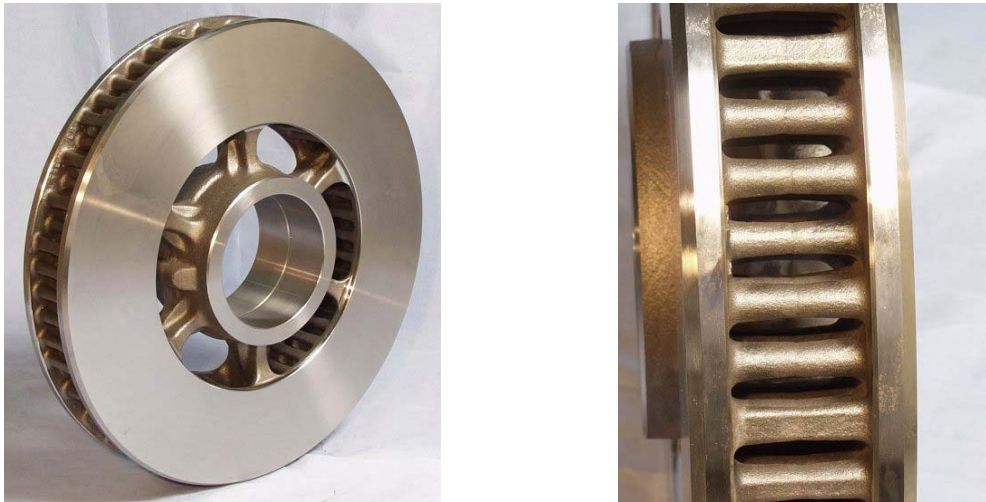
In Phase 3, Knorr identified and provided a replacement disc, and an axle equipped with brake discs of this alternate design was included in the test program. Figure 1.4 provides an illustration of the Knorr disc; Figure 1.5 shows a photograph of the spokes of the Knorr disc. The goal of this portion of the evaluation was to determine if the Knorr disc design demonstrated substantial improvements over the original disc design and was likely to be successful in service. The axle with the set of alternative discs was placed on an adjacent car within the test train, and the instrumentation suite was expanded to accommodate measurements on the axle equipped with the Knorr disc and on the axle equipped with the WABTEC/SAB-WABCO supplied disc. A final test series was run, during which direct comparisons were made between the Knorr disc and the WABTEC/SAB-WABCO supplied disc in over-the-road tests. Data was collected in a manner that would allow decisions to be made about the potential for success of the Knorr design in revenue service.

**Figure 1.4. Knorr Brake Disc**

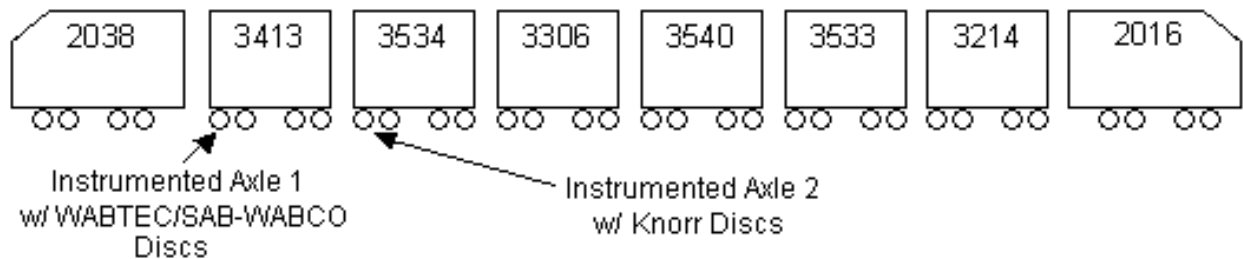
**Figure 2.1. Test Consist–Acela Trainset 10**

Acela Trainset 10 was used during all tests. Figure 2.1 depicts the test consist and the vehicle number of all coaches and power cars. The test axle employing the WABTEC/SAB-WABCO supplied discs, designated as Axle 1, was installed on the A-end truck of Coach 3413 in the axle 1 position. The test axle with the Knorr discs, designated as Axle 2, was located on the B-end truck of Coach 3534 in the axle 4 position. The following illustrates the position of both test axles.

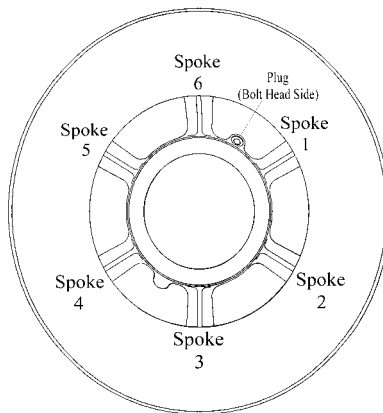
Figure 2.2 illustrates the designation of the spokes on the WABTEC/SAB-WABCO supplied brake disc. Figure 2.3 provides an illustration of the location of all strain gages employed during Phase 1 of the study. Figure 2.4 shows the installation of a weldable strain gage on one of the spokes of a WABTEC/SAB-WABCO supplied disc.

**Figure 2.2. Spoke Designations for the WABTEC/SAB-WABCO Supplied Brake Disc**

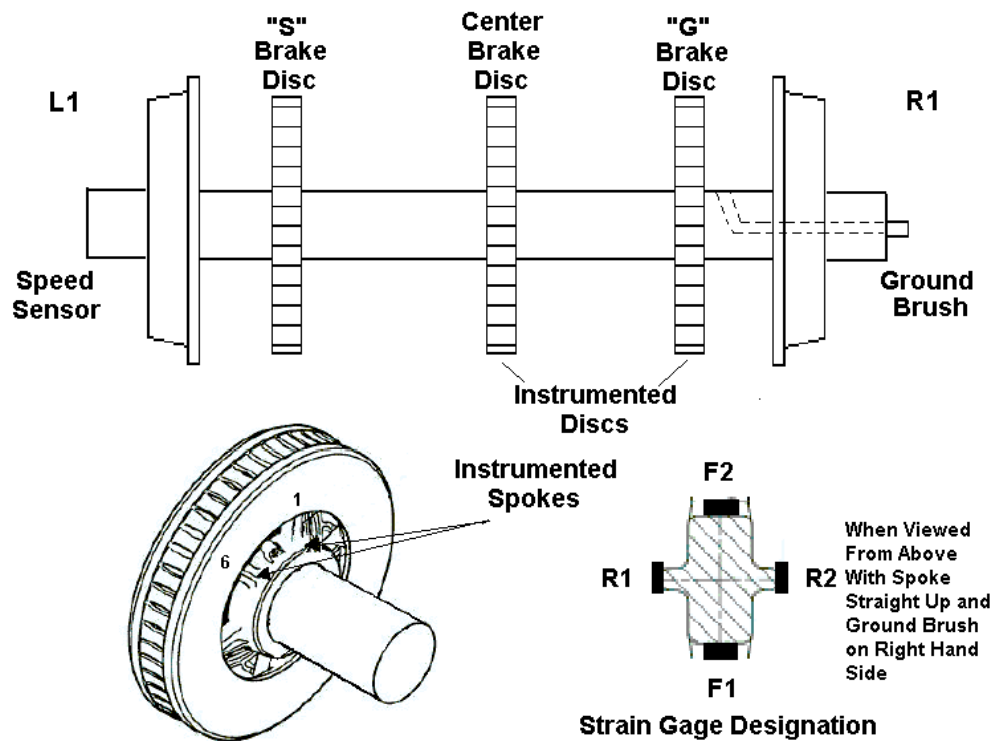
**Location of Instrumentation on WABTEC/SAB-WABCO Axle  
on Car 3413 During Phase 1 of Acela Brake Disc Study**

**Figure 2.3. Location of Strain Gages on WABTEC/SAB-WABCO Supplied Discs  
During Phase 1 of Study**

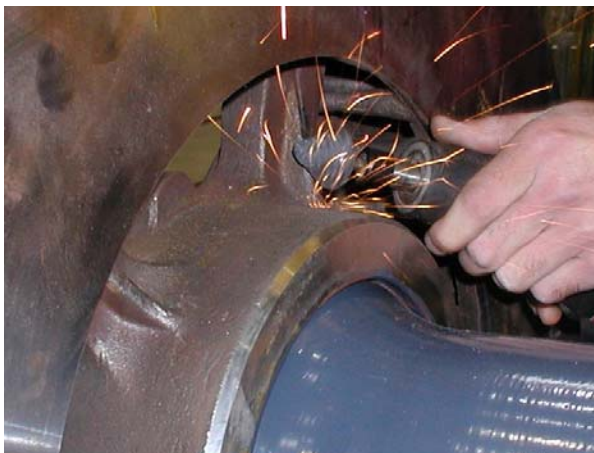
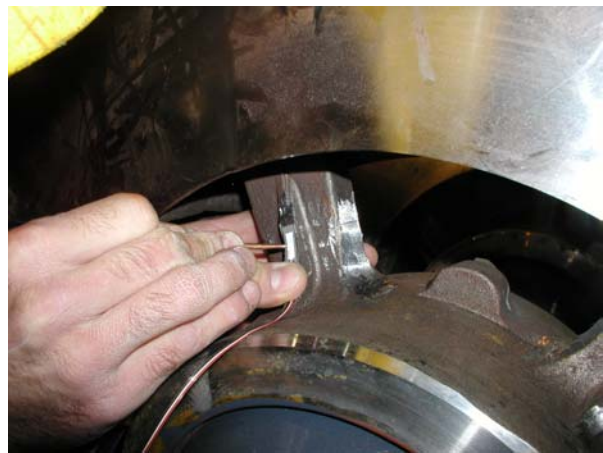
**Figure 2.4. Strain Gage Being Applied to a Spoke of the WABTEC/SAB-WABCO  
Supplied Brake Disc  
(Courtesy M. Perkins, Amtrak)**

**a) Spoke Grinding Process;  
Spoke to Left of Nut Unmodified**

**b) Gage Being Applied to Web  
on Spoke to Left of Nut**

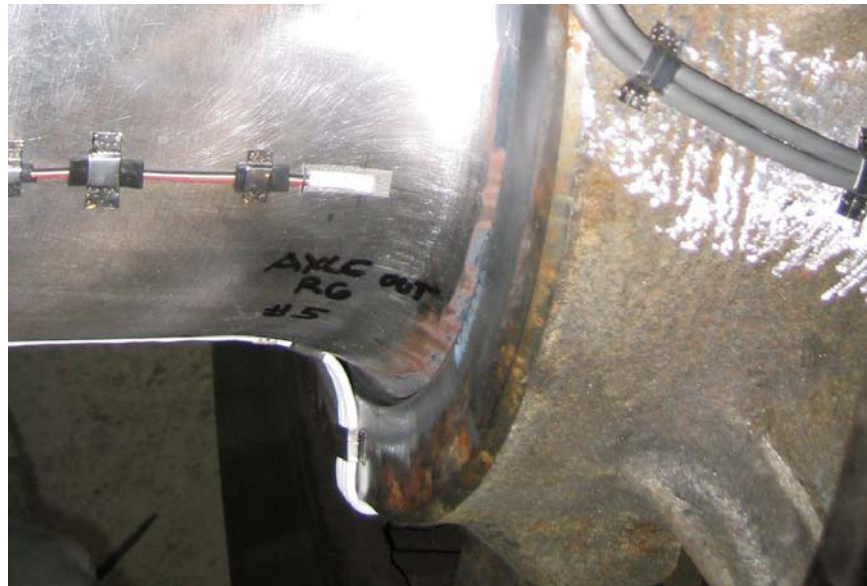
In addition to the new strain gages on spokes of the center disc, four strain gages were mounted to the axle, two gages 180° apart as close to the center disc as possible and two gages 180° apart at a location approximately ¼ of the distance between the two wheels. According to Knorr, the purpose of these gages was to observe the behavior of the axle, including the frequency associated with the second mode of axle bending. The strain gages were installed in a manner such that their location corresponded to spokes 6 and 3 of the center disc; due to the geometry of the axle, the geometric centers of the gages were located 9 inches from each other and centered within the space between the two discs. Figure 2.5 shows a picture of an axle-mounted strain gage. Figure 2.6 provides an illustration of the location of all strain gages employed during Phase 2 of the study.

**Figure 2.5. Strain Gage on Surface (Longitudinal Direction) of Axle with WABTEC/SAB-WABCO Supplied Discs**

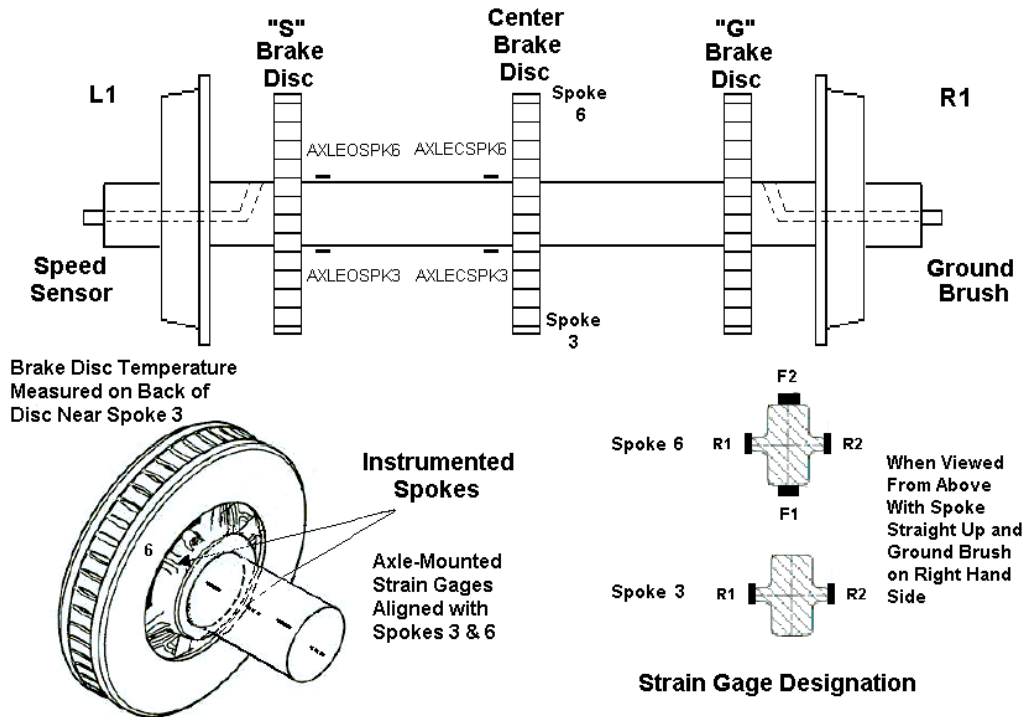
## Location of Instrumentation on WABTEC/SAB-WABCO Axle on Car 3413 During Phase 2 of Acela Brake Disc Study

**Figure 2.6. Location of Strain Gages on WABTEC/SAB-WABCO Test Axle During Phase 2 of Study**

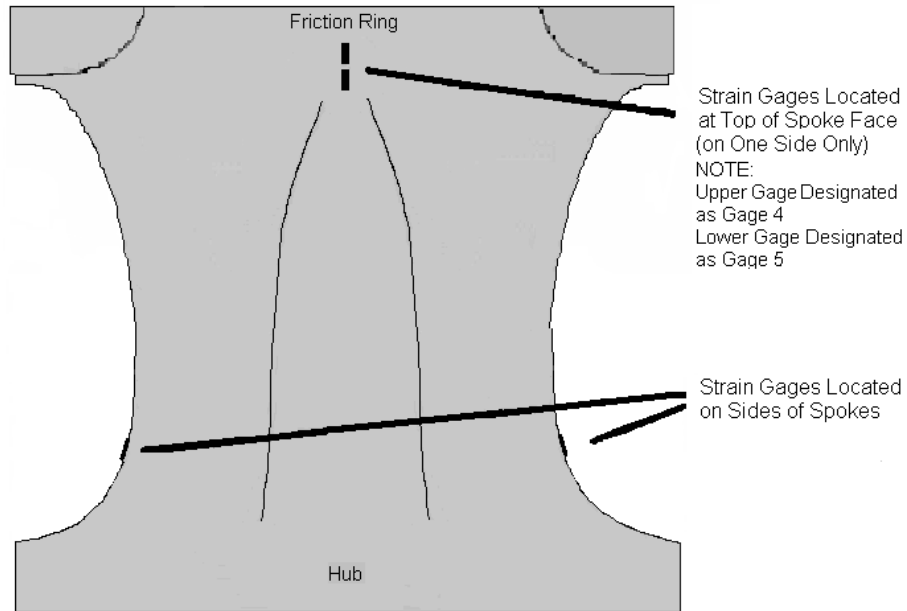
Strain gages were installed on the center-mounted disc at particular locations on spokes designated by Knorr; Figure 2.7 illustrates these locations. The strain gages were located to coincide with the sites of highest strain in the spoke under typical operating conditions determined by FEA treatments conducted by Knorr.

**Figure 2.7. Illustration of Strain Gage Locations on Knorr Disc Used During Phase 3 of Acela Brake Disc Study**

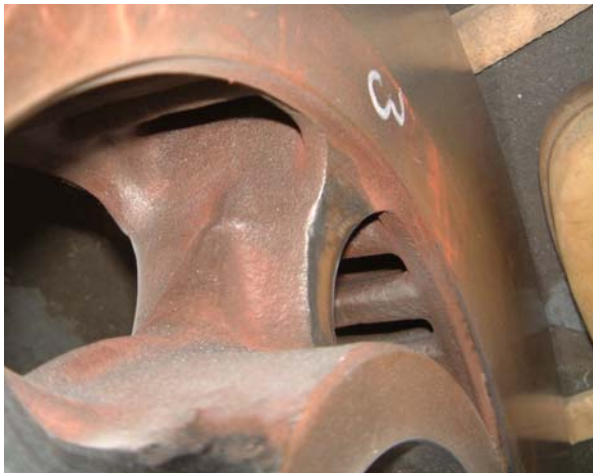
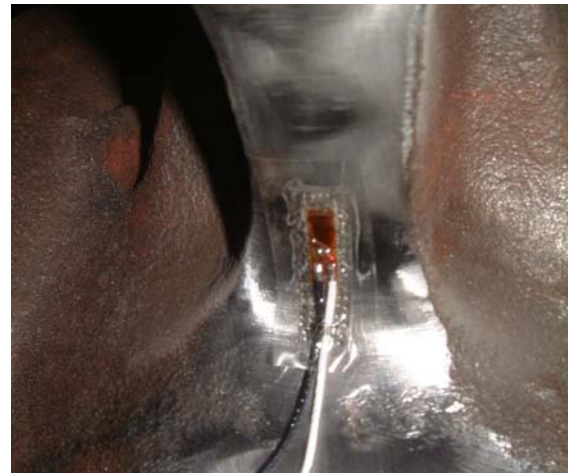
**Figure 2.8. Strain Gage Being Applied to Spoke 3 of the Knorr Brake Disc (Courtesy J. Gordon, VOLPE)**

Gages located near the bottom of the spokes were located 17 millimeters above the surface of the hub; gages located at the top of the spoke were located as close to the transition into the friction rings as possible. As was done in the earlier parts of the study, spokes 6 and 3 on the Knorr instrumented discs were designated as the spokes of interest during the test. Spokes 1 and 4 served as a set of backup spokes, but no reason existed to use the gages on spokes 1 and 4 during Phase 3 of the test. Figure 2.8 illustrates the installation of a weldable strain gage on the side of spoke 3 of the Knorr disc.

**a) Spoke 3 Following Grinding on Side**

**b) Gage Applied to Side of Spoke 3**

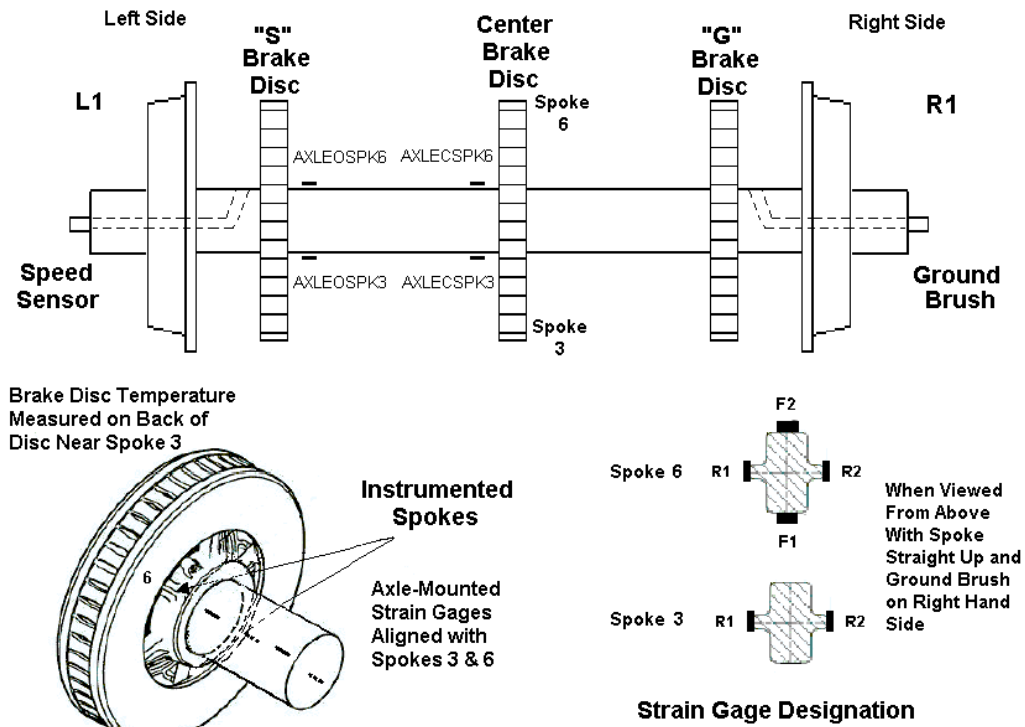
### Location of Instrumentation on WABTEC/SAB-WABCO Axle on Car 3413 During Phase 3 of Acela Brake Disc Study

Figure 2.9a. Location of Strain Gages on WABTEC/SAB-WABCO Test Axle During Phase 3 of Acela Brake Disc Study

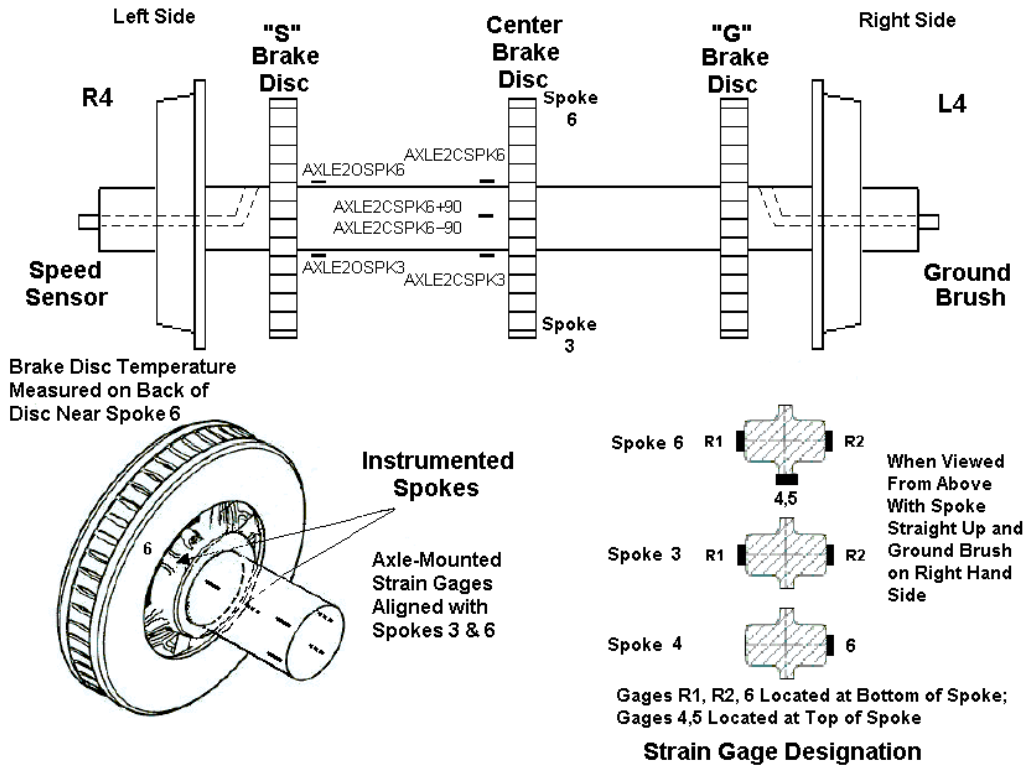
## Location of Instrumentation on Knorr Axle on Car 3534 During Phase 3 of Acela Brake Disc Study

**Figure 2.9b. Location of Strain Gages on Knorr Test Axle During Phase 3 of Acela Brake Disc Study**

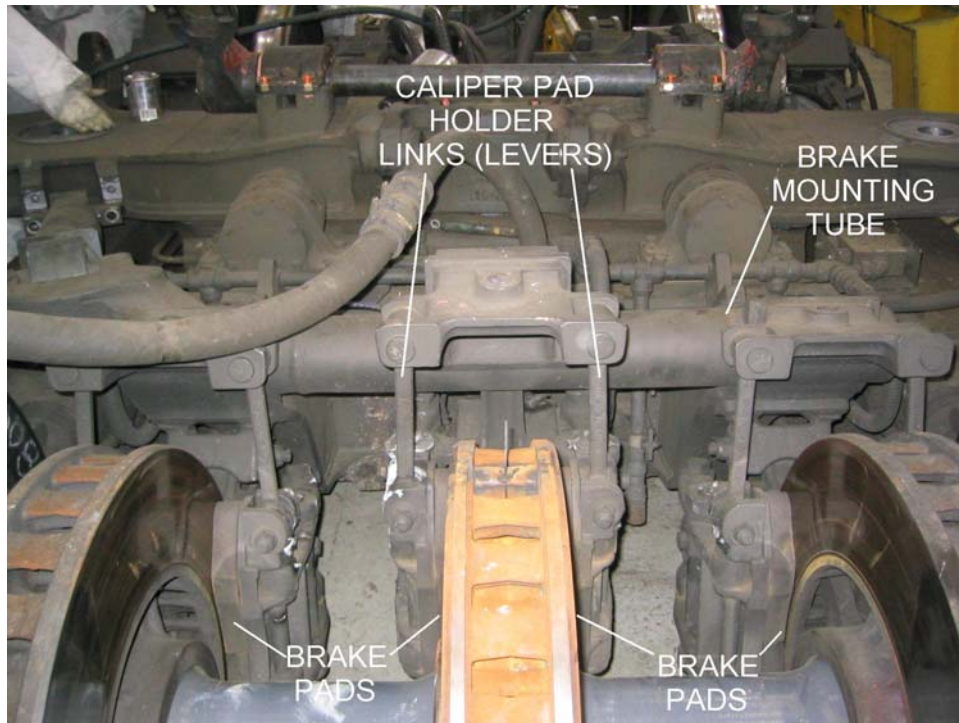
**Figure 2.10. Brake Caliper Support Links and Mounting Tube (Shown on Removed Truck for Clarity)**

In addition to strain gages mounted to the instrumented discs and the test axles, strain gages were installed on two caliper hanger links (levers) at the request of Bombardier. Figure 2.10 shows the caliper hanger links installed on a truck removed from a coach car. One gage was installed on each of the hangers employed by the center caliper assembly associated with the WABTEC/SAB-WABCO test axle. The gages were installed on the side of the hanger facing the adjacent power car, and the center of each gage was located as close to the geometric center of the link as possible.

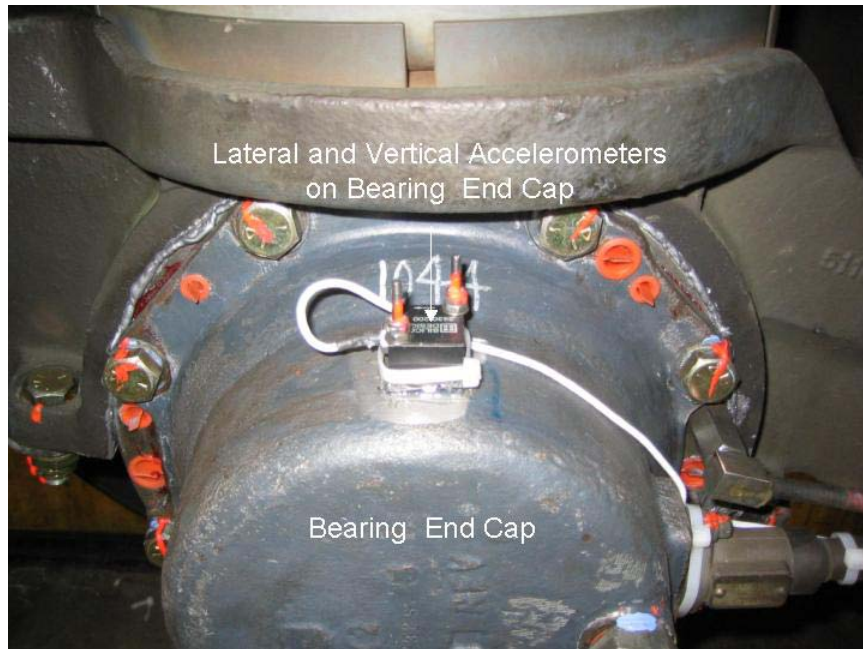
**Figure 2.11. Tri-Axial Accelerometer Originally Used to Measure Lateral and Vertical Accelerations on Ends of Test Axle**

The lateral and vertical accelerations experienced by both ends of the WABTEC/SAB-WABCO test axle on the non-rotating bearing housing were originally measured using Silicon Designs Model No. 2430-200 +/- 200 g tri-axial accelerometers (see Figure 2.11).

- ENSCO installed two Vibra-Metrics Model No. 7002HG2K +/- 500 g accelerometers to monitor the lateral accelerations of the test axles near the center-mounted instrumented discs. On the Knorr test axle, this sensor was mounted in a fashion similar to the one pictured in Figure 2.11. On the WABTEC/SAB-WABCO test axle, the Dytran Instruments accelerometer was replaced with a Vibra-Metrics accelerometer to improve the reliability of the axle lateral acceleration measurement. During Phase 3 of the study, the Vibra-Metrics accelerometer was referred to as AXLELAT2.

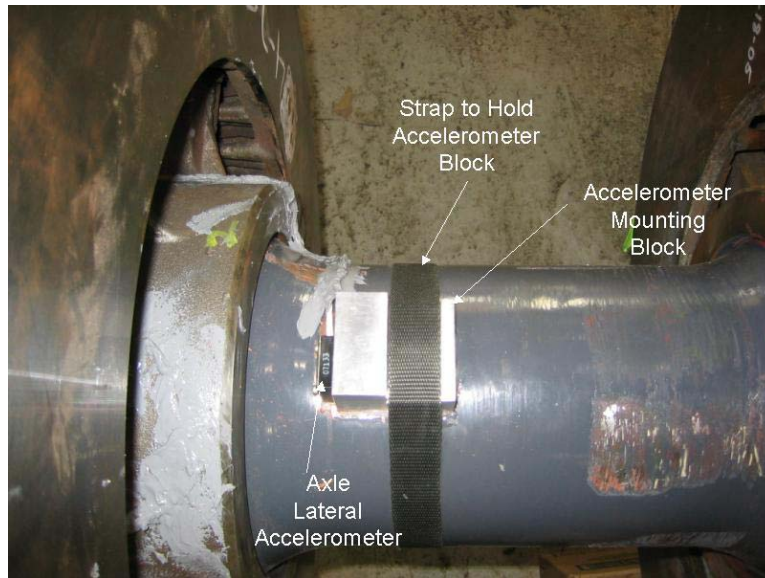
The lateral accelerations of the WABTEC/SAB-WABCO test axle in the vicinity of the center brake disc were recorded using a Silicon Designs Model No. 2410-200 +/- 200 g single-axis accelerometer (see Figure 2.12). The sensor was affixed to a mounting block that was held to the axle with a kevlar strap.

**Figure 2.12. Lateral Accelerometer Mounted Near Center Disc on WABTEC/SAB-WABCO Test Axle During Phase 1 of Acela Brake Disc Study**

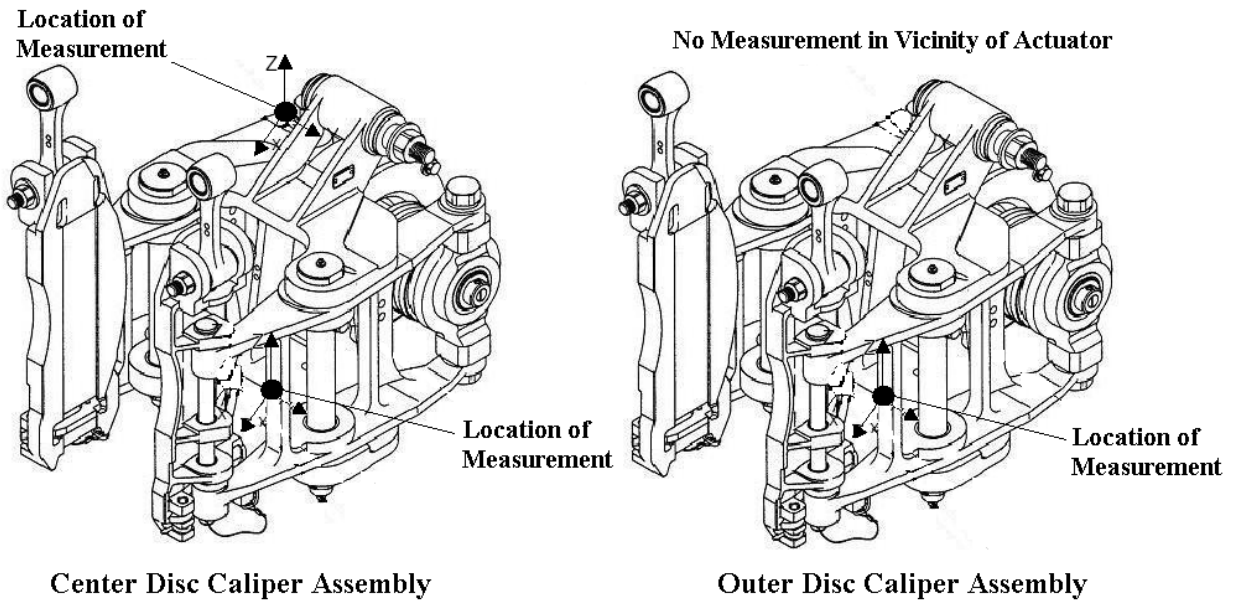
The lateral, vertical, and longitudinal accelerations experienced by the brake caliper assemblies associated with the center and outer instrumented discs were measured using Silicon Designs Model No. 2440-100 +/- 100 g tri-axial accelerometers. On the center caliper assembly, accelerations were monitored near one of the brake pads and on the upper portion of the assembly near the actuator. On the outer caliper assembly, only accelerations near one of the brake pads were measured. Figure 2.13 illustrates the locations of these measurements. Figures 2.14 and 2.15 show mounting brackets and sensors affixed to the calipers.

Figure 2.13. Acceleration Measurement Locations on the Caliper Assemblies

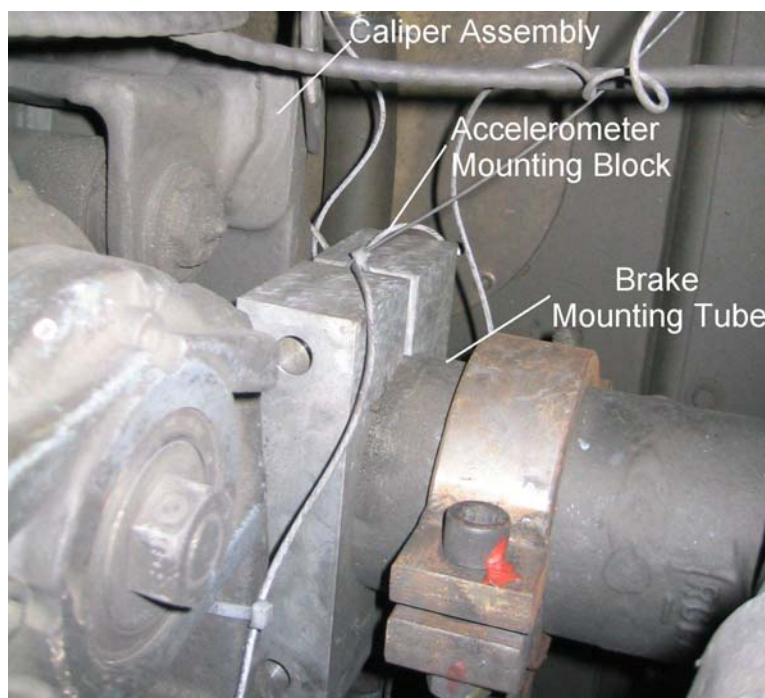
**Figure 2.16. Tri-Axial Accelerometer Mounted on Brake Mounting Tube Over WABTEC/SAB-WABCO/Knorr Test Axles, Phase 3 of Acela Brake Disc Study**

- Amtrak provided five additional ICP accelerometers, manufactured by PCB Piezotronics, Inc., for this portion of the effort. Two single-axis accelerometers were installed on each end of the Knorr test axle, one mounted in the lateral direction and one mounted in the vertical direction. In addition, one single-axis accelerometer was installed on the left end of the WABTEC/SAB-WABCO test axle in the longitudinal direction.
- A Silicon Designs Model No. 2440-025 +/- 25 g tri-axial accelerometer was mounted on the brake mounting tube over each of the two test axles approximately 5 inches from the center of the tube (i.e., near the center caliper assembly). Figure 2.16 shows the location of the sensor over one of the test axles.

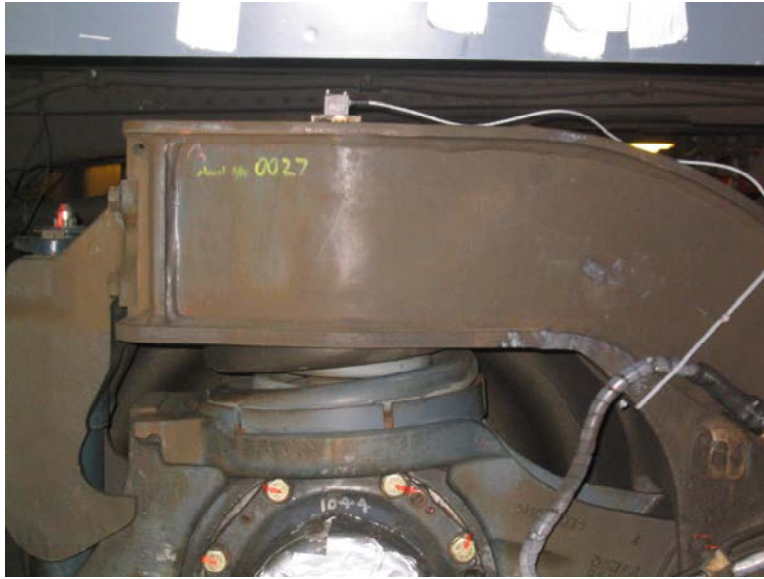
**Figure 2.17. Tri-Axial Accelerometer on Truck Frame Over Primary Suspension of Knorr Test Axle During Phase 3 of Acela Brake Disc Study**

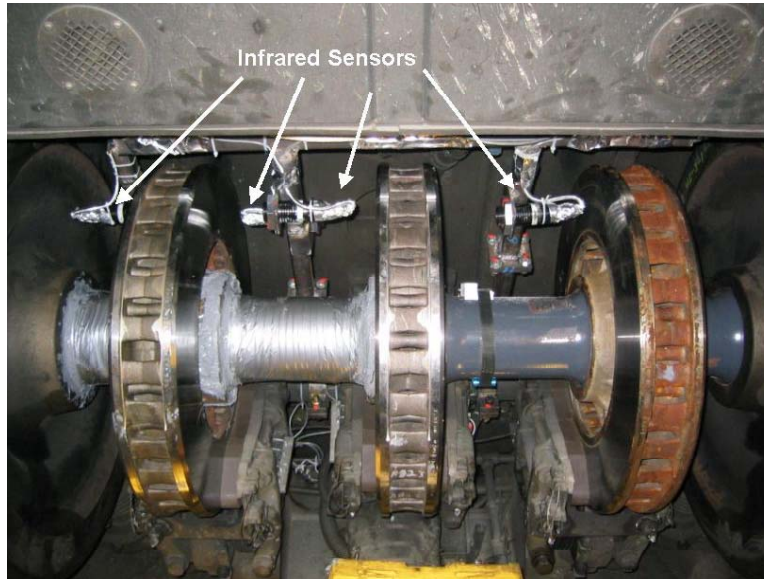
**Figure 2.18. Infrared Sensors Mounted to Measure Surface Temperatures of WABTEC/SAB-WABCO Supplied Discs in Center and Outer Positions During Phase 1 of Acela Brake Disc Study**

ENSCO employed four IR thermometers (Omega Engineering, Inc. Model No. OS553-V1-4) capable of measuring temperatures over a range of 0 °F to 1600 °F (-18 °C to 870 °C). The sensors were arranged such that a sensor was placed on each side of the disc of interest. Figure 2.18 illustrates the arrangement of the sensors.

The signal from the sensor was routed to a readout device mounted on the edge of the truck frame, which in turn supplied a 0-5 VDC signal to the data acquisition hardware for scaling and recording. The readout device also allows the user to specify the emissivity of the device; emissivity settings of 0.78 were established for all the sensors throughout the test program.

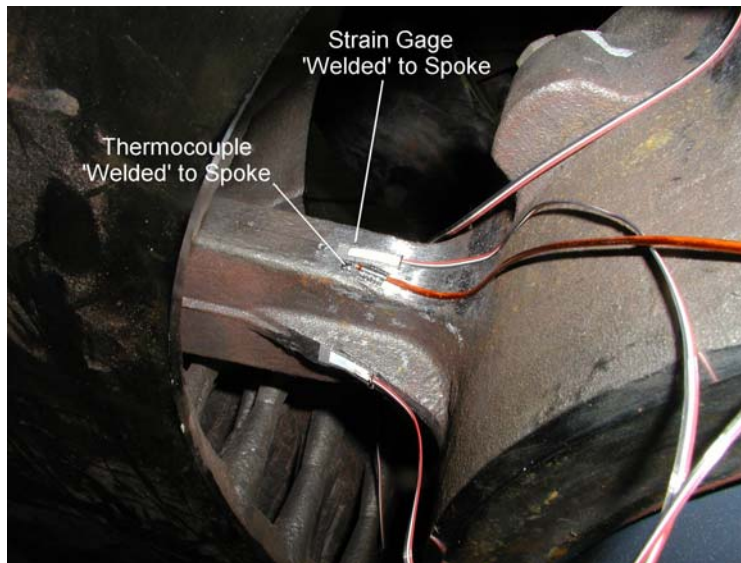
**Figure 2.19. Thermocouple Applied to Spoke on Instrumented WABTEC/SAB-WABCO Supplied Disc During Phase 1 of Acela Brake Disc Study**

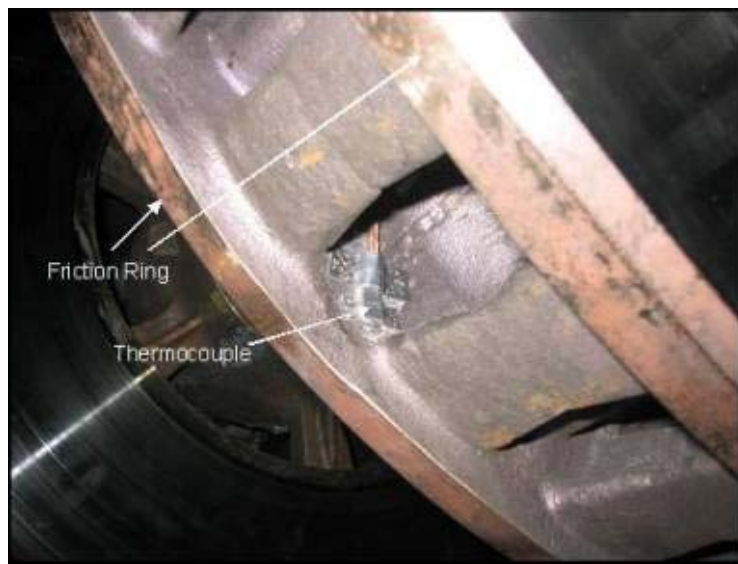
**Figure 2.20. Thermocouple Applied on Back of Friction Ring of Instrumented WABTEC/SAB-WABCO Supplied Disc During Phase 1 of Acela Brake Disc Study**

- Temperature measurements on the back of the friction ring on the instrumented WABTEC/SAB-WABCO supplied disc in the center position of the test axle commenced at FRA's request following the test runs conducted on May 16. A new thermocouple was installed on the back of the friction ring (see Figure 2.20) approximately  $\frac{3}{4}$  of an inch below the edge of the friction ring, and this temperature was considered the disc temperature for the remainder of the test program.

The thermocouple used for this measurement was the Omega Engineering, Inc. Model No. WTK-6-36 thermocouple, capable of measuring temperatures up to 900° F (480° C).

The center disc temperature during the second phase of the test continued to be based on the thermocouple mounted near the edge of the friction ring pictured in Figure 2.20.

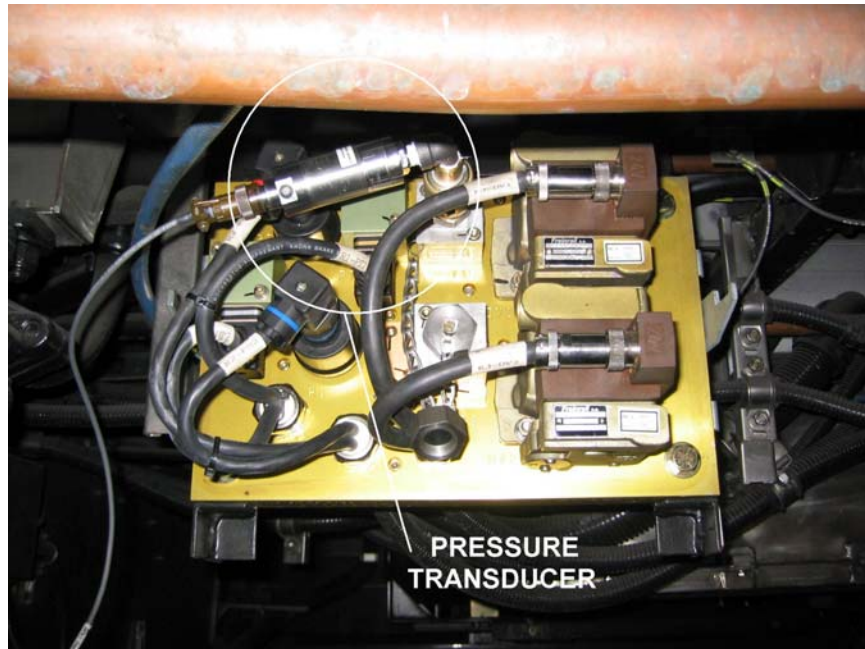
**Figure 2.21. Pressure Transducer Used to Measure Brake Cylinder Pressure on Coach Car 3413**

- Brake Cylinder Pressure—Measured by connecting a transducer to the test point labeled T1 on the manifold in the Dump Valve/Truck Cut-Out compartment at the A-end of Coach Car 3413.
- Brake Pipe Pressure—Measured by connecting a transducer to the test point labeled BPTP on the main brake manifold of Coach Car 3413, located at the B-end of the vehicle.
- Parking Brake Pressure—Measured by connecting a transducer to the test point labeled PBTP on the main brake manifold of Coach Car 3413, located at the B-end of the vehicle.

Figure 2.21 shows the pressure transducer used to monitor the brake cylinder pressure on Coach Car 3413.

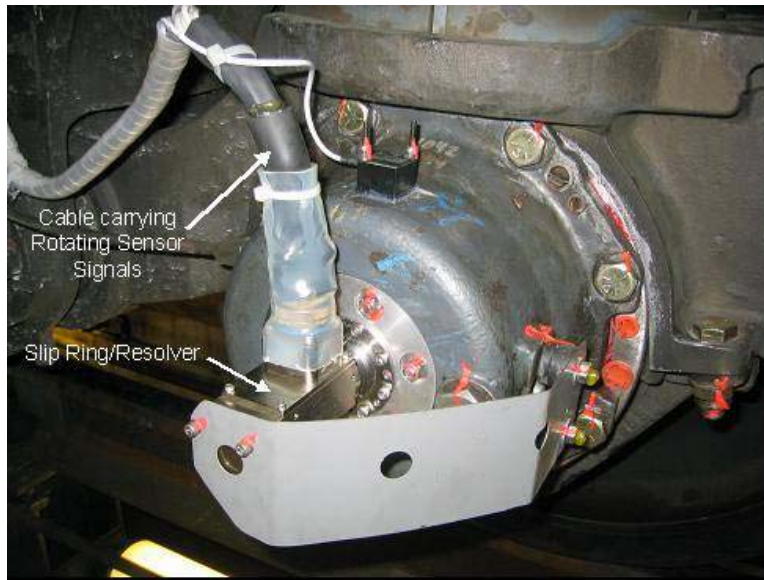
**Figure 2.22. Slip Ring/Resolver Assembly with Wheel Position Output**

The slip ring assembly used to transfer strain, accelerometer, and temperature signals from the rotating axle to the non-rotating instrumentation station was equipped with an angle resolver, which produces a single cycle of an analog sine wave signal for each revolution of the axle. Figure 2.22 shows the slip ring/resolver assembly.

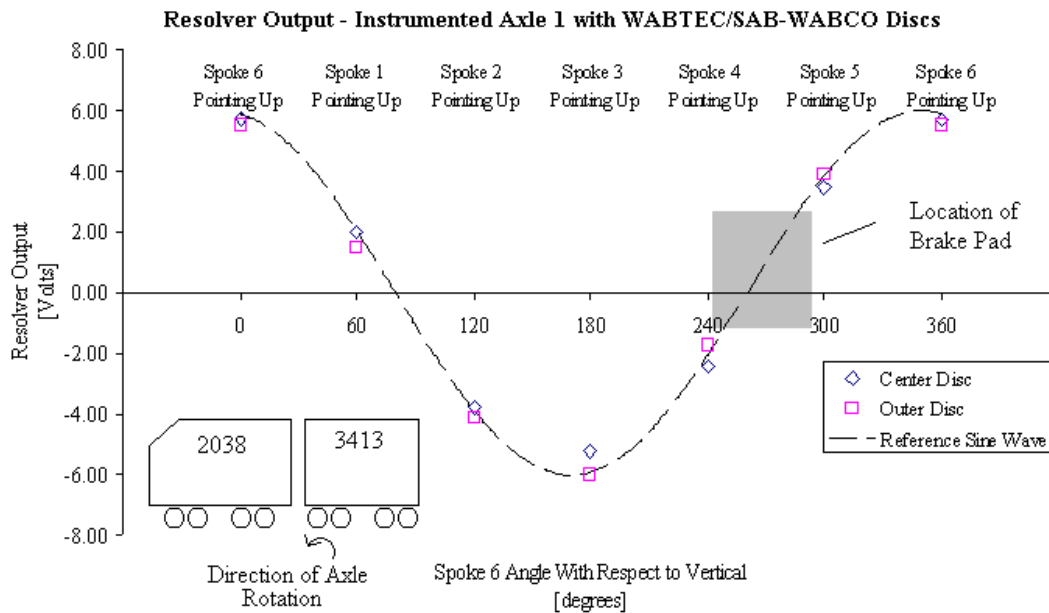
**Figure 2.23. Instrumented Spoke Phase Based on Wheel Angular Position, WABTEC/SAB-WABCO Supplied Discs**

The output of the resolver was used to determine the angular position of the instrumented brake discs at all times. In order to determine the relationship between the output of the resolver and the position of the brake discs following the installation of the instrumented axle with the WABTEC/SAB-WABCO supplied disc, the axle was positioned over a drop table and the rails were lowered until the wheels no longer touched the rail. The signal from the slip ring resolver was then recorded as the wheel was rotated by hand, pausing as each spoke was positioned in a straight up position. The axle was rotated towards Power Car 2038, the same manner in which the axle would be rotating if Power Car 2038 were the lead unit in the consist. This established the important phase relationship between the angular position of the strain-gaged spoke 6 of each disc and the sine wave output from the resolver that is shown in Figure 2.23. From this relationship, the angular location of spoke 6 for the center and outer discs could be determined at any time during the NEC testing. Based on observations, spoke 6 of the instrumented outer disc appeared to be approximately  $5^\circ$  from the instrumented center disc in a counter-clockwise direction when viewing the test axle from the R1 wheel.

The phase shift between a pure sine wave and the output of the resolver when spoke 6 on the center WABTEC/SAB-WABCO supplied disc was straight up was 100°; a small misalignment of the center and outer WABTEC/SAB-WABCO supplied discs occurred between approximately 5-10.° The phase shift

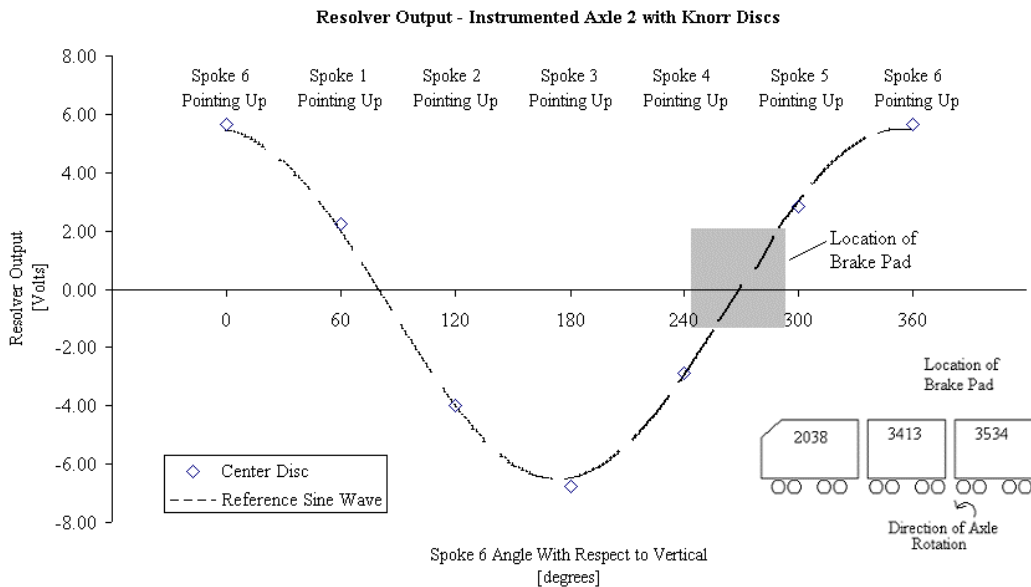
**Figure 2.24. Instrumented Spoke Phase Based on Wheel Angular Position, Knorr Disc**

A similar procedure was used in the determination of the relationship between the output of the resolver and the position of the brake discs on the instrumented axle with the Knorr brake discs. Figure 2.24 shows the results of this exercise.

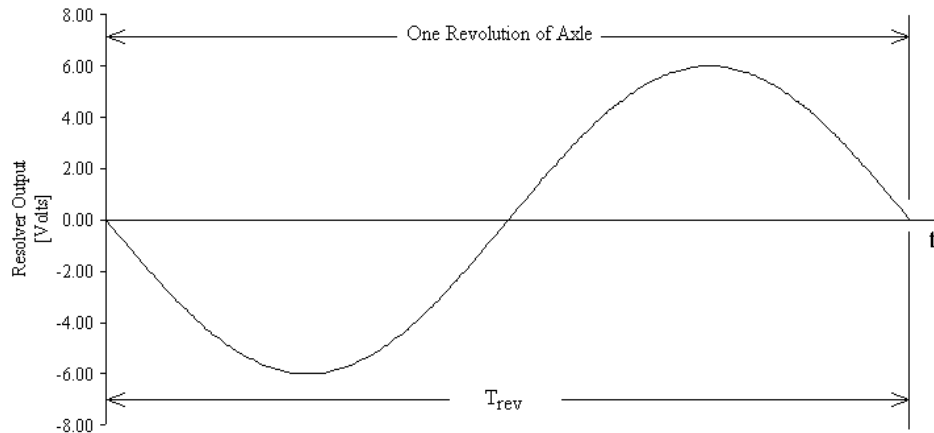
**Figure 2.25. Resolver Output During One Revolution of Instrumented Axle**

A signal reflective of speed was acquired by determining the time required for the sine wave produced by the slip ring/resolver assembly to produce two zero crossings; this represents the time required for the wheel to make a complete revolution, denoted as  $T_{rev}$  in Figure 2.25.

Knowing the time associated with one revolution of the axle and the circumference of the wheel allows for the calculation of speed as follows:

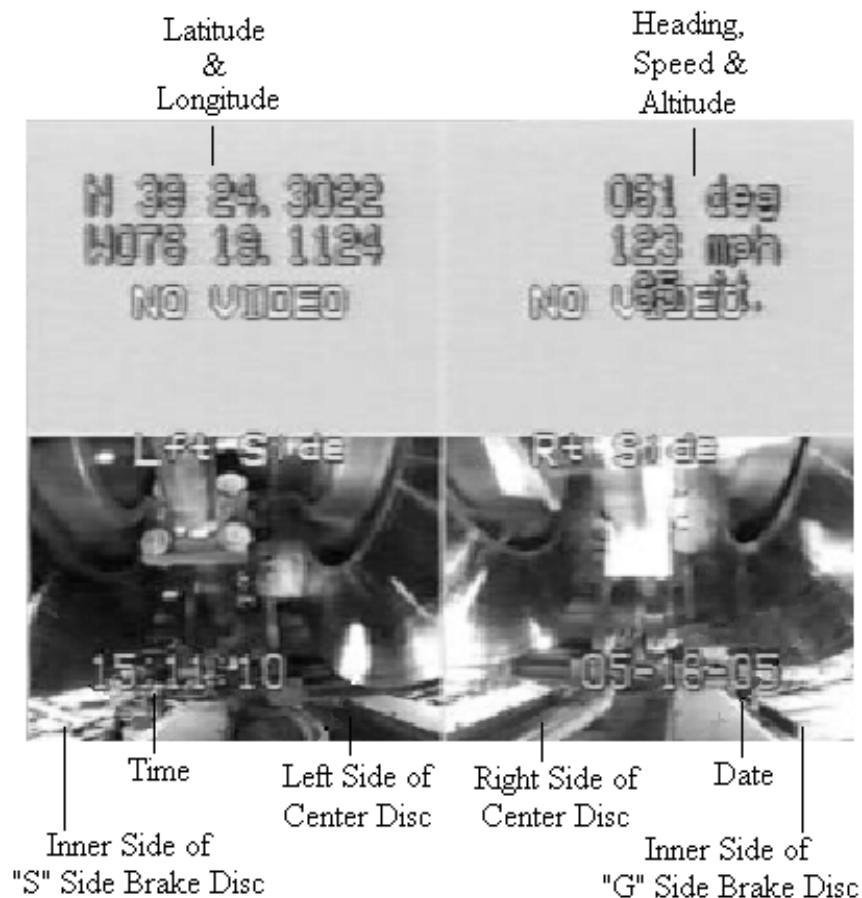
Figure 2.26. Example of Video Collected Over WABTEC/SAB-WABCO Test Axle

Figure 2.26 provides a sample frame from the video recorded over the WABTEC/SAB-WABCO test axle near MP 79 on the Philadelphia Division on May 16. Information provided on the video image and the views of the brake discs are labeled within the figure.

Upon review of the video images, it was felt that little value existed in the video images recorded throughout the test effort.

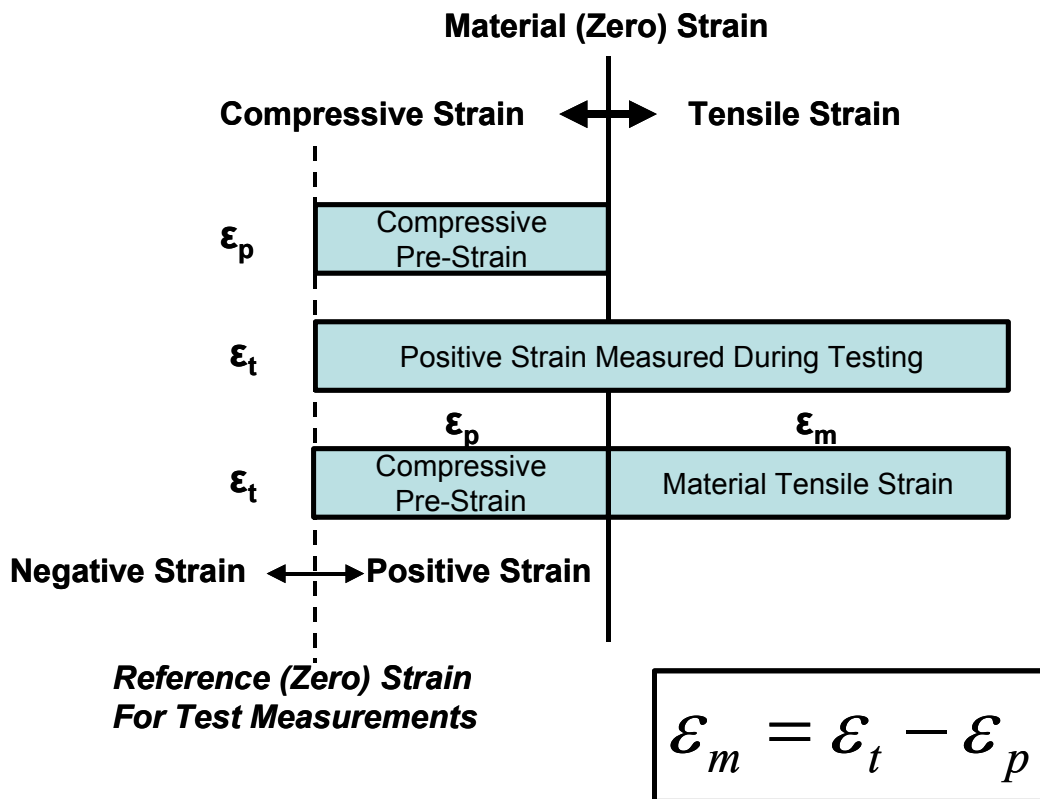
Figure 2.27. Illustration of Concept of Compressive Pre-Strain

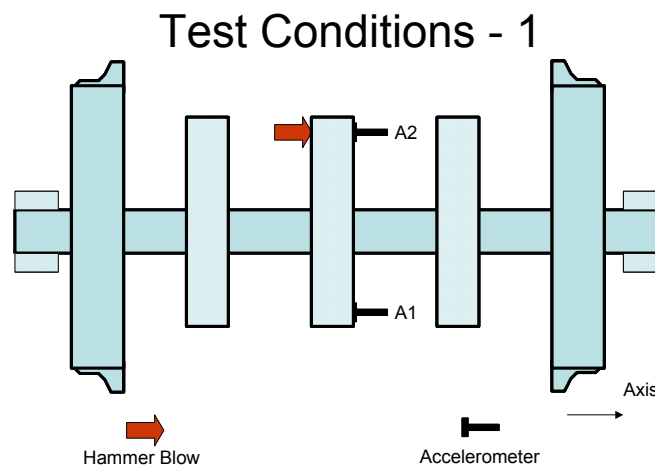
**Figure 2.28. Illustration of Typical Setup for Modal Assessment of Brake Discs**

Figure 2.28 provides an illustration of a typical test set-up. A force input was provided to the center disc being studied by striking it with a 45-ounce dead blow hammer. Response to the force input was measured using accelerometers, magnetically mounted to the disc. In the example shown in Figure 2.27, the accelerometers were placed at the top and bottom of the brake disc near the outer edge, 180° across from each other.

The frequency amplitude spectrum was computed for each acceleration signal over a 1-second window immediately following the force input. A comparison of the relationship between the responses of the two accelerometers was also computed. Appendix J, Part C, provides details of all of these tests.

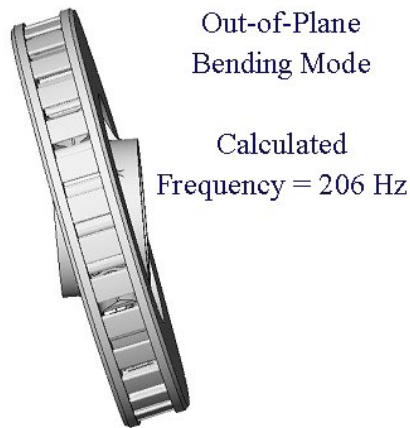
**Figure 3.1. Out-of-Plane Bending Mode Determined from FEA**

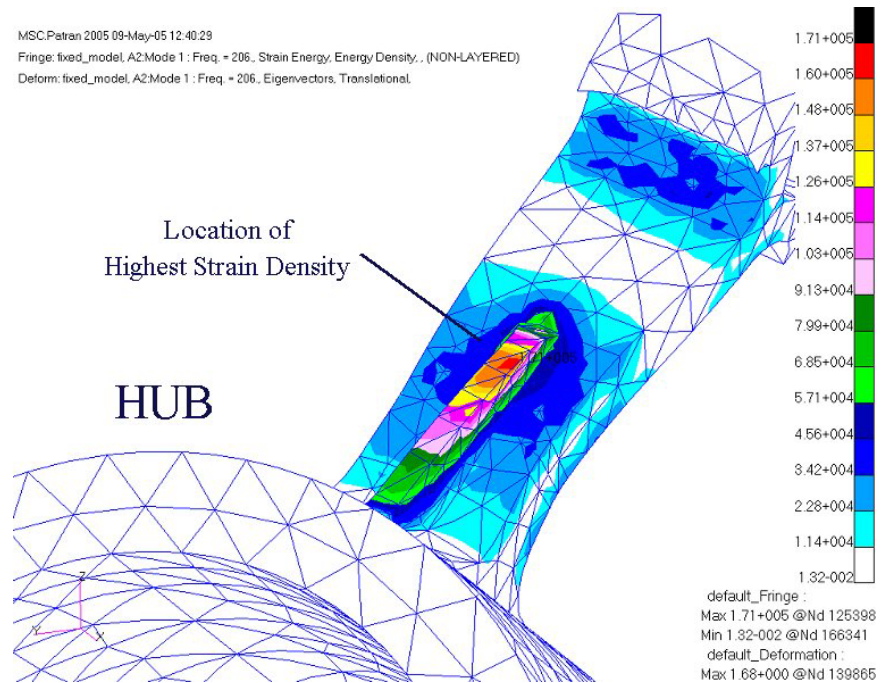
**Figure 3.2. Location of Highest Strain for Out-of-Plane Bending Mode Determined from FEA**
