U.S. Department  
of Transportation

**Federal Railroad  
Administration**

# Investigation of Cracks in Acela Coach Car Brake Discs: Test and Analysis Volume I - Final Report

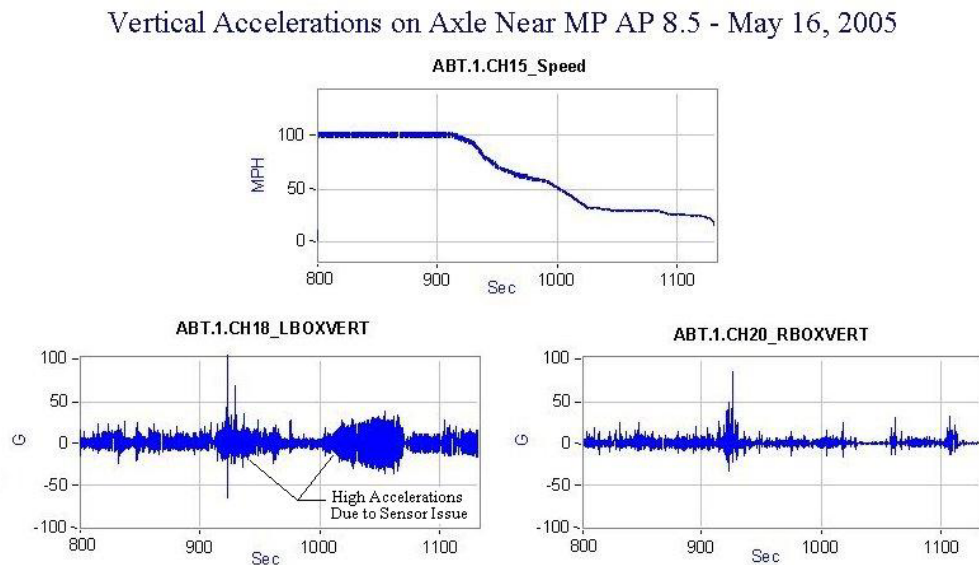
**Figure 3.3. Vertical Accelerations Measured on Instrumented Axle 1 Near MP AP 8.5 (File 051605\_08.ABT)–May 16, 2005**

As discussed in Chapter 2, the vertical load environment associated with the test axle was measured with accelerometers mounted on the bearing end caps located at both ends of the axle. During the early part of the initial test run between Washington and Boston on May 16, the accelerometers oriented in the lateral and vertical directions on the left end of the test axle displayed an unsatisfactory signal-to-noise ratio. Figure 3.3 provides an illustration of vertical accelerations measured between MP 8 and MP 9 south of Philadelphia.

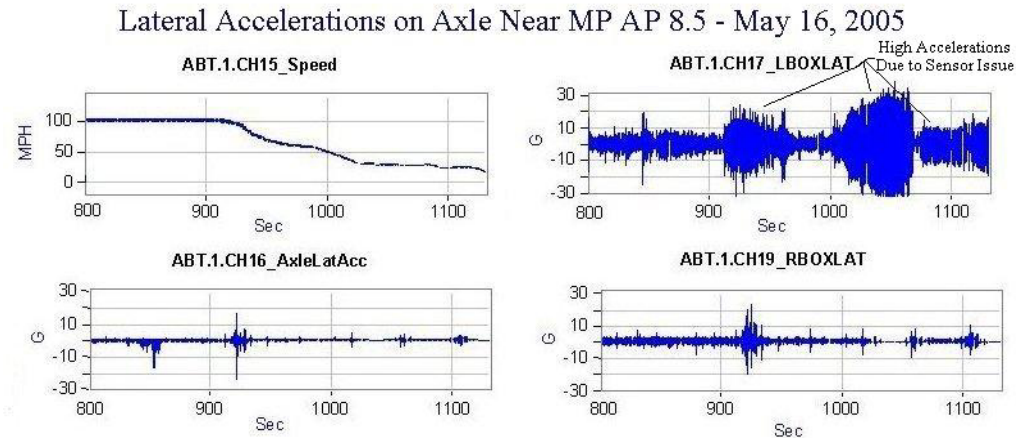
Figure 3.4 illustrates lateral accelerations measured on the axle at the same geographic location.

**Figure 3.4. Lateral Accelerations Measured on Instrumented Axle 1 Near MP AP 8.5 (File 051605\_08.ABT)–May 16, 2005**

Another issue associated with measured axle accelerations was identified during the initial phases of the test—an apparent saturation of the signal produced by the axle mounted accelerometer intended to measure lateral accelerations, resulting in extremely high accelerations not observed at other locations on the axle. This effect is noticeable in Figure 3.4 between  $t=800$  and  $t=900$ ; Figure 3.5 shows a more severe example of this effect.

Regarding lateral accelerations, six lateral shocks above 30 g were measured on the right end axle box of the WABTEC/SAB-WABCO test axle during Phase 1 testing; two were observed during the northbound test conducted on May 16, and four were observed during the southbound test conducted on May 17. Although many lateral accelerations above 30 g were measured on the left end axle box and on the middle of the test axle itself, these were affected by the signal quality issues highlighted in Figures 3.4 and 3.5 and were deemed unreliable.

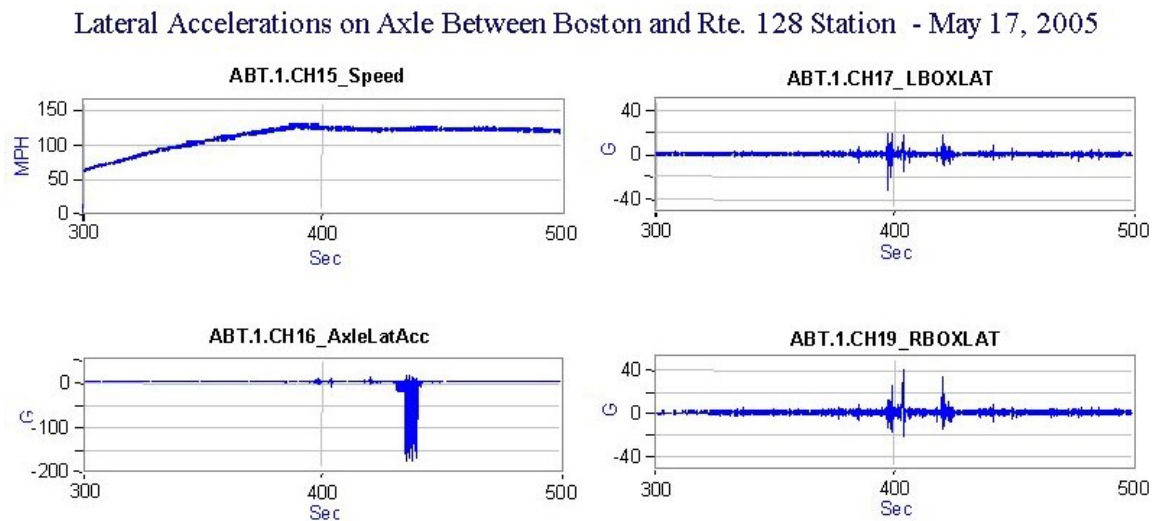
**Figure 3.5. Lateral Accelerations Measured on Instrumented Axle 1 Between Boston and Rte 128 Station (File 051705\_02.ABT)–May 17, 2005**

Consideration of the issue with the axle-mounted accelerometer led to the observations that this high amplitude signal only appeared while the test vehicle was moving through a curve and was usually

accompanied by an audible, high-pitched squealing. It was decided that these particular instances of high amplitude lateral accelerations should be disregarded and that lateral accelerations on the axle would be measured using sensors of alternative design during subsequent testing.

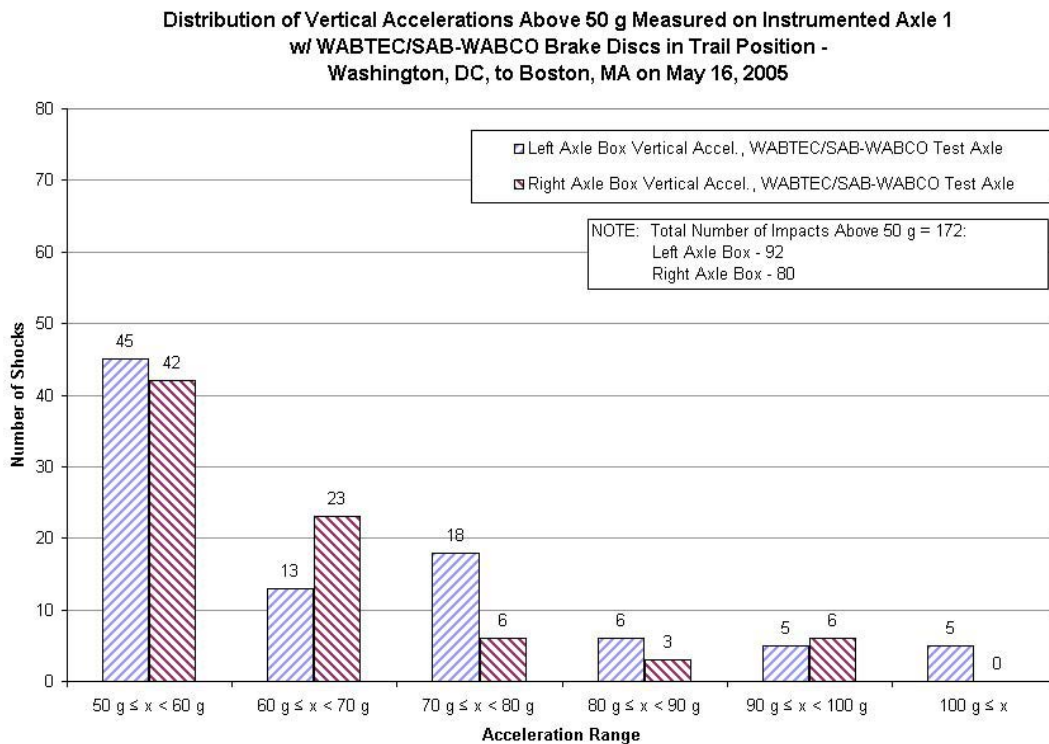
**Figure 3.6a. Distribution of Vertical Accelerations Above 50 g Measured on Instrumented Axle 1 with WABTEC/SAB-WABCO Supplied Brake Discs in Trail Position— Washington, DC, to Boston, MA, on May 16, 2005**

As indicated in the plots provided in Figure 3.6, 172 vertical shocks above 50 g were measured on the WABTEC/SAB-WABCO test axle during the northbound test conducted on May 16, 92 on the left end axle box and 80 on the right end axle box, and 161 vertical shocks above 50 g were measured during the southbound test conducted on May 17, 79 on the left end axle box and 82 on the right end axle box.

The highest vertical acceleration observed in Phase 1 testing was 126 g, measured on the left end of the axle on May 16 near Ham Interlocking at MP AN 55.5 while the test train was traveling at almost 111 mph. Appendix F provides the details associated with all the accelerations above 100 g, including location, speed of the test train, and information regarding the measured strains at the particular location, in tabular form.

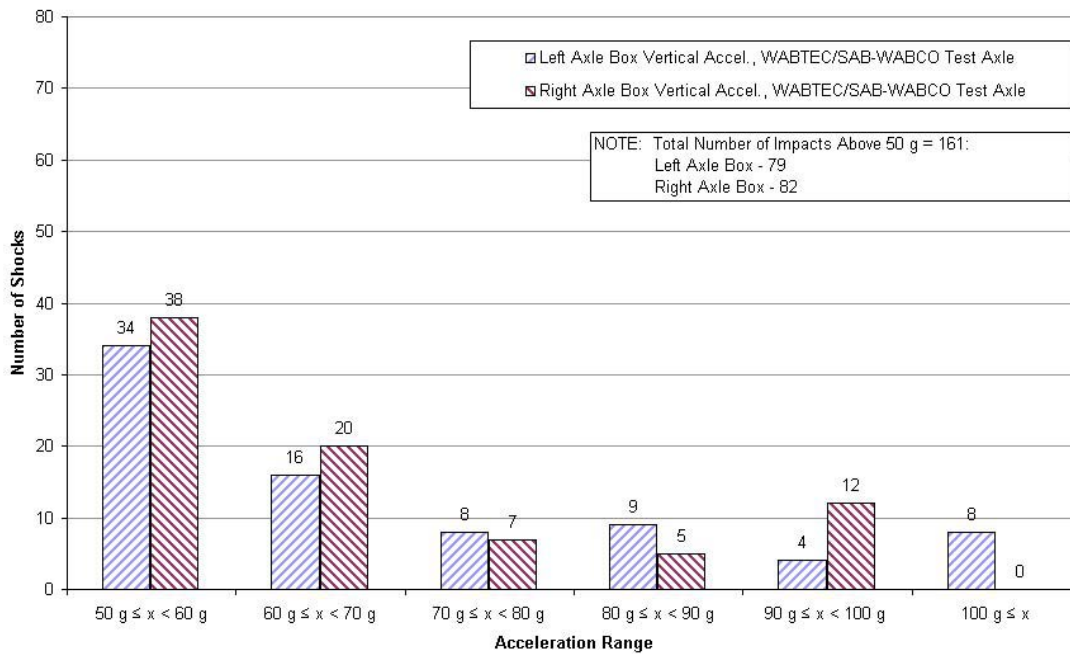
**Distribution of Vertical Accelerations Above 50 g Measured on Instrumented Axle 1  
w/ WABTEC/SAB-WABCO Brake Discs in Lead Position -  
Boston, MA, to Washington, DC on May 17, 2005**

**Figure 3.6b. Distribution of Vertical Accelerations Above 50 g Measured on Instrumented Axle 1  
with WABTEC/SAB-WABCO Supplied Brake Discs in Lead Position--  
Boston, MA, to Washington, DC, on May 17, 2005**

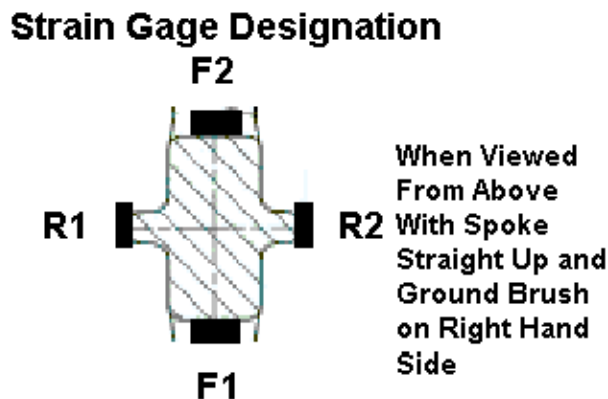
The analysis of strains collected during the test program was based the analysis of combinations of individual measurements to identify the effects of spoke tension, in-plane bending (BIP) of the spokes, and out-of-plane bending (BOP) of the spokes. These three types of spoke strain are used to characterize the response of the spokes throughout the test effort. Figure 3.7 illustrates the strain gage arrangement employed with spoke 6 on the instrumented brake discs in the center and outer positions.

**Figure 3.7. Designation of Strain Gages Used on Spoke 6 of Center and Outer Instrumented WABTEC/SAB-WABCO Supplied Discs During Phase 1 Testing**

The tensile strain in the spoke is produced by averaging the output of the four strain gages around the circumference of the spokes. In equation form, the tensile strain is given by:

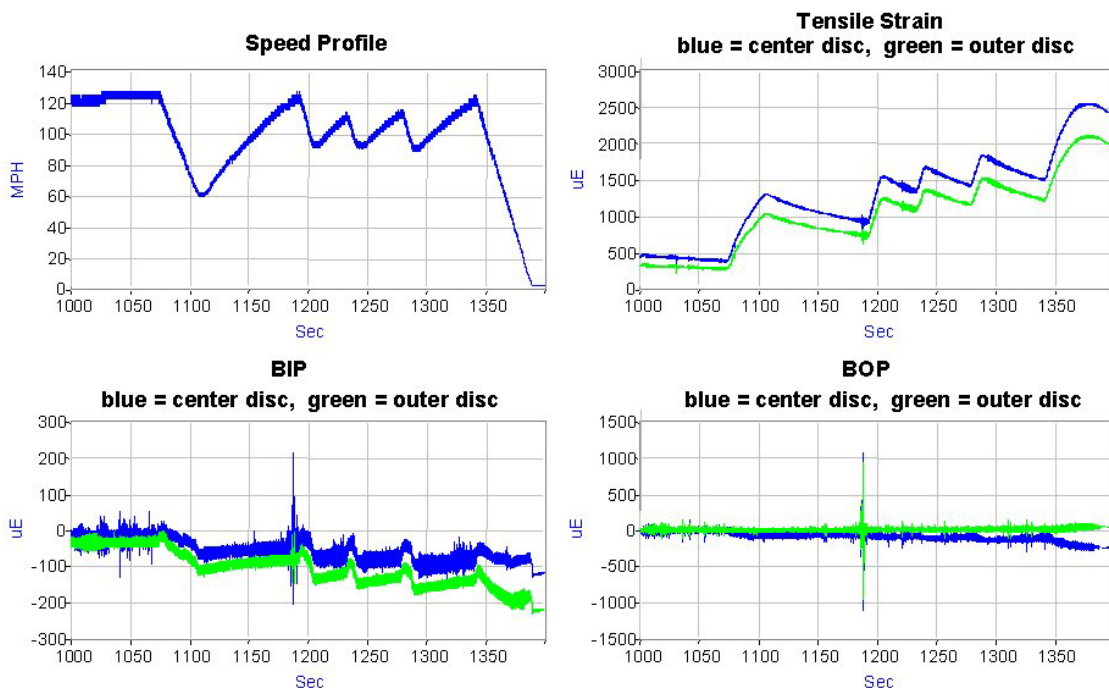
**Figure 3.8. Strains on Spoke 6 of Center and Outer WABTEC/SAB-WABCO Supplied Brake Discs During Brake Applications (File 051605\_09.ABT)–May 16, 2005**

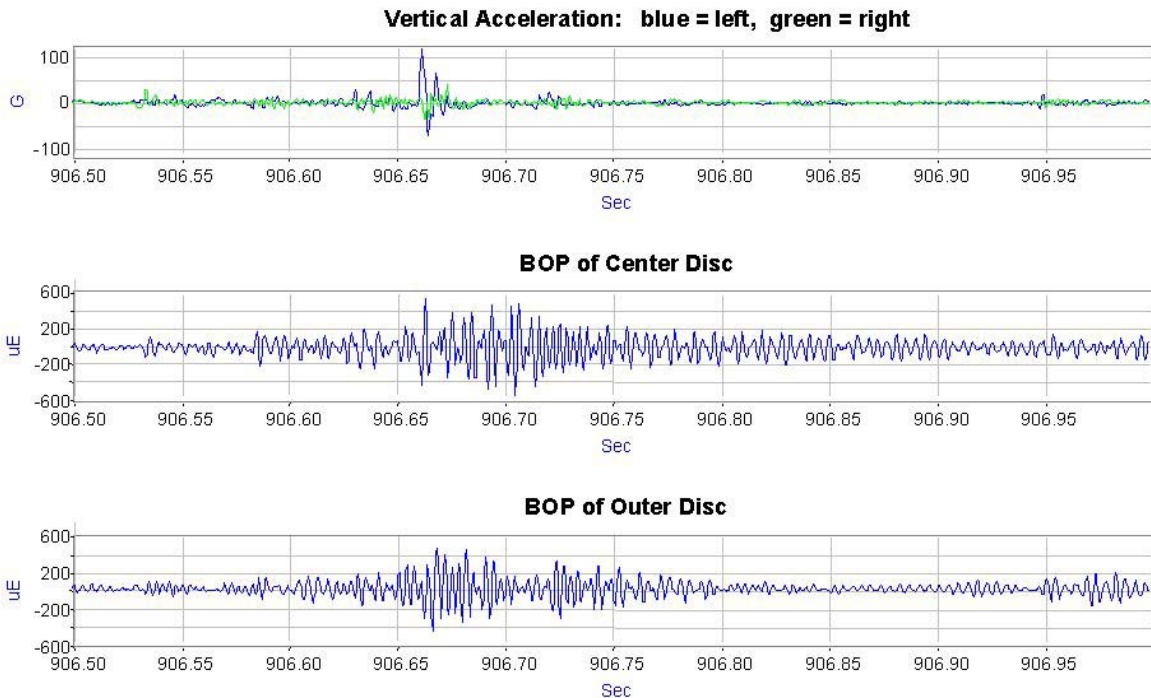
**Figure 3.9. Vertical Accelerations and BOP Strains on Spoke 6 of Center and Outer WABTEC/SAB-WABCO Supplied Brake Discs During Vertical Shock (File 051705\_19.ABT)– May 17, 2005**

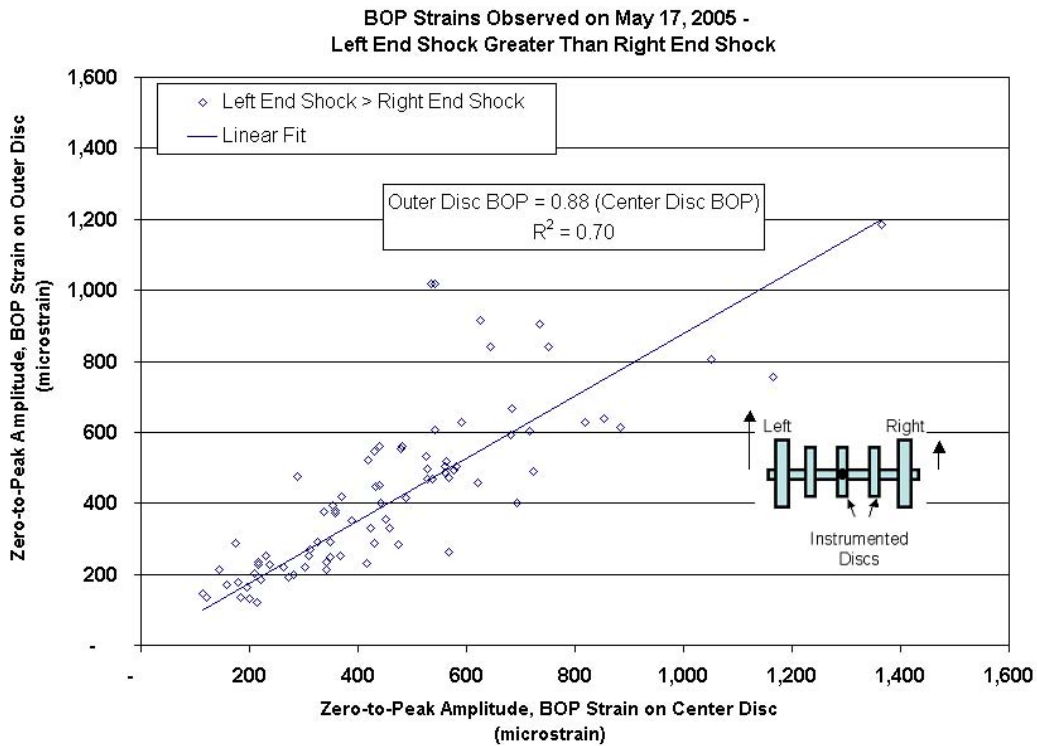
**Figure 3.10a. Comparison of BOP Amplitudes of WABTEC/SAB-WABCO Supplied Center and Outer Discs Measured During Vertical Impacts, Left End Shock Greater Than Right End Shock—May 17, 2005**

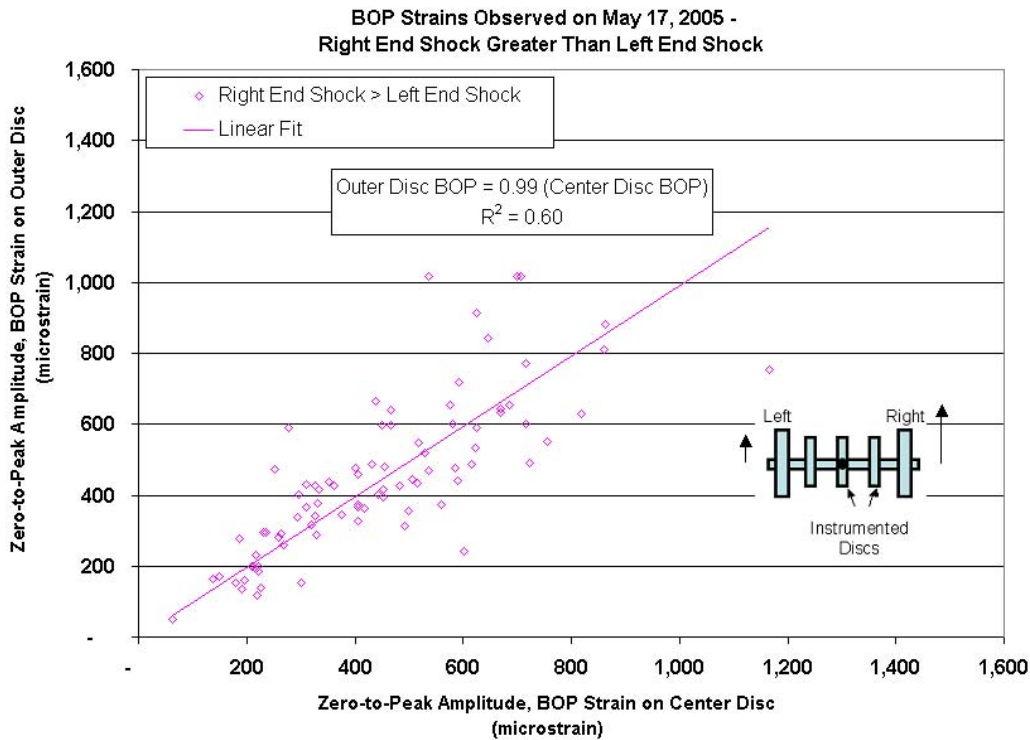
**Figure 3.10b. Comparison of BOP Amplitudes of WABTEC/SAB-WABCO Supplied Center and Outer Discs Measured During Vertical Impacts, Right End Shock Greater Than Left End Shock—May 17, 2005**

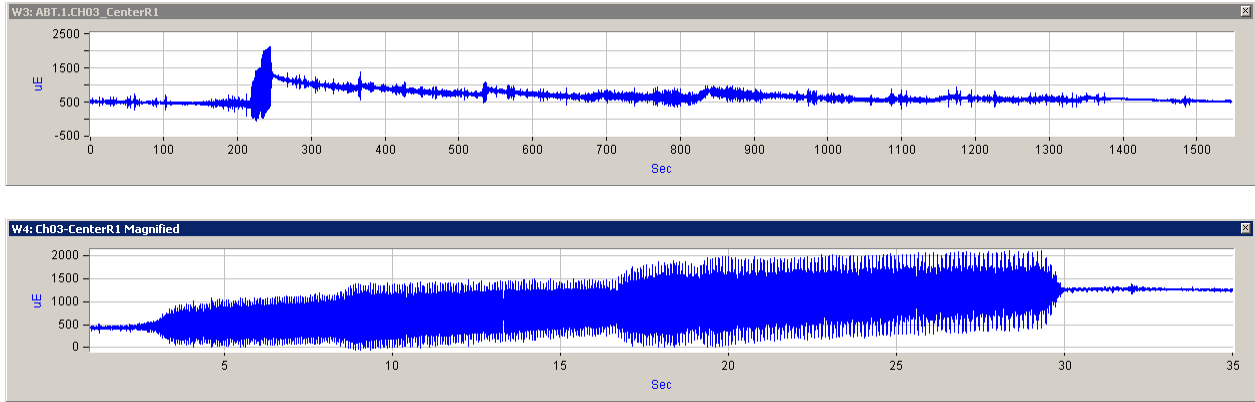
During the test run from Boston to Washington on May 17, high BOP strains were observed on the WABTEC/SAB-WABCO supplied brake discs, especially the one in the center position, under several brake applications. Figure 3.11 illustrates the output of the R1 strain gage on the center disc recorded near MP E17 as the test train was slowing down from 100 mph. The figure also provides a detailed plot of the strain gage activity. The oscillatory nature of the strain is similar to the one illustrated in Figure 3.9; however, it is superimposed over an increasing average tensile strain resulting from the buildup of heat during braking, and the oscillations persist for a much longer period of time than that seen in the response to the vertical shock shown in Figure 3.9.

**Figure 3.11. Strain Recorded on Gage R1 of Center WABTEC/SAB-WABCO Supplied Brake Disc During Braking Near MP E17 (File 051705\_17.ABT)–May 17, 2005**

The strain illustrated in Figure 3.11 is that measured on the side of the spoke of the center brake disc. Figure 3.12 provides the BOP strain measured on both the center and outer brake disc during this particular brake application. The upper portion of the illustration is the BOP strain measured on the two discs; the plot in the lower portion of the illustration is indicative of the amplitude of the oscillatory strains measured on each of the discs. It can be seen that the BOP strains measured on the center disc are between three and four times that of the strains recorded on the outer disc at the same time. It should be kept in mind that the overall rise in tensile strain experienced by the spoke is not observed in the BOP strains. The BOP strains represent the differences between the strains measured on either side of the spoke of interest.

- Because these oscillatory BOP strains occur during braking, they are superimposed on average tensile strains built up during the heating of the brake discs. The example provided in Figure 3.11 illustrates this action.

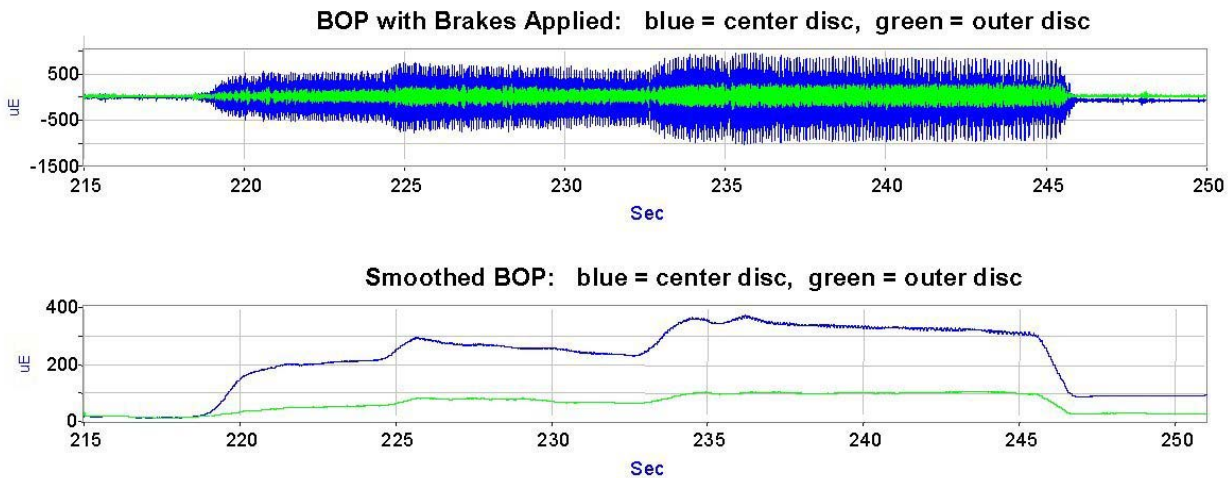
**Figure 3.12. BOP Strain Recorded on Center and Outer WABTEC/SAB-WABCO Supplied Brake Discs During Braking Near MP E17 (File 051705\_17.ABT)–May 17, 2005**

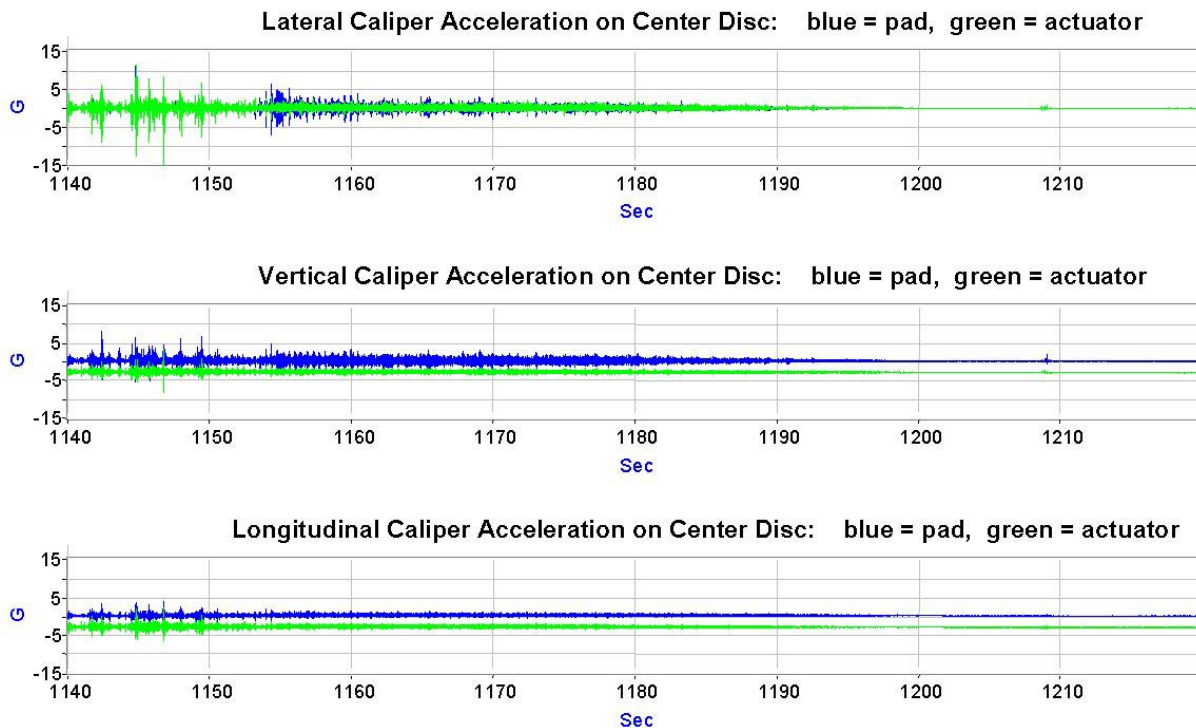
Figure 3.14 illustrates the three accelerations measured at each of the locations on the center caliper during a brake application from 135 mph to a near stop made while the test train was moving southbound near MP AN 41 on May 17. It can be seen that no significant level of activity occurs at either location; lateral accelerations on the actuator reached a peak level of 15 g, but accelerations at other locations on the caliper did not exceed approximately 8 g. Considering that the caliper is mounted to the truck, this is not an excessive level of excitation.

**Figure 3.14. Accelerations Measured on Center Caliper During Normal Brake Application (File 051705\_19.ABT)–May 17, 2005**

Figure 3.15 illustrates the three accelerations measured near the pads on both the center and outer caliper assembly during the same brake application pertaining to Figure 3.14. Again, it can be seen that no significant level of activity occurs on either caliper assembly.

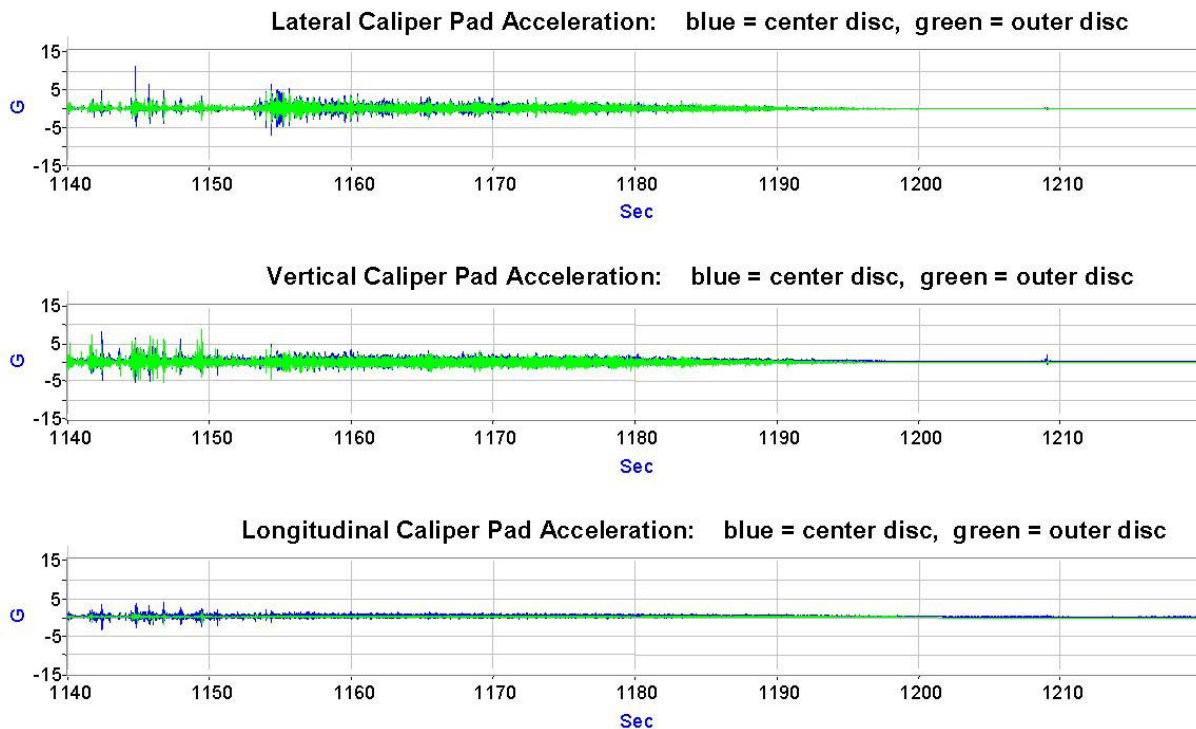
**Figure 3.15. Accelerations Measured on Center and Outer Calipers Near Pads During Normal Brake Application (File 051705\_19.ABT)–May 17, 2005**

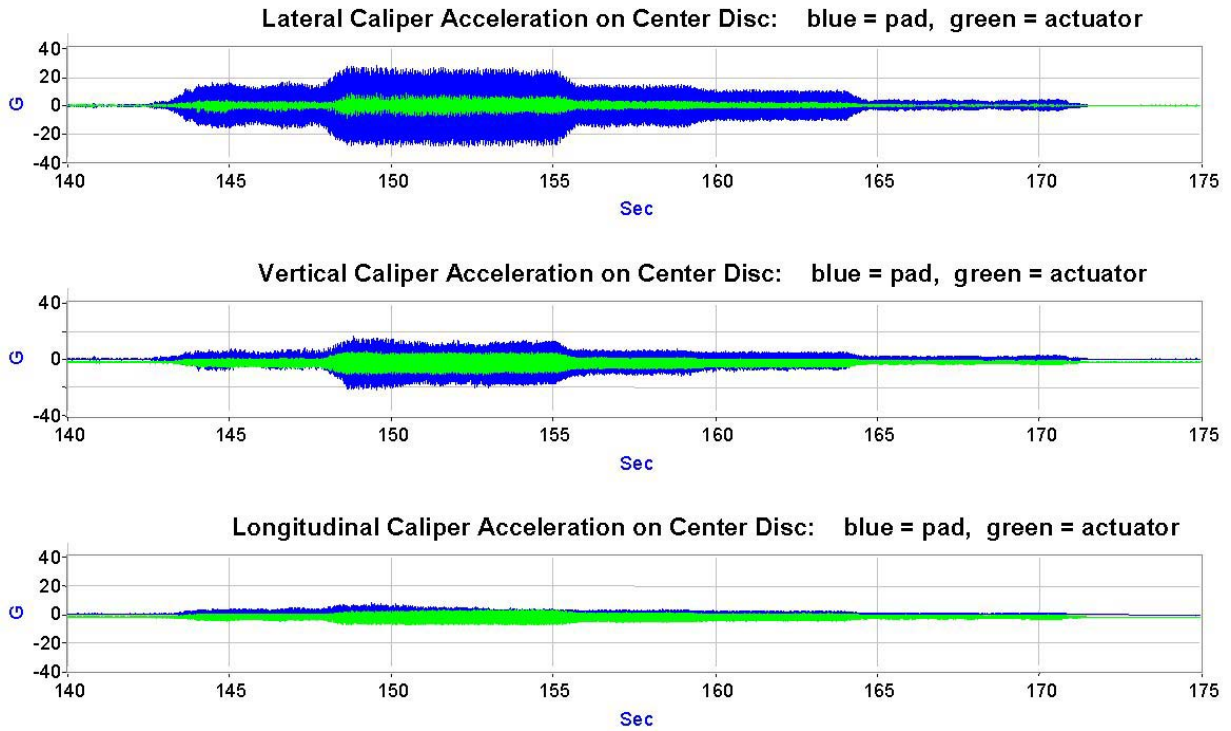
Figure 3.16 illustrates the three accelerations measured at each of the locations on the center caliper during the brake application illustrated in Figures 3.11 and 3.12 where high BOP strains were observed on the center WABTEC/SAB-WABCO supplied disc while the test train was slowing down from 100 mph near MP E17 on May 17. Clearly the accelerations measured near the pads are much higher than those measured near the actuator. In addition, it can be seen that the lateral accelerations measured on the pad while the brake disc in question is experiencing high BOP strains can reach high levels, in this case up to approximately 30 g. The lateral accelerations measured near the pad are higher than vertical accelerations and much higher than longitudinal accelerations measured at the same location; accelerations measured in the longitudinal direction are relatively low during this type of phenomenon. The frequency associated with these accelerations is 186 Hz, the same as that observed in the BOP strains of the brake disc.

**Figure 3.16. Accelerations Measured on Center Caliper During Brake Application with High BOP Strains (File 051705\_19.ABT)–May 17, 2005**

- Accelerations on the calipers can get quite high during incidents in which the brake disc is experiencing high levels of BOP strains if the brakes are applied. The highest accelerations were observed to be lateral accelerations recorded near the pad.
- During typical brake applications in which high levels of strain are not observed on the brake discs, the accelerations measured on the caliper assemblies are relatively low.
- Based on a review of the test data (print outs of which are provided in Appendix L) the calipers experience relatively low levels of excitation when the brakes are not applied.

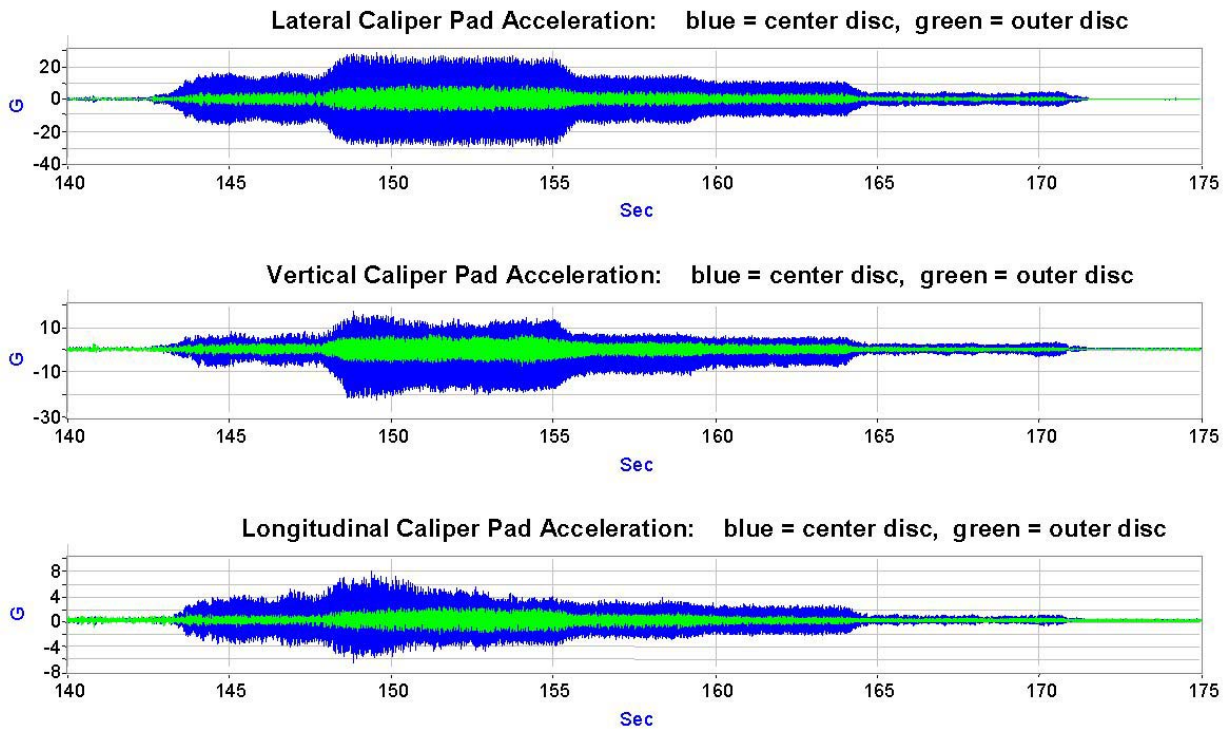
Figure 3.17 illustrates the three accelerations measured near the pads on the center and outer caliper assemblies during a brake application near MP AN 13 from 100 mph. Accelerations measured on the center caliper assembly are much higher than those measured on the outer caliper assembly in this situation, and the relative levels of acceleration are very similar to the relative levels of BOP strain illustrated in Figure 3.12.

**Figure 3.17. Accelerations Measured on Center and Outer Calipers Near Pads During Brake Application with High BOP Strains (File 051705\_19.ABT)–May 17, 2005**

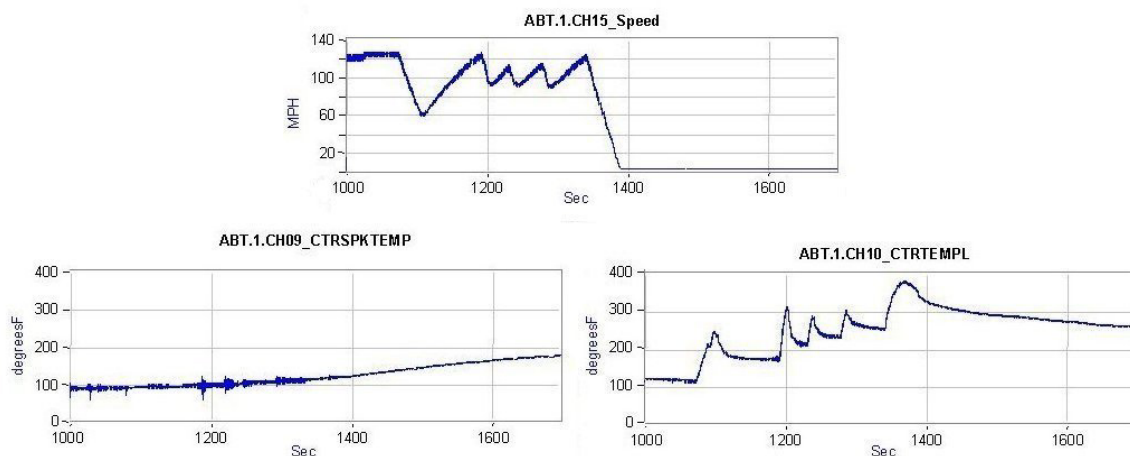
As described in Section 2.3.3, temperature measurements were made on the center disc using the IR sensors mounted in either side of the disc and with a thermocouple located on the disc itself. On May 16, the thermocouple was attached to spoke 6 in the vicinity of the strain gages. During testing on May 16, the initial location of the thermocouple was deemed unsatisfactory because the temperature of the spoke was not yielding useful information. Figure 3.18 illustrates the spoke temperature measured on the center WABTEC/SAB-WABCO supplied disc by the thermocouple and the temperature of the left side of the disc on the friction ring measured by one of the IR sensors during a series of brake applications on May 16 between Philadelphia, PA, and MP AN 60. The speed profile during this series of brake applications is provided for reference.

**Figure 3.18. Friction Ring and Spoke Temperatures Measured on Center WABTEC/SAB-WABCO Supplied Brake Disc During Brake Applications (File 051605\_09.ABT)–May 16, 2005**

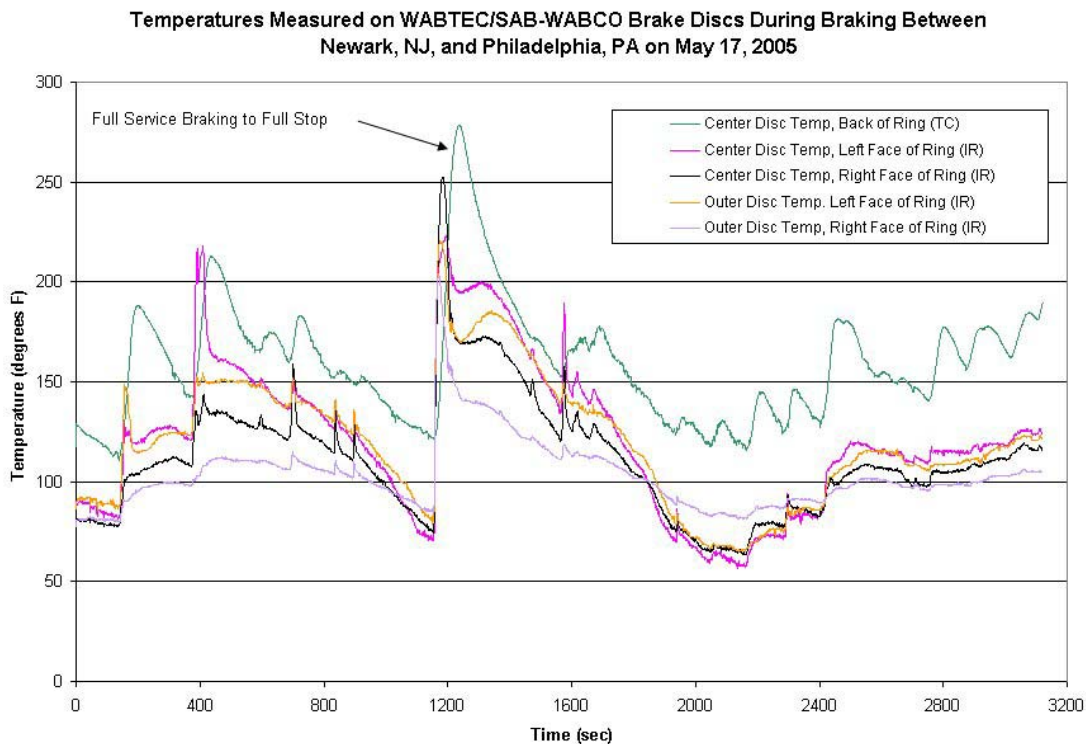
Figure 3.19 illustrates the temperatures measured with the IR sensors on both sides of the center and outer brake discs and the temperature measured on the back of the center disc's friction ring during the test run between Newark, NJ, and Philadelphia, PA, on May 17. As evidenced by the large temperature increase in the middle of this data sample, a full-service brake application was made during this portion of the test.

**Figure 3.19. Temperature Measurements Made During Testing Between Newark, NJ, and Philadelphia, PA–May 17, 2005**

In general, the trends of the various temperature measurements agree with each other. The temperature measured on the back of the friction ring tends to be higher than the temperatures measured by the IR sensors. Many factors influenced this difference, including the IR sensors' sensitivity to orientation or angle, with respect to the surface upon which measurements are made; the IR sensors' sensitivity to surface finish; and the proper selection of emissivity settings. Two separate corrections that can be applied to temperatures measured by the IR sensors on the friction rings to bring them into agreement

with temperatures measured by the thermocouple on the back of the center disc's friction ring were developed based on the data illustrated in Figure 3.19. Appendix I provides these corrections. One of these corrections involves a simple bias, or offset, shift while the other involves the application of both a scale factor and an offset shift.

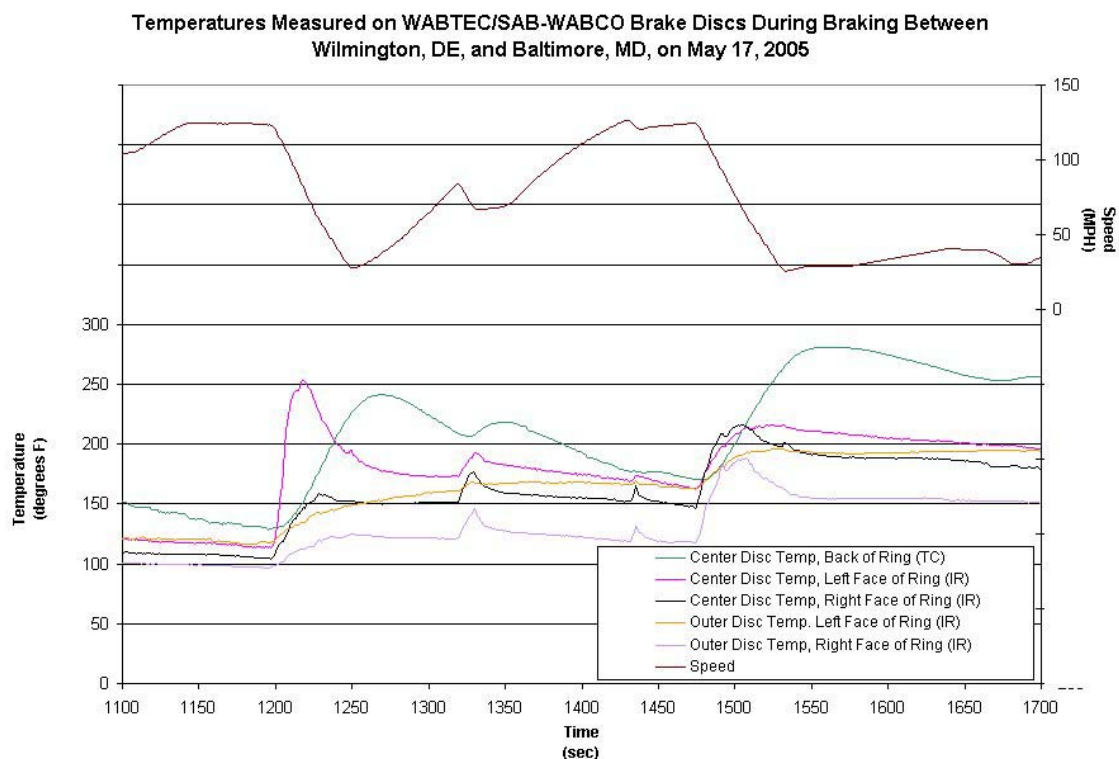
With these statements in mind, the IR sensor measurements, in combination with the temperatures measured on the back of the friction ring using the thermocouple, provided sufficient information to be able to make an assessment of the brake disc temperatures. The highest temperatures on the brake discs were observed between Wilmington, DE, and Baltimore, MD, on May 17 following the second of two brake applications from 125 mph to 30 mph between MP AP 65 and MP AP 72; Figure 3.20 shows this occurrence. The maximum temperature measured on the back of the friction ring of the center disc was close to 280 °F and was observed following the last of the brake applications shown in the illustration. The temperature measured on the left friction ring of the center brake disc reached a value of approximately 255 °F. The brake vendors did not identify these temperatures as excessive.

**Figure 3.20. Extreme Temperature Measurements Made During Testing Between Wilmington, DE, and Baltimore, MD–May 17, 2005**

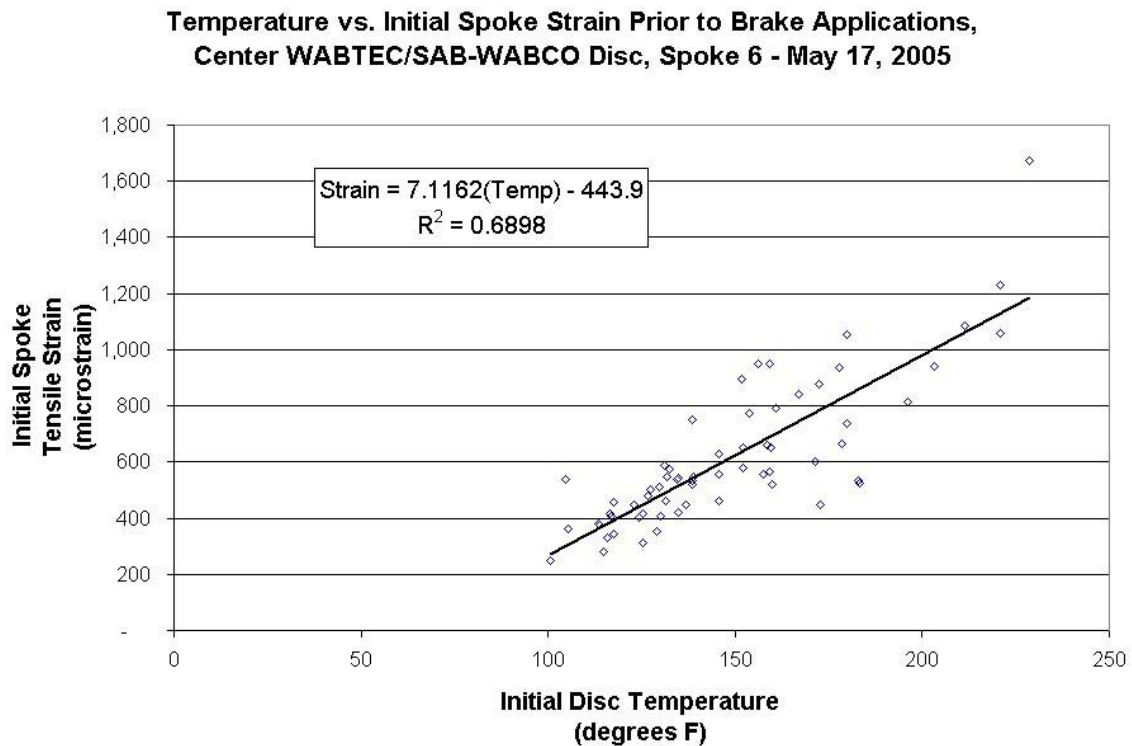
**Figure 3.21. Brake Disc Temperature versus Initial Spoke Tensile Strain Before Brake Applications, Center WABTEC/SAB-WABCO Supplied Disc, Spoke 6–May 17, 2005**

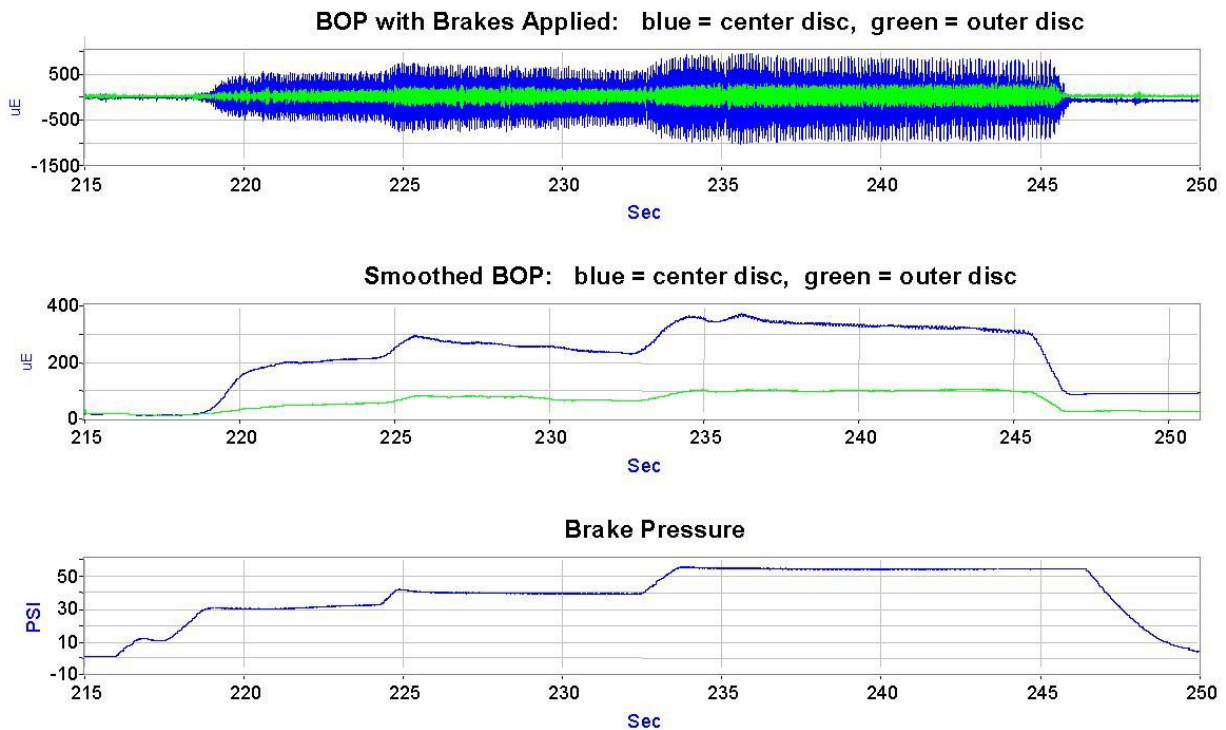
Review of brake cylinder pressure measurements revealed that the amplitude of the high BOP strains measured during seven brake applications on May 17 correlated with the brake application pressure reflected in the brake cylinder pressure. Figure 3.22 illustrates the BOP strains recorded on the center and outer WABTEC/SAB-WABCO supplied discs provided in Figure 3.12 along with the brake cylinder pressure recorded during the same time frame. It can clearly be seen that the amplitude of the strain oscillations increase with increasing brake pressure; the maximum amplitude oscillation is reached when the brakes are at full service pressure of 56 psi. Brake pressure, however, does not appear to be the trigger for this dynamic behavior. Based on the brake pressures at the start of this activity in the seven examples highlighted in Table 3.1, this activity can be initiated over a range of brake cylinder pressures, (31–45 psi).

**Figure 3.22. Brake Cylinder Pressure and BOP Strains Recorded on WABTEC/SAB-WABCO Supplied Brake Discs During Braking Near MP E17 (File 051705\_17.ABT)–May 17, 2005**

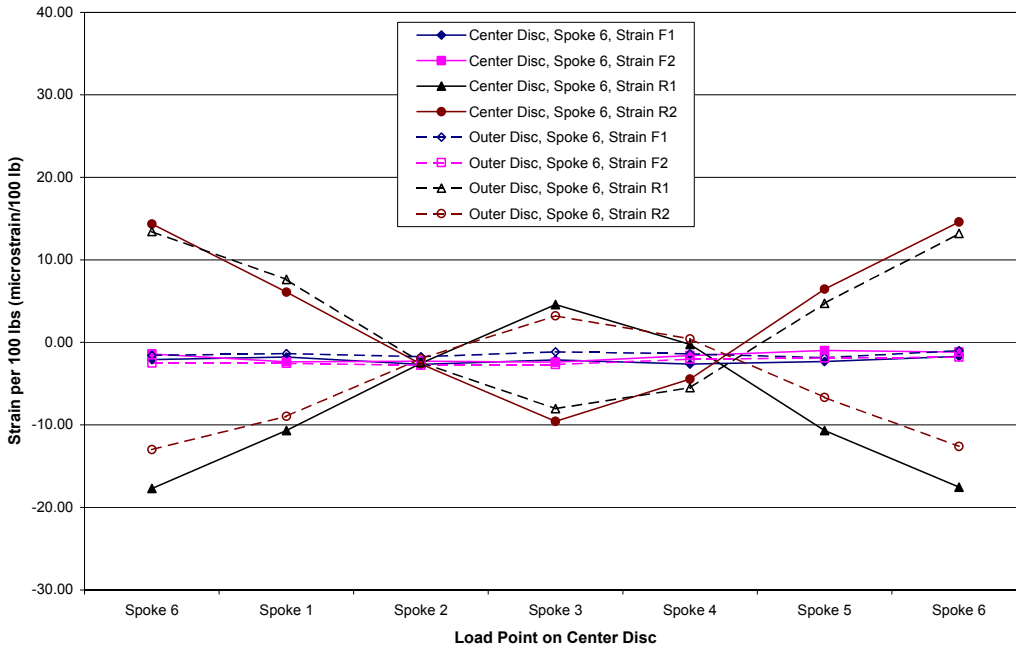
**Spreader Bar Test Results, 500 lb. Load Applied at Spokes on Center Disc**

Figure 3.23 provides strain measurements recorded from the instrumented spokes on each of the discs during both loadings. The graph in Figure 3.23a pertains to loadings aligned with spokes on the center disc, while Figure 3.23b pertains to loadings aligned with spokes on the outer disc. Part A of Appendix J includes strain readings illustrated in Figure 3.23.

**Figure 3.23a. Strains Measured During Spreader Bar Test, Load Aligned with Spokes of Center Disc**

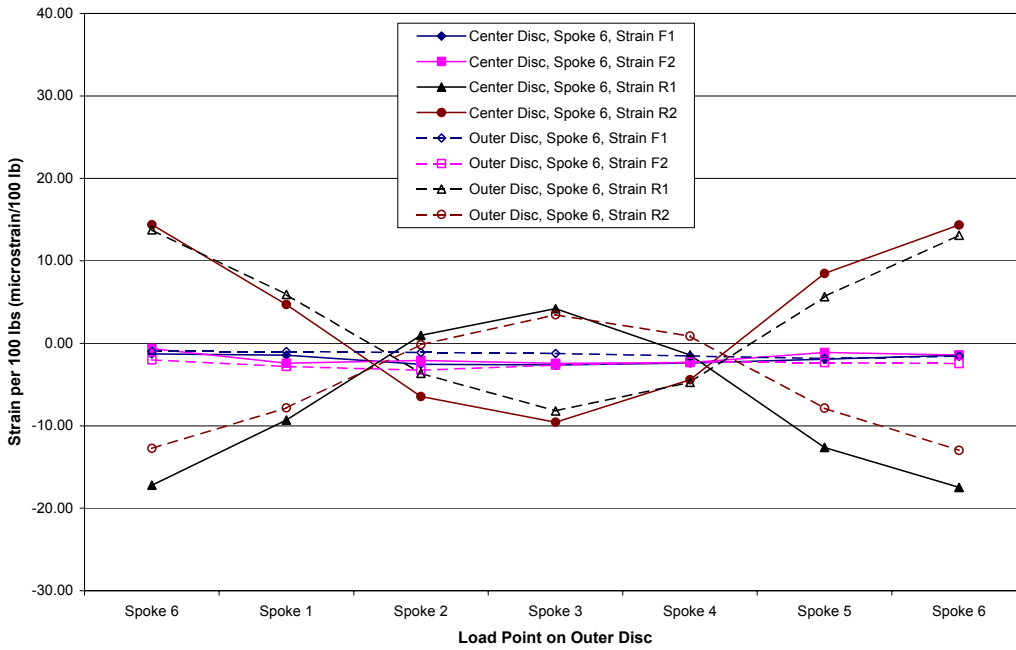
**Spreader Bar Test Results, 400 lb. Load Applied at Spokes on Outer Disc**

**Figure 3.23b. Strains Measured During Spreader Bar Test, Load Aligned with Spokes of Outer Disc**

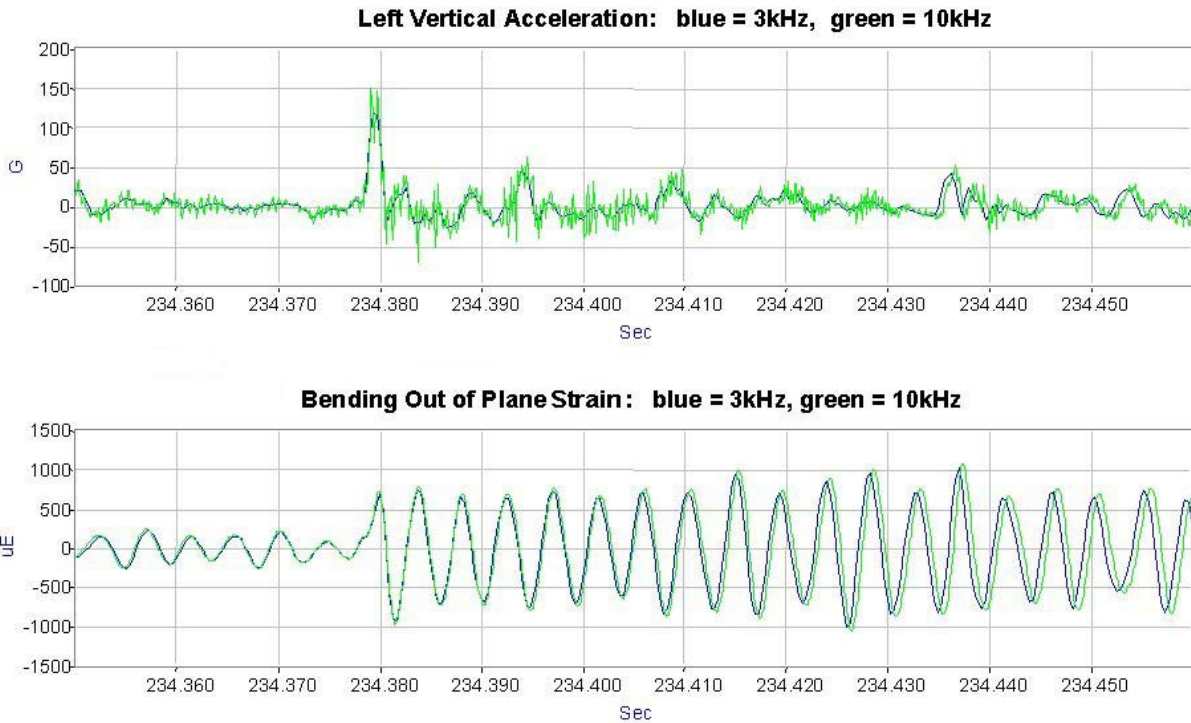
As described in Chapter 2, the sampling rate employed with the ENSCO data collection hardware was increased from 2,000 Hz to 3,000 Hz for Phase 2 testing; an anti-alias filter with a cut-off frequency of 750 Hz was used during Phase 2 testing. Amtrak provided a second data collection system that employed a sampling rate of 10,000 Hz to record axle accelerations and other selected parameters; no anti-alias filter was used with the Amtrak data collection system. Figure 3.24 illustrates a vertical shock measured on the left end axle box and corresponding BOP strain recorded on spoke 6 of the center disc, while the test train traveled through the Forest Interlocking near MP AB 223 at 120.4 mph during the May 26 test run. The ENSCO-based collection system recorded the amplitude of this shock as 116.6 g. As can be seen in the figure, the Amtrak-based collection system was able to record a higher acceleration during this event. This highlights an important consequence of the proper selection of a sampling rate—increasing the rate at which data is recorded, or increasing the bandwidth of the data, can result in higher recorded amplitudes of acceleration.

Further analysis of acceleration data collected at the two sampling rates by test personnel and the brake vendors indicated that no additional information critical to the study was provided by the data collected with the 10,000 Hz sampling rate. This is evidenced by the negligible difference in strains recorded spoke 6 at the two different sampling rates shown in Figure 3.24. Subsequent testing in Phase 3 did not employ the data collected with 10,000 Hz in the official test record. In light of the decisions made regarding the data collected with the higher sampling rate, discussion of results in this section will be limited those based on data recorded at 3,000 Hz.

**Figure 3.24. Comparison of Vertical Shock and BOP Strains Recorded with 3,000 Hz and 10,000 Hz Sampling Rates (Files 052605\_18.AB2 [3,000 Hz Data] and File 052605\_18.001 [10,000 Hz Data])–May 26, 2005**
