U.S. Department  
of Transportation

**Federal Railroad  
Administration**

# Investigation of Cracks in Acela Coach Car Brake Discs: Test and Analysis Volume I - Final Report

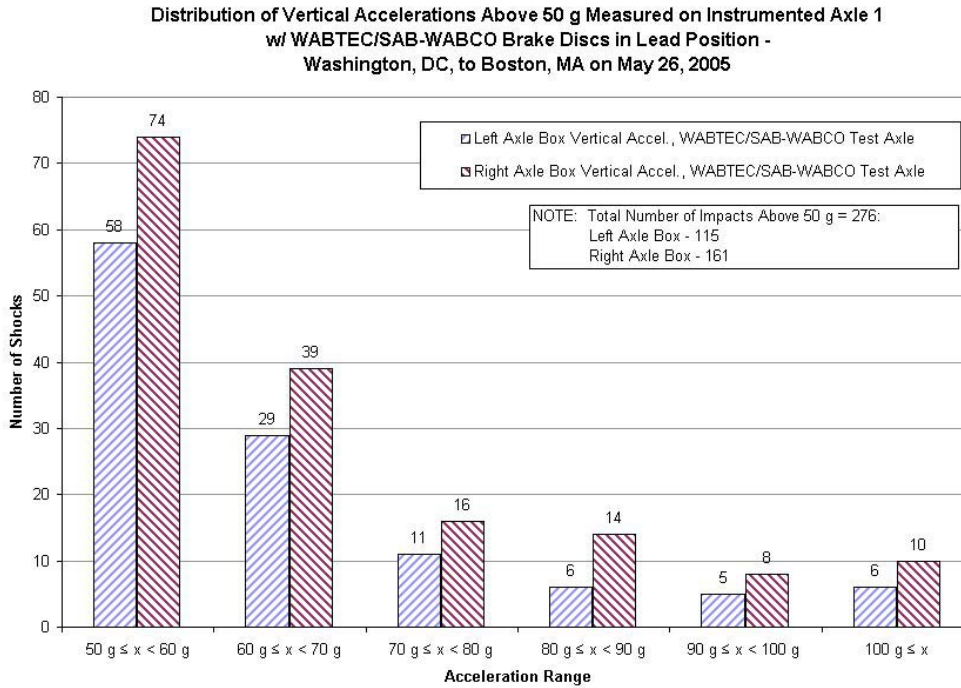
Figure 3.25a illustrates the distribution of vertical accelerations above 50 g recorded on the test axle from Washington to Boston on May 26 with the test axle in a leading position. Figure 3.25b illustrates the corresponding information for the data collected between Boston and Washington on May 27 with the test axle in a trailing position. Appendix F tabulates the data illustrated in Figure 3.25.

**Figure 3.25a. Distribution of Vertical Accelerations Above 50 g Measured on Instrumented Axle 1 with WABTEC/SAB-WABCO Supplied Brake Discs in Lead Position—Washington, DC, to Boston, MA, on May 26, 2005**

As shown in Figure 3.25, 276 vertical shocks above 50 g were measured on the WABTEC/SAB-WABCO test axle during the northbound test conducted on May 26, 115 on the left end axle box and 161 on the right end axle box, and 238 vertical shocks above 50 g were measured during the southbound test conducted on May 27, 101 on the left end axle box and 137 on the right end axle box. Regarding results from May 26, 16 shocks above 100 g were measured. Fifteen shocks over 100 g were measured on May 27.

The highest vertical acceleration observed in Phase 2 testing was 156 g, measured on the left end of the axle on May 26 near Union Interlocking near MP AN 20 while the test train was traveling at 113 mph. Appendix F provides the details associated with accelerations above 100 g in tabular form.

- 3) Vertical accelerations measured on axle bearing boxes exceed 50 g approximately 80-160 times per day [Section 3.1.2, Figure 3.6; Section 3.2.2, Figure 3.25; Section 3.3.3, Figure 3.46].

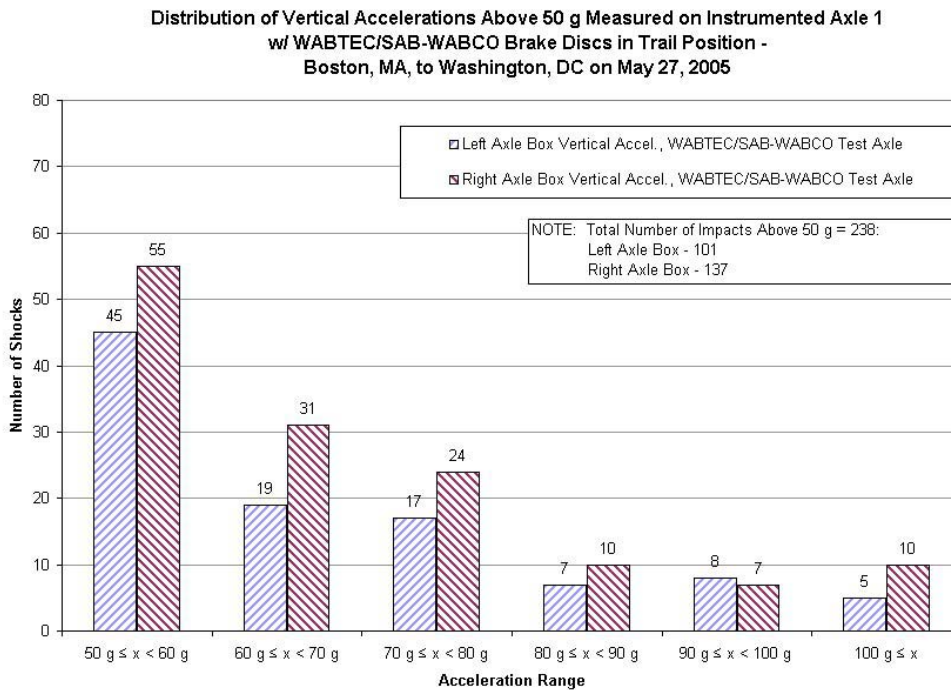
**Figure 3.25b. Distribution of Vertical Accelerations Above 50 g Measured on Instrumented Axle 1 with WABTEC/SAB-WABCO Supplied Brake Discs in Trail Position—Boston, MA, to Washington, DC, on May 27, 2005**

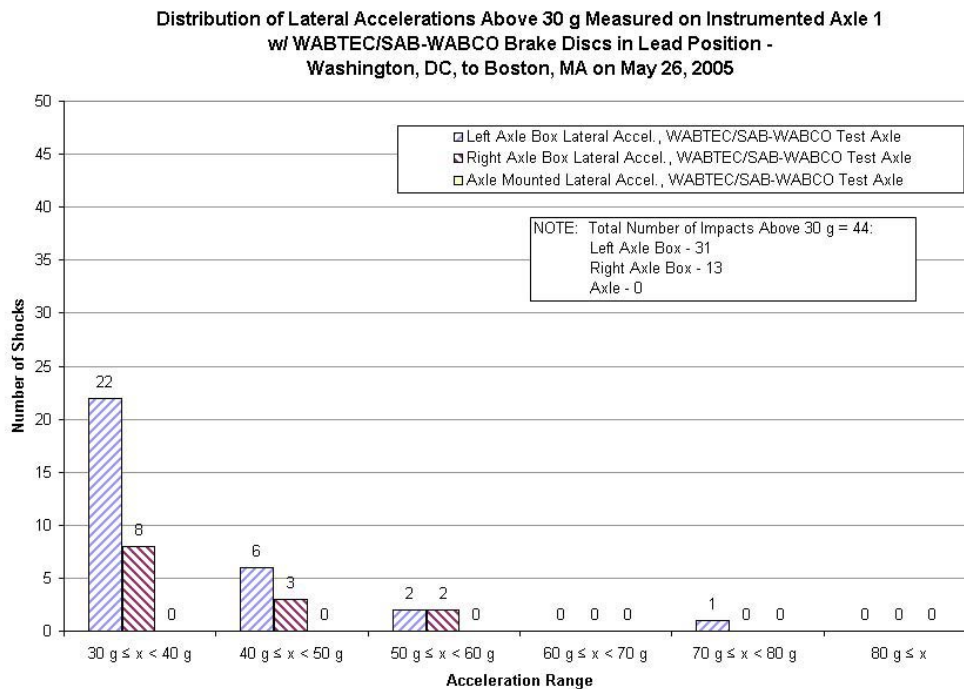
Figure 3.26a illustrates the distribution of lateral accelerations above 30 g recorded on the test axle from Washington to Boston on May 26 with the test axle in a leading position. Figure 3.26b illustrates the corresponding information for the data collected between Boston and Washington on May 27 with the test axle in a trailing position. Appendix F tabulates the data illustrated in Figure 3.26.

**Figure 3.26a. Distribution of Lateral Accelerations Above 30 g Measured on Instrumented Axle 1 with WABTEC/SAB-WABCO Supplied Brake Discs in Lead Position—Washington, DC, to Boston, MA, on May 26, 2005**

Forty-four lateral shocks above 30 g were measured on the WABTEC/SAB-WABCO test axle during the northbound test conducted on May 26, 31 on the left end axle box and 13 on the right end axle box. No accelerations were measured above 30 g on the axle that were reliable measurements. Thirty-three lateral shocks above 30 g were measured on the WABTEC/SAB-WABCO test axle during the southbound test conducted on May 27, 19 on the left end axle box and 14 on the right end axle box. No accelerations were measured above 30 g directly on the axle that were considered reasonable.

The highest lateral acceleration observed during Phase 2 testing was on the left end axle box. A 75.3 g shock was measured on May 26 at the Union Interlocking near MP AN20 while the test train was traveling at a speed near 112 mph.

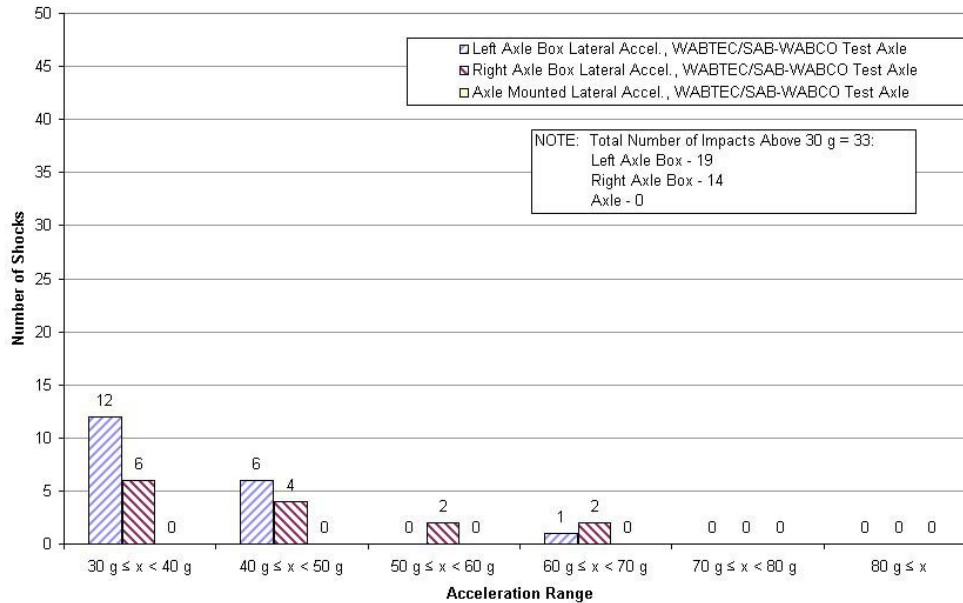
**Distribution of Lateral Accelerations Above 30 g Measured on Instrumented Axle 1  
w/ WABTEC/SAB-WABCO Brake Discs in Trail Position -  
Boston, MA, to Washington, DC, on May 27, 2005**

**Figure 3.26b. Distribution of Lateral Accelerations Above 30 g Measured on Instrumented Axle 1  
with WABTEC/SAB-WABCO Supplied Brake Discs in Trail Position–Boston, MA, to  
Washington, DC, on May 27, 2005**

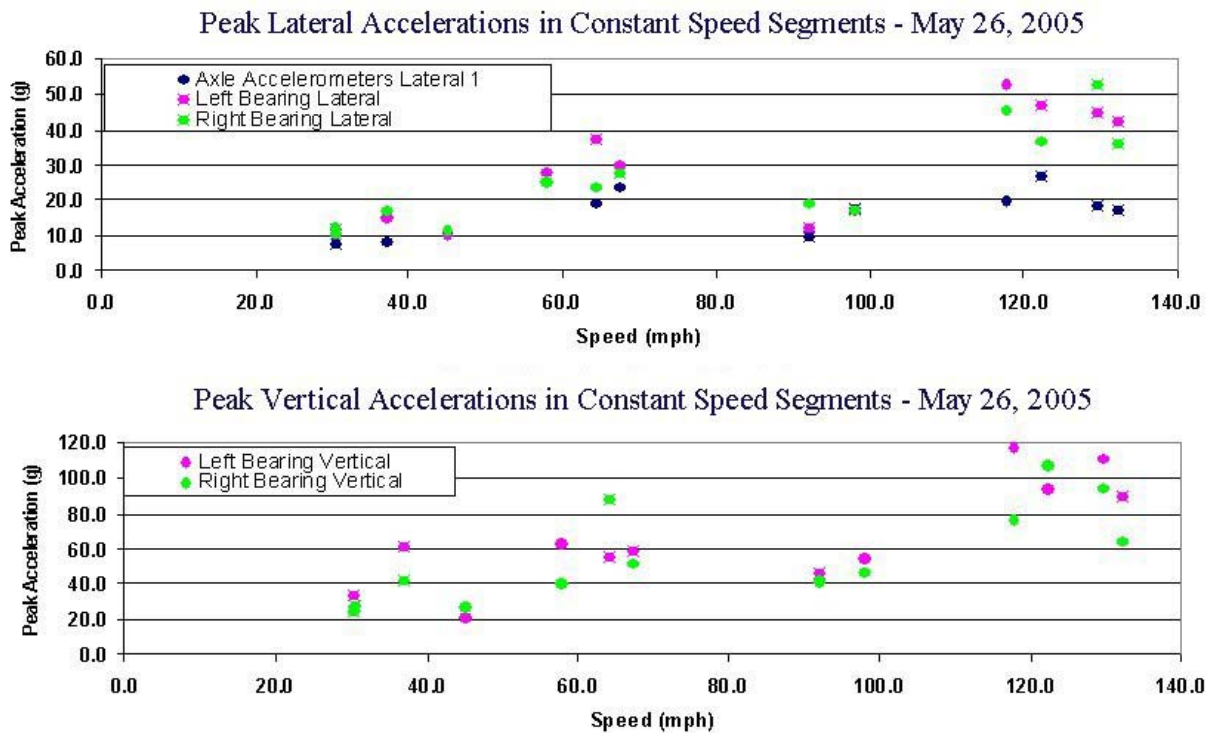
In order to characterize the typical load environment affecting the test axle, a number of segments of the data collected on May 26 and May 27 were identified in which near-constant speeds were maintained. Within each of these zones, the highest lateral and vertical accelerations were identified. Figure 3.27 provides the results of this analysis conducted with data collected on May 26. Lateral accelerations identified in this process are shown in the upper portion of the figure, and the corresponding information for vertical accelerations is shown in the lower portion of the figure. The results contained in these plots do not represent the entire run but only those constant speed segments selected for consideration.

**Figure 3.27. Peak Lateral and Vertical Accelerations Observed in Near-Constant Speed Segments as a Function of Speed—May 26, 2005**

A similar consideration was made for data collected on the southbound portion of the trip conducted on May 27. The results based on data collected on May 27 were similar to those shown in Figure 3.27 and are included in Appendix F.

- Accelerations measured on the test axles generally increase with speed [Section 3.2.2, Figure 3.27].
  - Lateral accelerations measured on the axle boxes at the end of the axle are generally higher than lateral accelerations measured on the axle [Section 3.1.2; Section 3.2.2, Figure 3.25; Section 3.3.3, Figure 3.47].

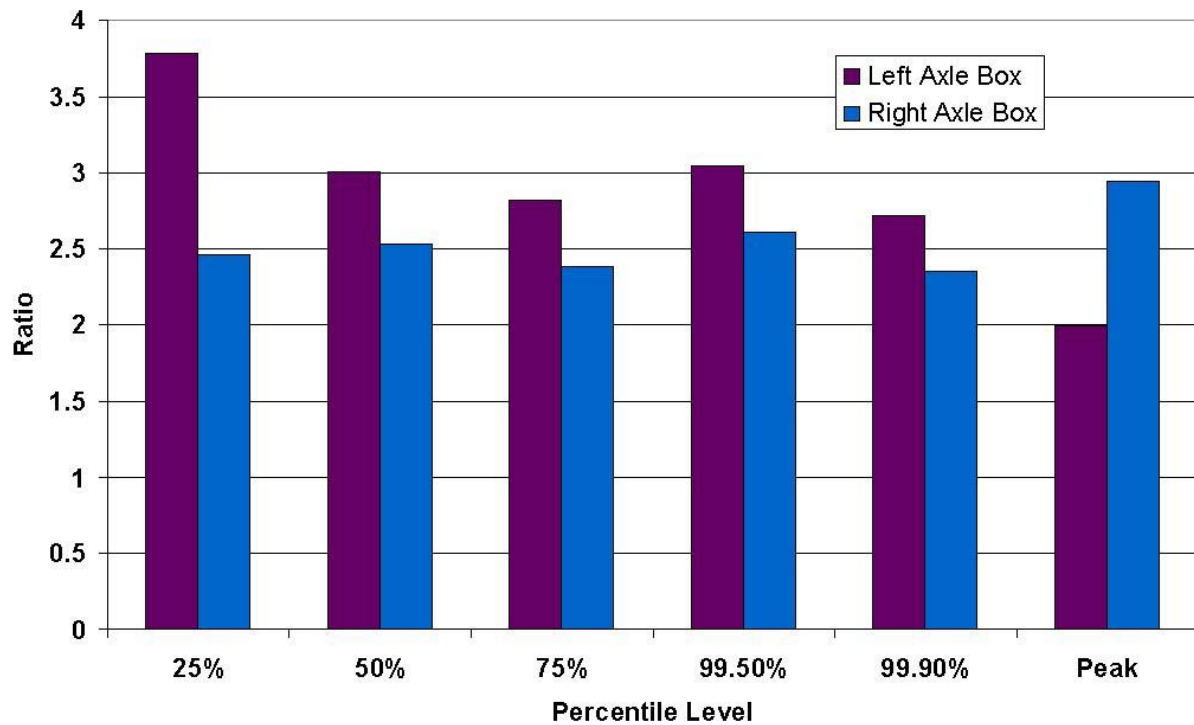
In addition to the peak lateral and vertical accelerations calculated in each near-constant speed data segment, several percentile values of acceleration were calculated. As an example, the 99.9 percentile value is the acceleration value below which 99.9 percent of all accelerations within the data segment reside. Calculating several percentile values of acceleration for each data segment considered in this analysis allowed for a more general characterization of the accelerations. Figure 3.28 illustrates the ratios of vertical to lateral accelerations for several percentile levels of acceleration determined within near-constant speed segments recorded at 122 mph. In this illustration, vertical accelerations measured on the axle boxes were typically 2 to 3.7 times as large as the lateral accelerations measured at the same location. Similar results were found for other data segments considered.

Ratios of Vertical to Lateral Accelerations in 122 MPH Constant Speed Segments - May 26, 2005

**Figure 3.28. Vertical to Lateral Acceleration Ratios Determined for Data Collected in Near-Constant Speed Segments at 122 MPH–May 26, 2005**

In summary, results from Phase 2 testing confirmed that the load environment associated with vertical impacts was much more severe than that associated with lateral impacts. It was established that vertical accelerations are typically between 2 and 3.7 times lateral accelerations, regardless of the level of accelerations considered.

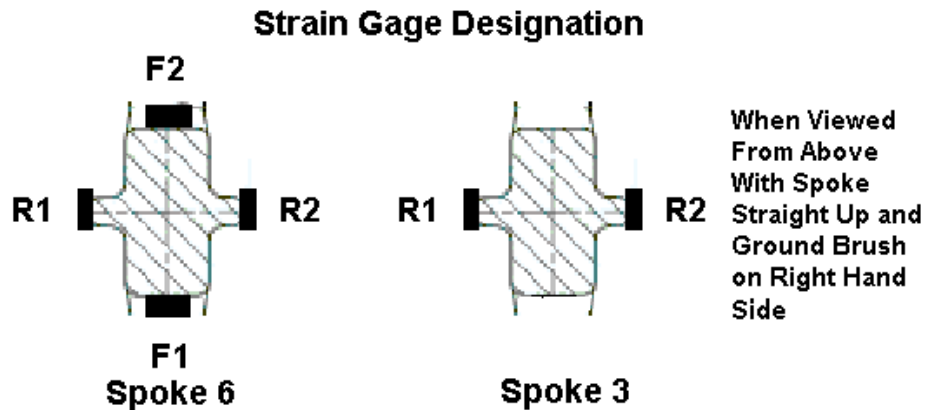
One of the goals of Phase 2 testing was to collect strain measurements on the WABTEC/SAB-WABCO supplied disc mounted in the center position of the axle from the spoke opposite the one that was subject of measurements in Phase 1. This was done so that sufficient information was available to be able to specify the motion of the brake disc. Figure 3.29 illustrates the arrangement of the strain gages on the spokes of the WABTEC/SAB-WABCO supplied disc mounted in the center position of the axle.

**Figure 3.29. Designation of Strain Gages Used on Spoke 6 and Spoke 3 of Instrumented Center WABTEC/SAB-WABCO Supplied Disc During Phase 2 Testing**

During Phase 2 testing, noise spikes were observed on the signals from the F1 and F2 strain gages on spoke 6. Caution had to be exercised when considering results that made use of these gages to ensure that the noise spikes did not adversely affect findings.

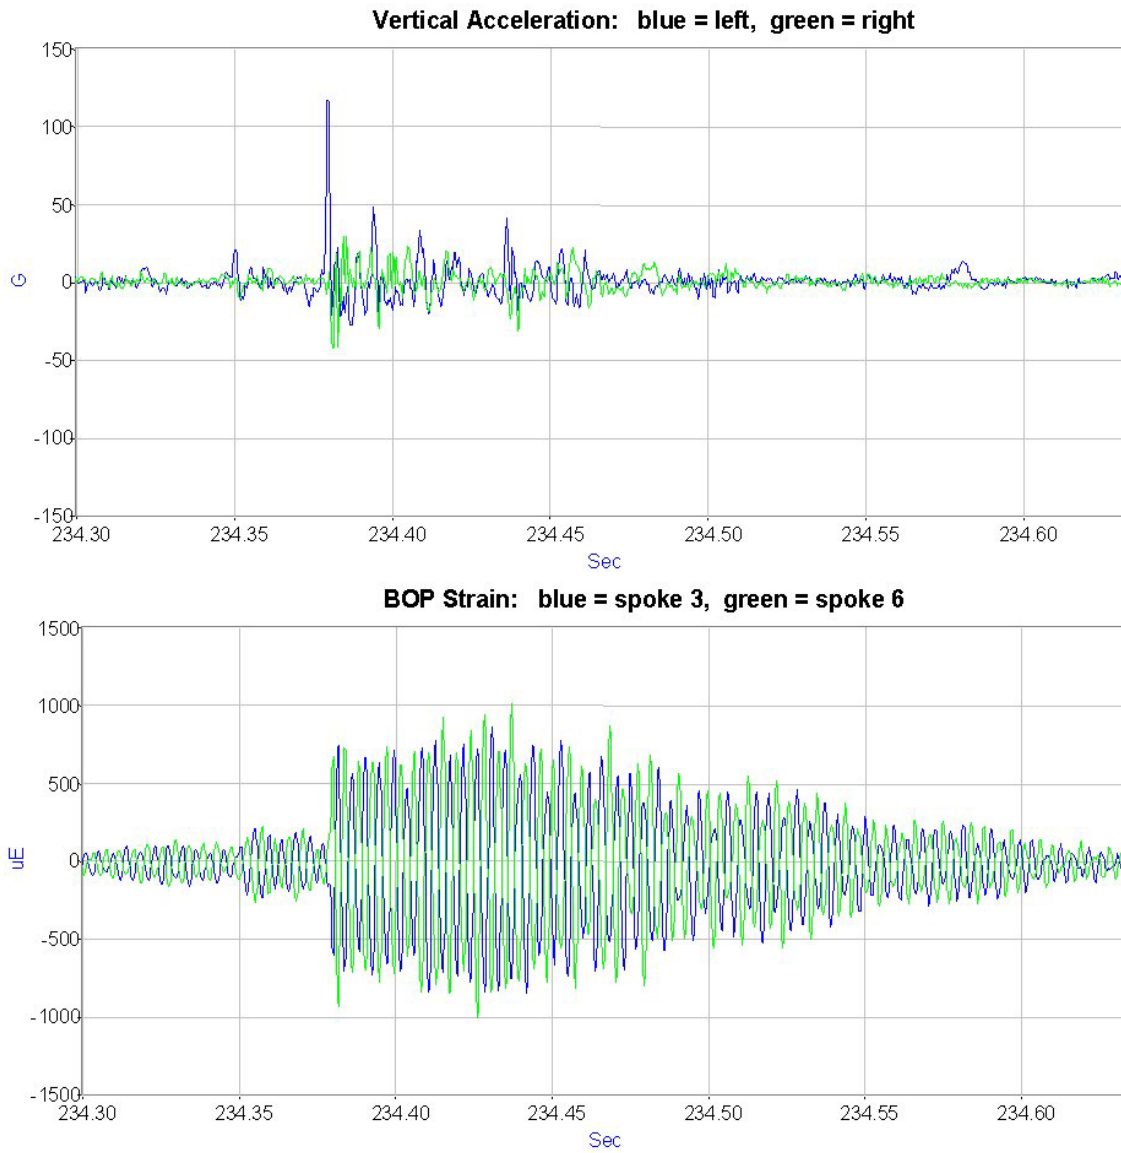
**Figure 3.30. Vertical Shock and BOP Strains Recorded on Center WABTEC/SAB-WABCO Supplied Brake Disc During Phase 2 Testing (File 052605\_18.AB2)–May 26, 2005**

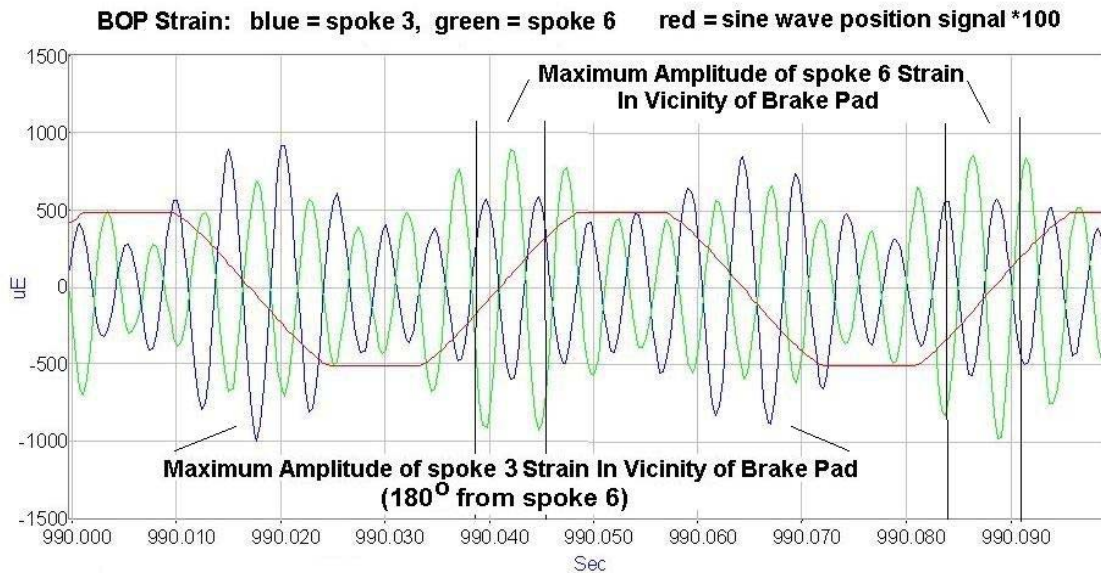
Figure 3.31 illustrates BOP strains observed during a brake application. In this example, the disc exhibited high BOP strains during a brake application from 150 mph near MP AB 158 during the northbound test run on May 26. Based on the relationship between the BOP strains recorded on the opposite spokes during this brake application, it is clear that the disc is vibrating out of the plane of rotation, just as exhibited by the disc in response to the vertical shock illustrated in Figure 3.30.

**Figure 3.31. BOP Strains Recorded During Braking on Center WABTEC/SAB-WABCO Supplied Brake Disc Near MP AB 158 During Phase 2 Testing (File 052605\_15.AB2)–May 26, 2005**

Figure 3.31 includes the wheel position signal generated by the slip ring indicating the rotational position of the brake discs. Figure 2.22 establishes the position of the axle with respect to this sine wave. The position of the brake disc indicated that a spoke experiences the largest strains when it is in the vicinity of the brake pads. This indicates that the calipers play a role in these high oscillations during particular brake applications.

The highest amplitude of sustained BOP oscillations on the center disc during a brake application was observed 1936' northeast of MP AB 158 during braking from 150 mph. In this case, BOP strain oscillations reached average-to-peak amplitudes of  $\pm 972$  microstrain or peak-to-peak amplitudes of 1,944 microstrain. These oscillations were superimposed on a mean measured strain that reached 1,764 microstrain.

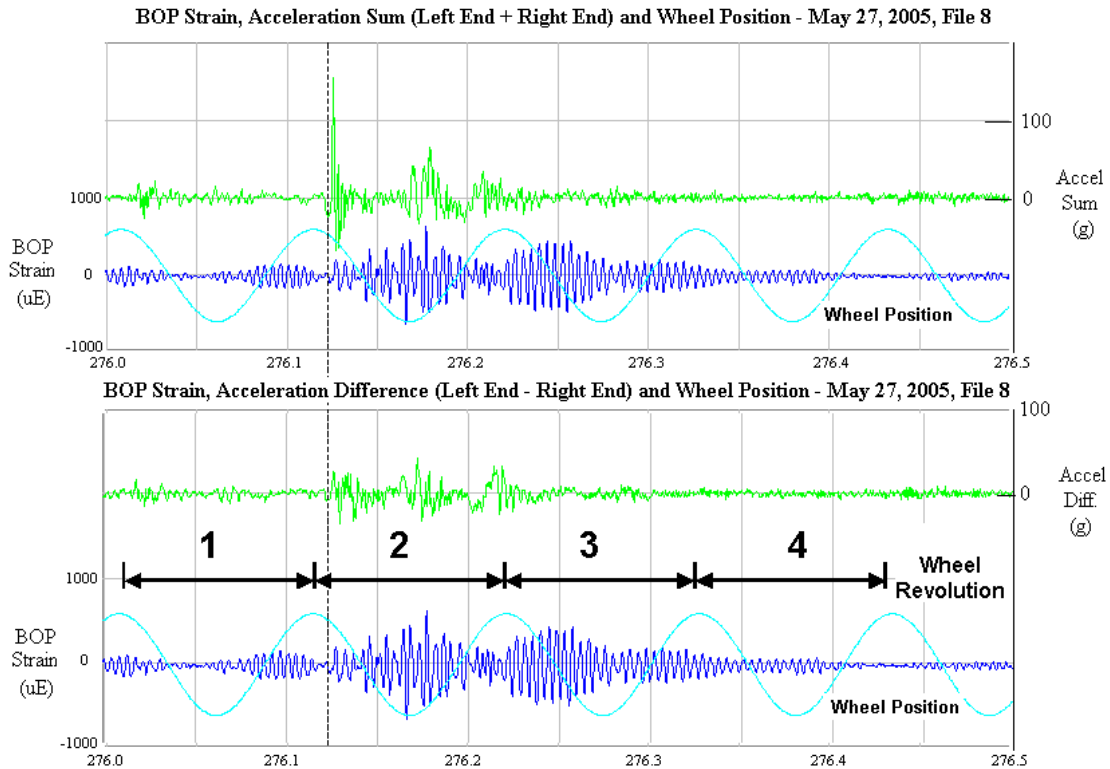
As shown in both Figure 3.9 and Figure 3.30, vertical shocks elicit large BOP strain amplitudes in the WABTEC/SAB-WABCO supplied brake disc that damp out within a short period of time. A common feature to the shocks illustrated in both of these figures is that the vertical shock on one end of the test axle is higher than that observed on the other end, referred to as an asymmetric shock. The vast majority of impacts observed during the test program were of this nature. Occasionally, impacts were measured on both ends of the test axle at nearly the same instant that did not elicit as large a BOP strain as some responses to asymmetric shocks. Figure 3.32 illustrates the response of the WABTEC/SAB-WABCO

supplied disc to shocks of similar magnitude on both ends of the axle. In this case, vertical impacts of 88.8 g and 66.5 g were recorded on the left and right ends of the test axle, respectively, while traveling southbound at 60 mph approximately 1400' northwest of MP AB 117. A lateral shock of approximately 40 g was recorded at the same location.

**Figure 3.32. BOP Strains on WABTEC/SAB-WABCO Supplied Center Disc Resulting from Vertical Shocks on Both Ends of Test Axle (File 052705\_08.AB2)–May 27, 2005**

The BOP strain response of the brake disc is illustrated in two separate plots, one showing the sum of the accelerations recorded at both ends of the axle and one showing the difference in accelerations recorded at both ends of the axle. One can observe that the maximum sum of the accelerations, indicated by the dashed line at the beginning of the second wheel revolution, reaches a value near 150 g but elicits little BOP strain response. The BOP strain response increases during the middle stage of the second wheel revolution and the third wheel revolution, which correlates well with the increase in the difference in the axle accelerations.

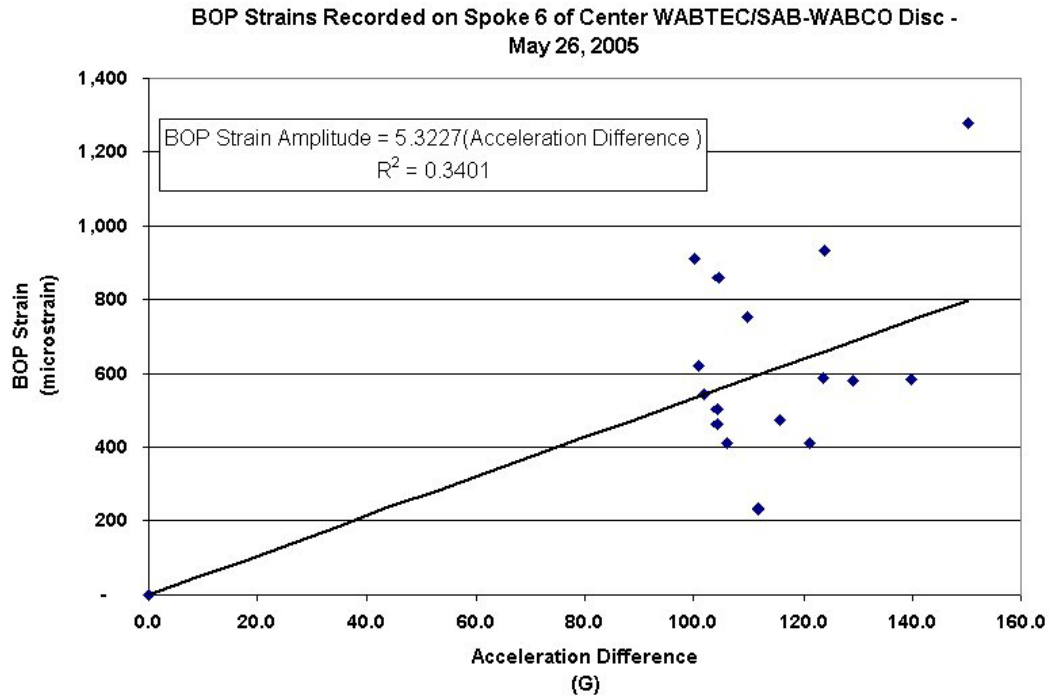
For the analysis of asymmetric shocks, impacts were selected and the BOP strain measured on spoke 6 was plotted against the arithmetic difference in accelerations measured on the ends of the test axle. Only

21 cases in which the acceleration difference was greater than 100 g were initially considered and only those cases with a single peak acceleration difference were analyzed, resulting in 17 examples included in this brief analysis. Figure 3.33 illustrates the results of this consideration. Any meaningful correlation does not appear to exist, as indicated by the low correlation factor.

**BOP Strains Recorded on Spoke6 of Center WABTEC/SAB\_WABCO Disc -  
May 26, 2005**

In the development of Figures 3.33 and 3.34, it was pointed out that only those cases with a single peak acceleration difference were analyzed. This was an important criterion to keep in mind. Many different loading conditions were observed in which the amplitude of the BOP strains did not vary linearly with the accelerations measured on the ends of the axle. As presented here, the angular position of the instrumented spoke is important but so is the acceleration time history associated with the peak accelerations. It can be shown that several peak accelerations experienced in rapid succession can actually diminish the peak BOP strains observed on the spokes. Appendix G treats this subject in more detail.

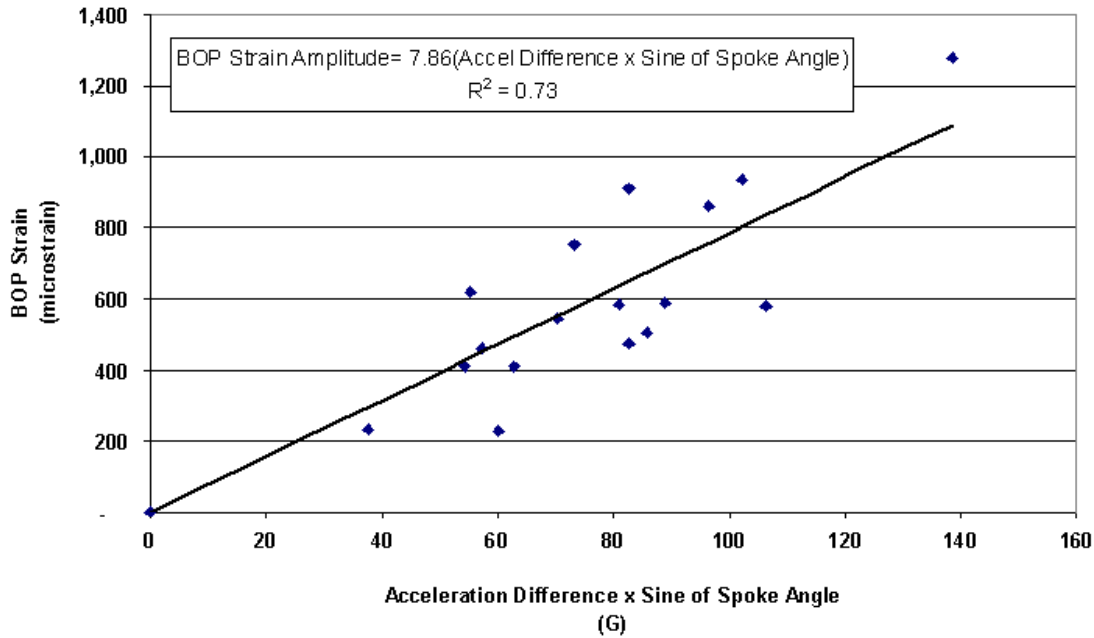
**Figure 3.34. Correlation of BOP Strain Amplitudes and Acceleration Differences  
Based on Measurements Collected on May 26, 2005**

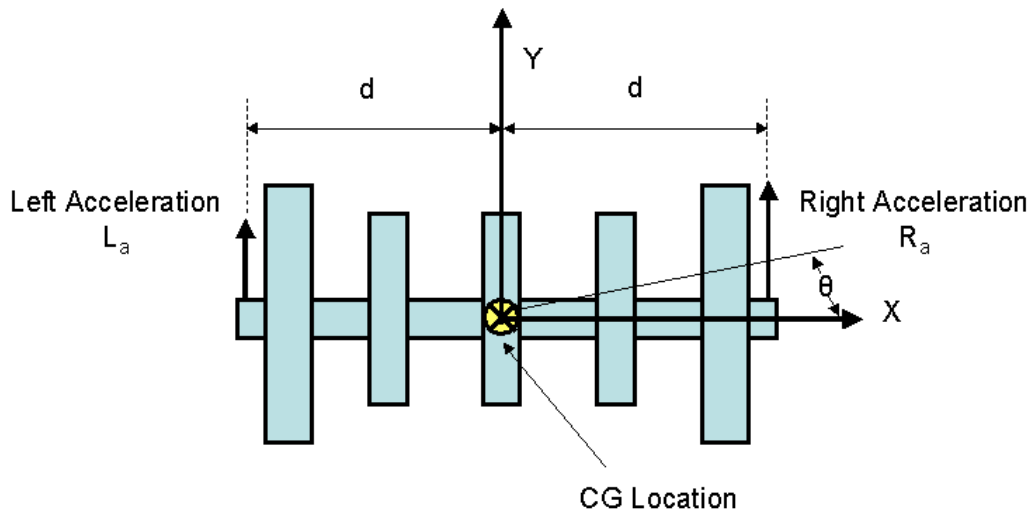
**Figure 3.35. Definition of Wheelset Acceleration Terminology**

Figure 3.35 illustrates an idealized wheelset. If one assumes that the wheelset/brake disc assembly is rigid and is limited to two degrees of freedom, vertical translation and rotation, then the accelerations measured on the ends of the axle can be used to specify the acceleration of any point on the rigid body through the following relationships:

Using this formulation, it can be seen that the acceleration difference reflected in Figures 3.33 and 3.34 is indicative of the rotational acceleration of the axle, which is constant over the length of the axle. The actual measured acceleration will depend on the location of the sensor along the axle. This leads to the conclusion that all three brake discs on the axle will respond in a similar fashion to a given difference in accelerations observed at each end of the axle. This is supported by some of the observations regarding relative responses of the inner and outer brake discs presented in Section 3.1.3.

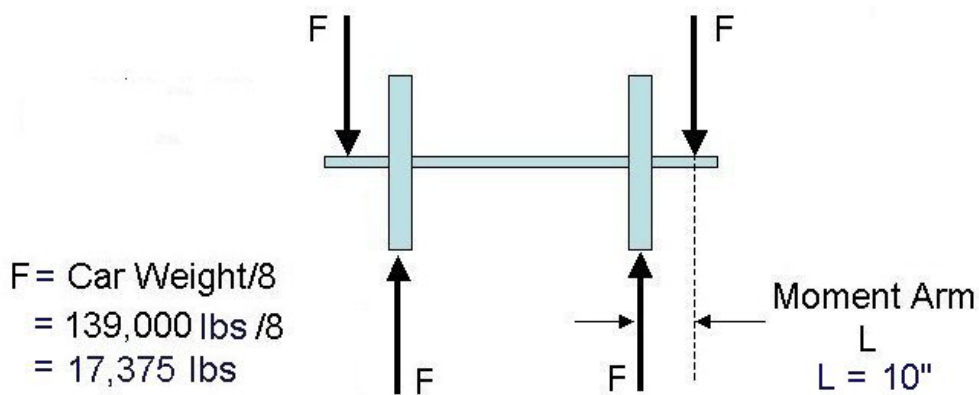
**Figure 3.36. Bending Moments in Generic Wheelset**

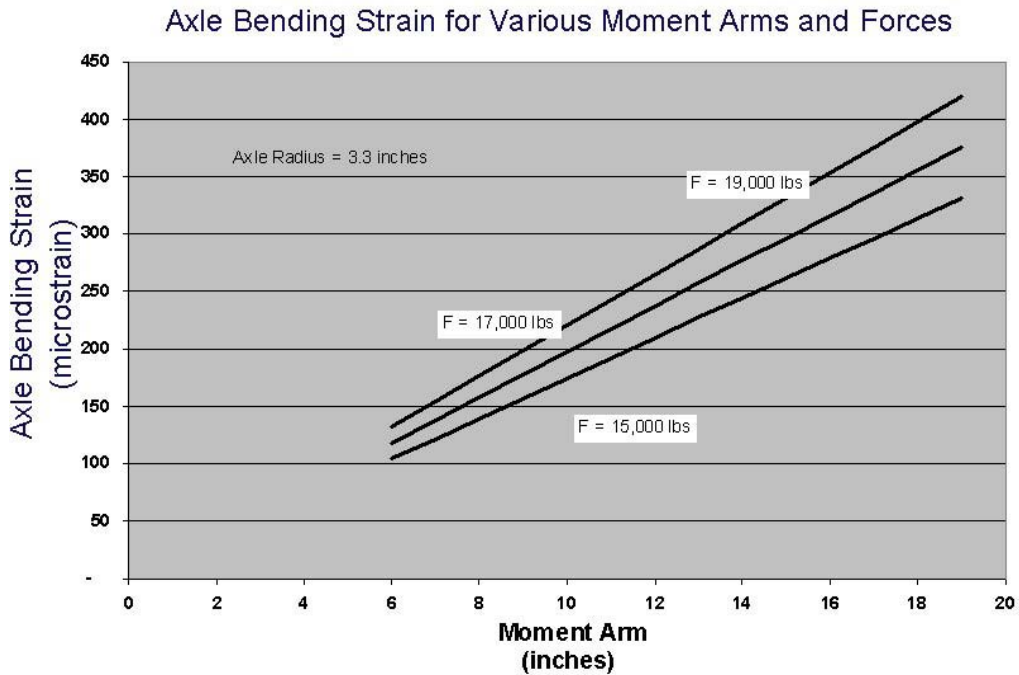
**Figure 3.37. Axle Bending Strain as a Function of Bearing Force and Moment Arm**

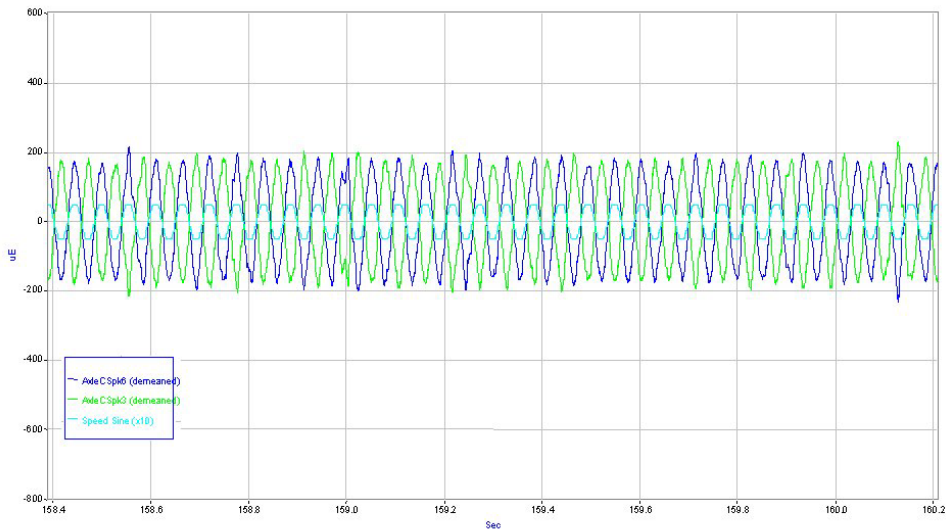
Figure 3.38 shows the output from a pair of axle-mounted strain gages as the test vehicle was moving over tangent track near MP AB 221 at 115 mph on May 26. The output from the strain gages have had the offset, or average reading, removed for presentation purposes. The output from the slip ring resolver is also plotted in this figure to illustrate the rotational rate of the axle.

**Figure 3.38. Typical Axle Bending Strains Recorded Over Tangent Track (File 052605\_18.AB2)–May 26, 2005**

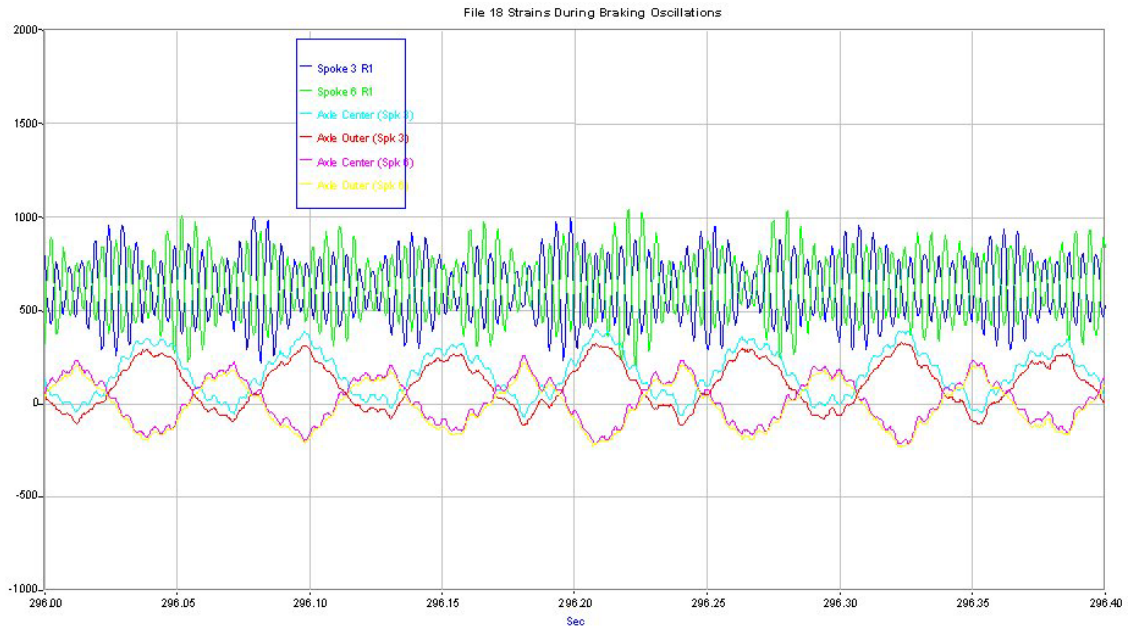
The behavior of the axle strains depended on many factors. The amplitude of the strains increased in proportion to the lateral accelerations exerted on the axle as a result of navigating through a curve. As the axle rotates, this bending moment is modulated by the wheel rotation rate. Figure 3.39 illustrates the axle strains and spoke strains recorded during a case of sustained oscillations during a brake application from 120 mph near MP AB 225.5 AB. In this particular case, the amplitude of the BOP oscillations is not considered to be high, and this case has not been identified as a case with high BOP strains, but it does serve to illustrate the behavior of the axle strain gages. The effects of the higher frequency content associated with the BOP strains on the brake disc are evident in the axle bending strains.

**Figure 3.39. Axle Bending Strains Recorded During Case of Small Oscillating BOP Strains During Brake Application (File 052605\_18.AB2)–May 26, 2005**

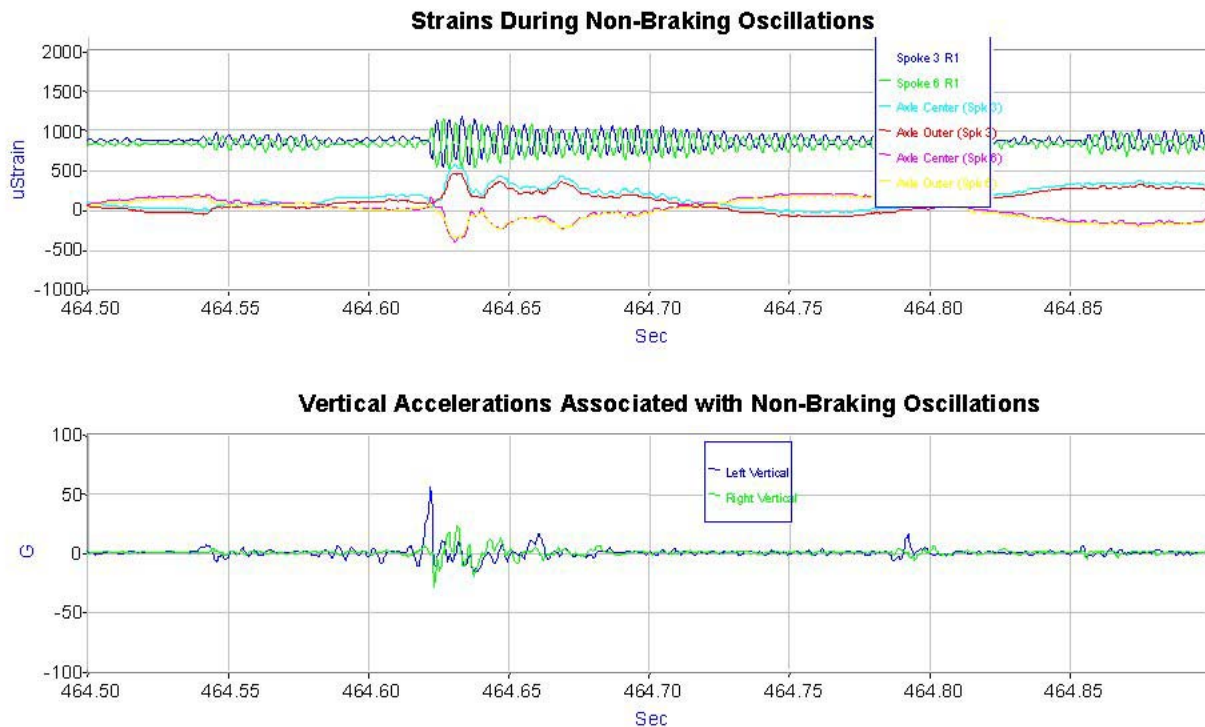
Figure 3.40 illustrates the strains recorded during a response to a vertical impact of 55.5 g experienced on the left end of the axle while traveling near the Route 128 Station at 30 mph on May 26. The effects of the impact can be seen on the axle. This illustration appears to indicate that the WABTEC/SAB-WABCO supplied brake disc responds to the impact and that the axle subsequently reacts to the motion of the disc.

**Figure 3.40. Axle Bending Strains Recorded During Response of WABTEC/SAB-WABCO Supplied Brake Disc to Vertical Impact (File 052605\_18.AB2)–May 26, 2005**

The frequency associated with the axle bending strain measurements are important, yet they are difficult to arrive at because, when the individual strain gages are at or near the neutral axis of the axle at particular times in the rotation cycle, the gages will see little bending and therefore very small strains. The frequency content of the axle strains will be considered in more detail during the discussion of Phase 3 testing.

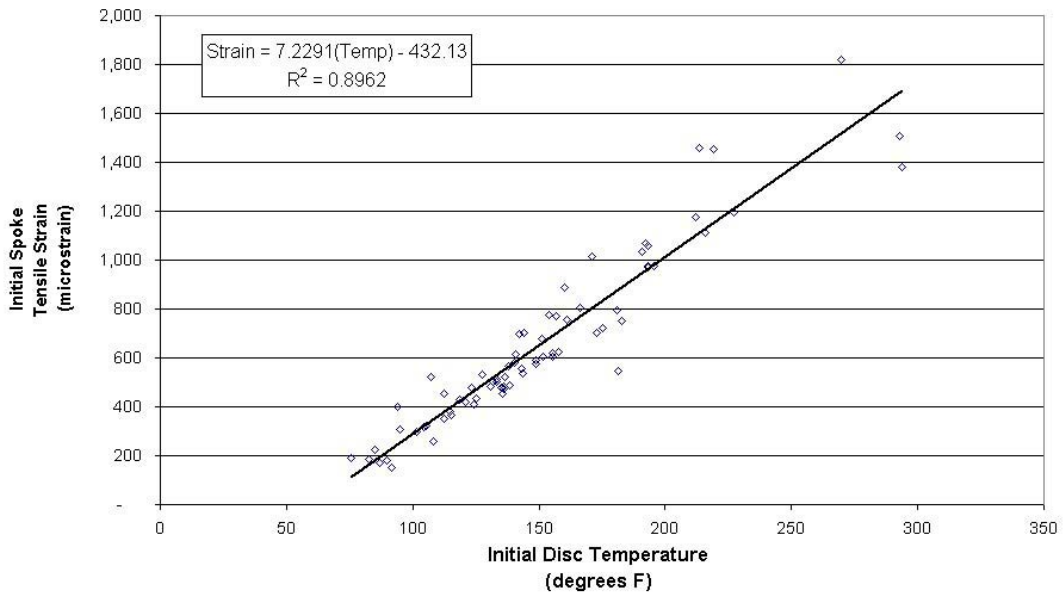
As done with temperature measurements collected from the back of the center disc’s friction ring during Phase 1 testing, friction ring temperatures were used to estimate the state of thermal stress in the spokes of the disc. Based on the analysis method described in Section 3.1.5, estimates of the thermal strains in the spoke were derived from data collected during testing on May 26 and 27. Figures 3.41 and 3.42 provide the results of this analysis with additional details in Appendix I. Results provided in these figures are similar to those determined during Phase 1 testing. These estimated thermal strains would not account for any existing pre-load strains in the spoke.

**Temperature vs. Initial Spoke Strain Prior to Brake Applications,  
Center WABTEC/SAB-WABCO Disc, Spoke 6 - May 27, 2005**

**Figure 3.41. Brake Disc Temperature versus Initial Spoke Tensile Strain Before Brake Applications, Center WABTEC/SAB-WABCO Supplied Disc, Spoke 6–May 26, 2005**

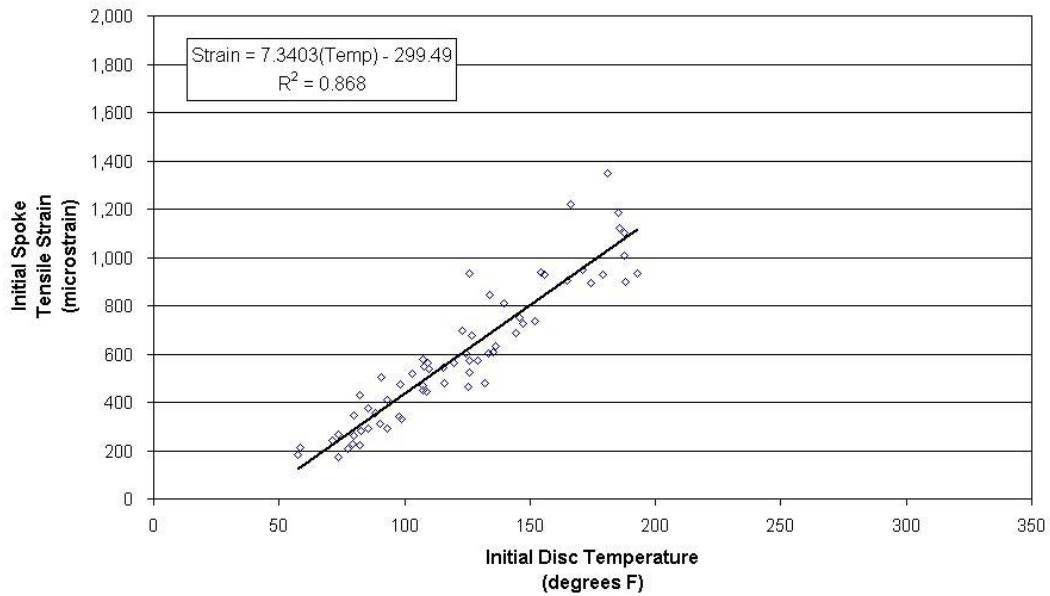
**Temperature vs. Initial Spoke Strain Prior to Brake Applications,  
Center WABTEC/SAB-WABCO Disc, Spoke 6 - May 26, 2005**

**Figure 3.42. Brake Disc Temperature versus Initial Spoke Tensile Strain Before Brake Applications, Center WABTEC/SAB-WABCO Supplied Disc, Spoke 6–May 27, 2005**

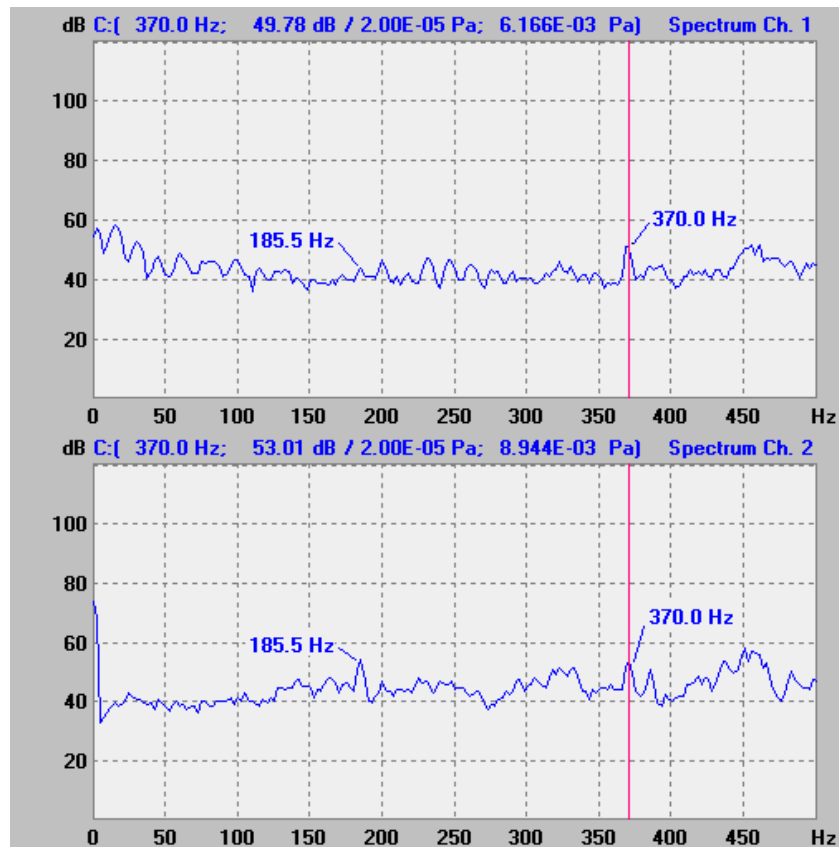
**Figure 3.43. Analysis of Sound Recorded During Sustained Oscillations While Braking Near MP AB 179—May 26, 2005**

Figure 3.43 illustrates the frequency analysis of sound measurements collected while the center WABTEC/SAB-WABCO supplied brake disc was exhibiting high BOP strains during a brake application from 137 mph near MP AB179 on May 26. In this analysis, the sound level expressed in decibels (dB) is plotted as a function of the frequency associated the particular component of the sound.

Within this recording, the sound on Channel 1 (the upper graph) and Channel 2 (the lower graph) has its strongest component of sound at a frequency of approximately 450 Hz. On both channels, a component of sound with a frequency of 370 Hz can be observed. In the sound recorded on Channel 2, evidence of contribution from a component with a frequency of 185.5 Hz exists. The 185.5 Hz frequency is close to the frequency associated with the sustained oscillations during braking observed in the strains.

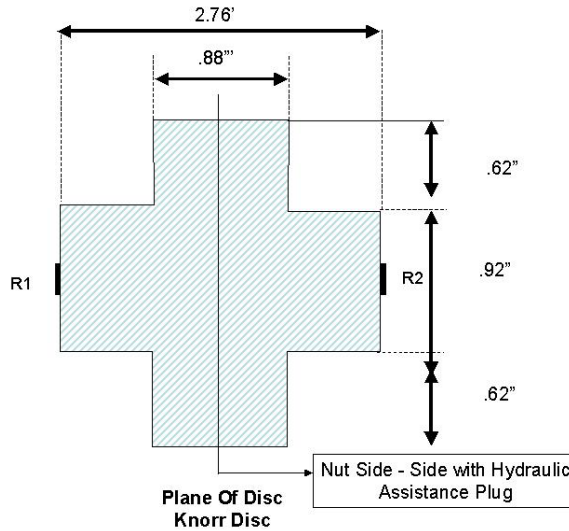
**Figure 3.44. Strain Gage Location and Cross Section Associated with Spoke of Knorr Brake Disc**

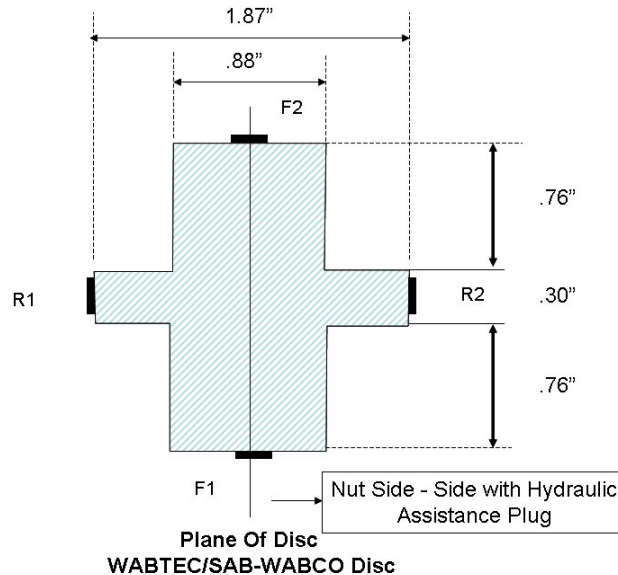
**Figure 3.45. Strain Gage Location and Cross Section Associated with Spoke of WABTEC/SAB-WABCO Supplied Brake Disc**

In Phase 3, axle 4 of Car 3534 (adjacent to Car 3413) was removed from the test trainset, and the existing WABTEC/SAB-WABCO supplied brake discs were removed and replaced with discs provided by Knorr. The newly outfitted axle and center Knorr brake disc were instrumented as specified in Figure 2.8b. Modal testing was conducted on the Knorr test axle, to be described in Section 3.3.2, and the axle was installed under Coach 3534. Figure 3.44 shows the locations of the strain gages on the spoke of the Knorr brake disc, recommended by Knorr. For the sake of comparison, Figure 3.45 illustrates the locations of the strain gages on the spokes of the WABTEC/SAB-WABCO supplied disc.

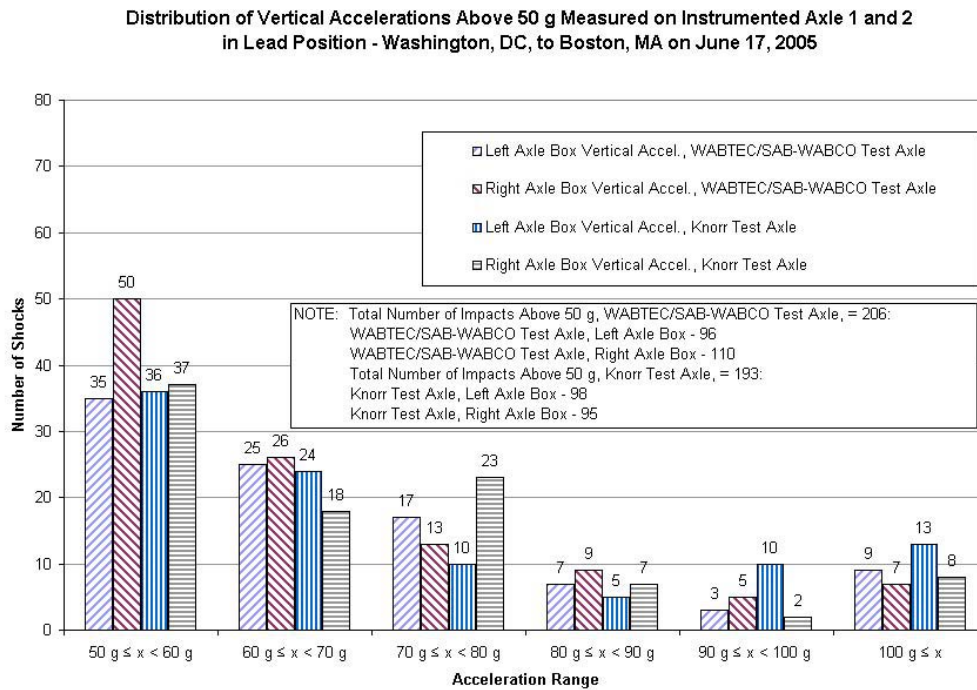
**Figure 3.46a. Distribution of Vertical Accelerations Above 50 g Measured on Instrumented Axles 1 and 2 in Lead Position—Washington, DC, to Boston, MA, on June 17, 2005**

Figure 3.46a illustrates the distribution of vertical accelerations above 50 g recorded on both the WABTEC/SAB-WABCO and Knorr test axles from Washington to Boston on June 17 with the test axles in a leading position. Figure 3.46b illustrates the corresponding information for the data collected between Boston and Washington on June 18, again with the test axles in a leading position. On these two test days, the accelerometers on the test axles exhibited effects from noise spikes and saturation from time to time, resulting in measurements that appeared similar to the data illustrated in Figure 3.3. Accelerations above 50 g were reviewed to ensure that any acceleration affected by the noise-related or saturation issues was disregarded. Appendix F tabulates the data illustrated in Figure 3.46.

There were 206 vertical shocks above 50 g measured on the WABTEC/SAB-WABCO test axle during the northbound test conducted on June 17, 96 on the left end axle box and 110 on the right end axle box, and 193 vertical shocks above 50 g were measured on the Knorr test axle during the same test run, 98 on the left end axle box and 95 on the right end axle box. Regarding the southbound test conducted on June 18, 159 vertical shocks above 50 g were measured on the WABTEC/SAB-WABCO test axle, 78 on the left end axle box and 81 on the right end axle box, and 169 vertical shocks above 50 g were measured on the Knorr test axle, 87 on the left end axle box and 82 on the right end axle box.

The highest vertical acceleration observed on the WABTEC/SAB-WABCO test axle during Phase 3 testing was 189 g, measured on the left end of the axle on June 17 near MP 56 of the Metro-North Rail Road while the test train was traveling at 48 mph. At this same location, the Knorr test axle experienced its highest vertical impact on the northbound trip, 172 g. During the southbound test conducted on June 18, the Knorr test axle experienced its highest vertical impact of the test, a 178 g impact on the left end of the axle in the vicinity of Transfer Interlocking near MP AB 218.5 while traveling at 131 mph. At this same location, the WABTEC/SAB-WABCO test axle experienced a vertical impact of 106 g on its left end.

- 4) Vertical accelerations measured on axle bearing boxes exceed 100 g between 5 and 21 times per day [Section 3.1.2, Figure 3.6; Section 3.2.2, Figure 3.25; Section 3.3.3, Figure 3.46].
