U.S. Department  
of Transportation

**Federal Railroad  
Administration**

# Investigation of Cracks in Acela Coach Car Brake Discs: Test and Analysis Volume I - Final Report

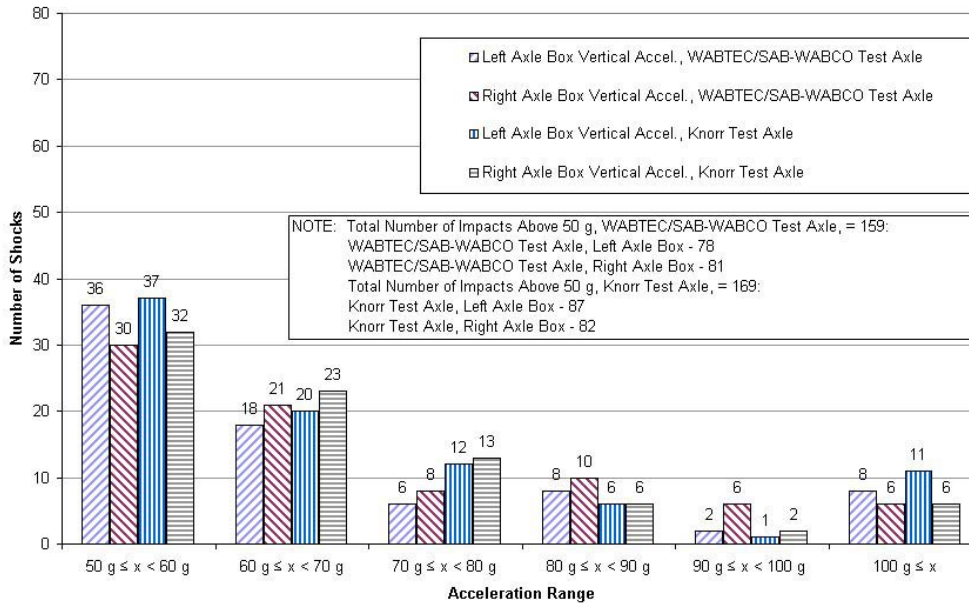
**Figure 3.46b. Distribution of Vertical Accelerations Above 50 g Measured on Instrumented Axles 1 and 2 in Lead Position—Boston, MA, to Washington, DC, on June 18, 2005**

Figure 3.46a illustrates the distribution of vertical accelerations above 50 g recorded on both the WABTEC/SAB-WABCO and Knorr test axles from Washington to Boston on June 17 with the test axles in a leading position. Figure 3.46b illustrates the corresponding information for the data collected between Boston and Washington on June 18, again with the test axles in a leading position. On these two test days, the accelerometers on the test axles exhibited effects from noise spikes and saturation from time to time, resulting in measurements that appeared similar to the data illustrated in Figure 3.3. Accelerations above 50 g were reviewed to ensure that any acceleration affected by the noise-related or saturation issues was disregarded. Appendix F tabulates the data illustrated in Figure 3.46.

There were 206 vertical shocks above 50 g measured on the WABTEC/SAB-WABCO test axle during the northbound test conducted on June 17, 96 on the left end axle box and 110 on the right end axle box, and 193 vertical shocks above 50 g were measured on the Knorr test axle during the same test run, 98 on the left end axle box and 95 on the right end axle box. Regarding the southbound test conducted on June 18, 159 vertical shocks above 50 g were measured on the WABTEC/SAB-WABCO test axle, 78 on the left end axle box and 81 on the right end axle box, and 169 vertical shocks above 50 g were measured on the Knorr test axle, 87 on the left end axle box and 82 on the right end axle box.

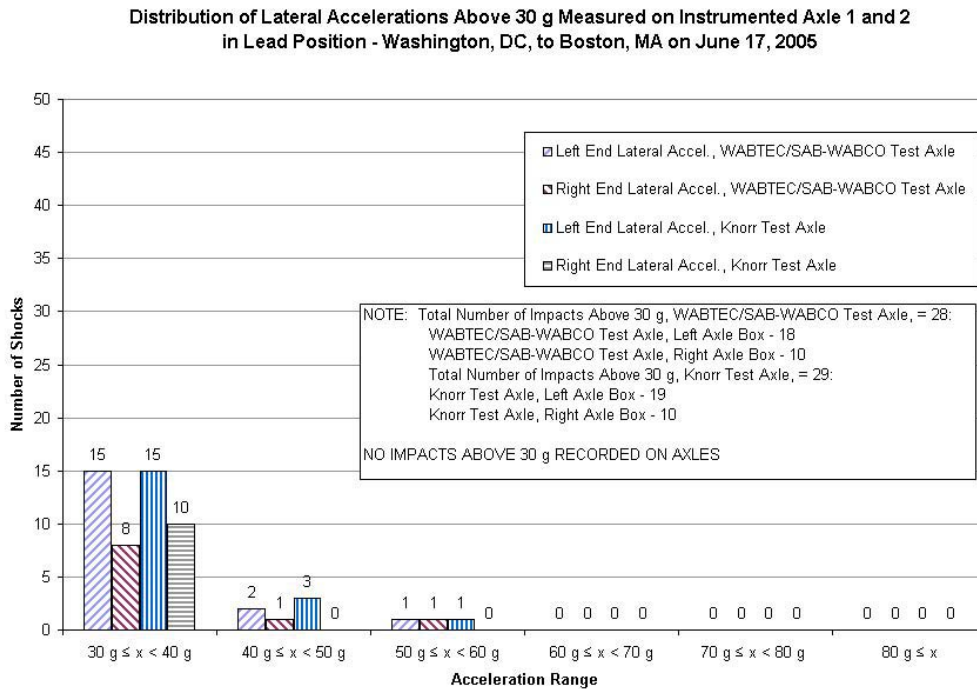
**Figure 3.47a. Distribution of Lateral Accelerations Above 30 g Measured on Instrumented Axles 1 and 2 in Lead Position—Washington, DC, to Boston, MA, on June 17, 2005**

Figure 3.47a illustrates the distribution of lateral accelerations above 30 g recorded on the test axle between Washington and Boston on June 17. Figure 3.46b illustrates the corresponding information for the data collected between Boston and Washington on June 18. Appendix F tabulates the data illustrated in Figure 3.47. On these two test days, the lateral accelerometers on the test axles exhibited effects from noise spikes and saturation from time to time. Accelerations above 30 g were reviewed to ensure that any acceleration affected by the noise-related or saturation issues was disregarded.

There were 28 lateral shocks above 30 g measured on the WABTEC/SAB-WABCO test axle during the northbound test conducted on June 17, 18 on the left end axle box and 10 on the right end axle box, and 29 lateral shocks above 30 g were measured on the Knorr test axle during the same test run, 19 on the left end axle box and ten 10 on the right end axle box. These counts represent those shocks in which the measurement was deemed reliable. No lateral shocks were measured directly on either test axle during the June 17 test run that were considered reliable. Regarding the southbound test conducted on June 18, 25 lateral shocks above 30 g were measured on the WABTEC/SAB-WABCO test axle, 16 on the left end axle box and 9 on the right end axle box, and 14 lateral shocks above 30 g were measured on the Knorr test axle, 6 on the left end axle box and 8 on the right end axle box. No lateral shocks were measured directly on either test axle during the June 18 test run that were considered reliable.

The highest lateral acceleration observed on the WABTEC/SAB-WABCO test axle during Phase 3 testing was 58.5 g, measured on the left end of the axle on June 17 in the vicinity of Union Interlocking near MP AN 20 while traveling at 113 mph. The Knorr test axle also experienced its highest lateral impact of the test on the June 17 northbound test run, a 58.4 g impact on the left end of the axle near Bowie Interlocking near MP AP 120.8 while traveling at 125 mph.

- Accelerations measured on the test axles generally increase with speed [Section 3.2.2, Figure 3.27].
  - Lateral accelerations measured on the axle boxes at the end of the axle are generally higher than lateral accelerations measured on the axle [Section 3.1.2; Section 3.2.2, Figure 3.25; Section 3.3.3, Figure 3.47].

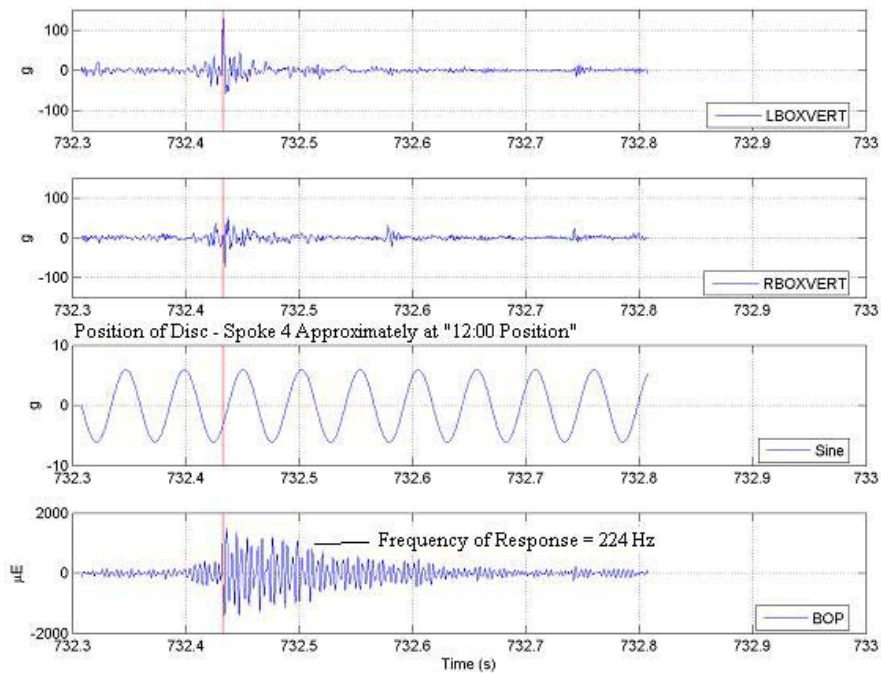
**Figure 3.48. Vertical Shock and BOP Spoke Strain Response of WABTEC/SAB-WABCO Supplied Brake Disc Measured Near Lane Interlocking (File 061805\_30.AB3)–June 18, 2005**

Regarding the response to vertical impacts, it was immediately evident during testing, as well as in post-test data analysis, that for comparable vertical shocks on the two test axles, the BOP strains recorded on the spokes of the Knorr brake disc were substantially lower than the BOP strains recorded on the spokes of the WABTEC/SAB-WABCO supplied brake disc. This observation is exemplified by the comparison of Figures 3.48 and 3.49.

Figure 3.48 illustrates a severe vertical impact and the response of the WABTEC/SAB-WABCO supplied brake disc as characterized by the BOP strains measured on spoke 6. The data shown in Figure 3.48 was recorded on June 18 while the test train was traveling southbound in the vicinity of Lane Interlocking near MP AN 12 at 124 mph. As seen in the plots of vertical accelerations within the figure, the axle was subjected to an asymmetric vertical, or tilting, acceleration in which a positive acceleration of 147 g was measured on the left end axle box and a negative acceleration of -73 g was measured on the right end axle box. Figure 3.49 illustrates the corresponding response of the Knorr disc to the same disturbance, measured as a positive acceleration of 145 g on the left end axle box and a negative acceleration of 49 g on the right end axle box. Spoke 6 of each of the center brake discs at the time of the impacts illustrated in Figures 3.48 and 3.49 was approaching the straight up or 12:00 position. Spoke 6 of the Knorr disc was approximately 20° from the 12:00 position; spoke 6 of the WABTEC/SAB-WABCO supplied disc was approximately 60° from the 12:00 position.

As seen in the bottom of Figure 3.48, the shock produces a BOP spoke strain on the WABTEC/SAB-WABCO supplied brake disc with an amplitude of 1,487 microstrain, zero-to-peak, that requires almost 0.20 seconds to die out. The asymmetric vertical shock produces a BOP spoke strain with an amplitude of 290 microstrain, zero-to-peak, in the Knorr brake disc that requires approximately 0.03 seconds to die out. The frequency associated with this particular response of the WABTEC/SAB-WABCO supplied brake disc is 224 Hz while the frequency associated with the Knorr disc is 344 Hz. Both of these frequencies are close to those associated with the out-of-phase responses of the respective discs determined in the modal tests conducted during Phase 3 testing (see Table 3.4 for WABTEC/SAB-WABCO supplied disc and Table 3.5 for Knorr disc). Similar results with respect to the relative responses of the two discs to vertical shocks were observed throughout Phase 3 testing. The highest strains on the center brake disc resulting from a vertical impact only during Phase 3 testing was the event illustrated in Figure 3.48.

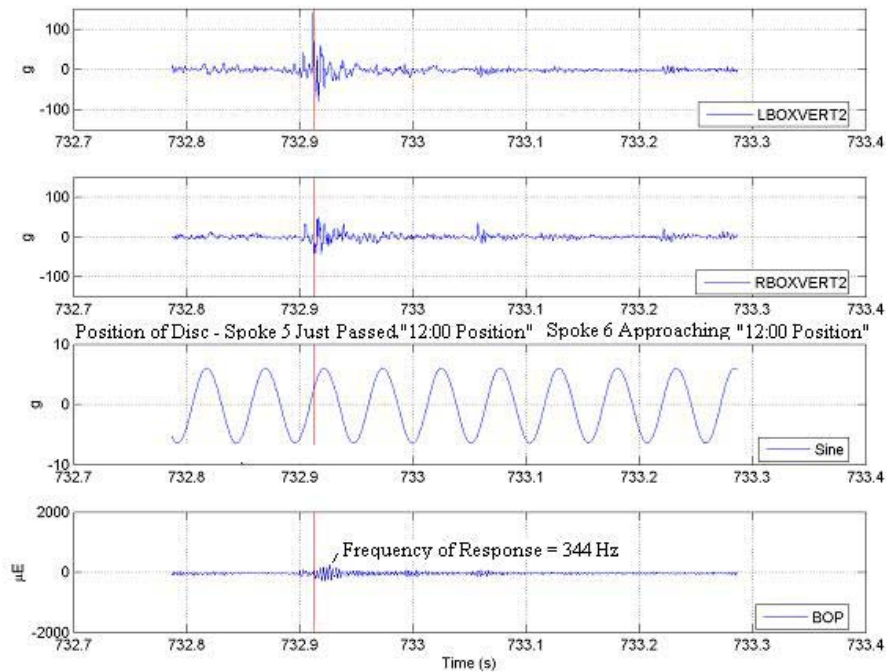
**Figure 3.49. Vertical Shock and BOP Spoke Strain Response of Knorr Brake Disc Measured Near Lane Interlocking (File 061805\_30.AB3)–June 18, 2005**

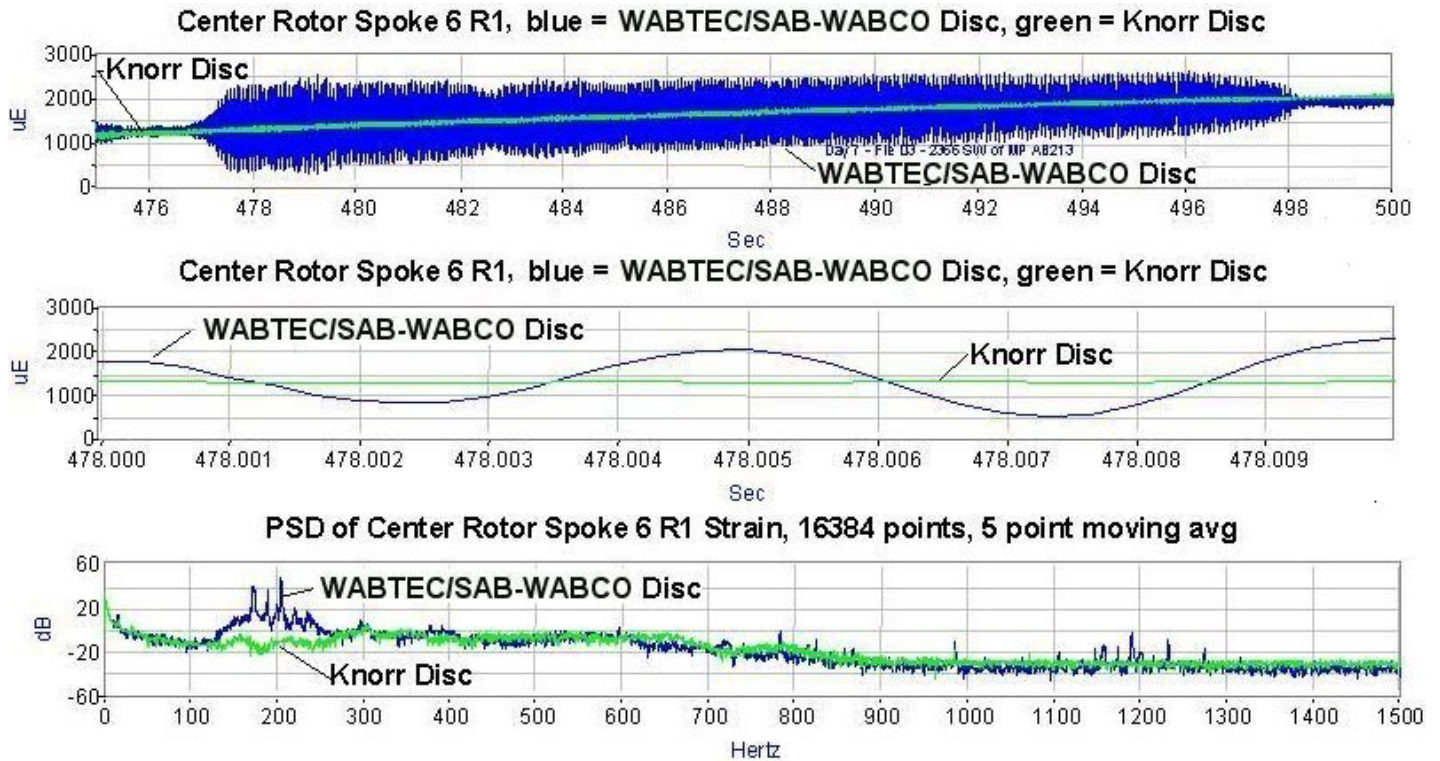
**Figure 3.50. Comparison of WABTEC/SAB-WABCO Supplied Disc and Knorr Disc During a Brake Application From 116 MPH with Sustained Oscillations (File 061805\_03.AB3)–June 18, 2005**

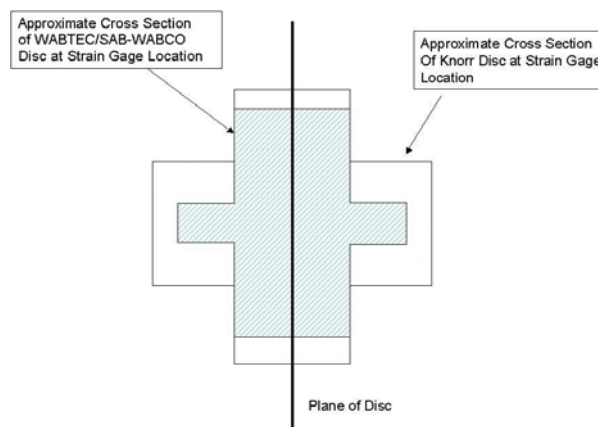
**Figure 3.51. Comparison of Cross Sections of Spokes from WABTEC/SAB-WABCO Supplied and Knorr Brake Discs**

One of the factors that affects the relative responses of the spokes of the two brake discs is the cross sectional geometry of the spokes. Figure 3.51 compares the geometry of the spokes for the different brake discs in the vicinity of the strain gages. The resistance of the spokes to bending depends on the cross-sectional moment of inertia. Table 3.9 provides a comparison of moment of inertia values for the cross sections of the WABTEC/SAB-WABCO supplied and Knorr brake disc spokes.

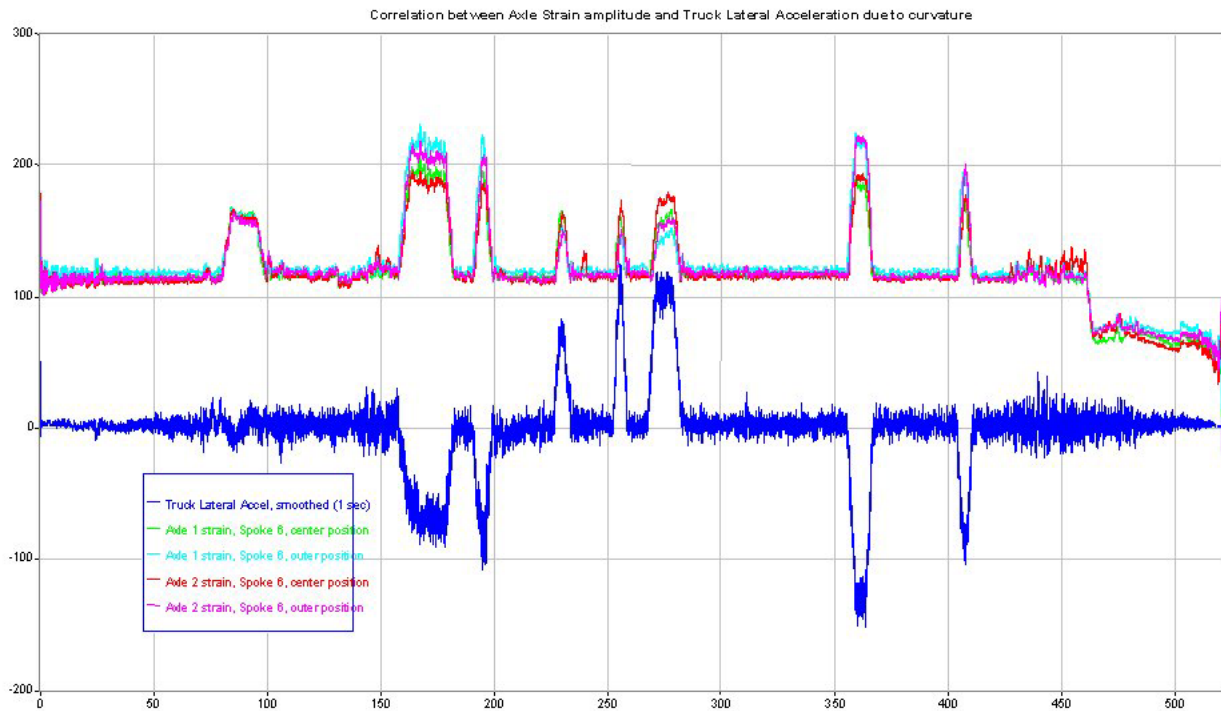
**Figure 3.52. Comparison of Truck Frame Lateral Accelerations and Axle Strains  
(File 061805\_03.AB3)–June 18, 2005**

To more clearly illustrate the change in axle strains with movement through a curve, the lateral accelerations recorded on the truck frame over a short portion of track are compared to axle strains recorded from both test axles in Figure 3.52. When the test vehicle moves over curved track, an increase or decrease in lateral acceleration will usually be recorded on the truck. A strong correlation exists between the presence of curves and the change in the amplitude of the axle strains.

During a review of axle strains measured during Phase 2 testing, it was observed that axle strains could be affected by modulation of the strain signals by the wheel rotational rate and the effects of the lateral acceleration imposed on the axle as it moves through curves. This became more evident in review of data collected in Phase 3 testing.

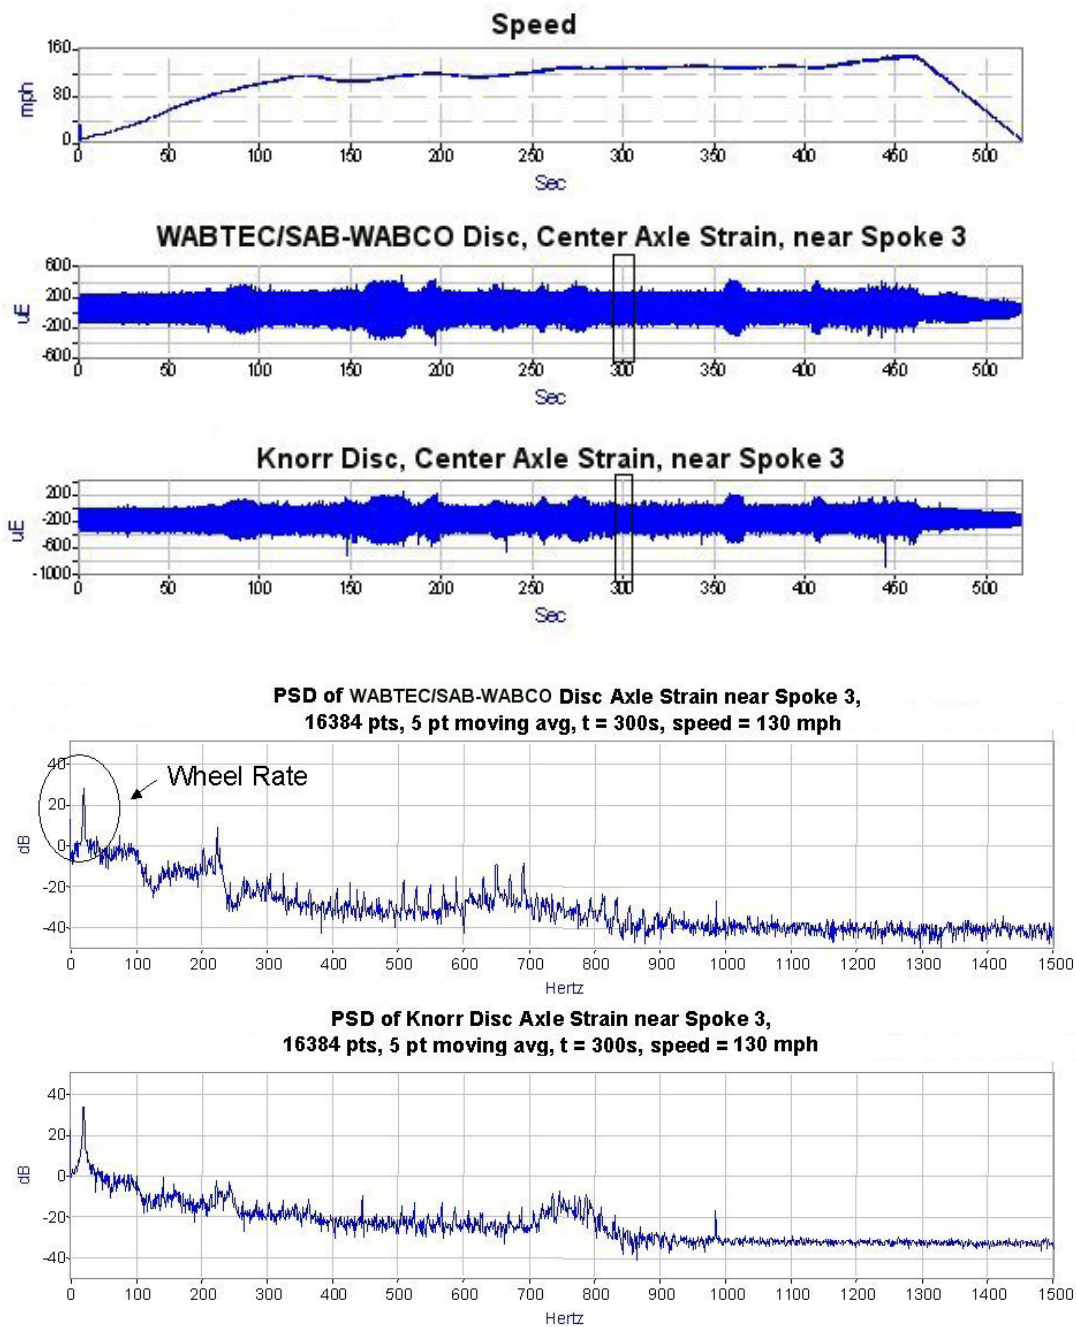
**Figure 3.53. PSD of Axle Strains Collected Over Tangent Section of Track (File 061805\_03.AB3)–June 18, 2005**

Figure 3.53 illustrates axle strains recorded on both test axles while traveling at speeds between 0 and 150 mph on June 18. The change in the overall amplitude of the axle strains can be seen to change as the speed increases; the effect of the rotational speed of the axle can be seen in the frequency spectra of both axles included in the lower portion of the figure. This frequency analysis was conducted for data collected on tangent track at relatively constant speed.

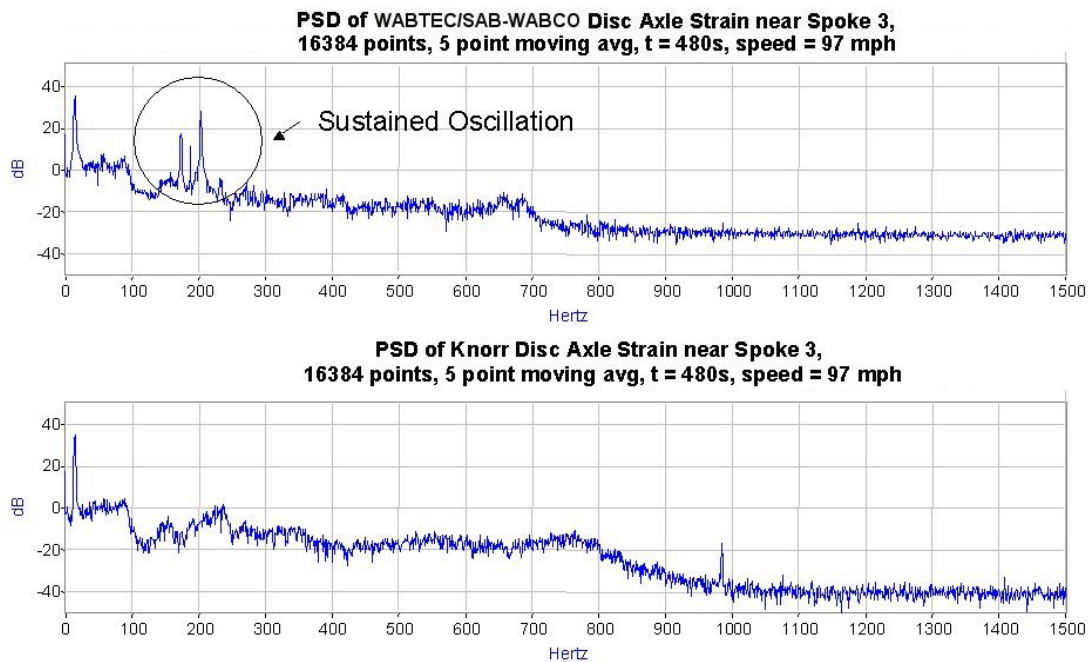
**Figure 3.54. PSD of Axle Strains of WABTEC/SAB-WABCO Supplied Disc and Knorr Disc During a Brake Application from 116 MPH with Sustained Oscillations (File 061805\_03.AB3)–June 18, 2005**

Figure 3.54 provides the PSD of axle strains recorded on the test axles during the brake application illustrated in Figure 3.50. One can see the effect of the vibration of the WABTEC/SAB-WABCO supplied brake disc in the strains recorded on the WABTEC/SAB-WABCO axle. The dominant frequencies evident in the lower portion of Figure 3.50 can be seen in the consideration of the WABTEC/SAB-WABCO axle in Figure 3.54.

As stated in Section 3.2.3, analysis of the axle strains requires one to be mindful of the effects of many factors. Appendix H discusses processing techniques to obtain more information from the modulated signals resulting from the axle-mounted strain gages.

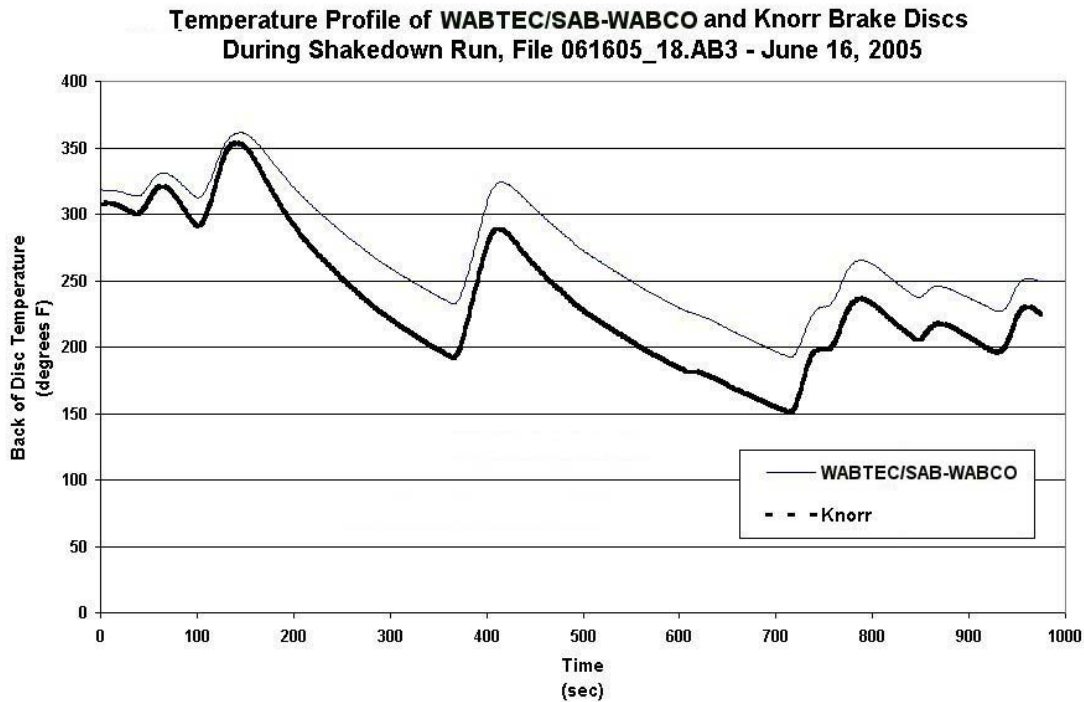
**Figure 3.55. Temperature Profiles from Back of WABTEC/SAB-WABCO Supplied and Knorr Brake Discs During Shakedown Run (File 061605\_18.AB3)–June 16, 2005**

The highest brake disc temperature recorded occurred during the shakedown run made on June 16. In one case, the temperature on the WABTEC/SAB-WABCO supplied disc reached 361 °F and the Knorr disc reached 352 °F between MP 55 AN and Philadelphia, PA (File 061605\_18.AB3). Figure 3.55 shows the temperature profiles recorded during this particular data file.

This illustration shows that the Knorr brake disc cools down faster than the WABTEC/SAB-WABCO supplied disc. The thermal time constant, a measure of how quickly the brake disc dissipates heat, was calculated for each brake disc using the temperatures shown above. Results of this analysis, details of which are provided in Appendix I, show that the thermal time constant for the Knorr brake disc is 4.6 while that for the WABTEC/SAB-WABCO supplied disc is 6.3, indicating that the Knorr disc will cool faster than the WABTEC/SAB-WABCO supplied disc.

- 1) For both the WABTEC/SAB-WABCO supplied and Knorr brake discs, the temperature measured on the back of the friction ring surface can reach a level of 360 °F [Section 3.3.6, Figure 3.55].
- 2) The Knorr brake disc heats up faster and cools down faster than the WABTEC/SAB-WABCO supplied brake disc. This difference in heating and cooling rates is considered to be small [Section 3.3.6].

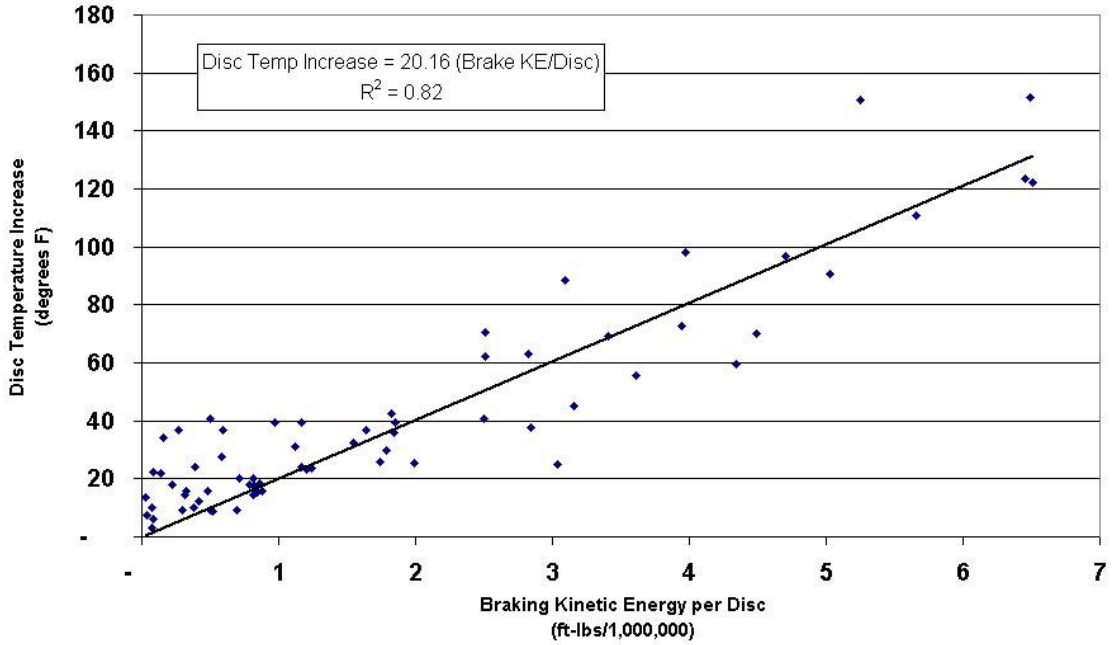
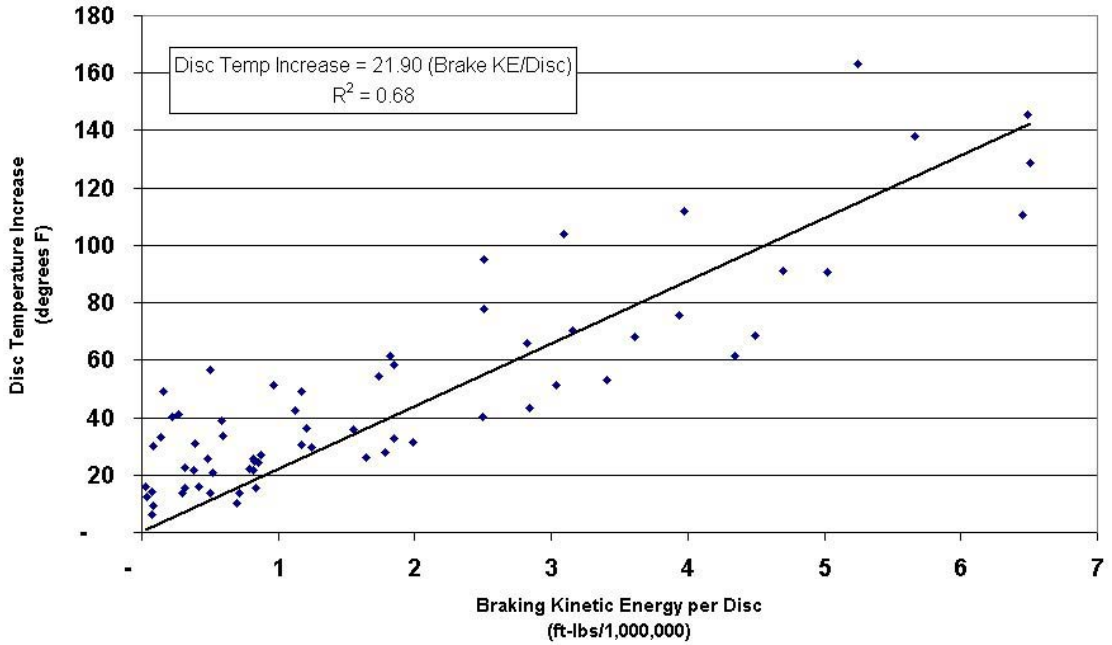
**Figure 3.56. Comparison of Disc Temperature Changes versus Dissipated Kinetic Energy for Knorr and WABTEC/SAB-WABCO Supplied Brake Discs—June 18, 2005**

An analysis of all the brake applications made during tests conducted on June 17 and 18 was performed to quantify the rate in which heat builds up within the discs. This was accomplished by identifying the temperature change of the Knorr and WABTEC/SAB-WABCO supplied brake discs due to the braking as a function of the kinetic energy dissipated. Details of this analysis are presented in Appendix I and the results of the analysis for testing conducted on June 18 are provided in Figure 3.56. In this analysis, it is presumed that each brake disc of a vehicle contributes an equal amount to the braking effort of the vehicle, a reasonable presumption to make in this analysis. Results from this graph, as well as those provided for the June 17 tests, indicate that on average, for a given change in dissipated kinetic energy, the Knorr disc experiences a slightly higher temperature change. This finding was consistent with observations made during the test.

**Disc Temperature Change vs. Braking Kinetic Energy/Disc  
WABTEC/SAB-WABCO Disc - June 18, 2005**

**Disc Temperature Change vs. Braking Kinetic Energy/Disc  
Knorr Disc - June 18, 2005**

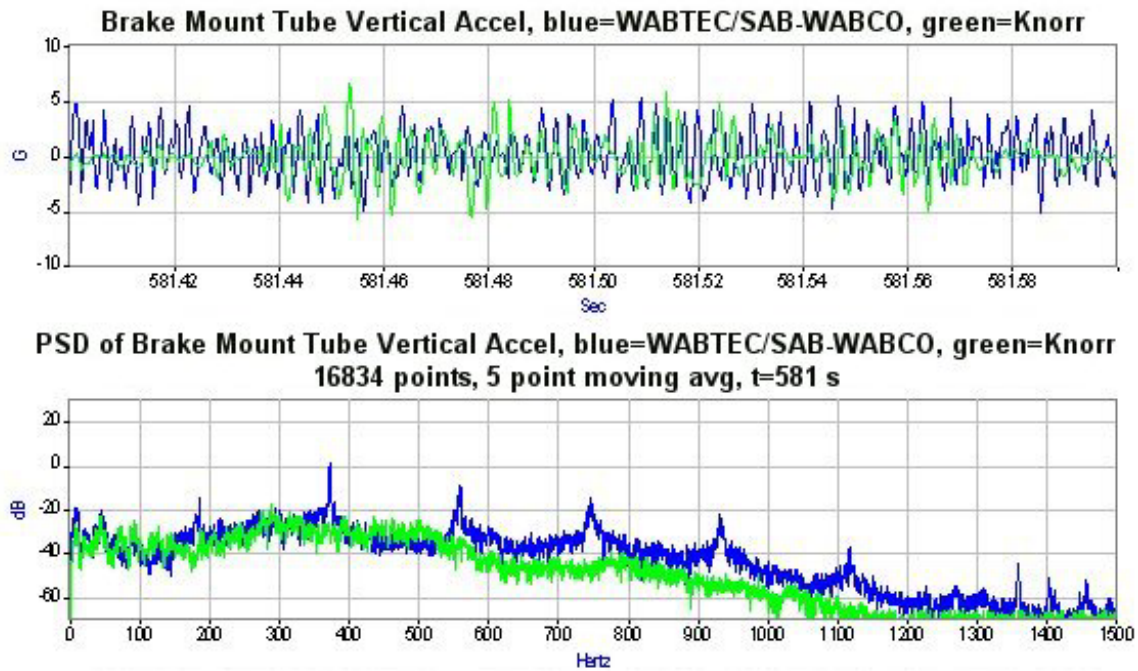
**Figure 3.57. Time History and PSD of Brake Mounting Tube Vertical Accelerations During Sustained Oscillations While Braking (File 061805\_24.AB3)—June 18, 2005**

During sustained oscillations within brake applications, accelerations measured on the brake mounting tube associated with the WABTEC/SAB-WABCO supplied brake disc test axle show a very strong harmonic characteristic. This same characteristic is not observed on the brake mounting tube above the Knorr brake disc test axle. Figure 3.57 provides an illustration of the time history and frequency content of the vertical accelerations measured on both brake mounting tubes during the period of sustained oscillations near MP AN 55 on June 18. Figure 3.58 shows the corresponding information for the lateral accelerations measured at the same locations. In both figures, a fundamental frequency of 187 Hz along with a number of harmonics are observed in the accelerations measured on the tube above the WABTEC/SAB-WABCO test axle. The amplitude of the vertical acceleration is approximately twice that of the lateral acceleration.

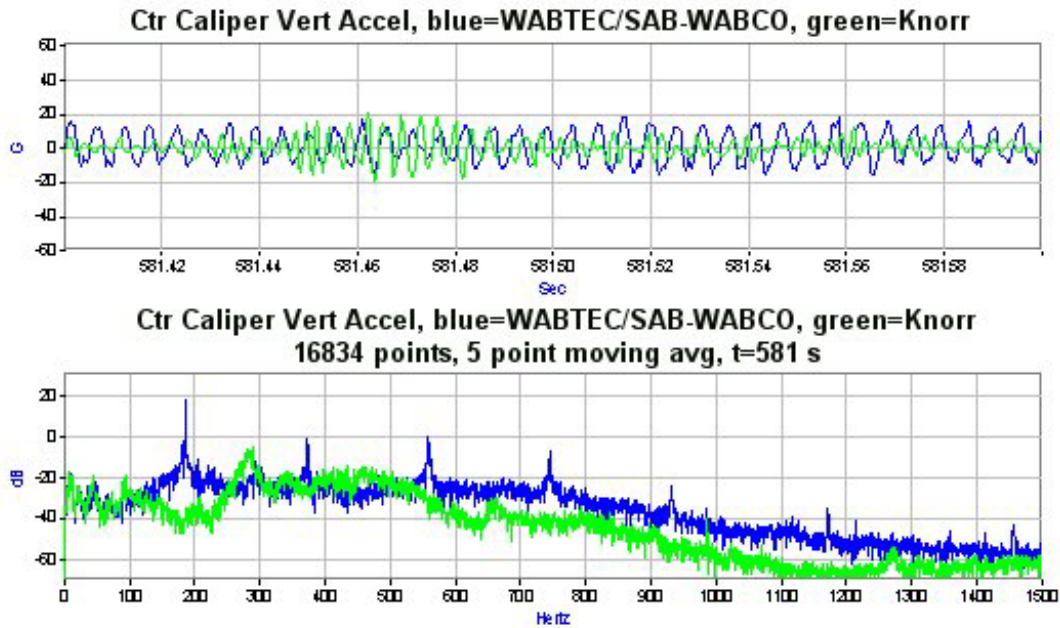
**Figure 3.59. Time History and PSD of Brake Caliper Pad Vertical Accelerations During Sustained Oscillations While Braking (File 061805\_24.AB3)–June 18, 2005**

Figures 3.59 and 3.60 provide the same type of information shown in the previous figures for the vertical and lateral accelerations measured near the center caliper pads over the two test axles. As seen in the previous figures, the same fundamental frequency of 187 Hz, along with a number of harmonics, are observed in the frequency distribution. On the brake pad, the lateral accelerations associated with the WABTEC/SAB-WABCO supplied disc reach levels as high as 30 g, while the vertical accelerations on the same pad are only as high as 20 g. The accelerations measured on the pad are characterized by a sawtooth shaped pattern.

The 187 Hz frequency observed in the strains on the links is a characteristic of the sustained oscillation events. The right link strains exhibit the same distinctive saw-tooth pattern observed in the caliper pad accelerations in Figures 3.59 and 3.60. The strains in the left link exhibit reversals. These patterns may be indicative of a slip-stick behavior at the interface of the brake pad and the friction ring. Appendix K examines this phenomenon, but no firm conclusions are reached.

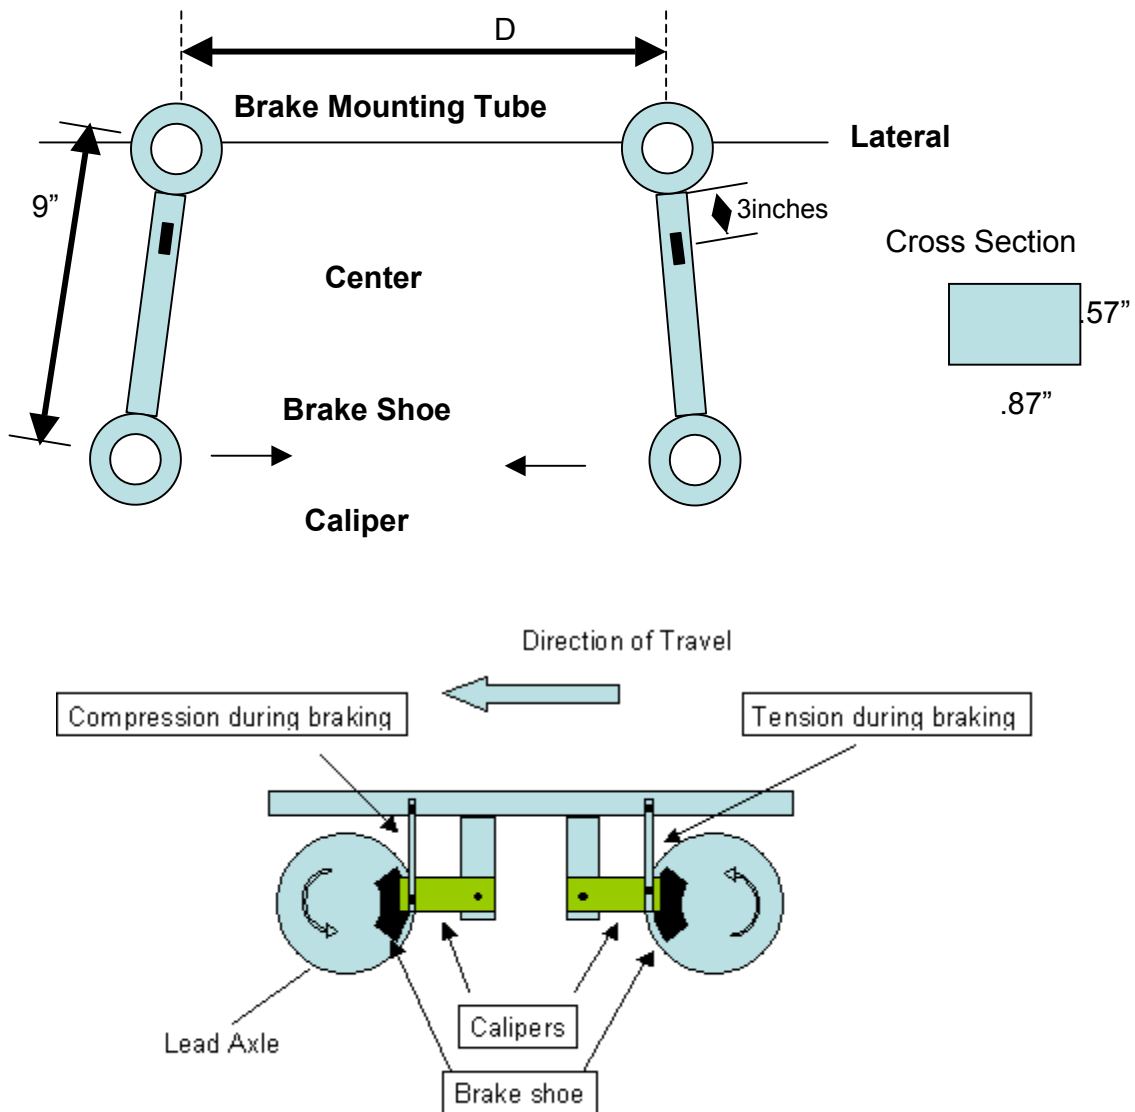
**Figure 3.61. Illustration of Instrumented Brake Links and Locations within Truck**

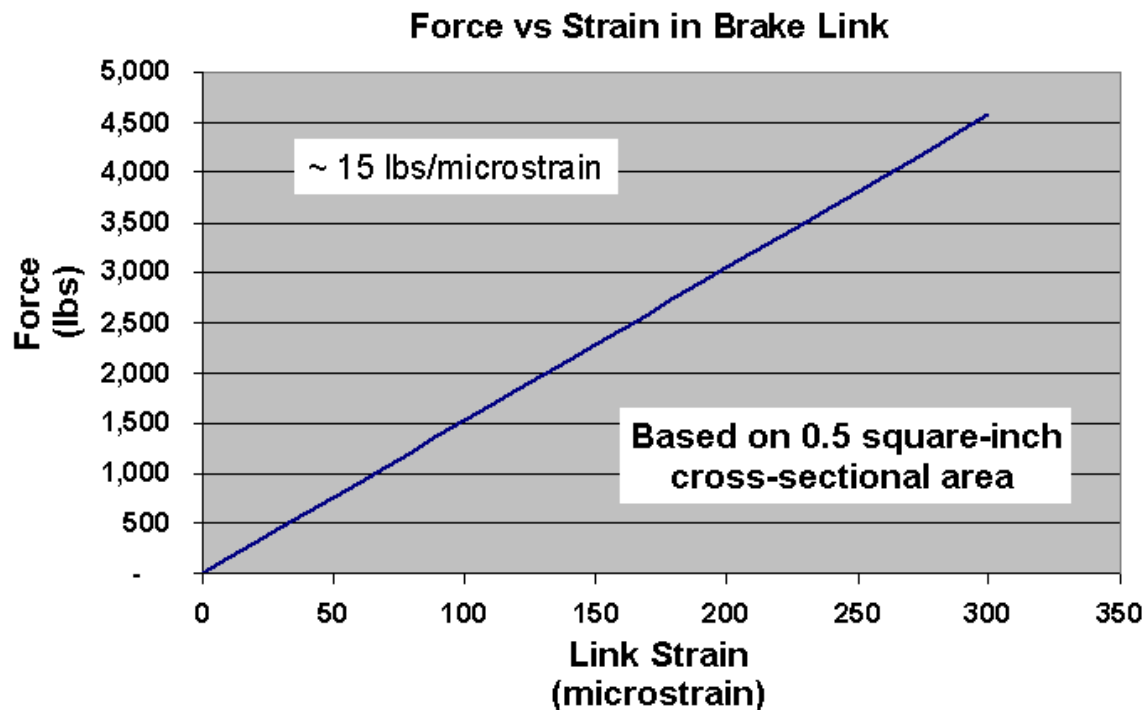
**Figure 3.62. Brake Link Strain Level–Force Relationship**

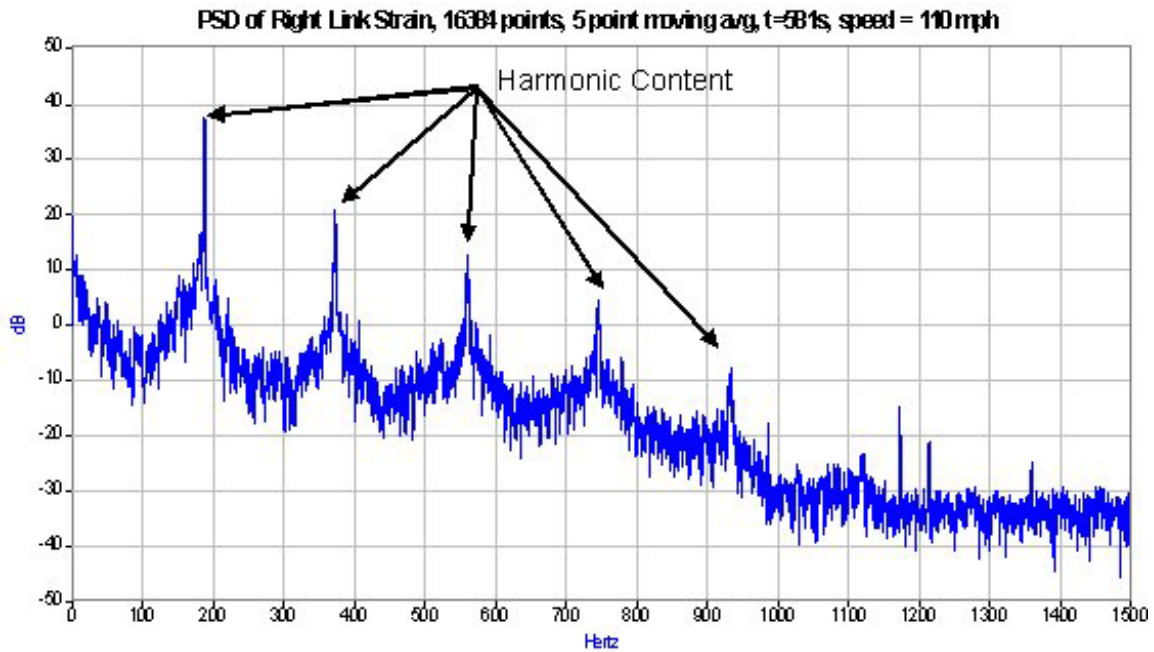
**Figure 3.63. Frequency Spectrum of Strains Recorded on Caliper Link During Sustained Oscillations While Braking (File 061805\_24.AB3)–June 18, 2005**

A major difference was observed between the strains when sustained oscillations were observed and those when no sustained oscillations were observed. When sustained oscillations were observed, the frequency spectrum of the strains recorded in the links exhibited a strong harmonic content. Figure 3.63 shows the frequency content of the strains recorded during the sustained oscillation of the WABTEC/SAB-WABCO supplied disc recorded near MP AN55 on June 18.

The fundamental frequency of this oscillation is 187 Hz. This frequency was observed at vehicle speeds of 69 and 110 mph. Four harmonic frequencies are clearly observed in the PSD. Based on the 750 Hz, anti-aliasing filters used during Phase 3 testing, the amplitude of the fourth harmonic is attenuated, and additional harmonics would be significantly attenuated. Figure 3.64 shows the time history of the strains recorded on the right and left links during this event.

- 6) During episodes of braking with sustained oscillations, the links exhibited oscillations of strain at a frequency of 187 Hz with strong harmonic content [Section 3.3.7, Figure 3.63].

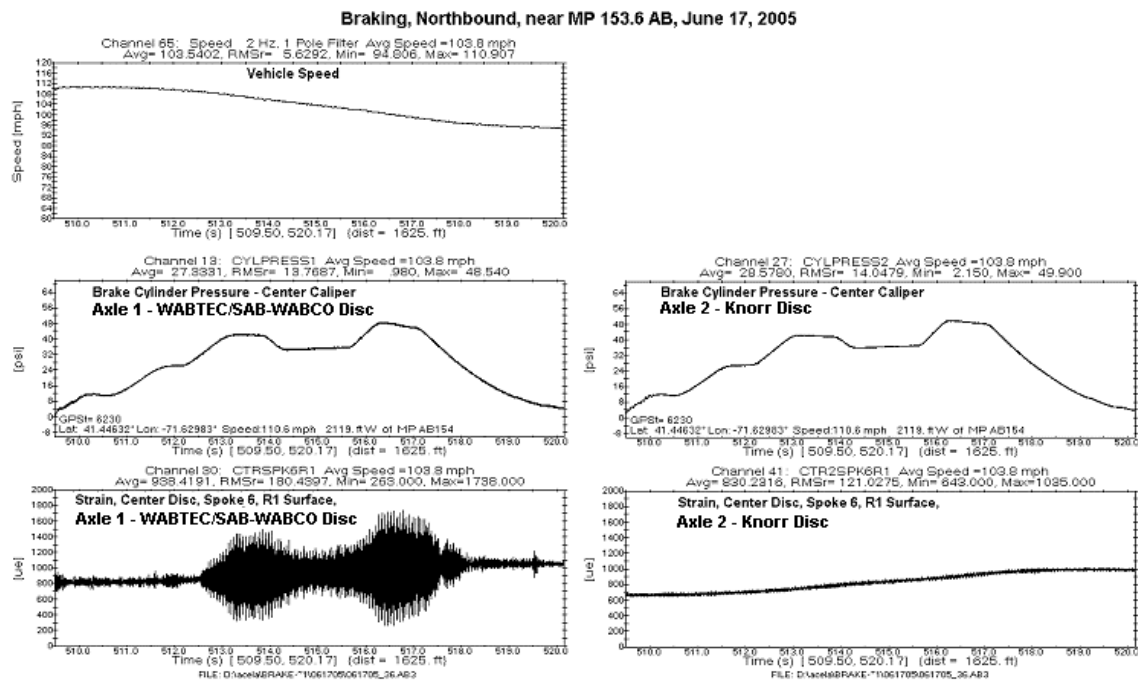
**Figure 3.65. Brake Cylinder Pressure and Strains Recorded on Side of WABTEC/SAB-WABCO Supplied and Knorr Brake Disc Spokes During Short Case of Sustained Oscillations (File 061705\_36.AB3)–June 17, 2005**

As illustrated in Section 3.1.6, brake cylinder pressure has a direct effect on the amplitude of the sustained oscillations of BOP strains in the brake applications in which they are observed. This trend was evident in data collected during the third phase of testing as well. Figure 3.65 illustrates the brake cylinder pressure variation and the strains on the sides of spoke 6 from each brake disc recorded on June 17 near MP AB 154 during a short exhibition of oscillations.

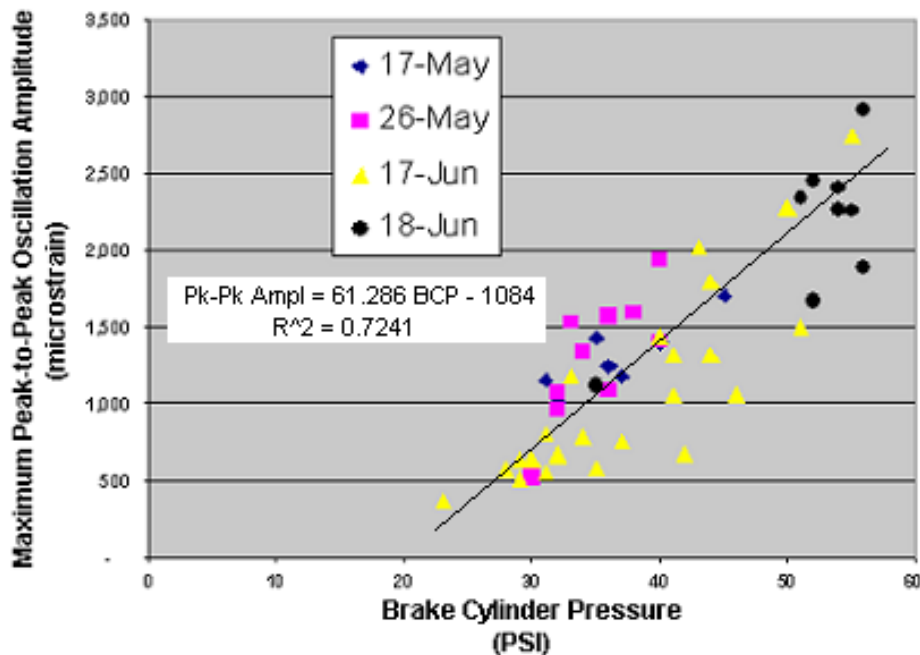
**Figure 3.66. Relationship of Peak-to-Peak Sustained Oscillations to Brake Cylinder Pressure, Data Collected Throughout Test Effort**

In general, testing on June 17 and 18 provided the largest peak-to-peak sustained oscillations observed during testing. Figure 3.66 shows the distribution of the maximum peak-to-peak sustained oscillations observed during Phase 3 testing as a function of the highest brake cylinder pressure realized during the brake application. Figure 3.66 also provides corresponding information from results collected during the first two phases of testing.

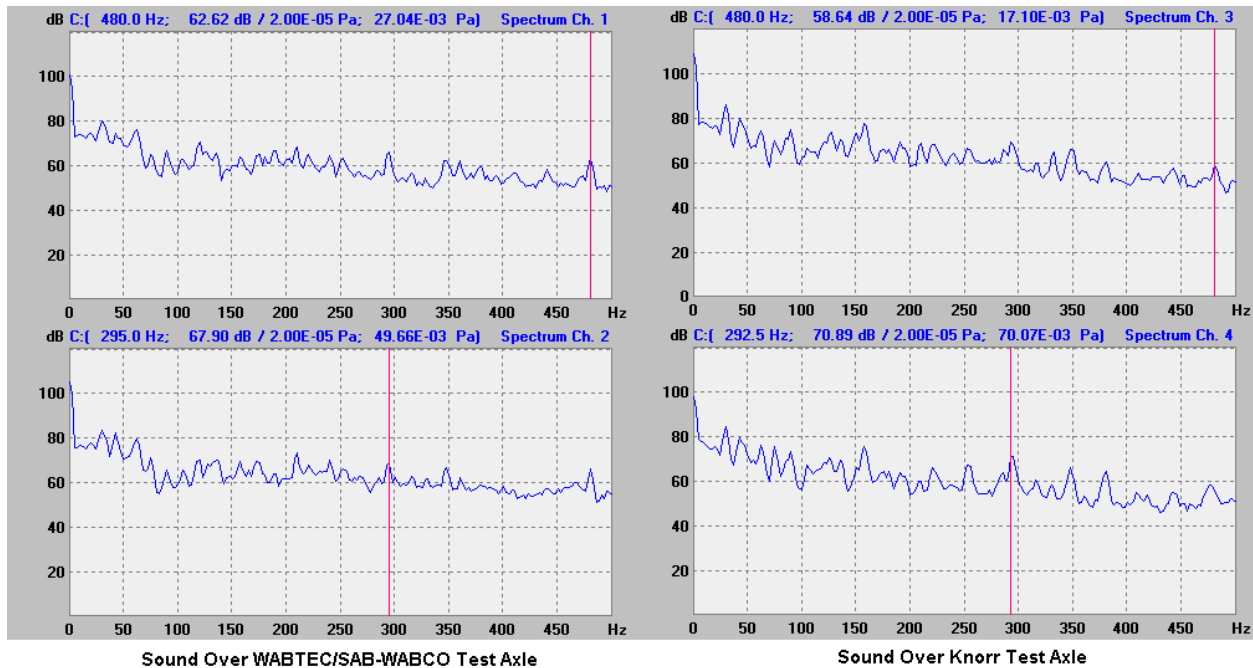
**Figure 3.67. Analysis of Sound Recorded Over Both Test Axles During Mild Case of Sustained Oscillations on WABTEC/SAB-WABCO Supplied Disc During Braking Near MP AB 179–June 17, 2005**

Figure 3.67 illustrates the frequency analysis of sound measurements collected while the center WABTEC/SAB-WABCO supplied brake disc was exhibiting mild BOP strains during a brake application near MP AB 179 on June 17. Recordings were made over both the WABTEC/SAB-WABCO and Knorr test axles. As was the case with data presented in Section 3.2.6, the sound level expressed in decibels is plotted as a function of the frequency associated the particular component of the sound.

Within this recording, it was difficult to identify any particular dominant component of sound in any of the channels. No frequencies that present themselves are consistent with other frequencies that have become evident throughout the test effort. Analysis of sound measurements collected during Phase 3 testing did not provide any useful information.
