U.S. Department  
of Transportation

**Federal Railroad  
Administration**

# Investigation of Cracks in Acela Coach Car Brake Discs: Test and Analysis Volume I - Final Report

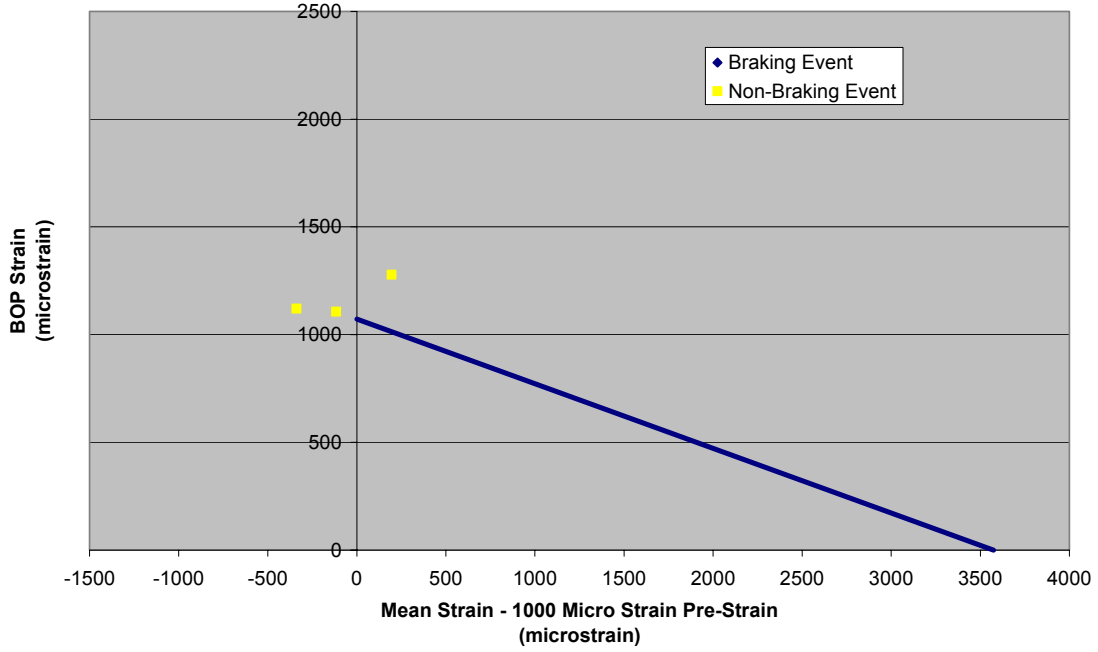
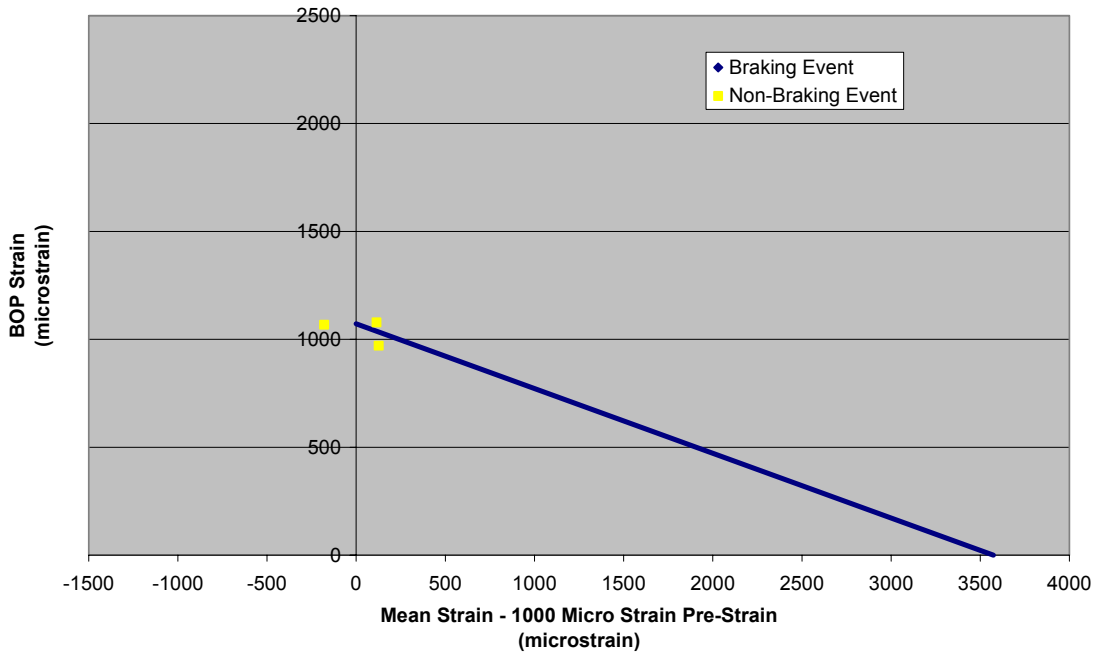
**Figure 3.68. Mean Strain versus Alternating Strain, Center and Outer WABTEC/SAB-WABCO  
Supplied Brake Discs, Spoke 6–May 16, 2005**

Figures 3.68 through 3.73 illustrate the occurrences identified in the analysis. Each figure contains two plots, one for the strains recorded on each spoke considered during a particular test. The results from a given test are contained within the same figure. Each plot is comprised of the alternating (BOP) strains plotted against the mean (tensile) strains. No plots are provided for strains recorded on the Knorr disc. Only those points approaching the Goodman line are provided on the graph in order to focus on the cases that have an implication of fatigue life of the material. Although plots provided in Figures 3.68 through 3.73 are typically presented in terms of stress, the illustrations provided here are in terms of strain because strains have been referenced throughout this report. Appendix G further addresses the presentation of this data in terms of strain, and not stress.

It is important to remember that the peak strain levels recorded during the test do not necessarily occur when either the BOP strains or mean strains are at a maximum. The peak stress level occurs when the sum of the BOP and mean strain is a maximum. For instance, a BOP strain of 1,700 microstrain and a mean strain of -500 microstrain produce a strain level of 1,200 microstrain. A similar strain can occur with a BOP strain level of only 1,000 microstrain but with a mean strain level of 200 microstrain.

The most activity is observed to have taken place during Phase 3 testing. Again, the high number of points on the Goodman diagrams are likely due to the number of brake applications in rapid succession that were made on the last 2 days of testing. Brake applications made in rapid succession resulted in the heating of the discs, therefore creating higher mean, or tensile, strains. Alternating strains due to sustained oscillations or impacts will be plotted towards the right within the Goodman diagrams, thus creating more points plotted on the diagrams.

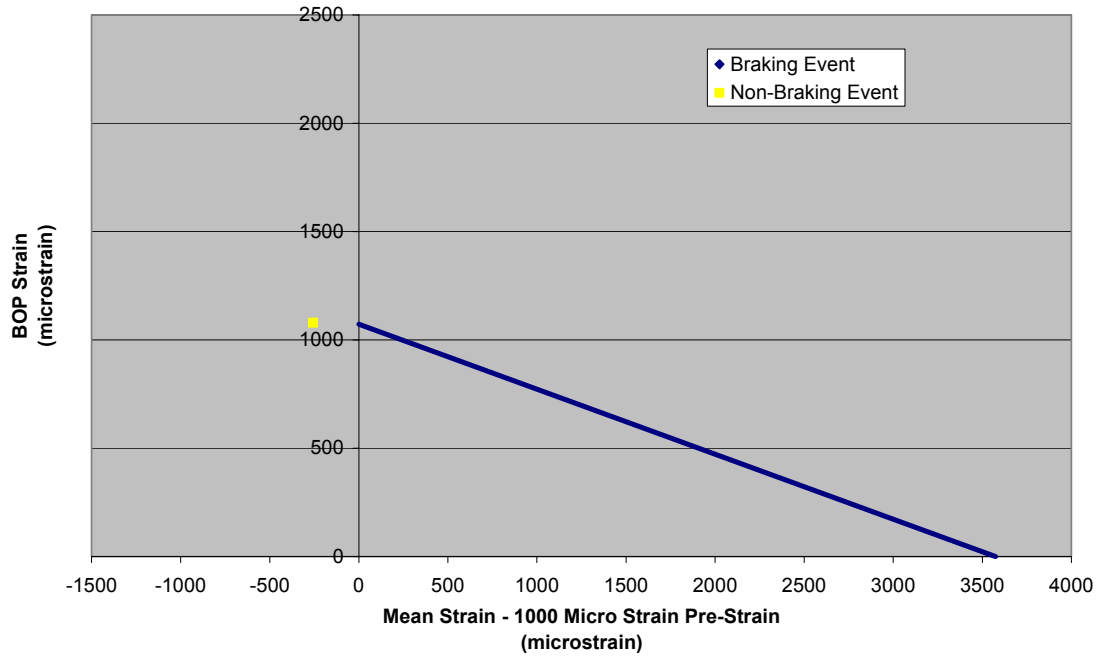
**Figure 3.69. Mean Strain versus Alternating Strain, Center and Outer WABTEC/SAB-WABCO  
Supplied Brake Discs, Spoke 6–May 17, 2005**

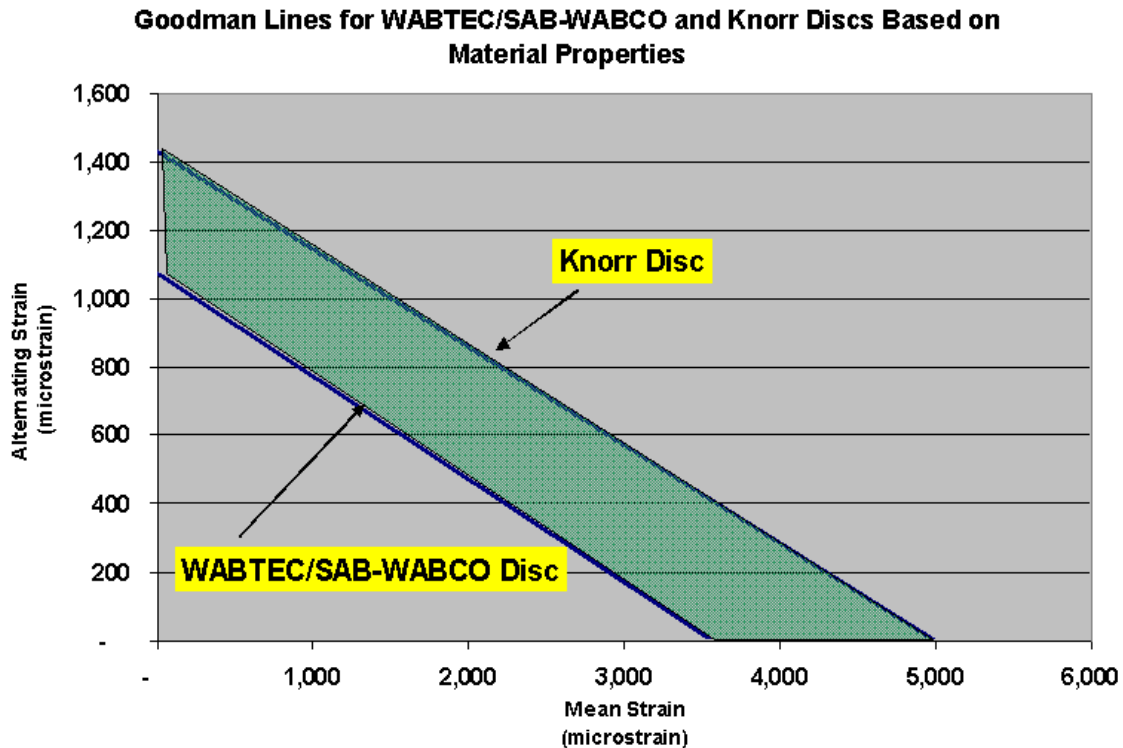
**Figure 3.74. Comparison of Goodman Lines for WABTEC/SAB-WABCO Supplied and Knorr Brake Discs**

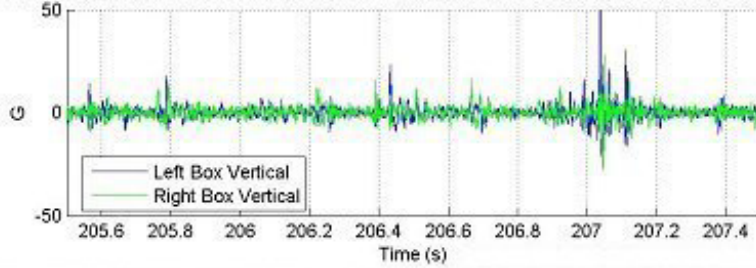
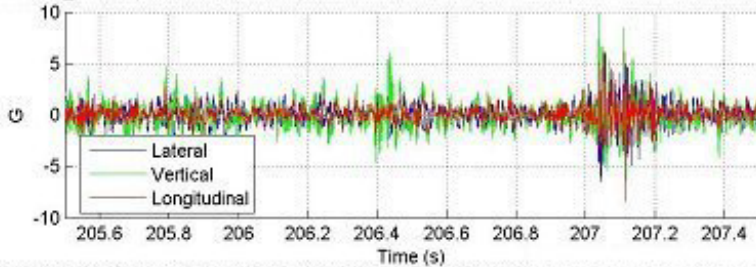
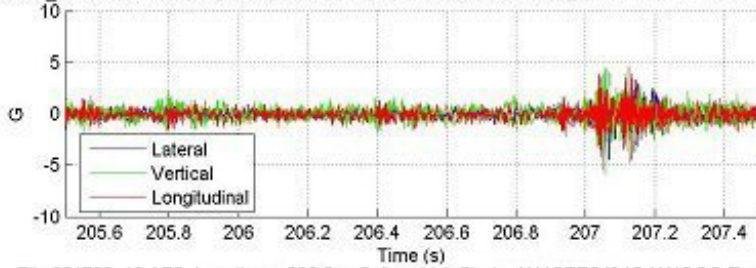
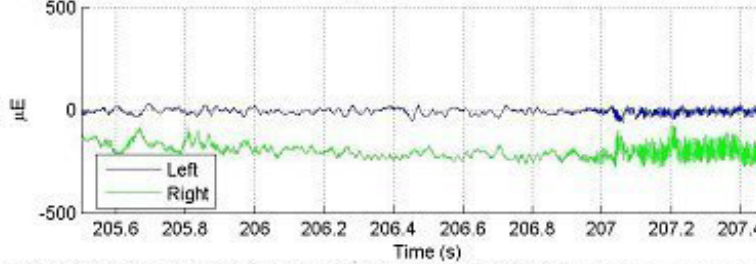
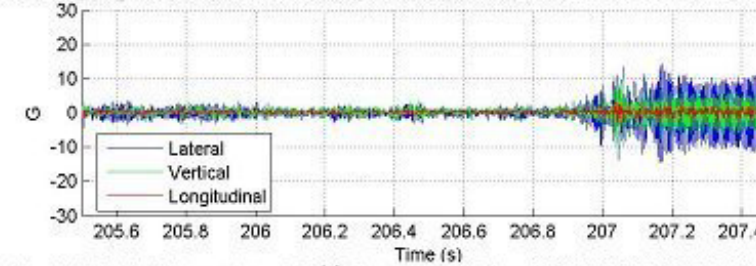
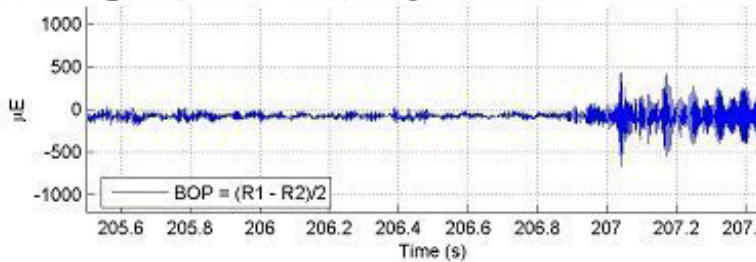
**Figure 3.75. Inception of Sustained Oscillations During Braking, Near MP AP 3.5 (File 061705\_10.AB3)– June 17, 2005**

Notes:  
Speed=85 MPH  
Initial Temp=169.2 °F

BOP Activity Starts t~206.9 s  
Vertical Shock t~207.4 s

- It appears that vertical shocks from the track can play a role in the development of the sustained oscillations during braking. Considering the event in Figure 3.75, clearly BOP strains and caliper pad motion have started before  $t \sim 207$  seconds, but the vertical shock measured at  $t \sim 207.05$  seconds appears to coincide with an increase in the amplitude of the BOP strain oscillation that continues to grow. The event that is depicted in Figure 3.78 shows that the BOP strain oscillations, the caliper pad motion, the strains in the caliper links, and the accelerations measured on the brake mounting tube all begin to show increased activity at the time that a vertical shock is measured on the test axle. The

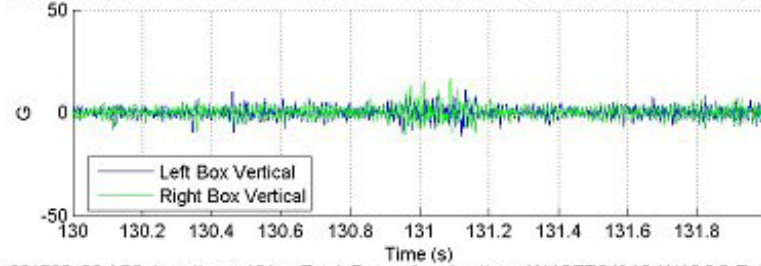
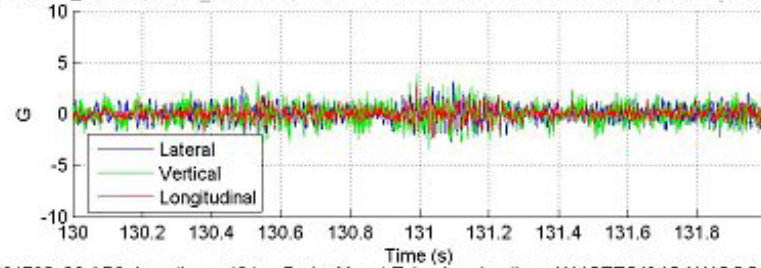
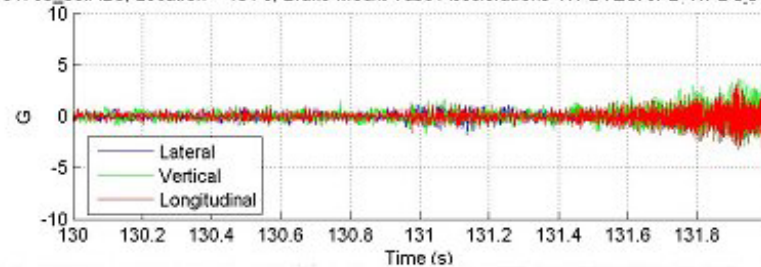
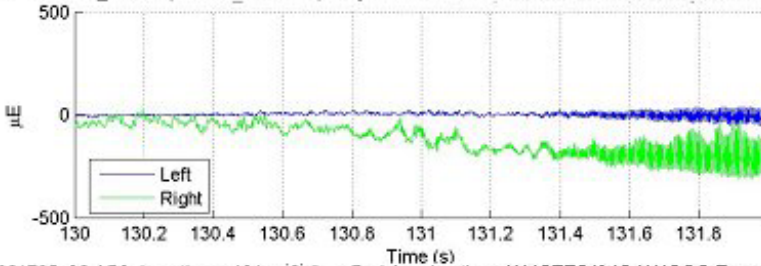
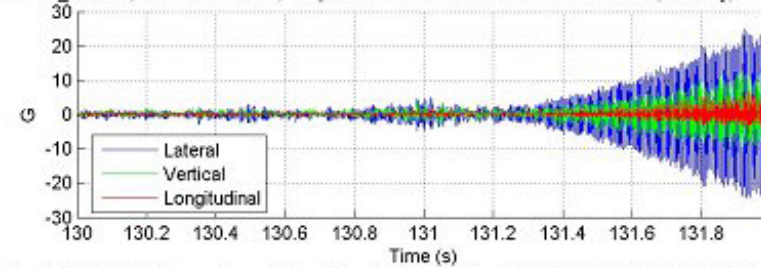
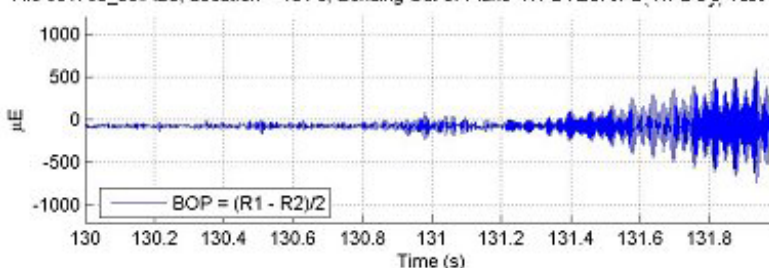
**Figure 3.76. Inception of Sustained Oscillations During Braking, Near MP AB 143 (File 061705\_36.AB3)– June 17, 2005**

Notes:  
Speed=107 MPH  
Initial Temp=222.3 °F

BOP Activity Starts  $t \sim 131.2$  s  
Small Vertical Shock  $t \sim 131$  s,  
but effects appear to die out  
before  $t \sim 131.2$  s

- It does not appear, however, that vertical excitation from the track is necessary to start the oscillations of the brake disc. In Figure 3.76, one can see the effects of a disturbance in the track at  $t \sim 131$  seconds on the brake disc, but this behavior appears to die out by  $t \sim 131.2$  seconds. The disc begins to display signs of increasing BOP strains at  $t \sim 131.3$  seconds, after the original activity has subsided. Inspection of Figure 3.77 shows that very little vertical activity is measured on the test axle, but the BOP strains in the brake disc have been initiated at  $t \sim 32.2$  seconds and continue to grow.

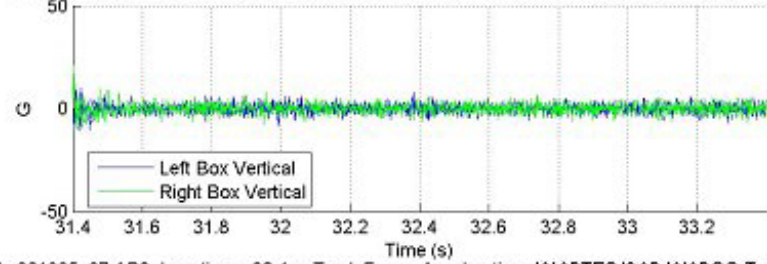
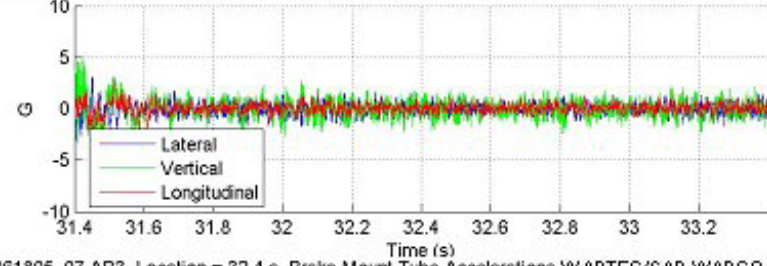
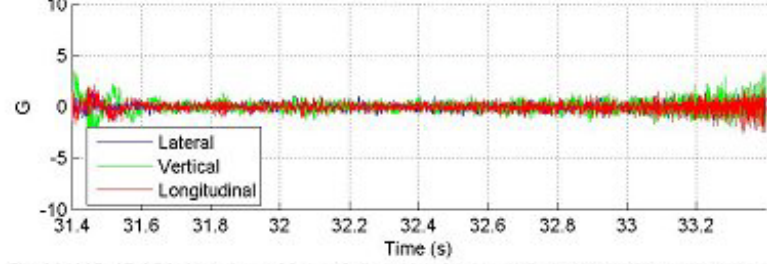
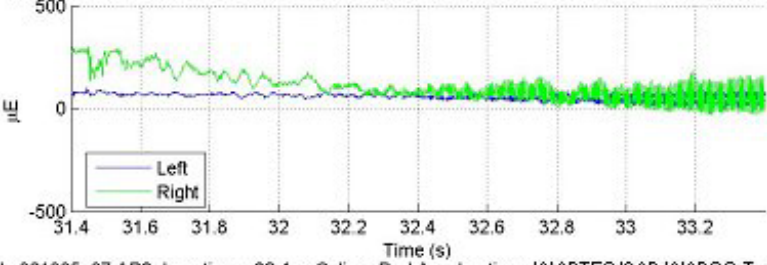
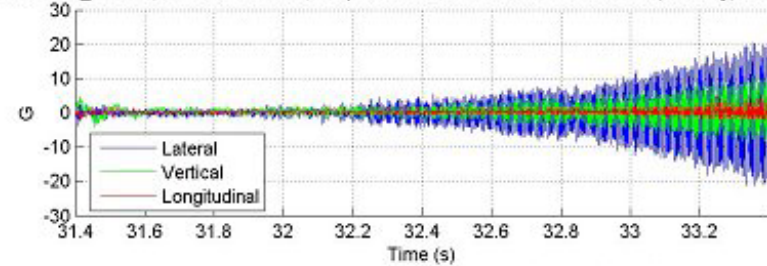
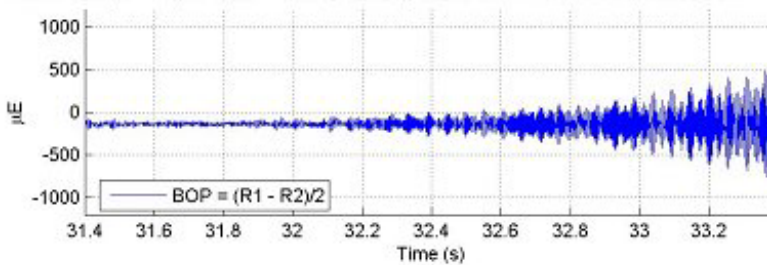
**Figure 3.77. Inception of Sustained Oscillations During Braking, Near MP AB 159 (File 061805\_07\_AB3)– June 18, 2005**

Notes:  
 Speed=120MPH  
 Initial Temp=249.6 °F

BOP Activity Starts t~32.1 s  
 No Excitation from Track

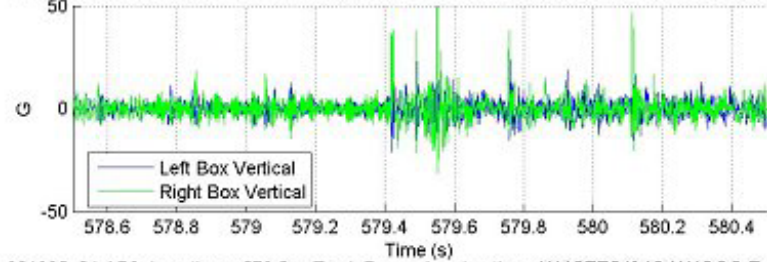
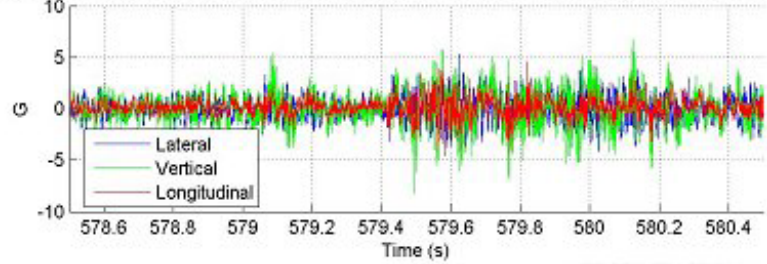
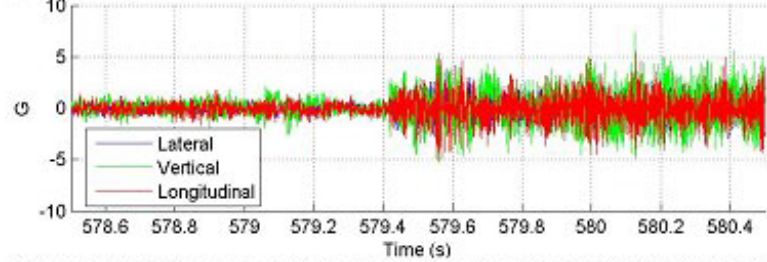
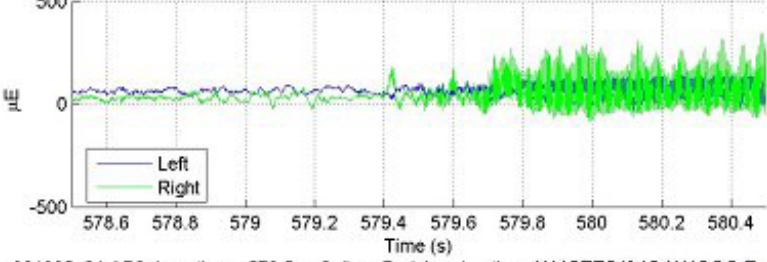
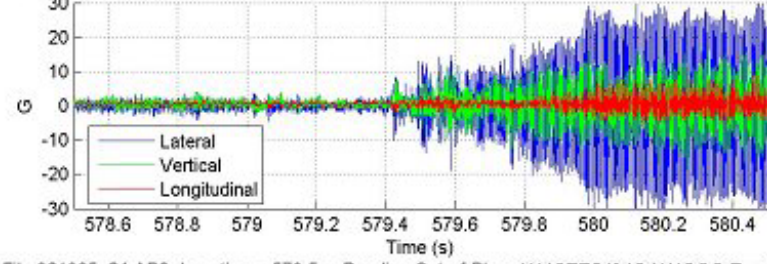
Notes:  
Speed=133 MPH  
Initial Temp=226.7 °F

BOP Activity Appears to Start at Same Time as Vertical Shock

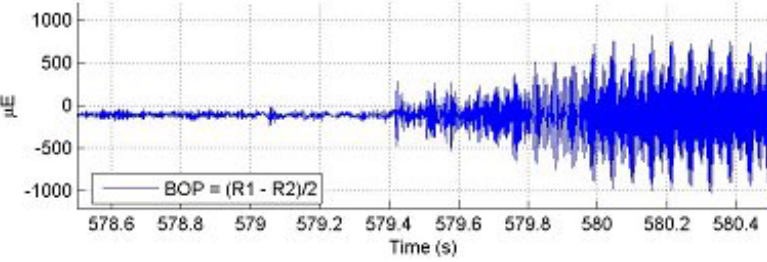
**Figure 3.78. Inception of Sustained Oscillations During Braking, Near MP AN 55 (File 061805\_24.AB3)– June 18, 2005**

File 061805\_24.AB3, Location = 579.5 s, Bending Out of Plane W/ABTEC/SAB-W/ABCO Test Axle
