**Demonstration Project No. 84-75
June 2000**

FIELD EVALUATION REPORT

**Non-Destructive Evaluation of the Thickness
of Linings and Pavements in Two Tunnels Using
Ground Penetrating Radar**

**Morton Mountain and Chimney Tops Mountain Tunnels
in the
Great Smoky Mountains National Park**

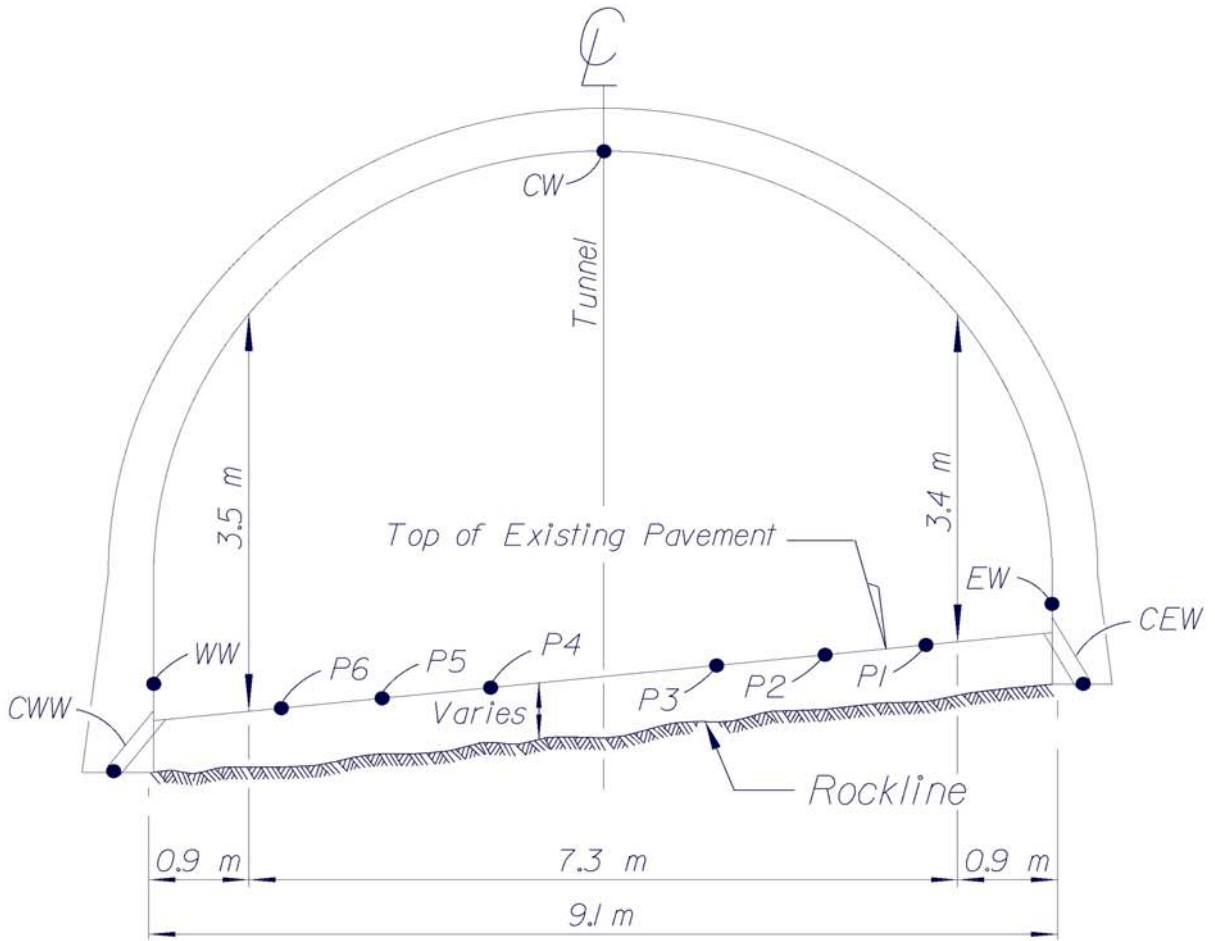
Figure 4A. Existing typical section through Morton Mountain Tunnel looking northbound toward Gatlinburg.

WW = Location of GPR pass on west wall.
 EW = Location of GPR pass on east wall.
 CW = Location of GPR pass on crown.
 CWW = Location of cores in west wall.
 CEW = Location of cores in east wall.
 P1 to P6 = Location of GPR passes on pavement inside tunnel.

Figure 4 shows section views of the tunnels indicating where radar survey passes were made on the walls (two passes), crown (one pass), and pavement (six passes) inside each tunnel and where cores were taken through the tunnel linings (two cores on each wall of both tunnels). Figure 5 shows the location of the radar passes on the approaches of each tunnel (six passes per approach) and the locations where cores were taken through the pavement inside each tunnel. In addition, one core was taken through the pavement in the Morton Mountain Tunnel to verify the results found by EFLHD. This core was taken adjacent to location B-3 in Figure 5A. All radar survey data were processed at a longitudinal interval of one meter. Results of the radar surveys and measurements made on the cores are discussed below.

GPR surveys were performed along six longitudinal lines in the driving lanes of each tunnel (see Figure 4). In each case, the survey initiated at the south end of the tunnel and continued along the entire length of the tunnel. The specific location of each GPR pass, when looking north, was as follows:

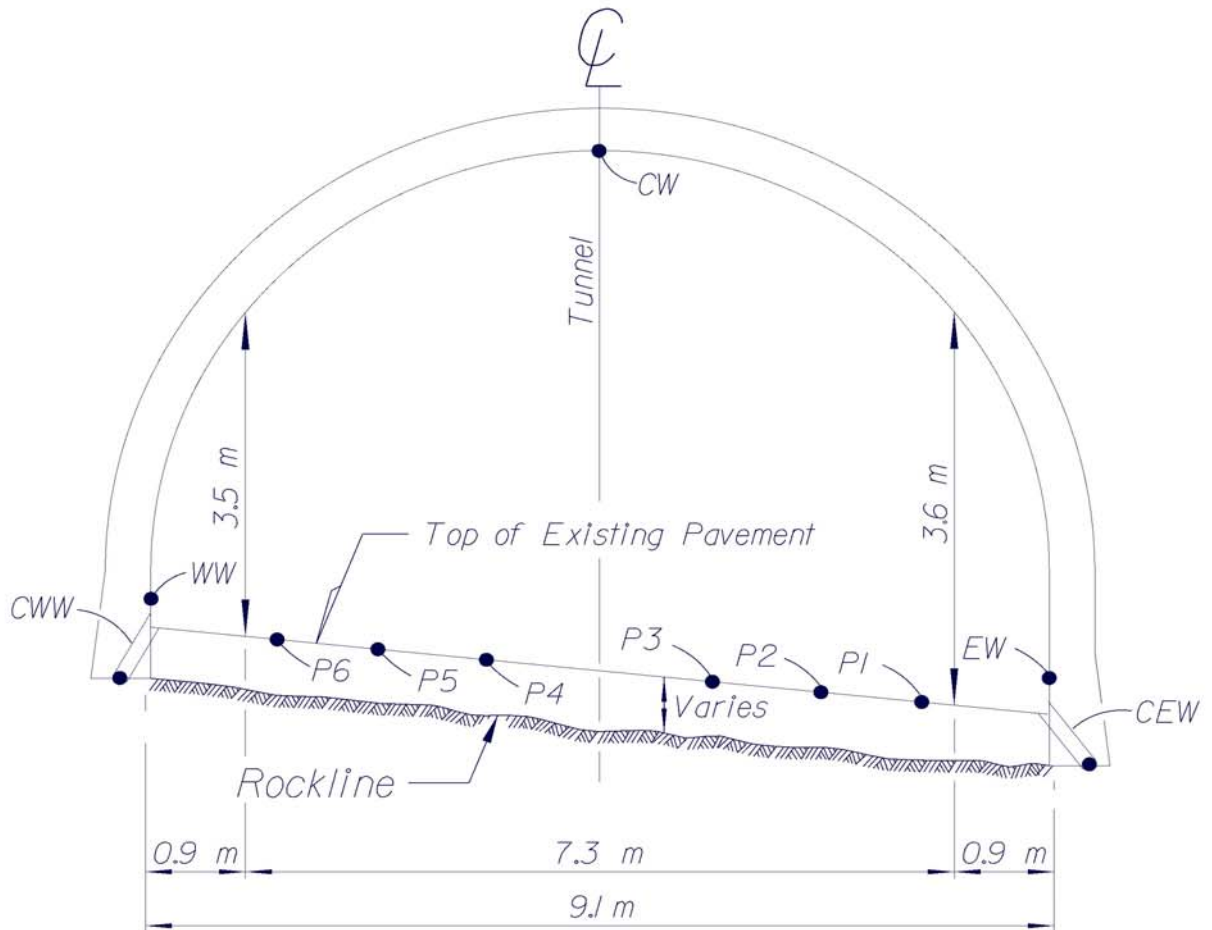
Figure 4B. Existing typical section through Chimney Tops Mountain Tunnel looking northbound toward Gatlinburg.

WW = Location of GPR pass on west wall.
 EW = Location of GPR pass on east wall.
 CW = Location of GPR pass on the crown.
 CWW = Location of cores in west wall.
 CEW = Location of cores in east wall.
 P1 to P6 = Location of GPR passes on pavement inside tunnel.

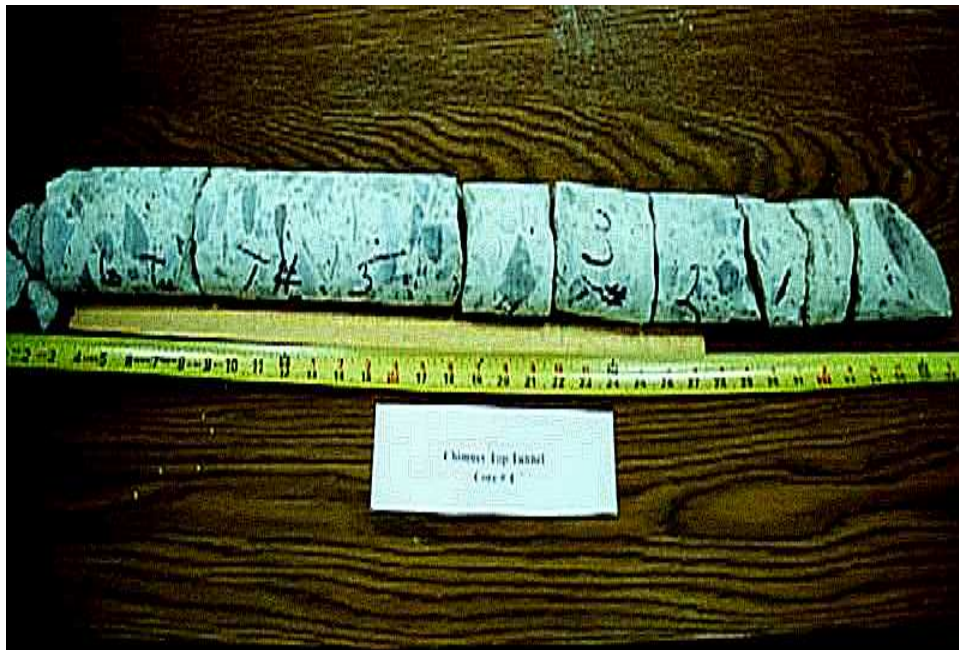
Figure 6. Typical core from the Chimney Tops Mountain tunnel.

3. The cores were extraordinarily long (ranging from 19 to 41 inches). A sample core is shown in Figure 6. Special coring rigs were rented and many problems were encountered with these. On several occasions, the rented equipment was found to be defective and had to be returned.
