Mine Safety and Health Administration  
Directorate of Technical Support  
Approval and Certification Center  
Mechanical Safety Division

Summary of Investigation

Eimco 915E Visibility Problem  
at Cottonwood Mine, Orangeville, Utah  
Technical Assistance No. TA-90-40

August 13, 1990

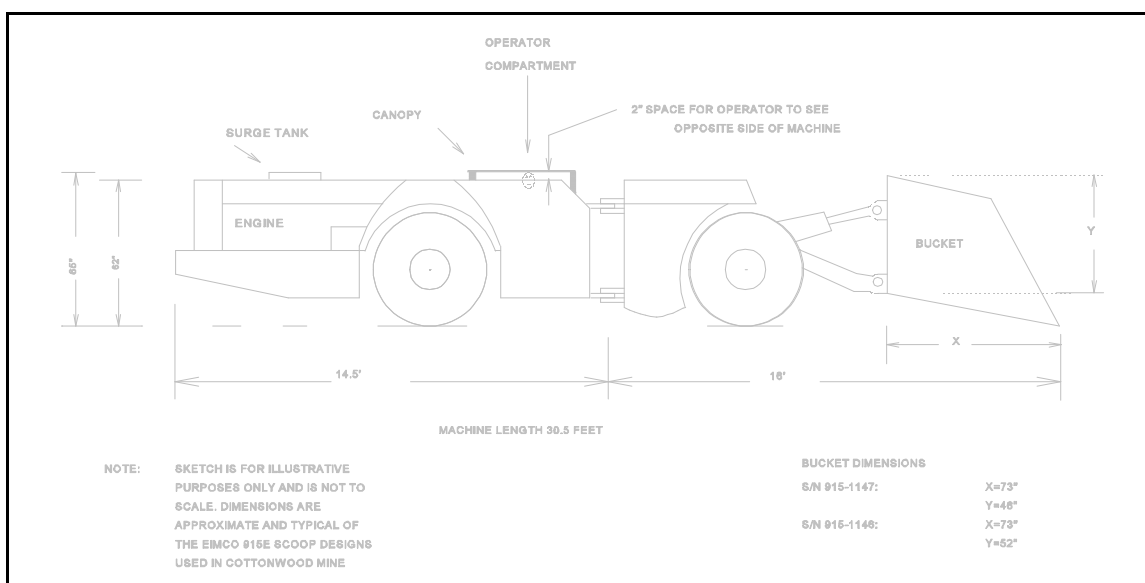
Dimensional measurements of the Eimco 915E Scoops, S/N's 915-1147 and 915-1146, were taken. The overall machine measurements are shown in Figure Nos. 1 and 2.

**Figure 1 – EIMCO 915E SCOOP SIDE VIEW**

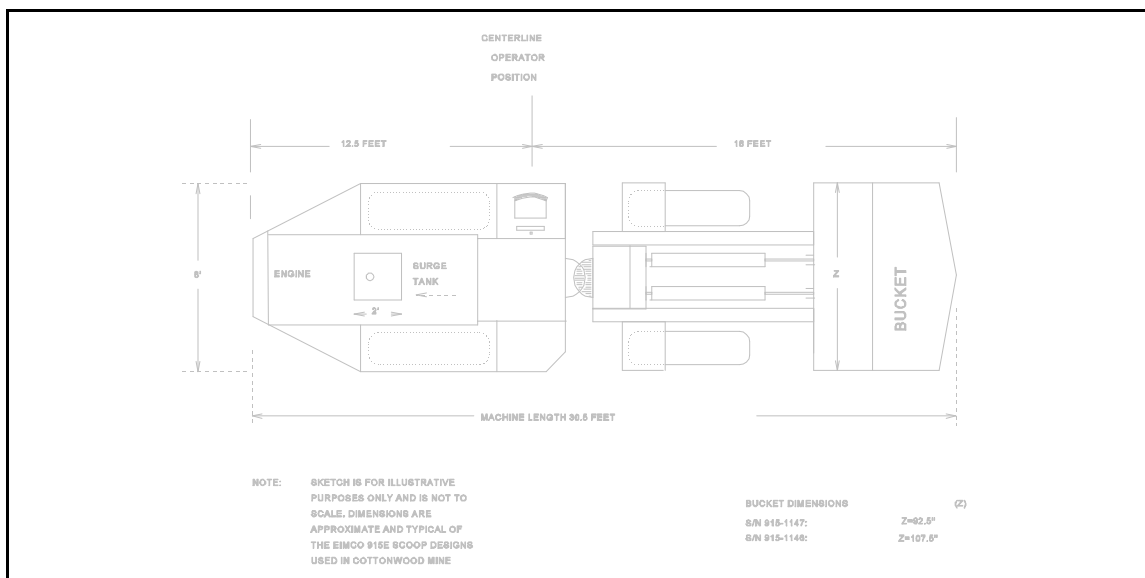
**Figure 2 – EIMCO 915E SCOOP TOP VIEW**

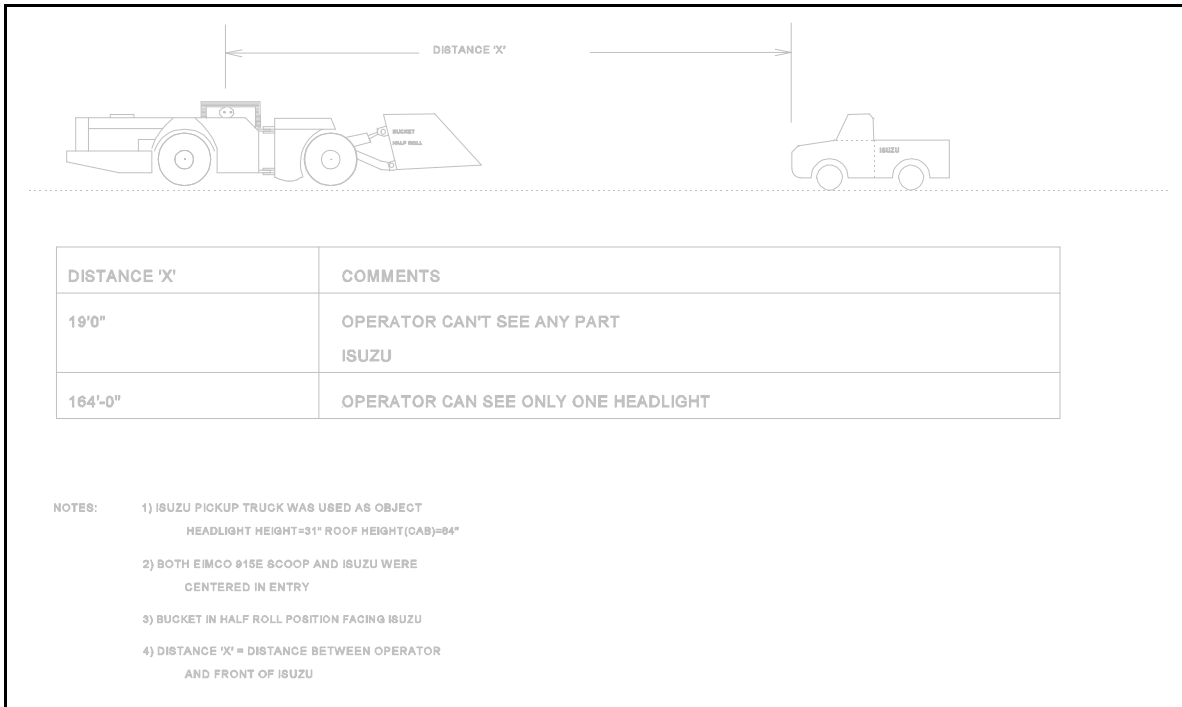
The location where the operator could see the direct beam of the headlights of the Isuzu pickup truck was established as a data point for the in-mine survey. The direct beams of the lights are the means reportedly utilized by mine personnel to identify the type of object based on their lighting arrangement and the location of the object. Reflections of light from the roof or ribs do not provide sufficient information to the scoop operator to allow him to identify the object or determine the distance to the object. For this survey, the area of inadequate visibility was considered to exist from the machine to the point where the operator could see the direct beam of the Isuzu pickup truck headlights which were located at a height of 31 inches above the ground. As shown in Figure Nos. 6-8, the areas where the pickup truck lights could not be seen ranged from 83 feet 6 inches to 164 feet from the operator, depending on the roll position of the bucket. The half roll position was the worst case for adequate visibility as shown by the distance of 164 feet.

Figure 7 – IN MINE BLIND SPOT SURVEY – BUCKET HALF ROLL

POSITION

4. The in-mine investigation showed that the operator could not adequately see the Isuzu pickup truck headlights at a range of distances of 55 feet to 269 feet from the operator. The worst case situation for operation in a straight section of the road was bucket forward in the half roll position. In this configuration, the operator could only see one headlight of the Isuzu pickup truck at a distance of 164 feet. The worst case situation overall was turning into a crosscut opposite the side of the operator. In this case, the Isuzu pickup truck was virtually invisible at any distance to the operator, except for reflections of the headlights off the roof and ribs.

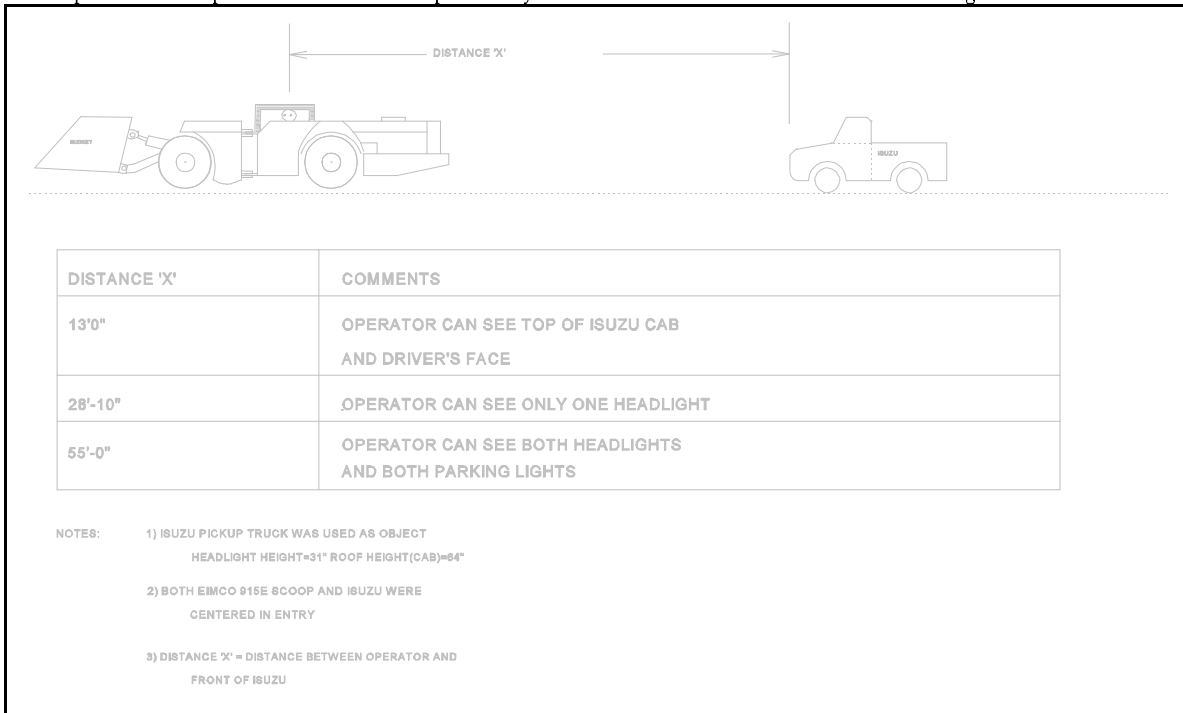
The second phase of this in-mine survey was conducted with the Isuzu pickup truck facing the engine end of the Eimco 915E Scoop. The same procedures described previously were used and the results are shown in Figure No. 9.

Figure 9 – IN MINE BLIND SPOT SURVEY – ISUZU CENTERED IN ENTRY FACING SCOOP ENGINE

As shown in Figure No. 9, the area of inadequate visibility was a distance of 55 feet from the operator when both vehicles were centered in the entry.

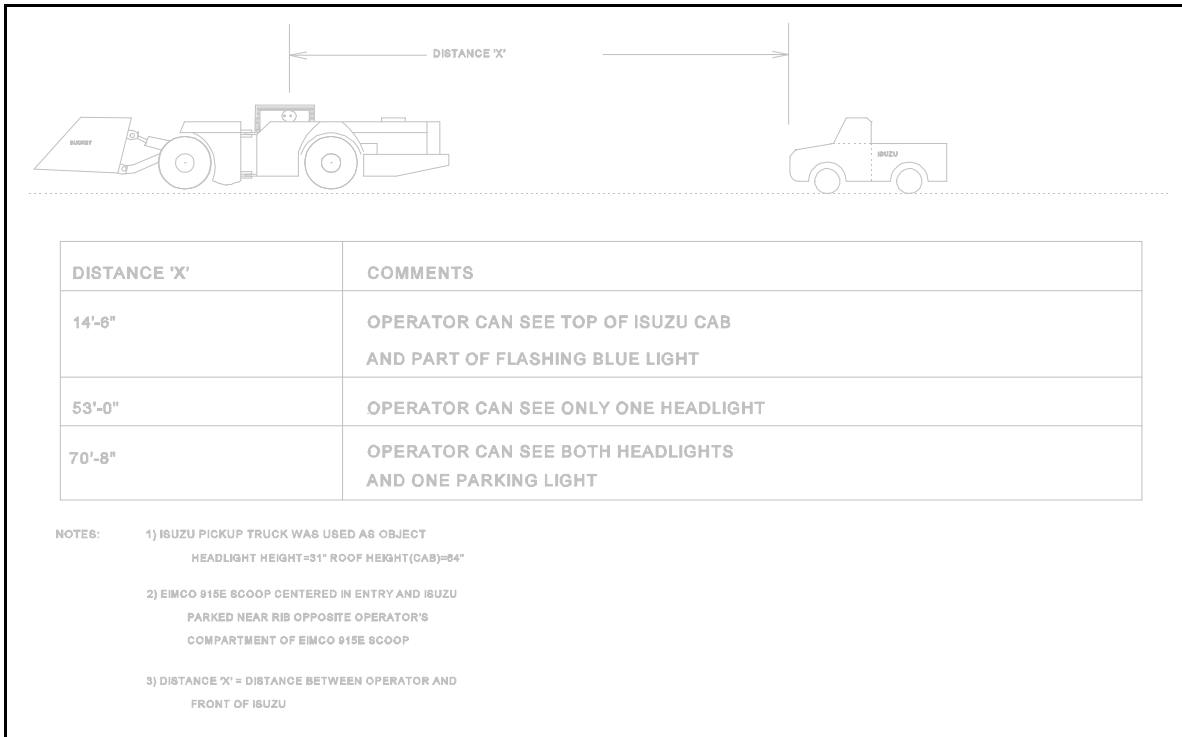
Since situations may occur where one vehicle may be off to the side of the entry, against the rib, a survey was conducted to determine the extent of the visibility problem in this type of situation. For this survey, the Eimco 915E Scoop was centered in the entry and the Isuzu pickup truck was located nearly against the rib, opposite the operator side of the scoop. The same procedures were used as previously described and the results are shown in Figure No. 10.

This part of the in-mine survey was similar to the above ground survey illustrated in Figure No. 5, where the 4-foot parallel distance from the side of the scoop was maintained and the distance from the operator to the point where he could see the 5'9" tall man's belt was determined. As shown by the results in Figure Nos. 5 and 10, the distance of approximately 71 feet, determined in both the above ground survey and the in-mine survey, corresponds very well for objects of similar height.

Figure 10 – IN MINE BLIND SPOT SURVEY – ISUZU NEAR RIB FACING SCOOP ENGINE

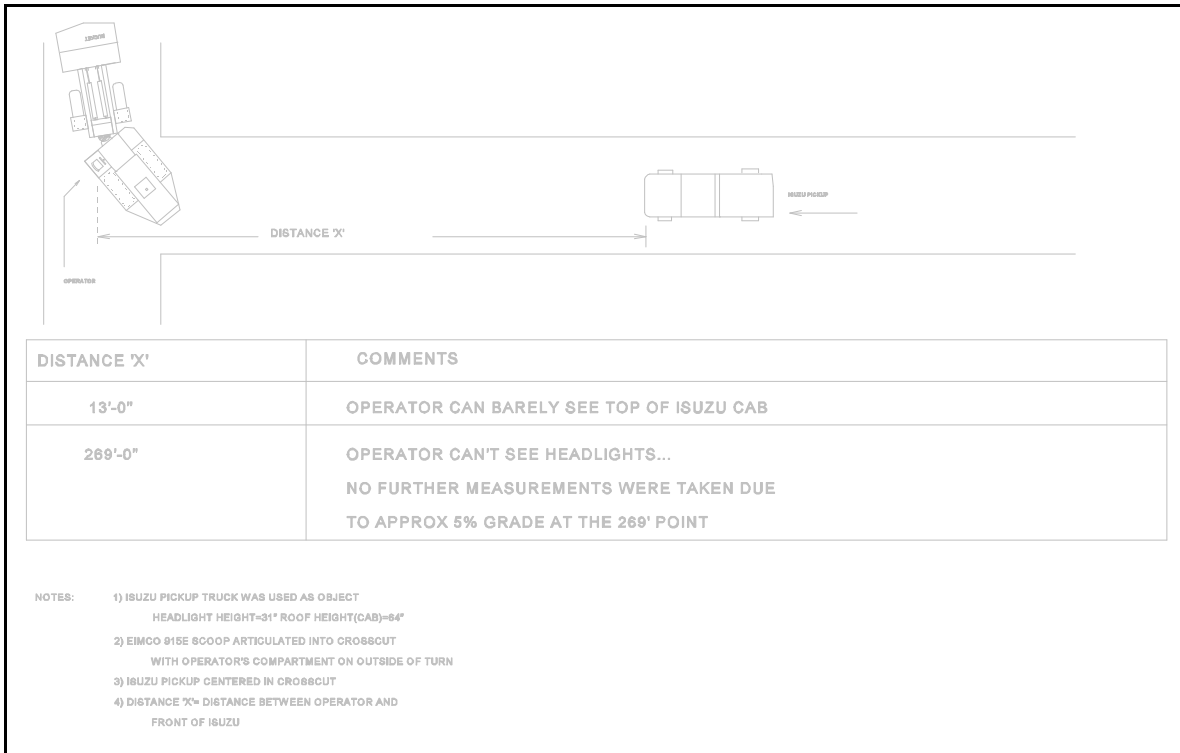
The final part of the in-mine survey was conducted to determine the extent of the visibility problem when the operator must turn the Eimco 915E Scoop into a crosscut opposite the operator's side of the machine. This survey was conducted by articulating the Eimco 915E Scoop into a crosscut, engine end first, until the operator's compartment was approximately centered in the crosscut. At this point, the Eimco 915E Scoop was parked and the Isuzu pickup truck was centered in the crosscut nearly against the engine end of the scoop. This is illustrated in Figure No. 11. The procedures previously described were used and the results are shown in Figure No. 11. From the initial location nearly against the scoop to the distance of 269 feet between the operator and the front of the Isuzu pickup truck, the pickup truck was virtually invisible to the operator. Only reflections of light off the roof and rib could be seen. This survey was not conducted beyond the point of 269 feet because the crosscut floor began to slope downward at approximately a five percent grade, and any data gathered would not have been representative of the other in-mine survey conditions.

Figure 11 – IN MINE BLIND SPOT SURVEY – SCOOP ARTICULATED INTO CROSSCUT
